Investigation of Cause of Cracked Stringer on the Blanchette Bridge

**UTC
R163**

INVESTIGATION OF CAUSE OF CRACKED STRINGER ON THE BLANCHETTE BRIDGE

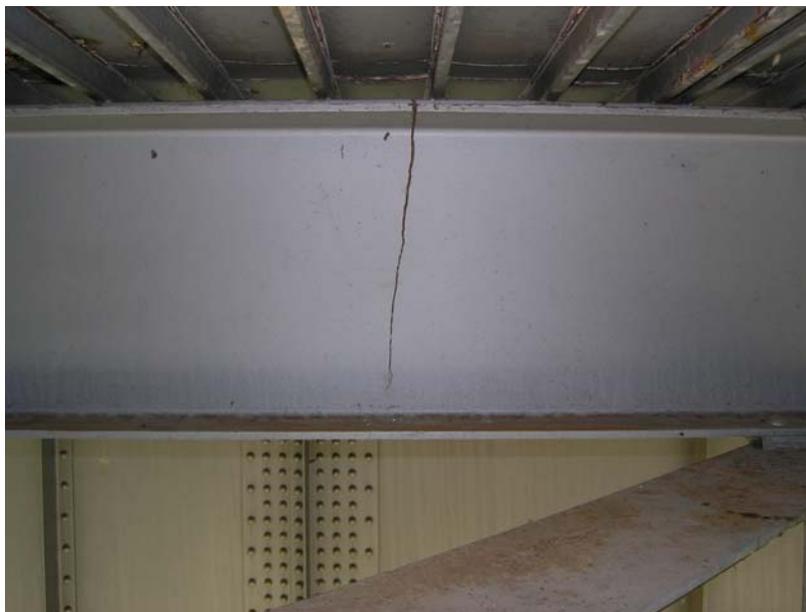
In 1999 and 2005, cracks were discovered in stringers on the bridge approach spans. The members cracked in a counter-intuitive fashion—from top to bottom at midspan between supports, where positive bending would be expected. The stringers were repaired with bolted splices. The Missouri Department of Transportation (MoDOT) worked with UMR to investigate the cause of these cracks.

Cracked stringer found during 2005 inspection (prior to repair).

1. The stringer cracking occurred at details that had very high stress concentration factors due to open shim butt joints with fillet welds crossing the joint.
2. Fatigue of the fillet welds due to traffic loading led to cracking of the weld material.
3. High negative bending stresses in the stringer resulted in cracking through most of the section after the weld crack propagated into the stringer.
4. The high negative bending stresses result from construction or temperature forces, or some combination of those, in addition to the effects of continuity on the stringer force distribution.
5. The redundancy and strength of the grid deck and stringers prevented serious distress or failure in the bridge deck.

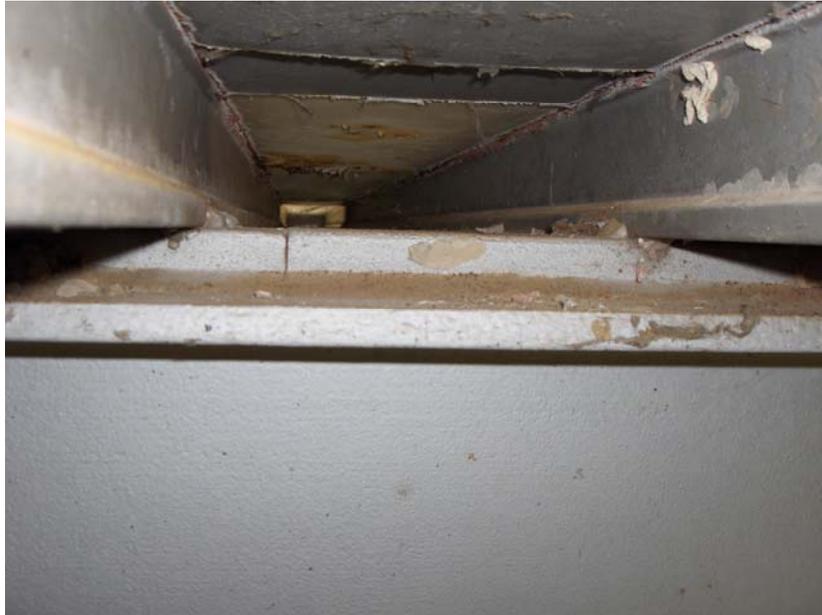
Shim plate and weld detail on stringer top flange.

The treatment of the fillet welds connecting the shim plate to the stringer top flange is a significant detail. Field inspection of the open butt joints in the shim plates showed that the fillet welds frequently were run across the gap between the shims. Field observations also show that the fillet welds are typically 3/8" to 1/2" in size, compared to the 1/4" size shown in the project drawings. The design drawings did not include a detail showing how the fillet weld should be treated at the butt joints in the shim plates.

The detail that led to the cracking was due to decisions made during the design and construction phases of the redecking project. A better understanding of the impact of replacing the original concrete deck with a grid deck, along with specific direction to the welders on how to terminate the shim plate fillet weld could have prevented this detail from occurring.

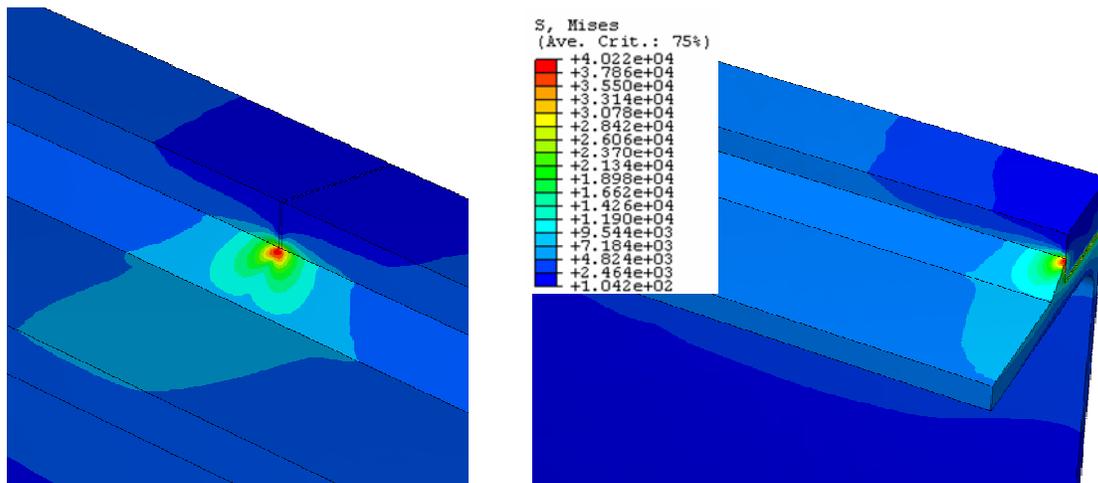
An approximate assessment of the fatigue life of the weld detail showed that if bending effects caused a net tensile stress at the shim plate butt joint, fatigue could cause cracking of the weld and stringer. A finite element analysis showed very high stress concentration at the butt joint, which can be seen in the graphical stress analysis results shown below.

Graphical rendering of stress analysis results at given negative bending moment.
*Sample contours of (a) Von Mises stress (in psi) at shim plate butt-joint and (b) thru-notch section view.
Note stress concentration at weld tip at notch location in red.

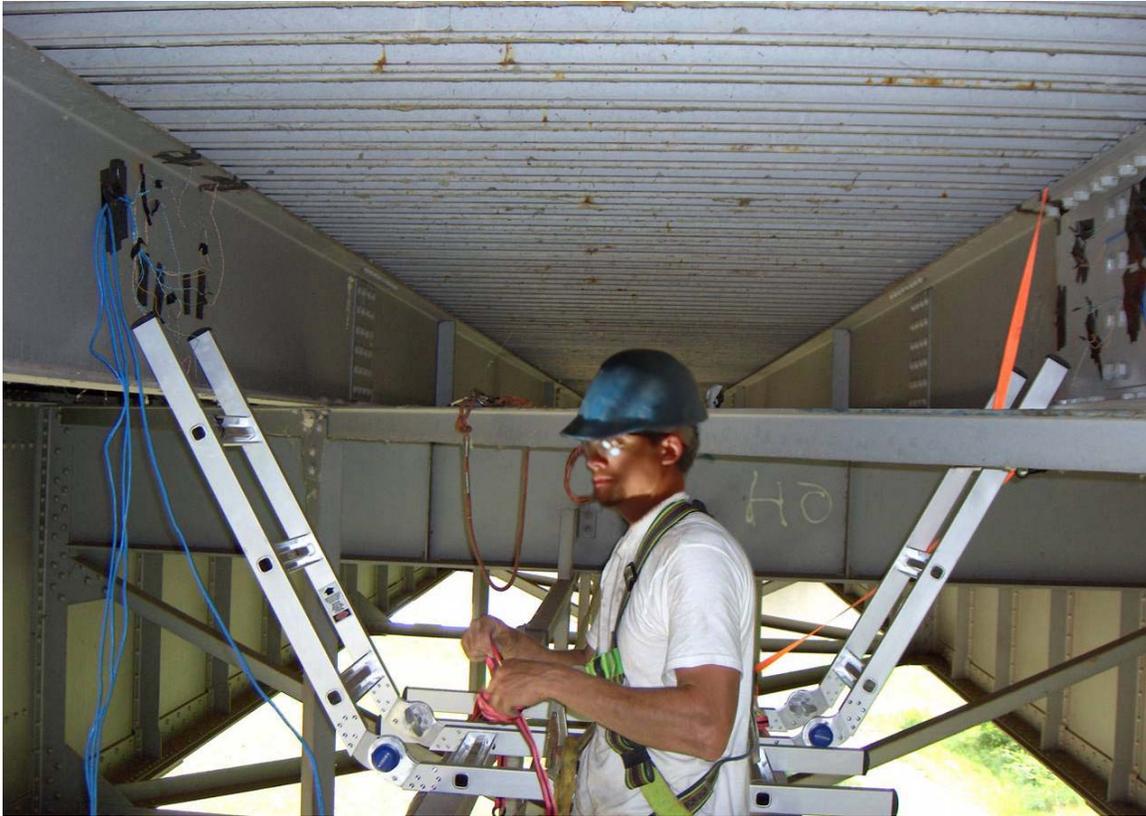
Field measurements of stringer stresses were taken over a several week period. These measurements showed that negative bending in the stringers occurred under live load. In addition, negative bending was caused in the stringers by thermal deformations in the grid deck due to day-night temperature cycling.

Strain gage installation.
