Investigation of Subsidence Along Segment of Missouri Route 65, Springfield, Missouri

Neil L. Anderson and Evgeniy V. Torgashov

**NUTC
R221**

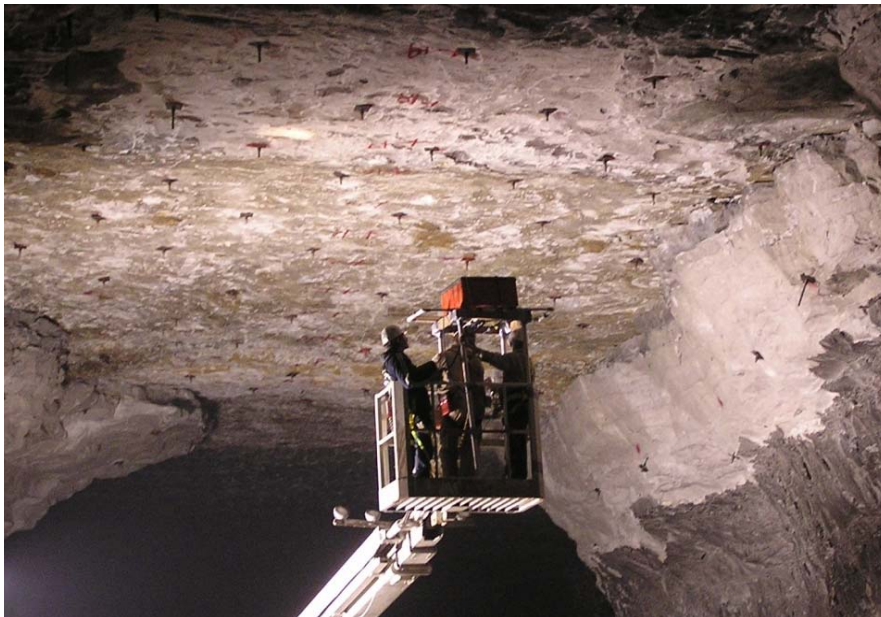
To prevent further rock fall, anchor bolts were installed immediately in the ceiling of the access tunnel (Figure 2). During the installation of the anchor bolts, workers encountered uniform Burlington-Keokuk limestone; there was no evidence of prominent clay-filled solution-widened fractures (Figures 2 and 3). However, water with entrained sediment flowed through several narrow fractures (estimated widths of less than 0.25 in) in the collapse zone (Figure 4). It was noted that the fractures through which water flowed were oriented east-northeast, rather than northwest (parallel to the projected lineament).

Figure 2: Photograph of ceiling of access tunnel several tens of feet to the west of the zone of failure. Newly installed rock bolts are observed. The crew is acquiring GPR data using a 200 MHz GSSI antenna in an effort to locate clay-filled solution-widened fractures.

The apparent relative uniformity of the roof rock immediately above the ceiling of the access tunnel is consistent with anchor bolt information and acquired ground penetrating radar (GPR) control. The workers who placed the anchor bolts reported relatively solid rock to depths of 10 ft at all anchor bolt locations. The interpretation of acquired GPR control also suggests the roof rock within 10 ft of the ceiling is not intensely karsted. On the GPR profile of Figure 7, a relatively uniform near-horizontal reflector (parallel to mine ceiling) is imaged at an estimated depth of about 10 ft (dielectric permittivity of 15 for moist limestone). Two less prominent vertical anomalies are observed centered at stations 39 and 46 (collapse zone). These anomalies appear to originate several feet from the mine ceiling and may be images of near-vertical fracture zones that are not prominently exposed on the mine ceiling.

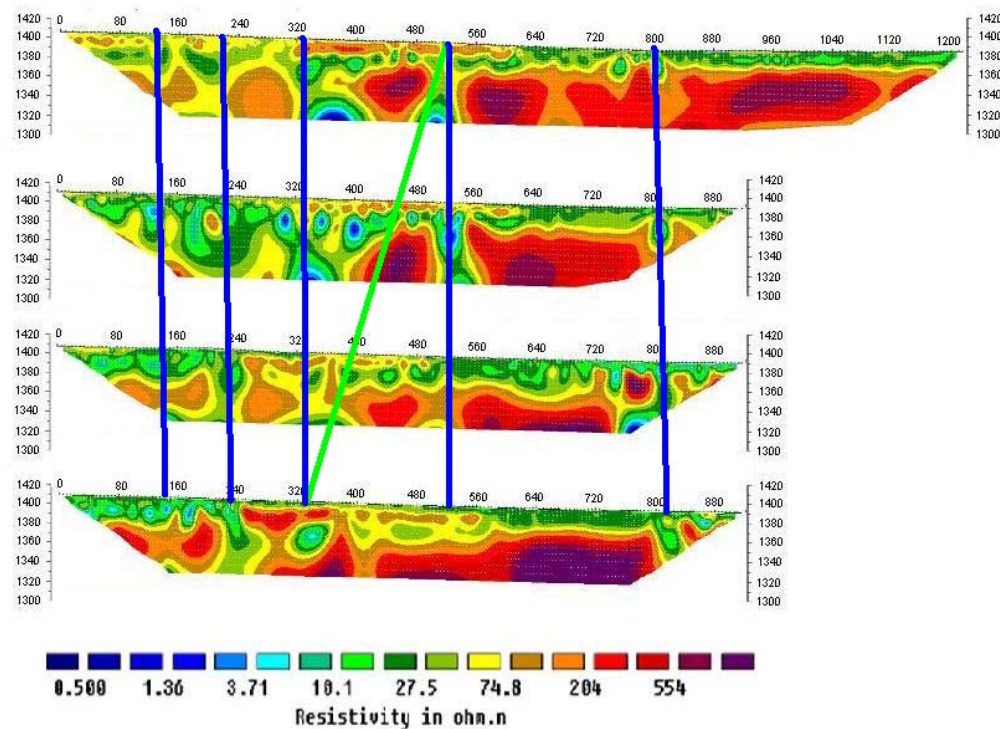
Figure 10: Interpreted ERT profiles (A-D; bottom to top; Figure 1). Several prominent interpreted solution-widened fractures (blue) and the projected lineament (green) have been superposed on the ERT profiles. Station 270 overlies the center of the mine access tunnel on all profiles.

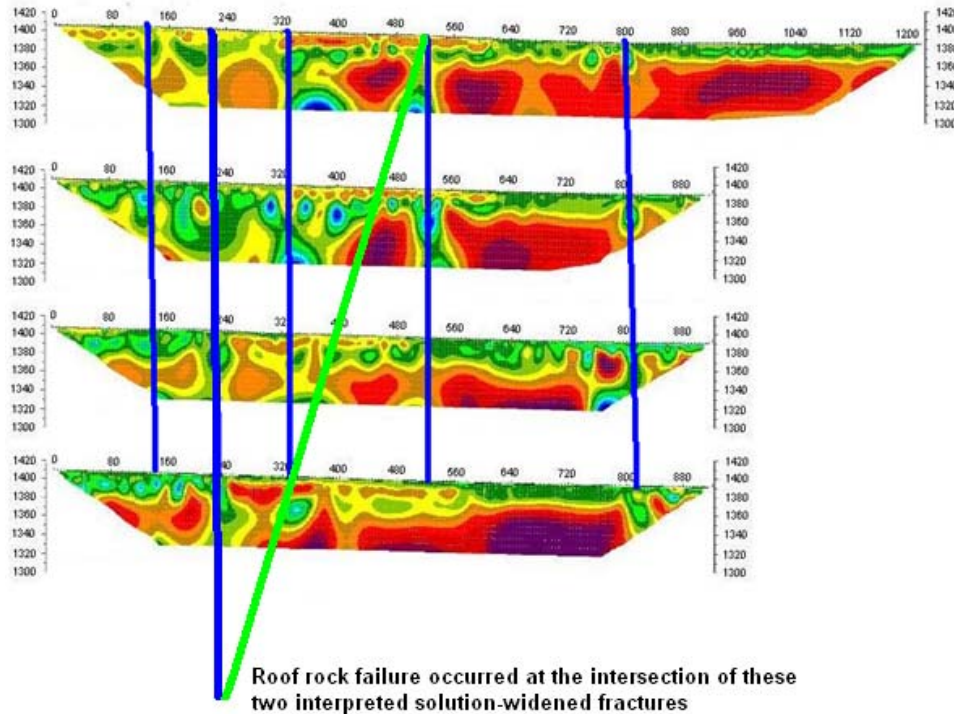
It is interesting to note that roof rock failure in the mine access tunnel occurred at the intersection of projected lineament and one of the more prominent interpreted solution-widened fractures (Figure 11), and speculate this zone was especially susceptible to failure. Similar observations have been reported by Robison and Anderson (2008).

Figure 11: Interpreted ERT profiles (A-D; bottom to top; Figure 1). Station 270 overlies the center of the mine access tunnel on all profiles. Roof rock failure in the mine access tunnel occurred at the intersection of the projected lineament (green) and one of the more prominent interpreted solution-widened fractures (blue).

Roof rock failure on the ceiling of the mine access tunnel appears to have occurred at the intersection of a two prominent solution-widened fractures: one trending northwest; one trending east-northeast. This intersection zone was probably most susceptible to failure.
