**An Investigation of Rock Fall
and Pore Water Pressure
Using LIDAR in
Highway 63 Rock Cuts**

Norbert Maerz

**NUTC
R364**

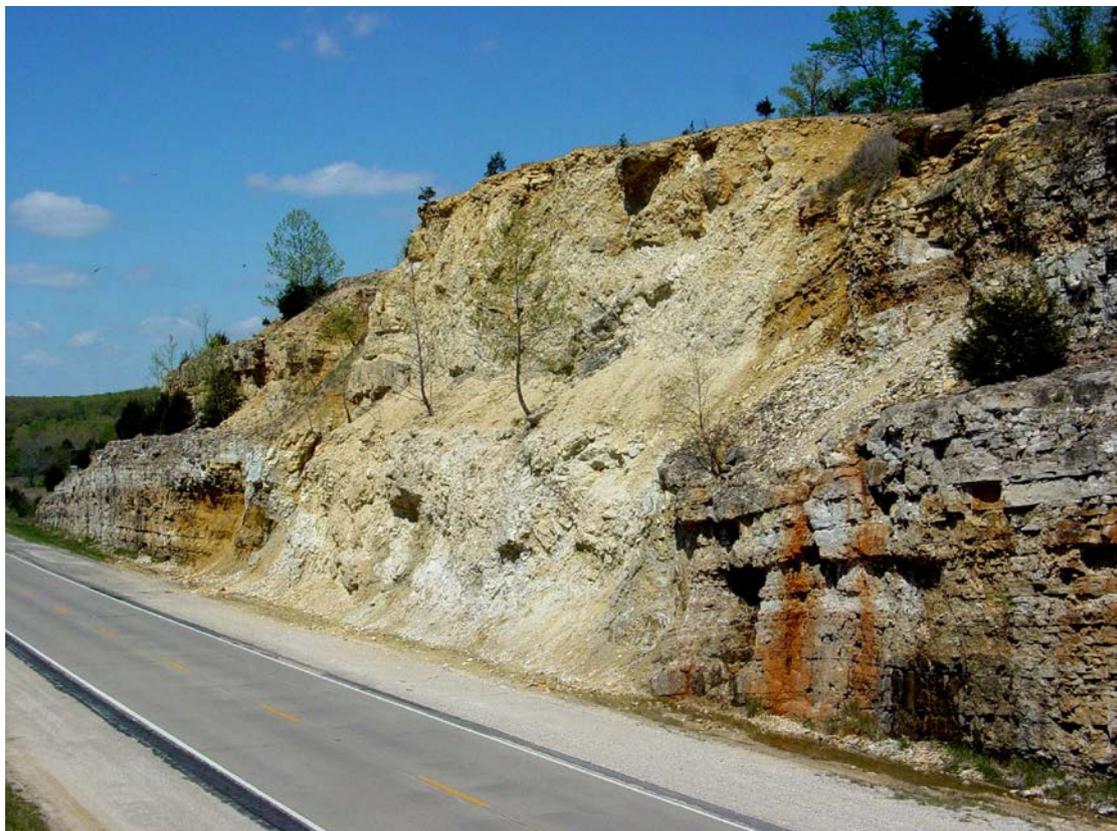
Two rock cuts were selected for this work along Highway 63 just north of Rolla (Figure 1). Site 1 (Figure 2) was located on a problematic rock cut that traverses across a filled sinkhole. This rock cut is constantly raveling and the ditches below this rock cut have been cleared of debris many times. Site 2 (Figure 3) was located just outside of a local operational quarry, where the seismic effects of blasting would contribute to rock fall. This location was chosen because there was evidence of both rock fall and groundwater leakage.

Figure 2: Site 1. This is a filled sinkhole that requires ongoing maintenance.

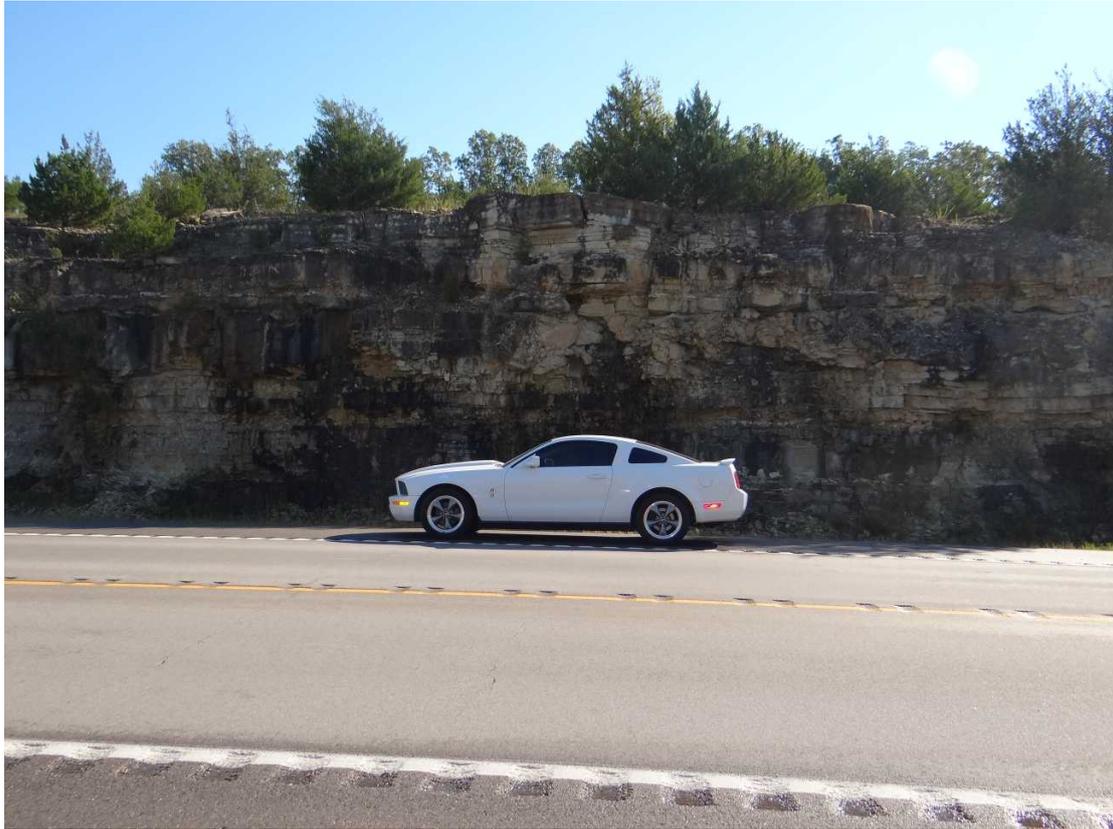
Figure 3: Site 2. Note the black stains on the rock indicating water flow.

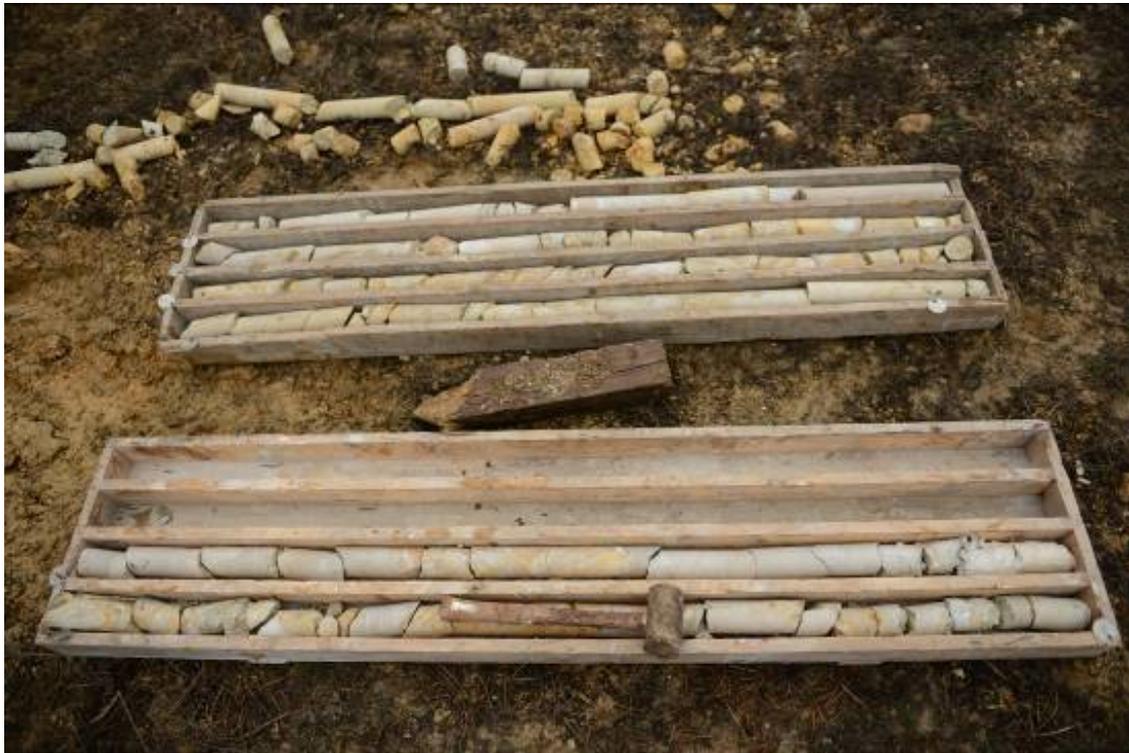
Figure 5: The rock core from Site 1.

0.4-5.4	13:55-14:05	5.0/5.0	0	46.78%	Main rock type is dolomitic. The color is from light grey to tan, highly weathered and highly fractured. There also some sandstone and clay seams. These sandstone seams and clay stone were found at depths of: 2ft, 5.5ft, 9ft, 11ft, 12.5ft, 15.4ft, 28ft, 31.5ft, 32.5ft, 33ft, 43ft, 48.5ft, 53ft, 58.5ft, 69ft.

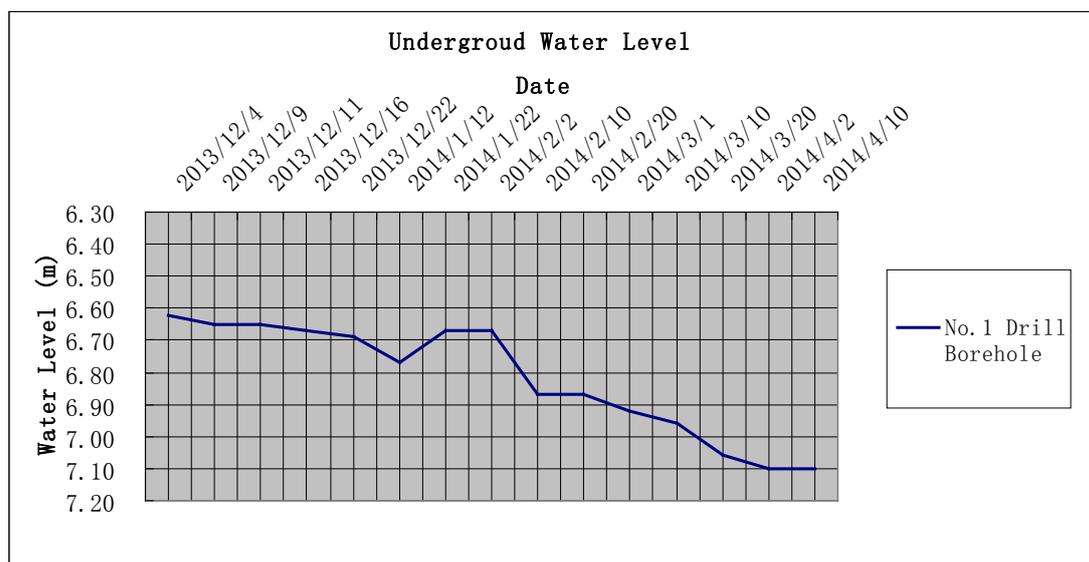
Water level measurements are made simply with a water level tape (Figure 7). Table 2 shows the water level in the piezometers. Table 2 shows the water level over the period of time of the study. In Table 3, we can find that the Boreholes 3, 4 and 5 are dry in most of time, and the variation in boreholes 1 and 2 is very small. Figures 8 and 9 show the water level as a function of time.

Figure 8: Underground water level in Borehole 1.

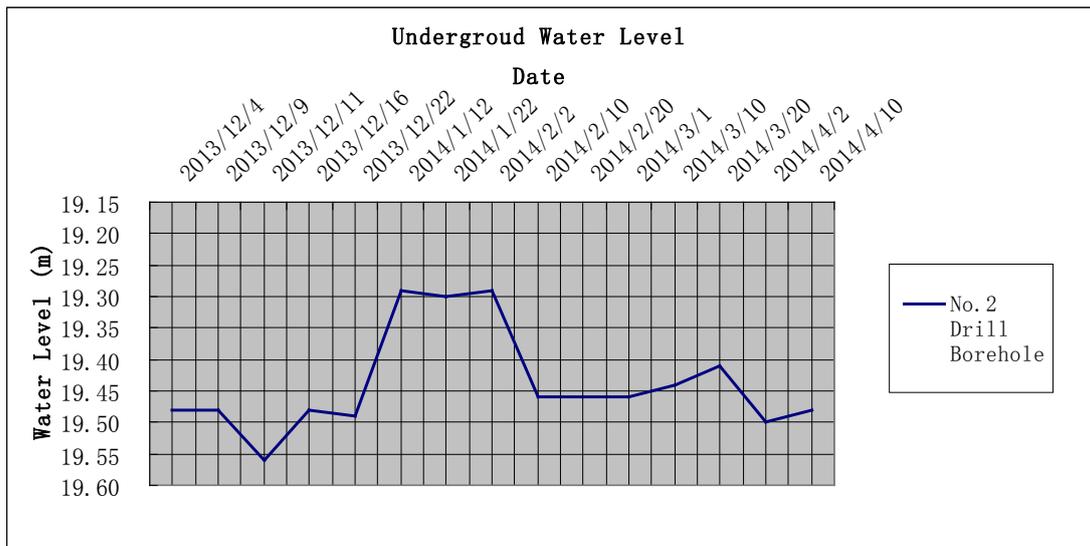
Figure 8: Underground water level in Borehole 2.

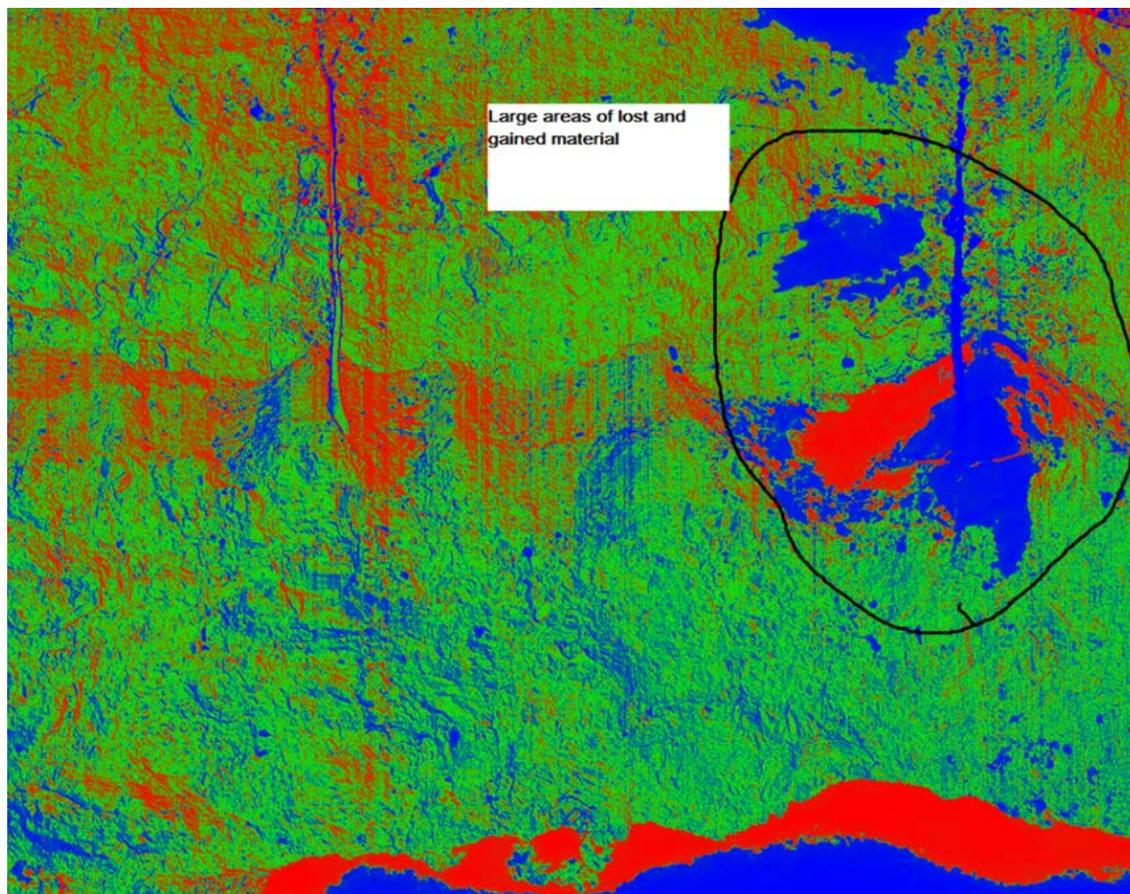
Figure 15 shows the raw results of the change detection algorithm, which nominally shows lost material in blue, gained material in red, and no change in green. The algorithm also has a vegetation removal aspect, however in Figure 15, the tree of Figure 14 (right hand true) is physically missing because it has either fallen down or been removed by the Missouri Department of Transportation personnel.

Figure 15: Initial results of change detection algorithm. Gained material is shown in red, and lost material is shown in blue. Note that tree in Figure 14 has been removed. The bottom of the image shows fallen rock.

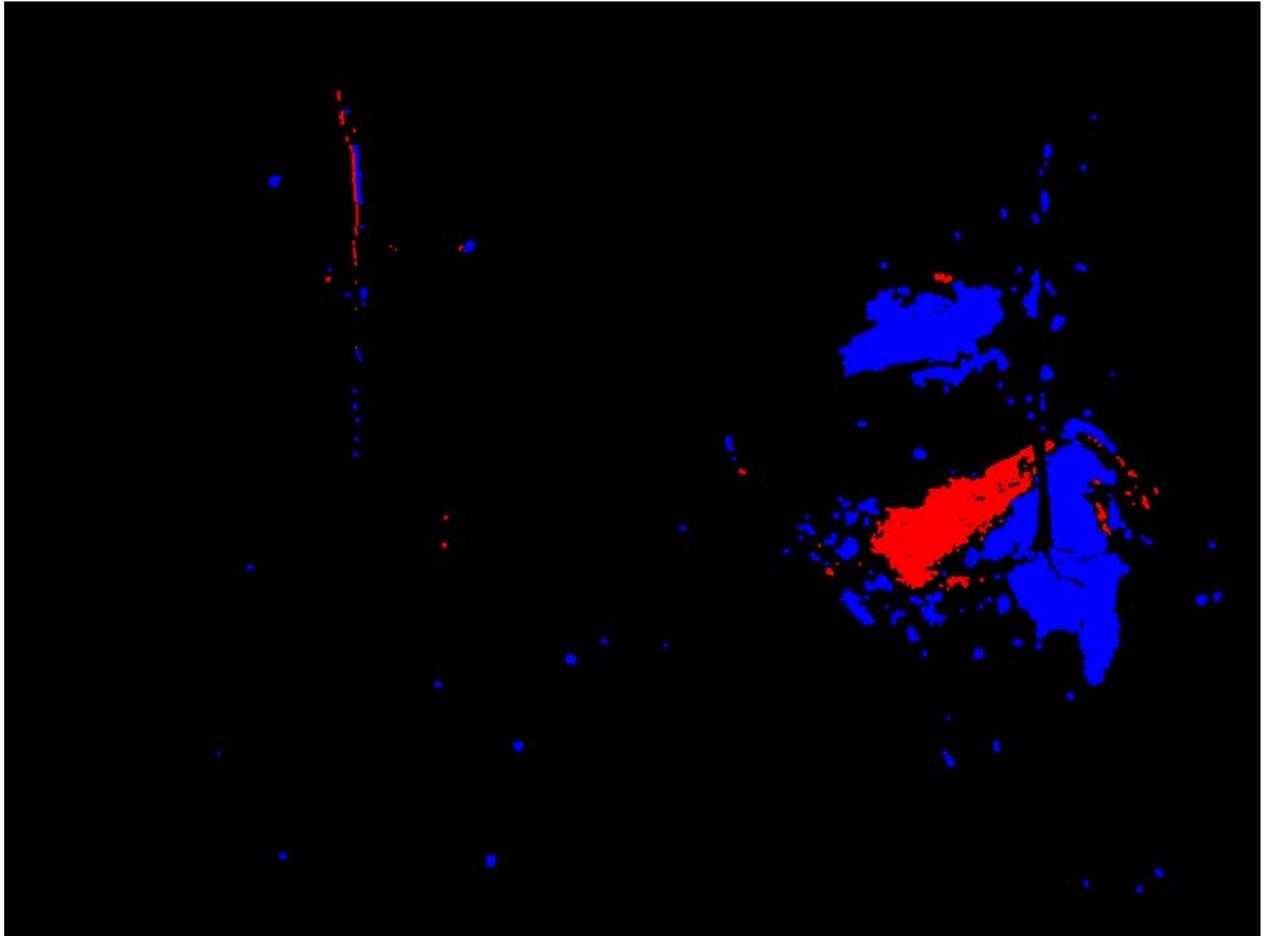
Figure 16 shows the final results of the change detection algorithm. Most of the fallen rock (blue) is as a result of the fallen/removed tree. Gained material (red) is typically the result of rock material that has fallen from higher up and has been left on the slope.

The statistics from this analysis show a lost rock volume of 8275.48 liters, and a gained rock volume of 2874.36 liters for a net loss of 5401.12 liters.

Figure 16: Final result of change detection algorithm by editing out the fallen rock at the bottom of the slope, and filtering the changes. Gained material is shown in red, and lost material is shown in blue.
