**Preservation of Missouri  
Transportation Infrastructures:  
Life-Cycle Inspection and Monitoring  
of FRP-Strengthened Concrete Structures  
using Near-Field Microwave Nondestructive  
Testing Methods**

S. Kharkovsky, V. Stephen,  
A.C. Ryley, J.T. Robbins and R. Zoughi

**UTC  
R97**

**PRESERVATION OF MISSOURI  
TRANSPORTATION INFRASTRUCTURES**  
VALIDATION OF FRP COMPOSITE TECHNOLOGY  
THROUGH FIELD TESTING

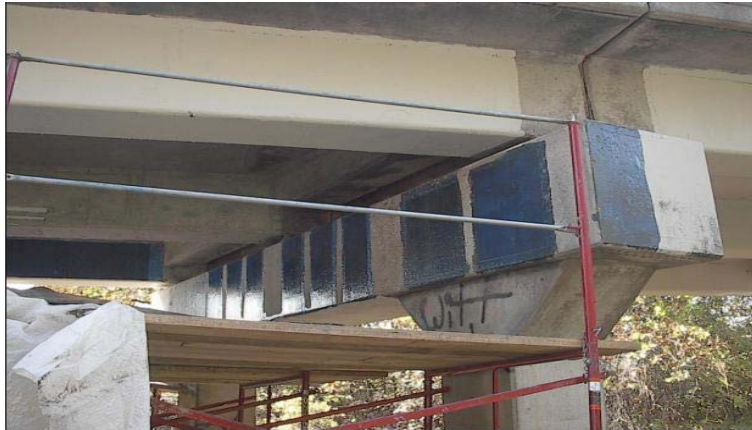
A number of artificial disbonds (intentional defects) were manufactured by injecting air between CFRP patches and concrete members at non-critical locations of the bonded CFRP patches when the epoxy adhesive was in its fresh state. The size and thickness (i.e. severity) of the disbonds were also varied using this process. The bonded CFRP patches in the abutment were used as reference since this part of the bridge is not usually strengthened by CFRP laminates. Moreover, the disbonds produced in the bent were thinner than the disbonds produced in the abutment. In addition, the bent with bonded CFRP patches were painted (Figure 4 shows the bent before it was painted).

Figure 4 - Picture of bent-A of the bridge P-0962 with FRP bonded patches before they were painted.

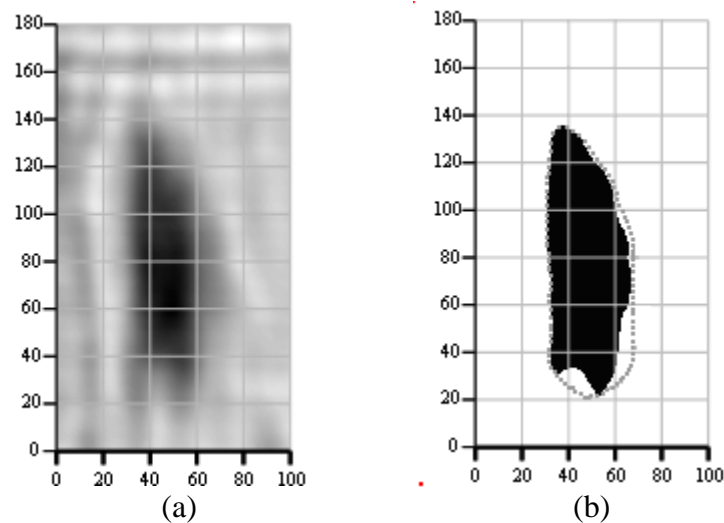
ly-polarized image. It must also be noted that the dimensions of the disbonded region associated with its image in Figure 13d corresponded well with its actual dimensions. This is one of the more important attributes of near-field microwave imaging [17]. To further illustrate this capability the following experiment was performed. Using this reflectometer, images of several disbonds with different sizes and shapes were produced and the disbond boundaries indicated by the respective compensated images were compared with the results of tap testing which can closely indicate the boundaries of a disbond. The compensated image of one of the disbonds in sample #2 is shown in Figure 14a. The results show that the shape of this disbond is complex while its exact boundary is not clear. Figure 14b shows the boundaries of this disbond corresponding to the 3-dB intensity level of the image and from tap testing (dash line). The results clearly indicate that compensated images of disbonds can provide close estimate of their boundaries. This is an important feature when considering repair of disbonded areas which is commonly accomplished by injecting epoxy into the disbonded region [14].

Figure 14 - (a) Microwave compensated image of the disbond generated using the dual-polarized reflectometer and (b) boundary of the disbond at the 3-dB level (dashed line shows the boundary of the disbond obtained by tapping method, (dimensions in mm)).

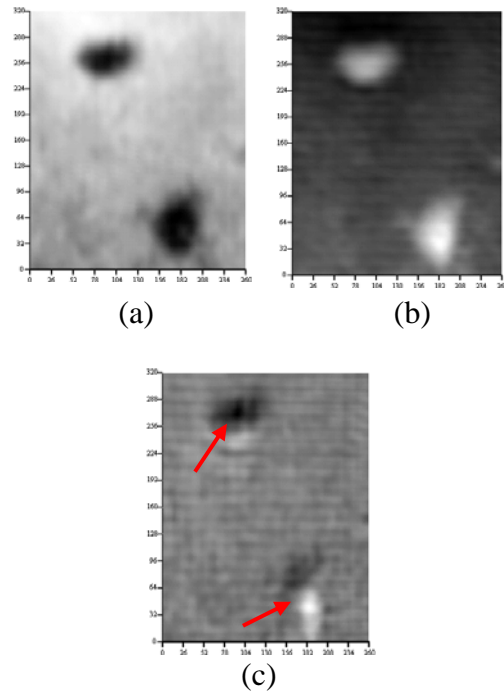
The dark indications in the perpendicular polarization image in Figure 16a represent two different disbonds. The indications of the slight surface bulging due to the presence of air between CFRP and concrete are also clearly visible in the image for parallel polarization (bright indications in Fig. 16b). The compensated image shown in Figure 16c clearly indicates the disbonds as well as the local non-uniformity associated with them. The locations and sizes of the detected disbonds, indicated by these compensated images, agreed well with their locations and sizes on the bonded CFRP patches and were corroborated by tap testing. These results clearly show the effectiveness of this novel reflectometer and inspection method for detecting and evaluating disbonds in CFRP-strengthened structural members.

Figure 16 - Microwave images of a CFRP patch at the abutment (dimensions in mm): (a) at perpendicular polarization, (b) at parallel polarization, and (c) compensated image (detected disbands are marked by red arrows).

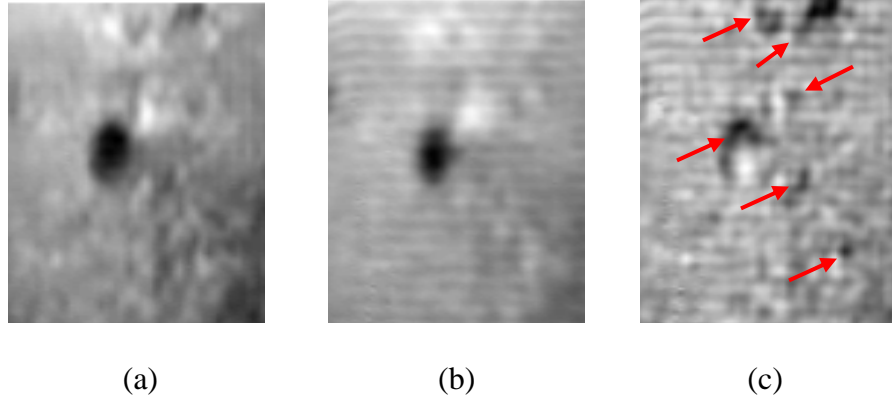
Close-up views of these images are shown in Figure 19. The dark and bright indications in the perpendicular polarization image in Figure 19a represent different disbonds and influence of surface roughness and any bulging that may be present as a result of air injection. The indications of the slight surface bulging and depressing due to the presence of air between CFRP and concrete and the surface roughness are also clearly visible in the image for parallel polarization (Figure 19b). The compensated image (shown in Figure 19c) was produced (in real-time) by removing the effect of bulging and standoff distance variation using the information from Figure 19b and removing it from the data in

Figure 19 - Microwave images of the portion (270 mm by 330 mm) of the CFRP patch at: (a) perpendicular polarization, (b) parallel polarization, and (c) compensated image (detected disbonds are marked by red arrows).

Figure 19a. Figure 19c clearly shows the disbonds as well as the local non-uniformity associated with them. The locations and sizes of the detected disbonds (indicated by this compensated image) in all of the investigated cases agreed well with their actual locations and sizes on the bonded CFRP patch and the results were further corroborated by tap testing.

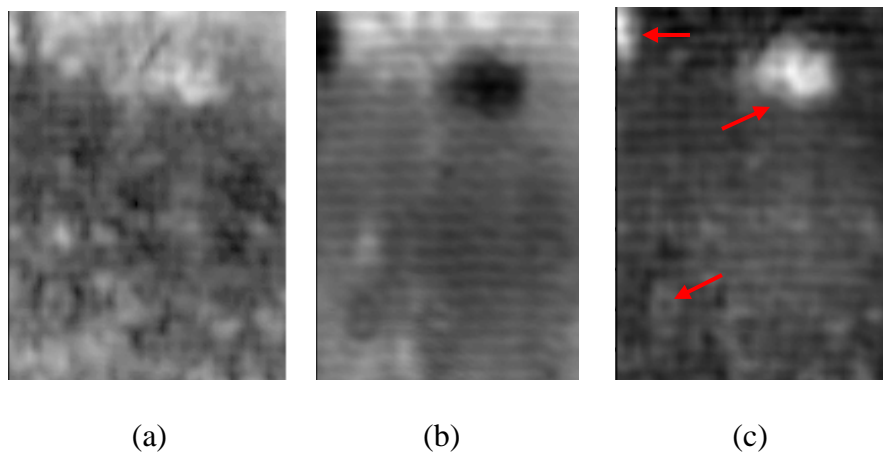
Figure 21 - Microwave images of a CFRP patch at the bent: (a) at perpendicular polarization, (b) at parallel polarization, and (c) compensated image (detected disbonds are marked by red arrows).

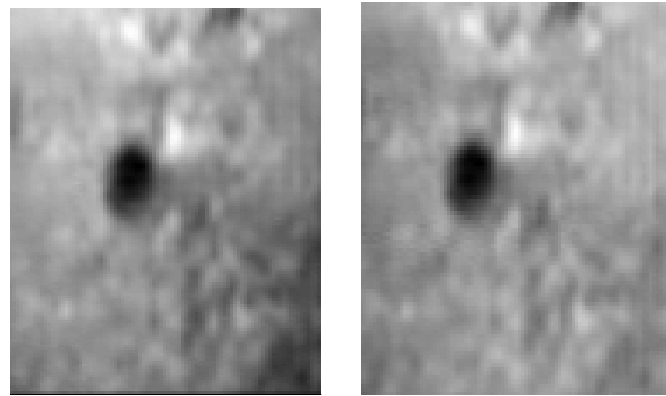
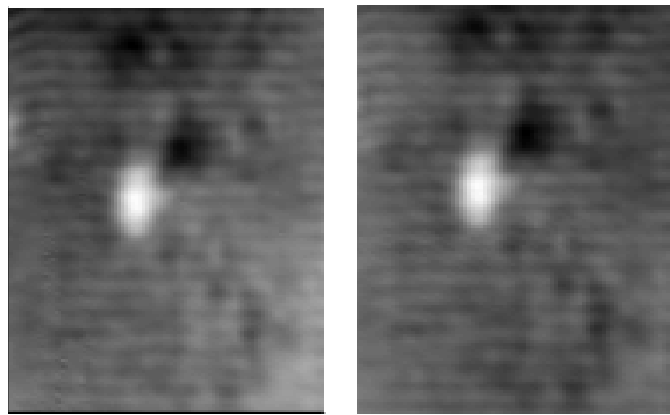
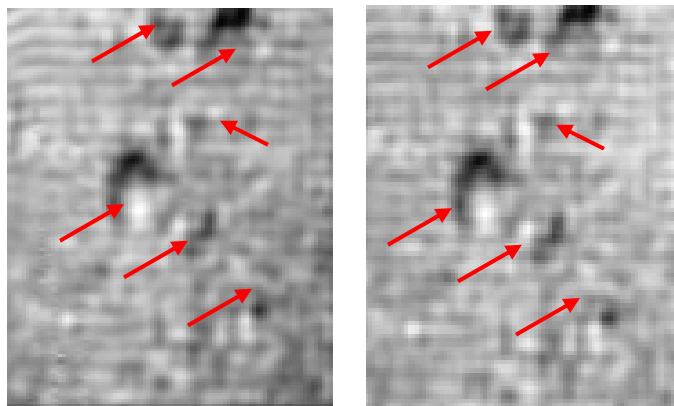
Figures 22 - 23 show the microwave images of CFRP patch #1 and patch #2, respectively, at the bent at perpendicular and parallel polarizations, and compensated image obtained in 2005 (October 14) and in 2006 (May 26). Scanned areas were 270 mm by 330 mm and 250 mm by 300 mm for patch #1 and #2, respectively, and standoff distance was 8 mm for both patches. It can be seen from Figures 22 - 23 that all corresponding images for each patch are very similar.

Figure 22 - Microwave images of a CFRP patch #1 at the bent: (a) at perpendicular polarization, (b) at parallel polarization, and (c) compensated image obtained in (left column) October 14, 2005 and (right column) May 26, 2006. Red arrows show disbonds.
