RI 97-019

SIGNAL MAST ARM FATIGUE FAILURE INVESTIGATION

MISSOURI DEPARTMENT OF TRANSPORTATION RESEARCH, DEVELOPMENT AND TECHNOLOGY

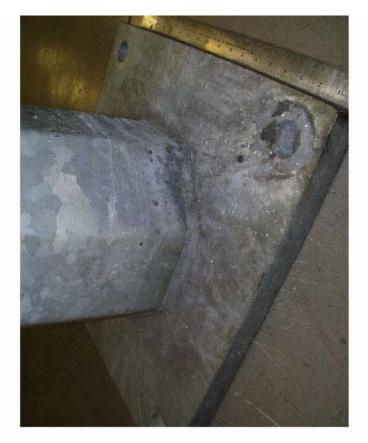
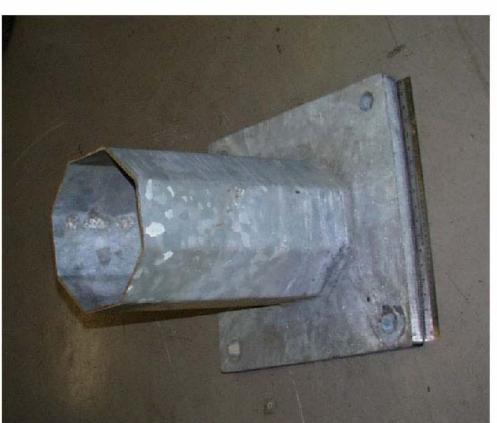
A cursory visual examination of a signal mast arm failure was also performed. The fracture showed lack of fusion in several places, and had the characteristic blue temper colors showing exposure to heat. Several locations on the fracture had a morphology that suggested fatigue that had initiated at multiple locations at the outer surface at the toe of the weld. Initiation and propagation of cracking was through the base metal. No beachmarks were observed. However, this is not unusual in weldments. No effort was made to confirm the presence of fatigue using the scanning electron microscope.

It is clear that the weld quality is poor. There is lack of fusion and lack of penetration. This can be improved by proper joint preparation and preheating the weld. Better penetration of the weld could be achieved by creating a small 45° bevel at the edge of the base plate where the mast arm meets the base plate. This bevel could be readily achieved by grinding immediately prior to welding. This would improve the amount of weld fusion and penetration. It would also provide a concave weld bead shape that is more conducive to fatigue service. This would reduce the sharp radius produced by the convex weld shape, reducing the high stress concentration.

However, failure of the mast arm did not result from poor penetration or lack of fusion. Failure occurred in the base metal. Even these poor welds were adequate to hold the base plate and the mast arm together. Failure initiated at a region of undercutting at the toe of the weld. This was aggravated by the undercutting in the region of the heat affected zone, where the base metal is softest, and least able to resist fatigue. The presence of undercutting, and the resultant large stress concentration factor is likely the source of premature fatigue crack initiation. Undercutting at the toe of a weld bead is caused by several things, including excessive current, too long of an arc, too large of an electrode and the incorrect electrode angle. It is symptomatic of poor welding procedures or inexperienced welding operators.

Figure 2.3 Overview of the failed arm-to-plate connection

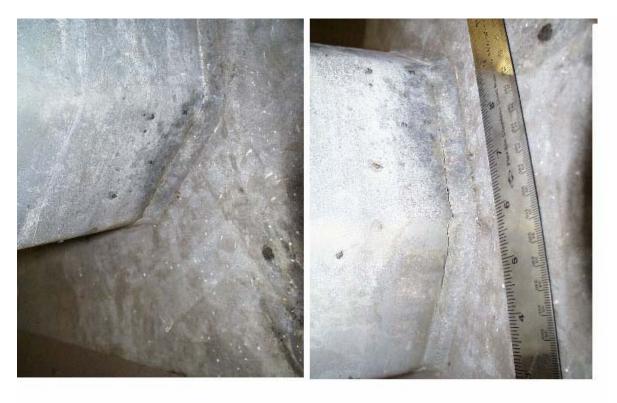
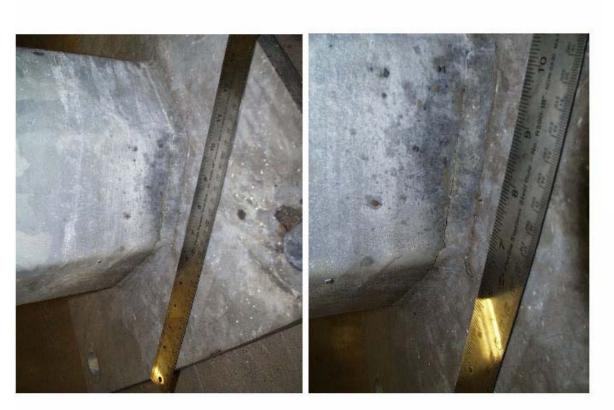
a Figure 2.4 View of the typical outer weld on the luminare stanchion

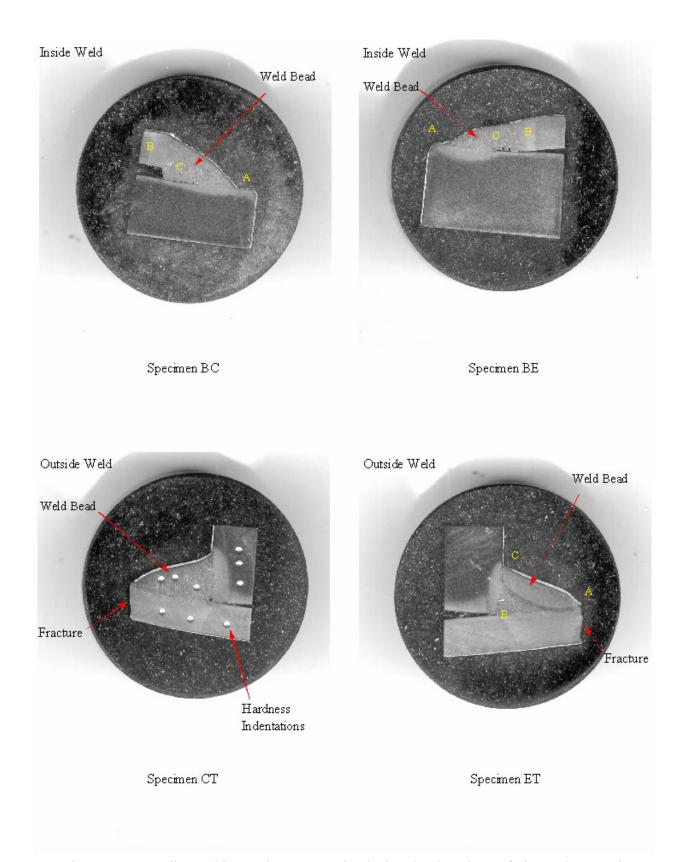
Four metallographic specimens were taken from a variety of locations in the mast arm assembly shown in Figure 2.2. Specifically, two specimens were cut from the outside weld in cracked and uncracked regions, which are respectively designated "CT: and "ET". The other two specimens were cut from the inside weld in cracked and uncracked regions, respectively denoted as "BC" and "BE". The metallographic sections were polished to remove any oxidation and were then etched using 2% Nital (2ml HNO₃, 98 ml CH₃OH). The resulting sections are shown in Figure 2.5.

Examination of these sections showed a lack of fusion in any of the metallographic sections. There is no evidence of any weld preparation. On the inside welds, the weld bead in Figures 2.6 and 2.7 showed a typical microstructure of acicular ferrite. The heat affected zone (HAZ) showed evidence of banded spherodized pearlite. The base material was also banded, and exhibited distinct regions of very fine pearlite. This structure is not unusual for A36 steel that has been hot rolled. The radius at the toe of the weld is sharp. A sharp undercut of the weld is also evident. The undercut is approximately 50 to $100 \,\mu$ m deep, and $200 \,\mu$ m wide. This is a very sharp notch, and occurs where the base material is the softest, and least resistant to fatigue.

e Figure 2.5 Metallographic specimens examined, showing locations of photomicrographs

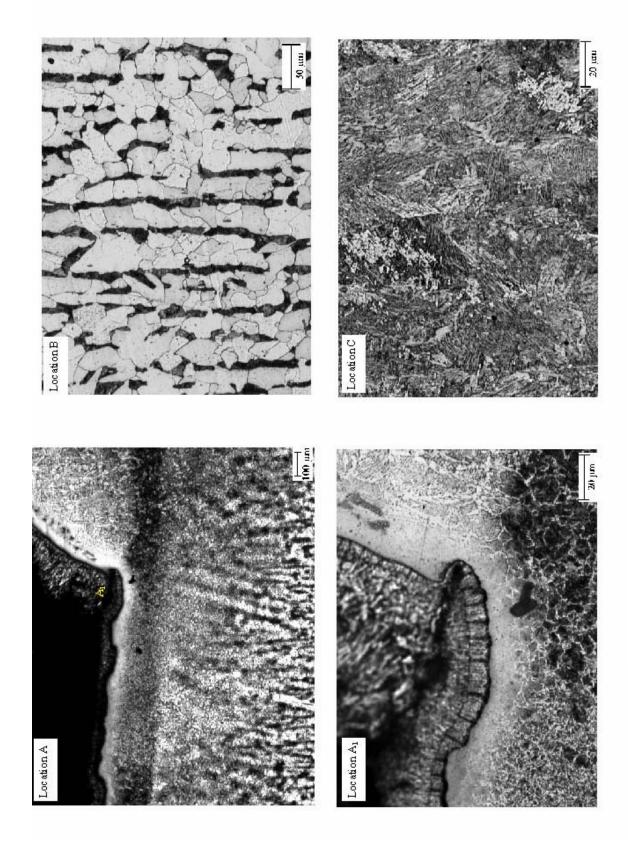
Figure 2.6 Selected photomicrographs from Specimen BC

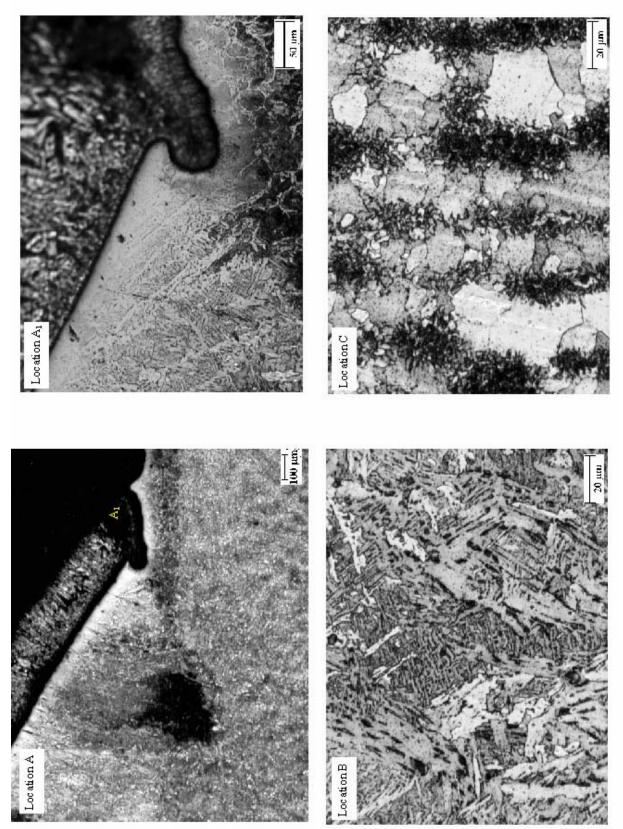
Figure 2.7 Selected photomicrographs from Specimen BE

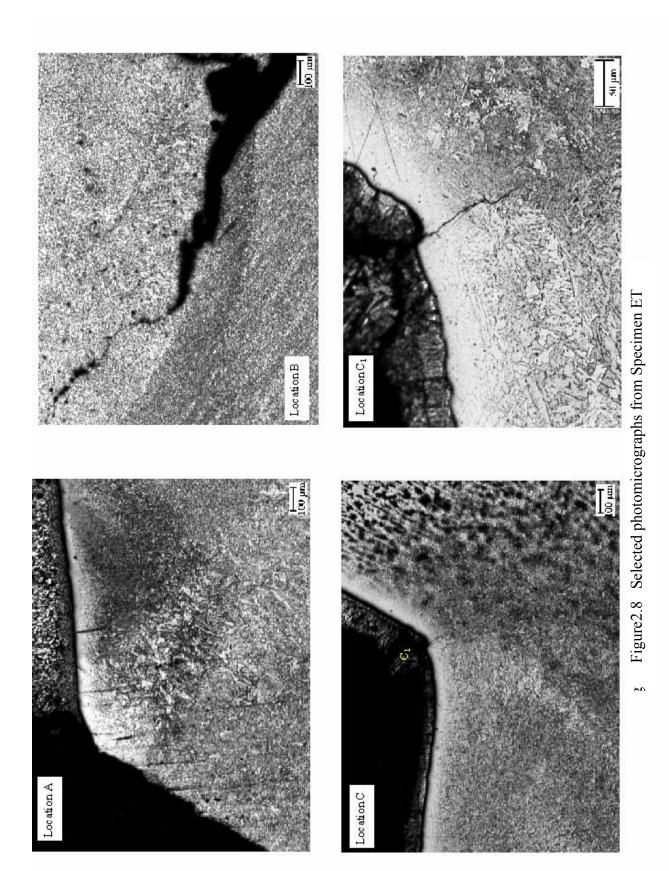
In the outside weld (Specimen ET), the weld bead shown in Figure 2.8 at three locations presented evidence of undercutting at the site of crack initiation of the fracture surface. The close-up view at location C1 confirmed the cracking. The small size of the shear lip indicates that the stress levels were small in comparison to the overall section size. At the region of the root of the fillet, evidence of porosity, and cracks linking regions of porosity, was observed. This probably occurred by overload, possible during the final failure. This is indicated by the direction of cracking, perpendicular to the fracture. However, this could have also occurred because of residual stresses in the weld.

At the fillet of the weld opposite the primary fracture, a small secondary crack, approximately 125 μ m long, was observed propagating parallel to the primary fracture. This crack was observed to be propagating from a region of undercut at the toe of the weld. The radius of the weld bead to the base material was also sharp. This indicates a substantial stress concentration. The straight nature of the crack is indicative of a fatigue crack. The presence of a small fatigue crack at the toe of the weld at the base plate, parallel to the primary fracture, shows that failure is not limited to crack initiation at the weld toe on the side of the signal mast arm.

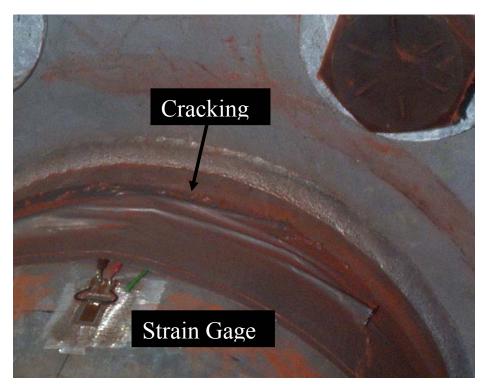
Table 2.1 shows the results of the five mast arm fatigue tests. All of the mast arms were circular in section, except the JEM had an octagon section. One of the three Valmont mast arms failed well prior to the theoretical Category E' 1.6 million cycles. It also happened to be welded with the "fatigue-resistant" detail. Two of the Valmont arms, one with the new and one with the old weld detail, survived past the mean Category E' 1.6 million cycles. The Union Metals mast arm failed early as did the JEM arm. Both used the old weld detail. The JEM arm seemed to be cracked at the start of the test with no cycles prior to evidence of a crack. All fatigue failures propagated from the toe of the weld at the top of the mast arm at the maximum tensile stress locations for the circular sections and at the corners for the octagon section. Figure 2.12 shows the crack at the toe of the weld in Valmont mast arm 254682.

Figure 2.12 Valmont Mast Arm 254682 Cracking and Strain Gage

The fatigue cracks in both specimens initiate at the toe of each weld in the mast arm. Specifically, the initiation site is at the toe of the weld at the junction of the weld metal and the coarse grained region.

The toe of the welds appears to have very sharp local toe angles. While it is not possible to directly measure the toe angle at the fracture initiation site, it is possible to examine the toe of the weld at the opposite side of the weld. The examination reveals that the sharp features found in the previous specimens cut from the in-service failed mast arms are nearly exactly reproduced in the two specimens. Both specimens are multi-pass weldments and appear to be "two pass" weldments. However, the advantages gained by the "fatigue-resistant" weld are negated due to the sharp features at the toe of the weld. Mast arms manufactured in this manner will continue to have less than expected fatigue life values as long as these sharp features at the toe of the welds are present. Even though the fatigue resistant welding procedure is utilized, the sharp features at the toe of the weldments will control the crack initiation or fatigue life.

In order to eliminate the sharp features of the weld, a thorough investigation of welding parameters must be accomplished. The optimum potential and current must be identified and combined with stringent quality control measures in order to eliminate these defective features in the weldments.
