UT **R223**

GEOPHYSICAL INVESTIGATION, LAKE SHERWOOD DAM SITE, EAST-CENTRAL MISSOURI

Neil Anderson and Maung Myat Department of Geological Sciences and Engineering Missouri University of Science and Technology

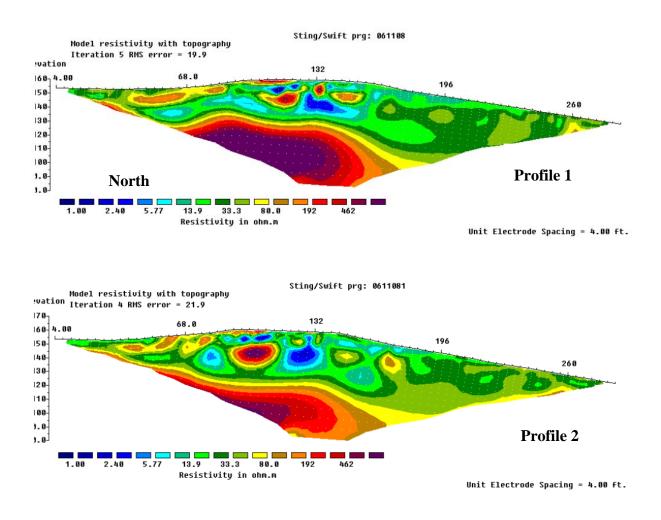
Figure 2: Electrical resistivity profiles 1-2.

The top of bedrock is thought to correlate reasonably well with the 80 ohm-m contour interval below elevation 130 feet. Above elevation 130 feet, contour intervals with values greater than 80 ohm-m are interpreted as grouted soils or very dry soils. The most significant feature on resistivity profiles 1-2 is the zone of anomalously low resistivity (<5 ohm-m) centered between stations 126 and 142 feet on profile 1 and between stations 118 and 134 feet on profile 2.

This zone of anomalously low resistivity is interpreted as indicative of "moist clay" and is consistent with current thoughts regarding the most probable location of the constructed keyway. This "zone of anomalously low resistivity" does not extend below the interpreted top of bedrock. We suspect this is because 1) the resistivity traverses do not cross the key at right angles, 2) more "smoothing" occurs at

depths greater than 40 feet than at depths less than 40 feet, and 3) some grout may have been injected into the clay key.

We note however, that bedrock on profile 2 beneath and to the northeast of the interpreted "clay key location" is characterized by low resistivities, especially at depths on the order of 60+ ft. This same feature is observed, but is not so pronounced, on profile 1. The zone of low resistivity at the base of the interpreted key could represent a flow pathway.

In our opinion, the zone of anomalously low resistivity (<5 ohm-m) centered between stations 126 and 142 feet on profile 1 and between stations 118 and 134 feet on profile 2 is probably indicative of "moist clay" and is consistent with current thoughts regarding the most probable location of the constructed keyway. We note that bedrock on profile 2 beneath and to the northeast of the interpreted "clay key location" is characterized by low resistivities, especially at depths on the order of 60+ ft. This same feature is observed, but is not so pronounced, on profile 1. The zone of low resistivity at the base of the interpreted key could represent a flow pathway.

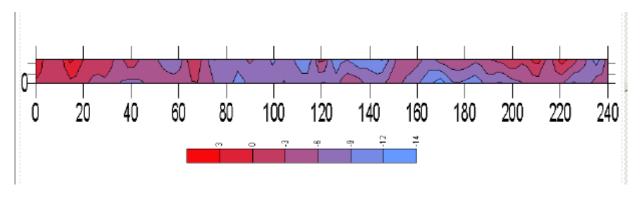
Figure 4: Lake Sherwood SP profile

Figure 4 shows SP profiles acquired along the southerly shore line of Lake Sherwood. Station 0 feet being the easterly end, station 200 feet being the westerly end and station 240 feet being the northerly end. Though the profile is shown as a linear feature, at station 200 feet, the physical layout of the land turns north. Four docks are constructed along this shore line with the first eastern dock centered at station

6 feet, the second centered at station 54 feet, the third one centered at station 113 feet and the fourth and the most westerly one centered at station 173 feet.

In our opinion, the zone of anomalously low (negative) SP readings represents possible inlet points for the higher temperature waters that exit the downstream face of the dam at the site denoted as the "waterfall". This interpretation should be considered by any geotechnical engineers involved in ongoing mitigation efforts.
