Quality Control And In-Service Inspection Technology for Hybrid-Composite Girder Bridges

**NUTC
R282**

1. Report No. NUTC R282		2. Government Accession No.		3. Recipient's Catalog No.	
4. Title and Subtitle Quality Control And In-Service Inspection Technology for Hybrid-Composite Girder Bridges				5. Report Date August 2014

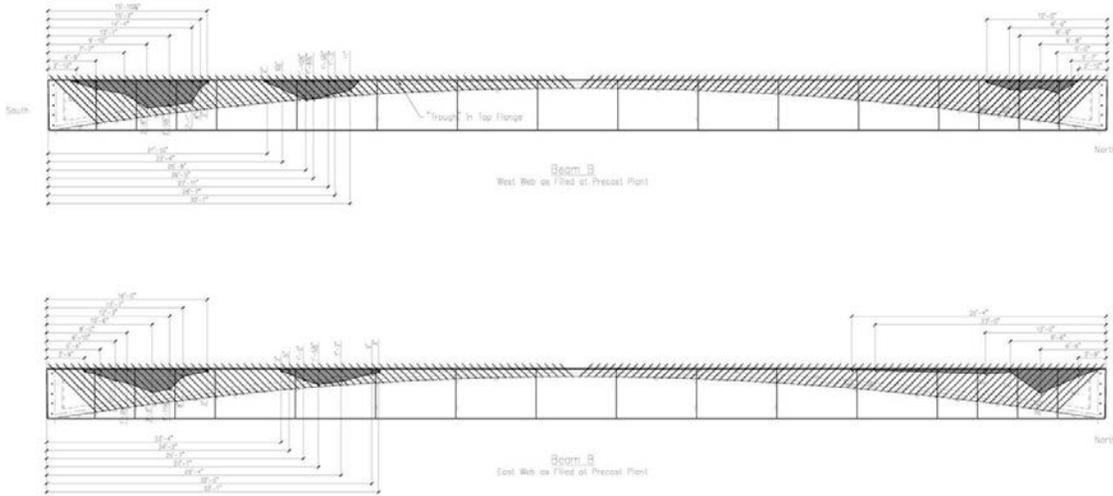
530 During the pour of the first double web beam, it became apparent to workers and
531 on-site quality control (QC) personnel that something had gone wrong with the concrete
532 pour into the arch. Workers realized that the concrete was not rising as it should to the
533 top of the arches inside the two webs. QC personnel then ran a simple test by sticking a
534 ruler down through the shear connectors and pour holes to see if there were any voids
535 in the concrete. A void map was then constructed from the information gathered and is
536 shown in Figure 9. Voids were present in both arches and both ends of the beam.
537 Additional concrete was poured into the arches through the shear connectors and
538 additional pour holes drilled into the beam to fill the voids approximately one week after
539 the original casting process. The voids were determined to be due to decreased
540 flowability in the concrete at the time of the pour.

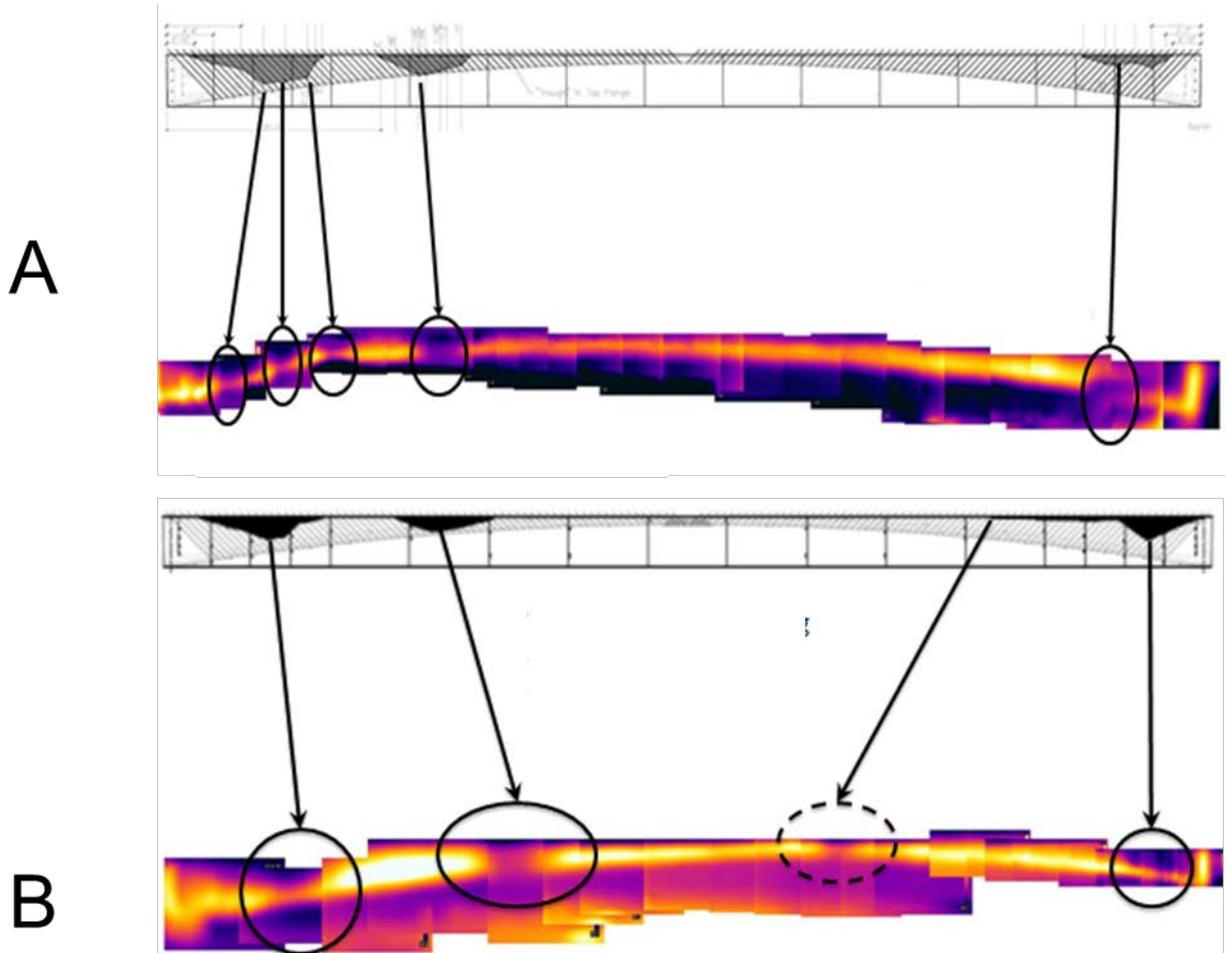
712 individual thermal images of portions of the beam. The blurriness of the images that
 713 can be observed in Figure 18 was attributed to high humidity at the time the images
 714 were captured. High humidity conditions can cause the auto-focus function of the

715 camera to not perform well. Regardless, the figure clearly shows the voids in the arch
716 of the beam. Shown in the figure is the West web (A) and the East web (B) of the
717 double – web HCB for bridge B0410. The void maps developed by on-site QC
718 personnel is also shown to verify the thermal imaging results.

719
720 **Figure 18. Composite thermal images of the West (A) and East (B) webs of beam 1, HCB B0410.**

721 The voids in the member result in the thermal signature of the arch disappearing
722 at the locations of the voids. At these locations, the heat of hydration of the concrete is
723 not available because the concrete is missing, i.e. there is a void. Figure 19 quantifies
724 the thermal detection of one of the voids detected in this member, from data captured
725 48 hrs after concrete placement. As shown in the figure, the signature of the concrete
726 arch is not apparent in the thermal images; the temperature variations along a line
727 shown in Figure 19A are shown in Figure 19B. The data presented in Figure 19B
728 quantitatively illustrate the color variation in Figure 19A.

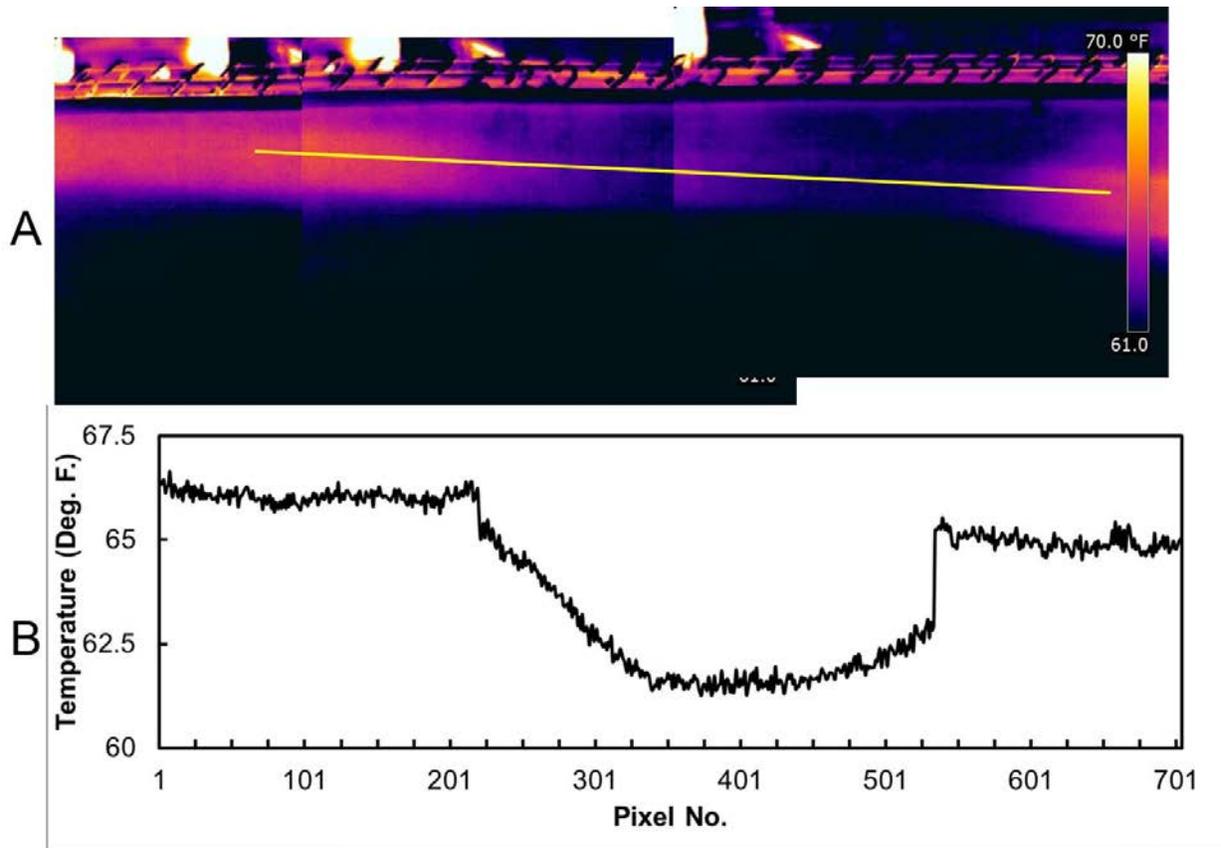
731 Figure 19. Composite thermal image of void in B0410 (A) and temperature variations (B) along the line
732 shown in (A).

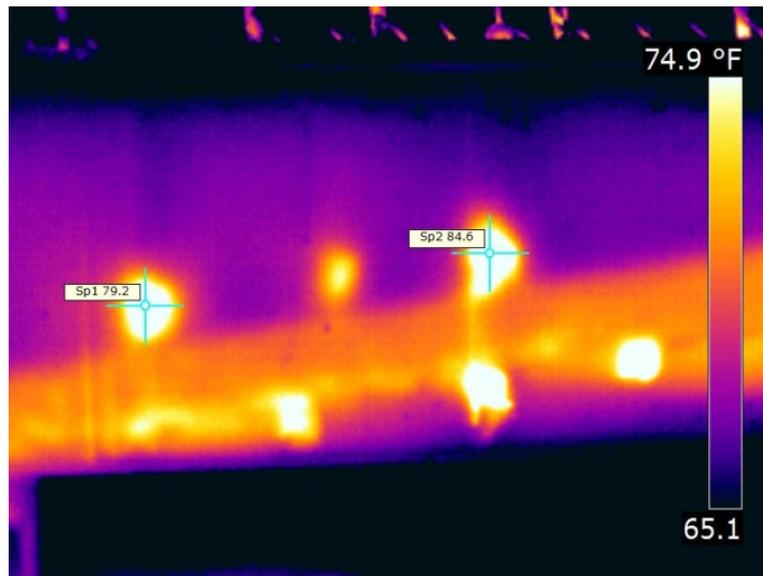
742 During the course of testing, there were a consistent pattern of anomalies
743 appearing in the thermal images. These anomalies were represented by periodic “hot
744 spot” appearing on the images, usually at locations on or near the surface above the

745 arch. Figure 20 illustrates some of the thermal anomalies observed. These “hot spots”
746 may have resulted from the concrete placed in the arch void leaking through the polyiso
747 foam, resulting in a larger thermal contrast reaching the surface of the composite shell
748 in localized areas adjacent to the arch. These “hot spots” have greater thermal contrast
749 than the arch itself, indicating that the heat of hydration is conducting across less
750 material, that is, this is concrete that has pushed through the foam included in the HCB,
751 and hence is closer to the surface. Leakage to the concrete through the foam inserts
752 was observed during the mock-up testing, as noted previously.

753
754 **Figure 20. Images showing thermal "hot spots" typically observed following concrete placement.**

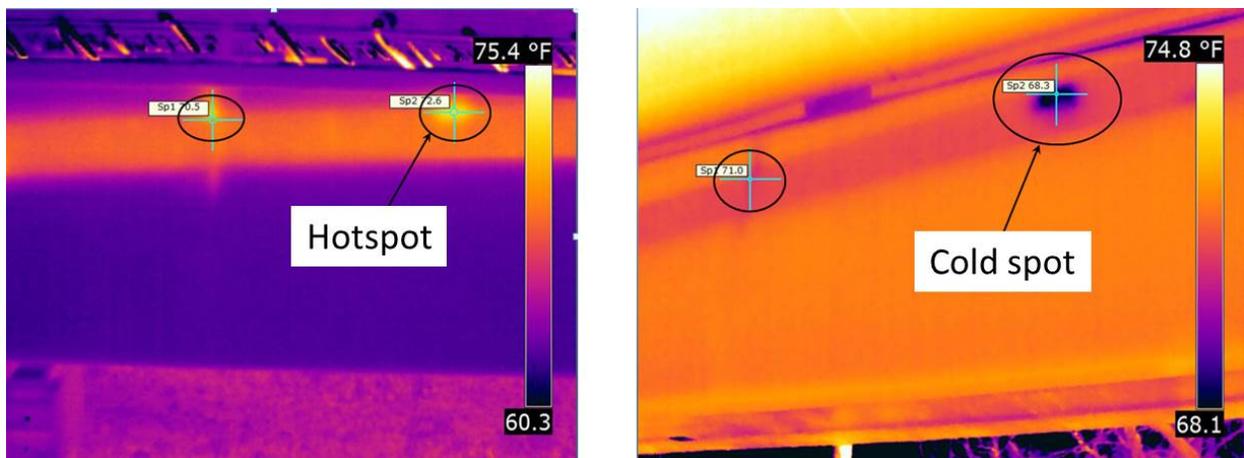
755 These anomalies were further assessed during testing 1 and 2 years after
756 placement of the concrete. Figure 21 illustrates the locations of the anomalies one
757 year after concrete placement for bridge B0439. As shown in these figures, the
758 anomalies generally follow the thermal pattern of the concrete arch, that is, they are
759 warmer during periods when the composite shell is cool, and cooler during periods
760 when the composite shell is warm. This is likely due to the thermal inertia of the arch,
761 which is out of phase with the variations in the surface temperature of the composite
762 shell. As a result, these anomalies appear as “hot spots” during the nighttime, and “cold
763 spots” during the warming cycle of the day. Thermal inertia or thermal mass, I , is a
764 measure of the ability of the material to conduct and store heat. It is computed as the

778 It is also possible that some of these thermal anomalies result from steel
779 connection or fasteners that are in contact with the composite shell and embedded in
780 the concrete, such that they follow the thermal pattern of the arch and conduct heat
781 toward the surface of the composite shell. Regardless, these anomalies are not
782 believed to be detrimental to the performance of the HCB.

783
784 Figure 21. Example of anomalies observed in the area of the arch one year during the night (left) and during
785 the day (right).
