MISSOURI
S&T

CENTER FOR TRANSPORTATION INFRASTRUCTURE AND SAFETY

NONDESTRUCTIVE EVALUATION OF MODOT BRIDGE DECKS – PILOT STUDY

**NUTC
R311**

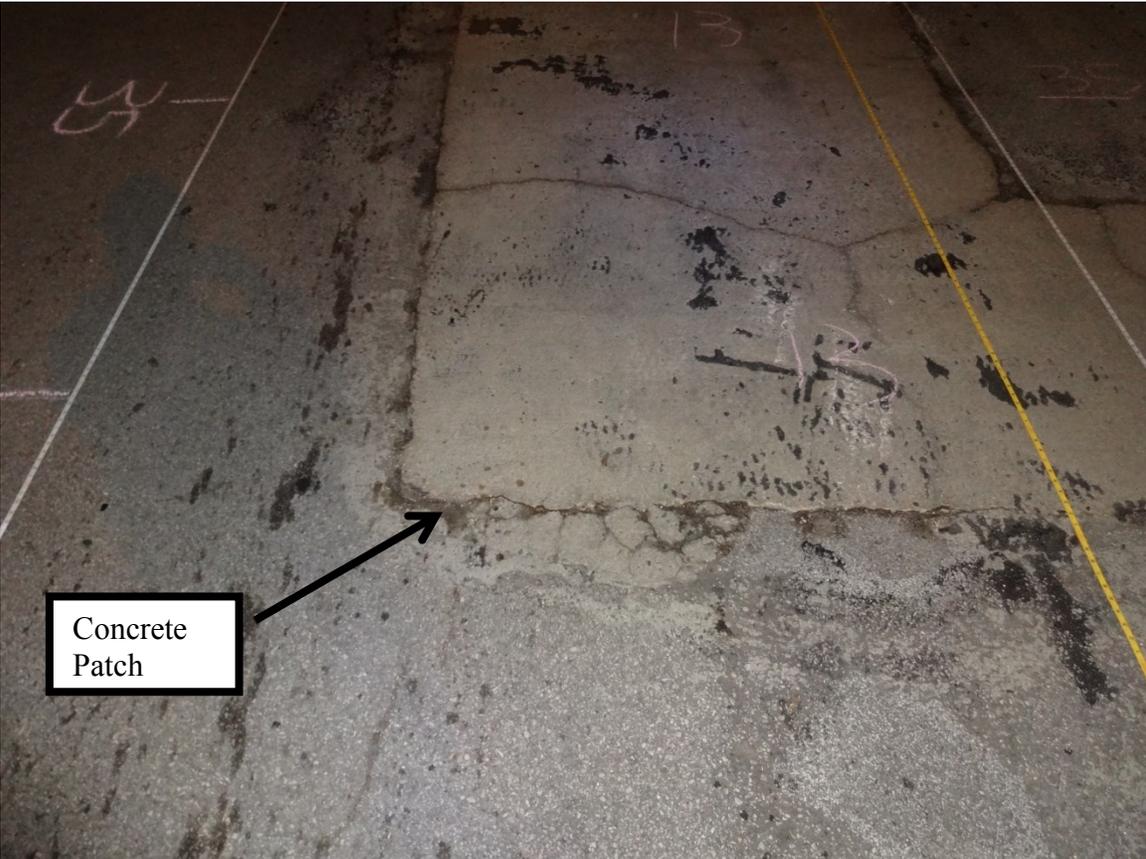
There were 20 defects documented during the field investigation of Bridge A0569. The deck contained an asphalt wearing surface that showed some signs of deterioration. Documented defects include concrete patches, asphalt rutting and shoving, and unfilled potholes in the concrete. Figure 3-1 below shows a concrete patch present on Bridge A0569, along with a deteriorated asphalt overlay around the patch.

Figure 3-1 Bridge A0569 Concrete Patch and Deteriorated Asphalt Overlay Observed During Field Investigation

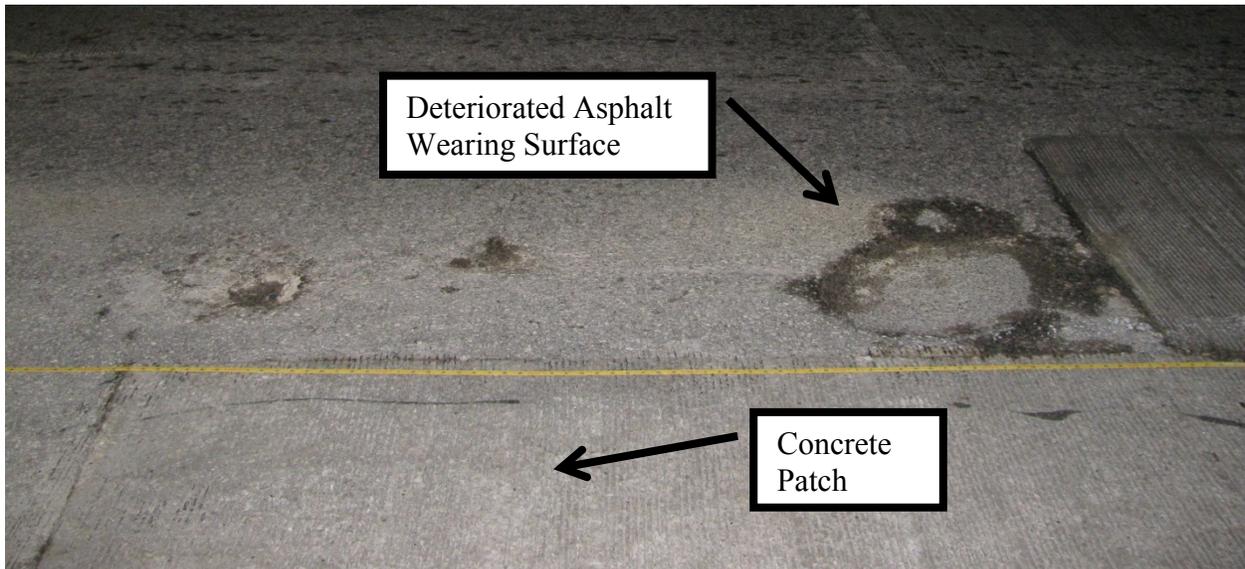
During the first investigation of Bridge A1187, the asphalt wearing surface was noted to be heavily deteriorated, and 52 individual surface defects were documented. These defects consisted mainly of concrete patches, but also included visible deterioration of the asphalt, such as rutting and shoving, as well as unfilled potholes. No defects were documented during the second visual investigation of Bridge A1187 after the wearing surface had been milled off and replaced with an approximately 1 in. thick asphalt wearing surface. Figure 3-2 shows Bridge A1187 during the first investigation. Figure 3-2 shows the deteriorated asphalt overlay and concrete patches. Figure 3-3 shows the top deck surface of the same bridge during the second investigation (approximately eight months later), with a new asphalt wearing surface.

Figure 3-2 Bridge A1187 Deteriorated Asphalt Wearing Surface Observed During First Investigation

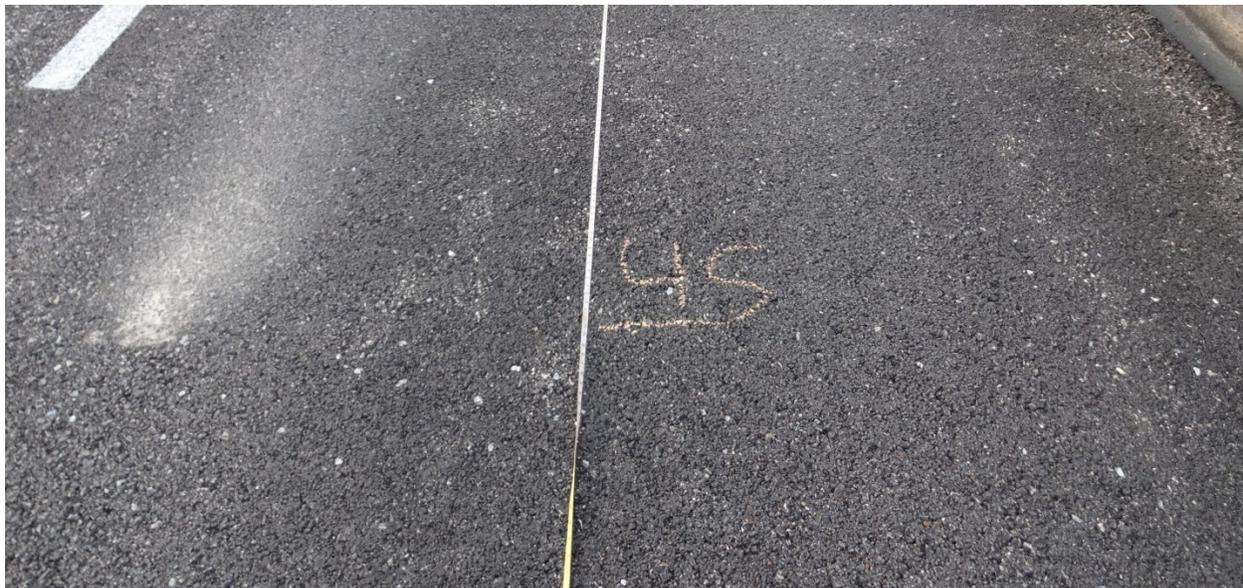
Figure 3-3 Bridge A1187 Deck Surface Observed During Second Investigation

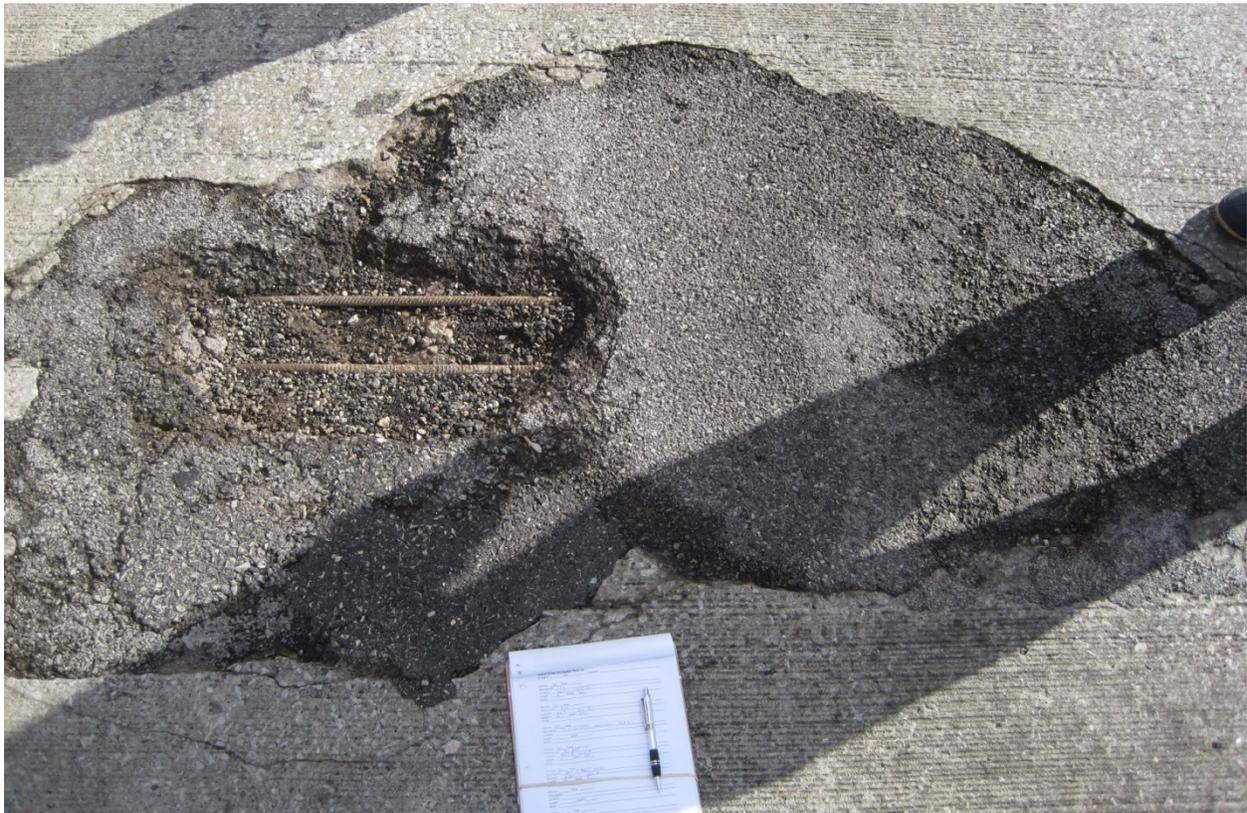
There were 81 defects documented during the field investigation of Bridge A1193. Due to time constraints of the time on site, the shoulders were not examined. The bridge deck surface did not appear to be heavily deteriorated. Most of the visible defects were asphalt filled potholes, and some unfilled potholes in the concrete were noted. Figure 3-4 shows a typical asphalt filled pothole found on the deck surface of Bridge A1193. This region also had exposed reinforcing steel.

Figure 3-4 Bridge A1193 Typical Asphalt Filled Pothole Observed During Field Investigation

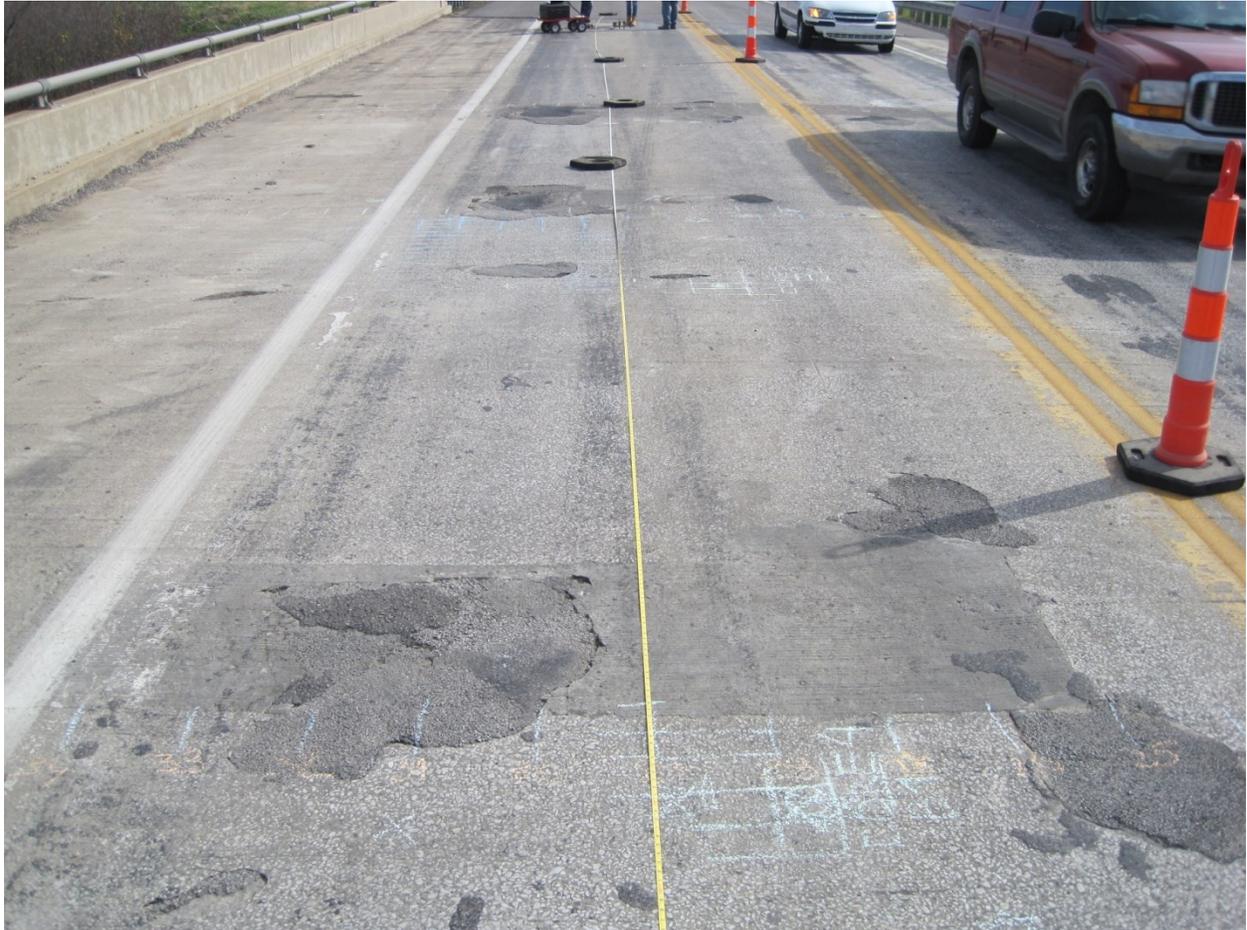
There were 69 defects documented during the field investigation of Bridge A1297. The deck had many traverse cracks, concrete patches, asphalt filled potholes, and unfilled potholes in the concrete. Figure 3-5 shows typical deterioration located during the field investigation of Bridge A1297.

Figure 3-5 Bridge A1297 Typical Deck Condition Observed During Field Investigation

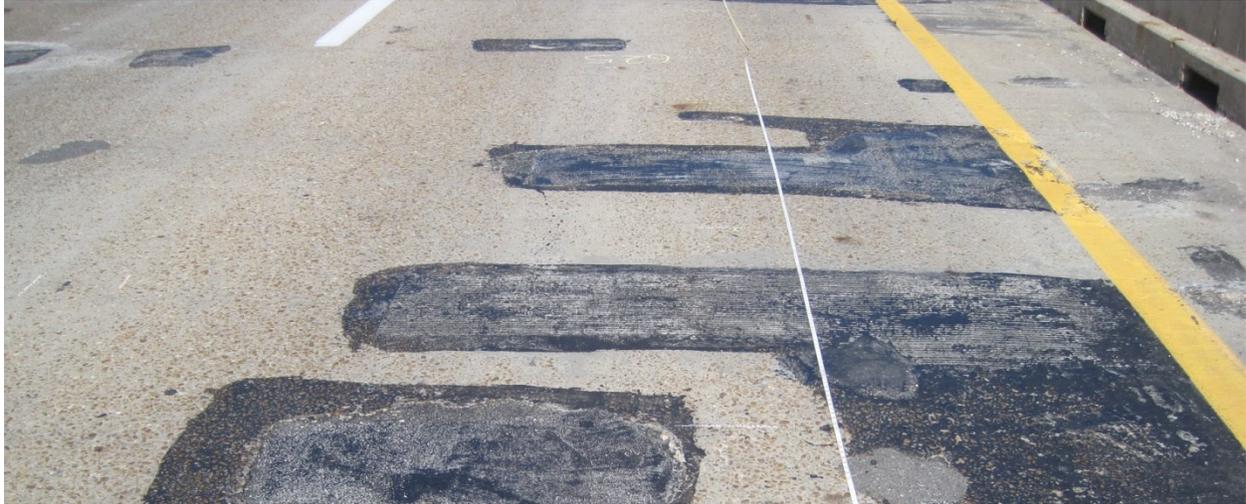
There were 161 defects documented during the field investigation of Bridge A1479. The deck surface appeared heavily deteriorated near the middle of the beam spans. Deterioration levels appeared to be much lower near the bent supports. The researchers noticed a lot of vibration of the bridge during the investigation as large trucks passed over the bridge. The deck curb drains were also severely deteriorated with reinforcing steel visible in several areas, especially along the soffit of the deck. Documented deterioration includes concrete patches, unfilled concrete potholes, asphalt filled potholes, and transverse cracks. Figure 3-6 shows an area of the deck with multiple concrete patches and asphalt filled potholes.

Figure 3-6 Bridge A1479 Typical Deck Condition Observed During Field Investigation

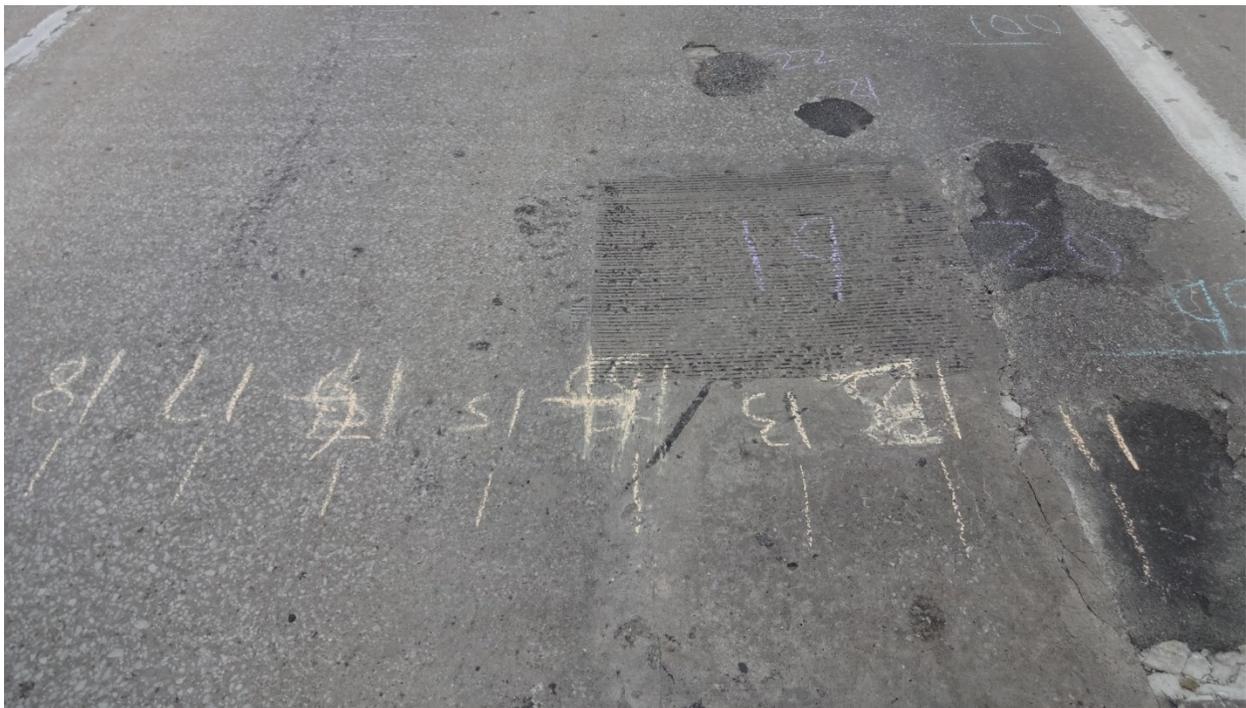
There were 50 defects documented during the field investigation of Bridge A2111. The deck contained several concrete patches, asphalt filled potholes, and unfilled potholes. There were several areas of the deck where delaminations were suspected because tapping on the concrete surface generated a “hollow” sound. Figure 3-7 shows typical deterioration that was observed on Bridge A2111, including concrete patches and asphalt filled potholes.

Figure 3-7 Bridge A2111 Typical Deck Condition Observed During Field Investigation

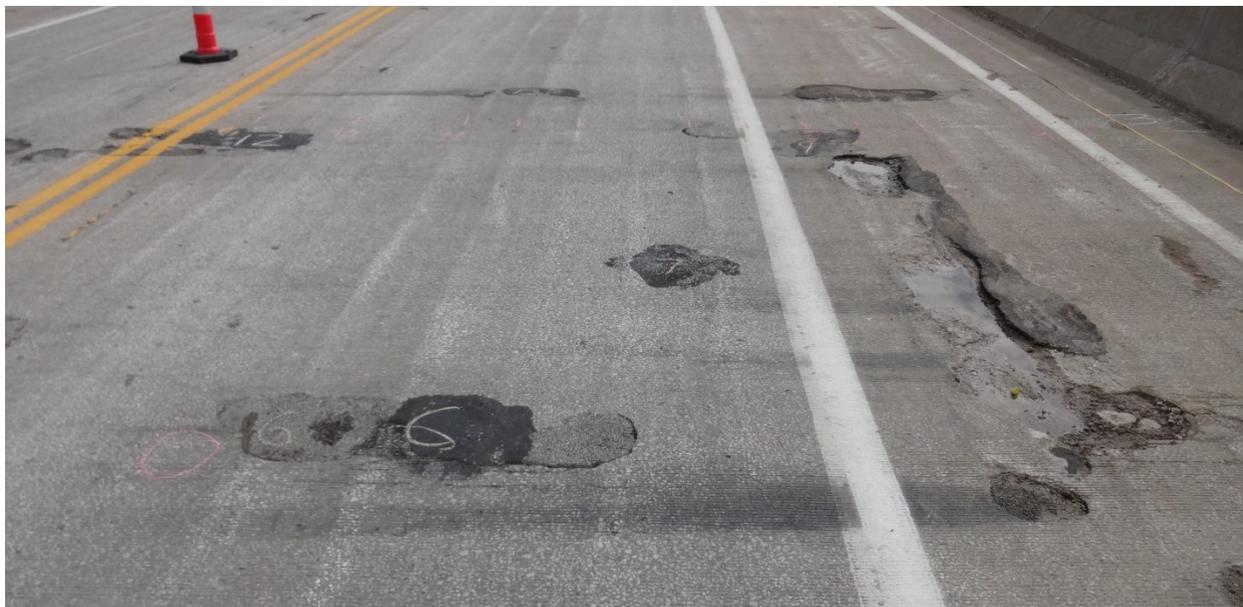
Figure 3-9 Bridge A3017 Typical Deck Deterioration Observed During Field Investigation

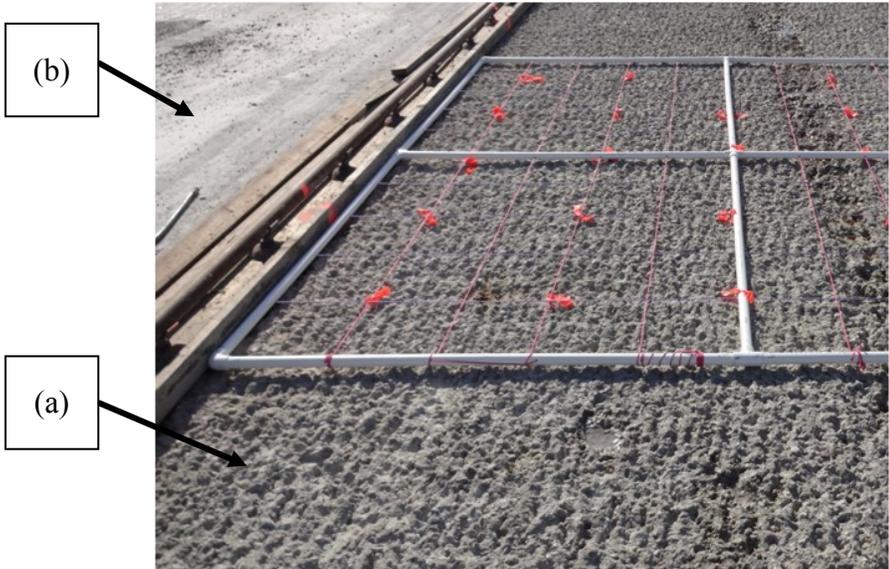
Figure 6-1 Rough Grooved Concrete Surface Caused by Milling (a) and Original As-Built Concrete Surface (b)

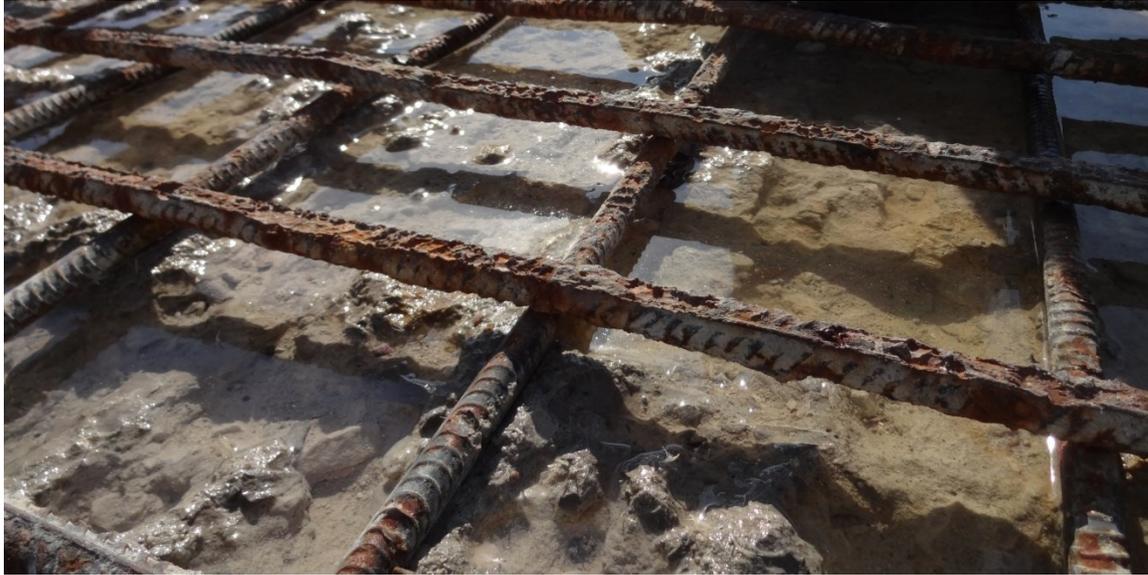
Figure 6-2 Corroded Rebar Exposed After Removal of Loose and Deteriorated Concrete by Hydro Demolition

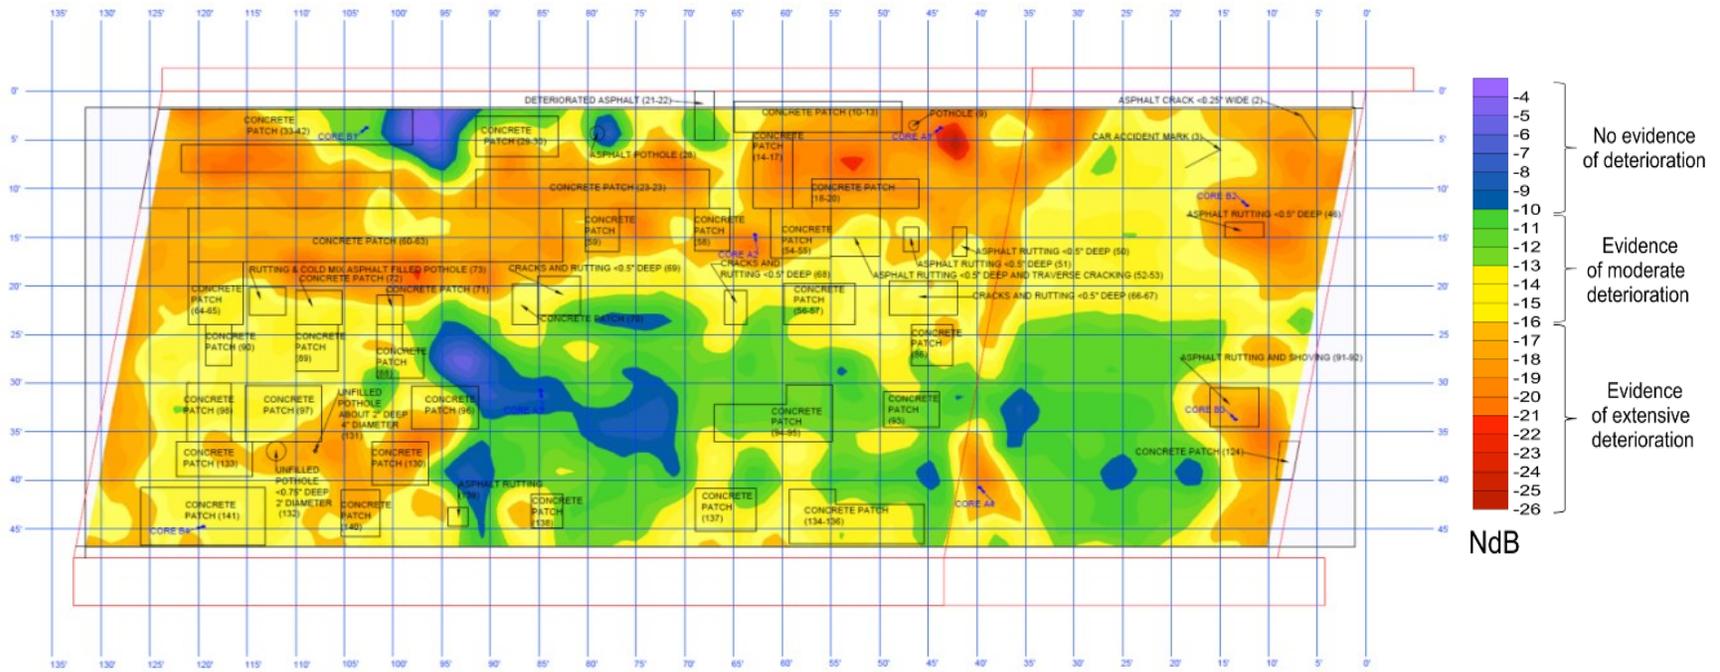
Figure 7-8 GPR Amplitude Map Based on Top Bar Reflection for Bridge Deck A187 with Superposed Core Locations and Visual Surface Condition Features, Prior to Resurfacing

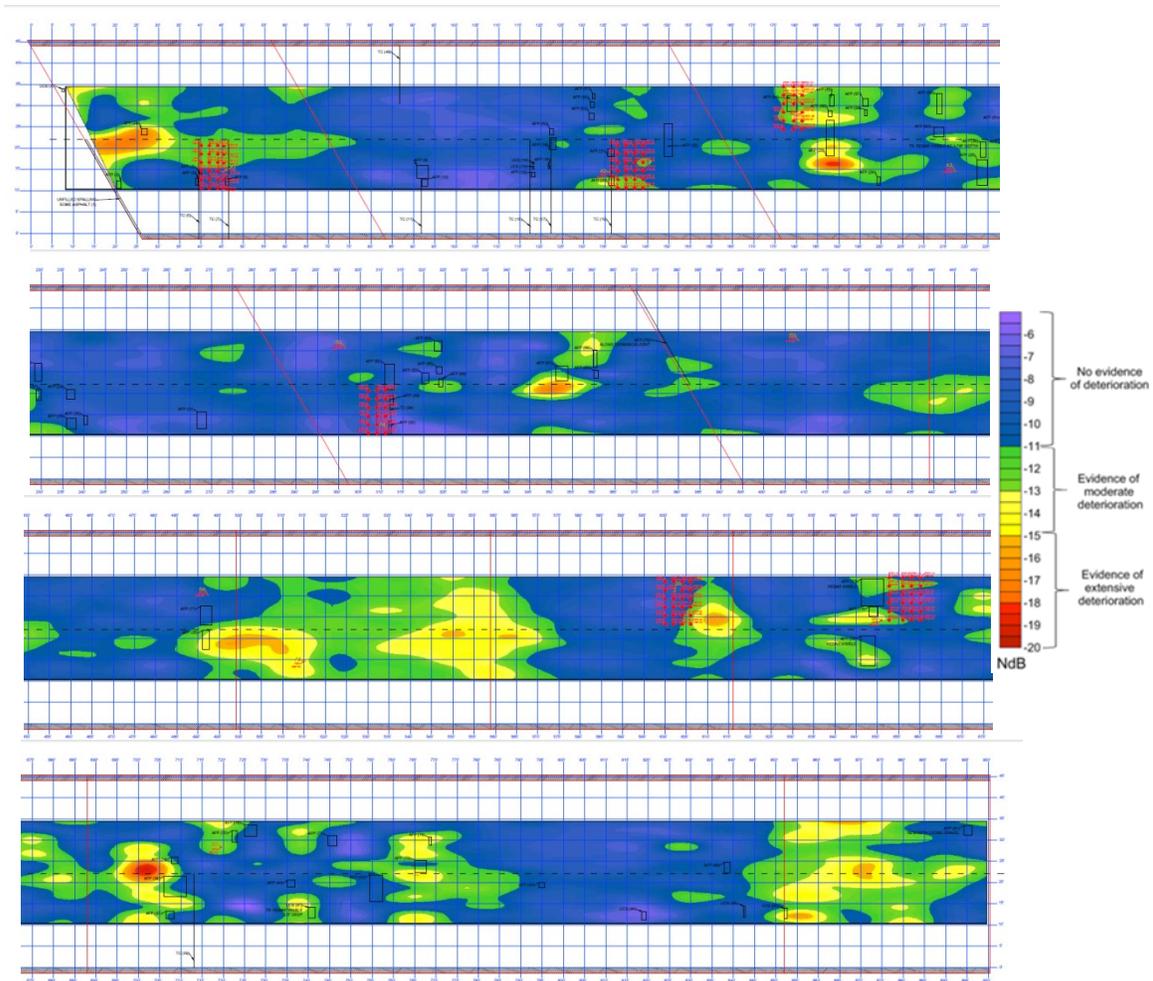
Figure 7-12 GPR Amplitude Map Based on Top Bar Reflection for Bridge Deck A1193 with Superposed Core Locations and Visual Surface Condition Features. Map Sections are Illustrated from Top to Bottom: 0-225 ft., 225-450 ft., 450-675 ft., 675-900 ft.

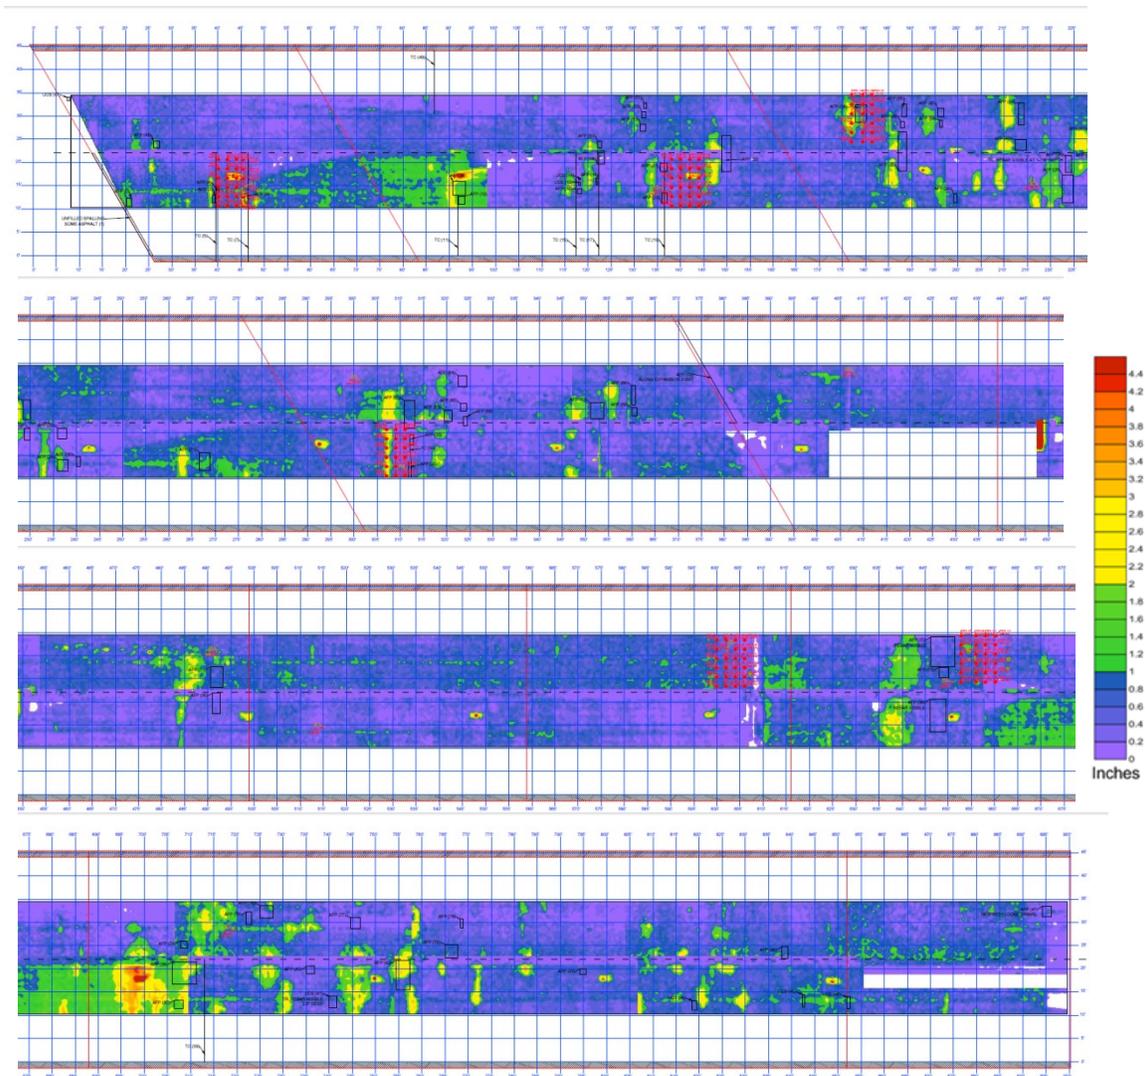
Figure 7-13 Lidar Map Showing Depth of Material Removed After the Hydro Demolition on Bridge Deck A1193. Depth Difference Between Lidar Scan Prior to Hydrodemolition and After Hydrodemolition is Shown in Inches. Map Sections are Illustrated from Top to Bottom: 0-225 ft., 225-450 ft., 450-675 ft., 675-900 ft.

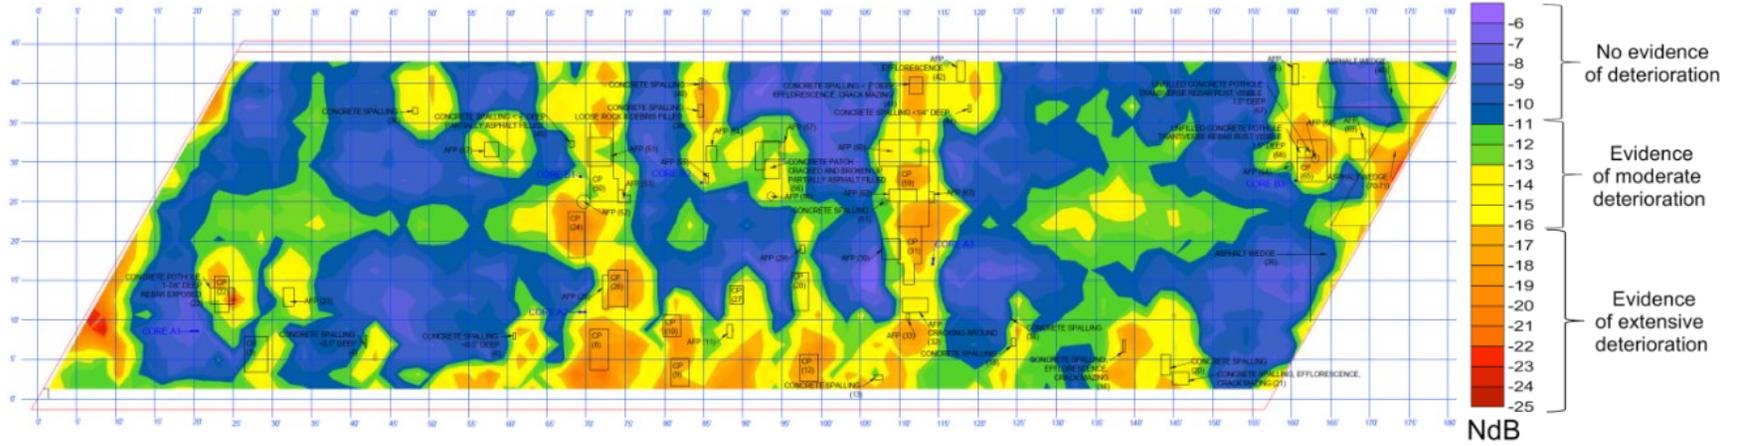
Figure 7-16 GPR Amplitude Map Based on Top Bar Reflection for Bridge Deck A1297 with Superposed Core Locations and Visual Surface Condition Features

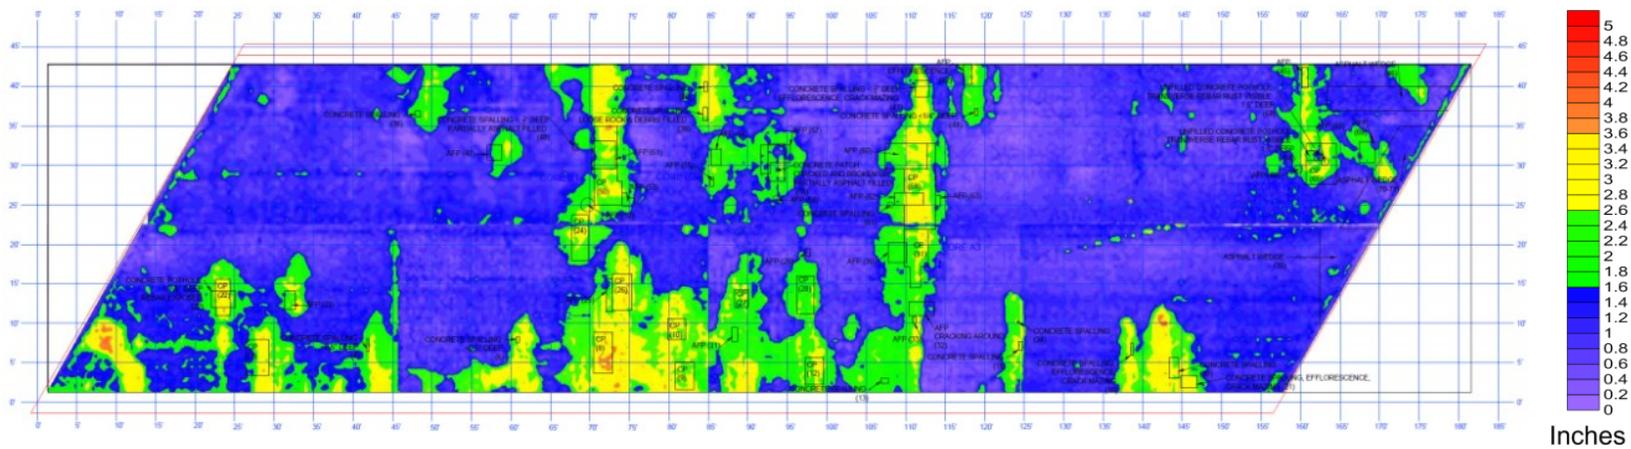
Figure 7-17 Lidar Map Showing Depth of Material Removed After the Hydro Demolition on Bridge Deck A1297. Depth Difference Between Lidar Scan Prior to Hydrodemolition and After Hydrodemolition is Shown in Inches.

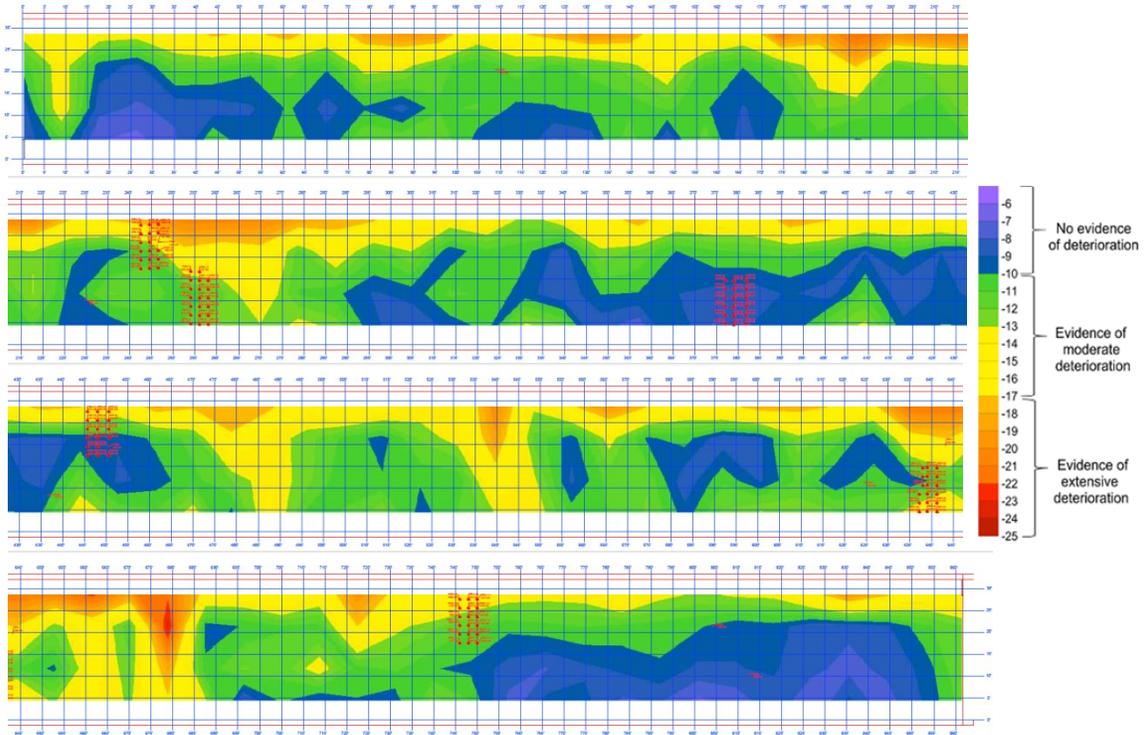
Figure 7-20 GPR Amplitude Map Based on Top Bar Reflection for Bridge Deck A1479 with Superposed Core Locations and Visual Surface Condition Features. Map Sections are Illustrated from Top to Bottom: 0-215 ft., 215-430 ft., 430-645 ft., 645-862 ft.

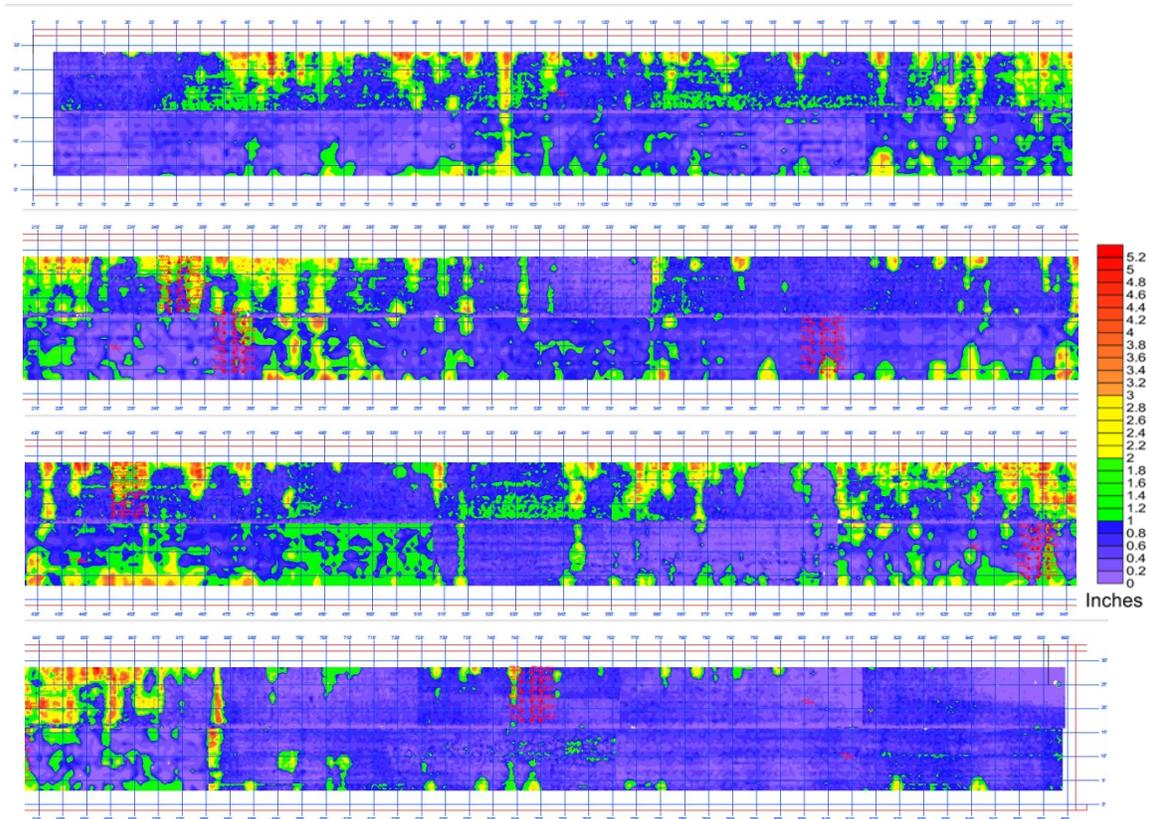
Figure 7-21 Lidar Map Showing Depth of Material Removed After the Hydro Demolition on Bridge Deck A1479. Depth Difference Between Lidar Scan Prior to Hydrodemolition and After Hydrodemolition is Shown in Inches. Map Sections are Illustrated from Top to Bottom: 0-215 ft., 215-430 ft., 430-645 ft., 645-862 ft.
