VALIDATION OF FRP COMPOSITE TECHNOLOGY THROUGH FIELD TESTING

Strengthening of Bridge T-0530 Crawford County, MO

Feb 19, 2004

Strengthening of Bridge T-0530

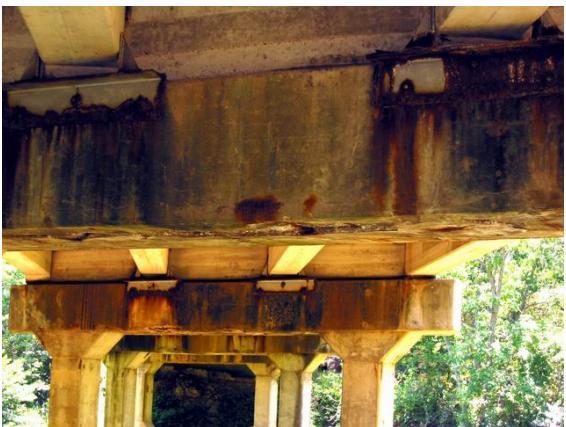
Figure 3. Condition of bents

- Some spalling of concrete along the edges of the bridge was evident. Concrete in beams and deck was in good condition. Minor cracking noticed; however, injection was not needed.
- Piers and abutments were in good condition. Some deterioration exists in the bents due to steel corrosion (Figure 3).

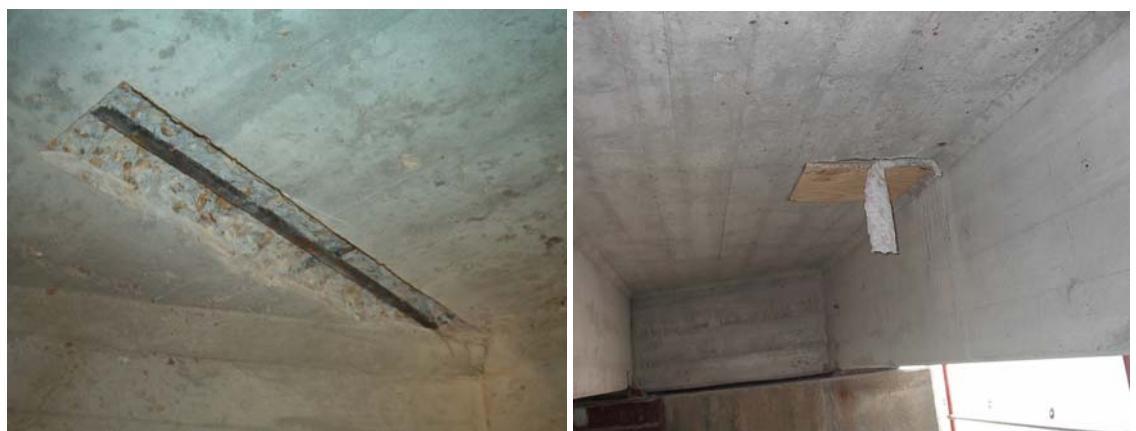
Figure 4. Repair of deteriorated areas on deck.

In order to place CFRP on the underside of the bent system, repair work was done by removing 10 cubic feet (0.28 m^3) of concrete from the deteriorate areas on deck, cleaning this area, installing repair materials, finishing and texturing (Figure 4).

- Partial-depth repairs of deteriorated concrete on deck and bents
- Removal of sound concrete along the deck and girders to establish a suitable surface profile

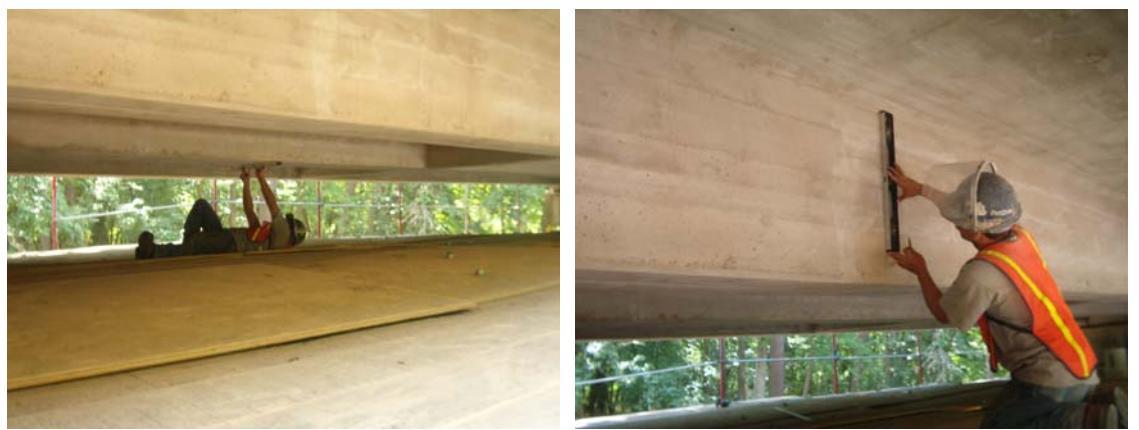
Figure 5. Leveled of surface

To promote continuous intimate contact between concrete and FRP, several important issues had to addressed in the surface preparation: concrete surface irregularities, fins, and/or sharp angles that may result in separation and delamination of carbon laminate from the concrete and/or in localized stress concentration. Concrete surface irregularities were removed and smoothed to less than 1 mm (see Figure 5)

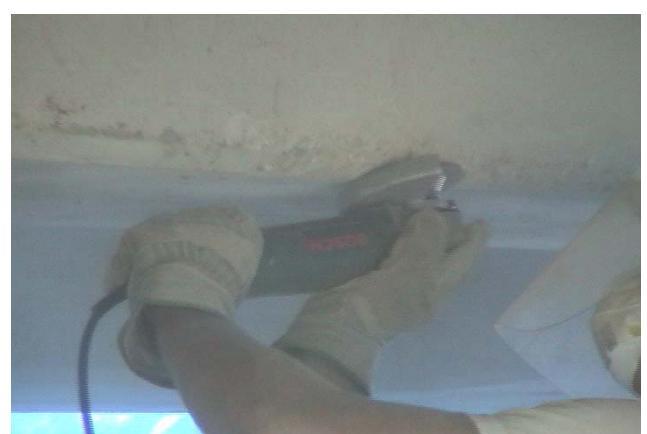
Figure 6. Rounding of corners on girder

Rounding of corners using grinders reduces stress concentration and results in improved bond between the FRP and concrete surface. The concrete angles were rounded to no less than 1/2-inch (12.7 mm) (see Figure 6)

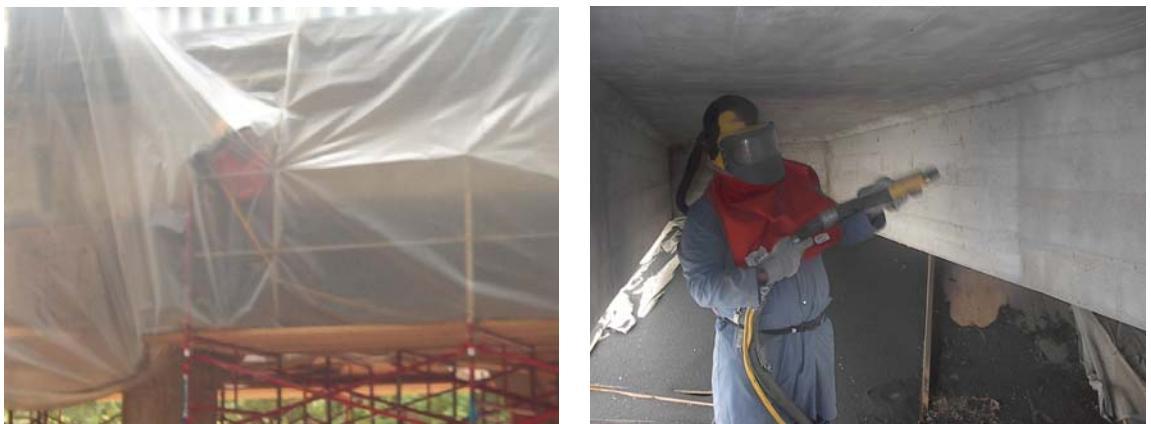
Figure 7. Preparation of appropriate roughness by sandblasting

Abrasive sandblasting was used to clean the concrete surfaces of dust, dirt, laitance, oil and any curing substance. Concrete surface roughness was equivalent to CSP 3 (Concrete Surface Profile number 3) as defined by the International Concrete Repair Institute. The sandblasting must be applied prior to CFRP. All loose particles, oil, dust, cement, paint and other contaminants were contained in accordance with State regulation (Figure 7)

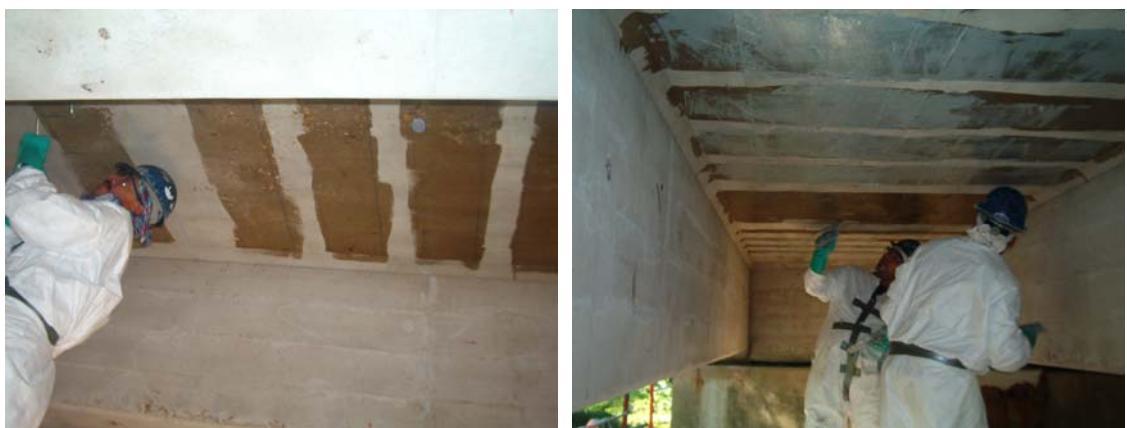
Figure 8. Filling of voids and defects by primer and putty collocation

Two-component epoxy primer (Table 2) was used to fill voids in the concrete surface. All surfaces to receive the carbon fiber fabric were primed with the penetrating primer (Figure 8)

A trowel was used to apply the putty in order to fill any surface defect (Figure 8). The material properties of the primer and putty that were used are listed in Table 2.

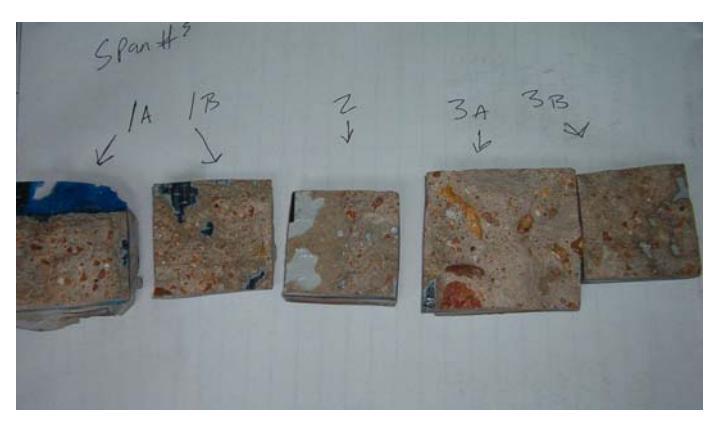
Figure 15. Pull-off test

A direct pull-off test based on ASTM D 4541-93 was used by the contractor in this project. This test allows to check the quality of the installation of the FRP. It consists in gluing an aluminum square plate on the strengthened part to be checked; afterwards, a core is drilled close to the aluminum plate through the laminate strip into the concrete substrate, providing an isolated test location for attachment of the pull-off tester (Figure 15). The tester records the force causing the failure, which, if divided by the core cross sectional area, will result in tensile strength (psi). Upon failure of the core specimen, a visual examination of the failure plane location reveals whether the failure occurred at the bond line or within the substrate. Failure of the concrete and not at the bond line was the only acceptable failure. The tensile bond strength must be more than 200 psi (1.4 MPa). One pull-off test was performed every $200 \text{ ft}^2 (20 \text{ m}^2)$ of area strengthened with carbon fiber strip system or once every deck span.

The results of single tests made on all spans are summarized in table 7. They show values of tensile bond strength bigger than the minimum required. Based on these results and that all failures occurs in the concrete and not at the bond line, installation of FRP was considered successful.
