JOINT KDOT-MODOT: EVALUATION OF FRP REPAIR METHOD FOR CRACKED PC BRIDGE MEMBERS

UTC
R37-R37A-
R63

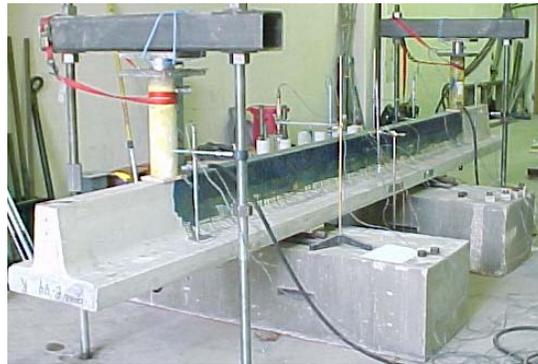
Figure 4-11: Test Set-Up

Direct current voltage transformers (DCVTs) were used to measure the displacement at the supports, load applications, and at the midspan. Strain gages were applied to the FRP at areas of interested to determine the strain in the girders upon loading and at failure. The girders were tested under quasi-static loading conditions. Load cells were placed on top of each hydraulic jack to carry out continuous measurements. All instrumentation was connected to a data acquisition system.

DCVTs were used as shown in Figure 4-11 to record girder deflection. The DCVTs were used to measure total deflection of the girder (Figure 6-7). This was done by taking the average of the deflections at the load points and adding the absolute value to the absolute value of the average of the deflections at the center of the girder. Looking at the results, the load-deflection graph shows that the total deflection at failure was a little over 1.7 inches (43.2mm). The deflection was lower than the analytically calculated value of 2.6 inches (66 mm). The deflection graph was linear for the first 6 kips of applied load. From there, the amount of deflection change kept increasing at a more and more rapid rate as additional load was applied until around 10 kips. From there, the deflection increased at a steady rate until failure.

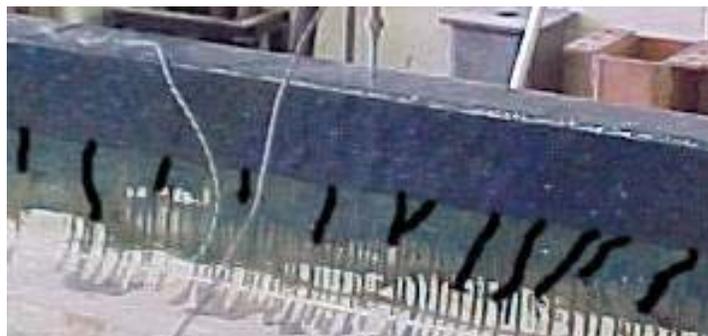
Figure 6-1: 1-UW Shear Failure

Shear. 1-UW strengthened using CFRP U-Wraps was the only girder to clearly experience shear failure, which occurred concurrently with shear U-Wrap debonding (Figure 6-1). Since debonding occurred, the added capacity of the U-Wraps could not be fully utilized. Shear failure consisted of shear cracks developing in the constant shear regions of the girders (between the load knives and the girder supports). Upon initiation, cracks propagated at a 60-degree angle, which is characteristic for prestressed girders. Once a crack propagated through the cross section of the girder, failure occurred as pictured below.

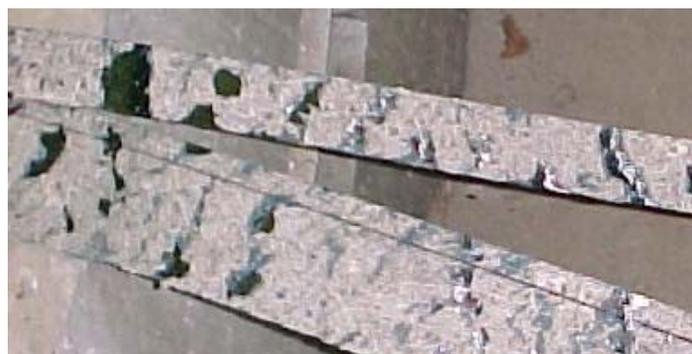
Figure 6-3: Existing Defects on Flexural FRP of 1-Sufficient

6.3.2. 1-Sufficient. 1-Sufficient was strengthened in such a way as to evaluate the effect the quality of FRP installation. The expected failure mode for 1-Sufficient was flexure with a load near 36.8 kips (163.7 kN). Before this load could be reached, however, the girder failed due to FRP debonding. At a load of 26.8 kips (119.2 kN), the three soffit plies debonded from the surface of the concrete. At this point, the girder was unloaded to more closely examine delamination. Upon inspection of the debonded flexural laminates, the defects introduced during installation could clearly be seen.

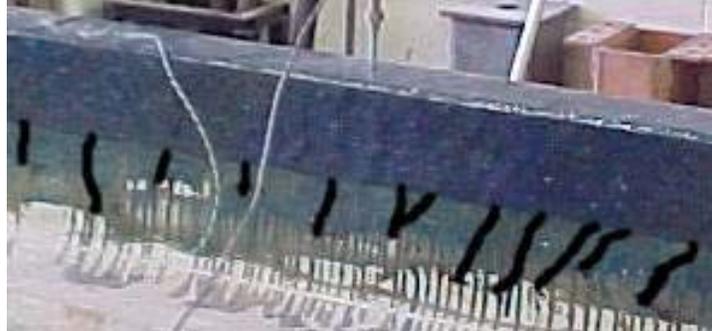
Figure 6-4: 1-Sufficient Shear Cracks

load. Although shear cracks were observed they did not lead to any decrease in load. Upon final inspection of the girder, the concrete substrate showed only small shear cracks.

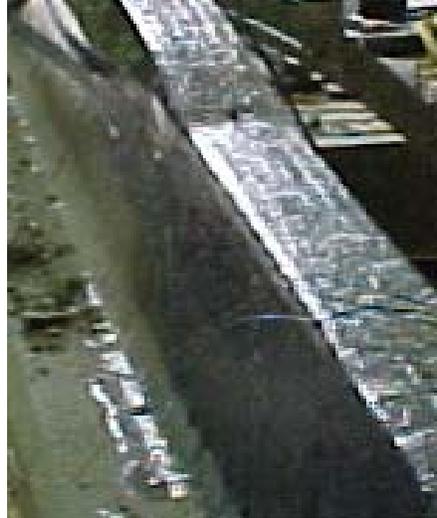
Figure 6-10: Debond Termination in U-Wrapped Anchored Region

During testing, examination of the debonding failure showed the initial areas of debond started towards the midpoint of the girder and propagated outward in both the lateral and soffit plies. The flexural anchorage acted to partially impede the propagation of debonding in the shear zone. In the U-Wrap anchored region the debond propagation terminated at the location of the U-Wrapped anchor (Figure 6-10). In the GFRP anchor region, propagation of the top two soffit plies continued while the bottom, anchored ply remained bonded to the girder (Figure 6-11).

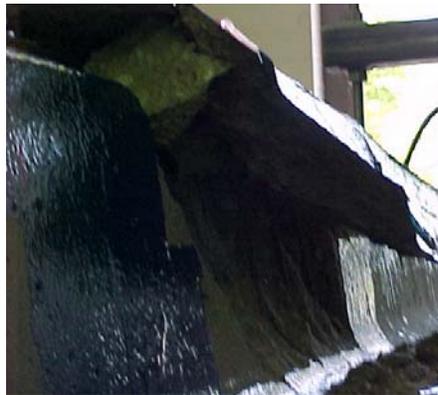
Figure 6-14: 2-Sufficient Shear Crack at Debond

The debonding failure initiated at the midspan of the girder and propagated outward, toward the U-Wrap anchored region where shear effects were greatest (Figure 6-15). Because of significant shear cracks in the U-Wrap anchored region, the debonding ripped the U-Wrapped anchors off the girder with large amounts of concrete still attached to it (Figure 6-14). The characteristic 60-degree crack can also be seen.
