# **IMPLEMENTATION ISSUES OF METALLIC**

# DAMPERS FOR SEISMIC RETROFIT OF HIGHWAY

# BRIDGES

UTC R57

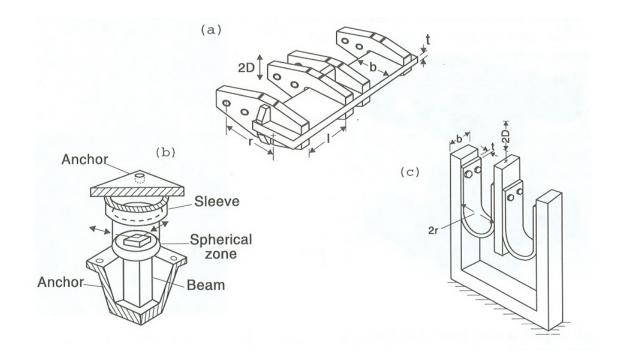
Figure 1.1 Metallic Damper Geometries (Skinner et al. 1975)

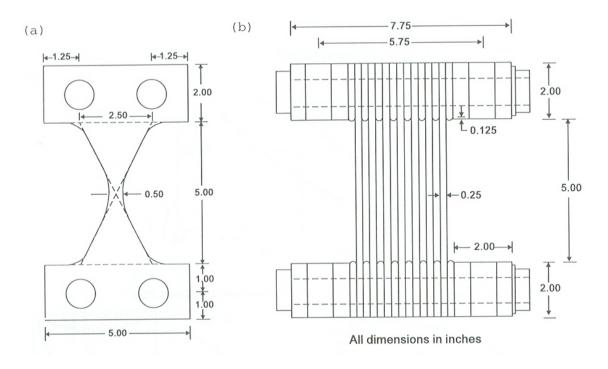
Figure 1.2 ADAS Element Geometry (Whittaker et al. 1991)

Included within Whittaker et al. (1991) was a comprehensive discussion of an experimental program that was performed at the University of California at Berkeley. This particular experiment focused on the evaluation of an X-shaped plate damper known as Added Damping And Stiffness (ADAS) elements. Dimensional characteristics of the ADAS element are presented in Figure 1.2, and an actual ADAS can be seen in Figure 1.3.

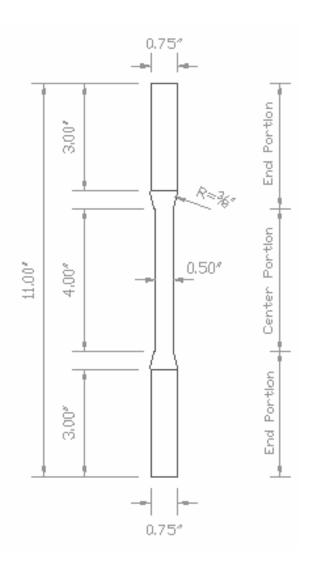
Figure 2.1 Tensile Test Specimen

To guarantee the material properties of HR 1018 would be acceptable, the need to test a small quantity of the material was evident. The size of the three round specimens that were tested in tension ranged from  $\frac{1}{2}$ " (center portion) to  $\frac{3}{4}$ " and they were eleven inches in height. It is schematically shown in Figure 2.1.

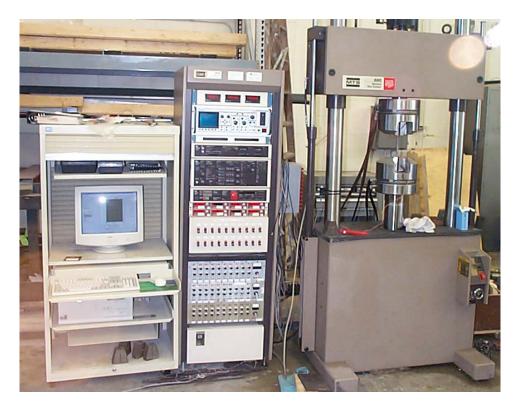
Figure 2.2 MTS880 Testing Machine

Each specimen was tested on the MTS880 Machine located in the Structures Laboratory of the UMR Civil Engineering Building. The two ends of the specimen were connected to the machine with a pair of grips. A load rate of 10 lbs/sec was applied until rupture occurred for the specimen. A picture of the test setup can be seen in Figure 2.2. The MTS880 Machine has an internal load cell and an internal Linear Variable Differential Transducer (LVDT), measuring the tensile load applied to the specimen and its corresponding displacement elongation, respectively. Since the potential slippage at the grips will result in reading larger than the actual deformation of the tested specimen, a strain gauge was attached to the center portion of the specimen for direct measurement of strain.

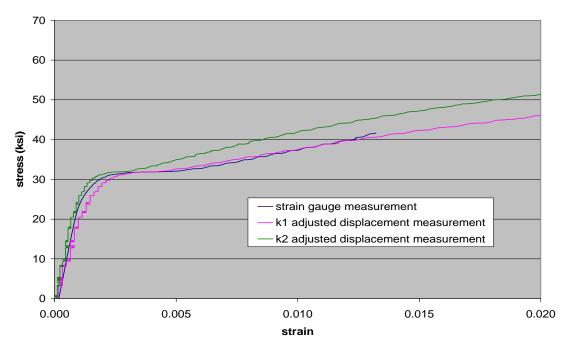
Figure 2.3 Tensile Test Specimen #1

As expected from low carbon steel, results show the yield stress was low and the ductility was high, even though hardening of the materials is gradual over a wide range of strain. This is in general acceptable for the applications, especially in the strain range of up to 0.02. Figure 2.6 also shows that the variability of the material properties is very small. The yield strength of the material is 32 ksi as specified in the Structural Alloys Handbook (1996).

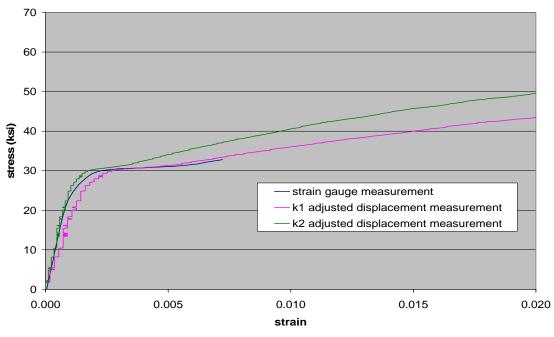
Figure 2.4 Tensile Test Specimen #2

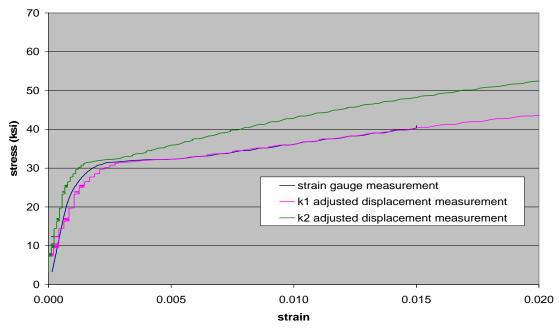
Figure 2.5 Tensile Test Specimen #3

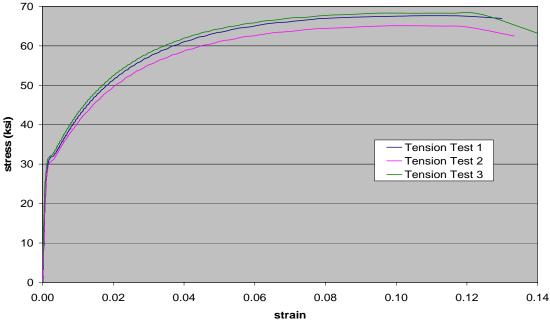
Figure 2.6 Tensile Test Comparison

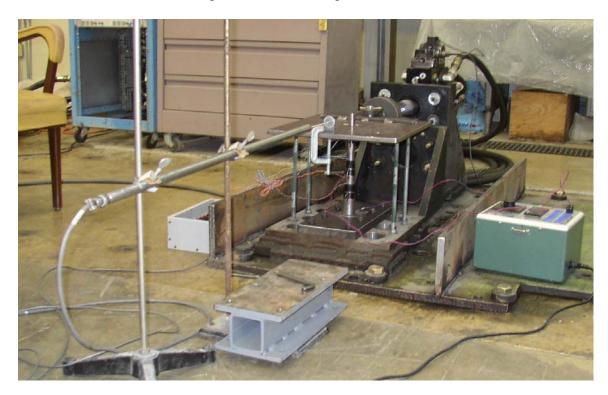
Figure 2.9 Test Setup and Instrumentation

Testing of the tapered steel rods took place at the High Bay Structures Lab in the Civil Engineering Building. The base of the rod was held fixed to the floor while the top of the rod was directly connected to the 20 kip actuator. Using the 20 kip actuator and an input signal from the MTS 407 Controller, a sinusoidal displacement controlled loading was applied to the tapered steel rods with the predetermined displacements. The MTS 407 input control screen used to manipulate the actuator can be seen in Figure 2.11. The frequency of the applied sinusoidal loading was entered into the MTS 407 Controller along with the number of cycles to be performed at a time. The number of cycles performed at a time was limited in order to reduce the temperature increase in the steel, depending on the displacement level. Thermal readings were continuously monitored at two locations on the steel, and the time between tests varied to avoid any excessive temperature rise in the specimen. The location of highest stress and 1.5" from the bottom were monitored for temperature, which were the same positions as the lower two strain gauge locations seen in Figure 2.8.

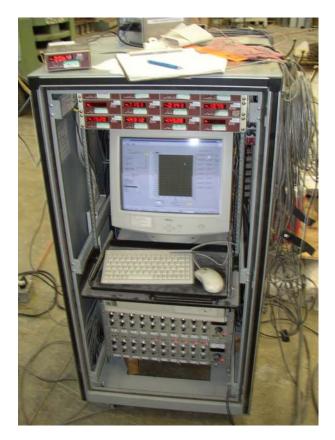
Figure 2.10 Data Acquisition Unit

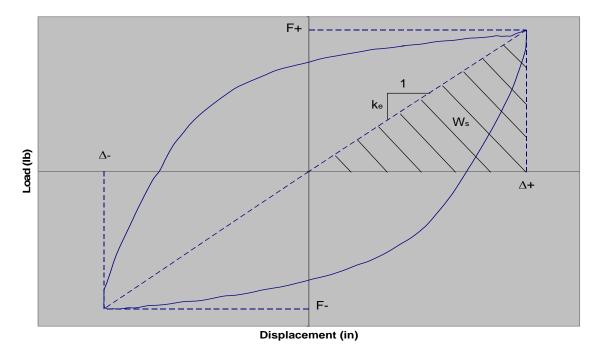
Figure 2.12 Typical Hysteresis Loop

in which  $W_s$  is the elastic energy associated with the effective stiffness and the maximum displacement, representing the shaded triangular area in Figure 2.12.

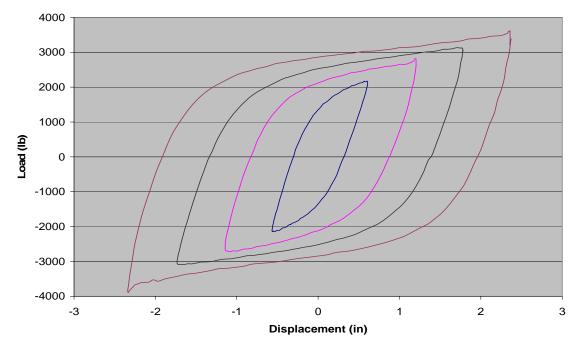
Figure 2.13 Hysteresis Loop Comparison

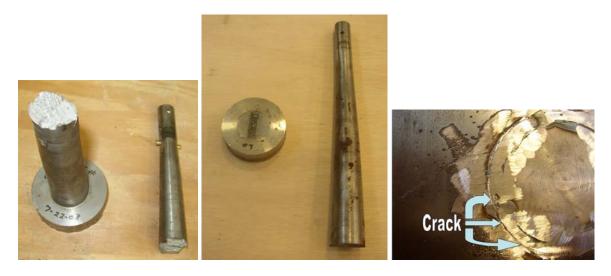
- (a) Fracture at location of highest stress
- (b) Fracture at the base of the rod
- (c) Crack in the rod to base weld

Figure 2.14 Failure Modes

which held the specimen to the base plate as can be seen in Figure 2.14(c). These results were likely attributable to two reasons. The stress at the base of a cantilevered rod is approximately 89.6% of the maximum stress at the theoretically failed location in the elastic range. As the rod is further loaded, the maximum stresses at the two locations becomes closer, for instance, 92.4% corresponds to a load of 3.1kip as will be discussed in Section 3.3 with a finite element model. More likely the stress reduction as a result of sudden cracking in the rod-to-base weld is significantly larger at the theoretically-fractured location. It is therefore important to create a quality weld for this connection.

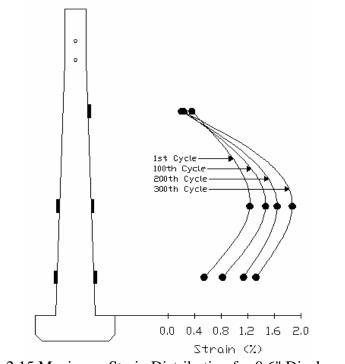
Figure 2.15 Maximum Strain Distribution for 0.6" Displacement

The strain distribution along the length of the tapered rod, determined with the assistance of strain gauges having locations as seen in Figure 2.8, is as expected. The actual strain distribution can be seen in Figure 2.15 for a test having a constant displacement amplitude of 0.6". The maximum strain for the 1<sup>st</sup> cycle is 1.23%. Noticed is the fact that the percent increase in strain from the 1<sup>st</sup> to the 300<sup>th</sup> cycle is 144% from the bottom strain gauge and only 52% from the middle gauge. This drastic change in strain could be a contributing factor causing some rods to fail at the base instead of the middle. To better understand the change of strain distribution with the number of cycles, the strain range and average strain are presented in Figure 2.16. It is noted that the applied load in the displacement-controlled test decreases after the 1<sup>st</sup> cycle due mainly to the slack in the test apparatus.

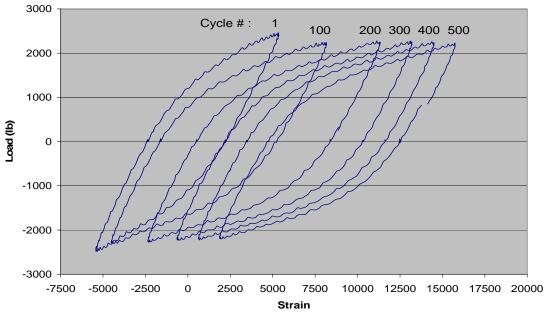
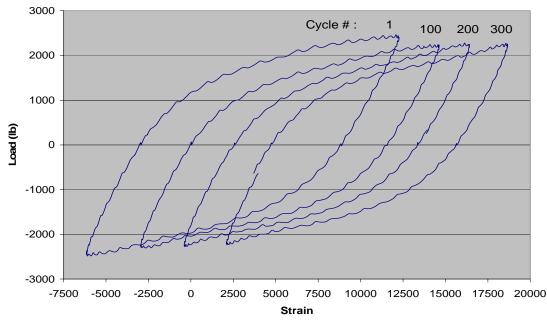
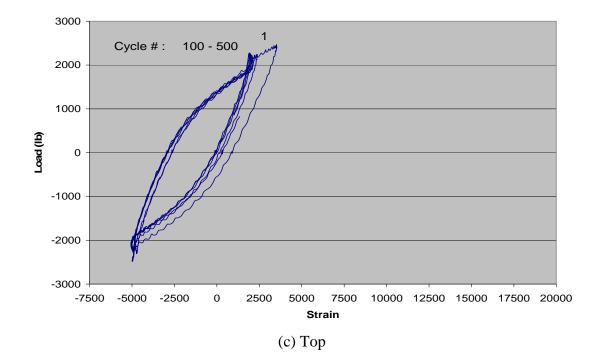
(a) Bottom

(b) Middle

Figure 2.16 Strain Movement for Given Location

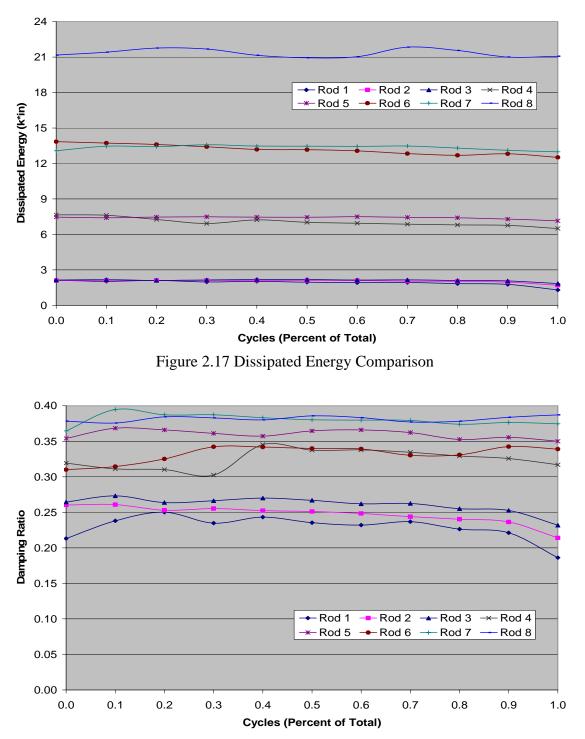
Figure 2.18 Damping Ratio Comparison

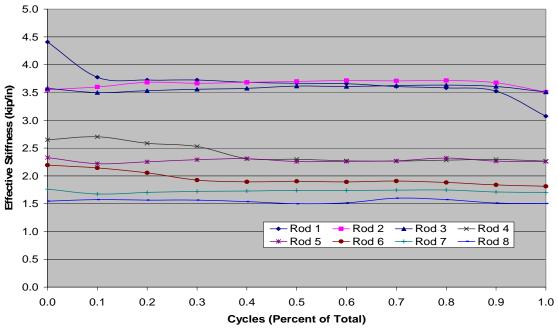
Figure 2.19 Effective Stiffness Comparison

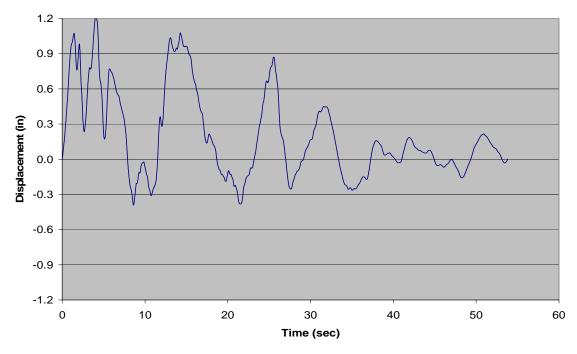
Figure 2.20 Reduced Amplitude Displacement Time History of El Centro Earthquake

Understanding how the tapered energy dissipaters will behave during an actual seismic event is of engineering importance. To do this, two different tests were performed using existing earthquake records. The first test utilized the North-South component of displacement from the 1940 El Centro, California, Earthquake and the second test used the North-South component of displacement from the 1994 Northridge, California Earthquake. The actual displacement time histories can be seen in Figure 2.20 and Figure 2.21.

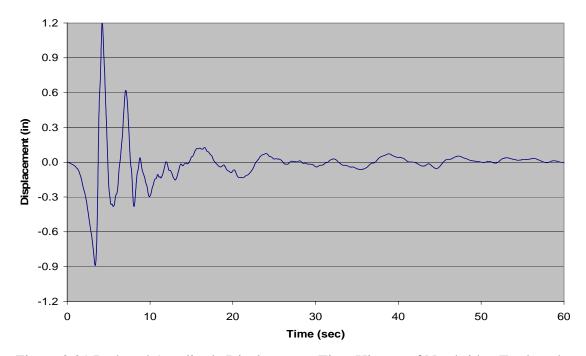
Figure 2.21 Reduced Amplitude Displacement Time History of Northridge Earthquake

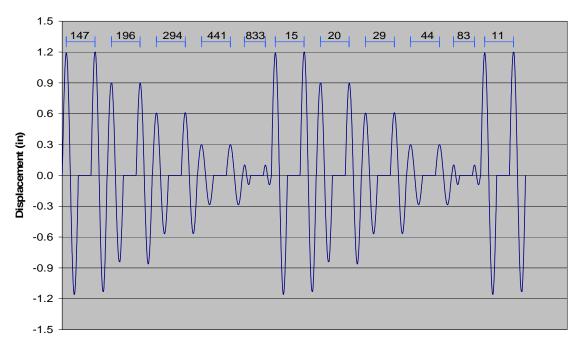
Figure 2.22 Displacement History Corresponding to El Centro Earthquake

Testing continued in this fashion until 10% of the total number of cycles was applied at the 0.1" displacement level, again for both specimens. Then testing went back to the 1.2" displacement level, where the ultimate failure of both test specimens occurred. At this level, failure occurred after completion of 11 cycles of the El Centro loading and after 10 cycles of the Northridge loading. This demonstrates the fact that the initial estimate of fatigue life presented in Table 2.5 is consistently off by slightly more than 10%. The fatigue life was underestimated by approximately the same amount for both earthquake records. A graphical representation of the entire loading sequence can be seen in Figure 2.22 and Figure 2.23, corresponding to the two earthquake records, respectively. Along the top of each plot are the cycle counts at each level.

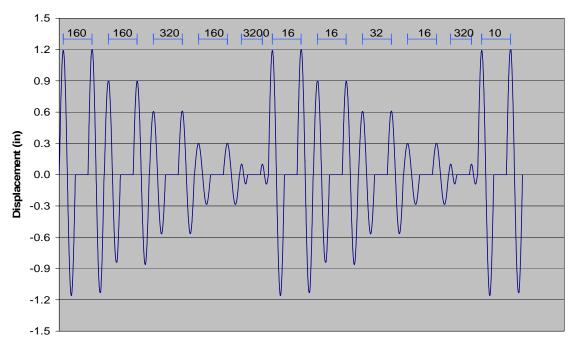
Figure 2.23 Displacement History Corresponding to Northridge Earthquake

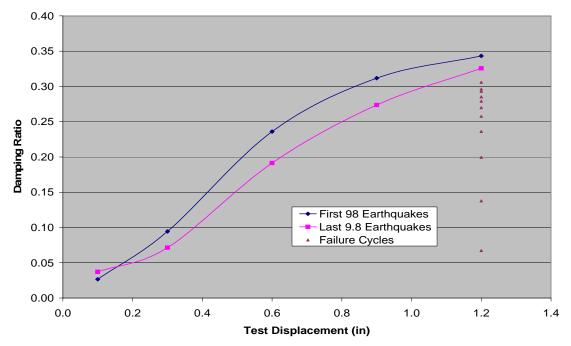
Figure 2.24 Damping Ratio Corresponding to El Centro Loading

Table 2.5. The light solid line represents the design parameter during application of the additional 10% total cycles, Table 2.6. Also shown is the design parameter during the last few cycles leading up to failure at the 1.2" displacement. It can be clearly seen from Figure 2.24 - Figure 2.27 that the stiffness of the rod degrades slightly after it was subjected to the number of cycles, equivalent to approximately 90% of the fatigue strength. This result is likely due to the residual plastic deformation from previous tests. Consequently the damping ratio seems to decrease when comparing the two curves. It is also seen that the degradation of stiffness is dramatic in the last few cycles due to fracture failure.

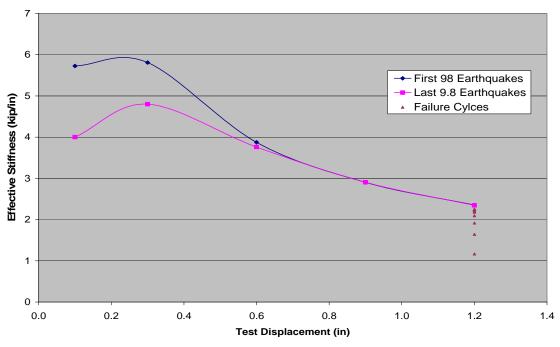
Figure 2.25 Effective Stiffness Corresponding to El Centro Loading

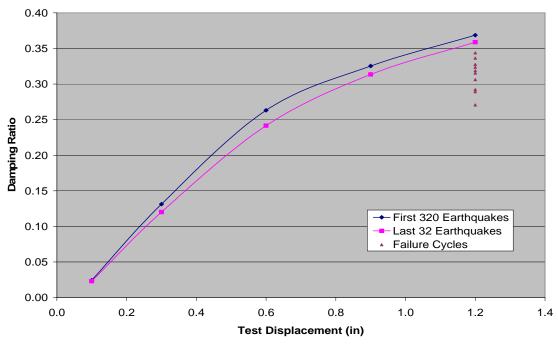
Figure 2.26 Damping Ratio Corresponding to Northridge Loading

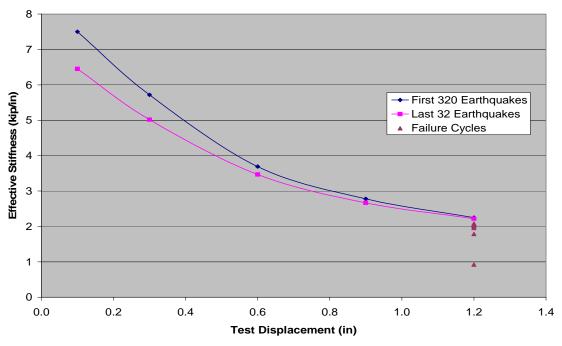
Figure 2.27 Effective Stiffness Corresponding to Northridge Loading

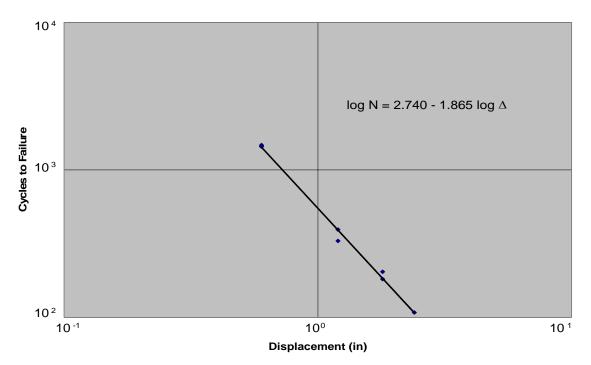
Figure 2.28 Validation of  $\alpha$  and  $\beta$

Because the initial estimate for the fatigue life was off by 10% for both tests an issue was raised concerning the accuracy of the constants determined  $(\alpha,\beta)$  used in the equation to calculate fatigue life (N). These constants were found using only the results from the 0.6" and 1.2" displacement levels. After the second round of testing was complete it was possible to make use of all eight regular loading tests. To re-calculate the constants  $(\alpha,\beta)$  a log-log plot of cycles to failure vs. displacement was generated to validate the constants, as seen in Figure 2.28.

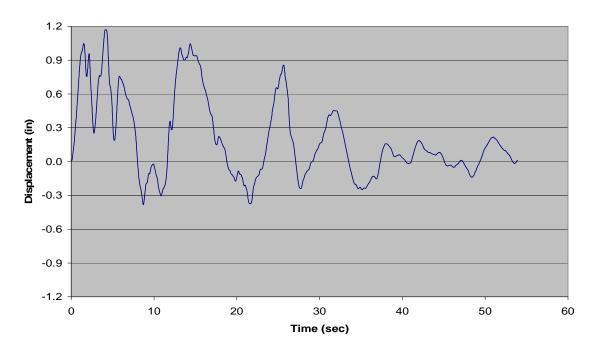
Figure 2.29 Recorded Displacement Time History Corresponding to the 1940 El Centro Earthquake

The recorded displacement time histories are plotted in Figure 2.29 and Figure 2.30, respectively, for the El Centro and Northridge earthquakes. They are the same as those in Figure 2.20 and Figure 2.21 except a slightly reduced peak value due to the dynamics of the work station and the hydraulic actuator.

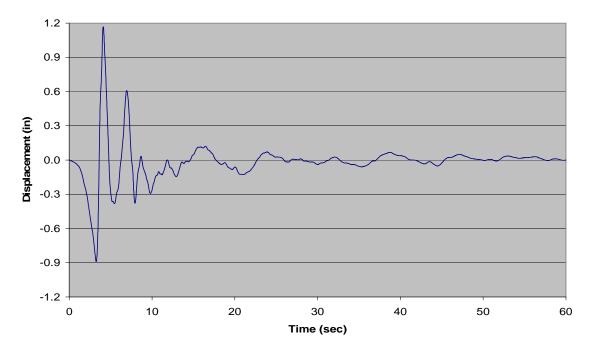
Figure 2.30 Recorded Displacement Time History Corresponding to the 1994 Northridge Earthquake

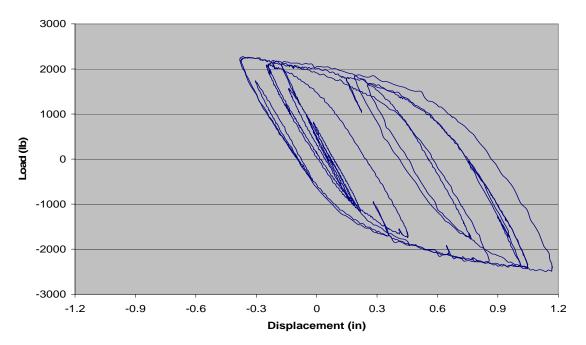
Figure 2.31 Hysteresis Loops under Reduced El Centro Earthquake (First Cycle)

The load vs. displacement plots are presented in Figure 2.31 and Figure 2.32 for the first applied cycle and for a cycle just before failure, respectively, under the modified El Centro earthquake. Similar curves are shown in Figure 2.33 and Figure 2.34 under the excitation of the modified Northridge earthquake. It can be seen from Figure 2.31 - Figure 2.34 that the hysteresis loops remain very much unaltered throughout the life of the specimen. This agrees with the results from the regular and irregular loading case results.

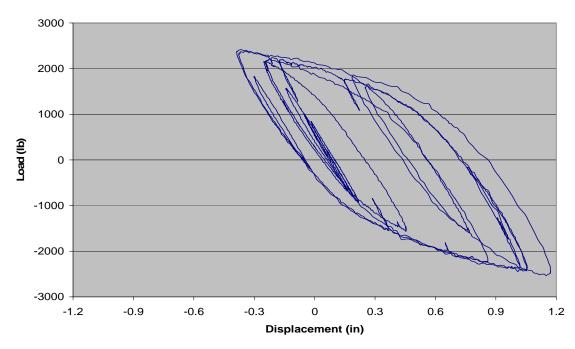
Figure 2.32 Hysteresis Loops under Reduced El Centro Earthquake (Just Before Failure Cycle)

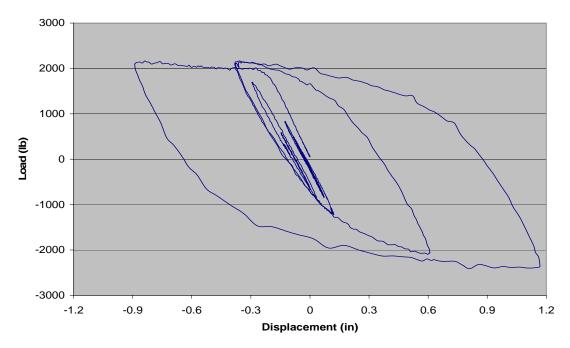
Figure 2.33 Hysteresis Loops under Reduced Northridge Earthquake (First Cycle)

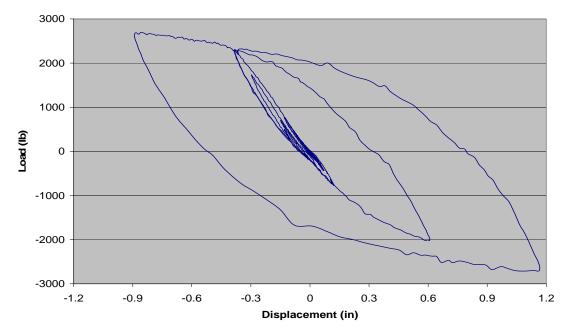
Figure 2.34 Hysteresis Loops under Reduced Northridge Earthquake (Just Before Failure Cycle)

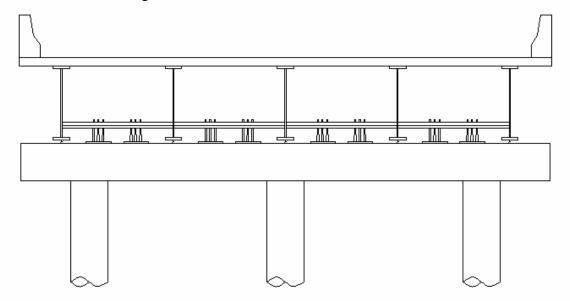
Figure 3.2 Installation of Metallic Dampers

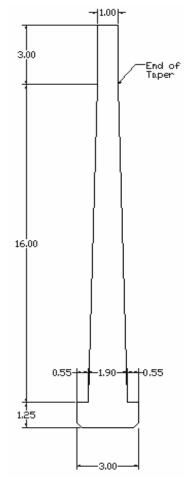
Figure 3.4 Selected Member for Retrofit Design

The selected member size can be seen in Figure 3.4. The largest diameter along the tapered portion of the rod is 1.9", and it has a total height along the tapered section of 16.0". The smallest diameter along the tapered portion is set to 1.0" so that the maximum stress occurs approximately at the middle height of the rod. This is derived as follows.

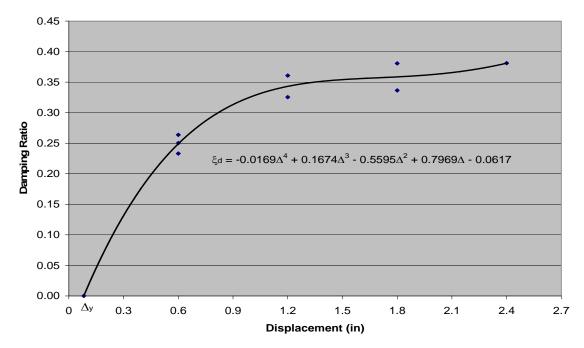
Figure 3.8 Damping Ratio

where  $\Delta$  is defined as the displacement under consideration. The yielding displacement of the rods ( $\Delta_y$ ), shown in Figure 3.8, is equal 0.082", which follows a calculation similar to the one to be summarized by Equation (3.78).

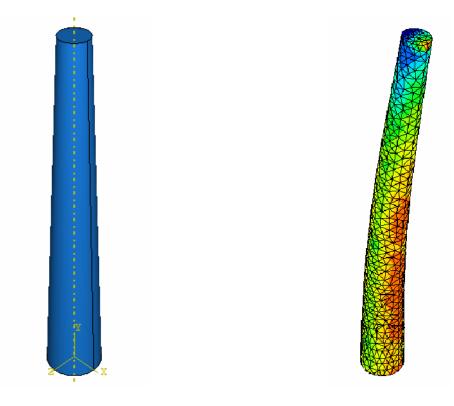
(a) Undeformed Shape

Validation of the results found using ABAQUS had to take place before the results could be entirely trusted. Therefore, a model was created in ABAQUS, Figure 3.9, that exactly matched the previously tested specimens size and shape, Figure 2.7. Figure 3.9 displays both the undeformed and the deformed shapes. The mesh, used for the finite element analysis, and the stress contours are visible within the deformed shape. The mesh was created with 16 seeds around the diameter and 30 seeds longitudinally, which created 674 nodes and 2311 linear tetrahedral elements. The material was defined with E = 29000ksi and v = 0.3, following the k<sub>2</sub>-adjusted stress-strain relation shown in Figure 2.3.

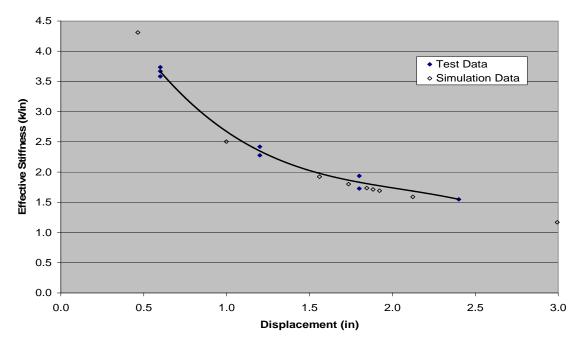
Figure 3.10 Effective Stiffness of the Tested Specimens

An analysis was performed to see how closely the results given by ABAQUS resembled the actual effective stiffness results. Both the test data from Table 2.2 and the numerical simulation results are presented in Figure 3.10. It is clearly seen from Figure 3.10 that, for a given displacement, the corresponding effective stiffness value from ABAQUS is accurate. Therefore, the analysis of any member with varying dimensions could be performed with a similar ABAQUS model and the corresponding results can be used for design.

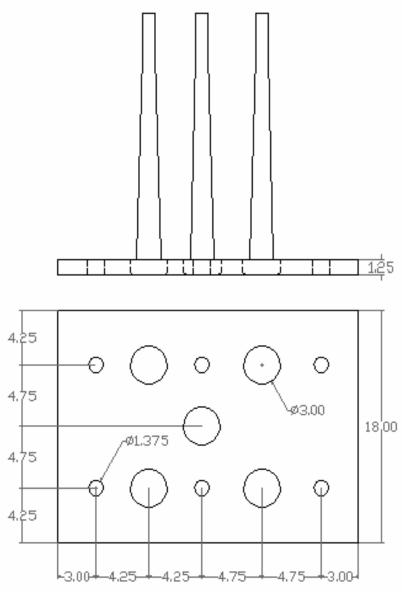
Figure 4.1 Five Rod Specimen

The retrofit design for the existing bridge under consideration provided the exact size and number of metallic dampers that would be required for the structures survival. This was discussed in Section 3. There are to be eight dampers of five rods on each of two intermediate bents. For testing purposes, the "full scale" refers to one of these sets of five rods. Testing one group provides the information required to validate the rod's energy dissipating abilities, but also the sufficiency of the connection. The actual rod size can be seen in Figure 3.4, but the five rod arrangement can be seen in Figure 4.1. This figure includes the layout of the base plate. This includes the dimensions for the bolt hole pattern, which match the existing pattern on the push beam to which it will be bolted.

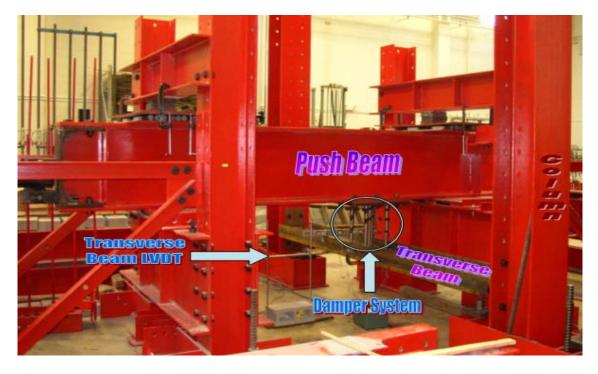
Figure 4.3 Overall Test Setup

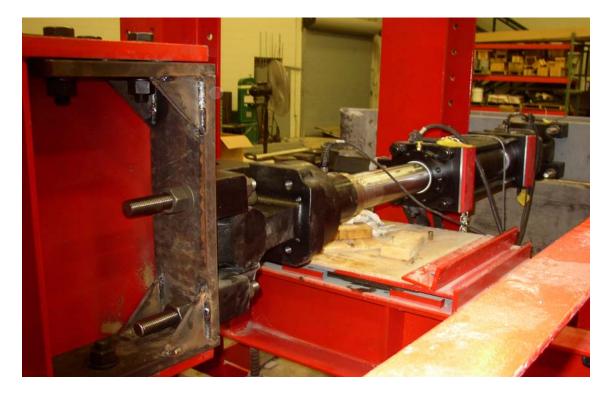
Figure 4.4 Actuator

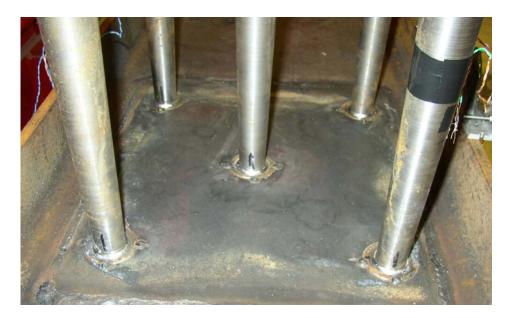
Figure 4.5 Ball Joint Connections

The tops of the rods are inserted through the web of the transverse beam, which is held fixed by a shear connection to columns on either side. For testing purposes, ball joints were welded into the web of the transverse beam to house the top ends of the dampers. This ball joint connection gives a smoother connection between the two components, which allow enhanced performance of the damper. This connection can be seen in Figure 4.5 with a close up in Figure 4.6. The actuator sends the push beam in the longitudinal direction with a predetermined displacement, the base of the specimens move with the beam, and the top of the rods are held in a fixed position due to restraint from the transverse beam. A closer view of how the push beam, five rod damper, and transverse beam interact can be seen in Figure 4.7.

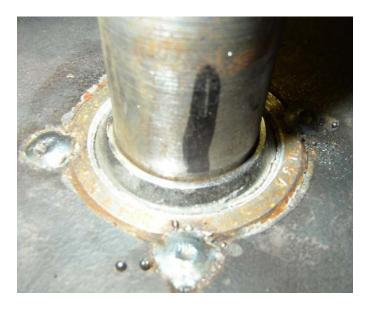
Figure 4.6 Ball Joint Close Up

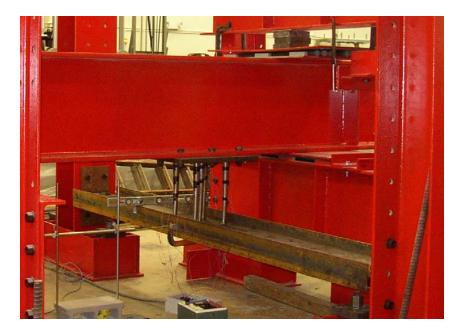
Figure 4.7 Test Components Interaction

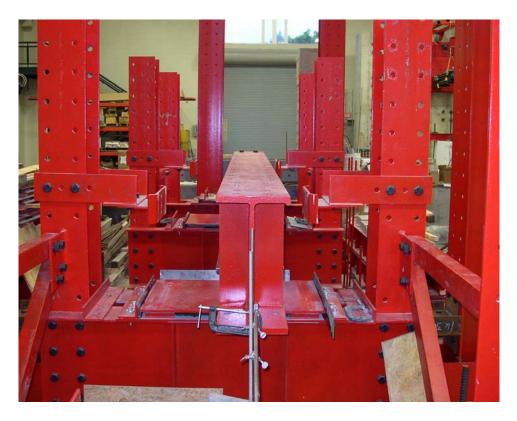
Figure 4.8 Longitudinal View of Incomplete Test Setup

A total of twelve strain gauges were applied along the length of various members in the plane of bending. The load applied was measured by an internal load cell within the actuator. The displacement of the system was measured using two different means; an internal LVDT included in the actuator and an external LVDT that was directly connected to the end of the push beam. Even though the transverse beam was economically designed to allow a miniscule amount of deflection during loading, the actual amount of deflection was measured using an external LVDT. In order to take this into account, during analysis this deflection is subtracted off of the total deflection. All data was recorded at 64 data points per second by a data acquisition unit, which can be seen in Figure 2.10. A side view of the test setup can be seen in Figure 4.3, but another view of the test setup can be seen in Figure 4.8. For a better view of the overall setup, this figure shows the test setup in the longitudinal direction without the vertical restraints on the push beam. The external LVDT is in line with the push beam and can be seen at the bottom of Figure 4.8.

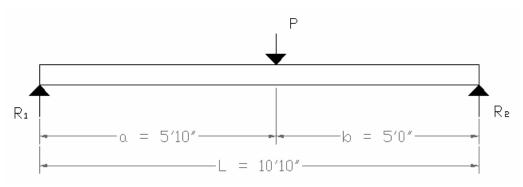
Figure 4.9 Simply Supported Beam

It is noted that the applied load from the actuator is not directly in the center of the beam due to the use of existing dywidag bar holes in the strong floor of the UMR structures lab.

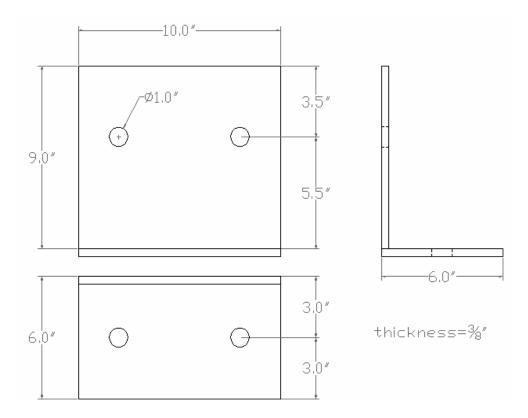
Figure 4.10 Angle Connector Schematic

For the test setup, the design for the bolt connection between the transverse beam and the columns is typical. It is simulated as a pin-pin connection. It must be able to resist the shear force generated and pass all the requirements of a bolt connection. Due to the existing bolt holes on the column and the size of the transverse beam, the basic geometry of the angle connector plates were defined before any design took place. The chosen plate thickness is 3/8". The size and type of the bolts were also defined due to a supply of bolts being purchased previously. The fasteners are 1.0" diameter A325 bolts having the threads included in the shear plane. The two legs of the angle connector can be seen schematically in Figure 4.10. The actual top connector on one side of the transverse beam can be seen in Figure 4.11. It is made of A36 steel.

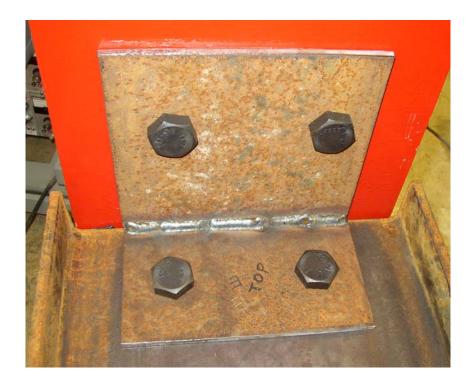
Figure 4.11 Actual Angle Connector

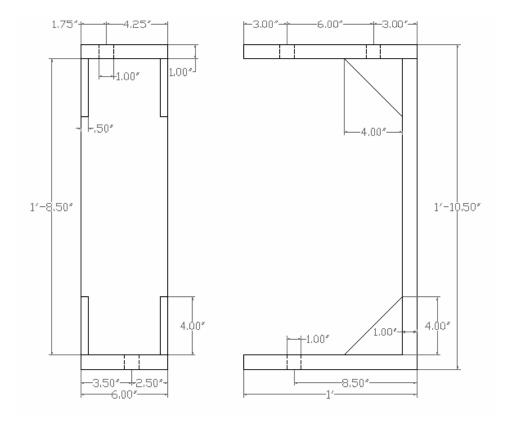
Figure 4.12 Connection Schematic

Initially the existing push beam did not have any way to connect directly to the actuator. Therefore a feasible way to connect them had to be designed, while again understanding that the bolt hole pattern and bolt type were already established. The connection schematic, showing all relevant dimensions, can be seen in Figure 4.12. The actual connection can be seen in Figure 4.13. The angle stiffeners at the corners are intended to minimize any deflection that may have existed.

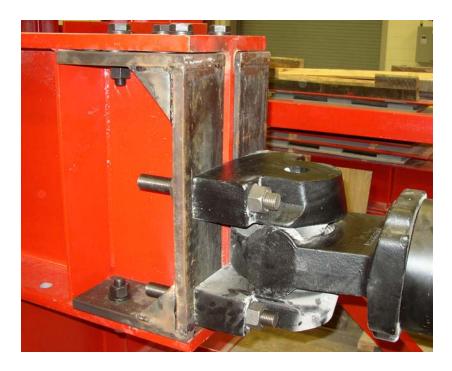
Figure 4.13 Actual Connection

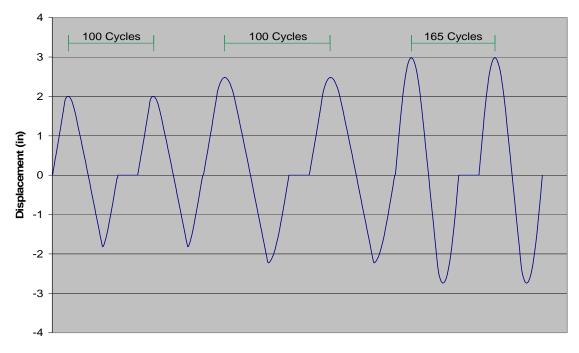
Figure 4.16 Full Scale Test Load History

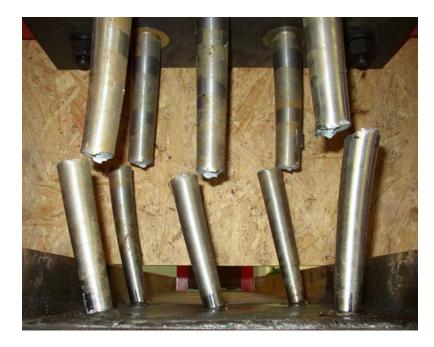
Figure 4.17 Damper/System Failure

Unlike the single rod fatigue test results, all five rods in the full-scale damper failed around mid heights of the rods as seen in Figure 4.17. Since all connecting structural components such as transverse beam and connectors, remain intact, the damper failure is equivalent to the failure of the damper and its supporting structural system. The average value for the actual failure location of the damper is  $x_{failure} = 7.1$ ", measured from the top of the tapered rods. This is close to the theoretically predicted location in Section 3.2.2,  $x_{max} = 8.889$ ". The difference is in part attributable to the fact that the load on the damper was applied slightly above the end of the tapered portion of the rods, which results in a slightly higher moment on the rods. It may also be attributable to the out-of-plane (vertical) motion of the transverse beam that was observed during the test. The vertical deflection of the transverse beam changed the length of the steel rods and thus the stress distribution in the rods. This effect can be eliminated by increasing the out-of-plane rigidity of the transverse beam.

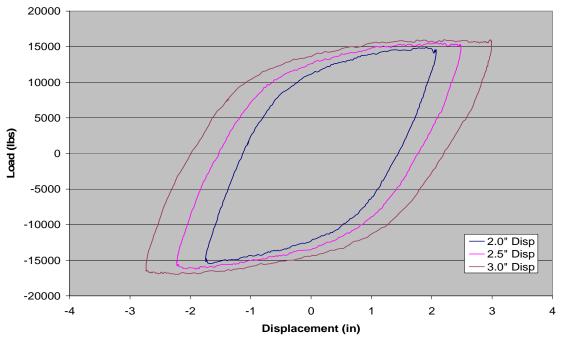
Figure 4.18 Full Scale Hysteresis Loop Comparison

Three typical hysteresis loops corresponding to the three different displacement levels in Table 4.2 can be seen in Figure 4.18. Once again, the hysteresis loops were developed steadily as the applied displacement increases.

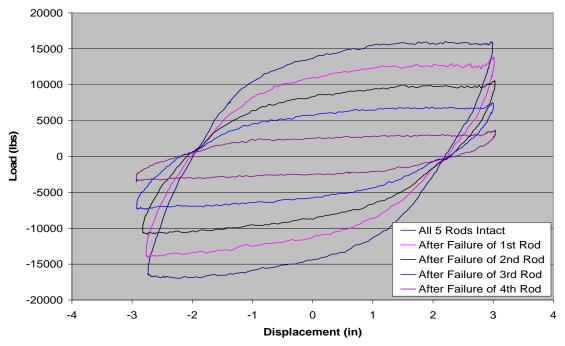
Figure 4.19 Hysteresis Loop Comparison During Failure Cycles

The hysteresis loops in Figure 4.19 illustrate the decline in the energy dissipation capabilities of the five-rod damper after the rods begin to fail. This decline is expected, obviously due to the reduction in the number of energy dissipating elements.

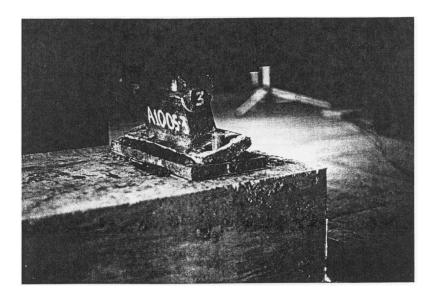
Figure 5.1 Bearing A1005 (Barker and Hartnagel 1997)

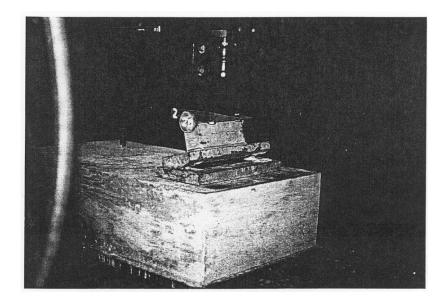
Figure 5.2 Bearing A860 (Barker and Hartnagel 1997)

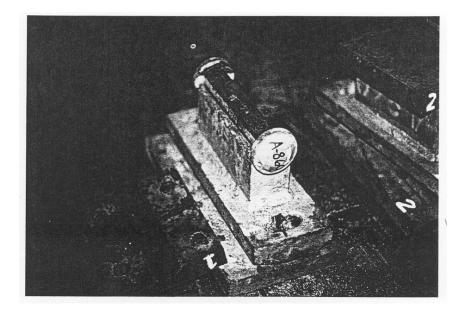
Figure 5.3 Bearing A860 (Barker and Hartnagel 1997)

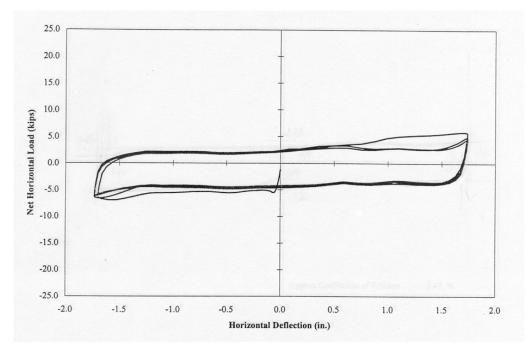
Figure 5.4 First 3 Cycles of a Mildly Deteriorated A860 Bearing (Barker and Hartnagel 1997)

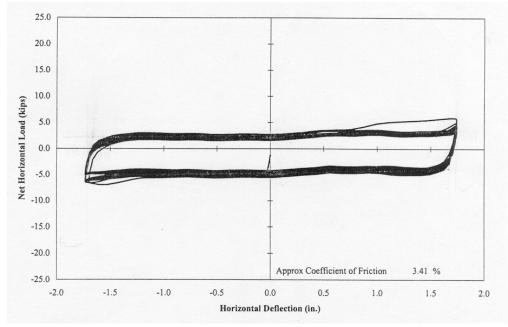
Figure 5.5 First 40 Cycles of a Mildly Deteriorated A860 Bearing (Barker and Hartnagel 1997)

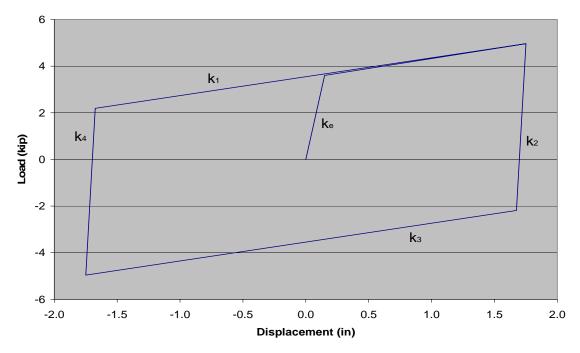
Figure 5.6 Analytical Model for Mildly Deteriorated Bearing A860 and L Series

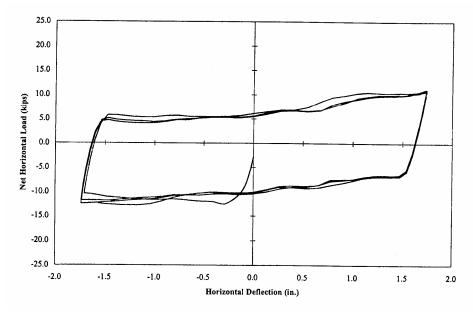
Figure 5.7 First 3 Cycles of a Mildly Deteriorated A1005 Bearing (Barker and Hartnagel 1997)

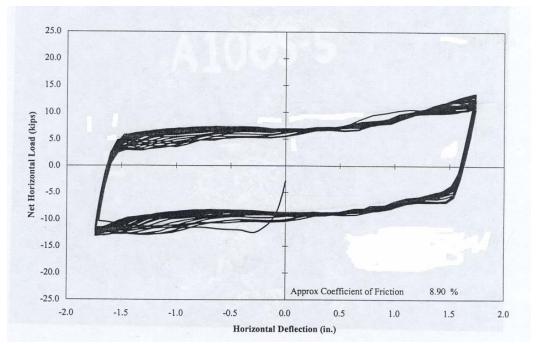
Figure 5.8 First 40 Cycles of a Mildly Deteriorated A1005 Bearing (Barker and Hartnagel 1997)

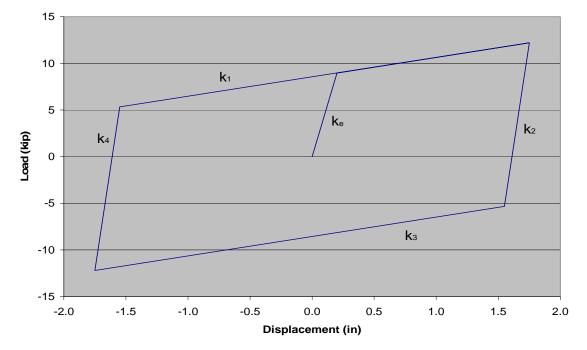
Figure 5.9 Analytical Model for Mildly Deteriorated A1005 Bearing

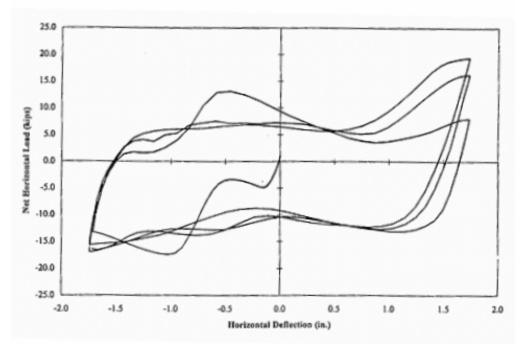
Figure 5.10 First 3 Cycles of a Heavily Deteriorated A1005 Bearing (Barker and Hartnagel 1997)

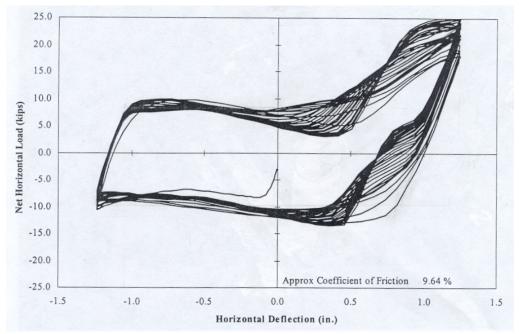
Figure 5.11 First 40 Cycles of a Heavily Deteriorated A1005 Bearing (Barker and Hartnagel 1997)

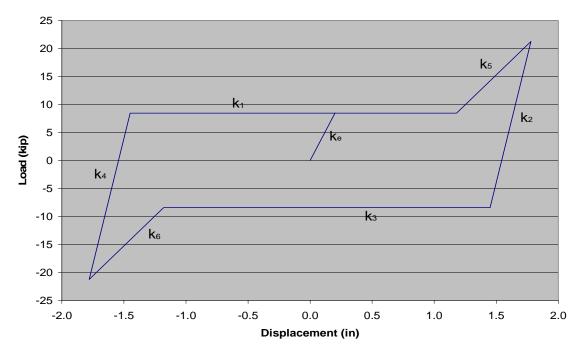
Figure 5.12 Analytical Model for Heavily Deteriorated A1005 Bearing

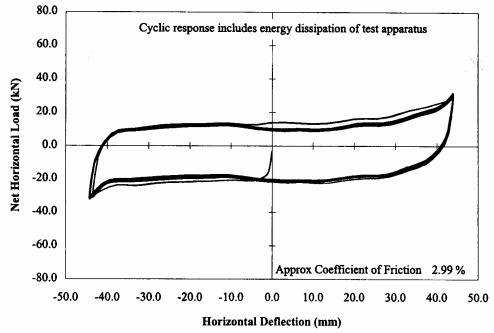
Figure 5.13 Heavily Deteriorated A1005 Bearing After Being Brushed and Greased (Barker and Hartnagel 1997)
