Rapid Strengthening of Reinforced Concrete Bridges

**UTC
R64**

**University Transportation Center Program at
The University of Missouri-Rolla**

| 16. Abstract In the proposed research study a new and innovative technique for rapidly strengthening reinforced concrete members with fiber reinforced plastic (FRP) strips will be demonstrated in a full-scale application on an existing bridge in the State of Wisconsin. A team of researchers from the university of Wisconsin-Madison in collaboration with the University of Missouri-Rolla, and industrial partners will strengthen an existing flat slab bridge and perform service load and ultimate load tests on the bridge to evaluate the efficiency of the proposed rapid strengthening method. | | | |

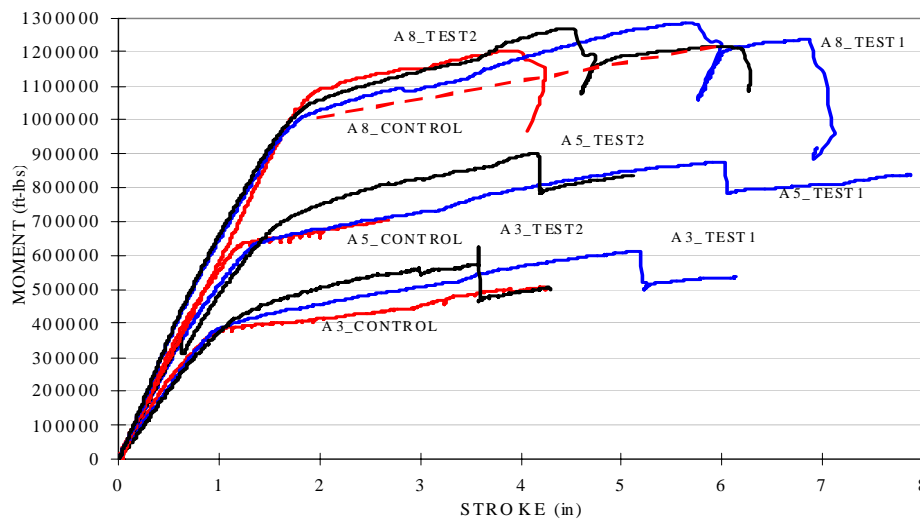
Figure 3.1. Moment-stroke data for 2001 T-beam tests

5) In 2001 a series of full-scale bridge T-beams strengthened with the MF-FRP method were tested at the Corps of Engineers laboratories (Bank et al., 2002b, Borowicz, 2002; Vlazquez et al., 2002). The T-beams were 29 ft long and had a 60 x 8 inch top flange and a 22 x 12 inch web section. They were reinforced with 5 # 9 grade 60 main longitudinal bars in the bottom of the web and # 4 stirrups at 12 in o.c. The flange was reinforced with a double layer of # 4 bars at 12 in o.c. in both directions. Beams were fabricated at the Corps of Engineers with 5000 psi concrete. Three different levels of tensile reinforcement were used, identified by the number of #9 main bars, A3, A5 and A8. For each reinforcement level 3 different strengthening levels were used – no strengthening, one FRP strip and two FRP strips. A termination length of 18 inches was used in all beams. All beams had the FRP strips fastened with Hilti X-ALH power actuated fasteners in two rows spaced at 2 inches and spaced at 2 inches along the length. In the A3 and A5 controls it was not possible to achieve ultimate failure of the beams due to the large displacement required. Only the A8 beam reached its ultimate load. All the strengthened beams failed due to strip delamination prior to achieving compressive failure in the concrete. Beams showed increases of between 10 and 20% in strength at yield and at ultimate load. Figure 3.1 shows the moment versus displacement data for all nine tests.

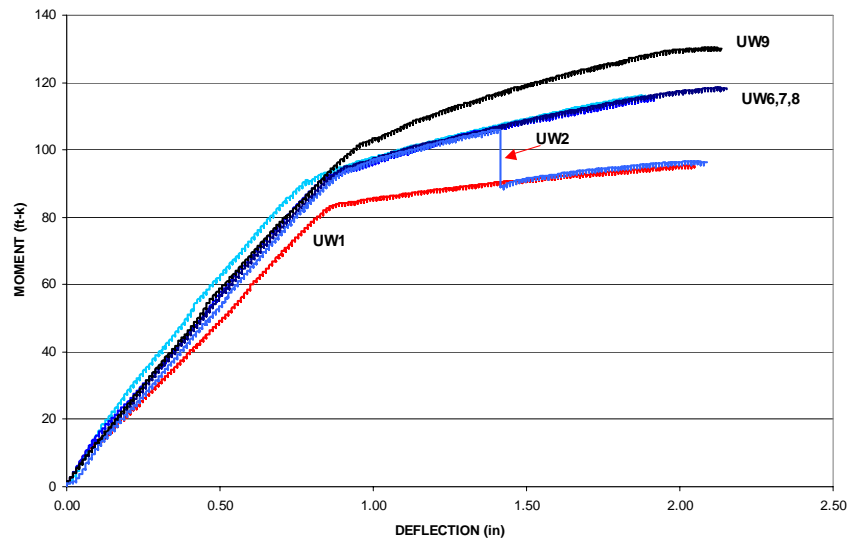
Figure 3.3. Unstrengthened beam (UW1) versus beams strengthened with one (UW6, 7,8) and two (UW9) FRP strips.

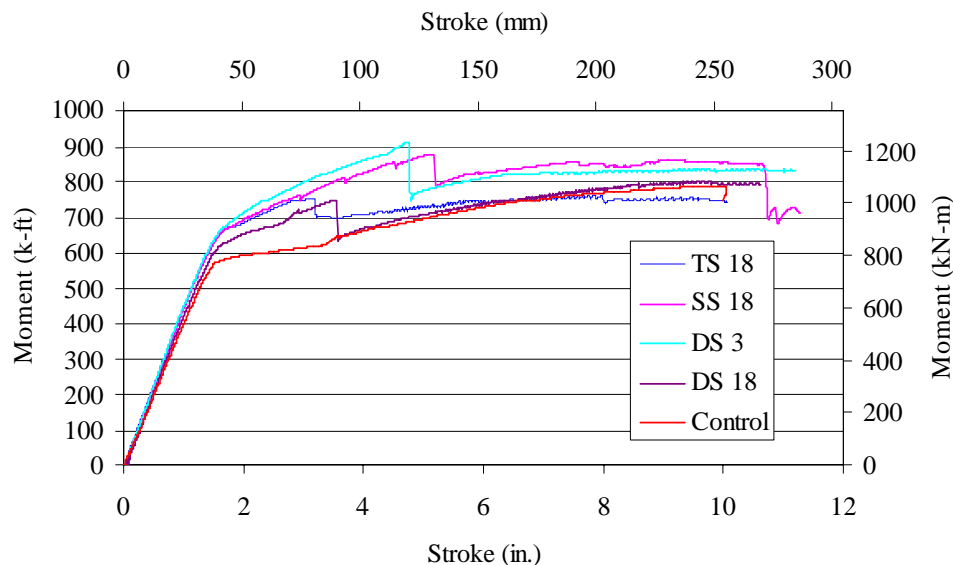
Figure 3.4. Results of 2002 T-beam tests

beams were strengthened with either one, two or three 4 inch wide by 1/8 in thick pultruded FRP strips, sold under the tradename of SafStrip™ and produced by Strongwell in Chatfield, MN, USA and attached with Hilti ALH fasteners embedded approximately 1.5 inches into the concrete. Other parameters studied included the “termination length” and the use of drilled expansion anchors at the strip ends to prevent end-delamination failures. The testing showed that significant strengthening of full-size T-beams could be achieved using the method. In this series increases in capacity over unstrengthened control beams of over 25% were obtained at large deflections (2.5 inches). All beams failed due to strip end-delamination at a large deflection (> 4 inches). Ultimate compression failure of the control beam was seen at 10 inches of midspan deflection. Two 2.5 inch long by 1/2 diameter expansion anchors were seen to significantly delay end-delamination of the strips and to increase both the deflection and load at failure. Shorter termination lengths (3 inches versus 18 inches from the support) also increased strengthening by delaying end-delamination as anticipated. The use of multiple FRP strips (in unbonded layers) did not yield significant increases in capacity of the strengthened beams over single strips due to premature end-delamination failures and the inability of the fasteners to transfer load into the outer strips. Figure 3.4 shows the test data for the five monotonically loaded beams. The beam subjected to the fatigue loading sustained the full 2 million cycles with no degradation of the strengthening system nor change in stiffness of the beam (Bank et al., 2003)

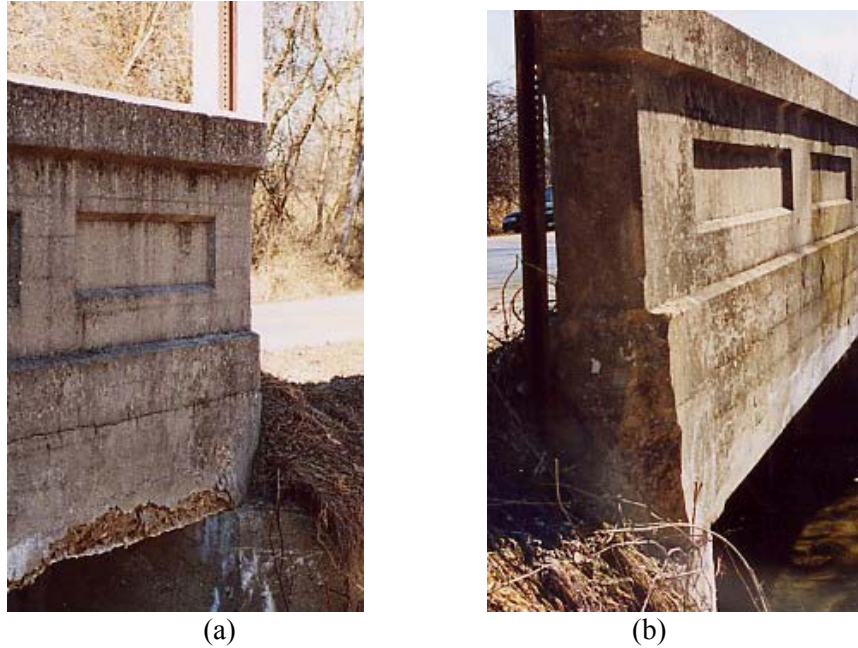
Figure 4.7. (a). Deterioration seen at one edge of the bridge (b). Barrier deterioration

The Average Daily Traffic (ADT) for the bridge in 1980 was recorded at 600. The last inspection conducted on the bridge in January of 2001 recommended a re-rating of the bridge for its capacity. Other comments noted on the inspection report were “deep deterioration of the deck edges and cracks” and “spalls about the abutments at the corners.” Over the years a 3 -5 in. bituminous overlay was placed on the bridge, however no record of when this was done was found. Figure 4.6 and Figure 4.7 show more details of the selected bridge.

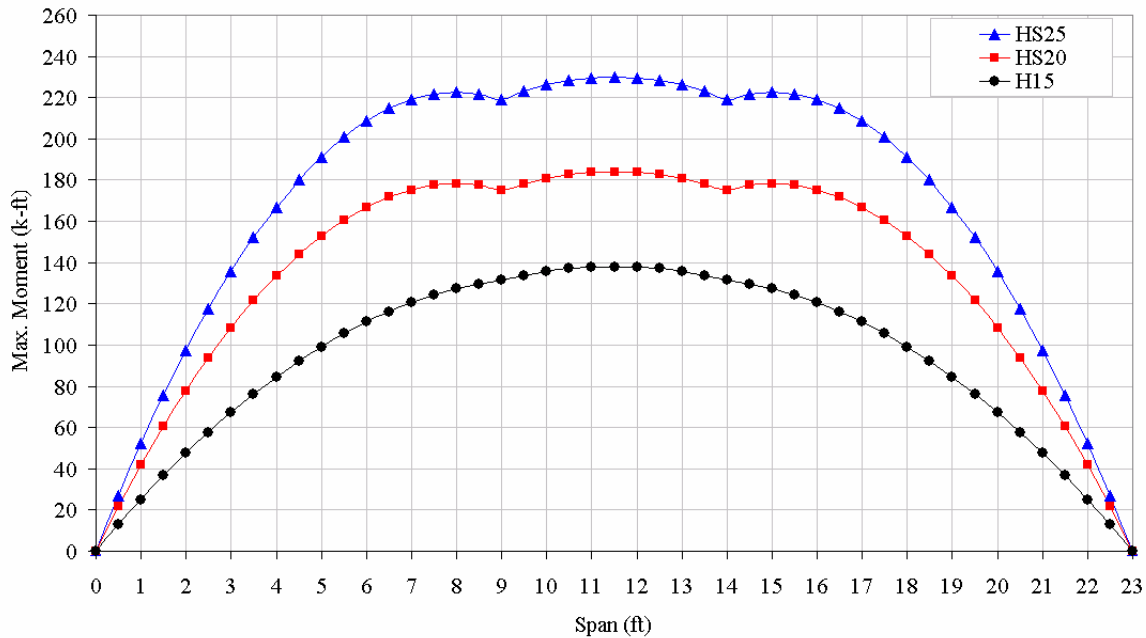
Figure 4.10. Moment envelope for the 23ft span bridge P-53-702

Load envelopes corresponding to the axle loads of standard trucks as they move along the length of the span are used to analyze the maximum load effects on a bridge structure. The bridge for the project was built in 1930 and was originally designed for an H15 standard truck loading. The moment envelopes for the different types of truck loadings on the bridge are shown in Figure 4.10. A significant increase in the demand for the bridge from the original H15 load to the current demands is noted. The increased live load moment demand for the existing bridge for different standard trucks specified by AASHTO is provided in Table 4.7.

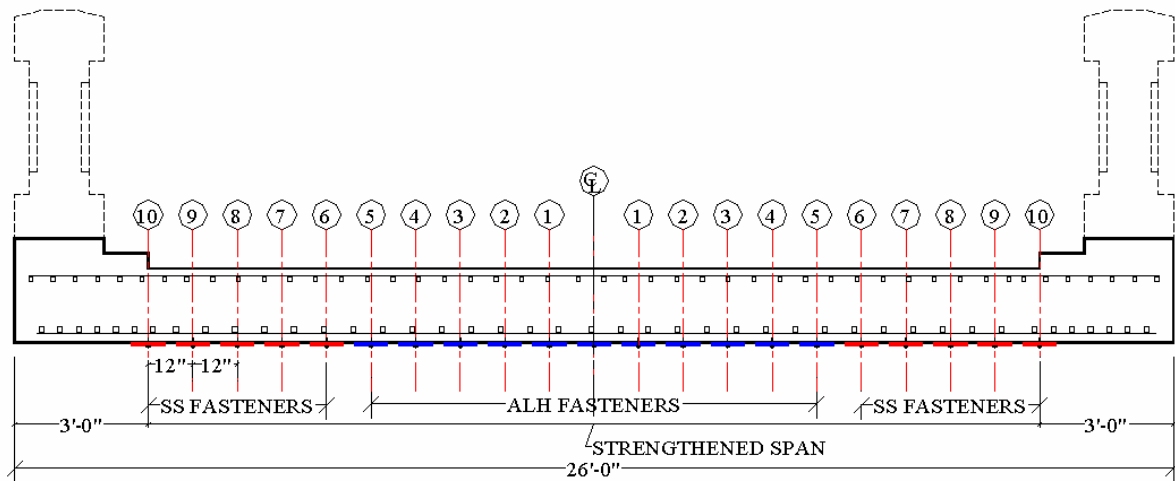
Figure 4.15. Final design layout of the FRP strips on the bridge

The final design for the MF-FRP system for the bridge is shown in Figure 4.15.

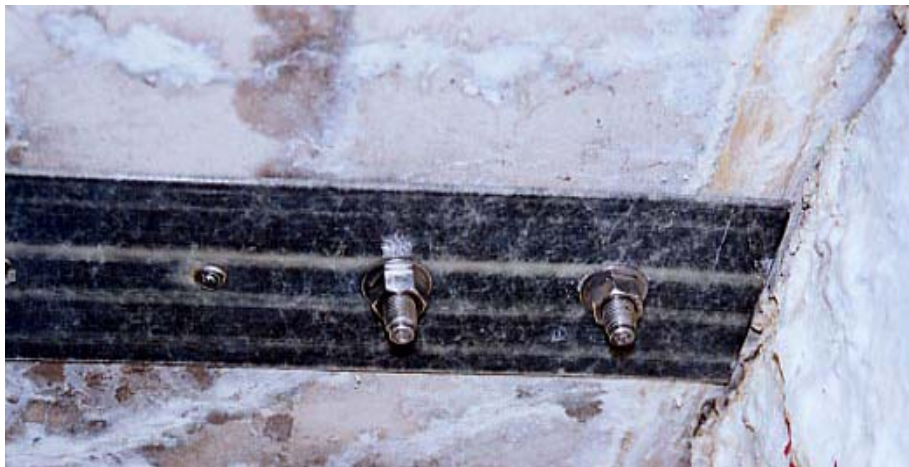
Figure 4.24. Installed end anchor next to the abutment

The strips were predrilled at the locations of the anchor bolts using the rotary hammer drill with the nominal diameter of the anchor bolt. The hole was then cleaned before the anchors bolts were inserted. Once the anchor was inserted in the drilled hole, the anchors were hammered into place (taking care not to damage the FRP strip). The anchor bolts were then tightened using a socket wrench. Figure 4.24 shows the installed end anchors near the support ends.

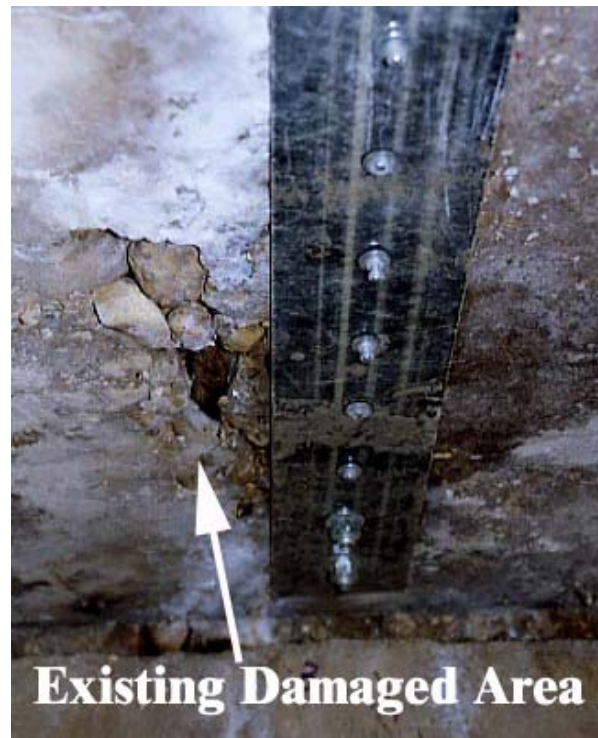
Figure 4.29. Relocated FRP strip near existing local damaged area

In a situation where the row of fasteners was anticipated to achieve improper embedment the FRP strip was slightly re-positioned. Figure 4.29 shows the position of the FRP strip in close proximity to a local damaged area. The strip was moved a few inches to avoid the damaged area.

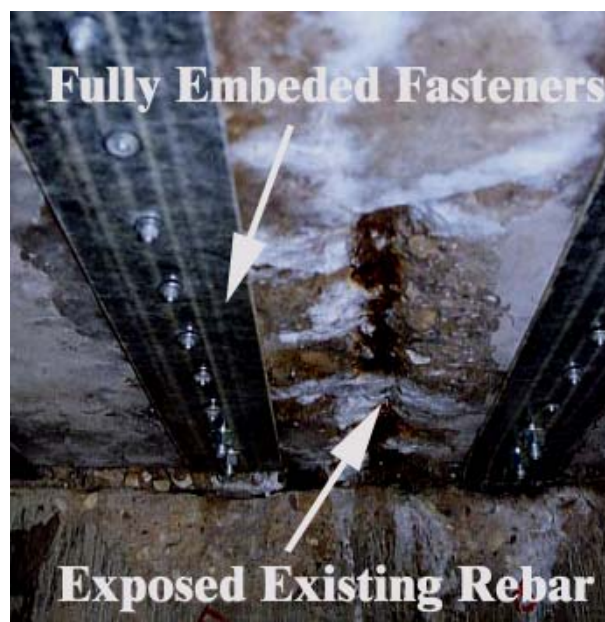
Figure 4.30. Existing damaged area in the bridge with the exposed steel reinforcement

Local damage in the existing concrete substrate did not cause a problem with the fastening of the FRP strip. Figure 4.30 shows an existing damaged area in the bridge with the exposed steel reinforcement.

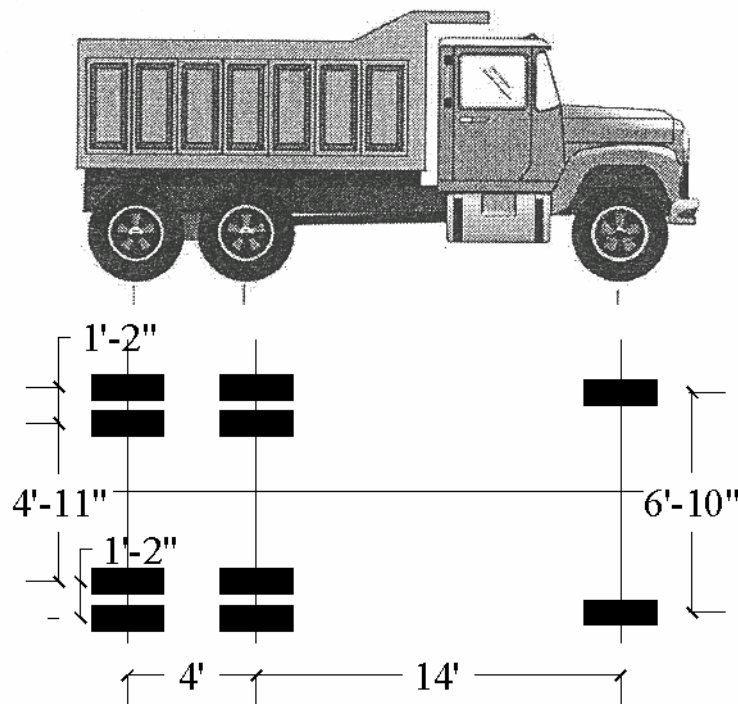
Figure 4.33. Wheel spacing for the truck used for service load testing

A three-axle truck with known wheel configurations was used for the service load testing of the bridge. It was calculated that a truck loaded between 50,000 and 60,000 lbs would produce acceptable response without causing any damage to the bridge. The truck was provided by Rock County DOT and was weighed prior to each load test. Figure 4.33 shows the wheel and axle spacing of the truck used. Table 4.27 provides the distribution of the weight.

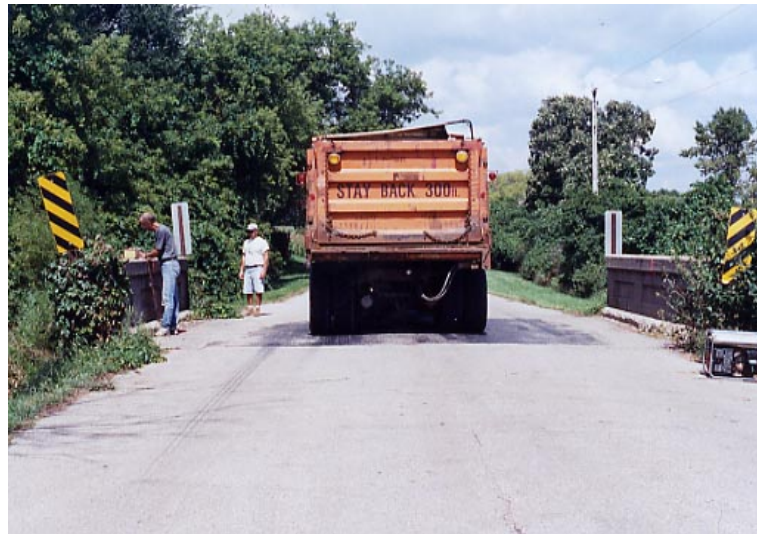
Figure 4.36. Load Case I on bridge P-53-702

The load cases were considered to represent the most extreme loading conditions possible. Because of the transverse symmetry of the structure, only one lane was tested. Figure 4.36 shows Load Case I on the bridge after strengthening.

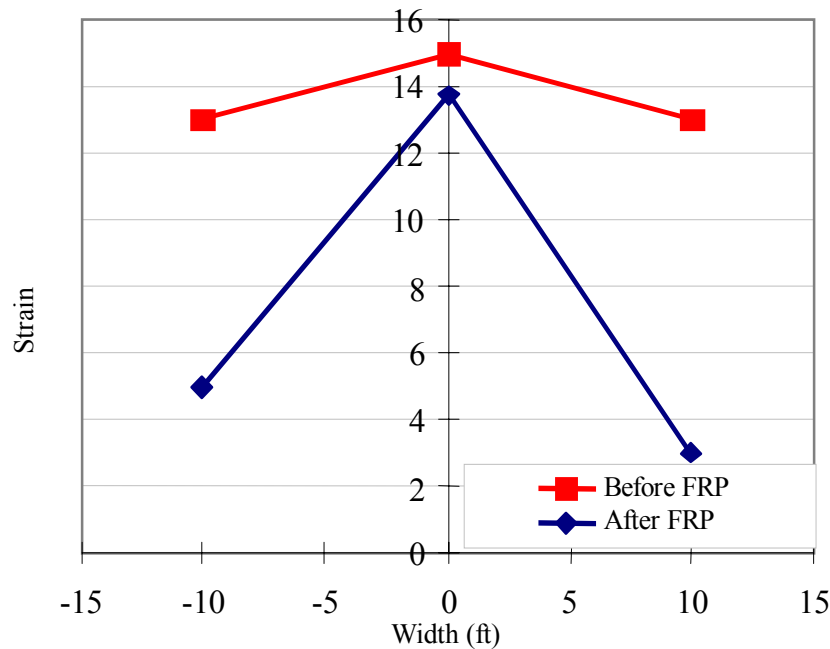
Figure 4.39. Strain distribution for Load Case I

The largest average strain reading measured was $30\mu\epsilon$ for load case 2 at the East end of the bridge. 90% of the strain measurements were below $30\mu\epsilon$. While such small strain readings may be inconclusive, some general trends were observed. The somewhat symmetrical distribution of the strain in the bridge is observed for the first two load cases (I and II). Figure 4.39 shows the plot of the strain distribution for the two series of tests, before and after the retrofit of the bridge for Load Case I. The reduction in strains is attributed to strengthening.

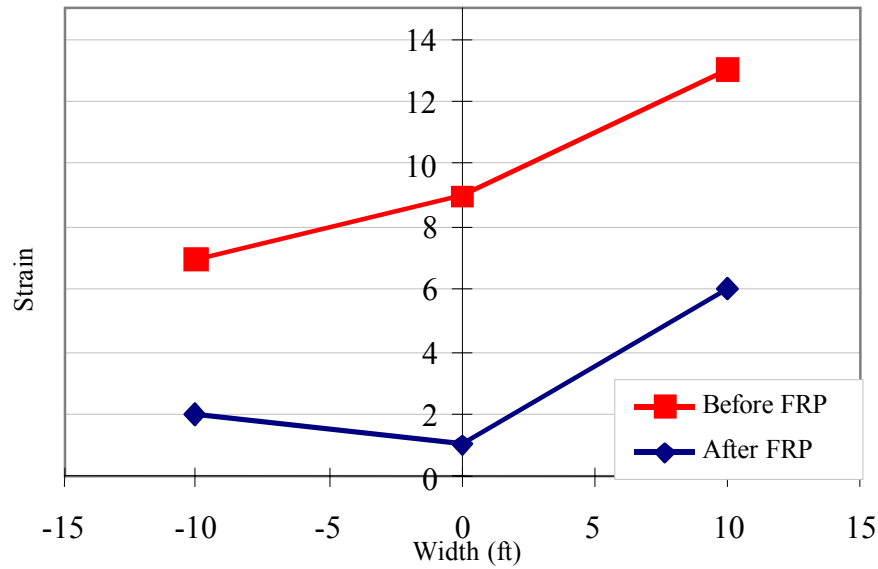
Figure 4.40. Strain distribution for Load Case III

The unsymmetrical distribution seen in Load Case II after strengthening was peculiar and is difficult to explain. Similar unsymmetrical behavior has been seen in research studies conducted on existing bridges (Stallings, et al, 2000). Therefore, Load Case II was not considered in later analysis. For Load Case III and IV, the unsymmetrical behavior is logical due to the offset loading of the truck. Figure 4.40 shows the strain distribution for Load Case III measured before and after the strengthening of the bridge.

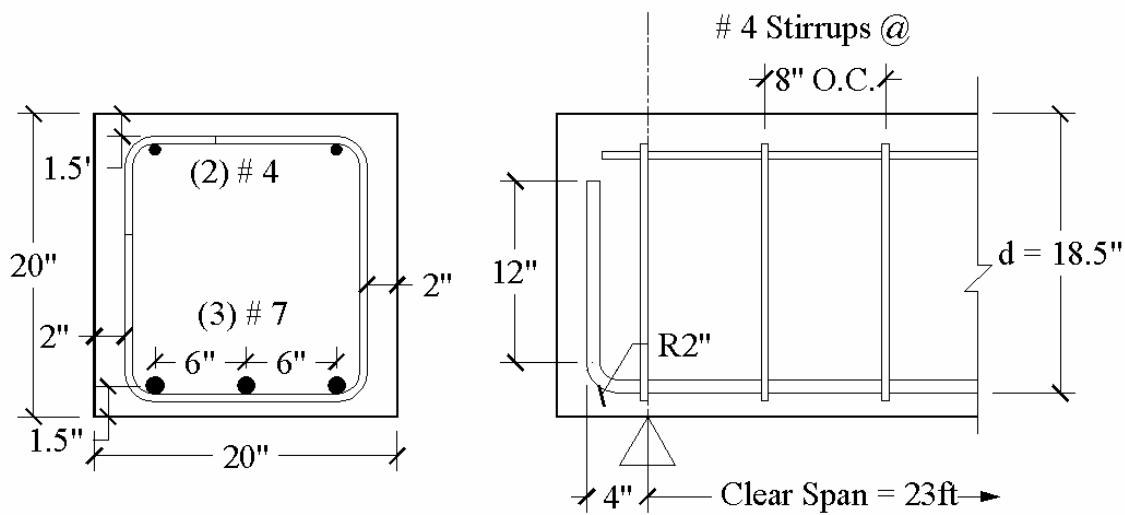
Figure 5.2. Steel reinforcement in laboratory beams

Four laboratory beams with nominal measurements of 20 in. x 20 in. x 24 ft were detailed in accordance with ACI 318-99. The beams were fabricated at the Structures and Material Testing Laboratory (SMTL) at the University of Wisconsin-Madison. As explained previously, shear reinforcement for the bridge slab was provided at the ends by means of bent bars. For the laboratory beams, shear reinforcement was provided by stirrups to ensure that flexural failure of the beams would occur. Figure 5.2 illustrates the reinforcement of the beams.

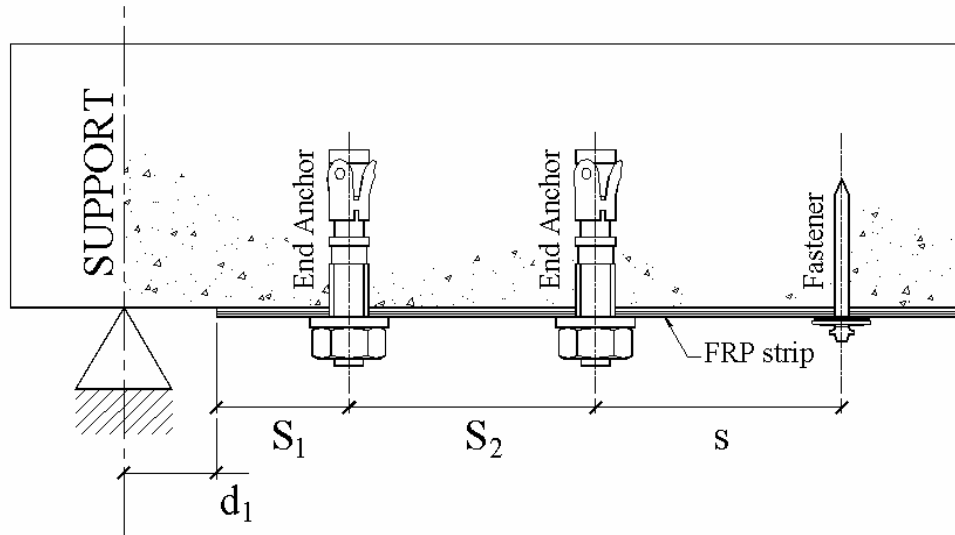
Figure 5.6. End condition for strengthened beams

Only a small amount of surface pre cracking was observed upon attachment of the FRP strip. Two end anchors at each support end were used for all three beams. The termination lengths and the anchor locations are illustrated in Figure 5.6. Figure 5.7 shows the end of one of the beams. Table 5.5 shows the dimensions and details of the four laboratory beams.

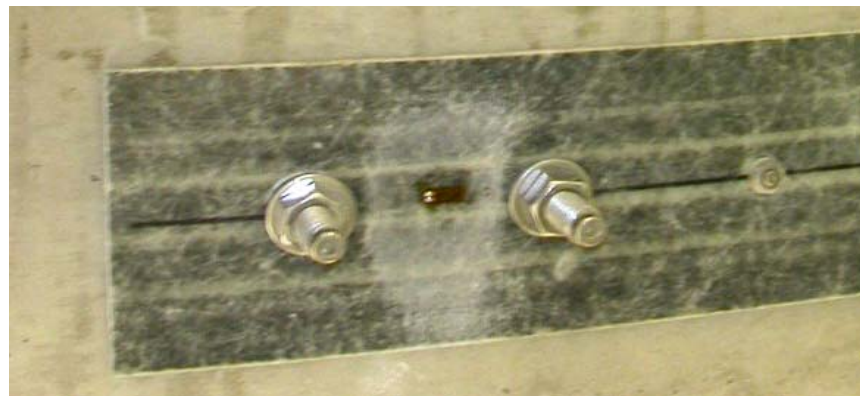
Figure 5.7. End anchor bolts and end fastener for FRP2 SS

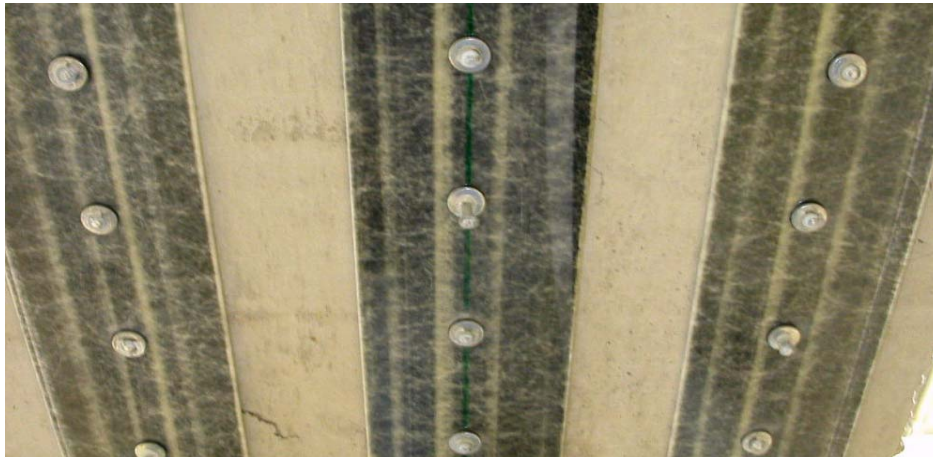
Figure 5.8. FRP 3 beam strengthened with three FRP strips

Figure 5.8 shows the relative positions of the FRP strips for beam FRP 3 strengthened with three FRP strips.

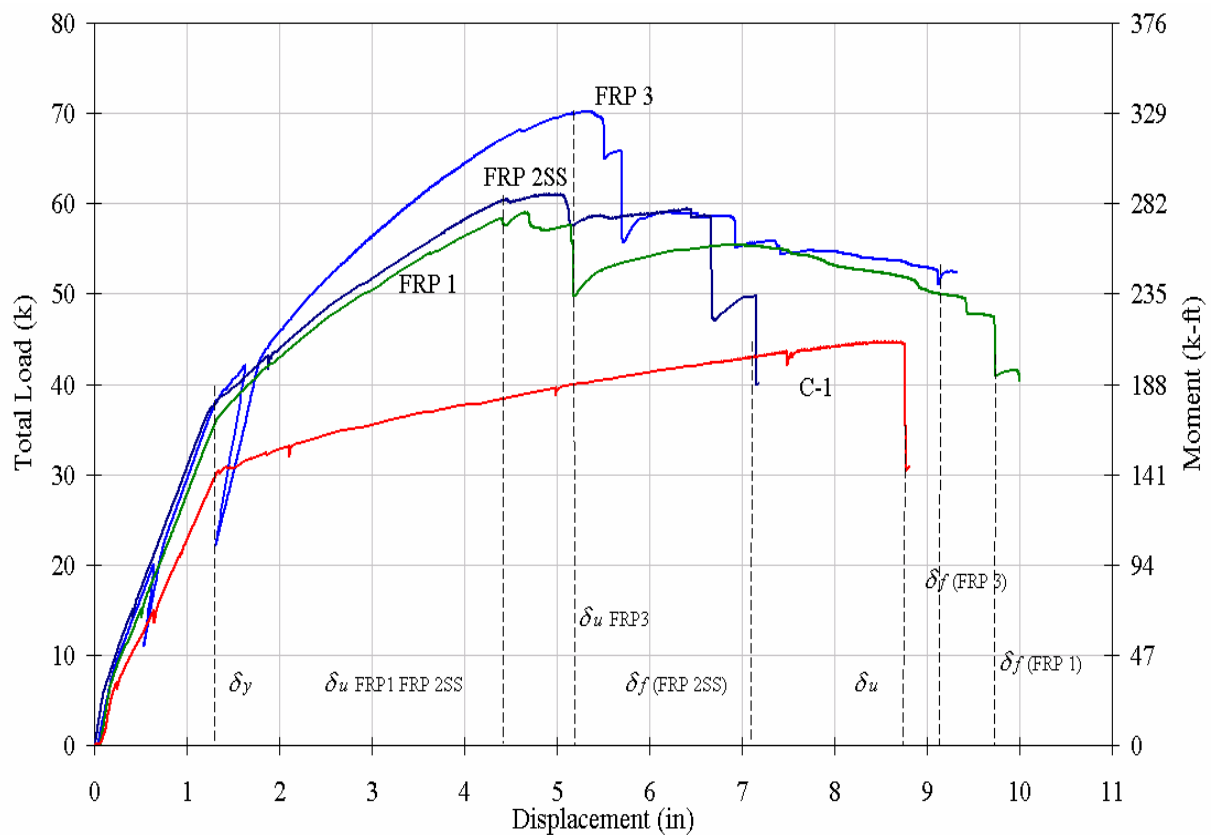
Figure 5.17. Load/Moment versus displacement curves for beams

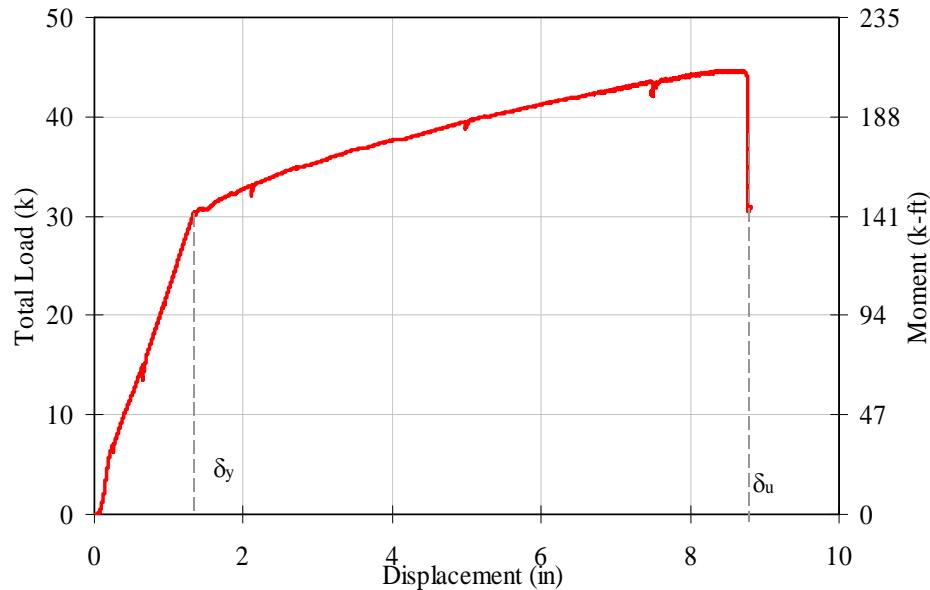
Figure 5.18. Load/Moment versus displacement for beam C-1

The control beam C-1 was tested to obtain the unstrengthened capacity of the Edgerton Bridge section and also to obtain the basis for comparison with the strengthened beams. The load and moment versus displacement curve for the control beam is shown in Figure 5.18.

The C-1 beam yielded at 30.5 kips corresponding to a moment of 143.6 k-ft. The ultimate moment of the control beam occurred at a load of 43.6 kips corresponding to a 208.7 k-ft moment. A 30% increase in the post-yield strength of the control beam is attributed to strain hardening of the steel reinforcement and progressive and continuous movement of the neutral axis of the beam. The 4-point bending applied to the control beam produced flexural and some shear cracks in the beam. After the cracking load flexural surface cracks began to appear in the constant moment region of the beam. With increasing load, the flexural cracks increased in width and started to travel up towards the top of the beam. At the point of yield, cracks were visible and began to open up. Beyond yield, the cracks were significantly larger. Some local crushing was seen near one of the load points. The beam failed due to concrete compression in the moment span. No further increase in load was observed after concrete compression. Figure 5.19 shows the compression failure of the beam in the moment span.

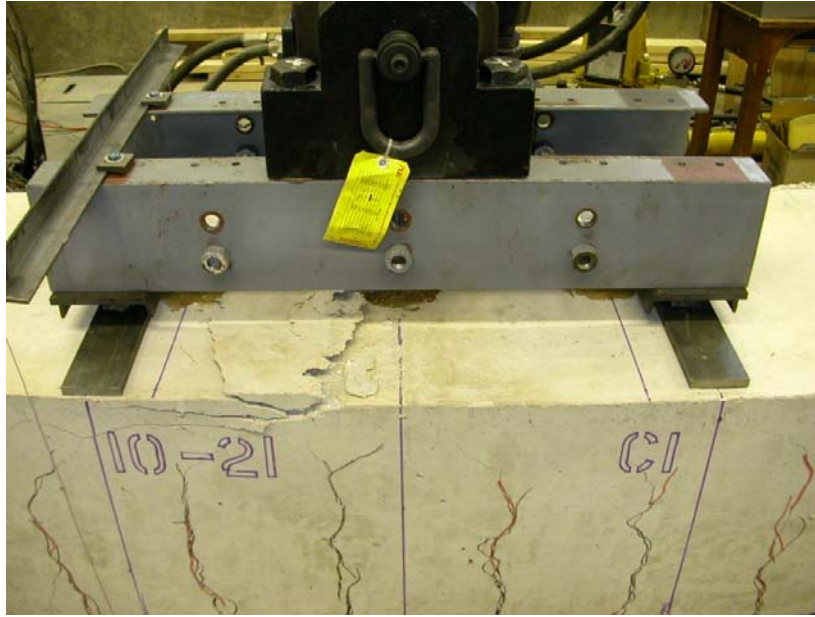
Figure 5.19. Concrete compression failure in the moment span in beam C-1

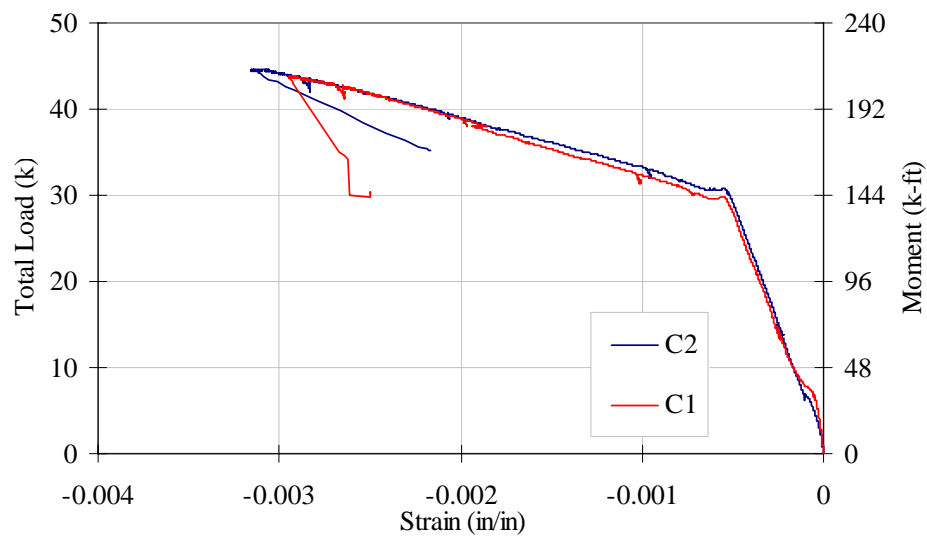
Figure 5.20. Moment vs. concrete strain for beam C-1

Figure 5.20 shows the moment vs. strain plot for the control beam showing concrete compression failure close to -0.3% (-0.003 in/in).

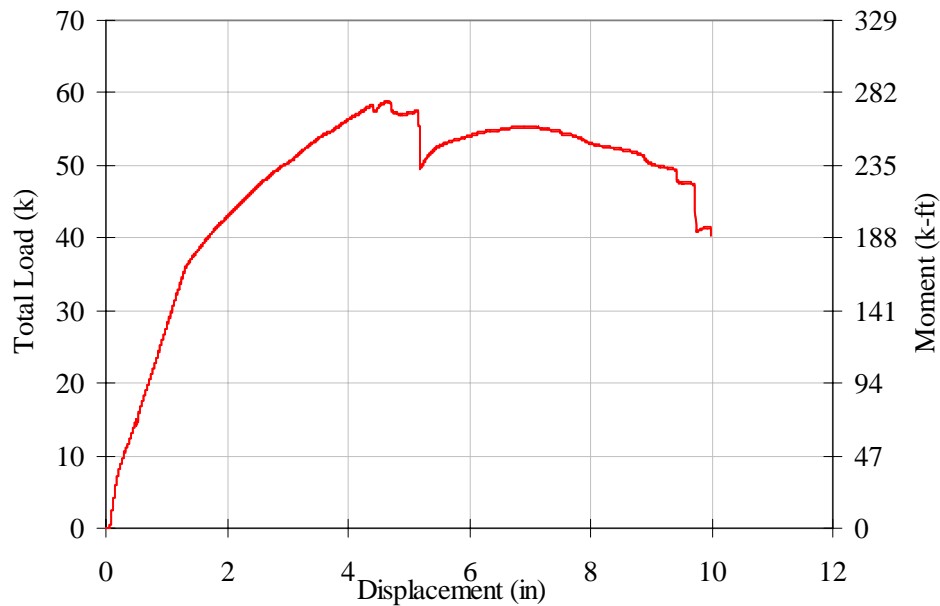
Figure 5.21. Load/moment versus displacement for beam FRP 1

Beam FRP 1 was strengthened with 2 FRP strips. The objective was to observe the increase in strength of the beam in addition to the deformability and the failure modes of the strengthened beam. Figure 5.21 shows the total load/moment versus displacement behavior of FRP 1.

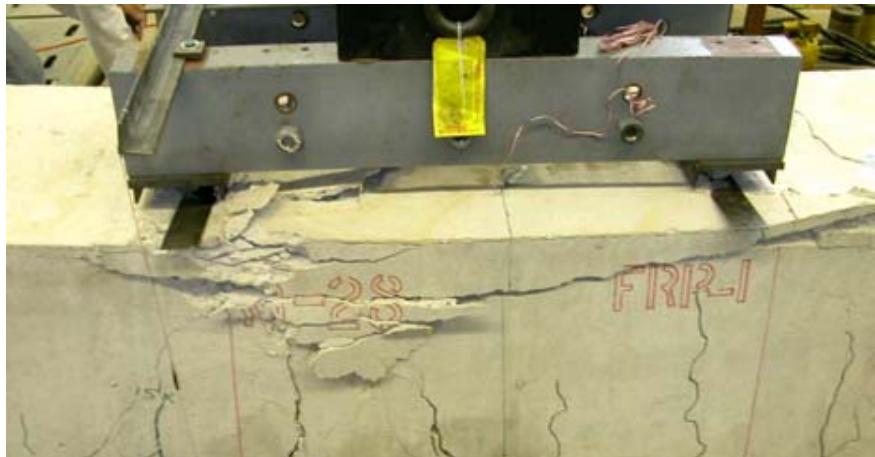
Figure 5.22. Concrete compression failure of FRP1

During the initial loading of the strengthened beam flexural cracks, which traveled upwards as the loading increased, were seen in the moment span. At the point of yield, the cracks in the moment span were visibly larger. Beyond the yielding of the concrete, the beam continued to gain strength until concrete compression failure occurred near one of the load points. At first, local crushing was observed which eventually developed into the entire top of the beam failing due to concrete compression. A load drop was seen at this point. Figure 5.22 shows the concrete compression failure in the moment span.

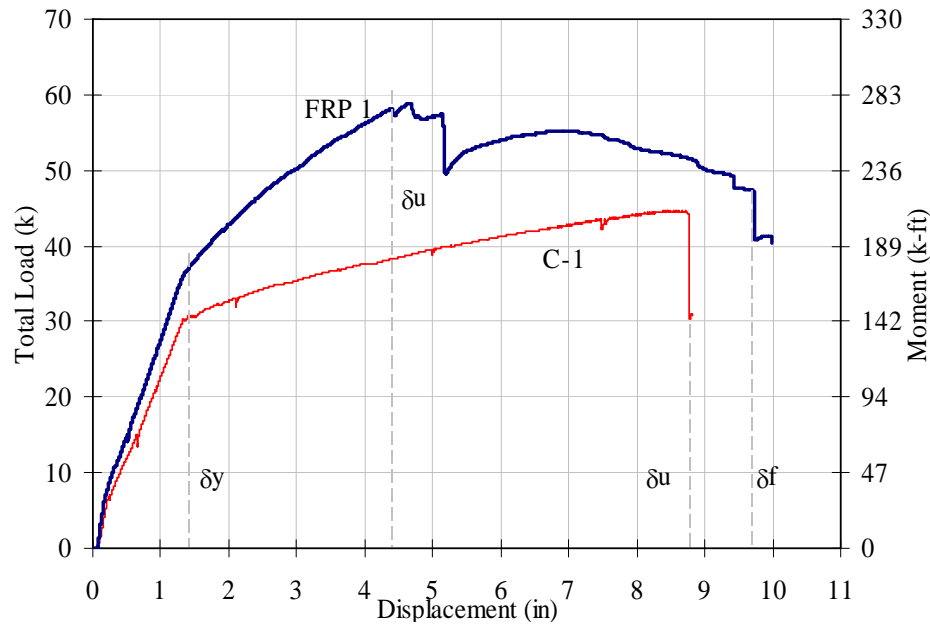
Figure 5.23. Comparison between FRP 1 and C-1

concrete beams. The beam ultimately collapsed when the fasteners near the load point pulled out. Beam FRP 1 yielded at 36 kips corresponding to a moment of 169.8 k-ft and the ultimate moment was seen when the beam failed by concrete compression at a load of 58.8 kips, corresponding to a moment of 277.2 k-ft. The strengthened beam showed an increase of 18% in the yield strength and 32.8% in the ultimate capacity over the control beam. In addition to the improved capacity, FRP-1 showed significant ductility. Even after concrete crushing, a significant level of load was sustained by the beam. Figure 5.23 shows the comparison between the control beam C-1 and the strengthened beam FRP 1.

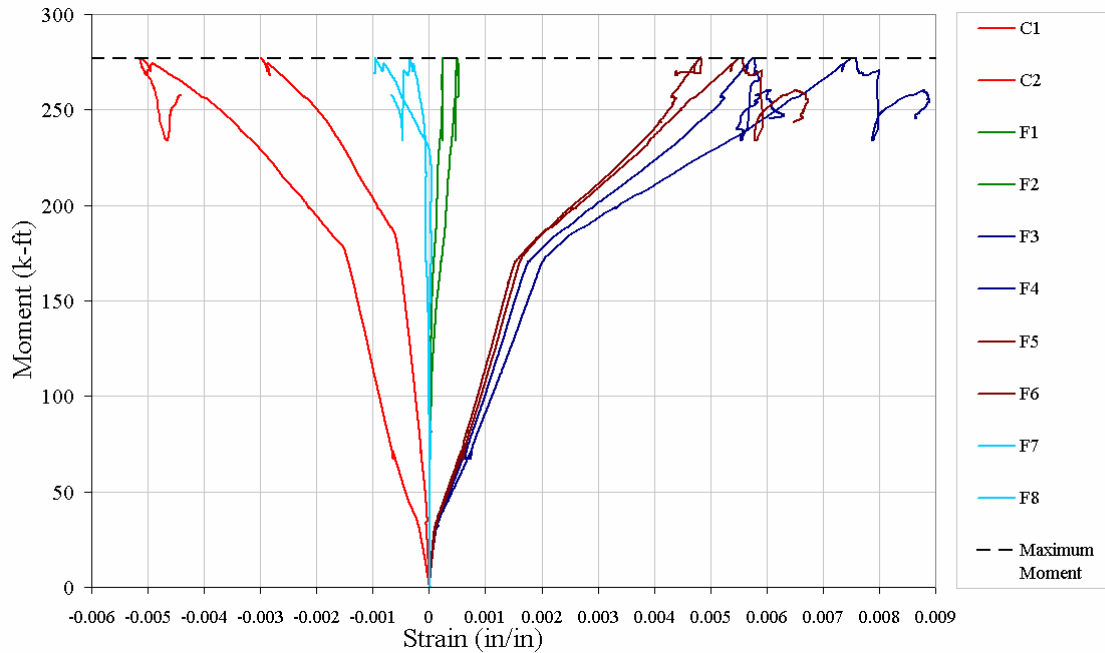
Figure 5.24. Strain distribution for beam FRP 1

Figure 5.24 shows the moment versus strain distribution of the beam. The strain distribution clearly indicates the composite behavior of the section and that strain is effectively transferred into the FRP strip. Strain gage C2 shows concrete compression failure at - 0.5% near the load point, while the gage C1 in the middle shows concrete compression at - 0.3%. The maximum strain seen in the FRP strip was 0.8%. At the ends of the beam negative strain corresponding to compression in the FRP strip near the support is seen. A general discussion on the strain distribution in all the beams is given at the end of this section.

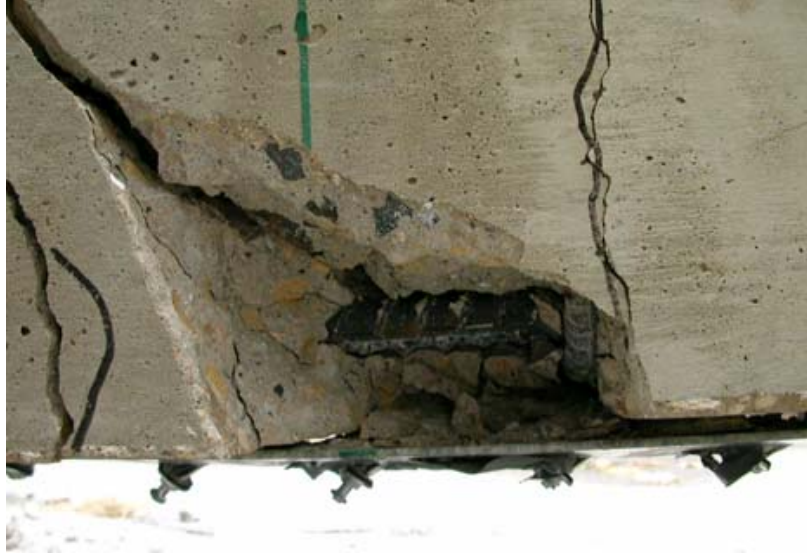
Figure 5.26. Secondary failure mode of beam FRP 1 due to fastener pullout

This bearing failure was seen to decrease towards the center of the beam. A shear-out failure of the FRP strips at one of the ends of the beams was seen. In the middle of the span, under one of the load points, fastener failure due to pullout was seen. A concrete “tooth” failure was also noted. Figure 5.26 shows this failure.

This failure mode occurred after the beam carried a significant load for a period of time after concrete compression failure was observed. Figure 5.27 diagrammatically illustrates the failure mode under the load point.

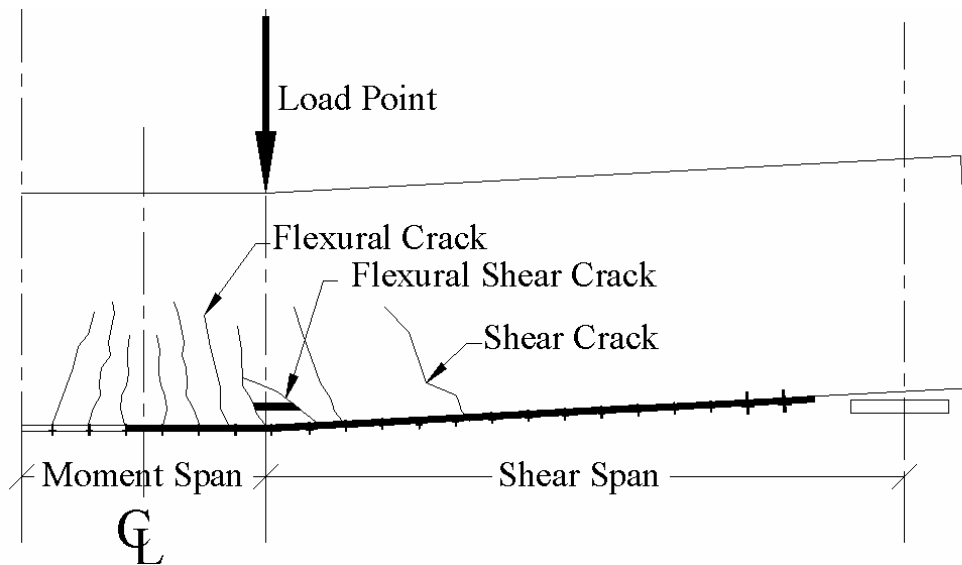
Figure 5.27. Concrete “tooth” failure due to flexural shear crack under the load point

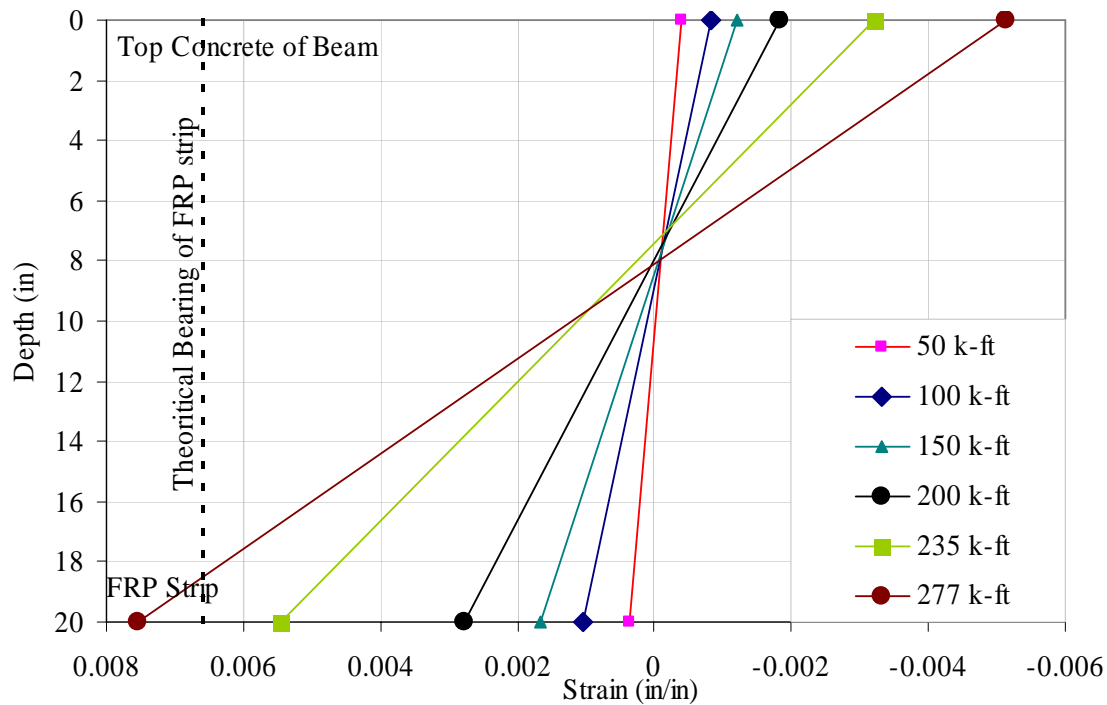
Figure 5.28. Variation of strain through the depth of beam FRP 1

it must be noted here that the FRP strip in this case remained attached to the concrete throughout the load history of the beam. Figure 5.28 shows the variation of the maximum strain versus the depth of the concrete beam with increasing applied moment. A downward progression of the neutral axis is observed at the ultimate moment of 277 k-ft where concrete compression failure occurred.

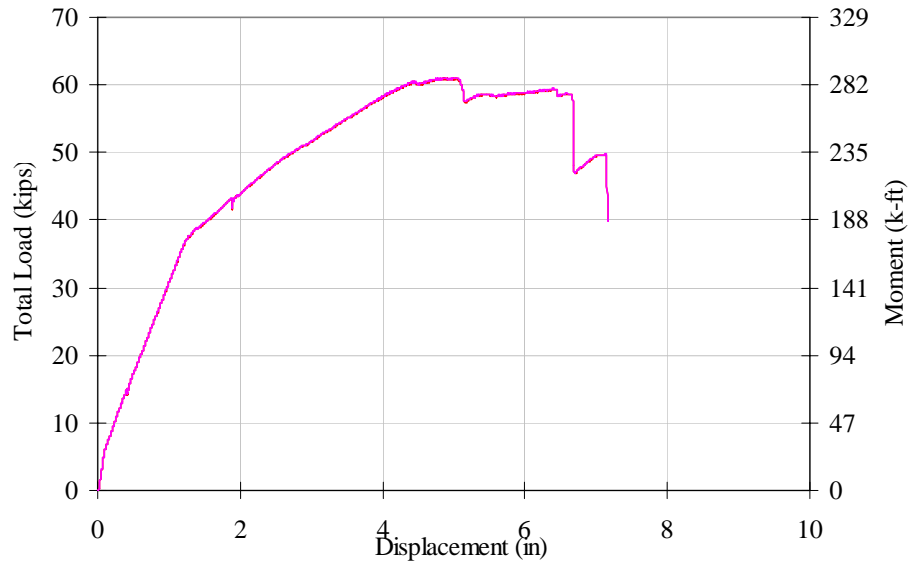
Figure 5.29. Load/Moment versus displacement for beam FRP 2SS

This configuration of the strengthened beam was used to observe the strengthening effect of 2 FRP strips attached with Hilti type X-CR SS (Stainless Steel) fasteners. Half of the bridge was strengthened using stainless steel fasteners and anchors, which provide increased corrosion resistance under aggressive environments. Data for strengthening using stainless fasteners was needed. Figure 5.29 shows the total load/moment versus displacement behavior of FRP 2SS.

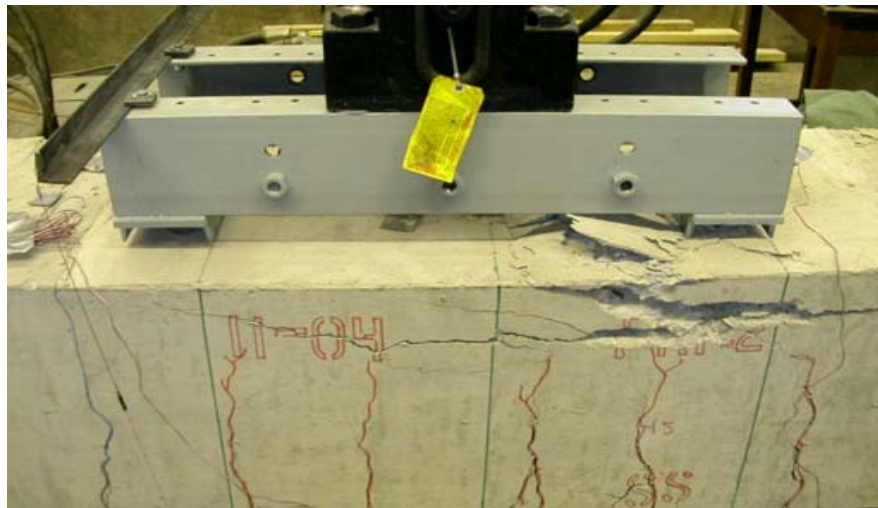
Figure 5.30. Concrete compression failure in beam FRP 2SS

The crack pattern for the beam was similar to beam FRP 1. Flexural cracks became visible in the midspan after the cracking load was reached. As the beam approached yield, flexural cracks outside the moment span began to “bend over” and become flexural-shear cracks. The ultimate strength of the beam was achieved when the concrete failed in compression in the moment span. Figure 5.30 shows the concrete compression failure mode. The loading was continued after the concrete compression failure and the load seemed to stabilize for a period of time until a secondary load drop was seen.

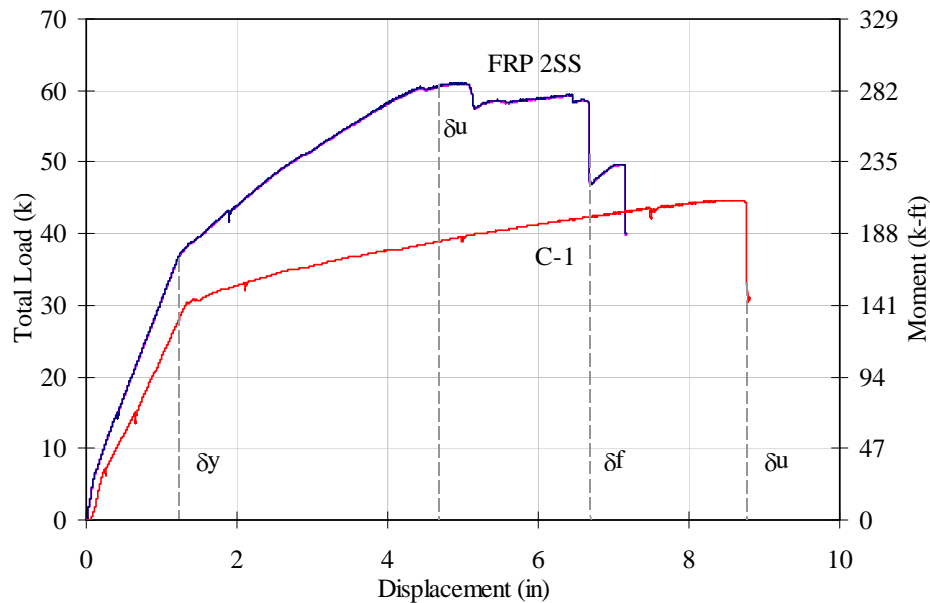
Figure 5.31. Comparison between FRP 2SS and C-1

increase was 23.3 percent while the ultimate strength increase was 37.5 percent. An overall increase in stiffness, strength and ductility was seen. Figure 5.31 shows the comparison between beam FRP 2SS and the control beam C-1.

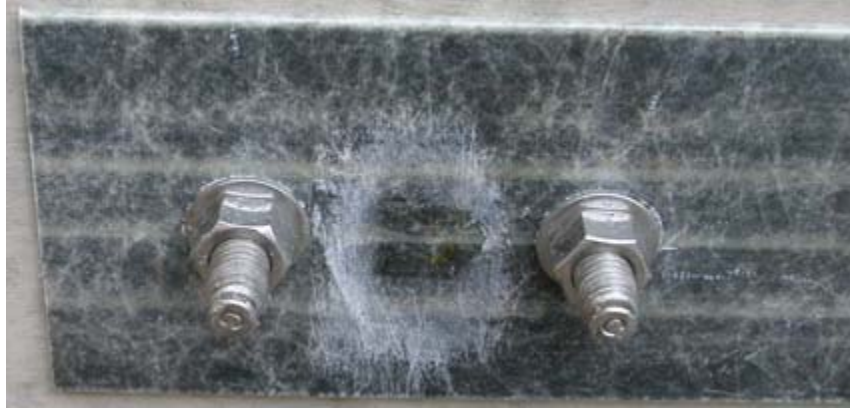
Figure 5.33. FRP strip at the end for beam FRP 2SS (post failure)

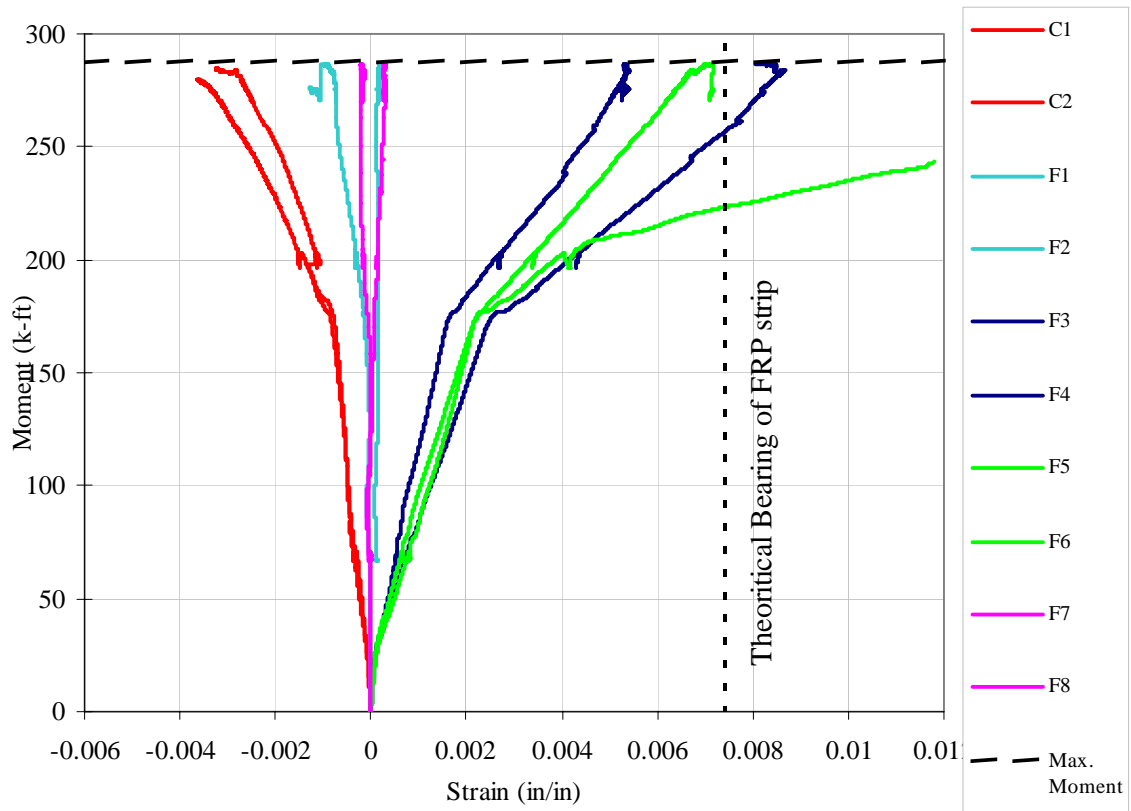
Figure 5.38. Strain distributions for FRP 2SS
