Rapid Strengthening of Reinforced Concrete Bridges

**UTC
R64**

**University Transportation Center Program at
The University of Missouri-Rolla**

| 16. Abstract In the proposed research study a new and innovative technique for rapidly strengthening reinforced concrete members with fiber reinforced plastic (FRP) strips will be demonstrated in a full-scale application on an existing bridge in the State of Wisconsin. A team of researchers from the university of Wisconsin-Madison in collaboration with the University of Missouri-Rolla, and industrial partners will strengthen an existing flat slab bridge and perform service load and ultimate load tests on the bridge to evaluate the efficiency of the proposed rapid strengthening method. | | | |

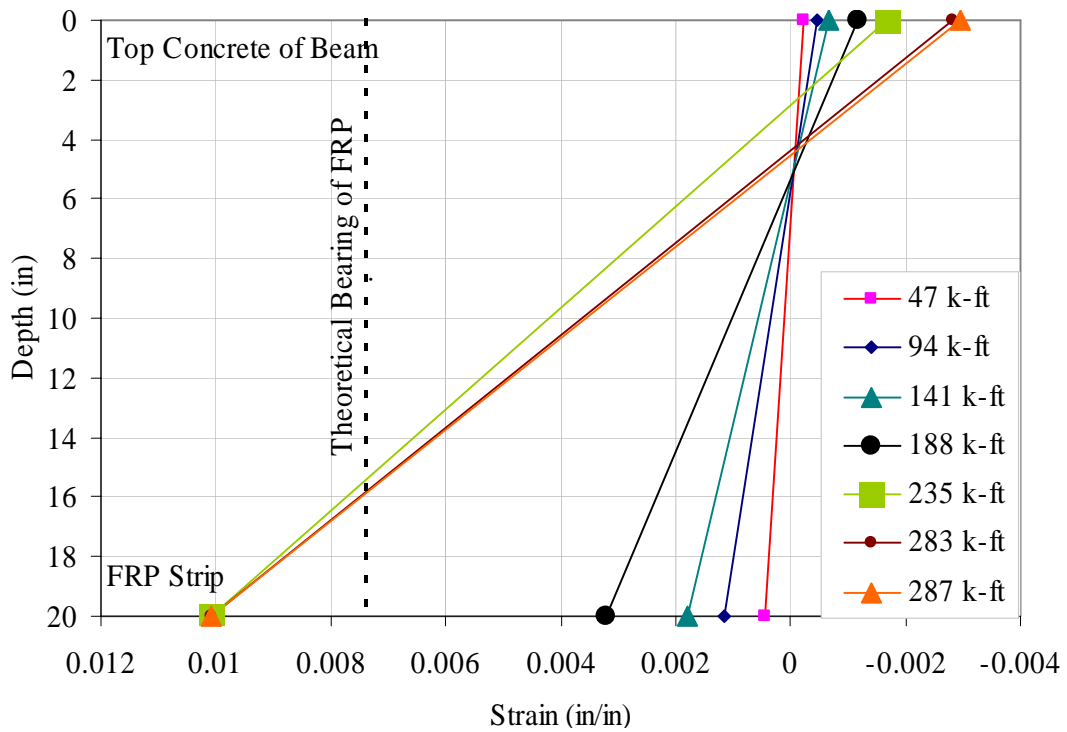
Figure 5.39. Variation of FRP strain through the depth of the beam FRP 2SS

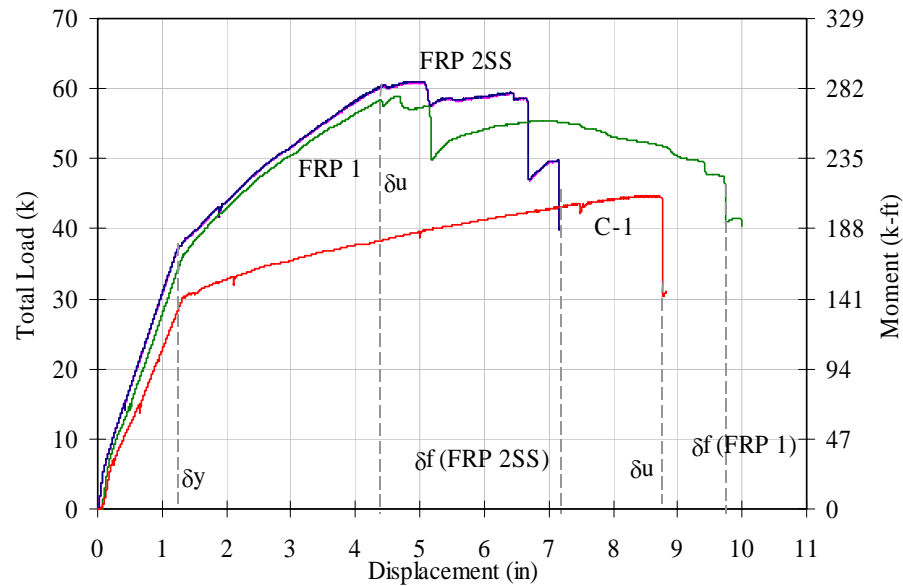
Figure 5.40. Comparison between beams FRP 1, FRP 2SS and C-1

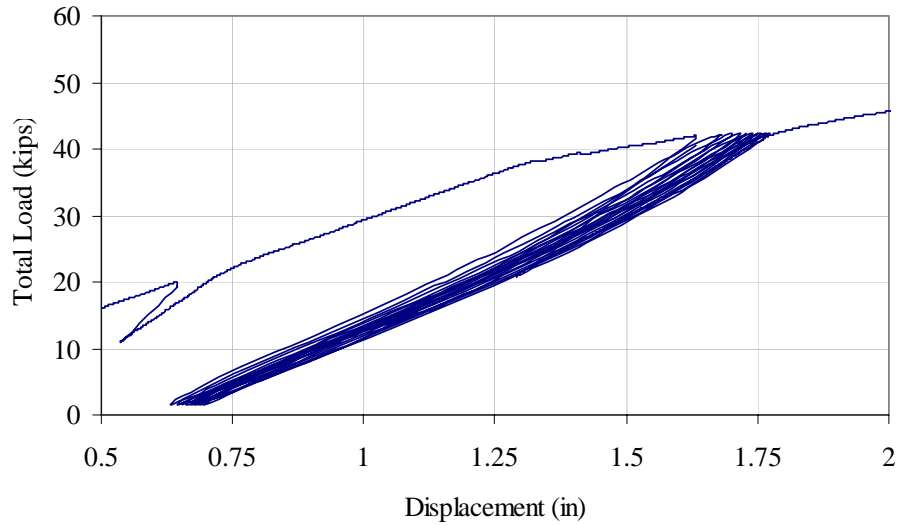
Figure 5.43. Load vs. Displacement plot for inelastic cyclic loading on FRP 3

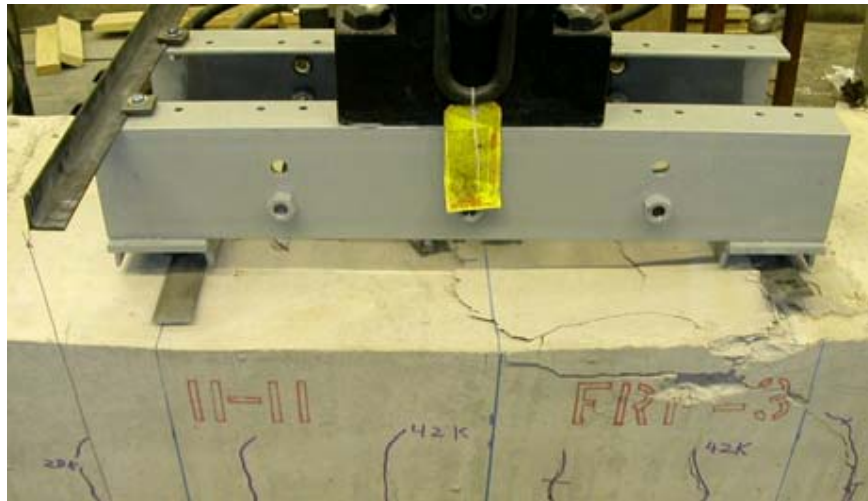
Figure 5.44. Concrete compression failure of FRP 3

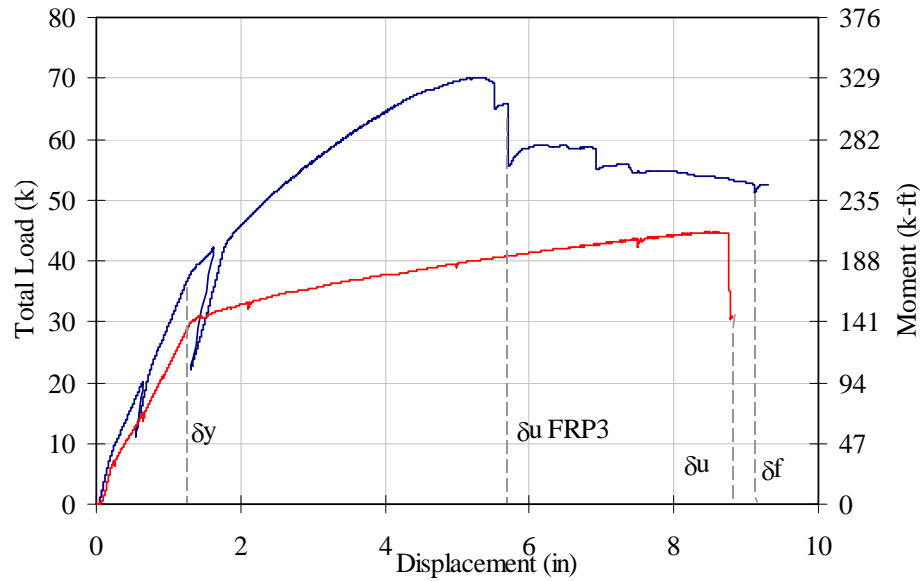
Figure 5.45. Comparison between beam FRP 3 and beam C-1

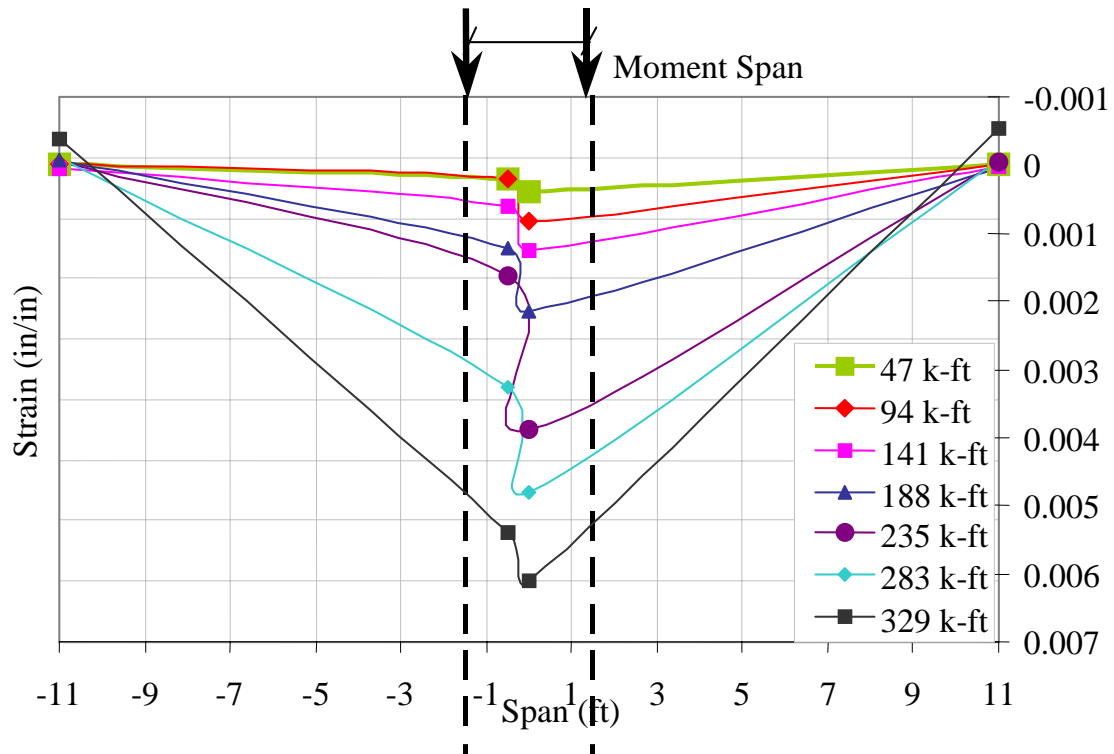
Figure 5.46. Maximum strain distribution for beam FRP 3 along the beam length

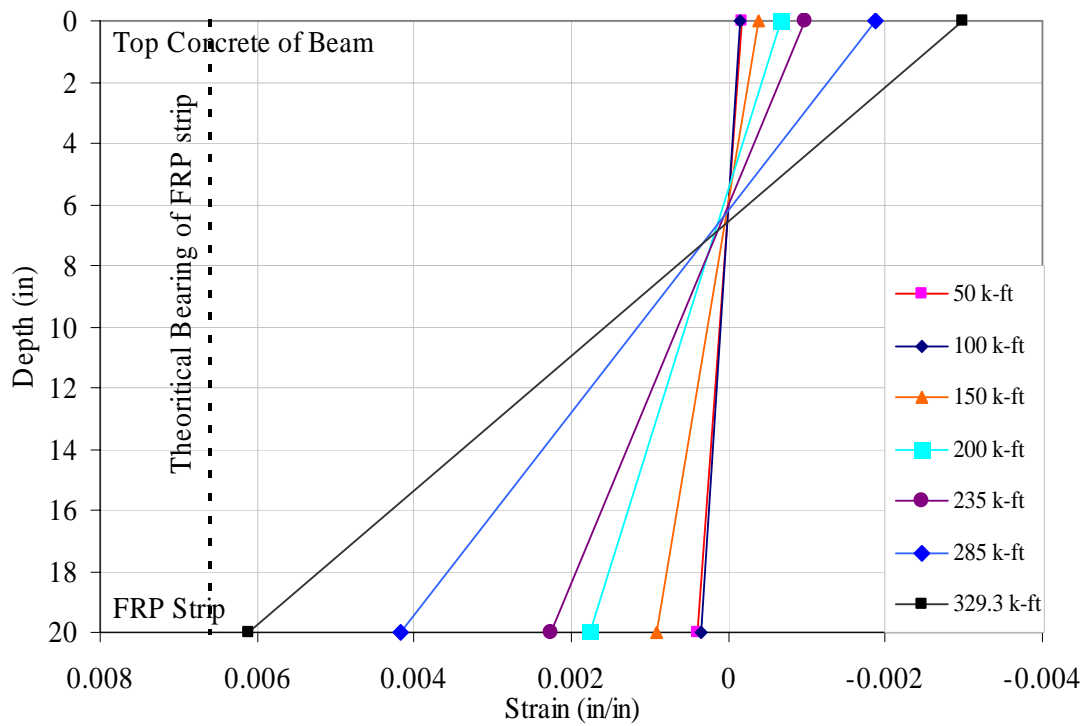
Figure 5.47. Variation of FRP strain through the depth of beam FRP3

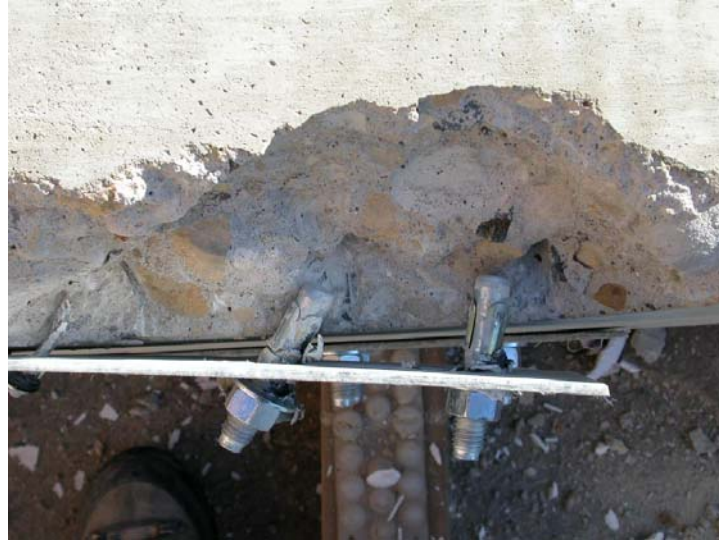
Figure 5.49. Final end-anchor pullout failure in beam FRP 3

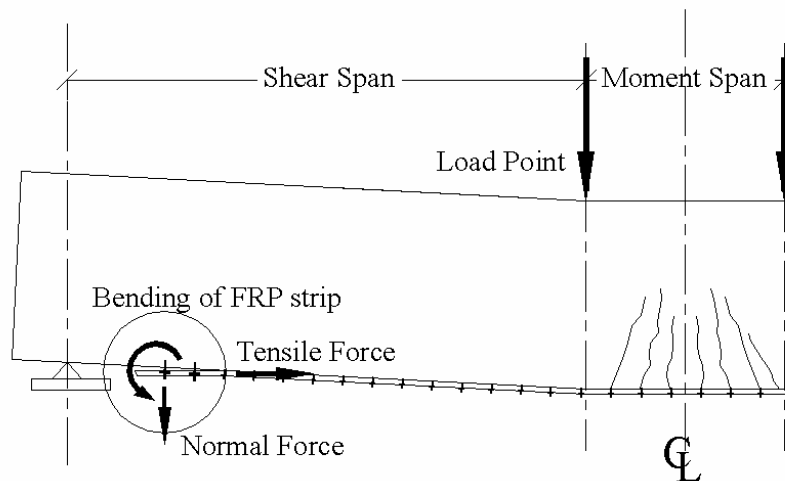
Figure 5.50. Anchorage pullout at the end due to reverse bending of the FRP strip

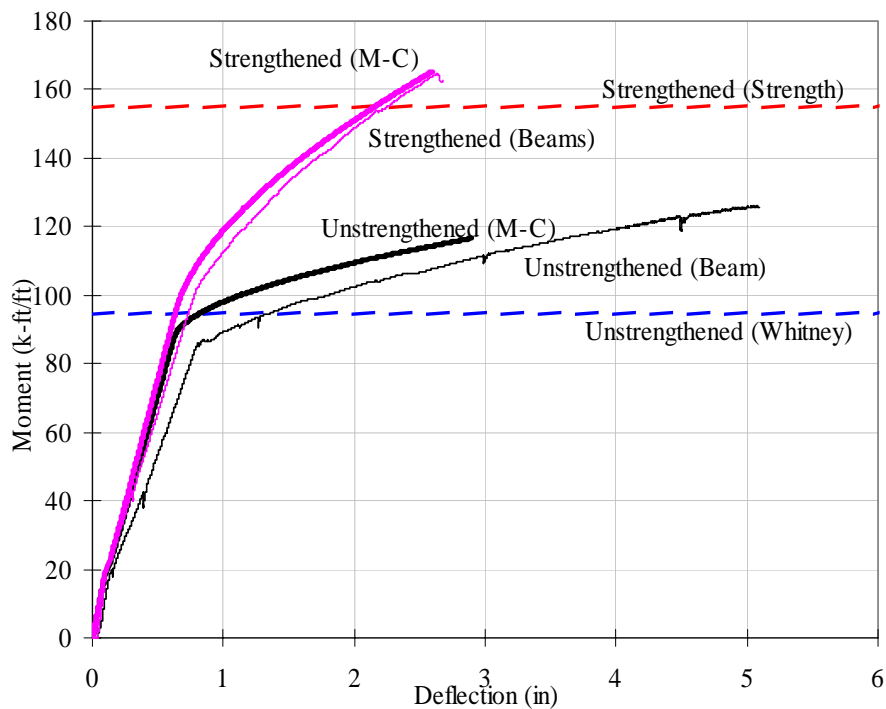
Figure 5.53. Comparison of predictions from moment-curvature model and strength model with scaled test results (predictions shown in bold and dashed lines)

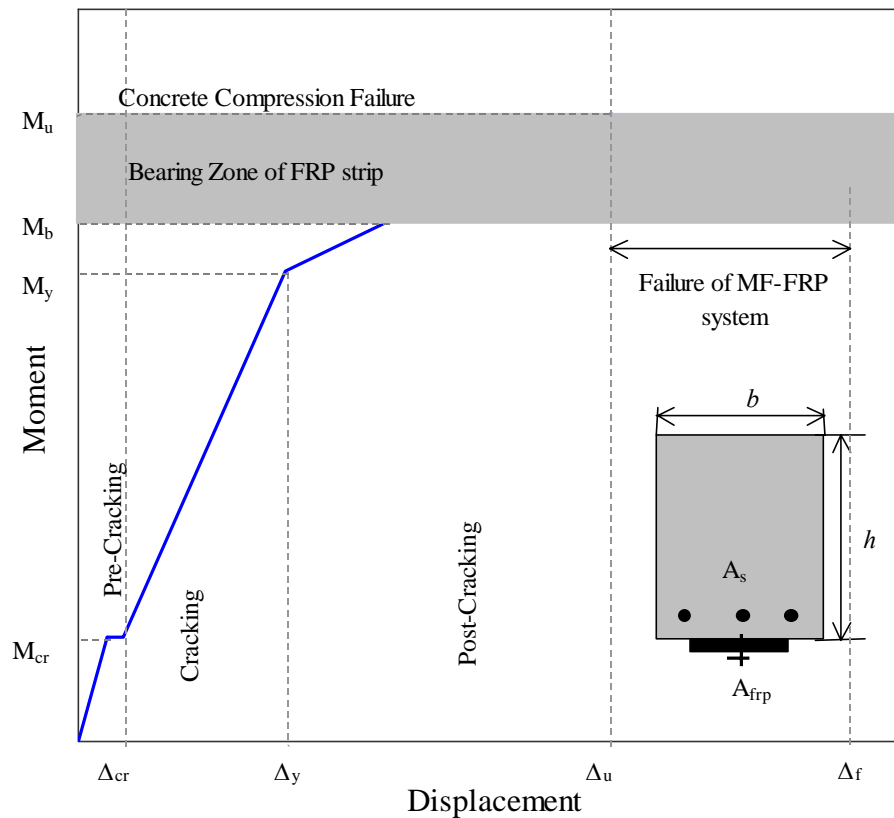
Figure 5.55. Idealized moment versus displacement behavior of MF-FRP strengthened beams

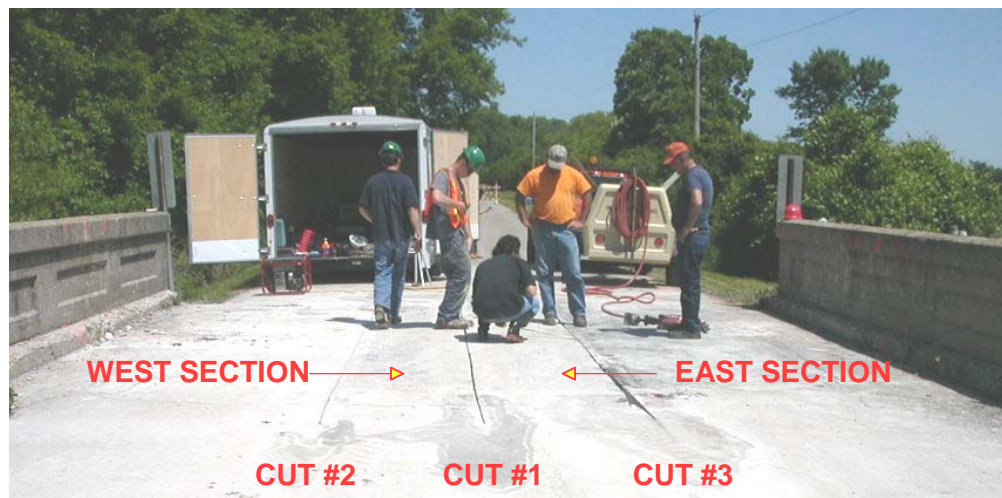
Figure 6.4. Test sections (looking north)

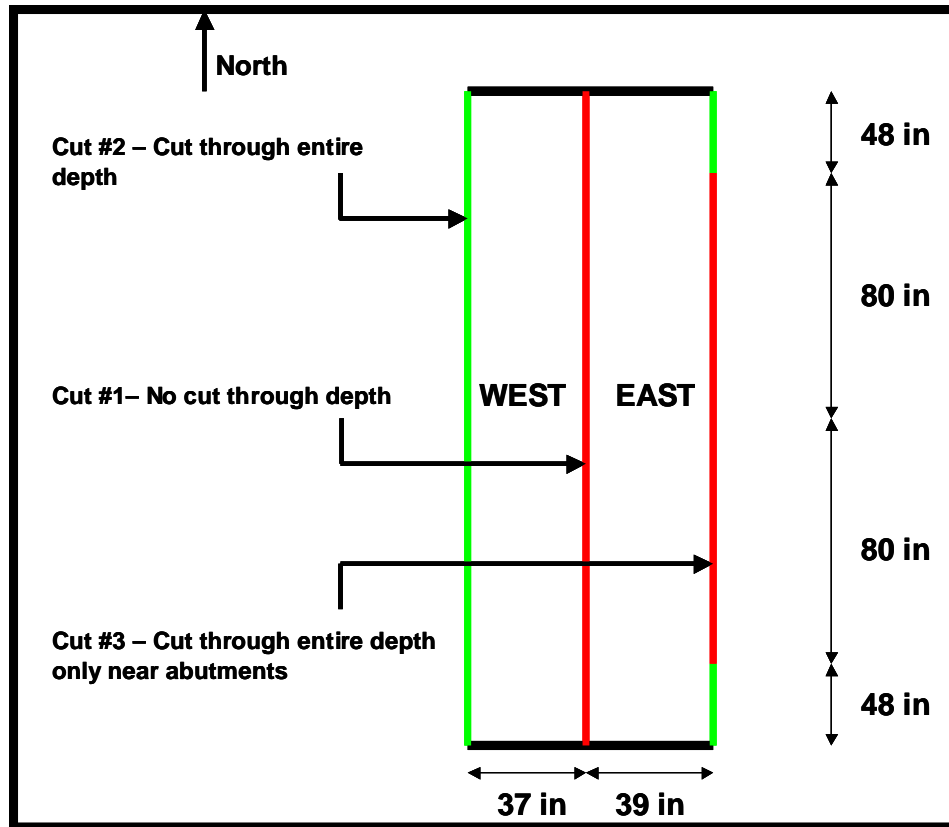
Figure 6.5. Top view of cut penetration

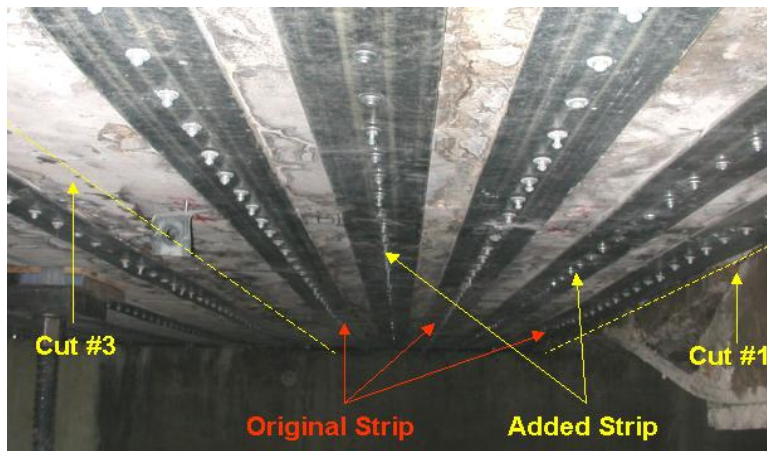
Figure 6.16. View of east section with two additional FRP strips (looking south)

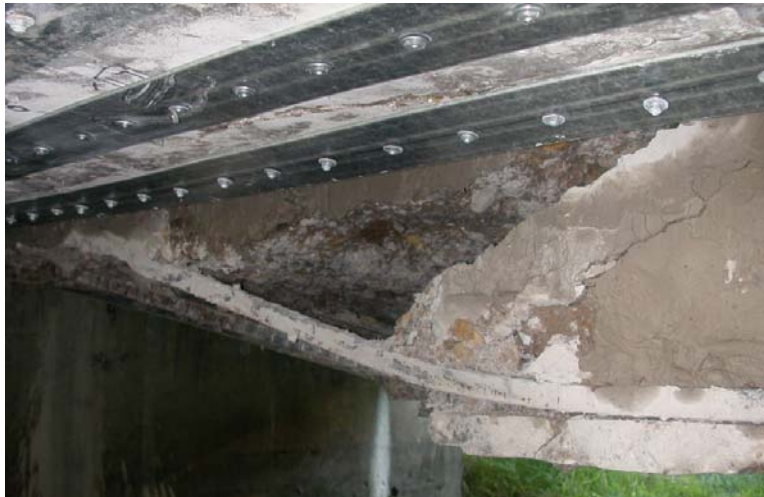
Figure 6.19. Shear failure and spalling along southeast portion of west section

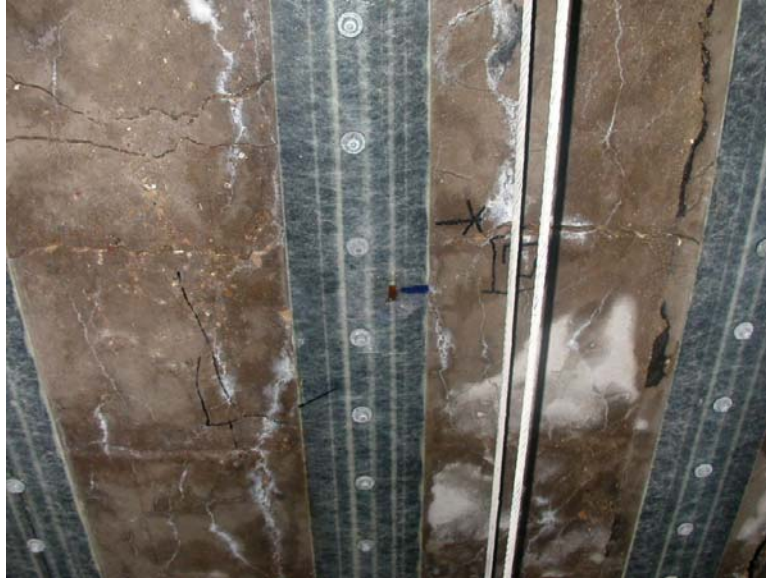
Figure 6.20. Flexural cracks at midspan of west section (during test)

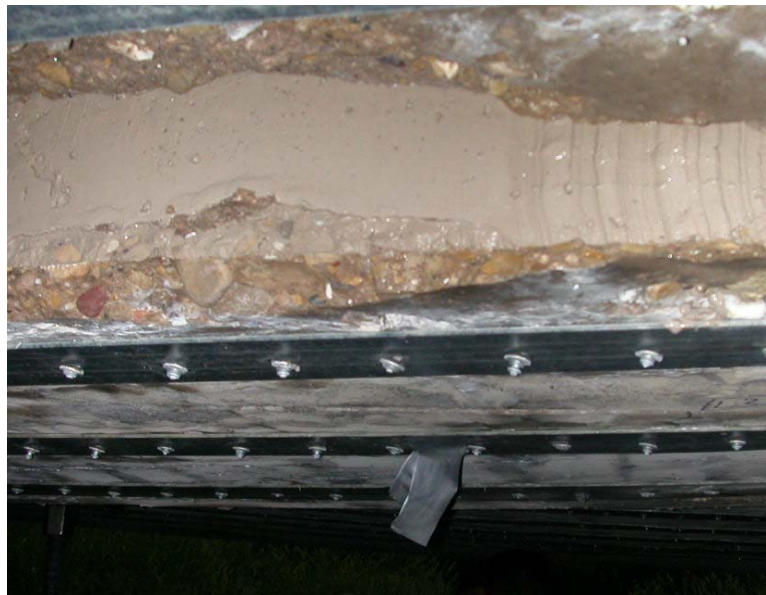
Figure 6.21. View of rotated fasteners along length of west section

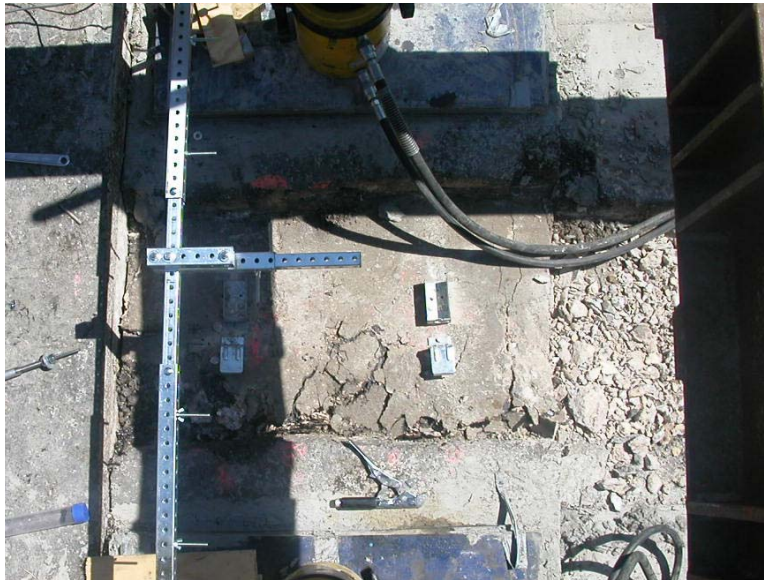
Figure 6.22. Concrete crushing along top of east section

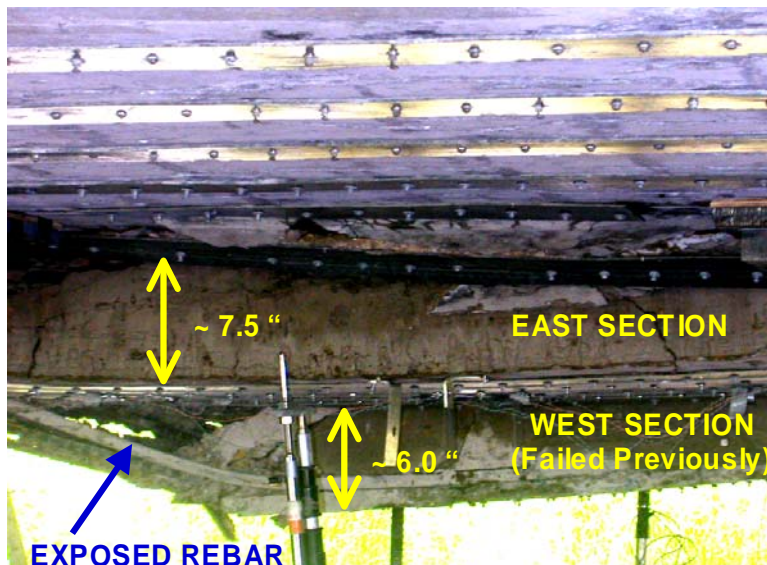
Figure 6.23. View of deflected east section (foreground)

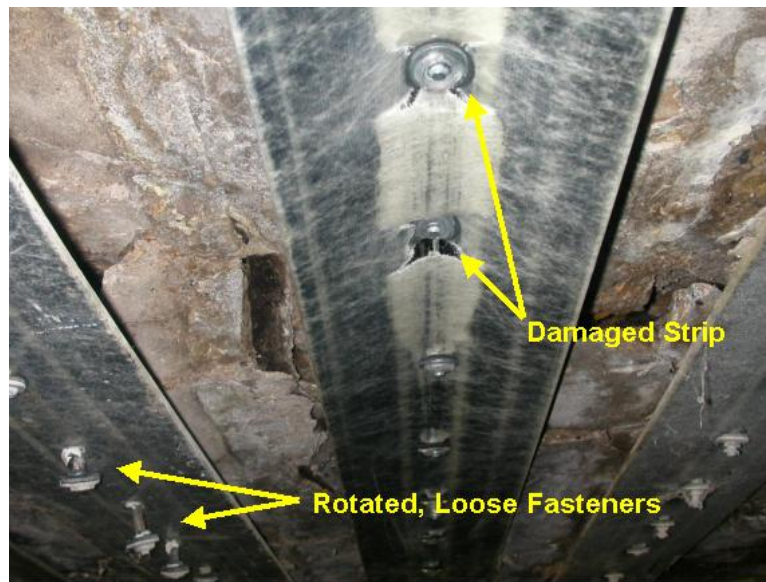
Figure 6.24. View of strips on east section after test completion

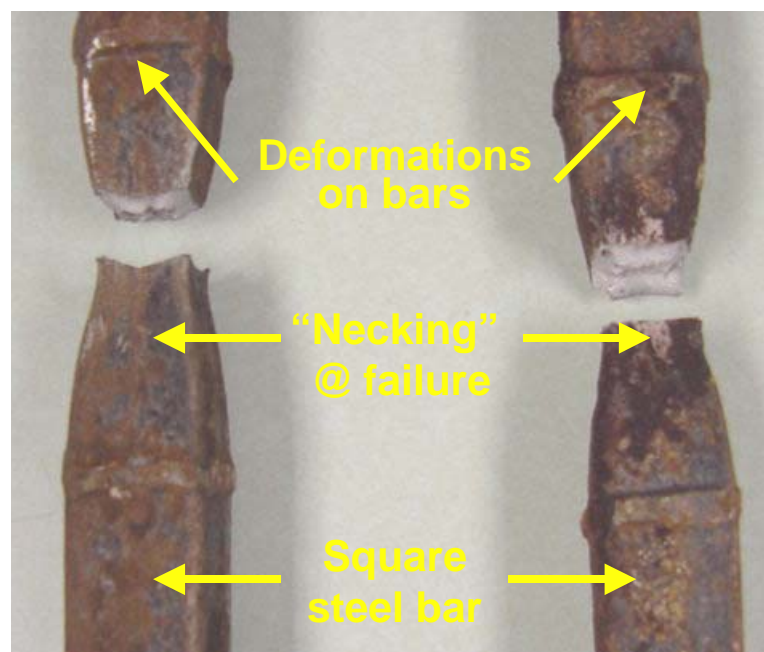
Figure 6.27. Steel samples post-failure

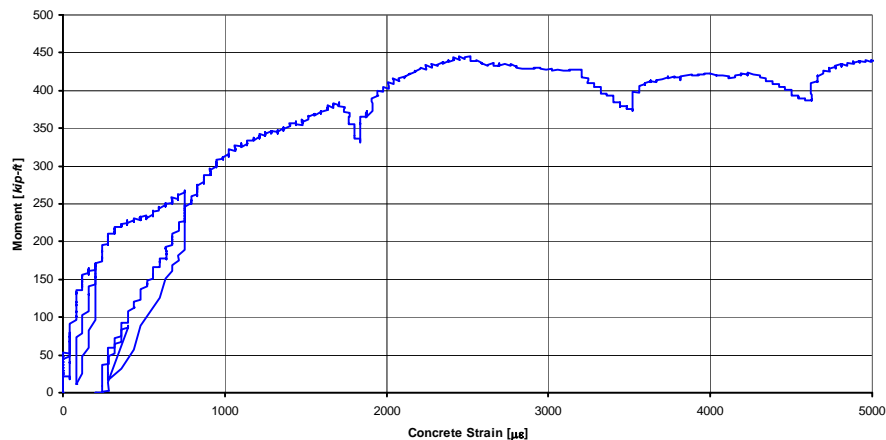
Fig. 6.30. Compressive Strain in Concrete for West section (3 strips)

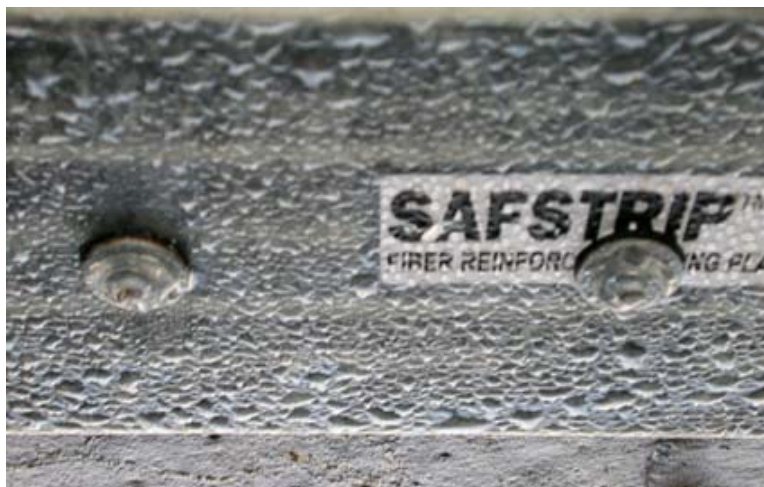
Figure 6.37. FRP strips covered with moisture (spring, 2003)

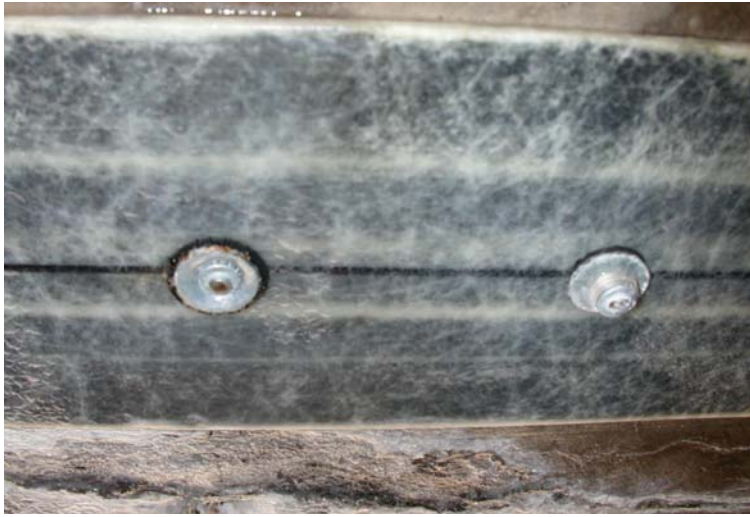
Figure 6.38. Small amount of corrosion seen at the southern end

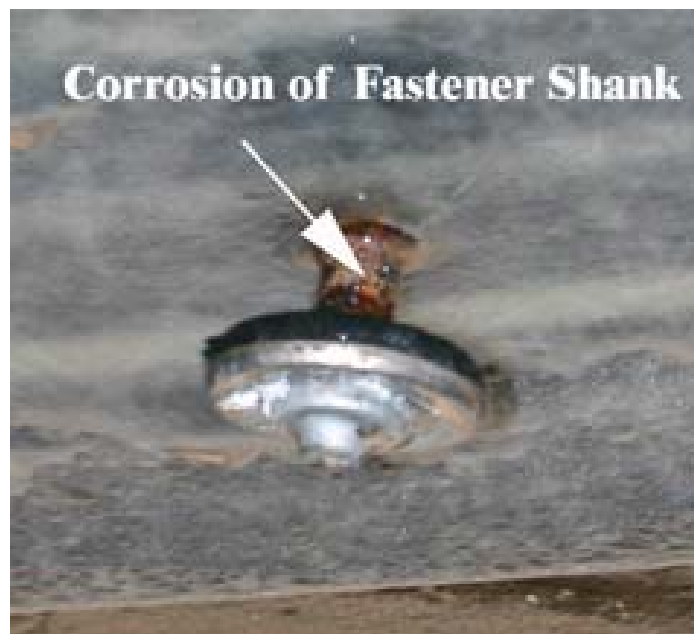
Figure 6.42. Corrosion of ALH fastener shank with incomplete embedment

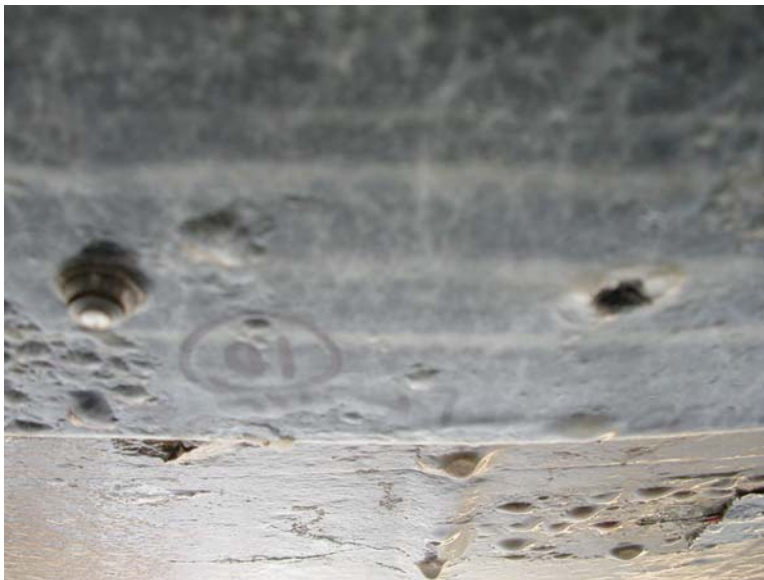
Figure 6.44. Deterioration of FRP strip at location of missing fastener

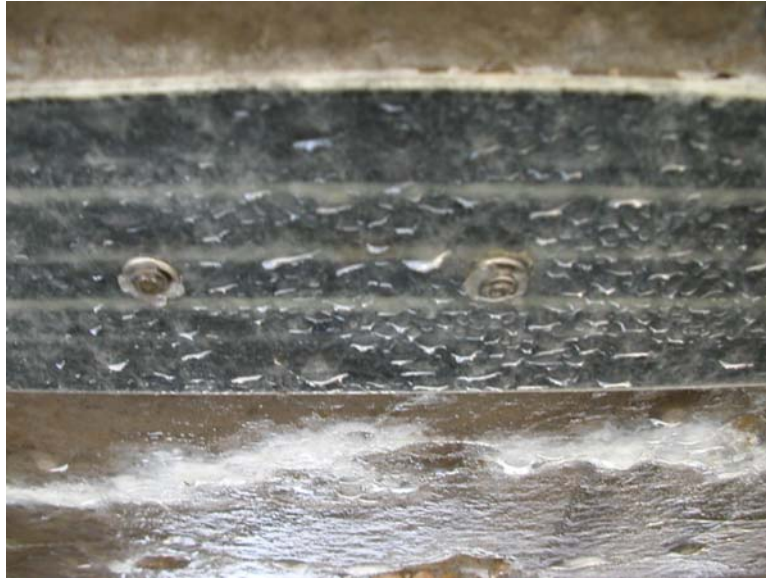
Figure 6.45. Edge of FRP strips covered with water

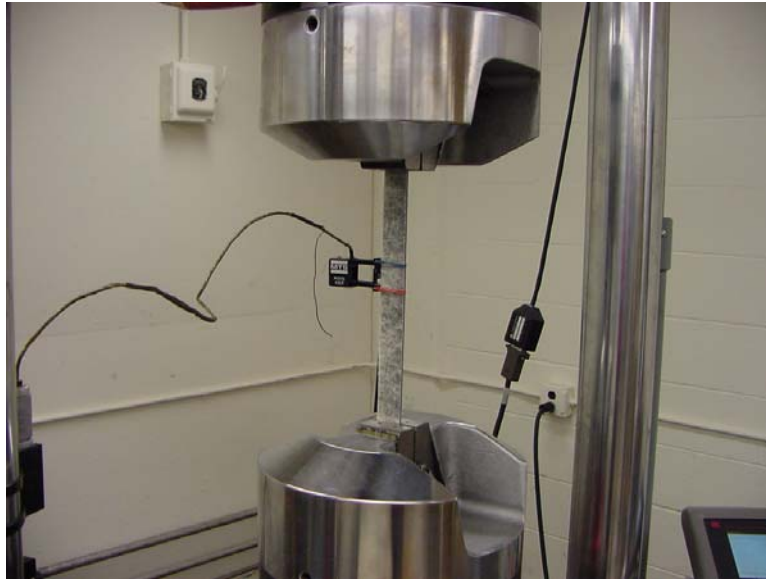
Figure 6.46. Testing a coupon of recovered material (no hole)
