Post-earthquake Damage Evaluation of Bridge Structures

**UTC
R90**

POST-EARTHQUAKE DAMAGE EVALUATION OF BRIDGE STRUCTURES

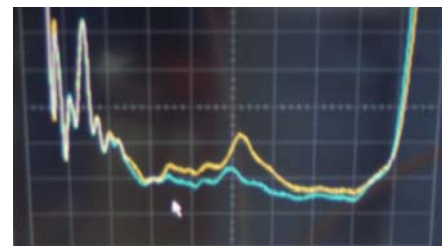
Figure 4 Real-time snapshot (top) and baseline data (bottom).

The measurement principle implemented in the crack detection system is electrical time-domain reflectometry (ETDR). This involves sending a pulse down a signal carrier, cable or sensor, and the reflection of that signal is then sampled, as illustrated in Figure 3. With a sampling device, time-domain reflectometer (TDR), a bandwidth of 20 GHz can be achieved for repetitive signals at a sampling rate of 200 kHz, using equivalent sampling techniques. If there is an impedance change or discontinuity at one location along the length of the cable, the reflection of the input signal at that location will be distinguishable from the remaining portion. This discontinuity is because of some type of change or interruption in the path of current. This is brought about by either a geometric change of the cable cross-section, or by a change in topology of one of the conductors. In the case of the distributed crack sensors in this study, the change in topology of the outer conductor is what causes an interruption of current flow at the location of a crack in the concrete, as illustrated in Figure 1. When the crack in the concrete propagates across the sensor, the solder across the joint between the spirals at that location is broken and the spirals are pulled

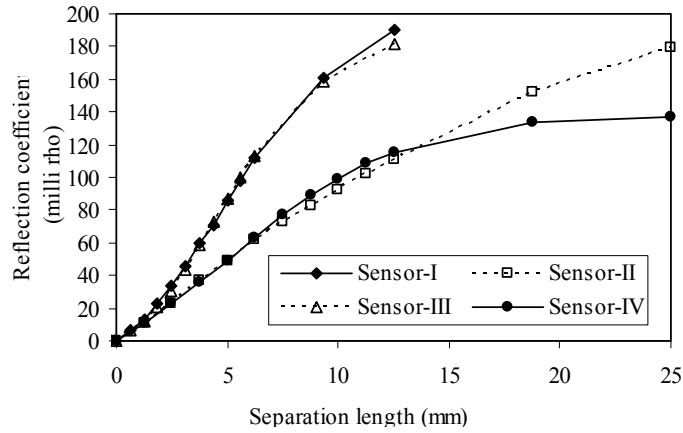
the sensors made of 3.175 mm (0.125 in.)-wide copper tapes, Sensor-I and Sensor-III, have a larger value of the reflection coefficient because of their higher turn density. The higher turn density corresponds to a larger value of lumped inductance for a given length of separation, and thus a larger reflection coefficient. The highest slope of the curves in Figure 7 corresponds to the most sensitive range of the sensors with respect to the length of separation. This range can be used to guide the optimum design of a sensor. For all four sensors, this range is up to 7.5 mm (0.3 in.), which is significantly higher than the width of a concrete crack of engineering interest (Nawy, 2003). Therefore, the design of all sensors seems appropriate for RC members. However, in terms of the length of separation, Sensor-I and Sensor-III are more sensitive than the other two, as clearly suggested in Figure 7.

Figure 7 Increase of reflection coefficient with separation length.

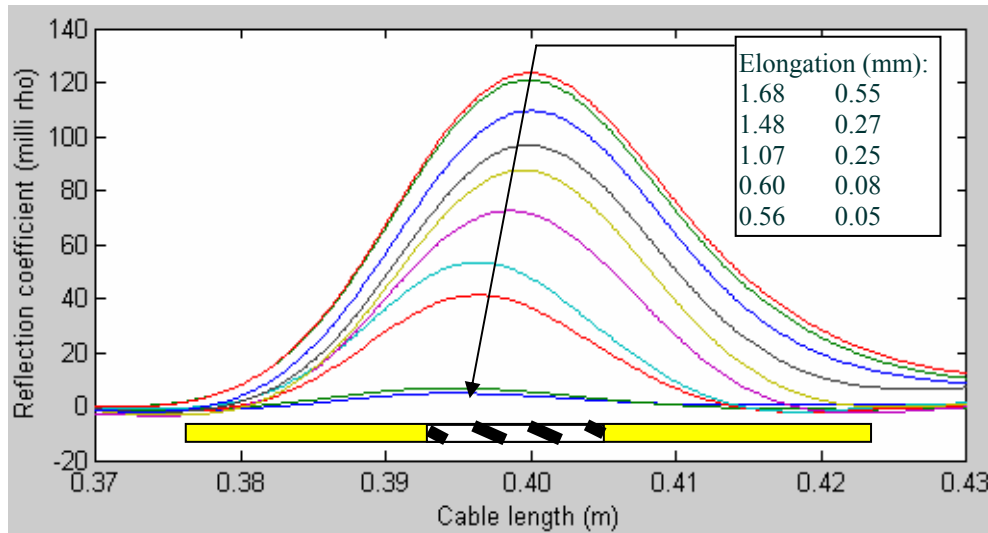
To visualize the change in reflection coefficient over the length of a cable, Figure 11 shows the waveforms (difference) of Cable “three3” at various strains with respect to the initial waveform at zero strain. The differenced waveforms are used to remove manufactured defects of a cable that may exist before the cable sensor is subjected to loading. As the applied strain increases, both the amplitude and bandwidth of a waveform increase steadily except for a significant jump at a strain of 4.67×10^{-4} . This significant increase in reflection coefficient corresponds to an appreciable separation of spiral tapes in the outer conductor of the cable.

Figure 11 Reflection waveform (difference) over the length of a new cable “three3.”

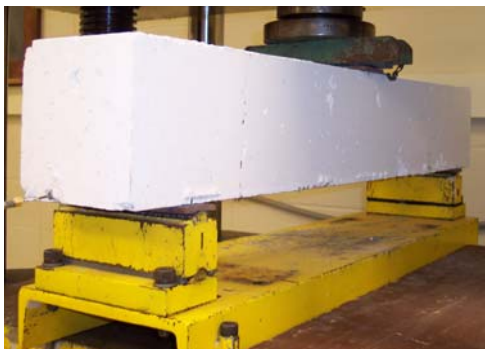
One Teflon sensor was installed in the tension face of each beam that was tested under a three-point loading system, as shown in Figure 15. The beam was simply supported 7.62 cm (3 in.) from each end, and the load was applied at the center point (mid-span) of the top of the beam through a roller bearing. This series of tests were conducted in three phases. The purpose of the first phase of the experiment was to correlate crack width to the change in the reflected signal with static tests, and to understand the effect of crack width on the memory feature. The second phase was intended to ascertain how many cycles it would take to develop a crack memory with cyclic tests. The last phase was designed to understand the effect of loading rate on the memory feature with additional cyclic tests.

Figure 15 Three-point loaded beam.

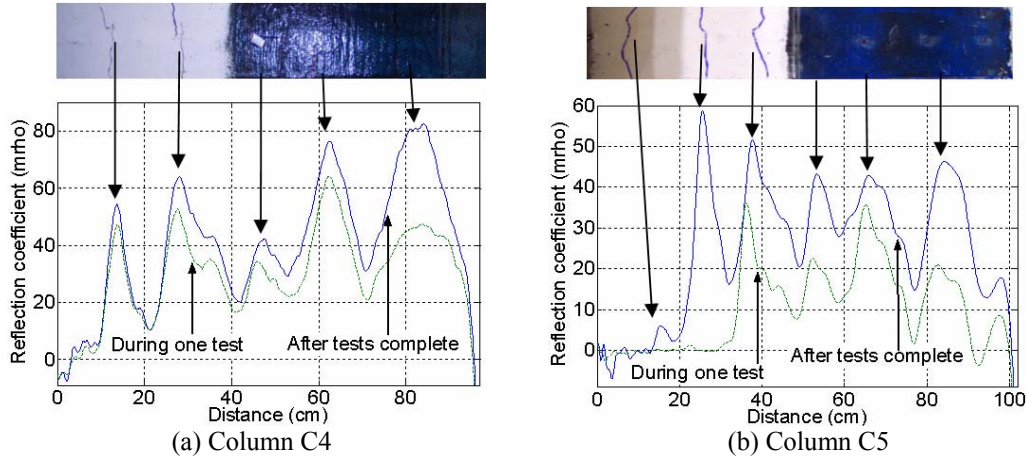
One of the more interesting discoveries after the dynamic column tests, was the observation of the sensor being able to “remember” where the cracks had occurred after testing was completed. While it was visually difficult to detect the cracks on the face of the column, the peaks in the signal from the sensor corresponding to cracking remained visible in the signal once testing was completed. This can be very useful in post-disaster evaluation of RC structural members by being able to more accurately and quickly ascertain the damage that occurred to the structure during the event. Figure 21 shows the signal from Columns C4 and C5 captured after testing was completed. It can be seen from Figure 21 that the cracks that had opened during motion are still visible in the sensor signal.

Figure 21 Difference data captured during testing and memorized after tests.

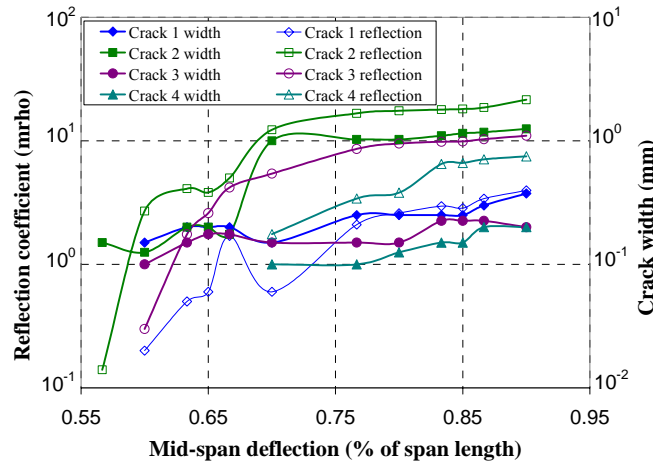
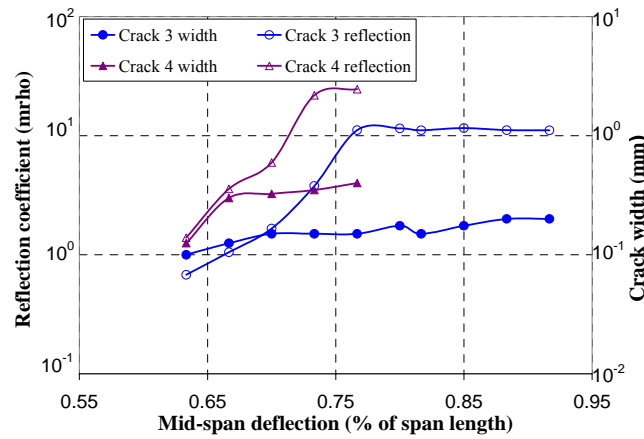
reflection coefficient as the crack width increases, especially at low loads. For each particular crack, the curves for the reflection coefficient and the crack width show an excellent trend for correlation. It is observed from Figure 24 that at a load level of approximately 0.70%, the crack width and the reflection coefficient corresponding to Crack #1 of Beam B2 drops steeply. This can be explained by the dramatic widening of the adjacent crack, Crack #2, at that loading level, resulting in stress redistribution of the beam. The curves corresponding to Crack #1 begin to increase again as the loading level increases. The presence of multiple cracks makes it difficult to establish a representative correlation between the reflection coefficient and the crack width. It is noted that, in Figure 23(d), several peaks were shown in the reflection waveform of Beam B4 between zero and approximately 15 cm (5.9 in.) due to loose contact of the end connection with TDR. This problem was identified during the testing and corrected before cyclic tests.

(a) Beam B2

(b) Beam B3

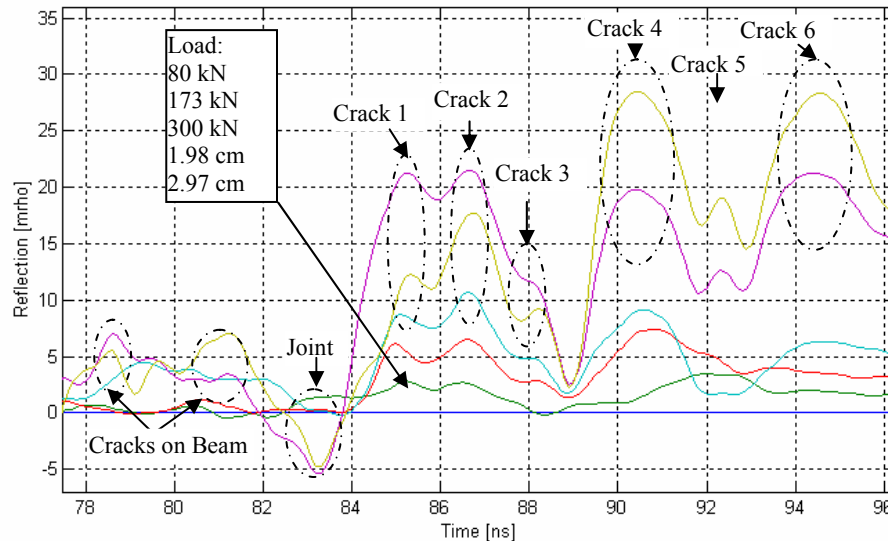
A rubber sensor was installed on the first beam-column assemblage, Specimen #1. Under tension loading, the difference waveforms measured from a crack sensor are presented in Figure 28, corresponding to a load of 80 kN (18 kips), 173 kN (39 kips), 300 kN (68 kips), 1.98 cm (0.78 in.), and 2.97 cm (1.17 in.). The crack numbers in Figure 28 correspond to the crack pattern illustrated in Figure 29(a, b), at 177.3 kN (38.85 kips) and 1.98 cm (0.78 in.), respectively.

Figure 28 Difference waveform under tension.

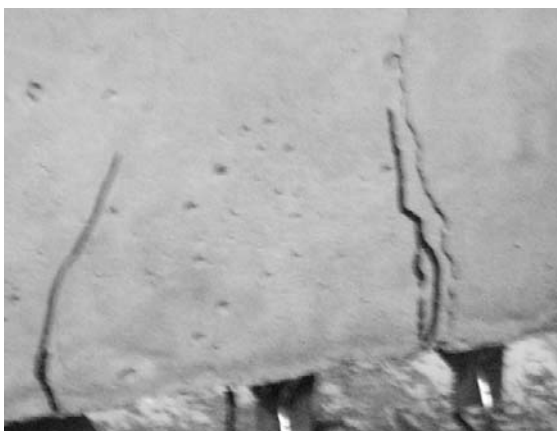
(a) Before cyclic test

(b) After cyclic test

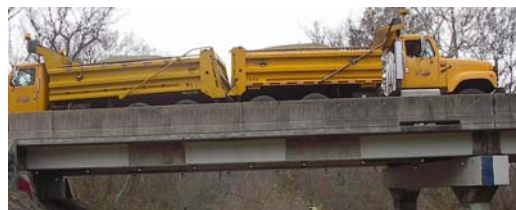
Figure 80 Trucks in loading position.

Two Teflon sensors were installed on the underside of the concrete deck of a bridge being load-tested, perpendicular to the traffic direction, as illustrated in Figure 79(a). The bridge is a three-span structure with a total length of 38.7m (127 ft), Figure 79(b), located in Dallas County, Missouri. The superstructure has three RC beams that were cast integrally with the deck. The sensors were installed in November of 2003 before tests were conducted. As expected, there were no significant changes due to the loading of the bridge. The vehicles were parked back to back, as seen in Figure 80, in the lane opposite to the lane directly above the location of the sensors. The second loading case which affected the sensors, the trucks were parked back to back, similar to Figure 80, but in the center of the bridge width. These tests were repeated in May of 2004. The sensors were once again measured under the same load cases. The data from Figure 81 and Figure 82 reflect the signal from each sensor at zero loading after each load case had been completed in both November and May. Sensor 2 showed little change during the months of inactivity, while Sensor 1 showed a very small crack after the loading test in May. The location of the sensor in the deck was visually inspected for cracks and none were seen.
