GPR and Resistivity to Determine Depth to Bedrock at the Roaring River Trout Hatchery

**UTC
R113**

Interpretation of Resistivity and Ground Penetrating Data: Roaring River State Park

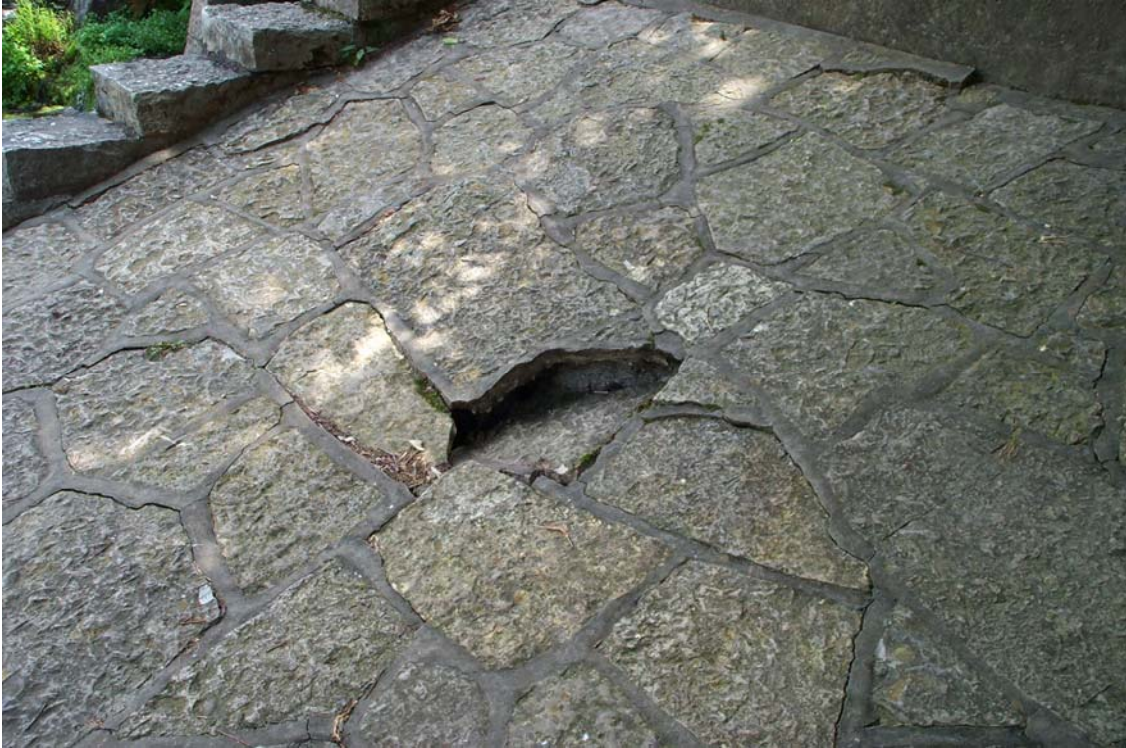
Figure 12: Interior erosion near double spillway.
