## **Development of Hand-Held Thermographic Inspection Technologies**

**NUTC  
R198**

**Development of Hand-held Thermographic  
Inspection Technologies**

**Final Report**

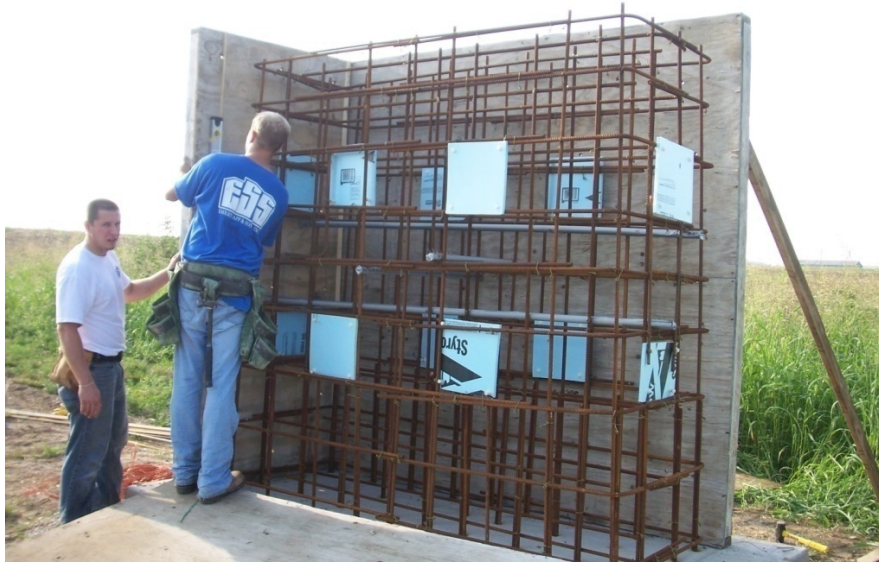
held in place with steel ties that traversed the block in the north-south and east-west directions. These steel ties held the forms at a fixed separation during the concrete pour. The ties were cast into the block and ground flush once the concrete was cured.

**Figure 3.3 : Photograph of the test block during construction showing the targets mounted on the rebar cage.**

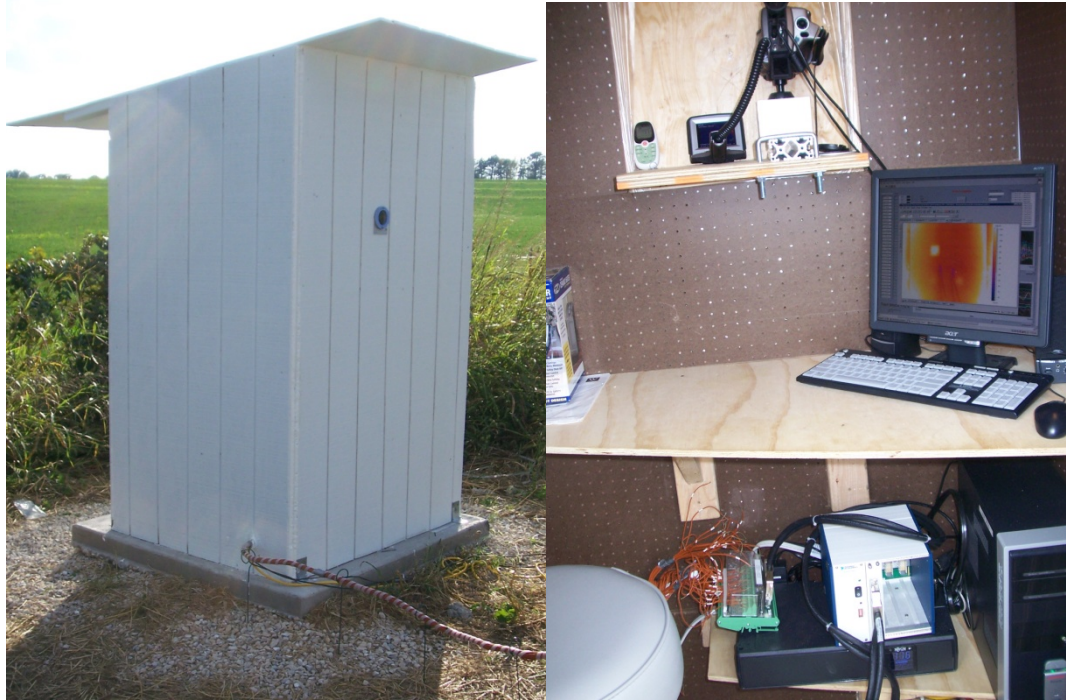
The computer and vital equipment were also powered through surge protection and an Uninterruptible Power Supply (UPS) to account for short power failures and surges in the area. The UPS could run the vital equipment for up to 30 minutes in the case of a short power failure.

**Figure 3.5 : Data house and inside layout with thermal imaging camera, standalone PC, and data acquisition (DAQ) equipment.**

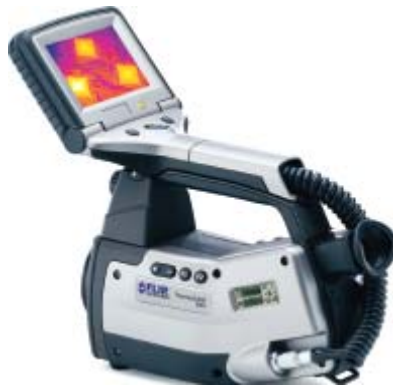
The images captured by the IR camera are displayed in the viewfinder and on the handheld LCD display, and stored on computer. Images were captured according to a pre-defined schedule of 1 image captured every 10 min, 24 hrs a day. The camera required a distance of approximately 6 m (20 ft.) to capture the entire 2.4 m x 2.4 m (8 ft. x 8 ft.) face of the test block with its regular lens. Figure 3.6 shows the FLIR S65 ThermoCAM.

**Figure 3.6 : FLIR ThermoCAM S65 infrared research camera.**

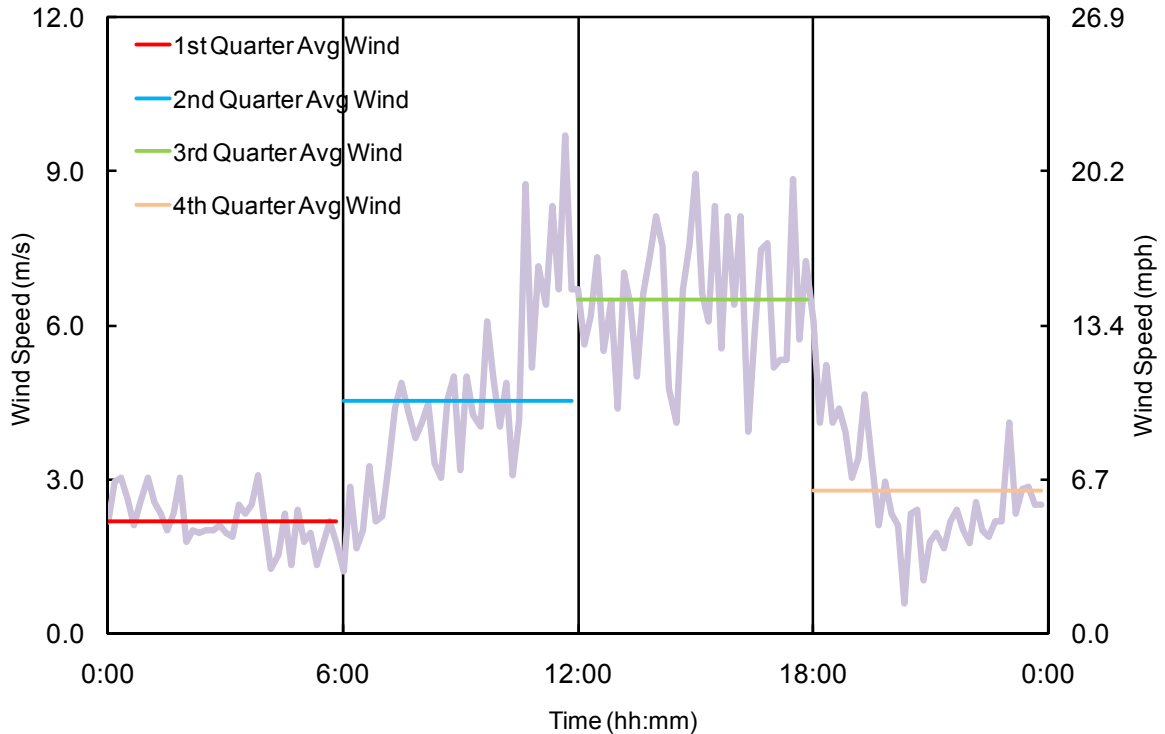
and 12:00 noon, while 2<sup>nd</sup> quarter wind speed for negative analysis takes place between 6:00 PM and 12:00 midnight). The second quarter wind speeds are important because these are the time periods when thermal contrast is being developed, and the rate of heat transfer from the environment to the concrete was thought to be most significant in terms of the resulting thermal contrast.

**Figure 4.3 : Wind speed quarter averages for 24 hours (June 7<sup>th</sup>, 2008).**

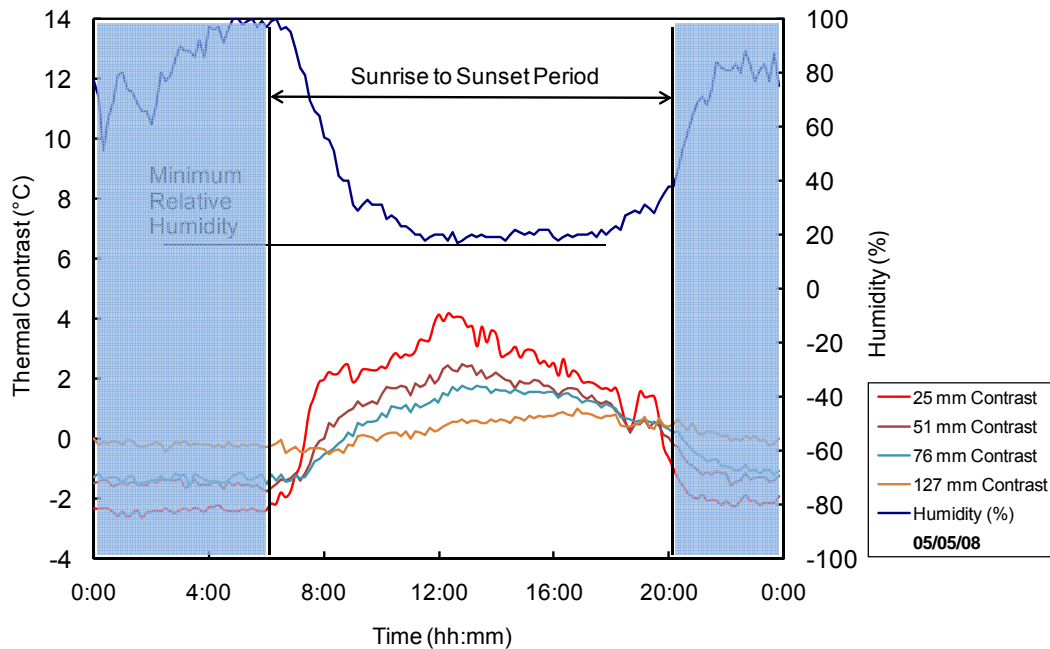
The values utilized to represent humidity in the analysis included average values acquired between sunrise and sunset for the positive analysis, and between sunset and sunrise for the negative analysis. Figure 4.4 shows the period that is used for positive analysis. It is typical for relative humidity values to be low during the day, and high during the night based on common weather patterns.

**Figure 4.4 : Example of data used in humidity positive analysis (May 5<sup>th</sup>, 2008).**

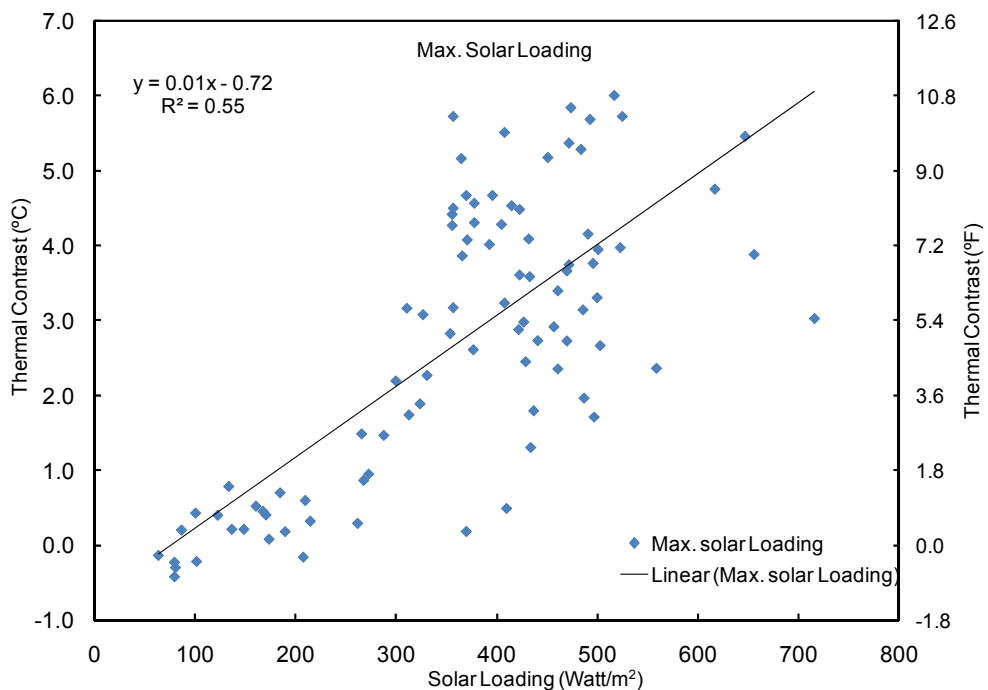
Data was analyzed to consider the solar loading imparted into the concrete over the course of the entire day. To calculate this value, the area under the solar loading curve was calculated for each day, and this value was then correlated with the observed maximum thermal contrast.

**Figure 5.2 : Scatter plot with trend line for maximum solar loading versus thermal contrast.**

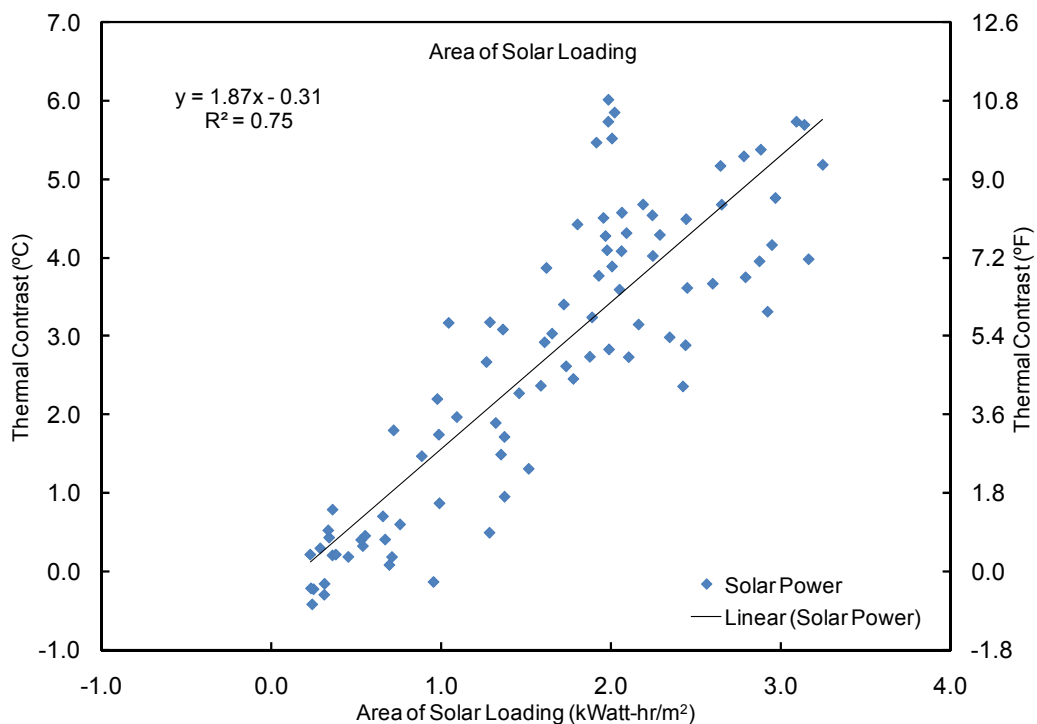
horizontal line, drawn at 1°C (1.8°F), with the trend line in the figure, and calculating the percentage of days remaining above 0.7 kW-hr/m<sup>2</sup> and 1°C (1.8°F) of contrast as a portion of all days with solar loading of at least 0.7 kW-hr/m<sup>2</sup>. The significance of this in terms of inspection is that periodic cloud cover that reduces the intensity of sunlight for short periods has a negative impact on the thermal contrast developed, and that the solar loading over the course of the day may be more important than the intensity of sunlight at any particular time. This is consistent with the importance of the radiant heating from the sun to develop thermal contrast in a concrete structure. Additionally, because the relationship between the area of solar loading and the thermal contrast was found to be linear, longer periods of intense sunlight are proportionally better than shorter time periods. In other words, inspection conducted during longer days (summer) will provide improved results over inspections conducted on shorter days (winter).

**Figure 5.3 : Scatter plot with trend line for area of solar loading versus thermal contrast.**

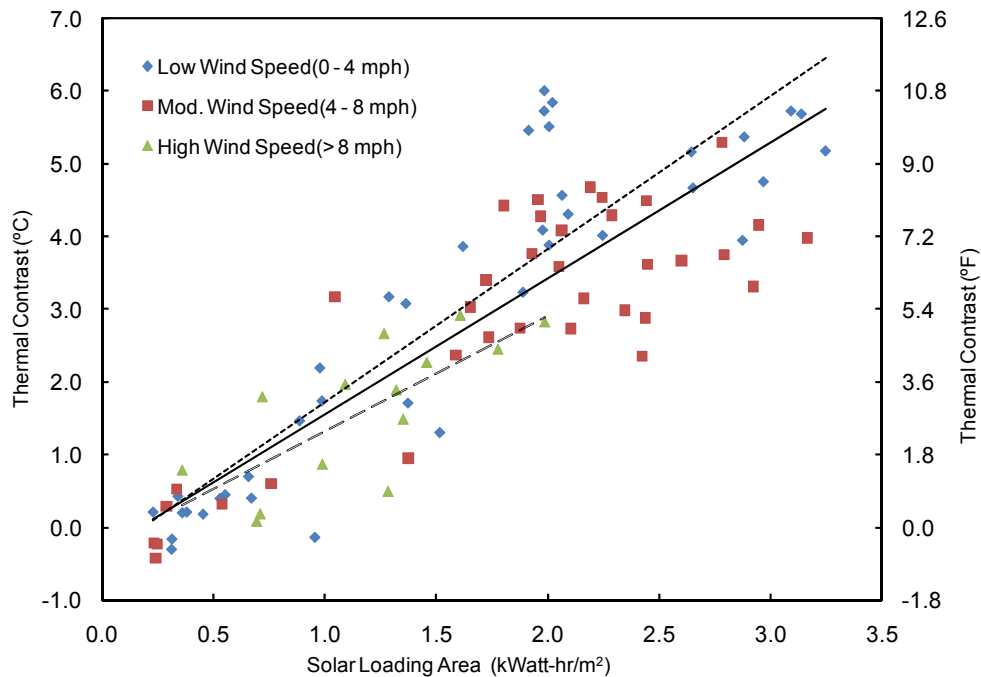
with high winds (>8 mph) relative to the trend for all days combined, and much lower than the trend when winds were low. Figure 5.6 shows the scatter plot for maximum thermal contrast vs. the solar loading area (kW-hr/m<sup>2</sup>), with the three wind categories, low, moderate and high shown as different markers. Also shown on the plot is the trend line for high winds (long dash lines), low winds (short dashed lines), and all of the data as one group (solid line). As can be seen, the trend of the correlation for days with low wind speeds is much higher than days with high winds. Figure 5.7 shows the same relationships for the 3<sup>rd</sup> quarter wind speeds. The third quarter is from the hours of 12:00 noon to 6:00 pm., which is envisioned as the primary time for inspections, due to the time delay for the concrete to warm over the course of the day.

**Figure 5.6 : Scatter plot of solar loading vs thermal contrast, with low, moderate and high wind speeds, 2<sup>nd</sup> quarter.**

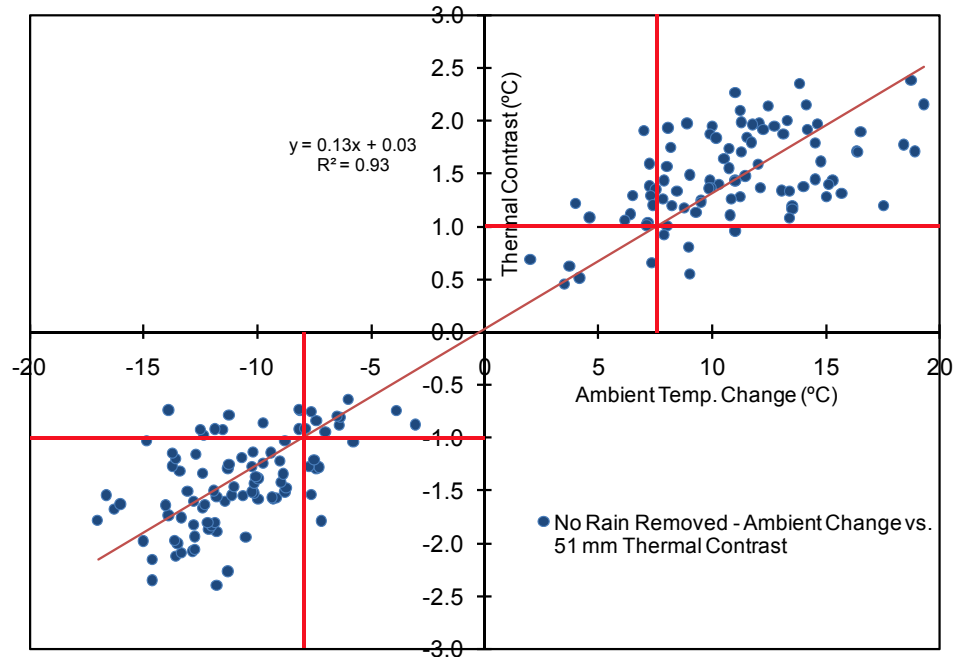
**Figure 5.8 : Thermal contrast in north side of test block compared with ambient temperature changes.**

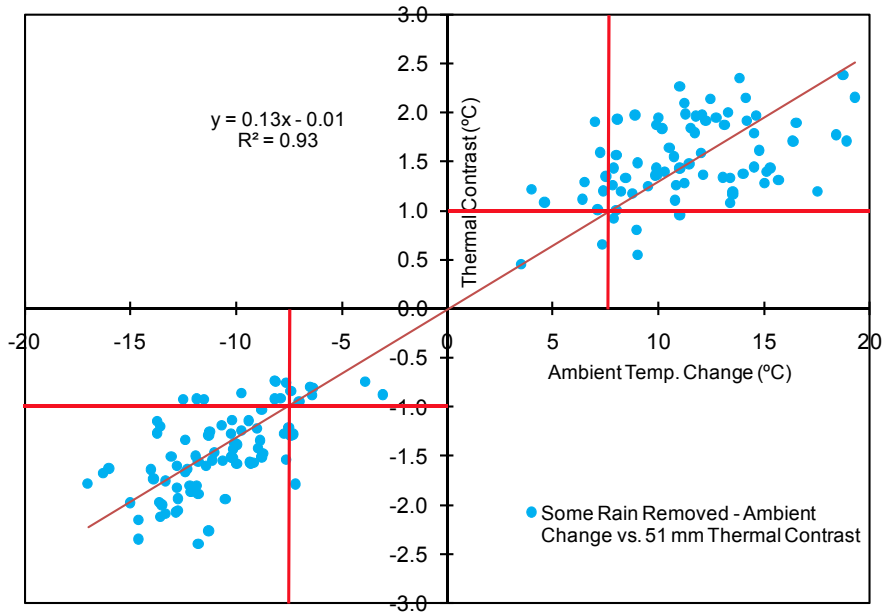
**Figure 5.9 : Thermal contrast in north side of test block compared with ambient temperature changes, with days including rain removed.**

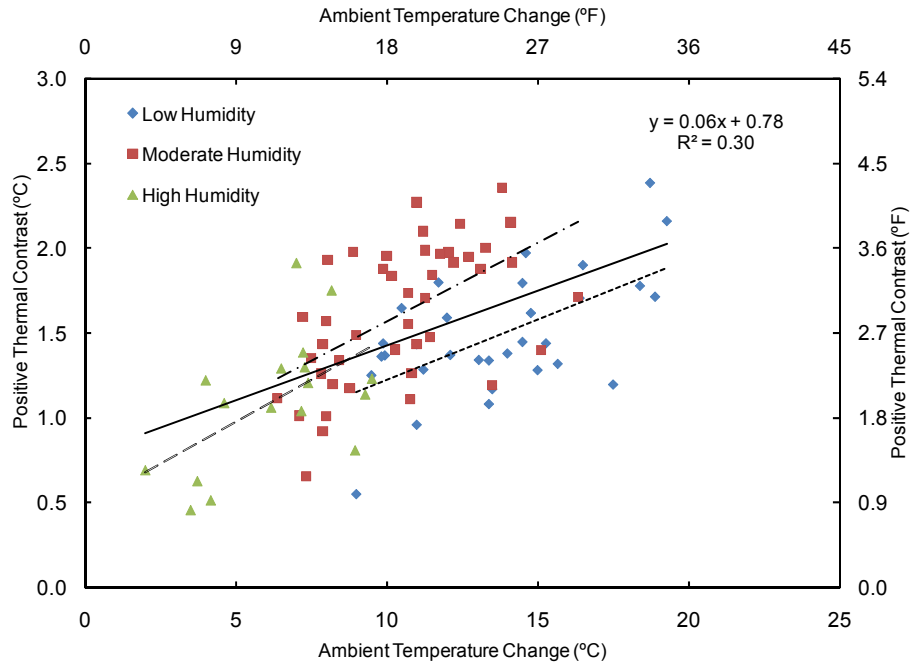
**Figure 5.12 : Thermal contrast vs. ambient temperature changes with markers indicating high, moderate and low humidity.**

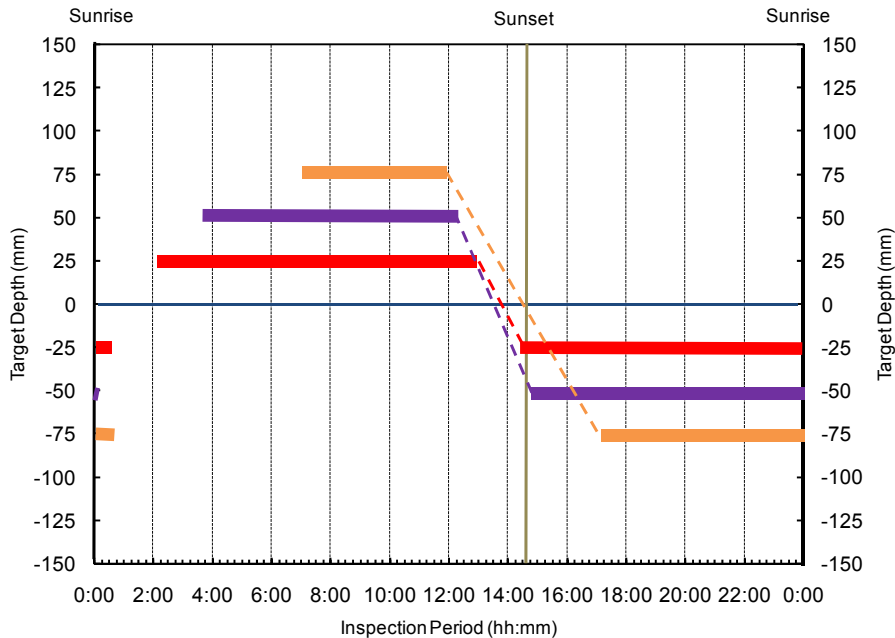
**Figure 5.13 : Indicates the suggested times of observation relative to sunrise and sunset. Separated by the y-axis centerline, the time and duration of positive and negative contrasts greater than +/- 1 °C can be taken directly from this guide.**

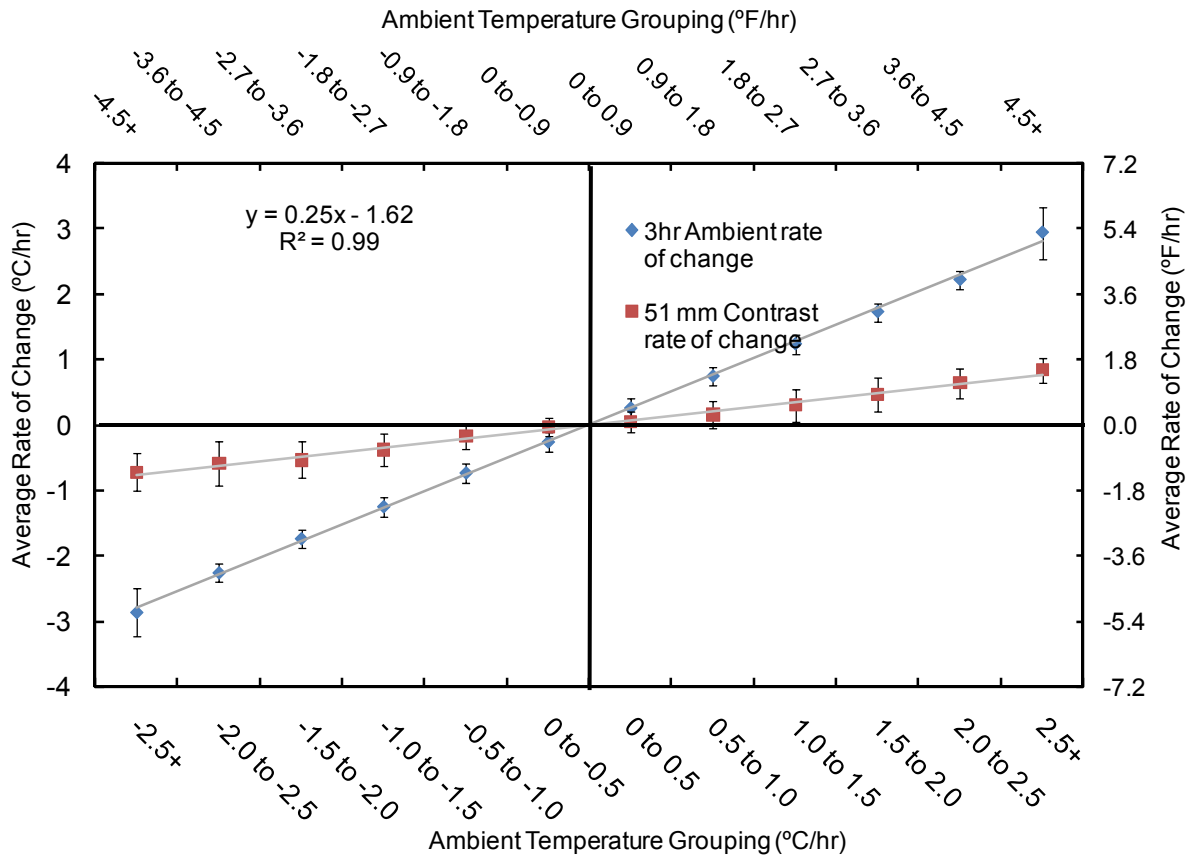
**Figure 5.18 : Relationship between ambient temperature rate of change (x-axis) and thermal contrast rate of change (y-axis).**

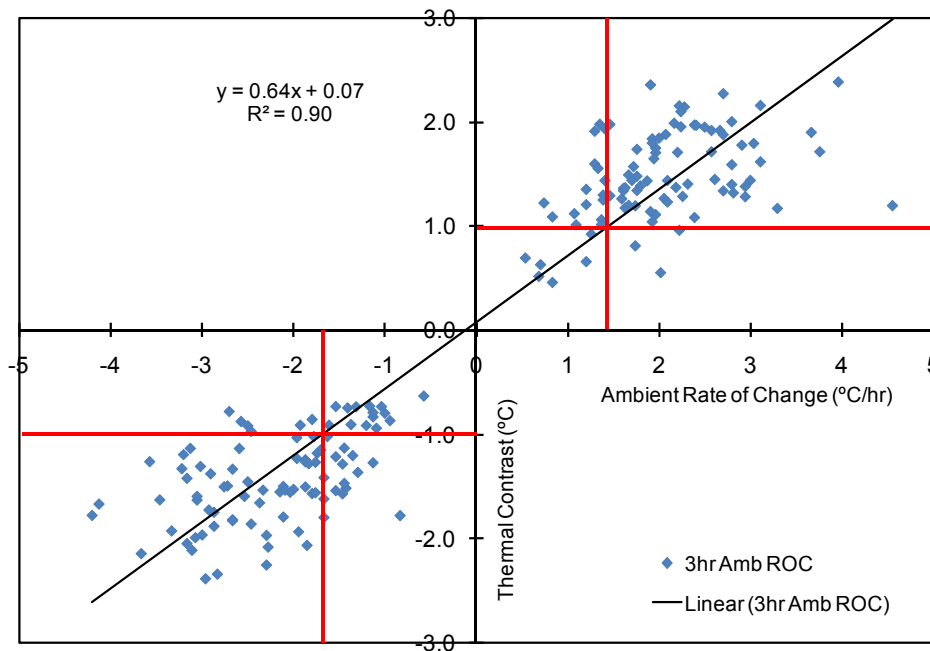
**Figure 5.19 : Maximum 3-hour ambient rate of change vs. 51 mm contrast with equation.**

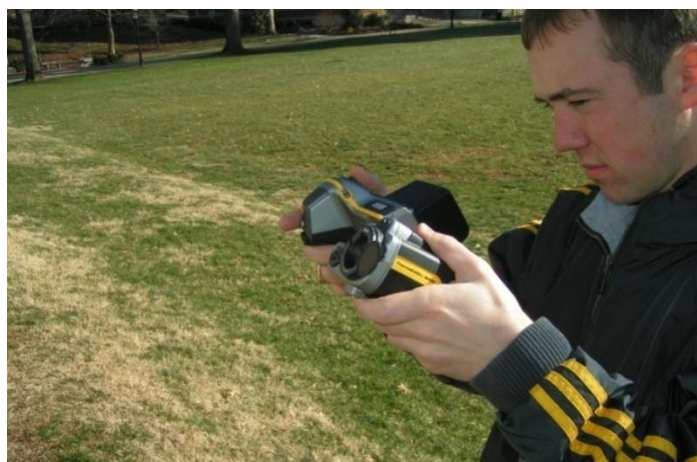
Figure 6.1 : Photograph of student holding B400 camera.

Participating states were provided with FLIR B400 hand-held infrared cameras. These cameras are designed for field operation, specifically for the inspection of buildings. The cameras have a variety of features to make them suitable for use in the field. The cameras are hardened to survive in the field, have an intuitive menu structure that can be quickly learned, and have ergonomic features (such as an articulating lens) that make them suitable for application in the field. Thermal images are stored in .jpg format so that they are easily transferrable between computers and integrate well with other programs. Reporting software provided with the cameras allows for thermal contrast in the images to be adjusted post-inspection for further analysis of images in the office. A photograph of the camera is shown in Figure 6.1.

Thermal images are observed on a 3.5 in. LCD display. A sunscreen is typically required to view images in sunlight, as is typical with computer screens. The cost of the cameras at the time they were purchased for the research was \$19,950. At the time of purchase, the camera was the latest development from the manufacturer, such that lower costs would be anticipated with time. The thermal resolution for the camera is 0.05°C, which is slightly better than the research camera used to observe the test block. In addition to the cameras, a wide angle lens was purchased (cost = \$3,500). The wide angle lens was provided to enable the inspection of a larger area, say a larger area of the deck, from a standing position along the side of the deck.

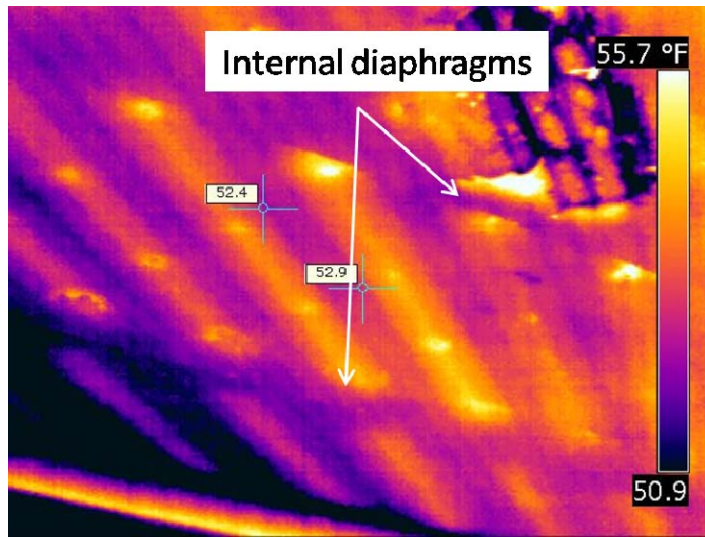
**Figure 6.7 : Thermal image of the soffit of a bridge deck showing thermal signature of internal sonatubes and diaphragms.**
