Validation of Coaxial Cable Sensors for Dynamic Crack Detection in RC Columns Under Blast Loads

**NUTC
R207**

Final Report
Agreement No. 59A0571

**VALIDATION OF COAXIAL CABLE SENSORS FOR DYNAMIC CRACK
DETECTION IN RC COLUMNS UNDER BLAST LOADS**

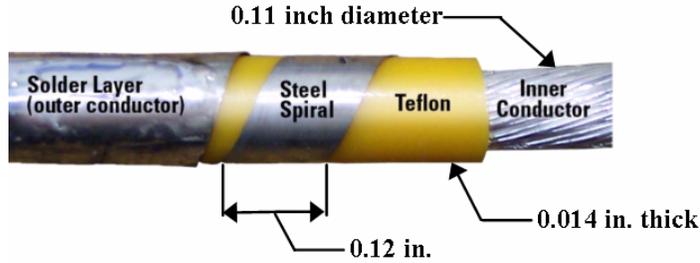
Figure 2.1 shows the cut-away view of a crack sensor.

Figure 2.1. Cut-Away View of Crack Sensor (McDaniel, 2004)

To fabricate a cable sensor, a 10 gage wire is wrapped with a stainless steel spiral along the entire length of the cable. A very thin layer of solder is then applied on top of the spirals to create a continuous outer conductor and to prevent premature separation of the spirals. In place of hand-soldering, a thermal spray system that uses plasma gas and a very fine copper powder can be used to create the continuity in the outer conductor. The coating can either be applied using a hand-operated spray gun or by using robotic equipment. Although the robotic equipment creates the most uniform coating, either method (hand or robot operated) has been proven to create a more consistent coating than the hand-soldering method in addition to being less time-consuming.

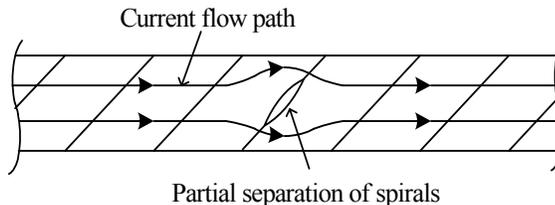
Figure 2.2. Path of Current along Disturbed Outer Conductor (McDaniel, 2004)

The propagation time scale can be converted to distance along the cable by dividing by two and multiplying by the signal propagation velocity, which is based on the electrical properties of the cable. The reflected voltage can be converted to a dimensionless measure called reflection coefficient (ρ) by dividing it by the voltage of the original pulse signal. Once these conversions are made, the signal is then in the form of reflection coefficient as a function of distance along the cable. From this data, the locations of various cracks along the member are easily established. Figure 2.3 demonstrates how the sensors work in an actual structure. As can be clearly observed in Figure 2.3, the spirals of the cable were separated around two cracks. Note that cracks do not have to be as large as the ones shown in Figure 2.3 for the sensor to work properly. Past tests indicated that a crack width of as small as 0.005" can be detected by cable sensors (Chen *et al.*, 2004) and two cracks of 1" apart can both be clearly identified from one sensor measurement.

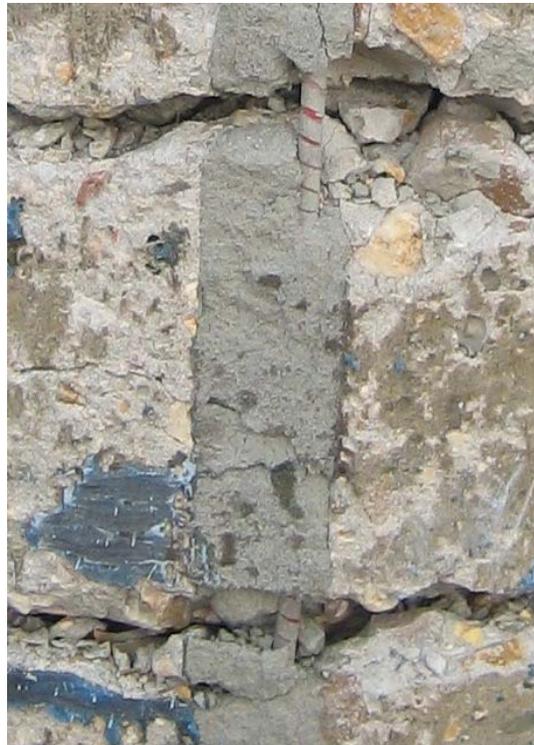
Figure 2.3. Separation of Steel Spirals in Two Cracks

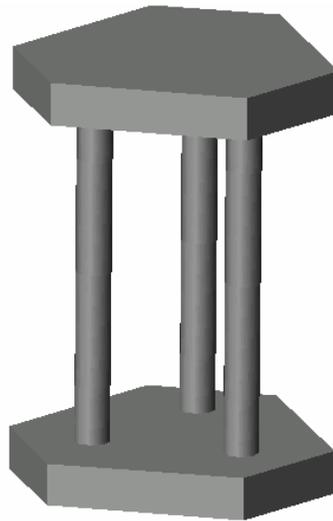
In order to create three identical columns (before strengthening), a three-column specimen was designed, as shown in Figure 3.1. Each column was designed as a 1/4-scale specimen of a prototype bridge column in Missouri.

Figure 3.1. 3-D Rendering of the Three-Column Specimen

Each column was 8 feet long and 10 inches in diameter; it was reinforced with 6 #3 deformed bars and #3 hoops every 6". All reinforcement was Grade 60, and the reinforcement and detailing was designed based on the provisions of ACI 318-02 (2002). The specimen had a 12" thick footing and a 12" thick slab on top. The purpose of the three-column layout is such that the explosive charge may be suspended from the top of the specimen so as to induce an identical blast load on each of the three columns. The top slab was also balanced over the three columns so that very little end moment would

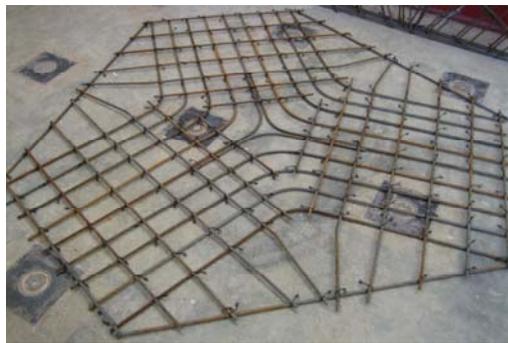
The steel cages that would be placed in the footing and top slab were constructed as shown in Figure 4.1. Each had reinforcement in the top and bottom, and all reinforcement was designed to be symmetrical about the central axis. The member dimensions, rebar sizes and details can be found in Appendix A.1.

Figure 4.1. One Layer of Reinforcement for Footing and Slab

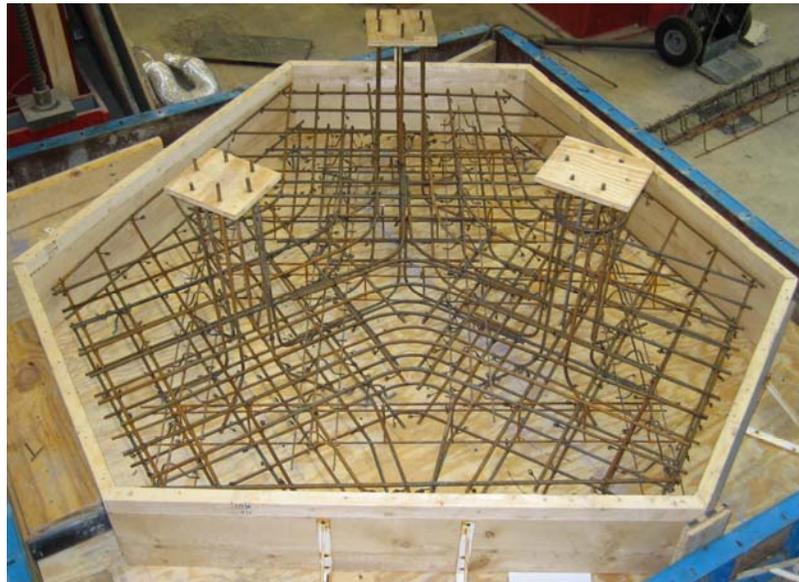
Once each layer of reinforcement was tied together, they were placed in the forms, and the reinforcement for the column-footing construction joints were tied in place as shown in Figure 4.2. As shown in the figure, standard 90° hooks detailed using ACI 318-02 (2002) were utilized at these joints.

Figure 4.2. Formwork and Reinforcement for Footing

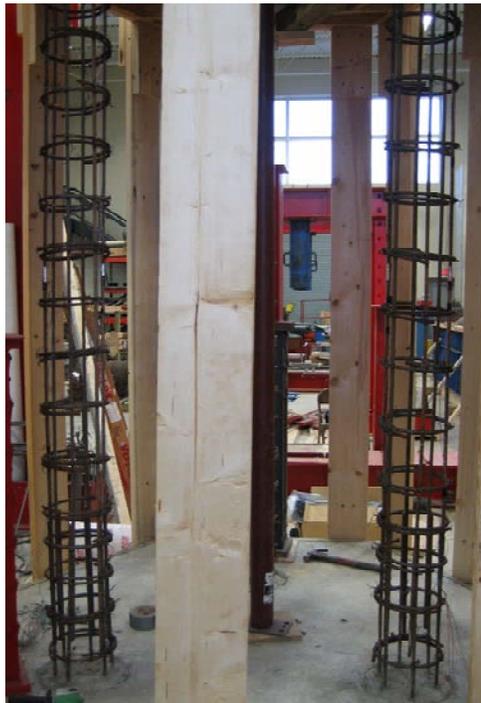
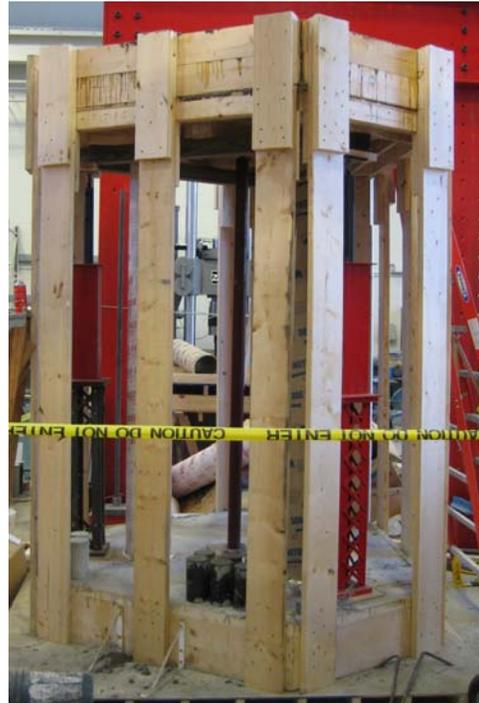
Once the column reinforcement was in place, the top slab was completed much in the same fashion as the footing, and a pipe was placed in the center of the slab so that the charges could be suspended from the top. Since the slab was only 12" thick, the longitudinal column reinforcement had to be bent into 90° hooks to ensure proper development length. Figure 4.3 (a) and (b) show the in-place column reinforcement before placing the forms, and the shoring and formwork for the slab, respectively.

Figure 4.3. (a) Column Reinforcement and (b) Shoring and Formwork for Slab

The reinforcement for the columns was tied separately and then attached to the dowel bars that were extended out from the footing. On each column reinforcement cage, six strain gages were attached at the points of maximum positive and negative moment. Since the reinforcement was spliced at the bottom joint, strain gages for negative moment were placed at the top of the column. Two gages were used for positive moment (one for tension and one for compression), and four were used for negative moment in the same fashion. Only two of the gages at the top of the column would be used, but four were applied for redundancy in case any of the gages were damaged during the pouring of the concrete.

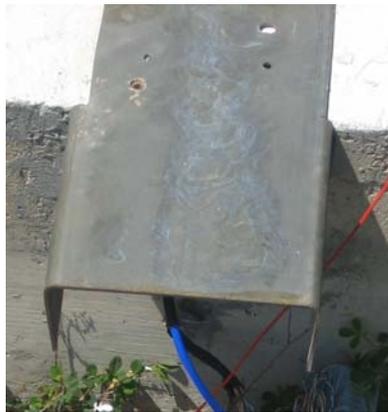
Each column had one coaxial cable crack sensor embedded on its back side (tension face). Normally, the sensor's connector would extend out of the base of the column. In this case, to protect the connector from the blast, the cable was bent at the base of the column and embedded in the top of the footing as well. To do this, a ½" by ½" groove was cut along the back of the column and in the footing that extended all the way to the edge of the footing. The sensor was then placed in the groove and grouted using Carter Waters CW100 Precision Grout that was mixed to a dry-pack consistency. Following the first blast, a large portion of the grout was separated from the column groove due partly to the tension reflected wave generated at the back side of the column under explosion. The main reason was that since the grout was mixed to a dry-pack consistency, it did not have a sufficiently high water content to create a good bond to the base concrete. To solve this problem, all subsequent grout repairs were done by first brushing Sikatop Plus Component A bonding agent into the groove before packing the grout. This significantly improved the bond between the grout and the concrete. Finally, to protect the sensors' connectors from the blast pressure and debris, steel plates were fabricated and attached to the footing as shown in Figure 4.4.

Figure 4.4. Steel Plate to Protect Sensor Connectors

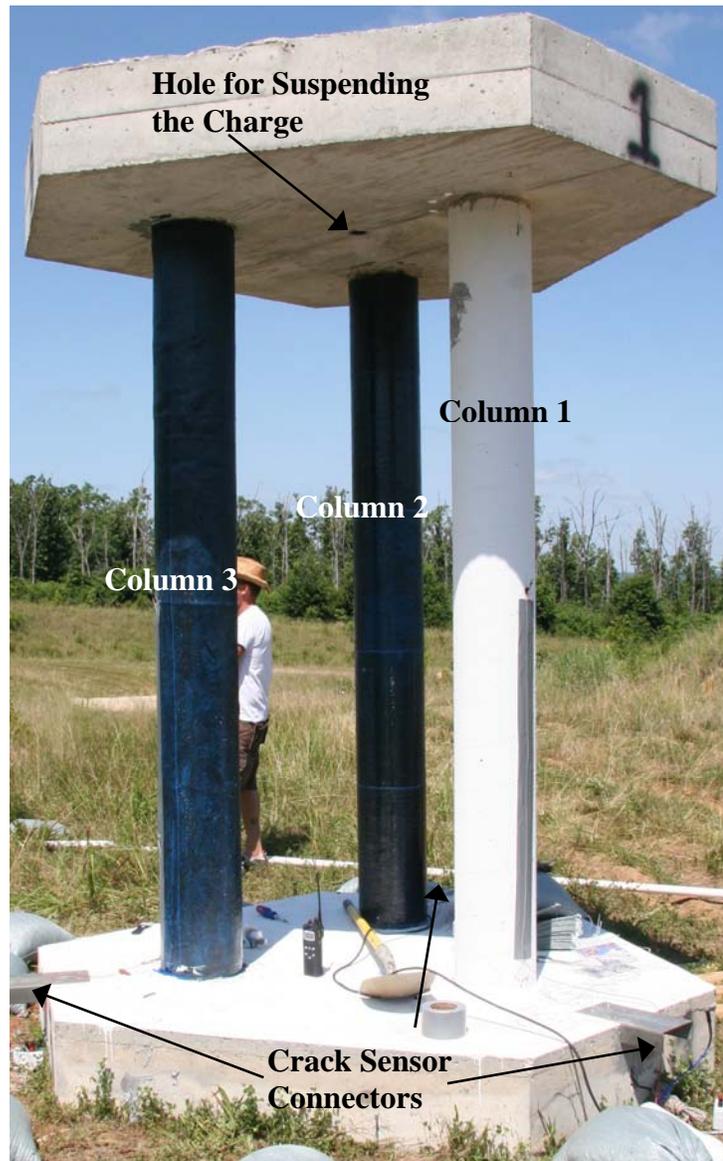
Figure 4.5. Final Column Specimen before Testing

On Column 3, the first layer of carbon FRP was applied in the same manner as Column 2. Once the saturant began to harden, the VE material was applied on top and another layer of saturant was brushed onto the VE material. The final layer of carbon FRP was then applied on top of the VE material in the same manner as the first, except that the fibers were oriented along the length of the column. Figure 4.5 shows the column specimen after strengthening and sensor installation.

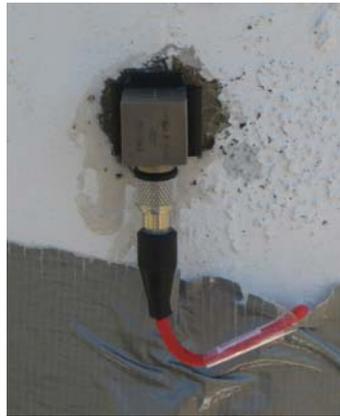
In addition to the crack sensors and the strain gages, each column was instrumented with one accelerometer. The accelerometers were attached by gluing a mounting clip to the back side of each column at mid-height. On Columns 1 and 2, the clip was glued directly to the concrete and FRP wrap, respectively. On Column 3, a small hole was cut in the outer FRP and VE material so that the clip could be glued to the first layer of FRP. This was done to obtain the acceleration of the column itself and to avoid a false acceleration from the much less stiff VE material. Figure 4.6 shows one of the accelerometers ready for measurement.

Figure 4.6. Accelerometer

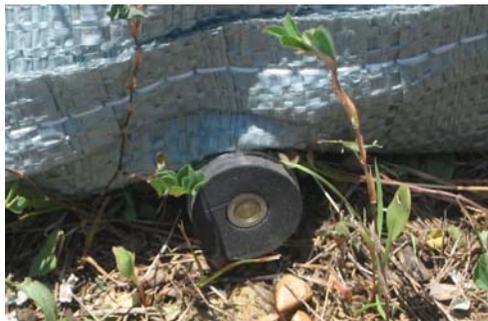
Three pressure transducers were also used to verify the blast pressures calculated by various computer programs. They were placed 18 feet from the center of the charge and were pointed directly towards it. This distance was selected based on the measurement range of the transducers and the maximum pressure that they would see during the largest blast. Each transducer was mounted in a pipe, embedded in the ground, and covered with a sandbag to ensure no movement occurred. Figure 4.7 shows one of the pressure transducers. Finally, a video camera was placed at a safe distance on top of a berm to record each blast.

Figure 4.7. Pressure Transducer

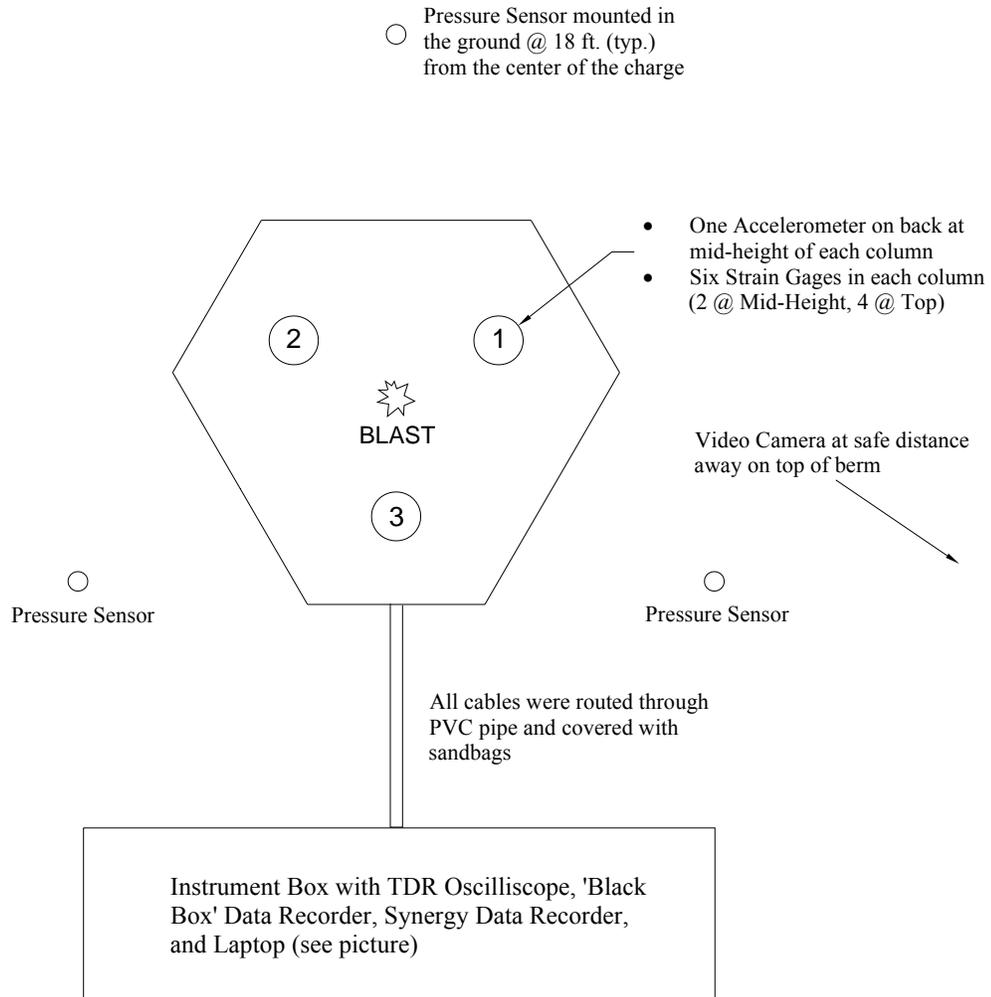
Figure 4.8. Instrumentation Layout

Several different systems were utilized for data acquisition. To acquire the strain and pressure data, a Synergy data recorder at very high sampling rates was used for the blast testing. For the accelerometers, a 'Black Box' data recorder was used. A sampling rate of 20 kHz was used for both the Synergy and 'Black Box' data recorders. For the crack sensors, a Digital TDR Oscilloscope was used along with a pulse generator which is used for dynamic measurements. The Oscilloscope only has one channel, so dynamic measurements were only taken from Column 1, but static measurements were taken on each column both before and after each blast. A laptop was also used to configure and record data from the Synergy and 'Black Box' data recorders. Finally, to protect all of the data acquisition systems from the blast, everything was placed in an aluminum box. The box was situated in a ditch next to the column specimen and covered with 6 x 6 timbers which were covered with plywood and sandbags. All of the cabling for the transducers was piped through PVC pipes which were secured with sandbags. Figure 4.8 and Figure 4.9 show the layout of the instrumentation and the aluminum box containing all of the data acquisition systems, respectively, and Figure 4.10 is a picture of the test site.

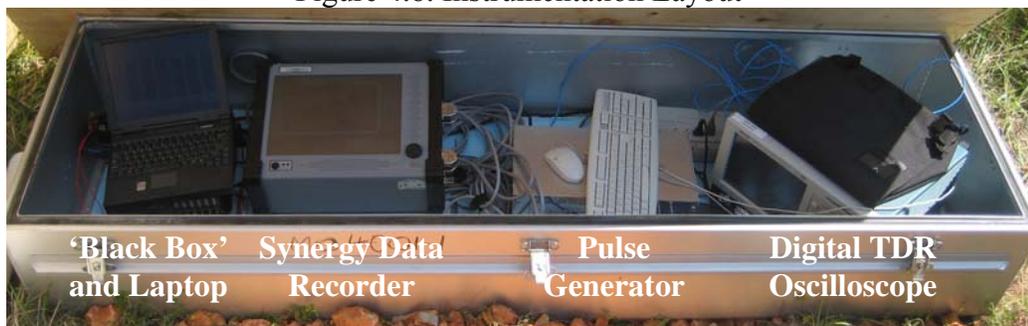
Figure 4.9. Aluminum Box with DAQ Systems

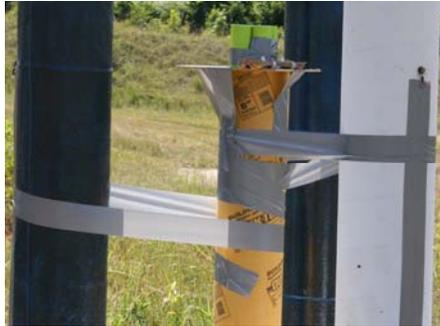
The first charge was placed on a piece of plywood which was sitting on a cardboard Sonotube, as shown in Figure 4.11. When inspecting the columns after the first blast, it was determined that the plywood had caused some of the damage to Column 3. While debris damage would be a normal occurrence during a blast, it is difficult to predict and was not considered in this research. Therefore, the second 4 lbs charge and

Figure 4.11. First 4 lbs Charge

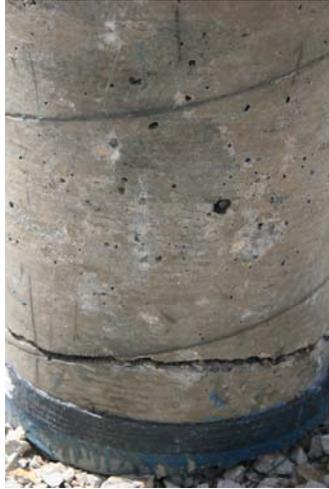
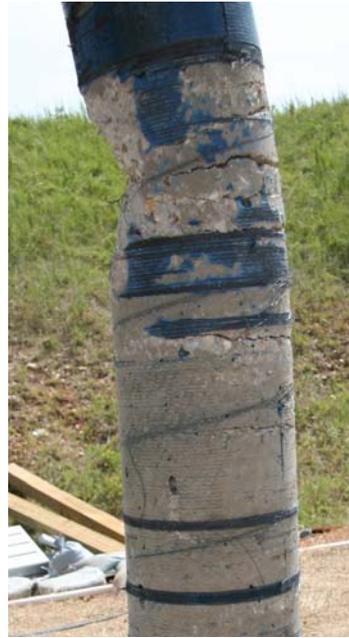
Removal of the FRP from Column 2 led to some interesting findings. Most cracks were located at the failure hinge. At the base of the column, one large crack was present on the tension side as seen in Figure 5.1 (a), but no other cracking was visible. The FRP was not removed at the top of the member, but it is expected that similar cracking occurred at that location since the loading was symmetric and the boundary conditions at the joint were the same as those at the base (except for the splice in the flexural reinforcement at the base). There were several separated cracks at the mid-height of the column as seen in Figure 5.1 (b), but they were all flexural cracks, and there were no diagonal or horizontal cracks connected together like those seen on the control column. Other than on the front face of the column at the mid-height, all of the concrete was intact, and there was no sign of loose material. This indicates that the FRP protected the concrete from spalling and from further cracking such as that seen on Column 1.

(a) Crack at Base

(b) Hinge at Mid-Height

Figure 5.1. Post-Test Inspection on Column 2

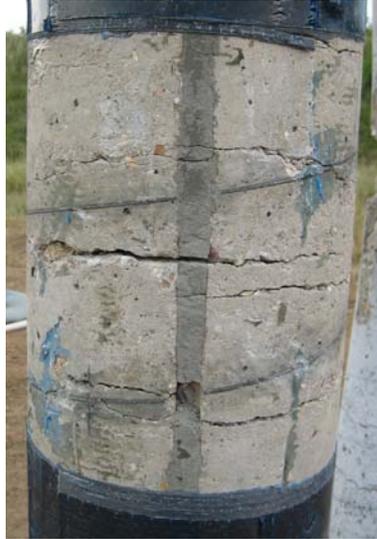
Removal of the FRP and VE materials from Column 3 led to similar findings. Most of the outer FRP and VE material along the column was removed, but only the inner layer of FRP that was around the failure hinge was removable because of its bond to the concrete. There was a small amount of spalling on the front of the column, but not enough to expose the reinforcement. The crack pattern on the back side of the failure hinge was similar to that of Column 2, but the cracks as shown in Figure 5.2 were narrower.

Figure 5.2. Back Side of Column 3

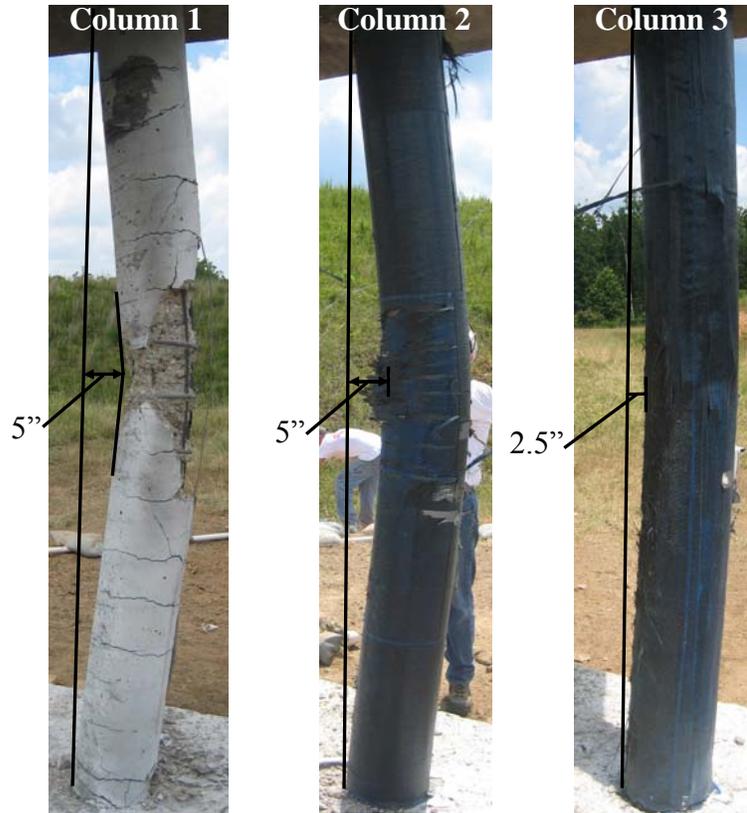
It can be seen from Figure 5.3 that after the blast, Column 3 had 50% less permanent deflection than the other two columns. This means that a significant amount of the energy generated by the blast was dissipated. Columns 2 and 3 both had a layer of FRP designed to confine the concrete. This confining action increases the ductility of the section, thereby dissipating energy when significant inelastic deformations are present. However, since Columns 2 and 3 had the same confinement FRP layer, and Columns 1 and 2 had approximately the same amount of permanent deflection, this additional energy dissipation could only be explained by the addition of the VE material. This alone provides evidence that this FRP-VE strengthening system adds a significant amount of damping as well as ductility to a reinforced concrete section.

Figure 5.3. Comparison of Permanent Deflections

As noted previously, the 30 lbs blast resulted in flexural failure of all three columns by creating a hinge at the mid-height of each member. It was noticed, however, that Column 3 did not have as much permanent deflection as Columns 1 and 2. Since it is very difficult to measure this deflection in the field, pictures were taken of each column and the deflection was estimated. Figure 5.3 shows a comparison of the three columns and their respective deflections following the 30 lbs. blast.

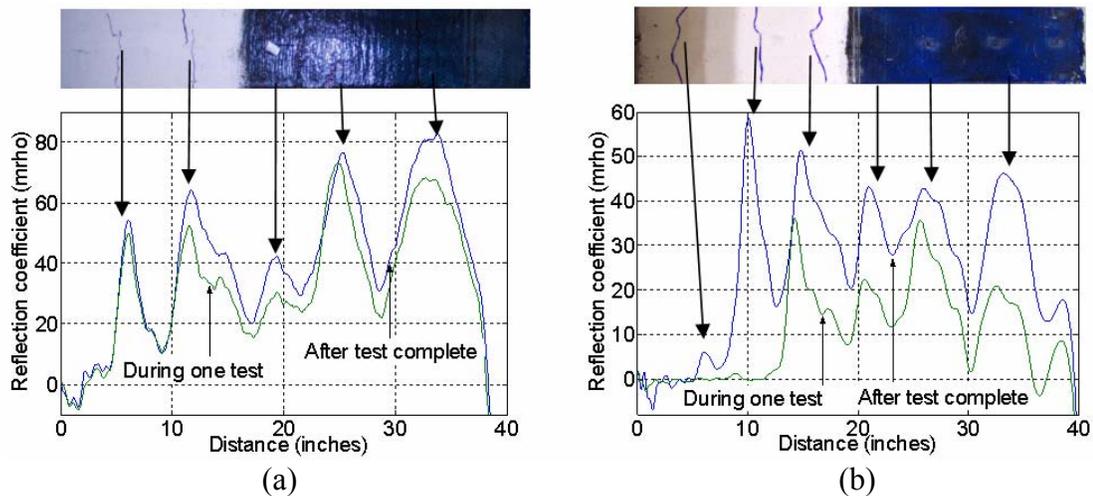
A number of tests were conducted in the Highbay Structures Laboratory at Missouri S&T. Figure 5.4 shows the signals from the shake table tests on two columns that have been wrapped with FRP (McDaniel, 2004).

Figure 5.4. Signals from Sensors in Two FRP-Wrapped Columns (McDaniel, 2004)

The figures demonstrate the successful application of the sensors in detecting cracks that are not visible due to a retrofitting system. They also demonstrate the memory feature of the sensors. The signals shown in blue were taken after the load had been removed from the columns and the cracks had closed due to gravity loads. The reflection coefficient measured indicated the presence of multiple cracks during the past shaking. It correlated well with one of the reflection coefficient curve taken during the shaking test.

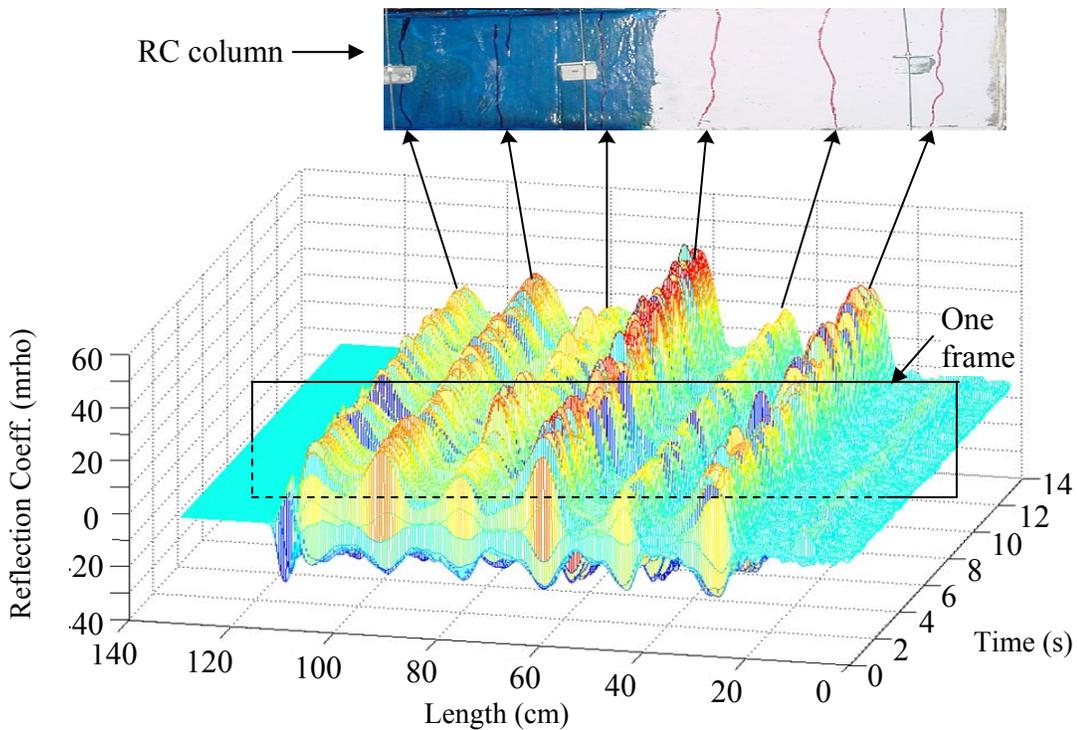
After Xue (2006) developed the dynamic testing equipment, it was possible to record data in real-time, such as that shown in Figure 5.5. The figure shows 14 seconds of data from a sensor embedded in a column. The column was tested on a shake table with an earthquake record input.

Figure 5.5. Time History of Sensor Signal from a Shake Table Test (Xue, 2006)

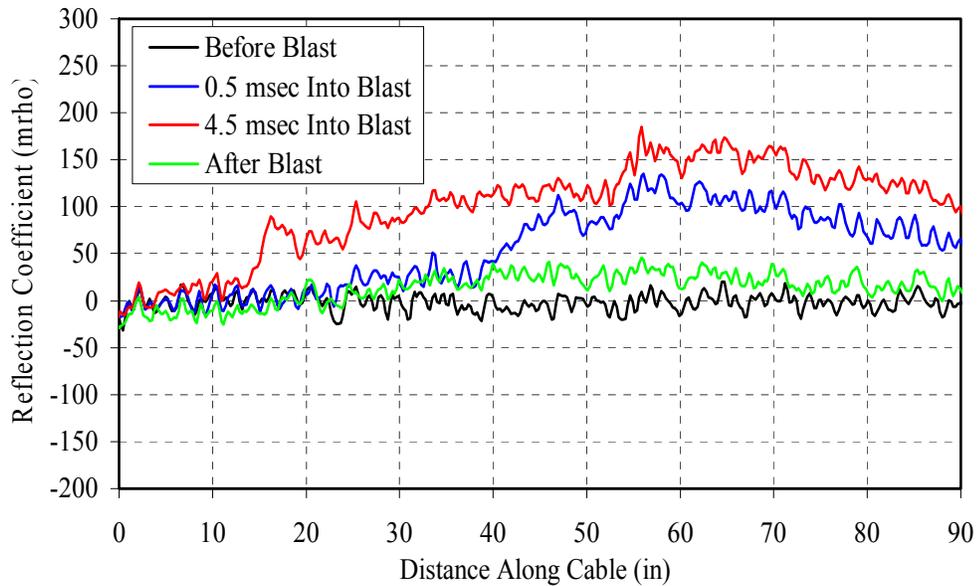
Figure 5.6. Dynamic Data from Column 1 during the 2nd 4 lbs Blast

Figure 5.6 shows that the reflection coefficient generally increases, then decreases, and finally approaches to its near original position. The 4 lbs blasts did not create severe damage to Column 1, but they did cause significant cracking around the mid-height. The green line in Figure 5.6 shows how this cracking affected the final signal along the sensor, as the signal was slightly off its original position. Similar trend has been observed in Figure 5.7 in a much more pronounced manner, as the 10 lbs blast caused significant spalling on the back of the column where the sensor was embedded. This phenomenon was investigated before and typically referred to as “memory” feature (Chen *et al.*, 2005b).

cracking during a loading event. One ‘frame’ of dynamic data was captured every 0.5 msec, which should be fast enough to capture the response of the column to the impulsive load since its natural period is approximately 18 msec. For clarity, ‘snapshots’ of certain frames of data were taken from the dynamic data and plotted to show the progression of cracking during the blast. Figure 5.6 shows dynamic data from the second 4 lbs blast and Figure 5.7 shows data from the 10 lbs blast. Dynamic data was not recorded for either the first 4 lbs blast or the 30 lbs blast.

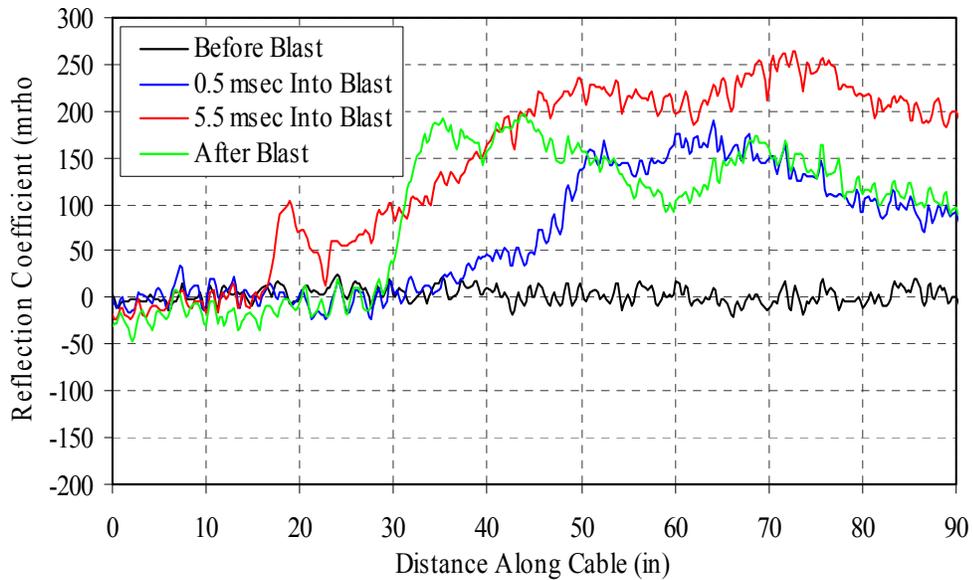
Figure 5.7. Dynamic Data from Column 1 during the 10 lbs Blast

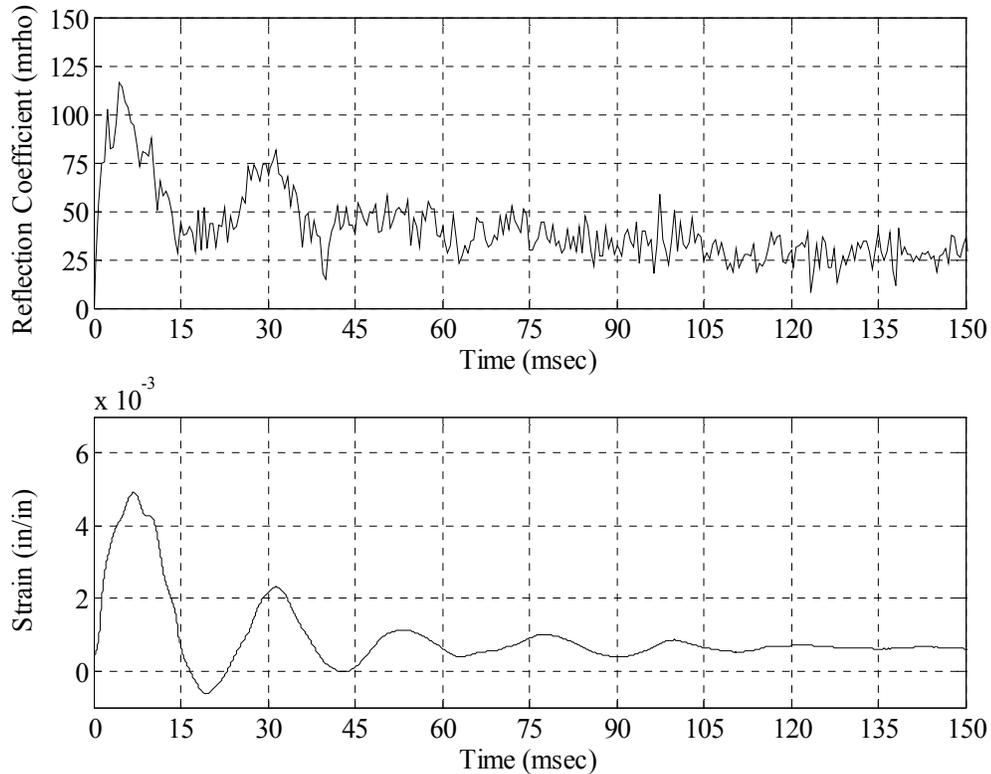
To relate strain to the crack sensor signal, a comparison was made relating the strain at the mid-height of the column to the crack sensor reflection coefficient at that location. Since the strain gage on the back side of the column (positive moment – tension) was at the same location as the crack sensor, this gage was used for comparison. The reflection coefficient at the mid-height of the column was extracted from each frame of dynamic data from the 4 lbs blast. Figure 5.8 shows this comparison. It is very clear that the shape of the strain response is similar to the shape of the crack sensor response. This is an anticipated yet interesting result since the width of cracks is directly related to the strain distribution across the member. It would be desirable to proceed with more testing in this area since one set of data is insufficient to make a tangible conclusion or an empirical correlation.

Figure 5.8. Tension Strain versus Crack Sensor Measurement at Mid-height

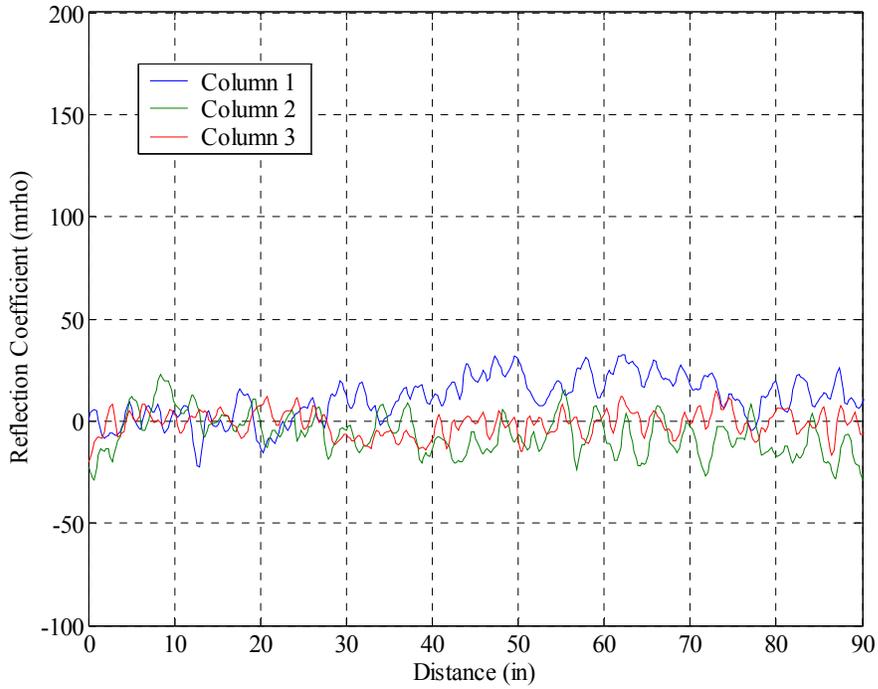
As can be seen in Figure 5.9, the blast did not cause severe cracking, and Column 1 was subjected to more cracking than Columns 2 and 3. As shown in Figure 5.10 and Figure 5.11, the 10 lbs blast caused much more cracking in Column 1 than the 4 lbs blast, but Columns 2 and 3 still had low levels of cracking. The only difference in the two figures is that Figure 5.10 is differenced with the signals taken before the 4 lbs blast while Figure 5.11 is differenced with the signals taken before the 10 lbs blast. In other words, Figure 5.10 shows the cracking caused from both the 4 lbs and 10 lbs blasts while Figure 5.11 only shows the cracking caused from the 10 lbs blast. This is why the blue curve in Figure 5.10 has higher amplitudes than the blue curve in Figure 5.11.

Figure 5.9. Crack Sensor Signals Taken after the 2nd 4 lb Blast (Differenced with the Signals Taken before the 2nd 4 lb Blast)

Static measurements were taken from the crack sensors embedded in all three columns at the following times: before and after the 2nd 4 lbs blast, before and after the 10 lbs blast, and after the 30 lbs blast. Due to equipment problems after the first blast, static measurements were not obtained from the first 4 lbs blast. Comparisons of the three columns and their corresponding crack sensor signals are shown in Figure 5.9 through Figure 5.12.

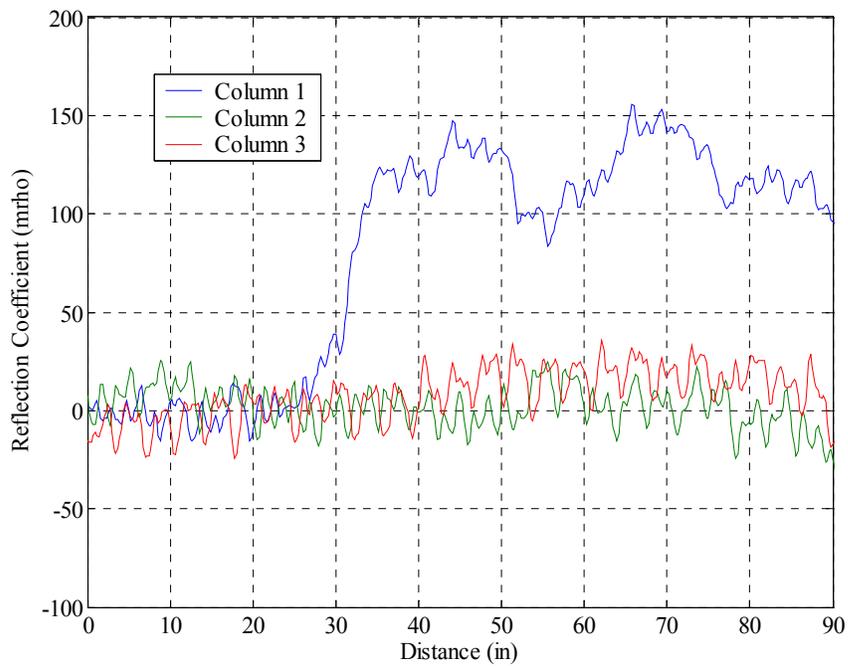
Figure 5.10. Crack Sensor Signals Taken after the 10 lbs Blast (Differenced with the Signals Taken before the 2nd 4 lb Blast)

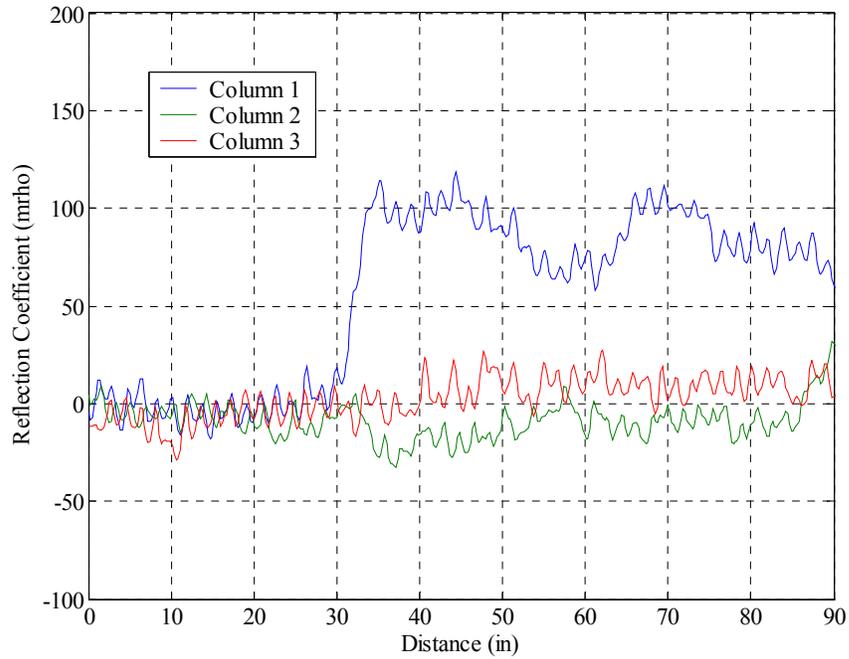
Figure 5.11. Crack Sensor Signals Taken after the 10 lbs Blast (Differenced with the Signals Taken before the 10 lb Blast)

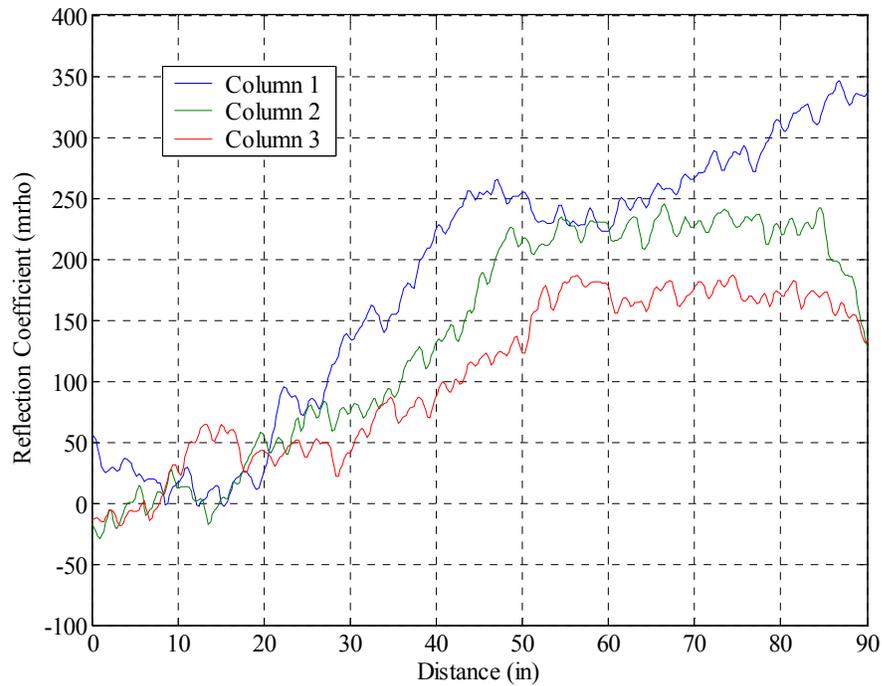
Figure 5.12. Crack Sensor Signals Taken after the 30 lb Blast (Differenced with the Signals Taken before the 2nd 4 lb Blast)

Figure 5.12 shows the severity of cracking that occurred from the 30 lbs blast, which failed all three columns. It does, however, show that there was a reduction in cracking from Column 1 to Columns 2 and 3. For each column, a sudden change in reflection coefficient can be observed around mid-height. This change is attributable to the formation of a plastic hinge at the mid-height of the column.

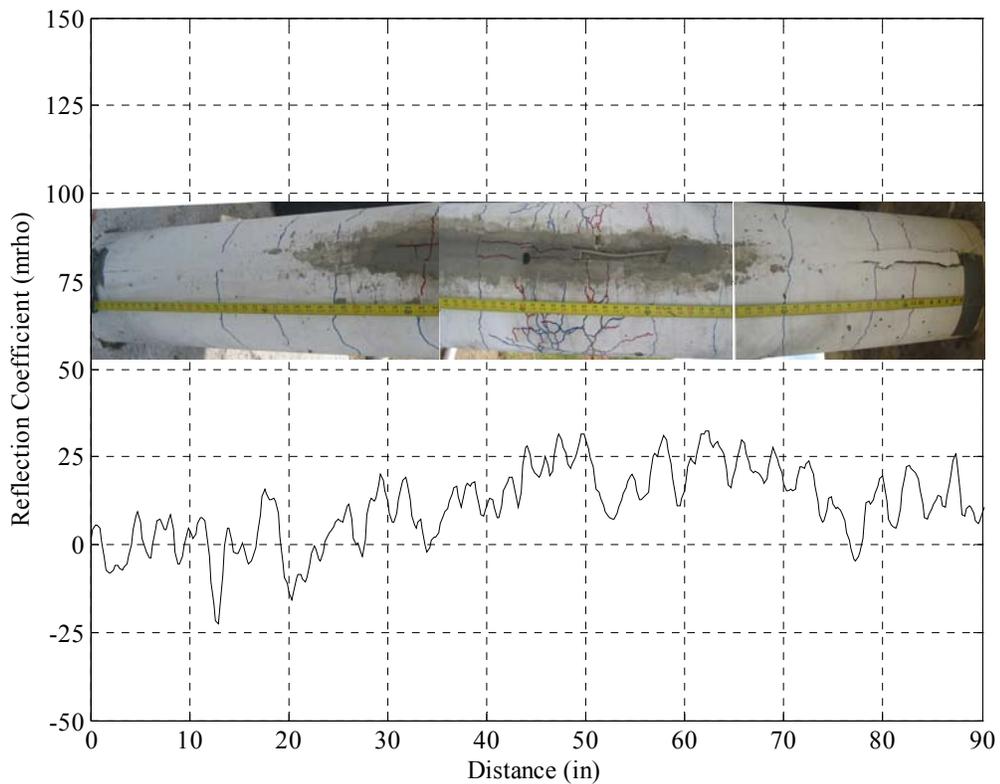
Column 1 was unstrengthened, allowing for visual inspection of cracking after each blast test. Figure 5.13 shows the reflection coefficient due to the 2nd 4 lb blast. The blue lines in the picture designate the cracks that occurred from the 1st 4 lb blast, and the red lines indicate the cracks that occurred from the 2nd 4 lb blast. It seems difficult to distinguish individual cracks in the signal. This could be due to the spatial resolution used to record the signal (distance between each data point). It can be seen, however, that the curve starts to increase around the mid-height of the column, where many cracks are located. This trend is also seen in Figure 5.14 and Figure 5.15.

Figure 5.13. Column 1 2nd 4 lbs Crack Sensor Signal Compared to Picture of Cracking

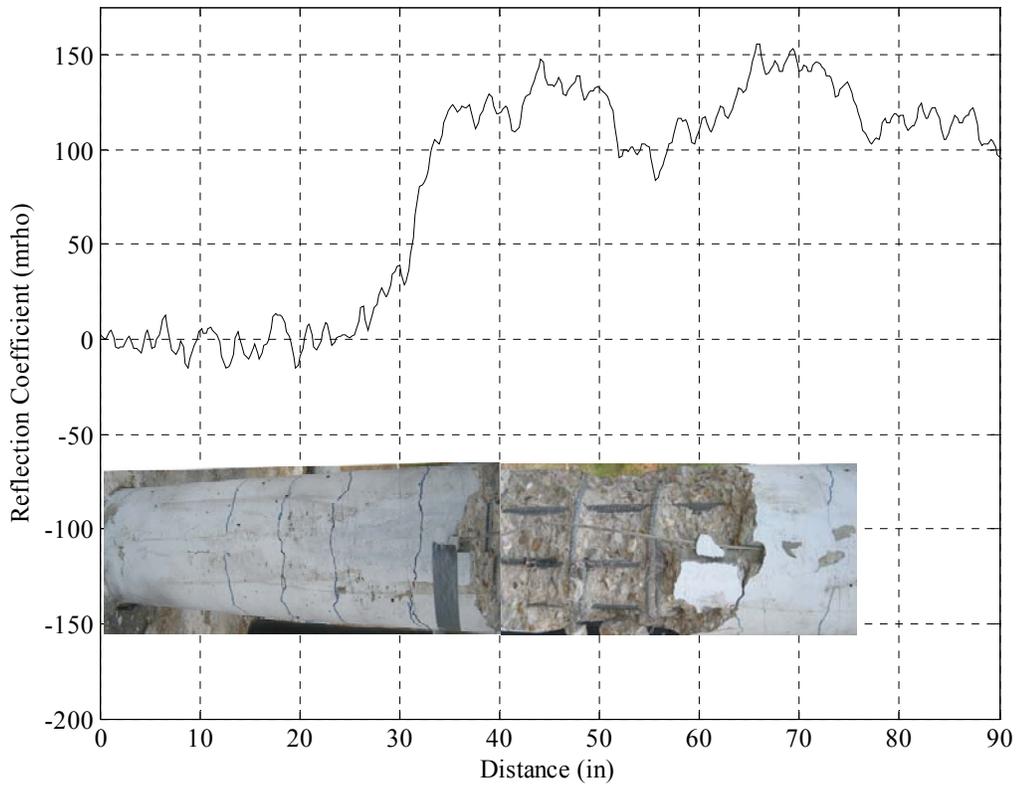
Figure 5.14. Column 1 10 lbs Crack Sensor Signal Compared to Picture of Cracking

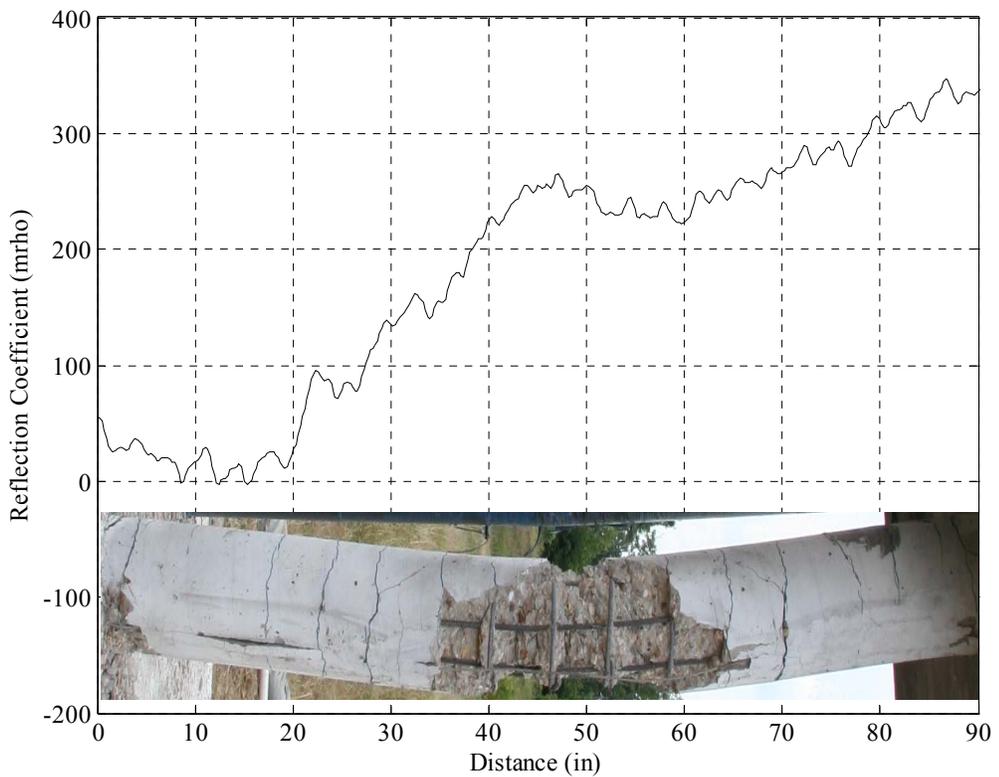
Figure 5.15. Column 1 30 lbs Crack Sensor Signal Compared to Picture of Cracking

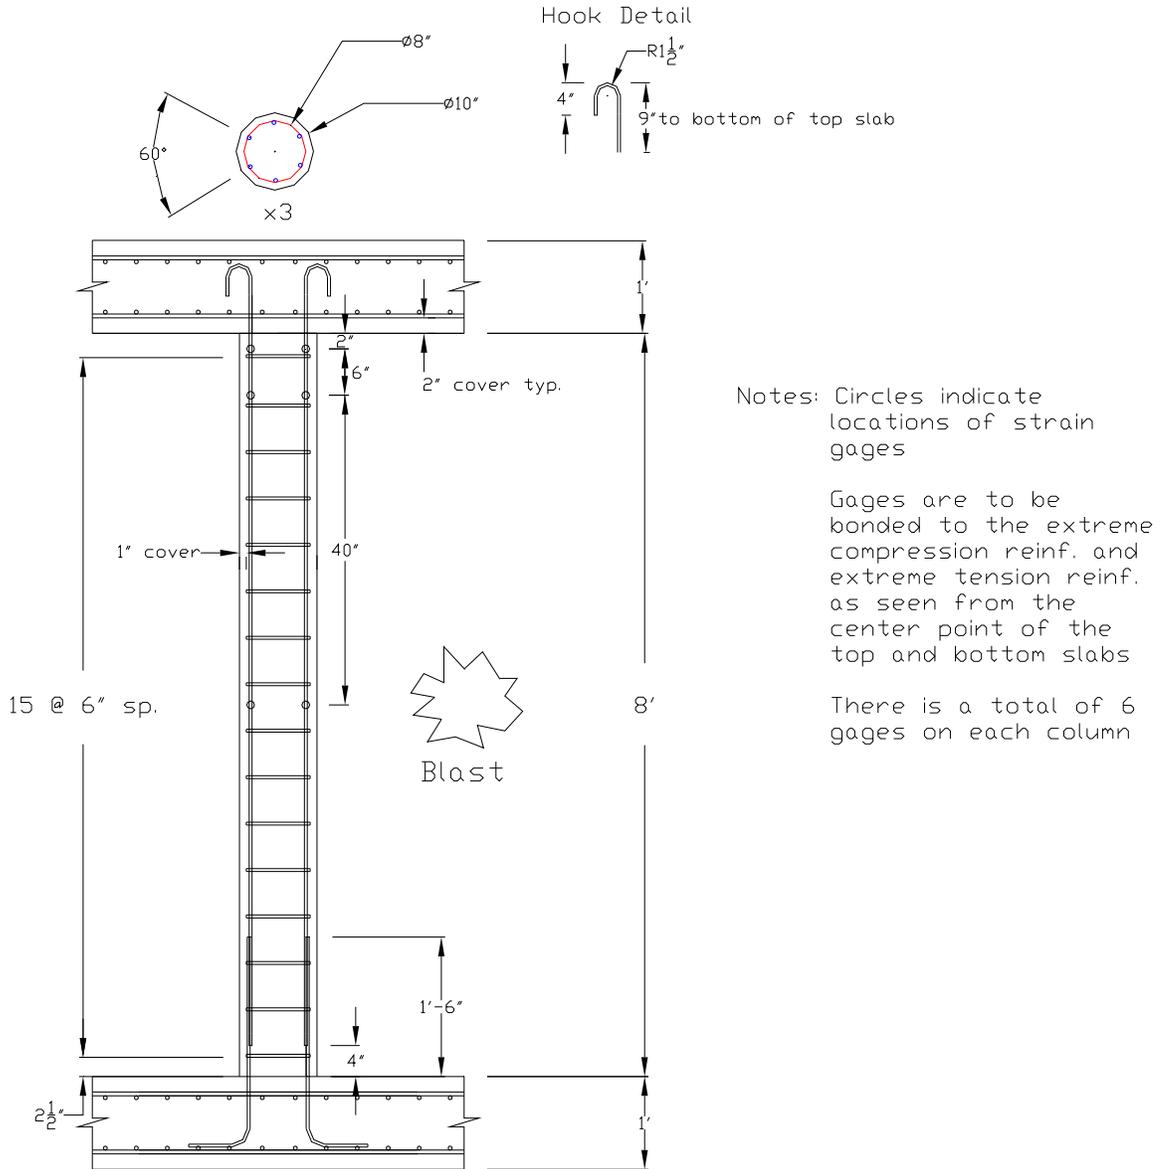
Figure A.1. Column Reinforcement Details

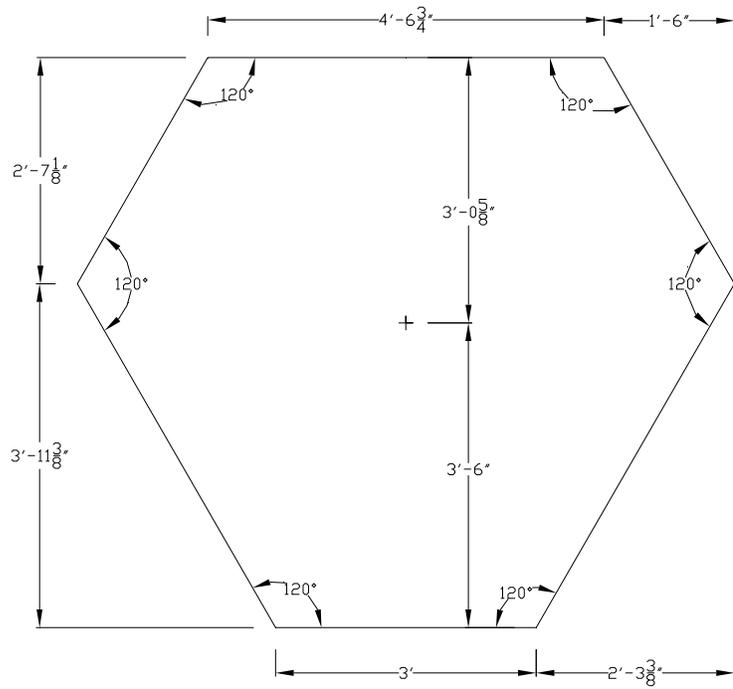
Figure A.2. Dimensions of Footing and Slab

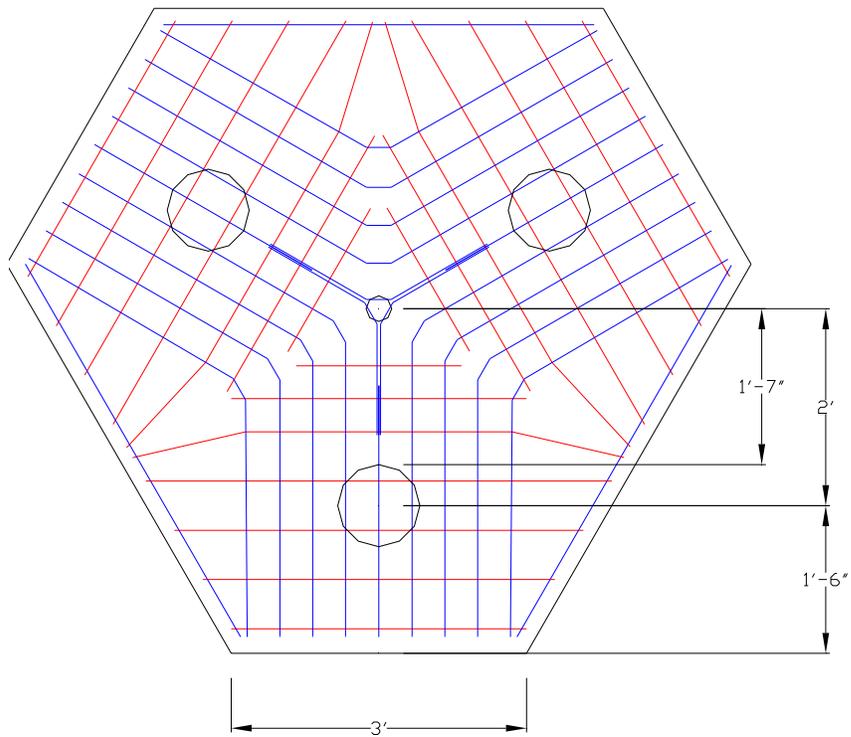
Figure A.3. Reinforcement Details for Footing and Slab

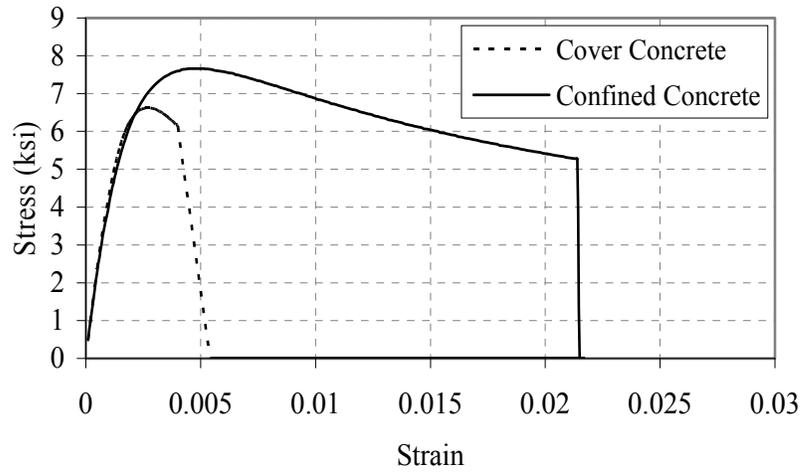
The RC column has a concrete compressive strength of 5.3 ksi, steel modulus of elasticity of 29000 ksi, steel yield strength of 66 ksi, and steel ultimate strength of 90 ksi. To take into account the strain-rate effect approximately, the dynamic increase factors specified in TM5-1300 are considered. They are 1.25, 1.23, and 1.05 for concrete compressive strength, steel yield strength, and steel ultimate strength, respectively. The Mander confinement model was used for the effect of steel ties.

Figure A.4. Stress-Strain Relationship for Concrete
