Validation of Coaxial Cable Sensors for Dynamic Crack Detection in RC Columns Under Blast Loads

**NUTC
R207**

Final Report
Agreement No. 59A0571

**VALIDATION OF COAXIAL CABLE SENSORS FOR DYNAMIC CRACK
DETECTION IN RC COLUMNS UNDER BLAST LOADS**

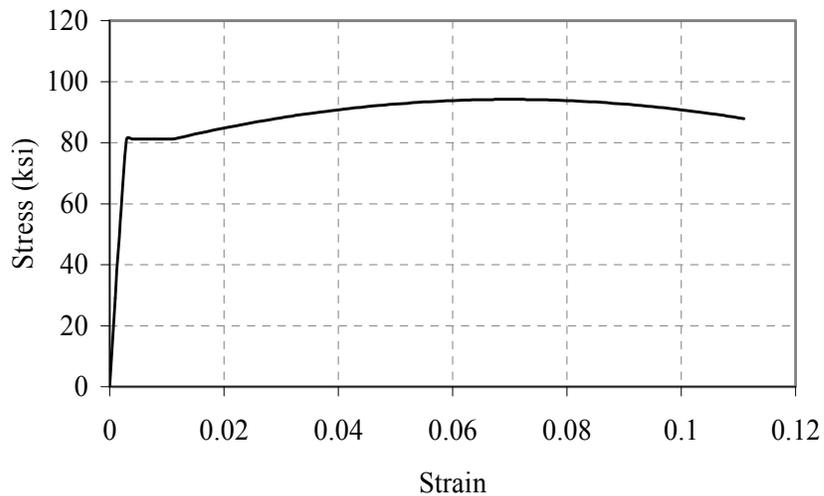
Figure A.5. Stress-Strain Relationship of Rebar

The RC column has a concrete compressive strength of 5.3 ksi, steel modulus of elasticity of 29000 ksi, steel yield strength of 66 ksi, and steel ultimate strength of 90 ksi. To take into account the strain-rate effect approximately, the dynamic increase factors specified in TM5-1300 are considered. They are 1.25, 1.23, and 1.05 for concrete compressive strength, steel yield strength, and steel ultimate strength, respectively. The Mander confinement model was used for the effect of steel ties.

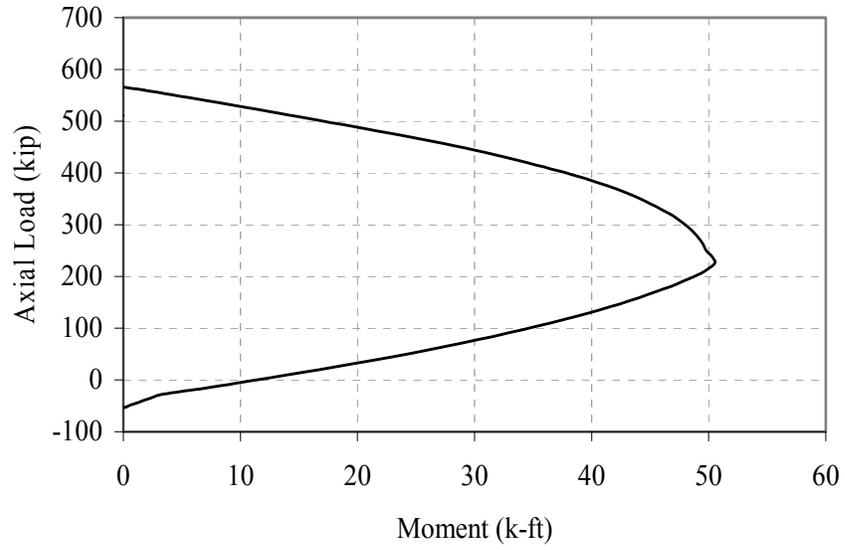
Figure A.6. Column Interaction Diagram

Moment-Axial Force Interaction and Moment-Curvature for a constant axial force of 1.84 kips (weight of slab) diagrams were developed with USC_RC for the column. The analysis was set to terminate when either the confined concrete exceeded the ultimate strain or the steel strain exceeded the rupture value. In this case, the confined concrete exceeded its ultimate strain much before the steel ruptured. The Moment-Curvature analysis yielded a maximum moment capacity of 18.7 k-ft and a curvature ductility ratio of 29 (at a maximum curvature of $9.49 \times 10^{-3} \text{ in}^{-1}$). A Force-Displacement diagram for a point load at the mid-height of the column was also developed. This yielded a lateral load capacity of 9.3 kips and a lateral displacement capacity of 2.4 inches (at mid-height). These diagrams are presented in Appendix A.2.

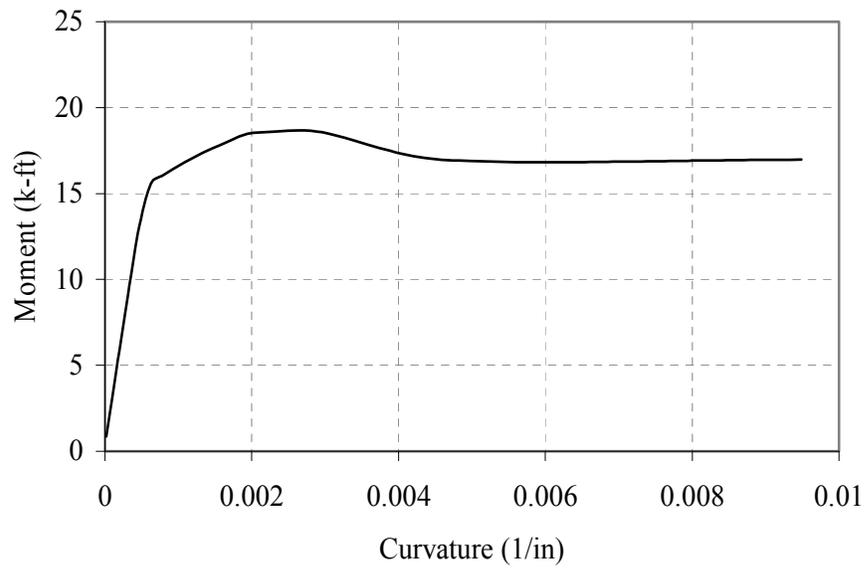
Figure A.7. Moment Curvature Diagram

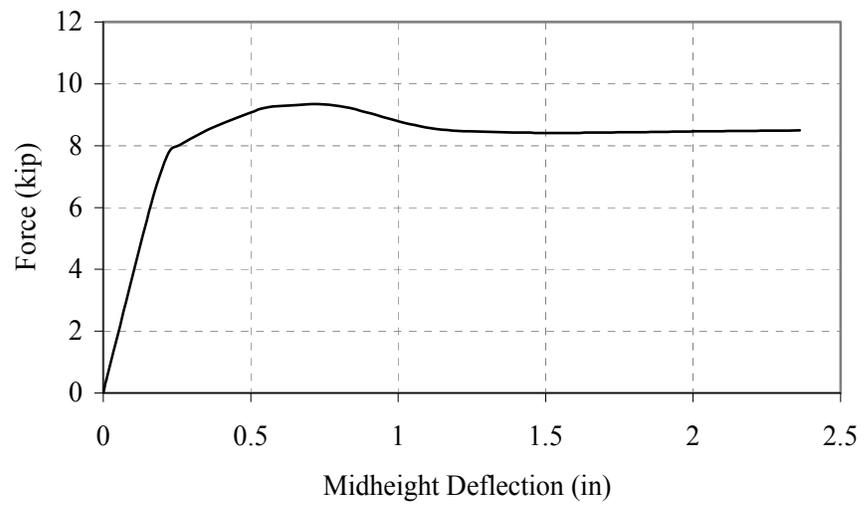
Figure A.8. Force-Deflection Diagram for a Point Load at Mid-height
