# CENTER FOR TRANSPORTATION INFRASTRUCTURE AND SAFETY

## **A Laboratory Investigation on Three-Sided Structures**

**NUTC  
R227**

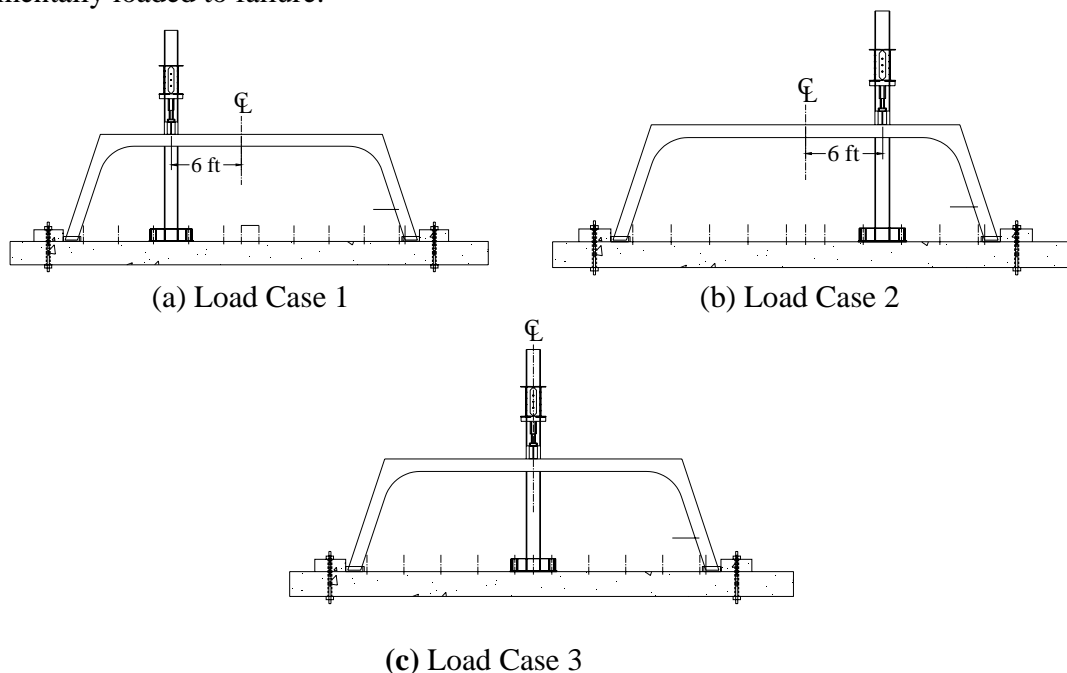
**Figure 2.1. Load Cases (West Side View)**

The test specimen was subjected to three different loading cases as shown in Figure 2.1. In Load Case 1, load was applied up to 25 kips which corresponded to a point around the calculated flexural cracking load at a location near the north side leg as shown in Figure 2.1(a). Then, the loading frame was moved to the other loading point near the south side leg and tested in the same manner as shown in Figure 2.1(b). After Load Case 2, the loading frame was placed at the centerline of the test specimen as shown in Figure 2.1(c), and the test specimen was incrementally loaded to failure.

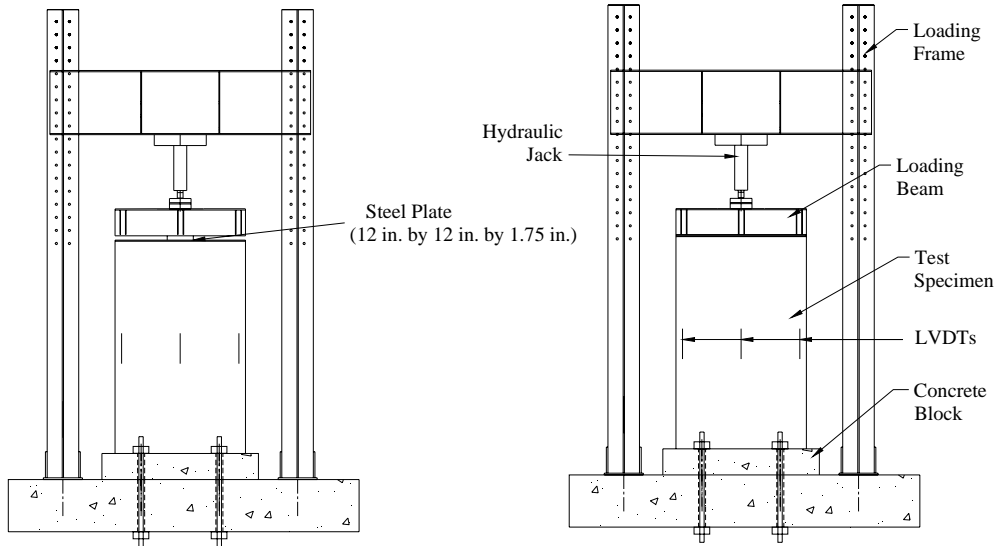
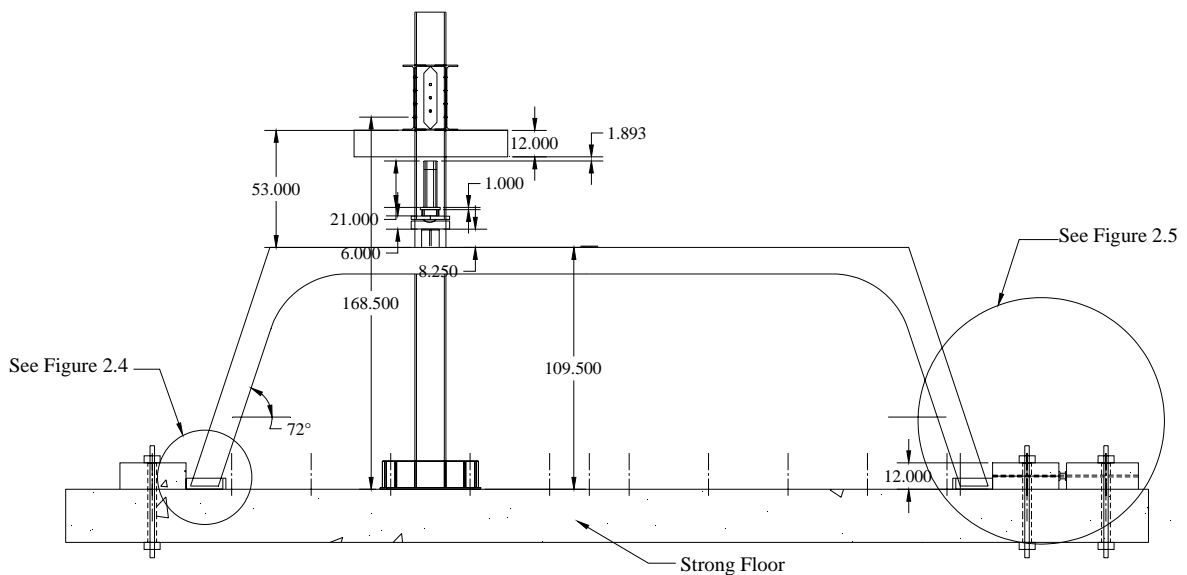
(a) South Side View for Load Case 3

(b) South Side View for Load Cases 1 and 2

(c) West Side View for Load Cases 1 and 2

**Figure 2.2. Test Set-up**

across the lay length with an 8 in. width, as shown in Figure 2.2(b), while Load Case 3 used a concentrated load at the center of the deck. The concentrated load was applied through a 1.75 in. thick steel plate (12 in. by 12 in.) inserted between the loading beam and the test specimen as shown in Figure 2.2(a). Figure 2.3 shows a photograph taken during testing while the test specimen was being subjected to Load Case 3.

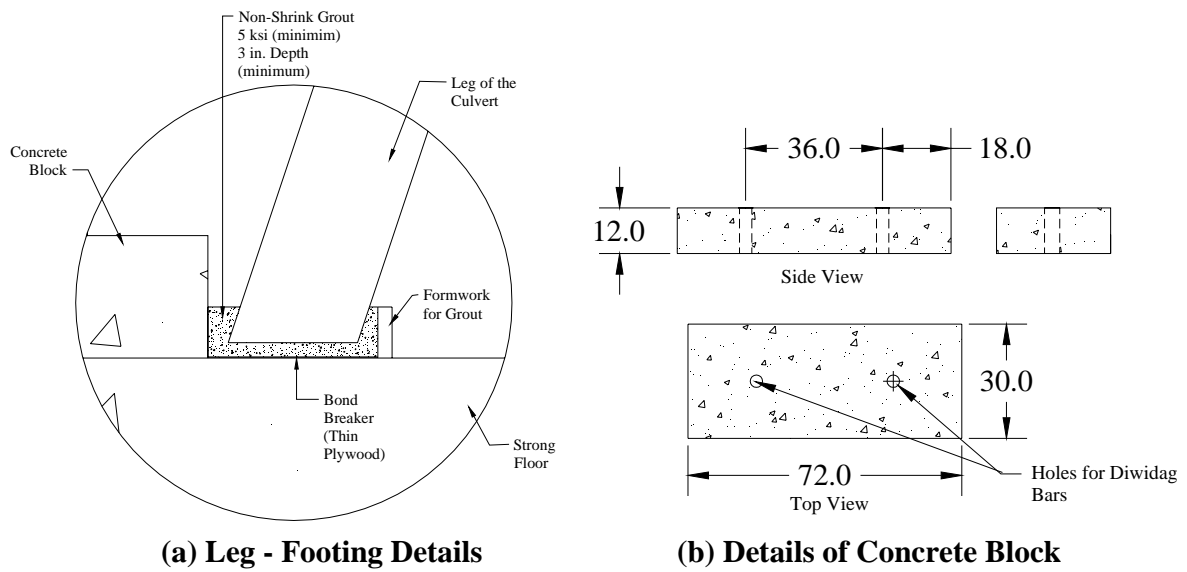
**Figure 2.4. Details of the Procedure to Simulate the Grout Between the Legs and Footing in the Laboratory (North Side)**

The typical installation of three-sided structures in the field requires a strip footing with a 3 in. deep recess or keyway. The legs of three-sided structure units are placed into the recess and leveled with shims. Then, the gap between the leg and recess is grouted. The strip footings and grouting was simulated as shown in Figure 2.2(c). The details of this procedure for the north side leg were depicted in Figure 2.4; while Figure 2.5 presents the details for the south side. As shown in Figure 2.4, a concrete block was first secured on the strong floor with a prestressing force of 75 kips applied to two Dywidag Bars to provide the horizontal restraint. Four small wooden blocks, 1 3/4" in thickness, were then placed between the strong floor and the leg. Then, formworks for grouting were installed and the grout was cast. Hydrostone<sup>TR</sup> was used for the grouting material.

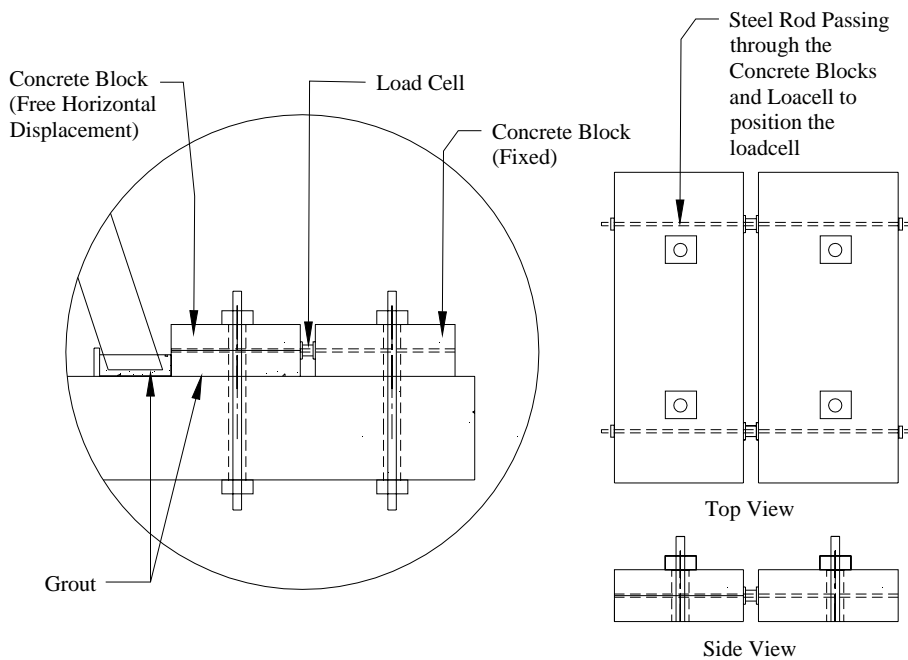
**Figure 2.5. Details of the Procedure to Simulate the Grout Between the Legs and Footing in the Laboratory (South Side) and to Measure Horizontal Reaction**

The procedure for the south side leg was similar to that used for the north side except that two concrete blocks were used instead of just one concrete block. The space between the two blocks provided a means to measure the horizontal reaction forces as shown in Figure 2.5. The procedure was as follows: (1) four layers of plastic sheeting were placed over the area on which the south side leg, grout and the first concrete block would be placed. The plastic sheets were used to reduce friction between the strong floor and the grout and concrete block. (2) The first concrete block was secured to the strong floor with a prestressing force of 75 kips. (3) The leg was placed and the grout was cast in the same way as described for the north leg. (4) The second concrete block was placed on the strong floor and load cells were inserted in between the first and second concrete blocks. (5) The second concrete block was pushed against the first concrete block with a fork lift so that the gaps between the load cells and the concrete blocks were eliminated. (6) The second concrete block was secured to the strong floor with a prestressing force of 75 kips applied to two Dywidag Bars. (7) The prestressing force applied to the first concrete block was released. In this way, it was assumed that the first concrete block and grouted area on the north side would be fixed against outward horizontal movement and the horizontal reaction forces could be measured using the two load cells to the south. Figure 2.6 shows a picture of the concrete blocks and the load cells.

The horizontal reaction forces were measured at the south side concrete block assembly using two load cells (see Figure 2.5 for more detail) and the obtained results are presented in Figure 3.7. As shown in Figure 3.7, the total horizontal reaction force, sum of Load Cells 1 and 2, was linearly proportional and reached slightly greater than 8.0 kips which was about 32% of the maximum applied load of 25 kips.

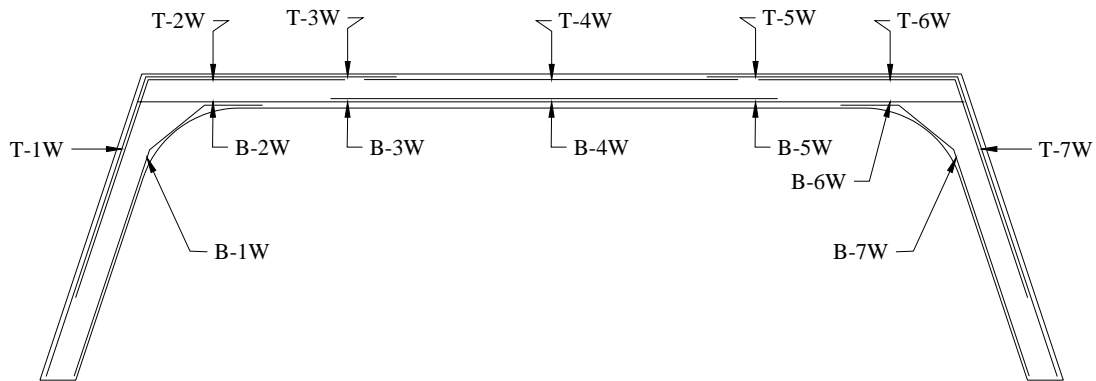
**Figure 2.7. Locations of Strain Gages (West Side)**

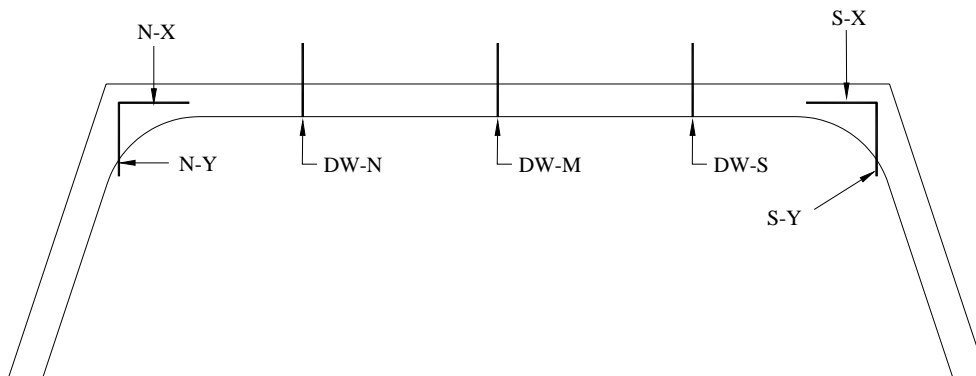
**Figure 2.8. Locations of LVDTs and String Transducers (West Side)**

Vertical and horizontal deformations were also measured using Linear Variable Displacement Transducers (LVDTs) at various locations as shown in Figure 2.8. LVDTs N-X and N-Y were installed in the north haunch region to monitor horizontal and vertical deformations, respectively. LVDTs S-X and S-Y were installed in the south haunch region to monitor horizontal and vertical deformations, respectively. LVDTs DW-N, DW-M, and DW-S were located at the loading points of the three load cases along the west side of the specimen. Although it is not depicted in the figure, LVDTs DM-N, DM-M, and DM-S were also installed along the middle line in terms of the lay length of the unit; while LVDTs DE-N, DE-M, and DE-S were installed along the east side in terms of the lay length of the unit.

The horizontal and vertical displacement of a point in the north and south corners of the specimen were monitored with 2 LVDTs installed at each corner (see Figure 2.8 for more detail). Since the applied load was not very significant as compared to the ultimate failure load, the movement of the point was minimal as shown in Figure 3.6, especially in the horizontal direction.

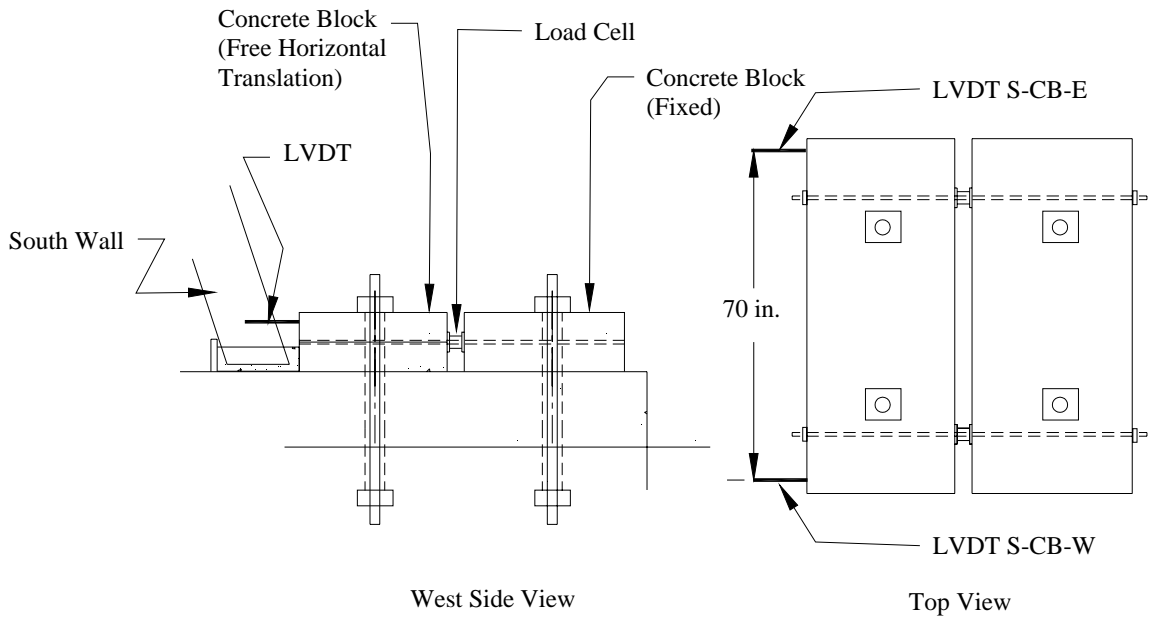
**Figure 2.10. Locations LVDTs to Measure Horizontal Movement**

The horizontal movements of the concrete blocks were also monitored with LVDTs. Figure 2.10 shows the locations of LVDTs to measure the horizontal movements of the concrete block on the south side. Two LVDTs were attached to each side (i.e., LVDTs S-CE-W and S-CB-E for the west and east sides of the concrete block, respectively), 1 in. from the outside of the concrete block as shown in Figure 2.10. The concrete block in the north side was instrumented with two LVDTs in a similar manner. The LVDTs on the concrete block at the north side were denoted N-CE-W and N-CB-E.

In addition, it was also observed from Figure 3.16 that both legs were twisted instead of moving together in one direction, especially in the case of the south side leg. However, the rotation angle calculated using the maximum values of LVDTs S-CE-W and S-CE-E, shown in Figure 3.16(a), and the geometries shown in Figure 2.10, appeared to be 0.8 degrees which appears to be negligible.

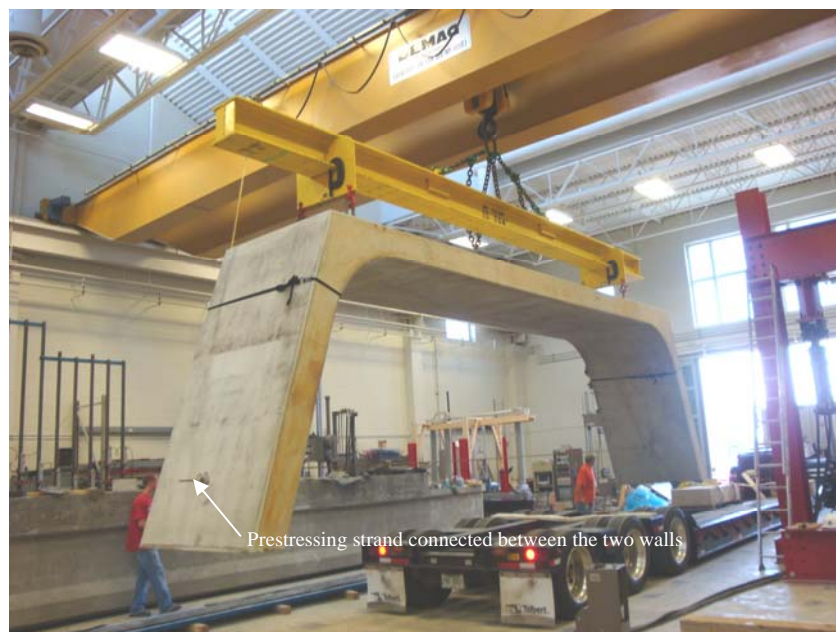
**Figure 3.1. Handling of the Test Specimen in the Laboratory showing the Prestressing Strand Connected between the Two Inclined Legs**

The test specimen was constructed at a plant operated by Egyptian Concrete Co. and delivered to the High-bay Structures Laboratory at Missouri S&T with 0.5 inch nominal diameter, 7-wire prestressing strand between the inclined legs to keep them from sliding or spreading during transportation and handling as shown in Figure 3.1. After the legs were placed on the strong floor and grouted with the concrete blocks (see Figures 2.4 and 2.5), the prestressing force of the strand was released as the cramps at one end of the strand was loosened.

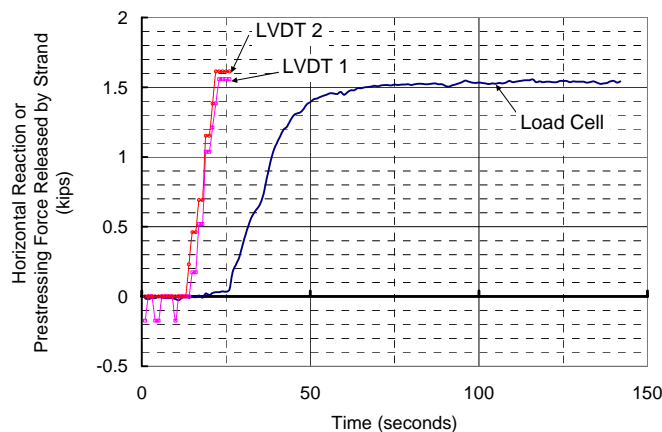
**Figure 3.2. Horizontal Reaction Force Caused by Detensioning**

During the detensioning process, the strain variation of the strand was monitored with two LVDTs attached to the strand. The strain values then were used to calculate the prestressing force released during the detensioning process. For calculation purposes, the area of the strand was taken as the nominal area,  $0.153 \text{ in}^2$  and the elastic modulus was taken as 27,500 ksi. Meanwhile, the horizontal reaction force created during the detensioning process was measured with the two load cells at the south side leg of the test specimen (see Figure 2.5 for more detail). The results were compared in Figure 3.2. As shown in Figure 3.2, the measured prestressing force released by the strand was 1.56 and 1.61 kips for LVDTs 1 and 2, respectively; while the measured horizontal reaction force reached 1.56 kips. Thus, it can be said that the entire prestressing force was transferred to the horizontal reaction force and that the plastic sheets used to reduce the friction force between the strong floor and the grout / concrete block assembly worked very well.

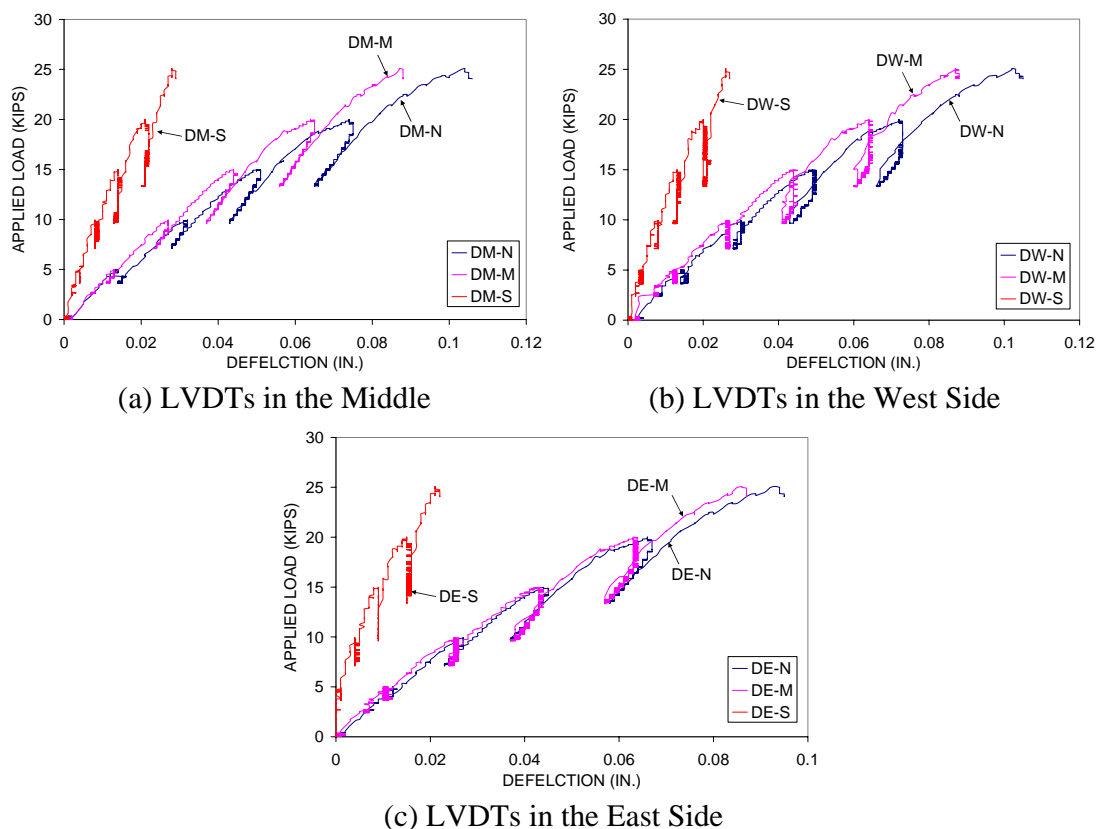
**Figure 3.3. Deflections in the Slabs Due to Load Case 1**

As loads were applied, deflections were measured with LVDTs at three different locations along the width of the slab, i.e., DW-series for the west side of the slab, DE-series for the east side and DM-series for middle of the slab. In each series of LVDTs, three LVDTs were placed at three different locations across the span of the slab, that is, the north and south side loading points and the mid-span of the slab, which were denoted with N, S or M at the end of the names of each LVDT as shown in the following figures in this section (see Figure 2.8 for more detail). Figures 3.3 and 3.4 present the load vs. deflection graphs obtained from those LVDTs for Load Cases 1 and 2, respectively.

According to the figures, it is apparent that the deflections were highest at the loading points and became smaller with the increase in distance from the loading points. These figures also show that the deflections at the three different locations across the width of the section, i.e., the east and west side, and the middle of the slab, were nearly the same at every loading step.

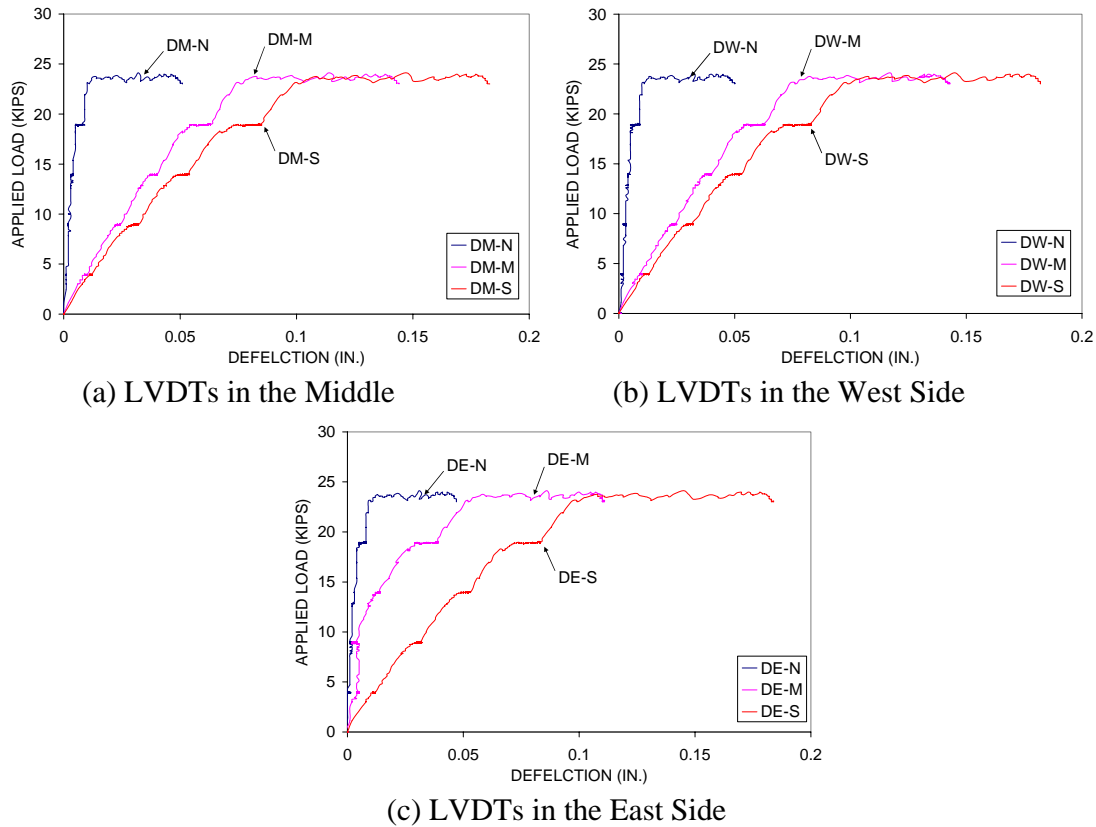
**Figure 3.4. Deflections in the Slabs Due to Load Case 2**

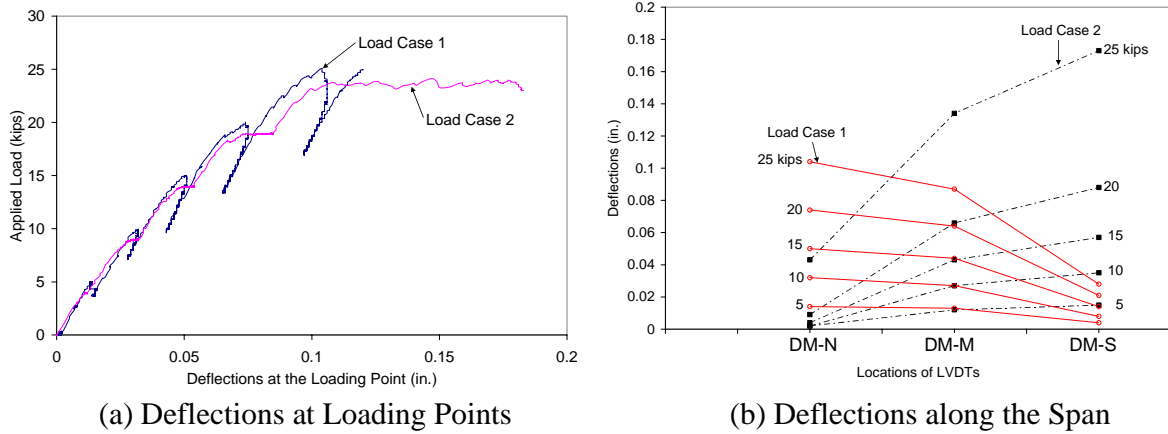
**Figure 3.5. Comparisons of Load vs. Deflection Relationship between Load Cases 1 and 2**

Figure 3.5(a) shows that the deflections at the loading points of both load cases, i.e., the deflection curve for Load Case 1 in the figure represents the deflections measured with LVDT DM-N while the deflection curve for Load Case 2 represents LVDT DM-S. As shown in Figure 3.5(a), the maximum deflections were 0.12 in. and 0.18 in. for Load Cases 1 and 2, respectively. In addition, it was exhibited that the deflections due to Load Case 2 were slightly higher than those due to Load Case 1 at every load step. This could be a result of some minor damage that occurred in the test specimen during Load Case 1; and thus the flexural stiffness of the test specimen during Load Case 2 was slightly smaller than that of Load Case 1. This phenomenon can be shown more clearly in Figure 3.5(b), which compares the deflections along the span length for both load cases. It can also be noticed from Figure 3.5(b) that for both load cases the deflection increment between 20 kips and 25 kips were greater than the deflection increments between other loading steps (i.e., 0 to 5 kips, 5 to 10 kips, 10 to 15 kips, and 15 to 20 kips). This implies that the stiffness of the test specimen has slightly decreased between loads of 20 and 25

kips, due to the flexural cracking as discussed in the previous section. The slight change of the stiffness of the test specimen at around 20 kips can also be observed in Figure 3.5(a).

In addition, it was observed that in Load Case 1 the applied load would drop by about 5 kips in between load steps as shown in Figure 3.5(a). To avoid this during Load Case 2, a small amount of additional hydraulic pressure had to be continuously supplied to the hydraulic jack in order to keep the load constant. Thus, the applied load vs. deflection curves of Load Cases 1 and 2 were slightly different. From Figure 3.5(a), it was noticed that the deflection increased while the applied load was maintained at about 25 kips in the case of Load Case 2 while Load Case 1 did not show such increase in deflection. This could be due to the fact that the existing cracks kept opening while maintaining a constant load near the flexural cracking capacity of the test specimen. However, the increase in deflection resulting from the constant load was just 0.07 in. and can be easily ignored when considering the entire behavior of the test specimen.

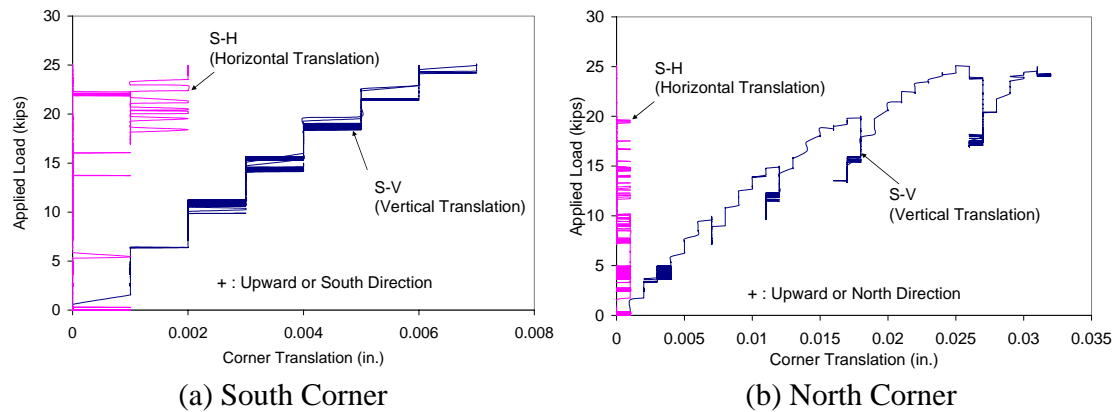
**Figure 3.6. Corner Translation**

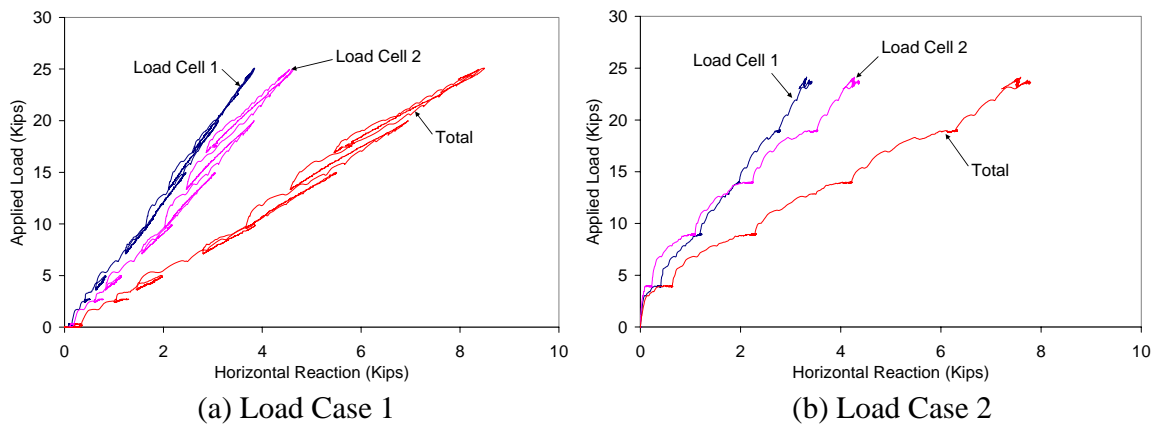
**Figure 3.7. Horizontal Reaction Forces**

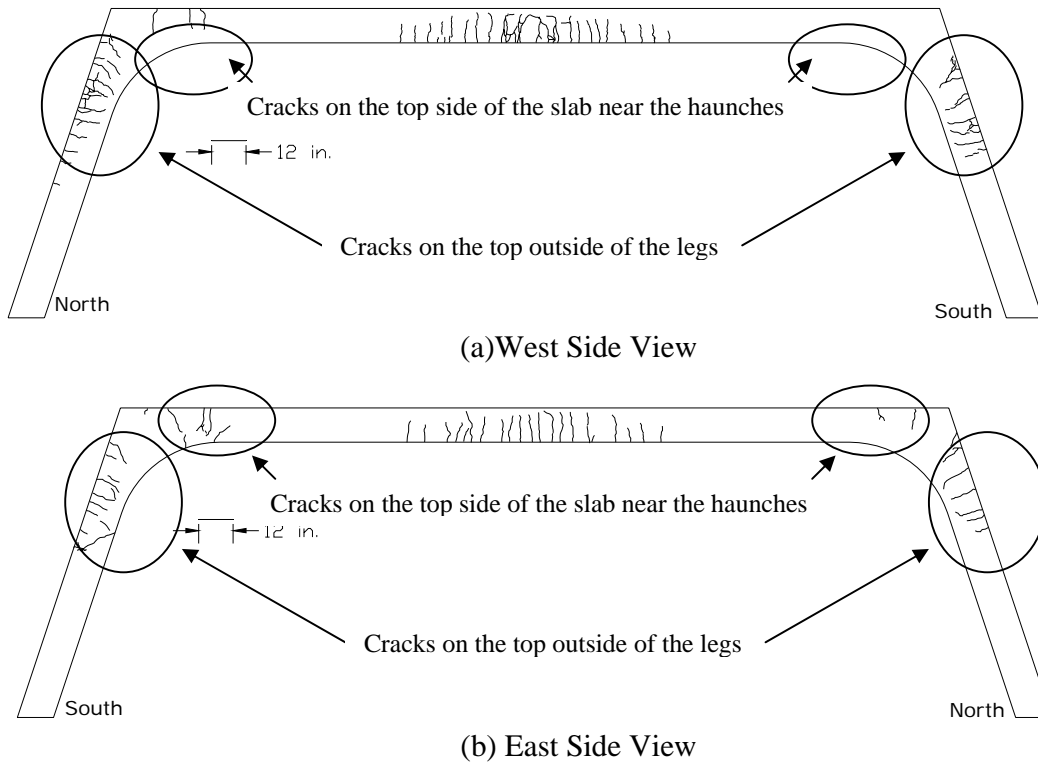
**Figure 3.9. Crack Patterns for the Sides of the Test Specimen**

As the load was applied beyond the flexural cracking load, many new flexural cracks developed. The crack patterns for Load Case 3 can be found in Figures C.1(d), C.2(d), C.3(d), and C.4(d) of Appendix C. The cracks were observed mostly on the bottom side of the slab near the mid-span due to the positive moment, on the top side of the slab near the haunches, and on the top outside surfaces of the legs near the haunches due to the negative moment. Considering the number of cracks as well as the depth of the cracks, it seemed that the effects of the negative moment was more significant on the top outside of the legs than on the top side of the slab near the haunches as shown in Figure 3.9. This can also be evidenced by the strains in the reinforcement which will be discussed later in this section.

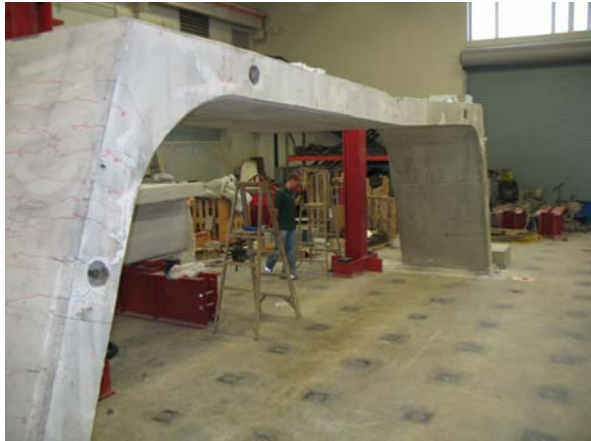
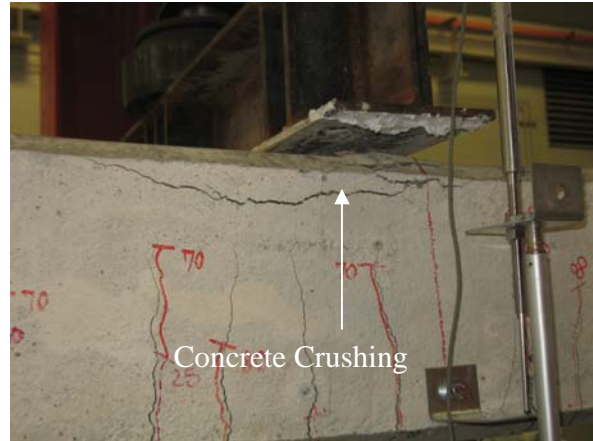
(a) Failed Specimen

(b) Close-up of the Concrete Crushing

**Figure 3.11. Photos Taken after the Failure of the Test Specimen**

The yielding of the tensile reinforcement at the mid-span of the slab occurred at about 70 kips of applied load and 1.0 in. of the deflection. Beyond this load, the test specimen underwent a large deflection of up to 5.3 in., and eventually failed due to concrete crushing at the top of the slab at mid-span. Failure occurred at 107 kips of applied load as shown in Figure 3.10. Figure 3.11 presents the photos taken after the failure of the test specimen, and clearly shows the concrete crushing at the top of the slab.

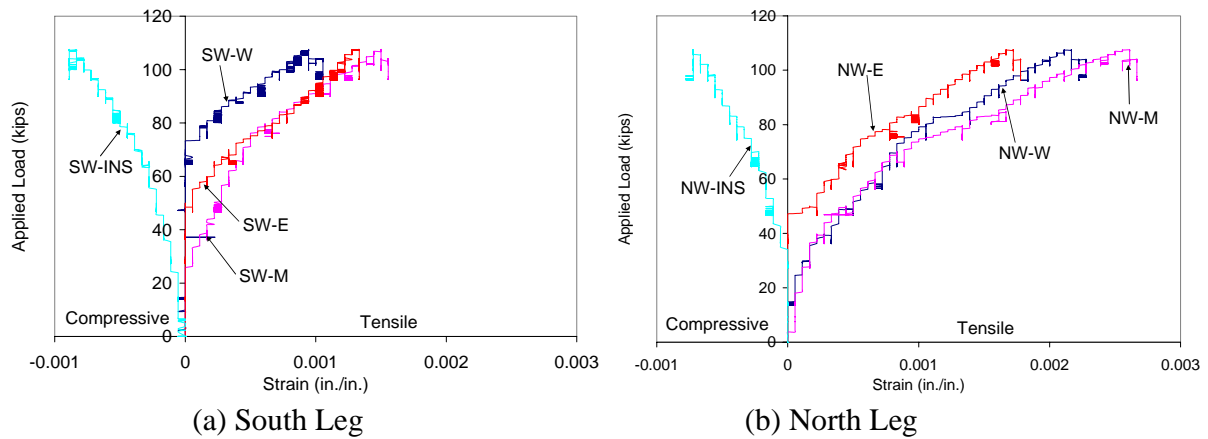
**Figure 3.14. Strains in the Mid-Height of the Legs**

In previous sections, the discussions were made with the focus on the flexural behavior of the slabs and the regions near the haunches. This section deals with the flexural behavior of the legs by investigating the strains measured with LVDTs at the mid-height of the legs. The LVDTs attached to the inside and outside of the legs had a gage length of 18 in and bridged over several cracks depending on their locations (see Figure 2.9 for more detail). Thus, the strains measured with these LVDTs would represent the average strains. Figure 3.14 shows the measured strains for both legs. As shown in Figure 3.14., the insides of the legs were compressed and the maximum compressive strains were less than 0.001 for both legs at the time of failure of the test specimen, while the outsides of the legs were subjected to tensile stresses and the maximum

tensile strains at the time of failure were 0.0016 and 0.0027 for the south and north legs, respectively. It should be noted, however, that the strains shown in Figure 3.14 do not represent either strains on the surface of concrete or strains in the reinforcement. As shown in Figure 3.15, LVDTs were attached to the legs and the locations of the LVDTs were about 1 in. above the concrete surface. Thus, the actual average tensile strains in the reinforcement would be significantly smaller than the strains measured with the LVDTs, which can be calculated based on the strain compatibility condition. The calculated maximum average tensile strains at the time of failure of the test specimen were 0.0010 and 0.0017 for the south and north legs, respectively. Therefore, it can be said that the reinforcement below the mid-height of the inclined legs would not yield during the entire loading history of the test specimen.

It should be also noticed from Figure 3.14 that the average tensile strains of the north leg were about 60% higher than those of the south leg. In order to find the reasons for the difference, the horizontal movements of the concrete blocks used to provide the horizontal restraint for the legs are investigated. One LVDT was attached at both the west and east side of each concrete block, respectively as shown in Figure 2.10. For the south side concrete block, one LVDT located at the west side was denoted S-CB-W and the LVDT located at the east side was denoted S-CB-E. Similarly, for the north side the LVDTs were denoted N-CB-W and N-CB-E. Then, the horizontal movements of the centerline of the concrete blocks were calculated using the two LVDTs located at the west and east side of the concrete block and identified as ‘AVERAGE’ in Figure 3.16. As shown in Figure 3.16, the average horizontal movement of the south side concrete block was about 0.34 in., while that of the north was 0.034 in. That is, the horizontal restraint provided to the south side leg was not as rigid as the horizontal restraint provided to the north side leg. As a result, the moment in the south side leg should be smaller than that of the north side leg. Note that the tensile strains measured from the LVDTs were also smaller in the south side leg than in the north side leg.

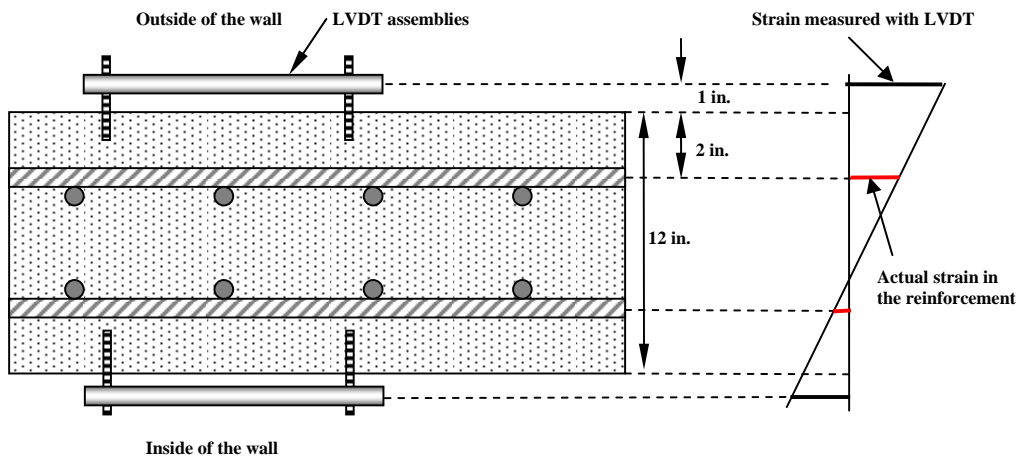
**Figure 3.15. Strain Measurement in the Legs with LVDTs**

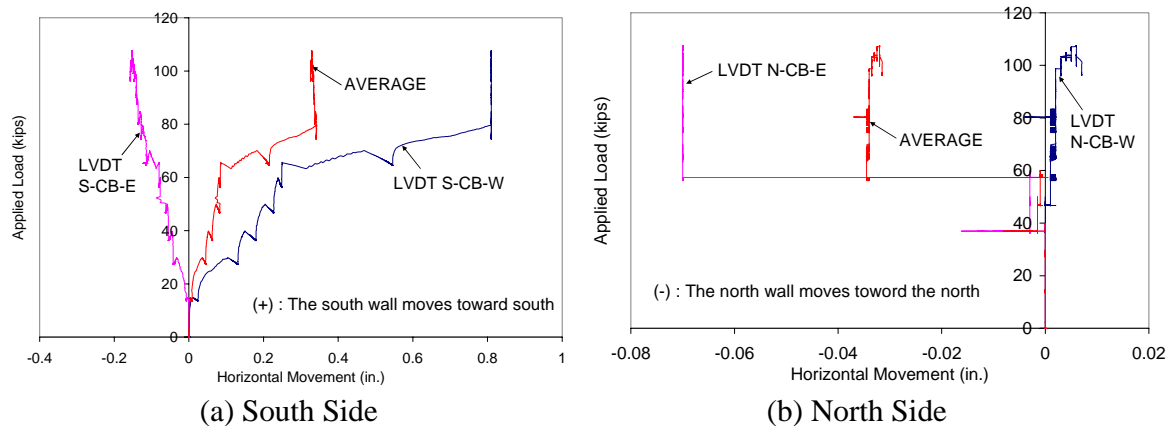
**Figure 3.16. Horizontal Movement of the Concrete Block Assemblies at the Side of the Legs**

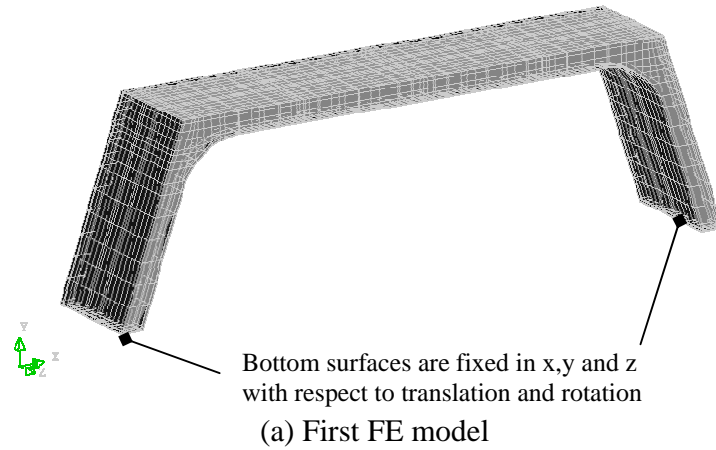
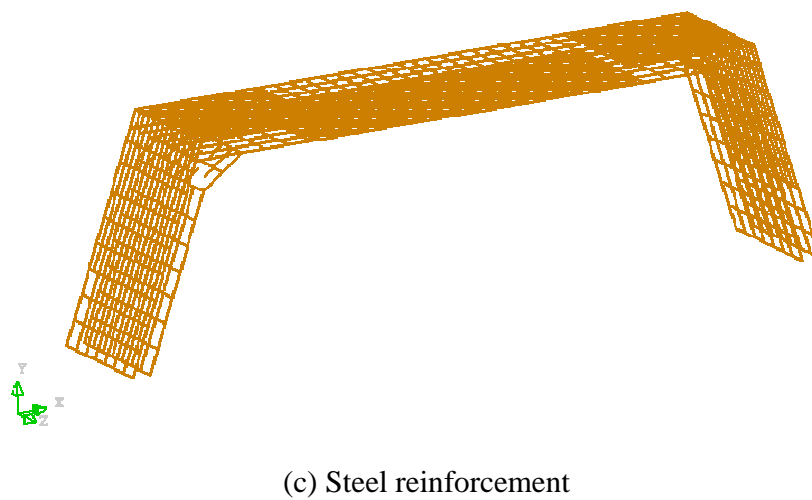
**Figure 4.1. Configuration of FE Models**

There were several changes in the geometrical aspects of the FE model between the first and second series of analyses. The most significant change was in the change of the boundary conditions. In the first FE model, fixed constraints are applied to the entire bottom surface of the support region without any changes to the element properties in this region as shown in Figure 4.1(a). After testing, significantly different local behavior within the supporting region was observed between the analytical and experimental results. These differences will be explained in the following section. The noted phenomenon forced a change of the boundary conditions for the second FE model. More detailed and realistic considerations when compared to the test results were added into the second FE model. Formerly fixed constraints were changed to pinned conditions along the middle line of the bottom support surfaces and a high stiffness material property was given to the end of supporting region as shown in Figure 4.1(b). Modeling the support surfaces in this way prevents a local failure in the constraint nodes and better simulates the real test set-up configurations. Figure 4.1(c) shows the detailed reinforcement arrangement modeled in both FE models. This reinforcement configuration matches the

reinforcement in the test specimen and eliminates lumped reinforcement that is prevalent using other analytical techniques.

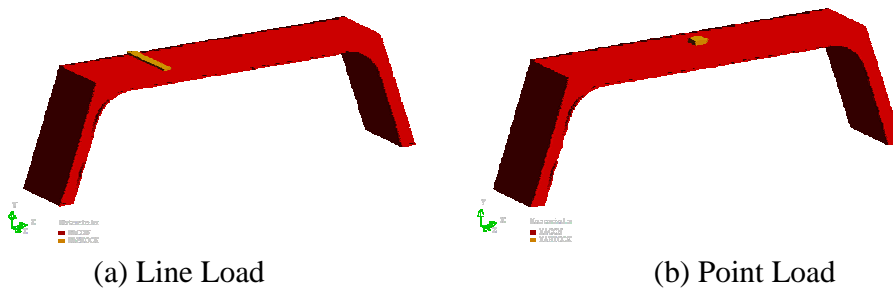
**Figure 4.2. Load Cases in the First FE Model**

As in the experimental portion of the project, three load cases were applied to the FE models. Two load cases used a line load, which was applied to the test specimen with a steel beam offset 6ft in both directions from the mid-span of the slab. The magnitude of the total applied load was near the calculated cracking load of the test specimen. Following these two load cases, a concentrated load was applied at the center of test specimen in incrementally increased until failure. In the first FE model, load was applied up to failure for the first two load cases using displacement control for prediction. Because these load cases were symmetric and not interdependent, only one simulation was carried out. A concentrated load was also applied up to failure using displacement control. Figure 4.2. shows the analysis cases for the first FE model.

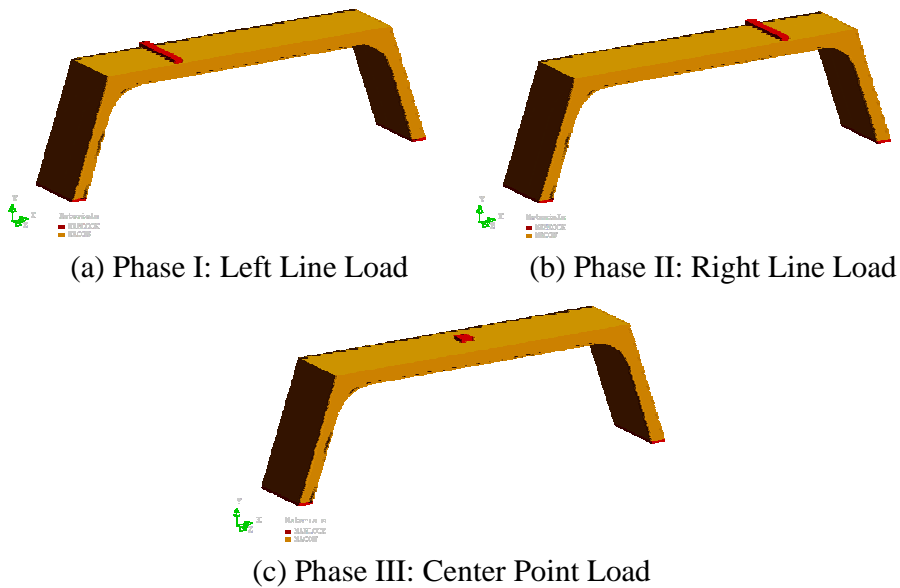
**Figure 4.3. Load Cases in the Second FE Model**

Unlike the first FE model, the load cases applied to the second FE model were exactly the same as the experimental load cases. For the two line loads, load was applied in 5 kip increments up to a total of 25 kips. After these first two load cases, a point load incrementally applied until the analysis came to a halt using the displacement control. In addition, a phase analysis technique was applied to simulate the phased state of the test specimen under a time dependent loading history as shown in Figure 4.3.

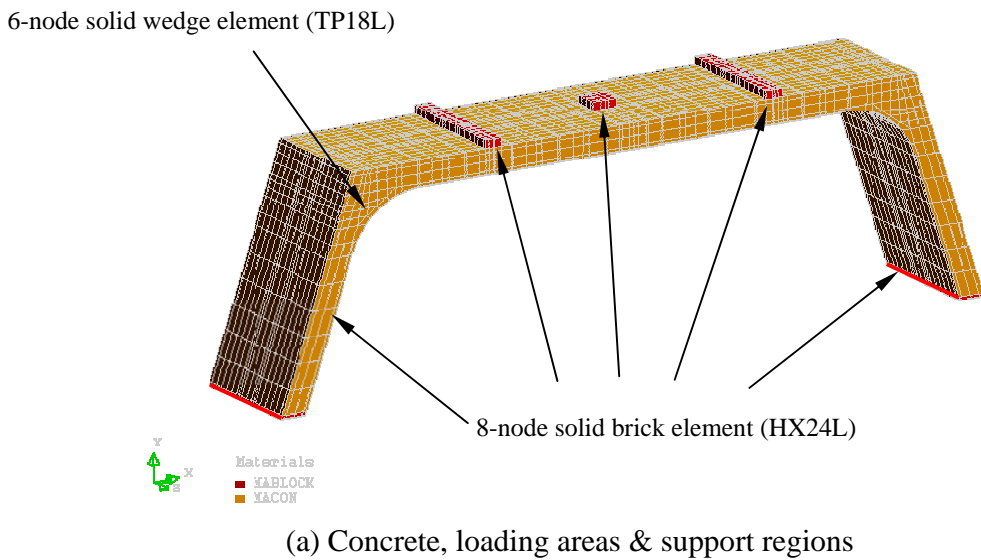
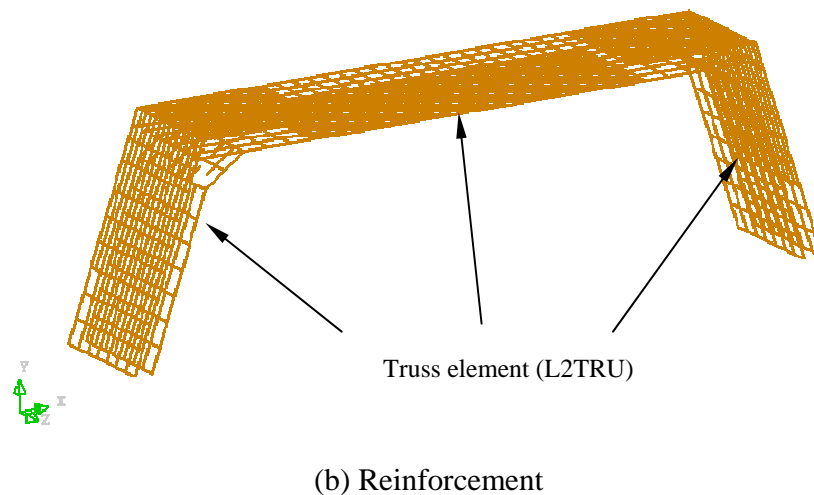
**Figure 4.4. Finite Element Model**

Detailed views of the FE model are illustrated in Figure 4.4. The eight-node isoparametric solid brick element was chosen to model the concrete elements except for haunch areas which used six-node isoparametric solid wedge elements. The material behavior of the concrete elements utilizes an orthotropic, smeared crack model, parallel to the principal strain directions, based on the rotating crack behavior. This concrete material model follows the method by Thorenfeldt et al. (1987) using the ultimate strength obtained from cylinder tests. The reinforcing steel was modeled as truss elements and assumes an elasto-plastic material property. For the loading areas and support regions, the same 8-node elements were used, but with linear elastic material properties and a high stiffness.

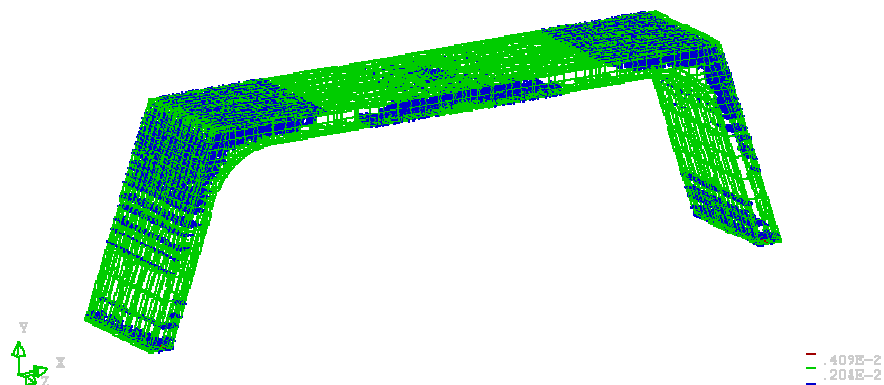
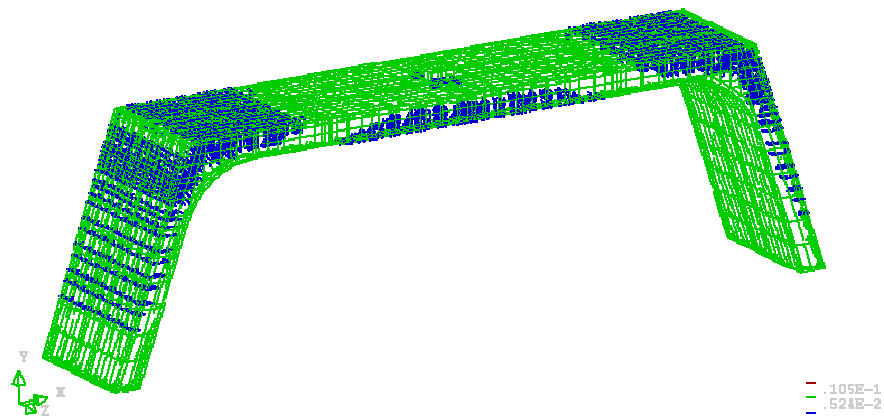
(a) First FE Model

(b) Second FE model

**Figure 4.5. Crack Patterns at the Ultimate State**

was a significant difference in the failure mode between the experimental and analytical results of the first FE model. Crack patterns of the first FE model at the ultimate state are shown in Figure 4.5(a). Many cracks are shown on both the inside and outside surfaces of both legs. This type of crack behavior was not observed during any of the test load cases. The crack patterns from the second FE model are shown in Figure 4.5(b) and much more closely resemble the crack patterns observed during testing. Thus, it is clear that the first FE model was not suitable for comparison with the experimental results and the initial assumption of fixed boundary conditions was incorrect.

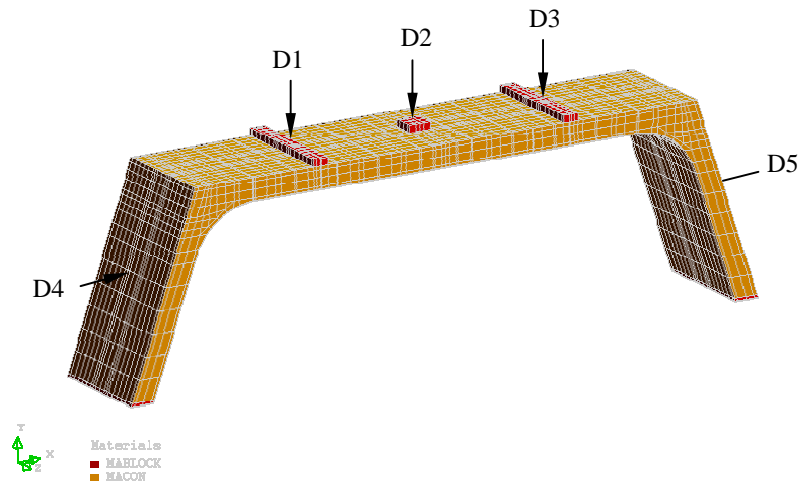
**Figure 4.7. Measuring Points for Displacement**

Deformed shapes at the ultimate state in each phase are illustrated in Figure 4.6. Load-displacement relationships are evaluated at the locations noted in Figure 4.7. Actual displacements for D1, D2 and D3 were taken from the bottom surface of slab while the figure indicates that these points are on the upper surface simply for the sake of visuals. Figure 4.8 shows the displacements of D1, D2 & D3 with respect to each phase.

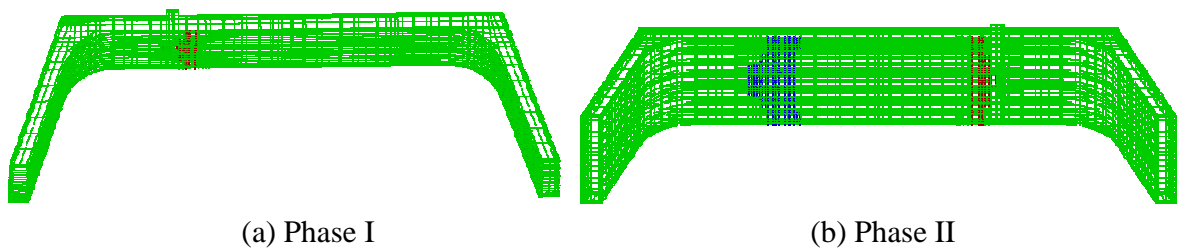
**Figure 4.12. Crack Patterns of Phase I and II**

Figure 4.12 shows the crack patterns of phase I and II at the peak load of 25 kips. Pre-existing cracks caused by phase I loading are shown in Figure 4.12(b). In phase III, there were two peak points as shown in Figure 4.8(d). The first peak point was caused by yielding of the bottom reinforcement in the positive moment region. Beyond that, the top surface of the slab in the positive moment region began to crush with the simultaneous yielding of the top reinforcement

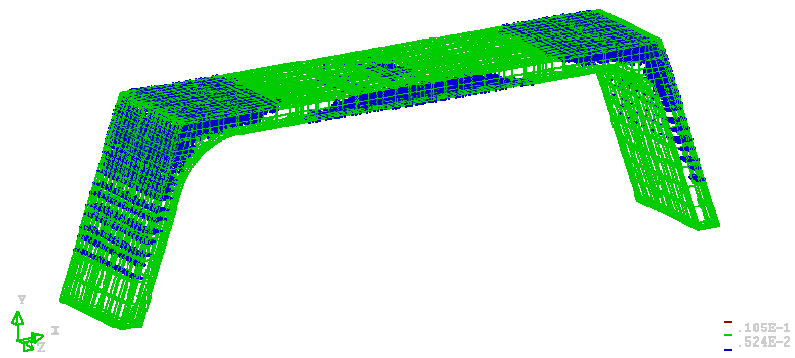
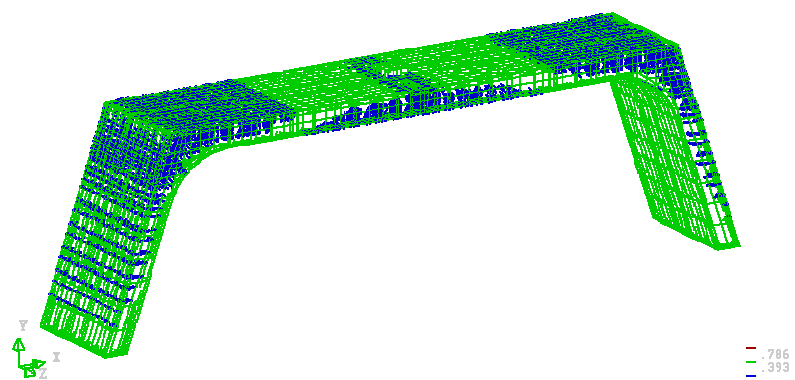
(a) Upper view for the first peak point

(c) Upper view for the second peak point

**Figure 4.13. Crack Patterns of Phase III**

in the negative moment region. This failure mode can be observed from the crack patterns shown in Figure 4.13. The crack patterns at the first peak point are illustrated in Figure 4.13(a) and 4.13(b) while Figure 4.13(c) illustrates the second peak point.
