# CENTER FOR TRANSPORTATION INFRASTRUCTURE AND SAFETY

## **A Laboratory Investigation on Three-Sided Structures**

**NUTC  
R227**

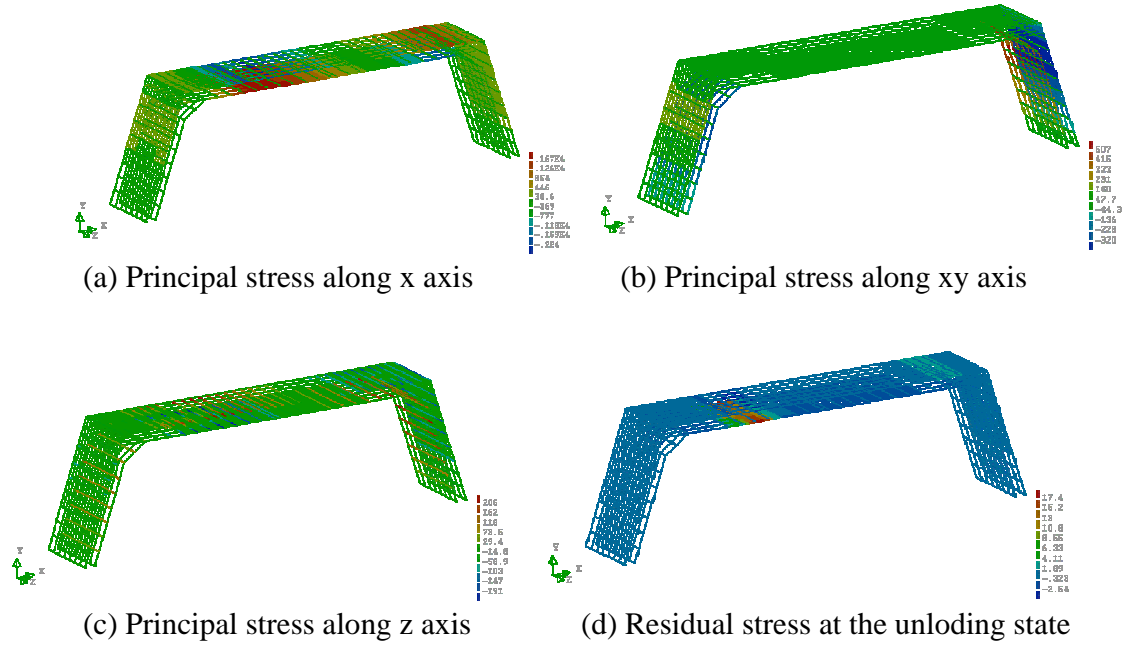
**Figure 4.17. Principal Stress on Steel for Phase I**

Principal stresses on all reinforcement are shown in Figures 4.17 through Figure 4.20. These stress variations supplement the failure modes described above.

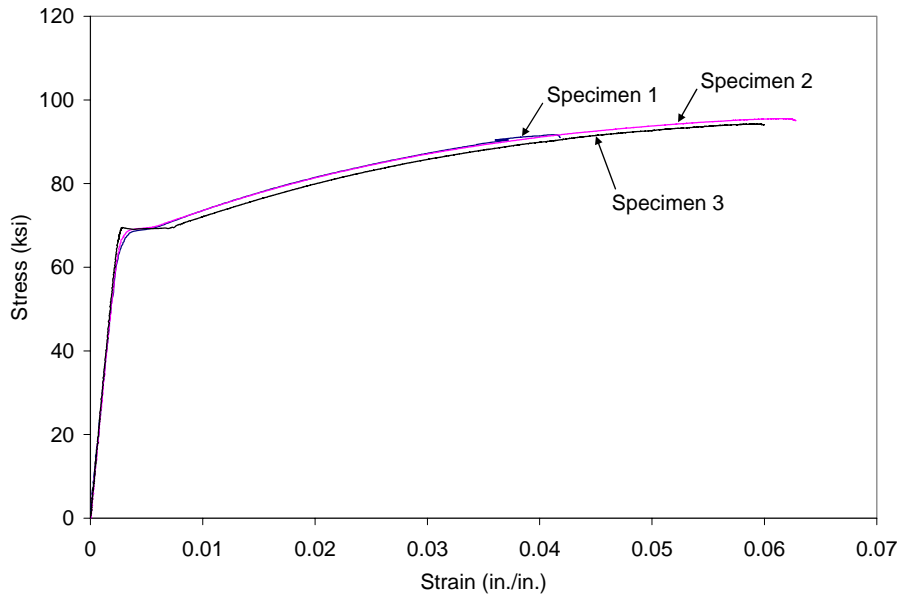
Figure B.1 Tensile Test Results of #4 Rebars

Three samples of #4 and #5 reinforcing bars were tested in the Materials Laboratory at Missouri S and T and the results are presented in this appendix.

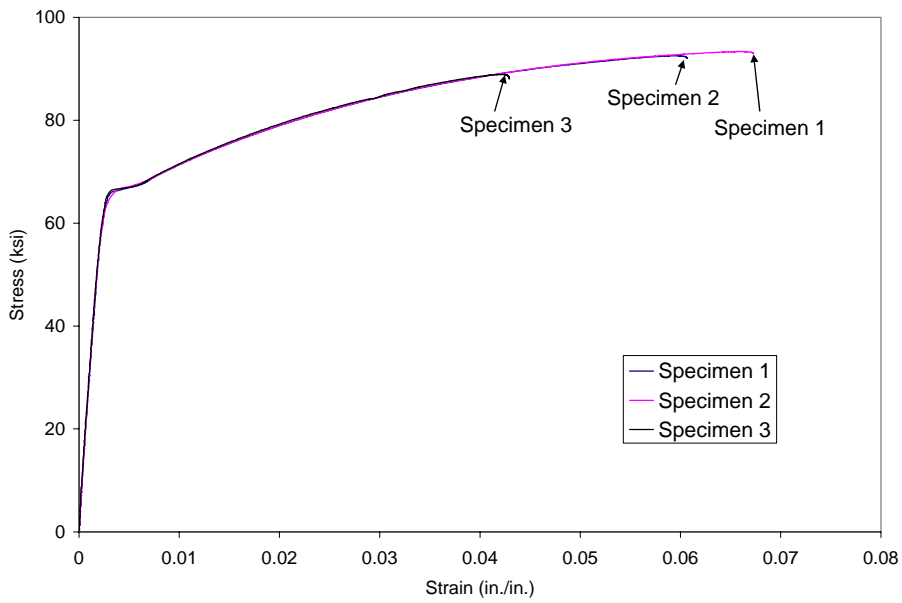
Figure B.2 Tensile Test Results of #5 Rebars

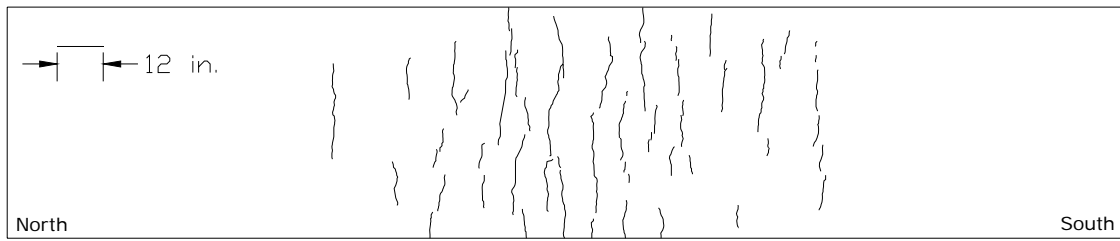
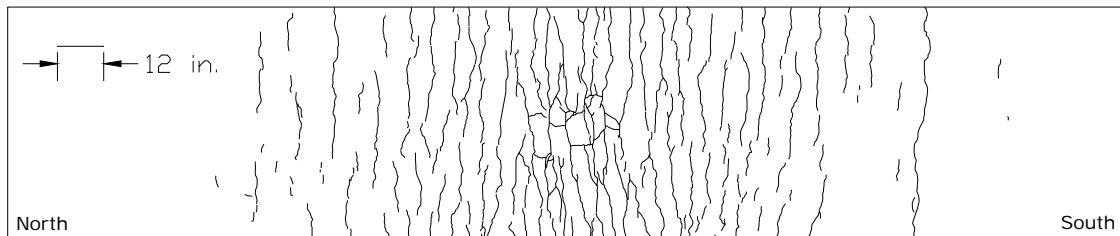
(a) Dry Shrinkage

(d) D-S + Load Case 1 + Load Case 2 + Load Case 3

**Figure C.1. Crack Patterns of Bottom Side of the Slab**

Before the test began, the existing cracks, which were considered to be shrinkage cracks, were found and are shown in Figures C.1(a), C.2(a) and C.3(a) in Appendix C. As shown in the figures, most cracks were found near the mid-span of the slab with some near the lifting anchors on the east side of the test specimen. The spacing between the cracks on the bottom surface of the slab was less than the thickness of the slab and the maximum spacing of the shrinkage and temperature reinforcement in the slab, both of which were 12 in.

Cracks were marked at each load step, i.e., 5, 10, 15, 20 and 25 kips of loading and the obtained crack patterns are provided in Figures C.1(b), C.2(b) and C.3(b) for Load Case 1 and Figures C.1(c), C.2(c) and C.3(c) for Load Case 2 in Appendix C.

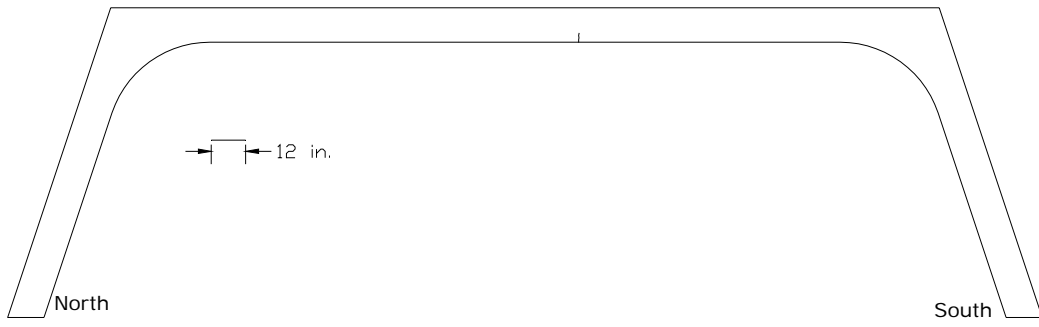
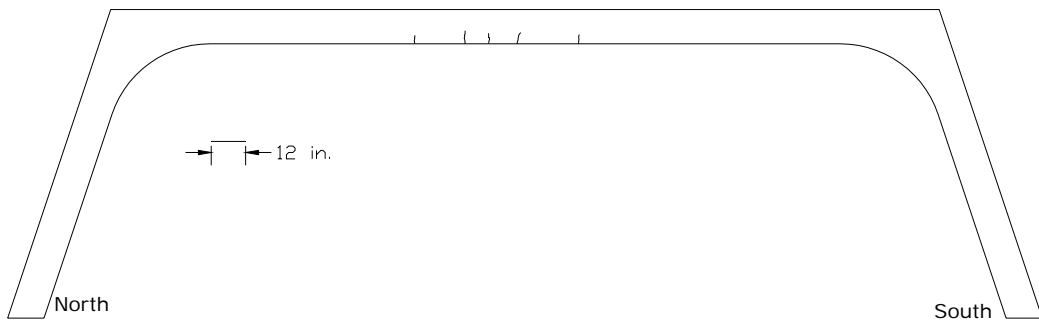
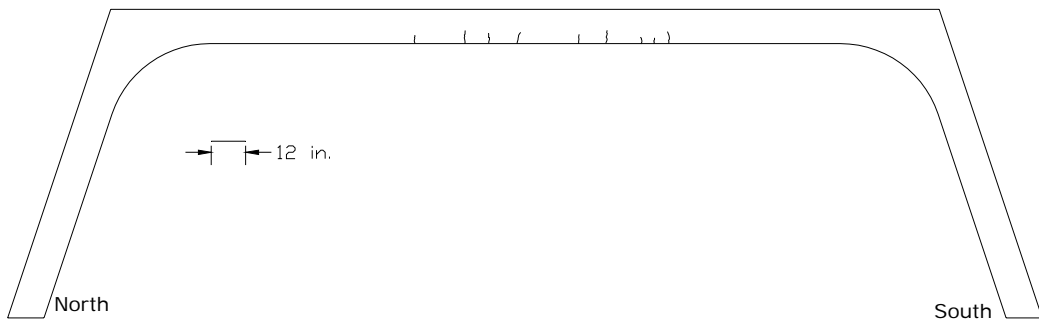
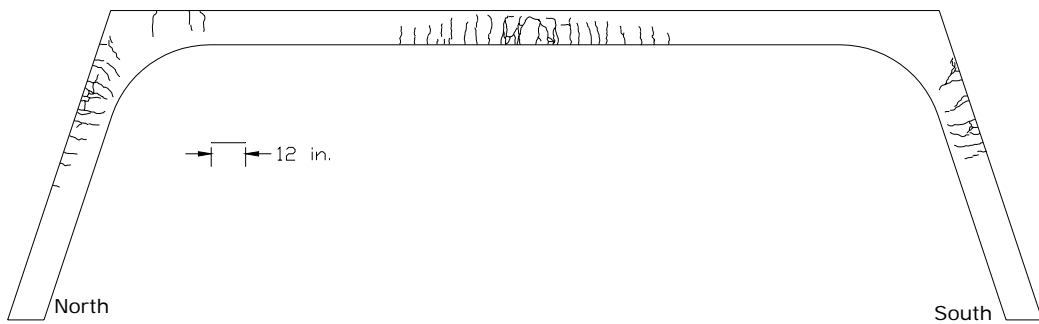
**Figure C.2. Crack Patterns for West Side**

As the load was applied beyond the flexural cracking load, many new flexural cracks developed. The crack patterns for Load Case 3 can be found in Figures C.1(d), C.2(d), C.3(d), and C.4(d) of Appendix C. The cracks were observed mostly on the bottom side of the slab near the mid-span due to the positive moment, on the top side of the slab near the haunches, and on the top outside surfaces of the legs near the haunches due to the negative moment. Considering the number of cracks as well as the depth of the cracks, it seemed that the effects of the negative moment was more significant on the top outside of the legs than on the top side of the slab near the haunches as shown in Figure 3.9. This can also be evidenced by the strains in the reinforcement which will be discussed later in this section.

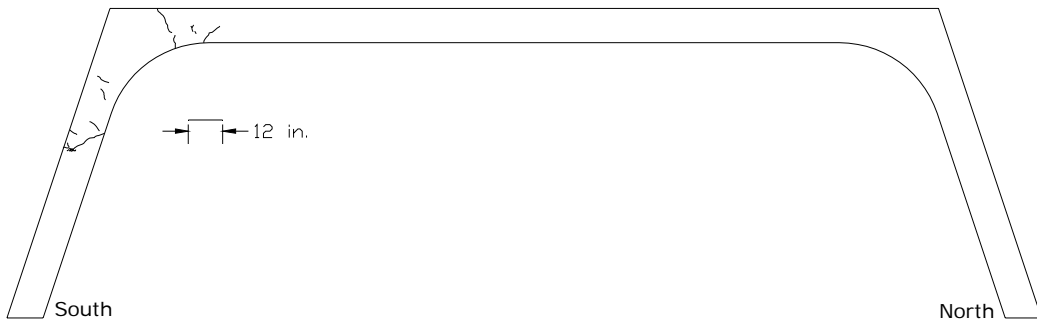
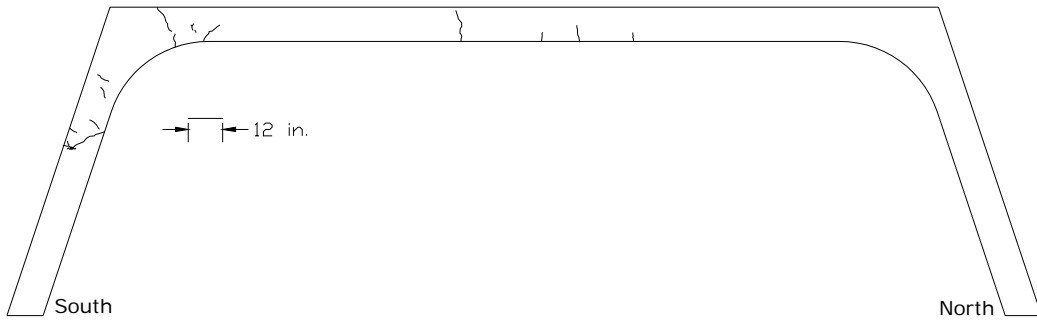
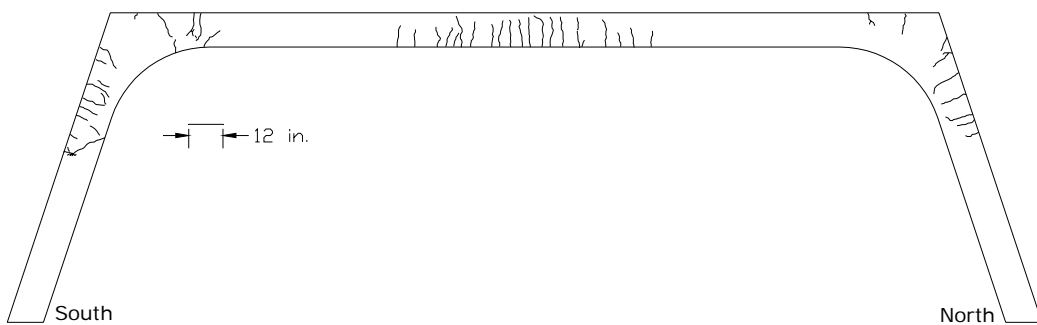
**Figure C.3. Crack Patterns for East Side**

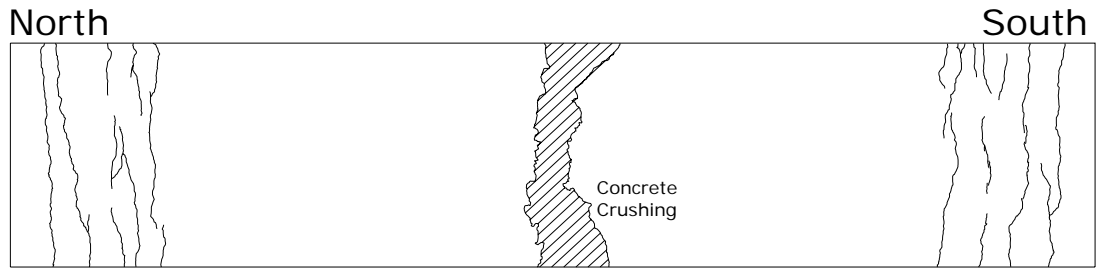
Note: All cracks in this figure were developed due to Load Case 3. No cracks due to dry-shrinkage, Load Cases 1 and 2 were observed.

**Figure C.4. Crack Patterns for the Top Side of the Slab**
