Testing and Assessment of Portable Seismic Property Analyzer

**NUTC
R297**

**Neil Anderson
Mengxing Li
Missouri Science & Technology**

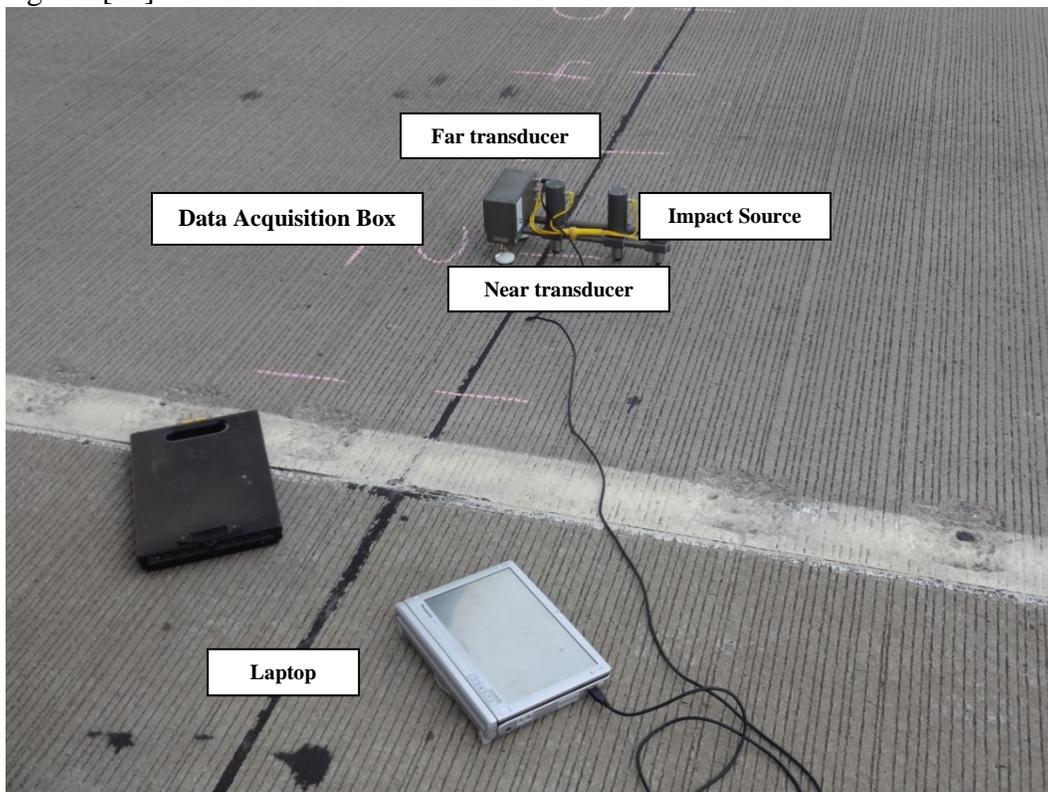
The portable seismic property analyzer (PSPA), shown in Figure 01, is an integrated ultrasonic seismic devices that measurement the change of elastic modulus and the thickness of bridge deck or pavement surface layers [20]. The PSPA is based on the nondestructive device developed by Dr. Baker [38] and consists of a source and two transducers packaged into a portable system for performing seismic tests in the field [36]. The device is connected to a laptop computer through a cable that carries commands to the PSPA and stores the signals collected by the transducers. The source package is also equipped with a transducer for consistency in triggering and for some advanced analysis of the signals [35].

Figure 01: The Composition of Portable Seismic Property Analyzer (PSPA).

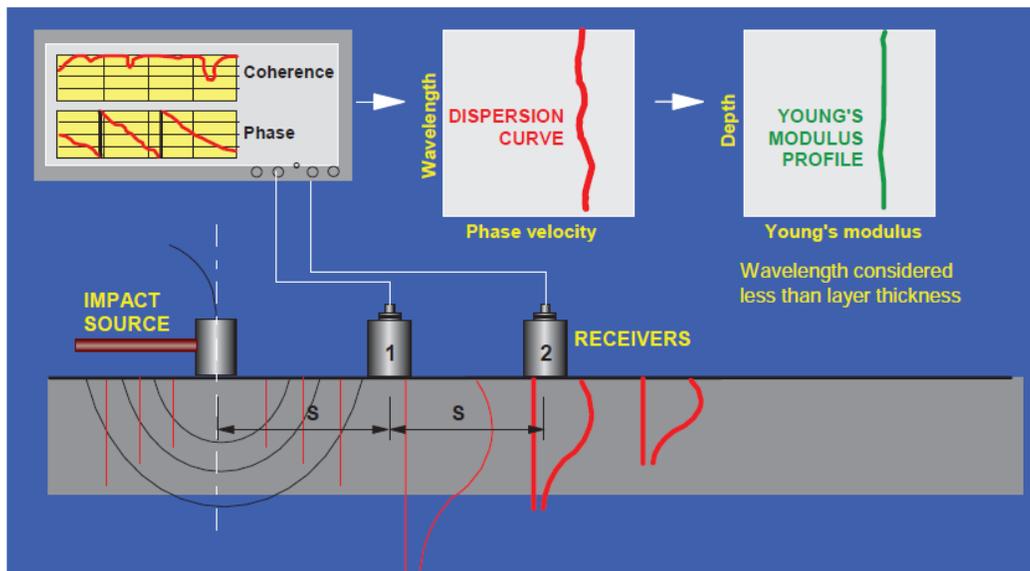
The variability of test results with the PSPA on Portland cement concrete is less than 3% without moving the device and around 7% when the device is moved in a small area [38]. The general procedure of evaluation the elastic modulus of the material through the ultrasonic surface wave method has been shown in Figure 02.

Figure 02: The Procedure of Elastic Modulus Measurement by PSPA.

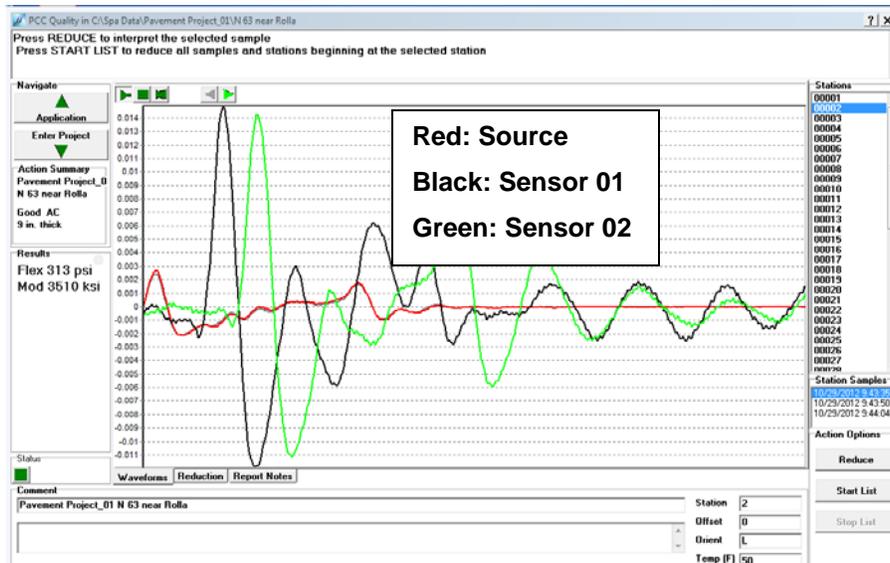
Figure 03: Typical Time Records of Three Transducers.

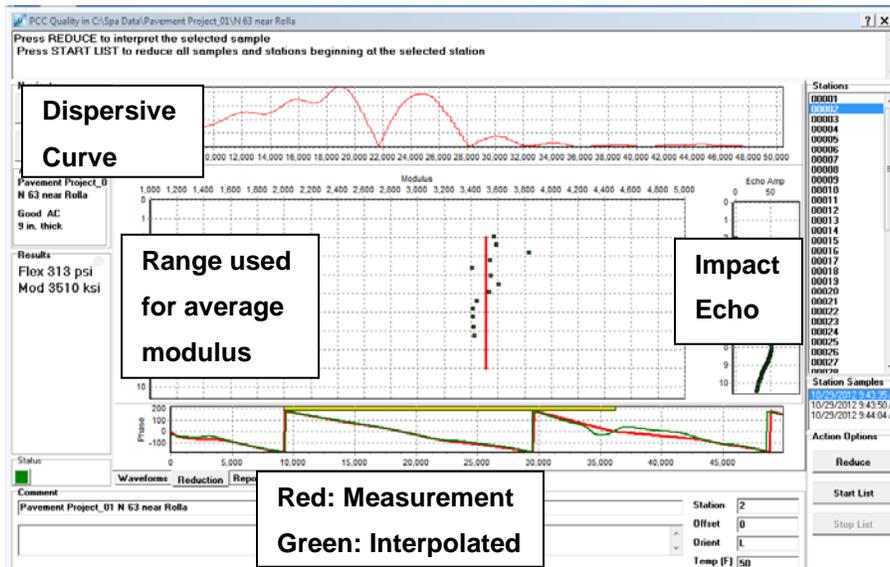
In case of relatively homogeneous materials, such as concrete or asphalt, the velocity of the surface wave or phase velocity does not vary significantly with frequency. The surface wave velocity can be precisely related to the material elastic modulus using either the assumed or measured mass density and Poisson ratio of the material. An average velocity (Vertical red line shown in Figure 04) is used to correlate it to the concrete modulus of the top layer. Significant variation in the phase velocity will be an indication of the presence of a deterioration anomaly. However, the elastic modulus evaluation becomes more complicated for multiple layered systems, such as pavements or bridged decks with asphalt concrete overlays, where the elastic modulus of each layers differ significantly [18].

Figure 04: Typical Dispersion Curve Obtained from the Time Records in Figure 03.

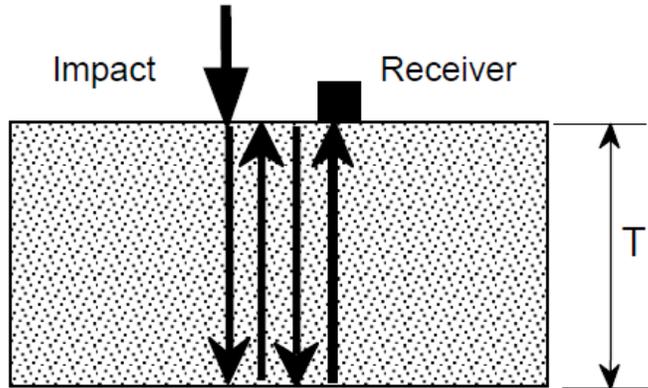
Figure 05: The Configuration of Impact Echo Testing.

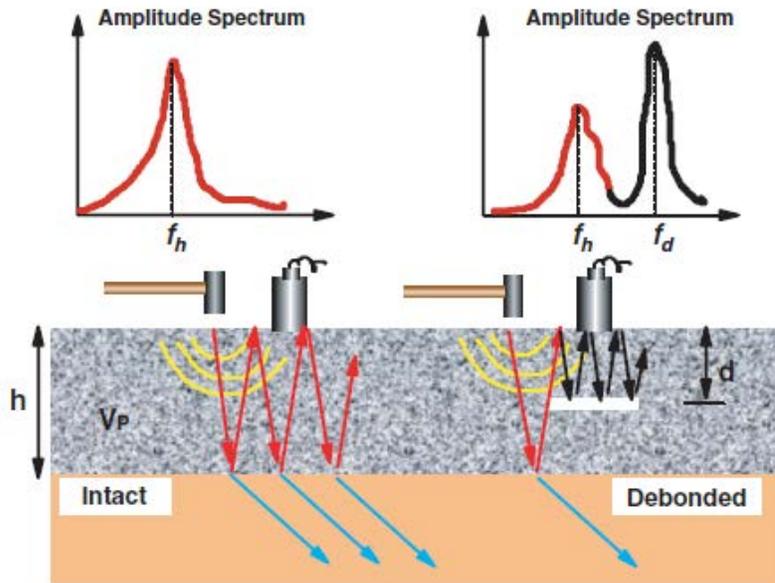
The Figure 06 has shown the example of amplitude spectrum (frequency spectrum) contrast between intact and deboned concrete slabs. For the case of the intact slab, a large portion of input energy is reflected back from the bottom of the slab or concrete base interface. Some of the energy is transmitted into the base and subgrade. For the case of the deboned slab, a portion of the energy will be reflected from the concrete-air interface created by the deboning.

Figure 06: The Amplitude Spectrum Contrast between Intact and Debonded Concrete Slabs.

Therefore, other than the full slab thickness frequency f_h , the amplitude spectrum will show one or more frequency peaks at $f_d = \frac{V_p}{2d}$, corresponding to the frequency of reflections from the debonding at a depth of $d < h$. The relative amplitude of the peaks depends on a number of factors, including the extent, depth, continuity, and position of debonding, as well as the frequency content of the impact source [21].

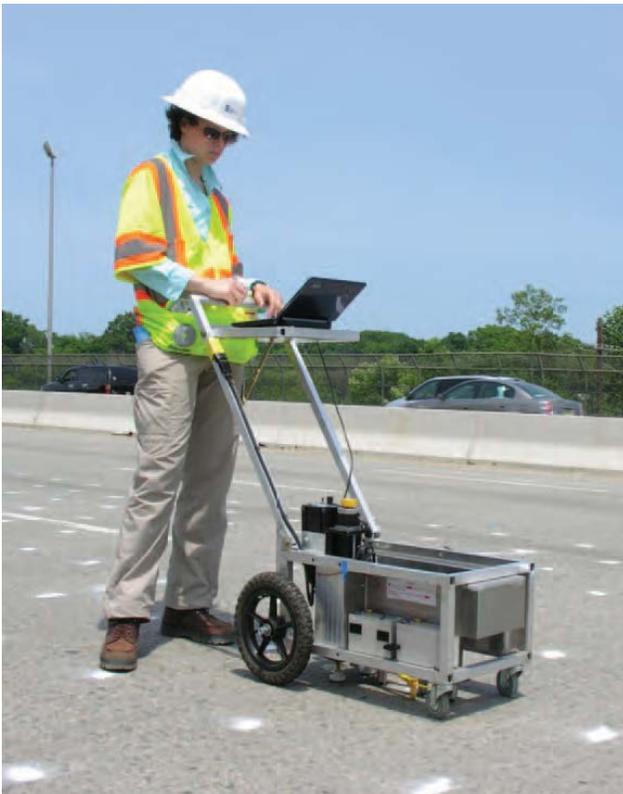
In order to mitigate the potential problems of PSPA data acquisition statement in previous section, the locations of reinforcement steel are marked before conducted PSPA field tests. The PSPA instrument has been placed avoid overlaid on the top of reinforcement steels during the field tests of bridge decks evaluation.

Figure 07: PSPA Data Acquisition on the Bridge Deck with 2×2 feet Grid Spacing [18].

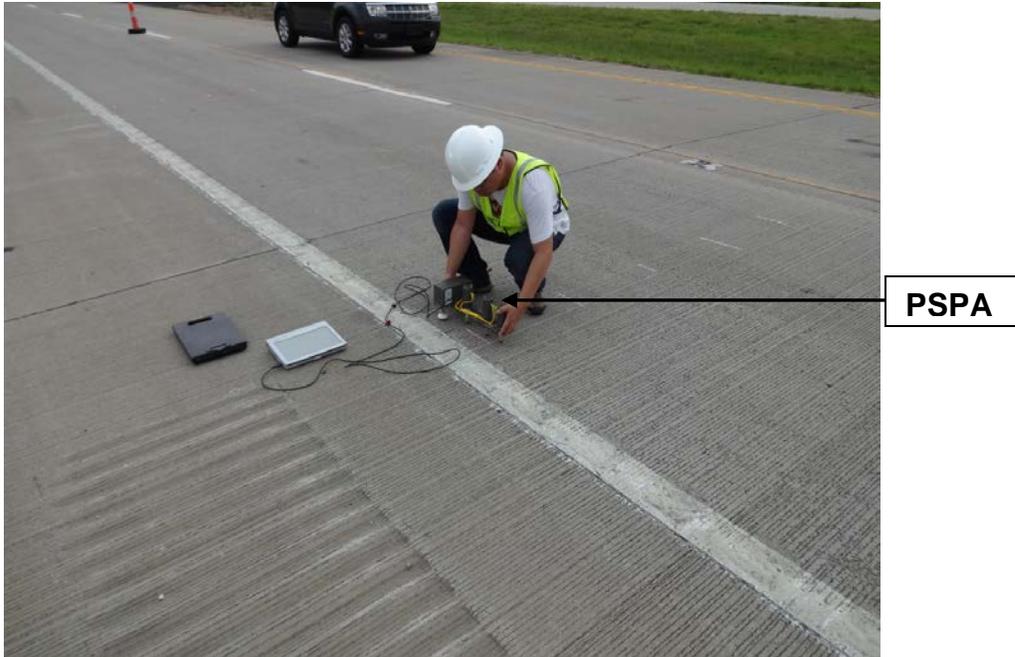
The length of PSPA test for pavements evaluation in this project is 1000 feet. A 100 feet interval is conducted for PSPA data collection in longitude direction of the pavement. The half lane of the pavement is covered by PSPA test point with 2 feet intervals in traverse direction. The investigation width of the pavement is 10 feet. The field data acquisition procedure has been shown in Figure 08. The location and scale of PSPA test for pavement evaluations is mainly based on several factors: speed of data acquisition, the material type of top pavement layers and the severity degree of the pavement.

Figure 08: PSPA Data Collection in the Field for Pavement Evaluation.

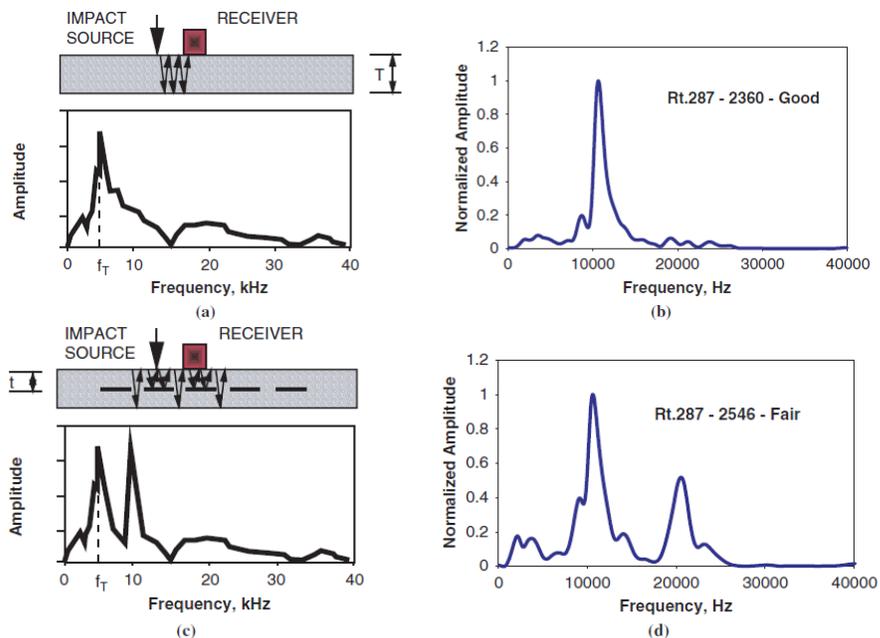
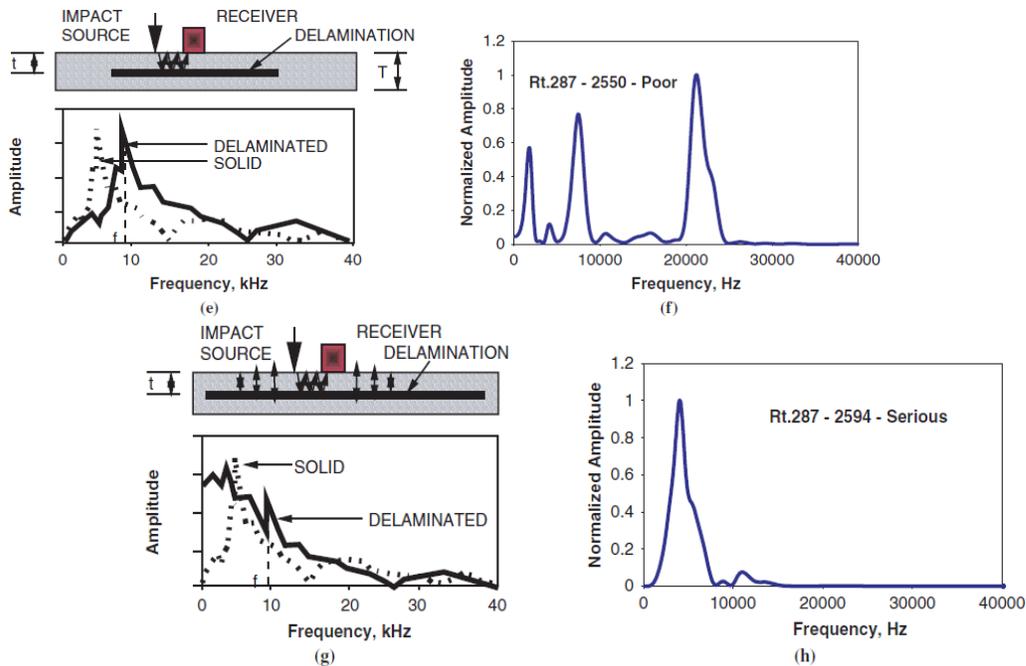
In the case of a delaminated deck, reflections of the P-wave occur at shallower depths causing a shift in the response toward higher frequencies. Depending on the extent and continuity of the delamination, the partition of energy of elastic waves may vary and different grades can be assigned to that particular section of a deck as a part of the condition assessment process [20]. The grades selection based on the various degree of deck delamination has been shown in Figure 09. In the case of a sound deck (one in good condition, Figure 09a and 09b), a distinctive peak in the response spectrum corresponding to the full depth of the deck can be observed, as shown by two spectra under the cross section of the bridge deck. Figure 09a represents a schematic of the expected spectrum, while Figure 09b is taken from actual field testing. Initial delamination (deck in fair condition, Figure 09c and 09d) is described as occasional separation between the two deck zones. It can be identified through the presence of two distinct peaks, indicating energy partition from two dominant wave propagation patterns. The first peak corresponds to reflections from the bottom of the deck, while the second corresponds to reflections from the delamination. Progressed delamination (deck in poor condition, Figures 09e and 09f) is characterized by a single peak at a frequency corresponding to a reflector depth that is shallower than the deck thickness, indicating that little or no energy is being propagated toward the bottom of the deck. Finally, in a very severe case of a wide delamination (serious condition, Figures 09g and 09h), the dominant response of the deck to an impact is characterized by a low-frequency response of flexural-mode oscillations of the upper delaminated portion of the deck. This response is almost always in the audible frequency range, unlike response of the deck in the fair and poor conditions, which may be in the ultrasonic range. Because this response is significantly lower than the return frequency for the deck bottom, it produces an apparent reflector depth that is larger than the deck thickness.

FIGURE 09: Grades for various degrees of deck delamination shown, respectively, with schematic of expected spectrum and spectrum from field testing: (a) and (b) for good (intact) condition, (c) and (d) for fair condition, (e) and (f) for poor condition, (g) and (h) for serious condition [20].

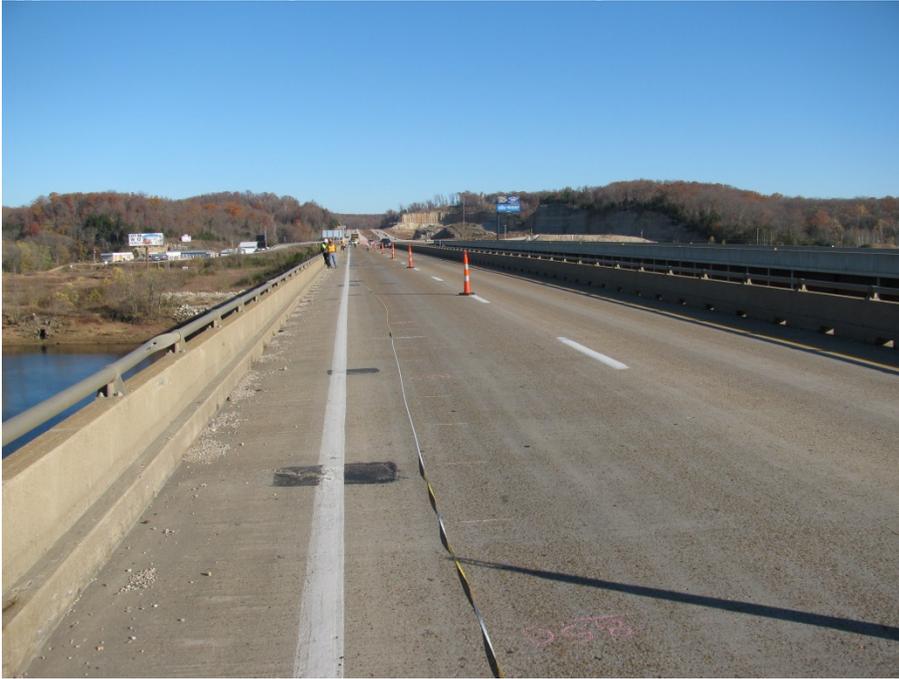
Figure 10: The Appearance of the Concrete Bridge A1479.

The concrete bridge A1479 is located on the state highway US 54 W over Osage River. The bridge was constructed in 1966 with the total lengths of 869.1 ft with the deck width of 34.5 ft. The bridge deck is composed of six concrete spans with two lanes. The appearance of the bridge has been shown in Figure 10.

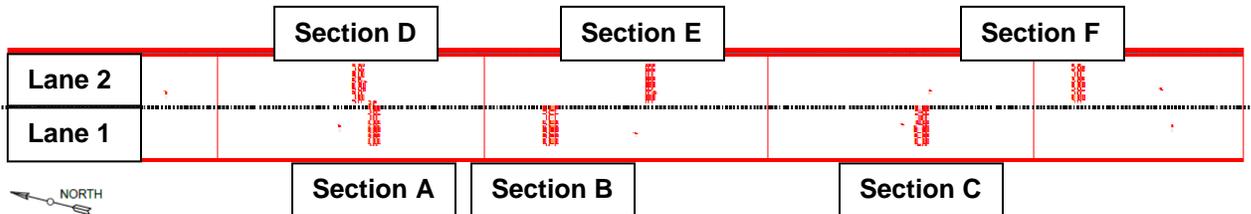
Six PSPA test grid areas (10 × 4 ft) with 2 × 2 ft grid spacing have been selected to conduct PSPA field tests on the bridge deck of A1479 has been shown in Figure 11. One of the PSPA test results, section D compared with Lidar and GPR test results will be presented in the following sections.

Figure 11: The Selected PSPA Tests Area for the Bridge A1479.

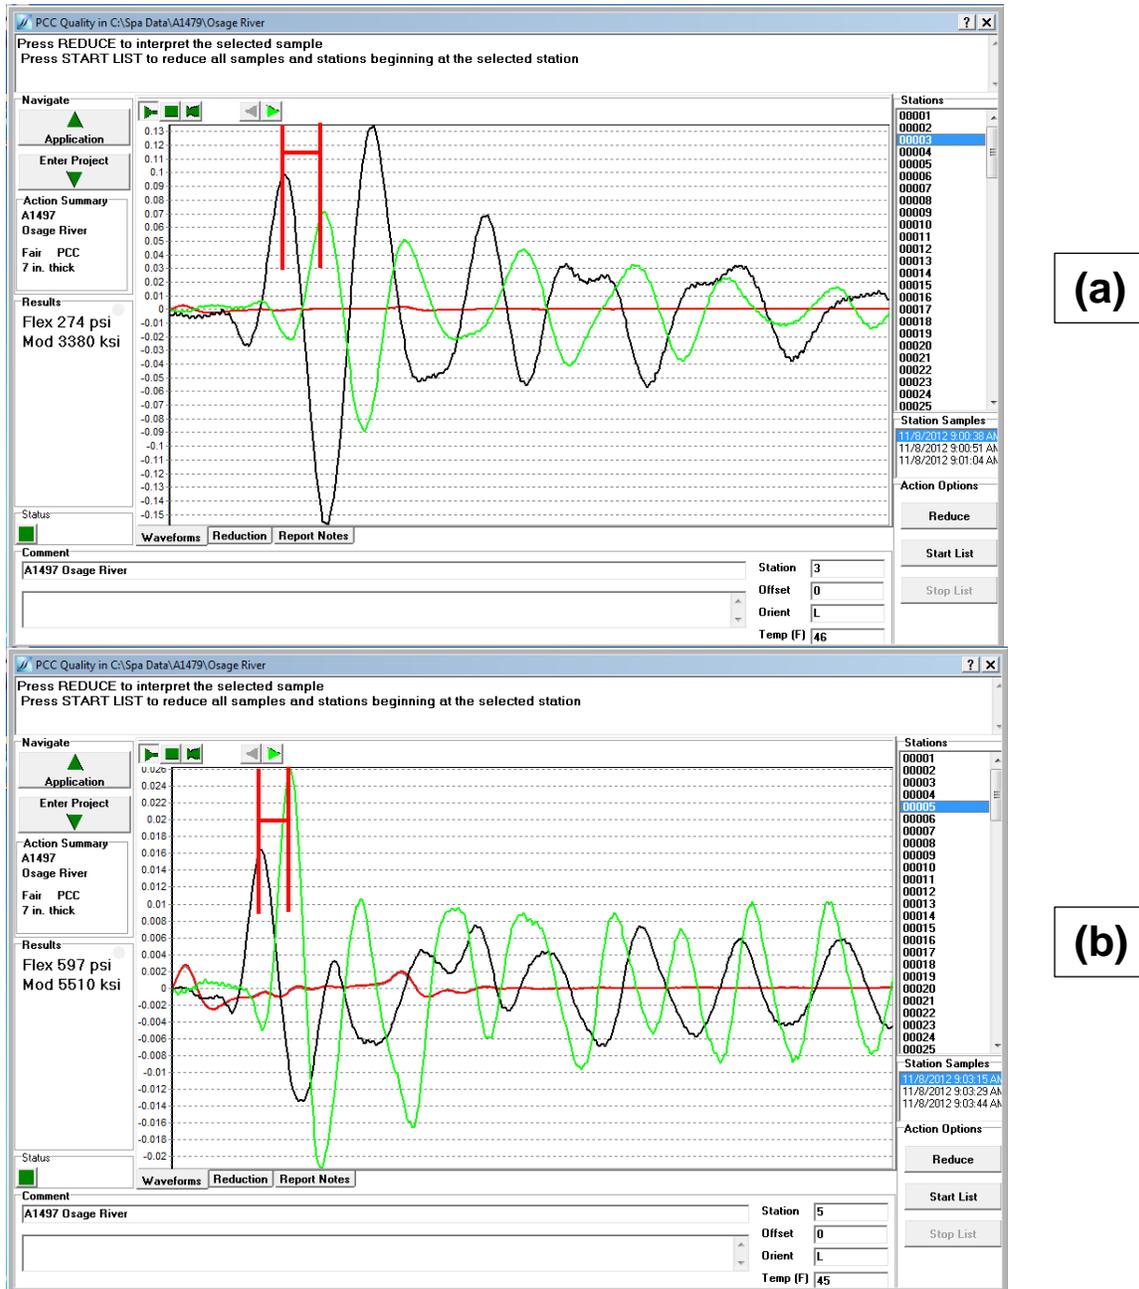
The contrast typical time records of PSPA data between delaminated concrete (a) and intact concrete (b) has been shown in Figure 12.

Figure 12: The Time Records (waveform) of Delaminated Concrete (a) and Intact Concrete (b)

For the delaminated concrete, the time difference (the distance between two vertical red lines) between two surface wave peaks is obviously wider than the intact concrete. Thus, the propagation of surface wave velocity in delaminated concrete will be much slower comparing with the intact concrete. And the elastic modulus of delaminated concrete will be much lower than intact concrete.

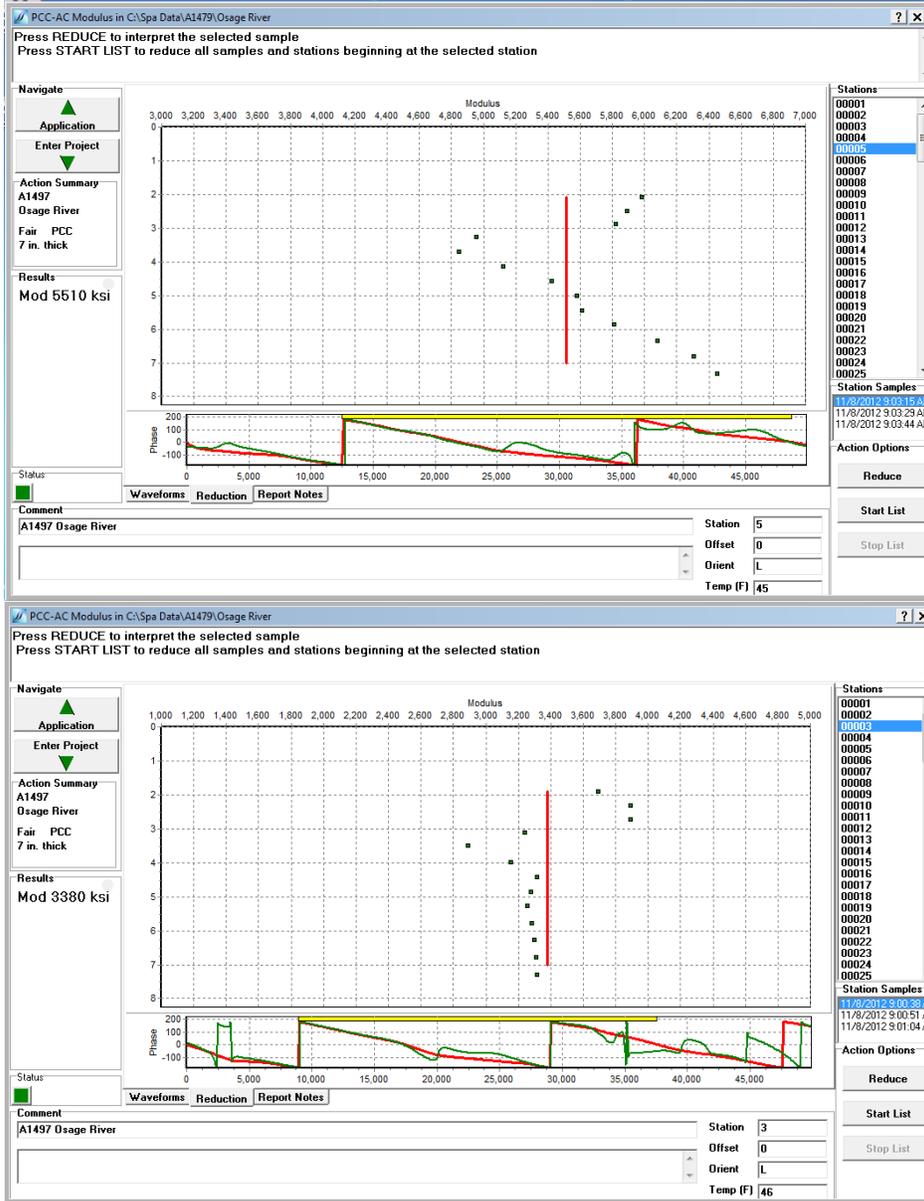
The typical dispersive curves contrast between intact concrete (c) and delaminated concrete has been shown in Figure 13. The average elastic modulus (the vertical red line) of delaminated concrete is significant lower compared with the intact concrete.

Figure 13: The Dispersion Curves of Intact Concrete (c) and Delaminated Concrete (d).

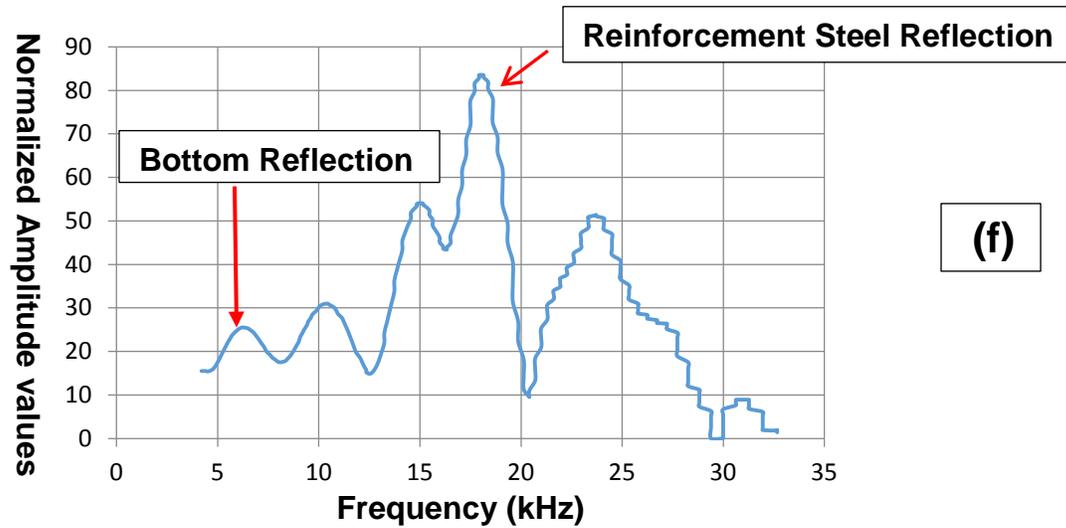
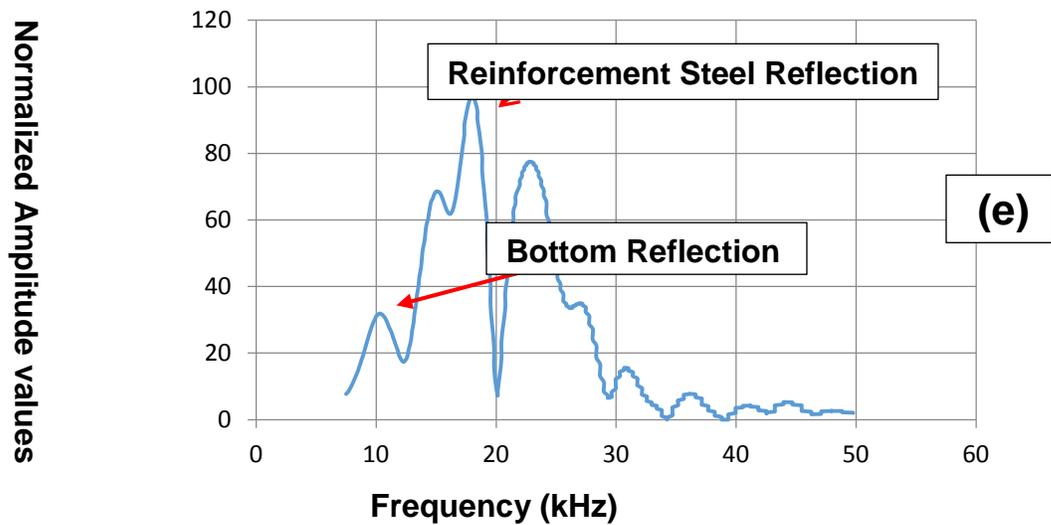
Figure 14 shown the typical frequency spectrum contrast between intact concrete (e) and delaminated concrete (f). The influence of reinforcement steel to impact echo data interpretation is significant. Furthermore, the frequency spectrum difference between delaminated and intact concrete can be observed from several aspects: First of all, the bottom reflection frequency of delaminated concrete is much lower than intact concrete. Second, the frequency distribution range for delaminated concrete (5-33 kHz) is also much lower than intact concrete (10-50 kHz). Last, the shape of frequency distribution for delaminated concrete is wider than intact concrete.

Figure 14: The Frequency Spectrum of Intact Concrete (e) and Delaminated Concrete (f).

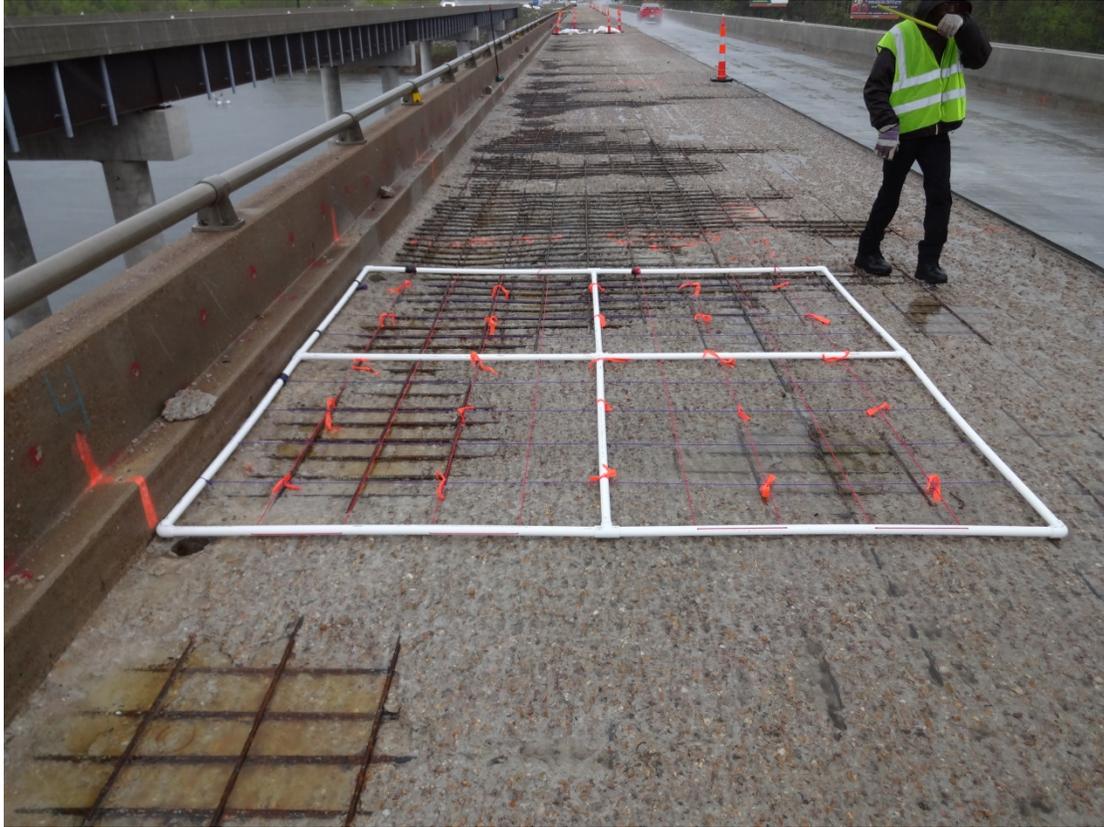
The hydro-demolition test (Figure 15) and ground penetrate radar scan has been carried out for the entire bridge in order to verify the PSPA test results. Furthermore, the Lidar scan has been conducted with hydro-demolition test for the entire bridge in order to map the depth difference between the intact concrete and delaminated concrete.

Figure 15: The Bridge Deck Surface after Conducted Hydro-demolition Test.

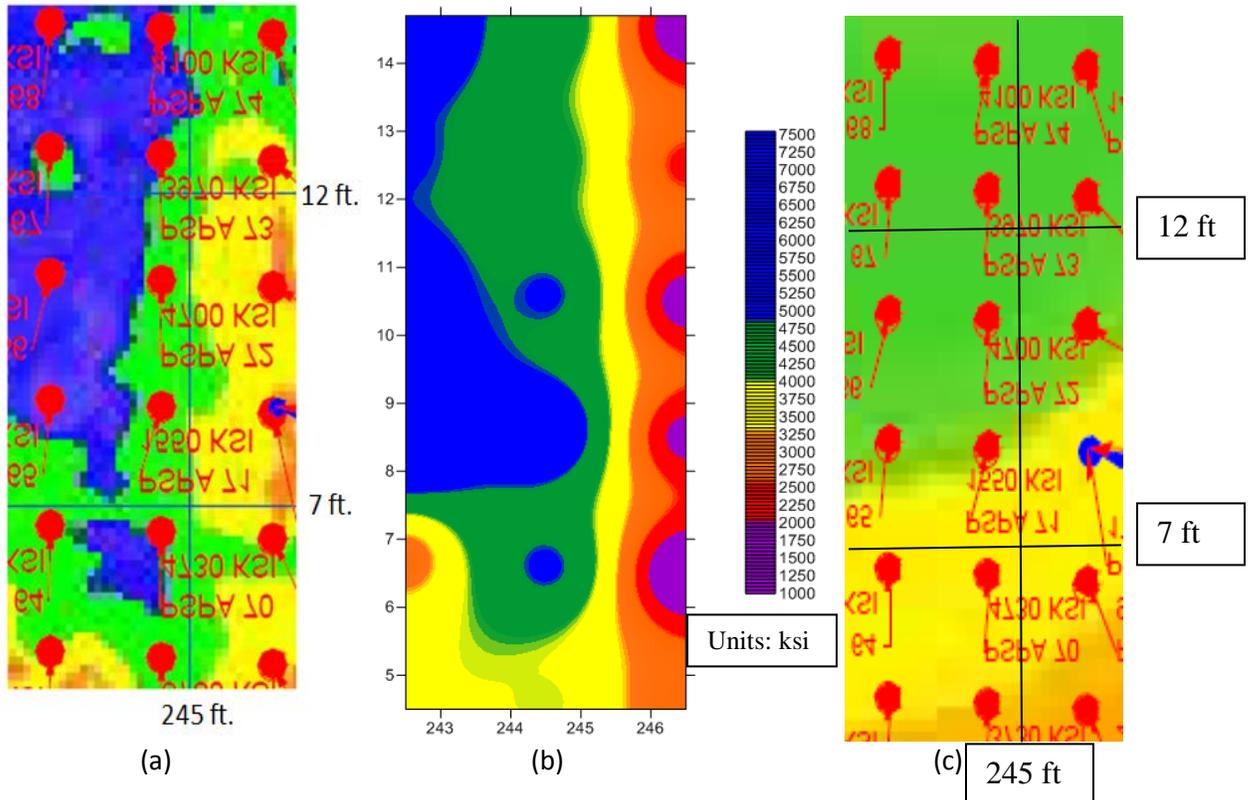
2D contour map of average elastic modulus distribution for each PSPA test sections has been generated in order to obtain a better understanding of deterioration conditions for the entire bridge deck. One of the modulus contour map (section D) compared with Lidar and GPR test results has been demonstrated in Figure 16. For Lidar data map, the deterioration condition of the bridge deck represented by the different colors (a). The blue color represented the good condition and the orange with green color represented the severe and poor condition. Furthermore, the red spots in the map represented each PSPA point test locations in the field. For PSPA data map, the deterioration condition of the bridge deck represented by different modulus range. Low elastic modulus range with purple color represented the severe condition, and the high elastic modulus range with blue color represented the good condition. For GPR map, the green color area represented the moderate deterioration condition, and the yellow or orange area represented the poor condition. The deterioration area shown in the elastic modulus map correlated very well with the Lidar results. Thus, the accuracy of USW method for bridge deck assessment has been demonstrated.

Figure 16: The Comparison Data Results of Test Section D among Lidar Data (a), PSPA Data (b) and GPR Data (c).

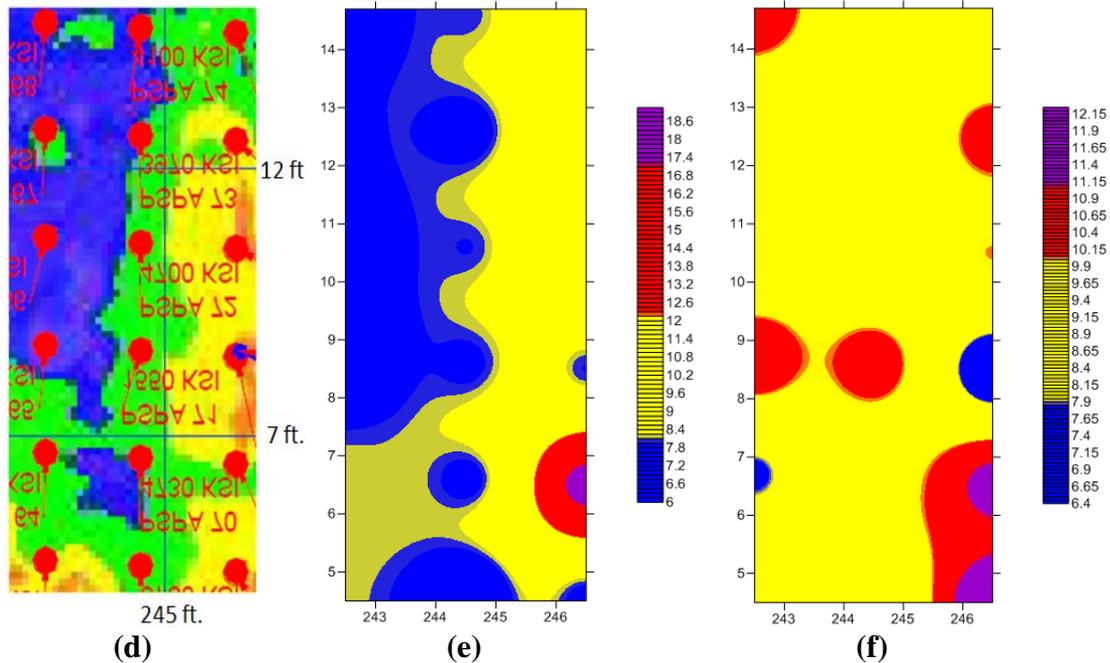
The first frequency peak on the frequency spectrum has been identified as the reflection frequency from the bottom of the bridge deck. For delaminated concrete, the deck thickness will much thicker than intact concrete and out of normal range of the deck thickness based on the previous calculation equations. 2D bridge deck thickness reflection map compared with Lidar test results has been shown in Figure 17. Based on the principles of PSPA, the P-wave velocity estimated from the surface wave velocity, thus, the P-wave velocity in the delaminated concrete will much slower than intact concrete. The test results of 2D deck thickness map (f) based on the PSPA principle has been demonstrated is not accurate compared with Lidar test results. Several reasons can be explained for the inaccurate test results. First of all, the propagation direction of P-wave (vertical) and Surface wave (horizontal) in the concrete slab is different. Second, the indirect calculation procedures based on previous equations will cause the overestimate P-wave velocity results. Thus, the uniform P-wave velocity (3800m/s) instead of current P-wave velocity has been used for the calculation of deck thickness based on the bottom reflection frequency values obtained from impact-echo data. The new 2D reflection map (e) has been demonstrated more accurate and effective than automatic PSPA test results compared with the Lidar test results.

Figure 17: The Comparison Test Results between Lidar Data (d), Impact Echo Data (Manual) and Impact Echo Data (Automatic).

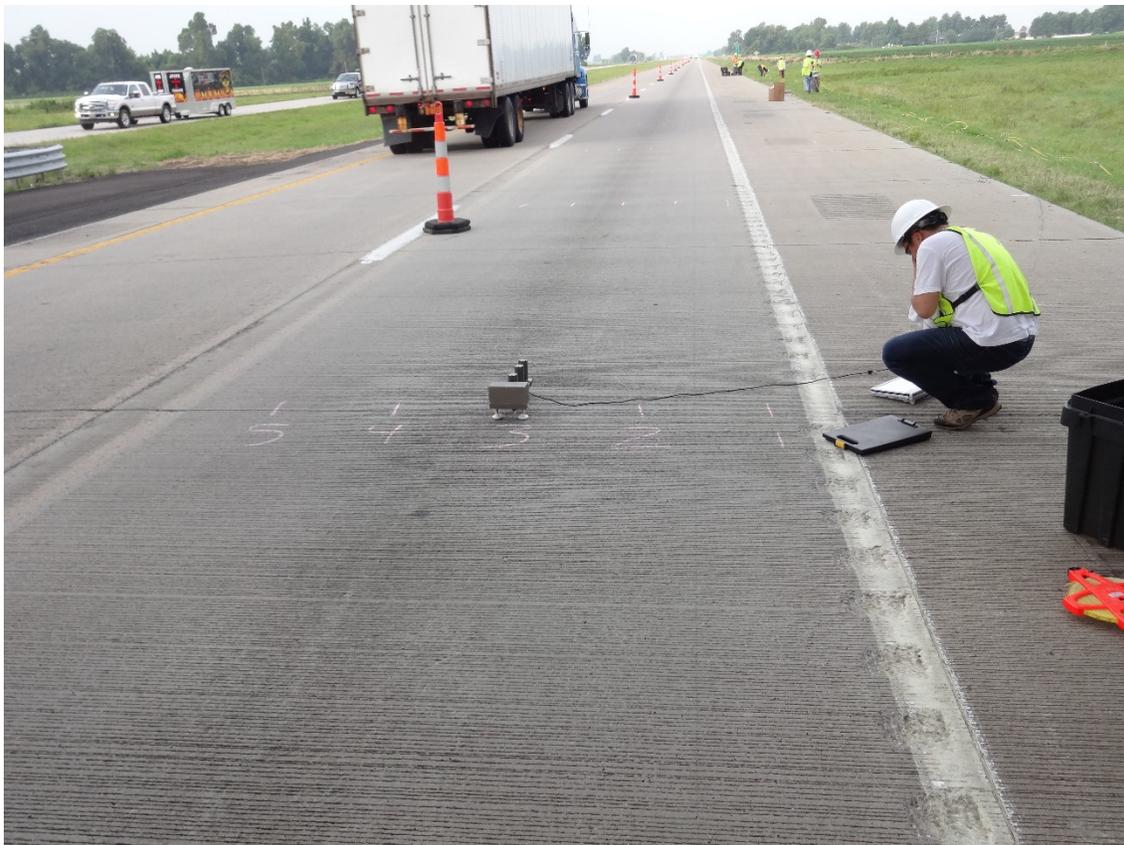
Figure 18: The PSPA In-situ Testing on Pavement Section 05.

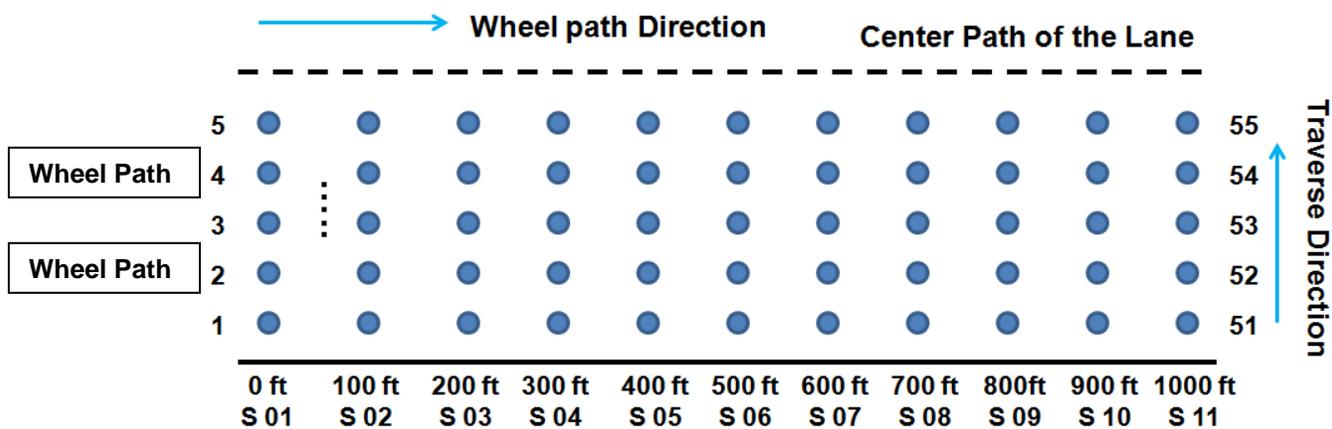
Figure 19: The Sketch of PSPA Data Acquisition in the Field (S 01 = Section 01).

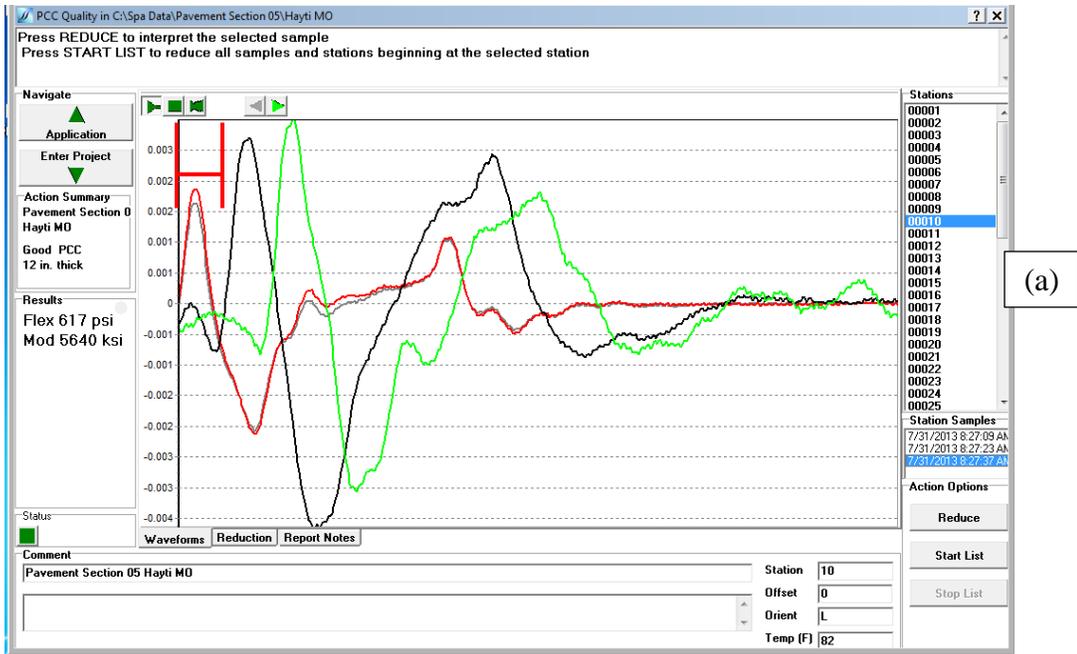
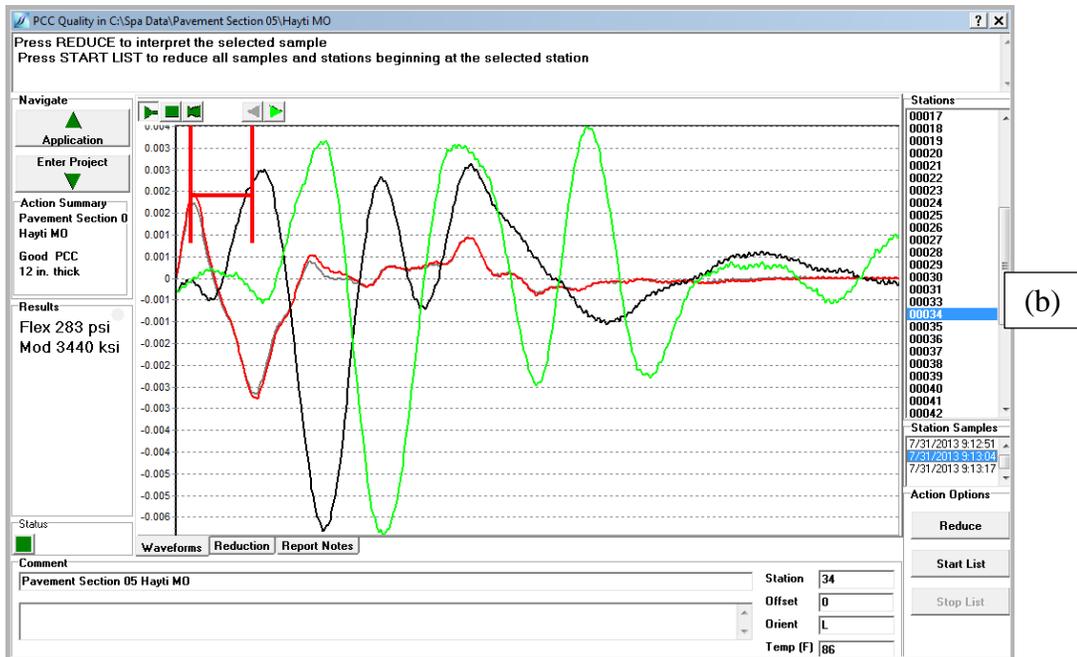
The typical time records (waveform) for intact concrete layers (a) and debonded concrete layers (b) has been shown in Figure 20. The time difference (Distance between two red vertical lines) of debonded concrete is obviously wider than intact concrete. In addition, the irregularity time records of the impact source (red line) generated due to the groove structure of testing concrete surface.

Figure 20: The Typical Time Records of Intact (a) and Debonded (b) Concrete Layers.

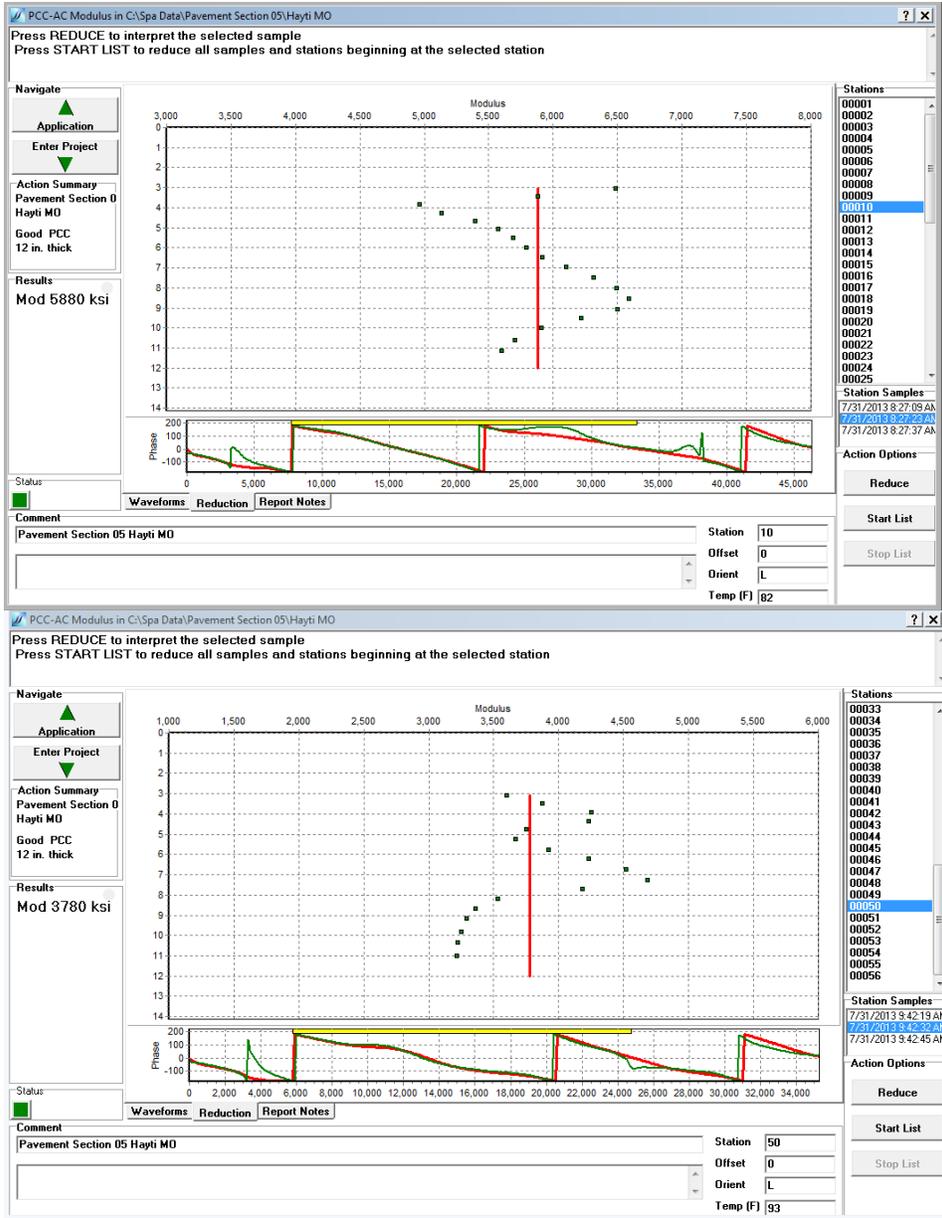
Typical dispersion curves for intact concrete layers (c) and debonded concrete layers (d) has been shown in Figure 21. The average elastic modulus of deboned concrete is much lower than intact concrete.

Figure 21: The Typical Dispersive Curves of Intact (c) and Debonded (d) Concrete Layers.

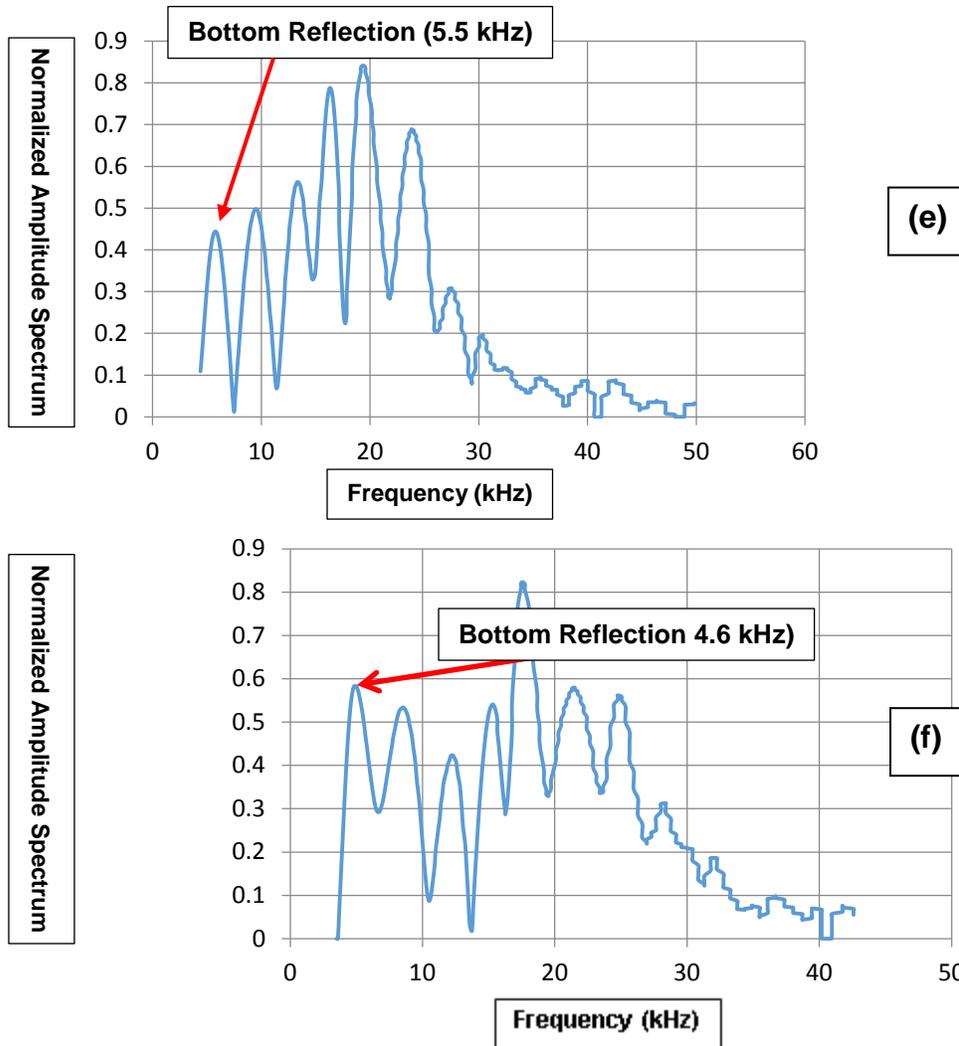
Typical frequency spectrums of intact (e) and debonded (f) concrete layers have been shown in Figure 22. The complex reflection singles obtained from concrete pavement section 05. However, the frequency range (3-40 kHz) of deboned concrete is relatively lower than intact concrete (5-50 kHz).

Figure 22: Typical Frequency Spectrum of Intact (e) and Debonded (f) Concrete Layers.
