Testing and Assessment of Portable Seismic Property Analyzer

**NUTC
R297**

**Neil Anderson
Mengxing Li
Missouri Science & Technology**

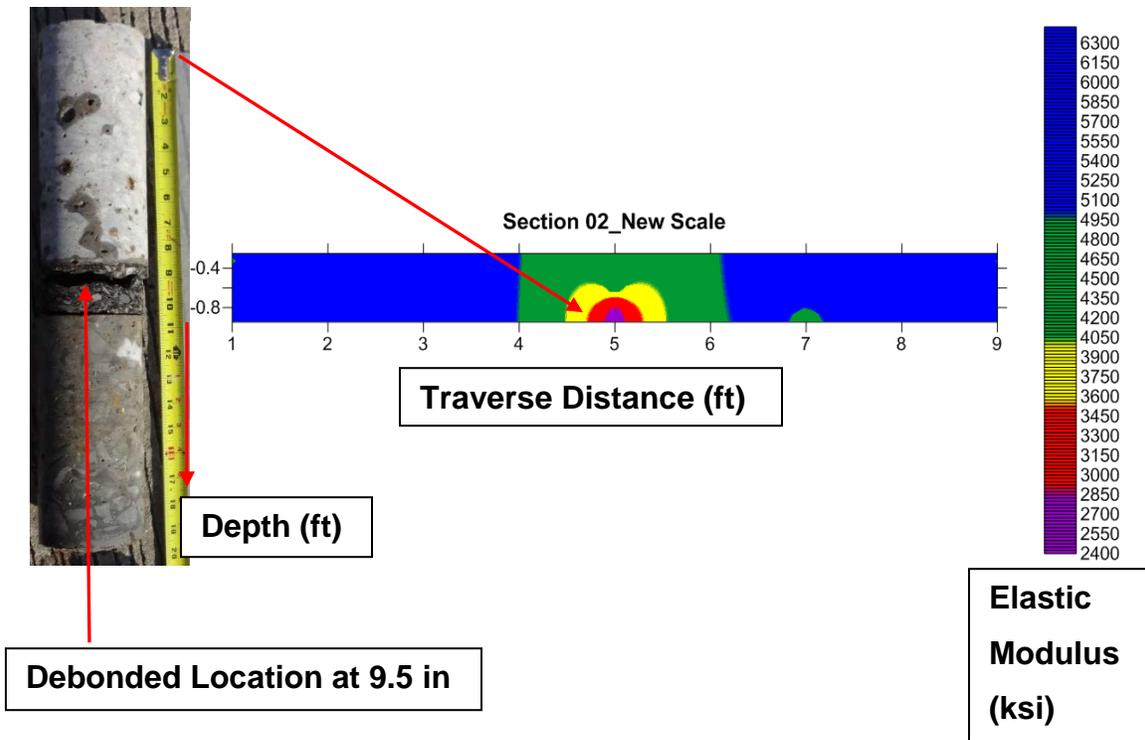
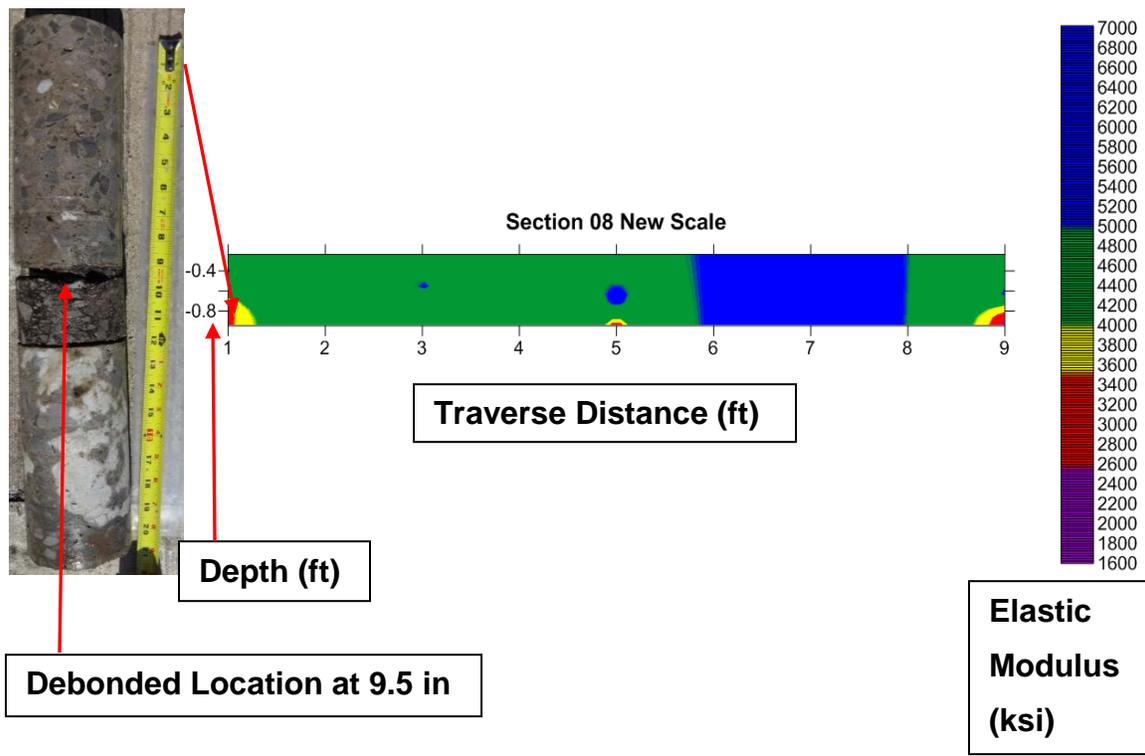
The 2D elastic modulus contour map for each sections has been generated in order to obtain a better understanding of elastic modulus variation with the depths. The test results of section 02 & 08 has been shown in Figure 23. Two test coring have been retrieved from section 02 & 08, both of them deboned from bottom of the first concrete layers, which are matched very well with the PSPA test results.

Figure 23: The 2D Elastic Modulus Contour Map Verified by the Coring Control.

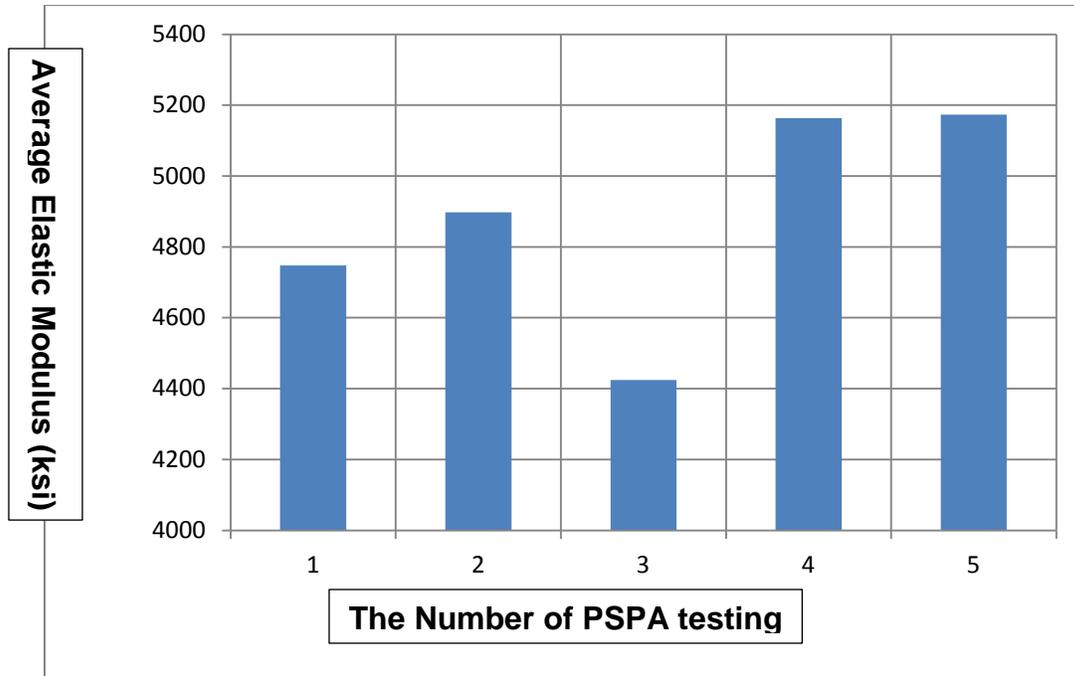
A statistical analysis of PSPA data for pavement section 05 has been established in order to evaluate the condition of entire pavement sections. The results shown in Figure 24 demonstrated that the lowest average elastic modulus obtained in the middle of the lane.

Figure 24: Statistical Analysis Results of PSPA Data.
