# CENTER FOR TRANSPORTATION INFRASTRUCTURE AND SAFETY

## **Long-term Behavior of GFRP Reinforced Panels after Eight Years of Field Exposure**

**NUTC  
R352**

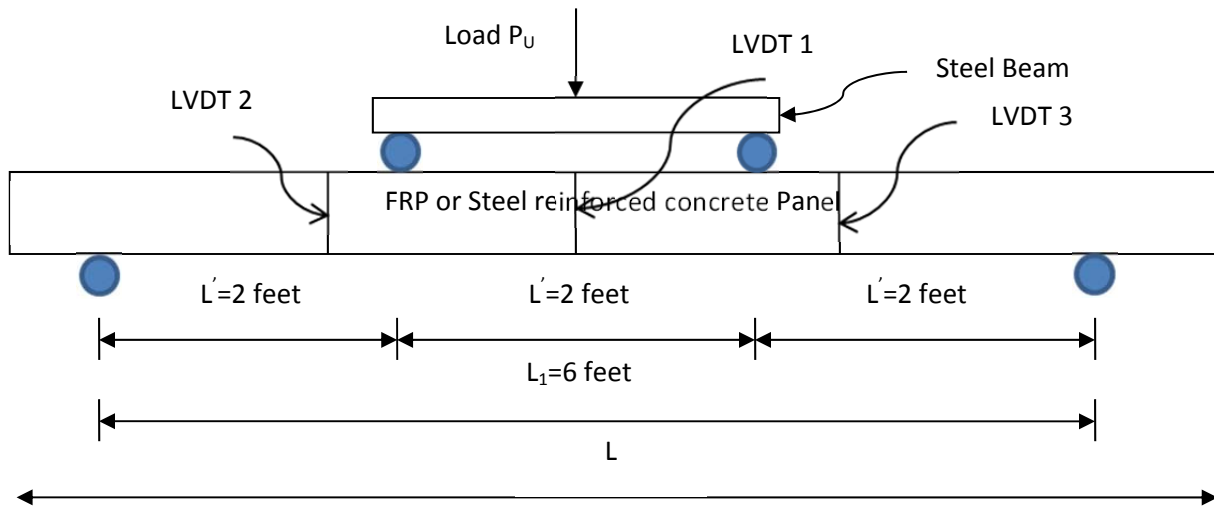
**Figure 1:** Profile of Four-point Load Testing for P-1 Through P-6

In the Branham and Myers study [1], six concrete panels were fabricated, each with a different value of reinforcement ratio. The first specimen (Panel P-1) was reinforced with Grade 40 steel reinforcement with a tested tensile yield strength of 50.02 ksi (344.9 MPa) and ultimate tensile capacity of 75.34 ksi (519.5 MPa). The latter five specimens (Panels P-2 through P-6) were reinforced with GFRP reinforcement with an ultimate tensile capacity of 110 ksi (758.4 MPa) as reported by the manufacturer. The panels were fabricated at a 30 feet (9.14 m) span length consisting of four spans of 7.5 feet (2.286 m) and a depth of 5 in. (127 mm). Interior supports consisted of a roller support while each end of the panel had a fixed support. Table 1 shows the panels ID with reinforcement and panels' size details. All panels were cast outside and left exposed to the ambient environment. For this forensic study, an uncracked section of each panel was dissected after seven years of field exposure for load testing and further analysis. There were no visible cracks on the surfaces of these smaller panel sections. These six simply supported rectangular panels were tested in four-point bending to evaluate the behavior of steel or GFRP-reinforced panels. The flexural load test (Four-Point Load Bending Testing) was conducted to evaluate the residual strength of each panel section. Three linear variable displacement transducers (LVDTs) were used to monitor the mid-span deflection and side-span deflections (the displacement capacity of mid-span LVDT is  $\pm 2$  in. (50.8 mm) and side-span LVDTs displacement range is  $\pm 1$  in. (25.4 mm)). Figure 1 shows a schematic profile of this testing and the locations of the LVDTs. An HP-55 hand pump was used to apply load to the loading points. The panel specimens were tested in four-point bending over a 6 feet (1.83 m) span length. Steel plates, 6 in. (152 mm) wide, were positioned at the supports to distribute the loads and to avoid

local crushing of concrete. One 2 in. (50.8 mm) diameter steel bar which was welded on a thicker steel plate (5 in. (127 mm) wide, 3 feet (914 mm) long, and 0.75 in. (19 mm) thick) was used to serve as a roller support.

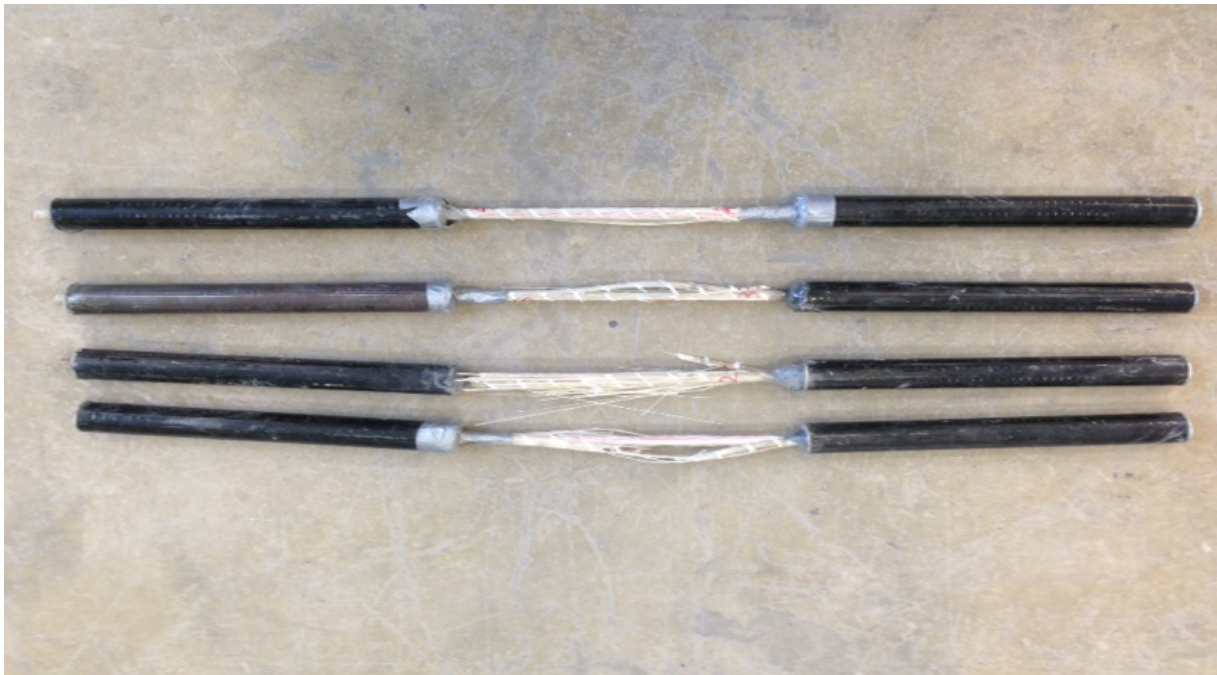
**Figure 3:** Post Test: Fractured GFRP bar specimens

longitudinal tensile properties, prepared in accordance to ASTM D7205/D7205M -06 (Reapproved 11), were tested using a Tinius Olsen L240 machine. The GFRP specimens used in this study were cut to a length of 39 in. (991 mm) and grouted with a resin mixture (EPON Resin 828 and EPIKURE 3140 Curing Agent, 1:1 by weight) inside 12 in. (305 mm) long threaded steel tubes at both ends, as shown in Figure 2. The peak loads, the ultimate tensile stresses and Modulus of Elasticity were recorded using a data acquisition system. The tested properties of extracted bars from autopsied panels are summarized in Table 5. The utmost care was taken to extract the bars without inducing any damage. A picture of the failed specimens is shown in Figure 3 and SEM image in Figure 22. The experimental data of GFRP were used to calculate the ultimate loads of these panels in this report. It may be noted that the tested bar properties, on average, were 80.6 percent of the manufacturer reported properties in Table 4. No experimental tensile test was undertaken on the GFRP bars at the time of construction on a virgin GFRP bar to benchmark the base GFRP bar properties, but bars tested by the manufacturer indicated a tested tensile strength of 129 ksi (892 MPa) on bars in 2002 at the same general period of lot production. It is unknown if these results were from the same lot, but do provide a general idea of tested bar properties at the time of manufacture. Because this study involved GFRP reinforced concrete panels at the secondary reinforcement level (i.e. low levels of reinforcement), the bars on panels 2-6 were subjected to sustained stress levels throughout the exposure conditioning due to the dead load weight of the panels. These generated maximum positive and negative moments as illustrated in Table 6. Table 6 also details the resulting sustained stress levels in the bars at critical moment locations due to the dead load self-weight and estimates a stress level of 15.1% of the autopsied tested  $f_{tu}$ . While this estimated sustained stress level is below the widely reported creep rupture level of many GFRP bars, this stress level does not include the seasonal

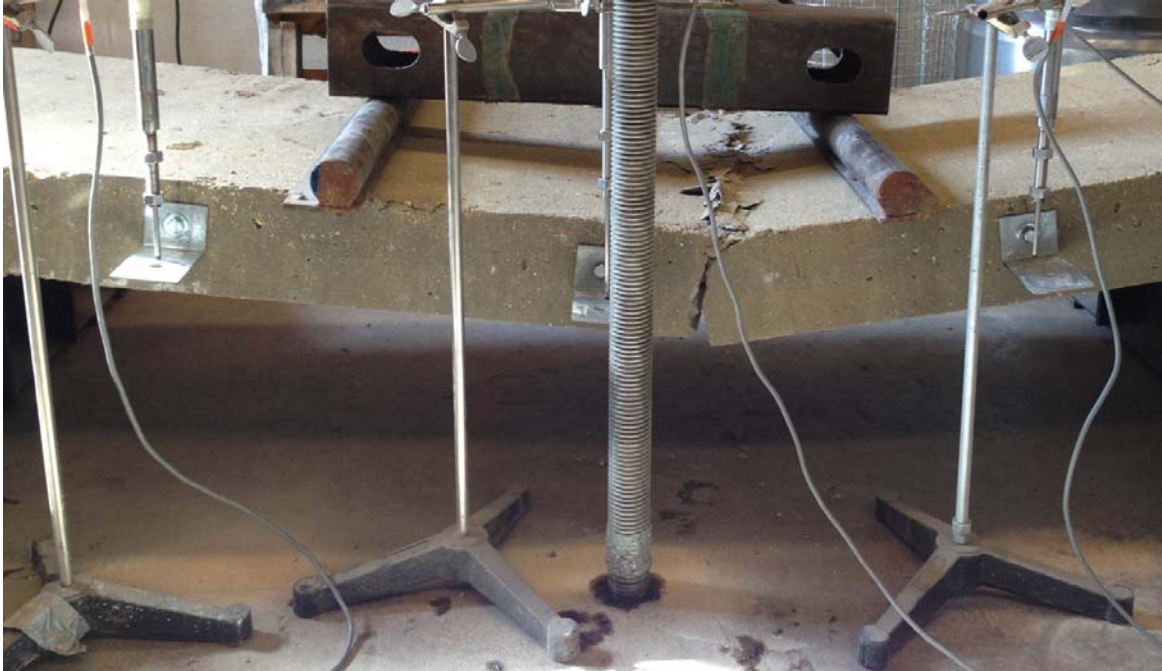
**Figure 4:** Image of Four-Point Load Testing for Panel P-1

In this flexural testing series, panel P-1, as shown in Figure 4, only exhibited one primary flexural crack on the surface until failure. For panel P-2, five primary flexural cracks developed on the tensile face occurring over the loading history of the panel. The widths of the first four

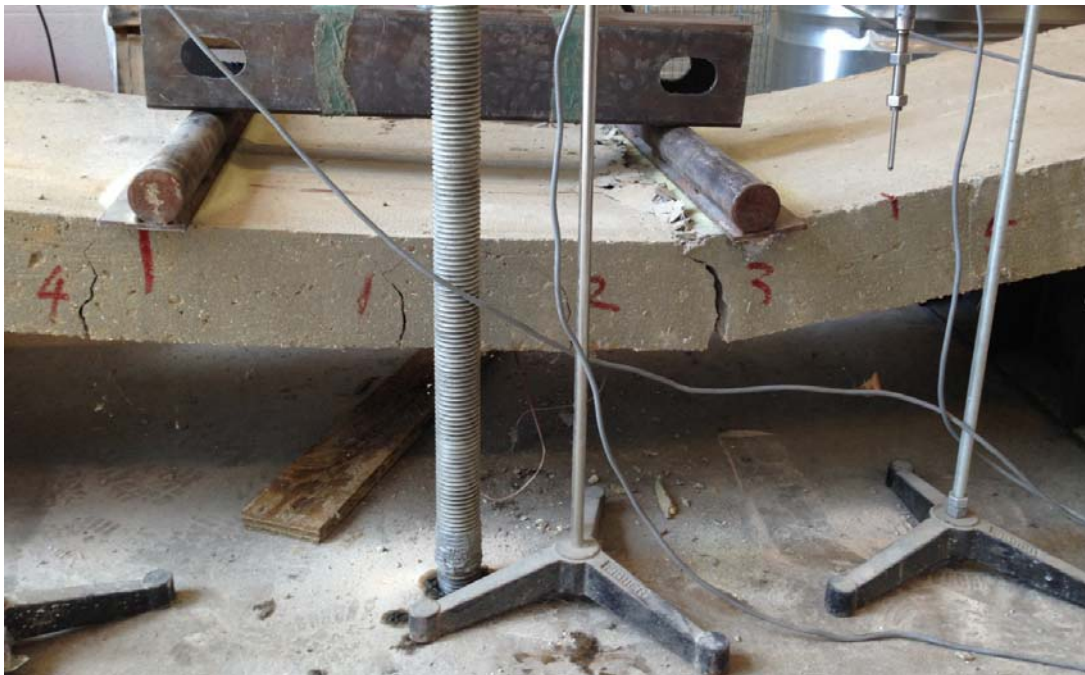
**Figure 5:** Image of Four-Point Load Testing for Panel P-2

cracks were observed to be larger than the width of the crack development for panel P-1. Panel P-2 exhibited the largest number of flexural crack development during load testing compared to the other GFRP panels, shown in Figure 5. Only one crack, as shown in Figure 6, appears on the surface of panel P-3 and it failed suddenly without any warning into two separate segments. From Figure 7, we can observe that two flexural cracks appeared on the surface of panel P-4 prior to ultimate failure. The first crack did not continue to extend vertically, but spread horizontally. Three flexural cracks appeared on the surface of panel P-5 throughout its loading history shown in Figure 8. This panel also failed suddenly without any warning and separated two segments. Two cracks, as shown in Figure 9, appeared on the surface of panel P-6. It failed suddenly and separated two segments. Table 7 summarizes the crack formation details, and failure mode. Table 8 details the peak load, and ultimate load at failure compared to the analytical load estimate based on the material properties previously discussed. The analytical model is discussed in greater detail below.

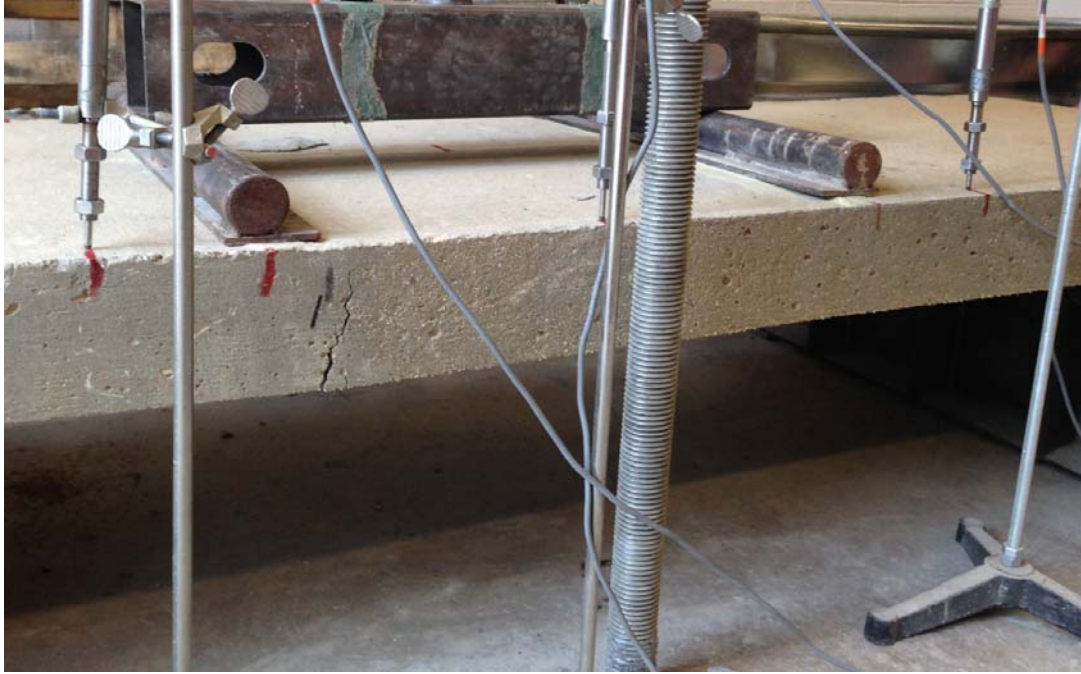
**Figure 6:** Image of Four-Point Load Testing for Panel P-3

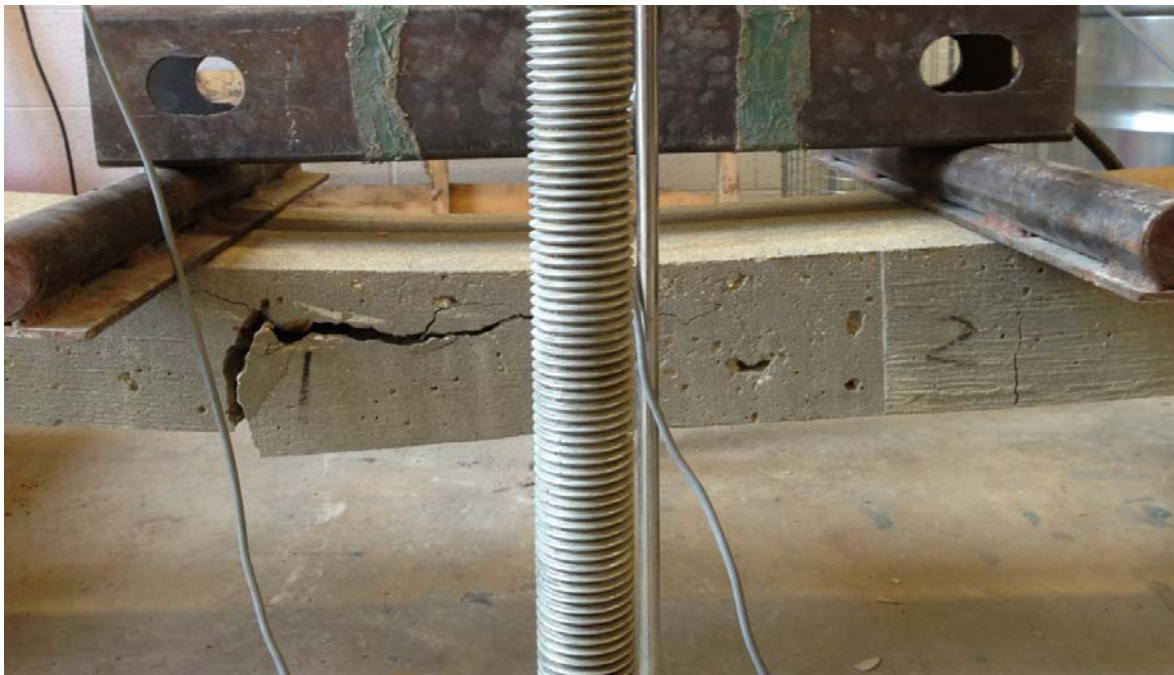
**Figure 7:** Image of Four-Point Load Testing for Panel P-4

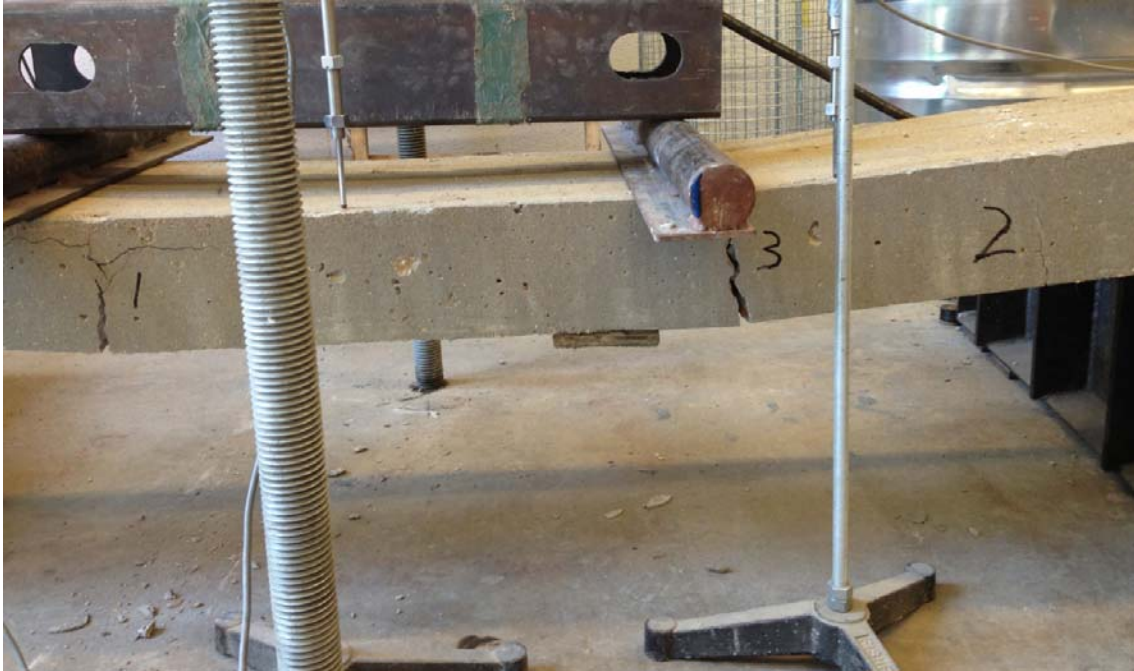
**Figure 8:** Image of Four-Point Load Testing for Panel P-5

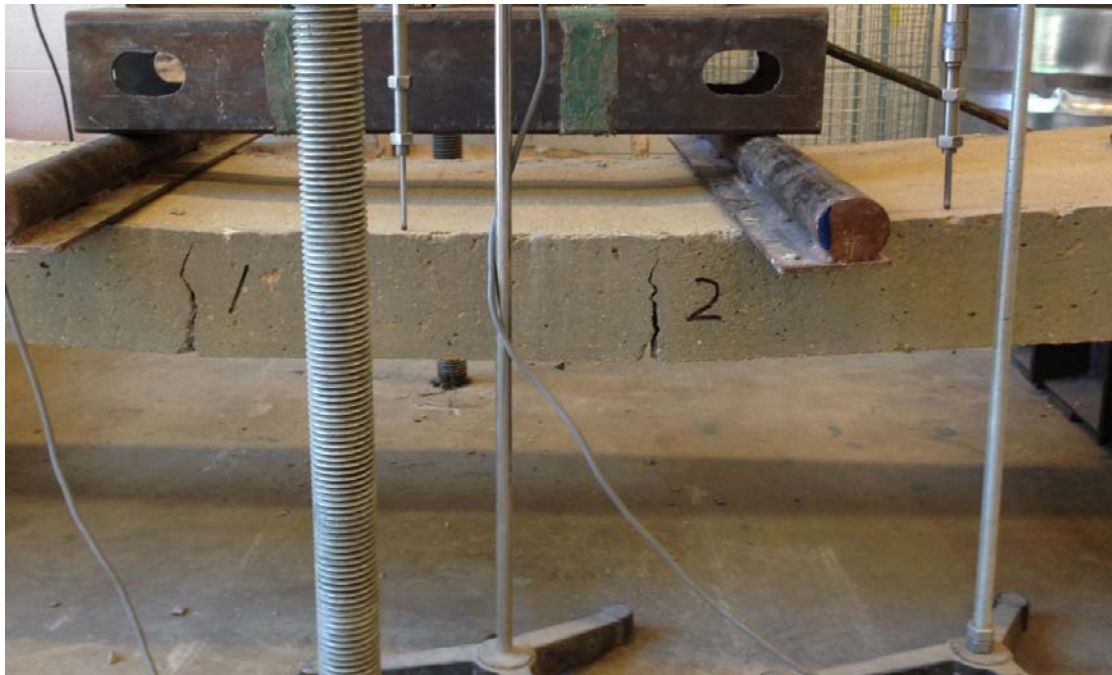
**Figure 9:** Image of Four-Point Load Testing for Panel P-6

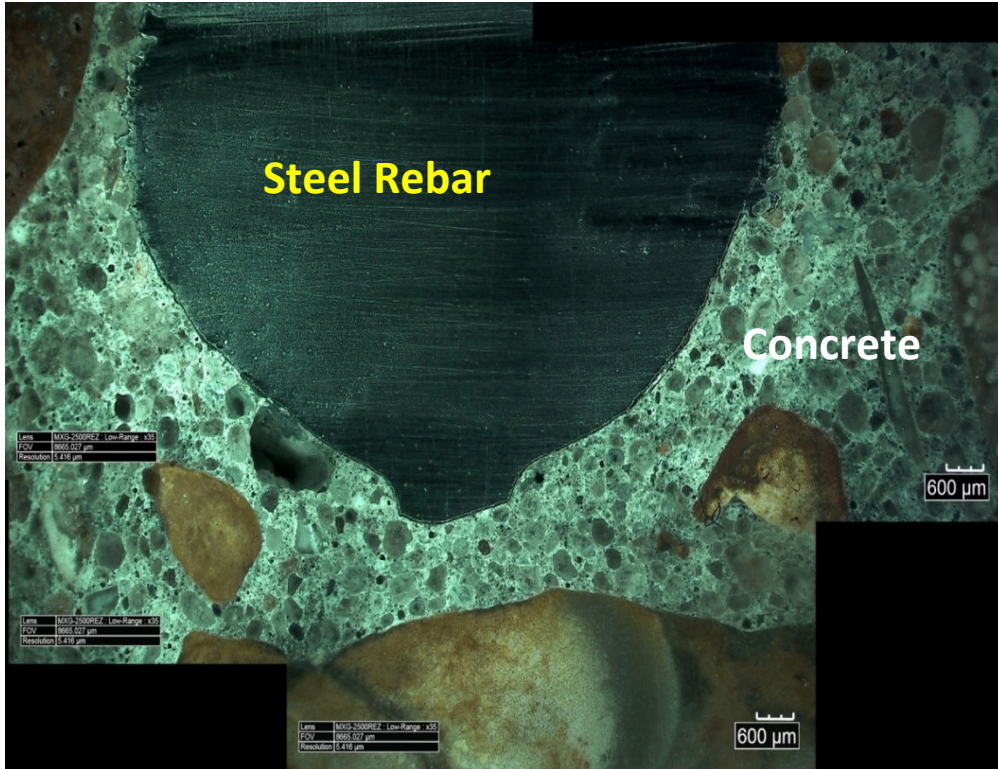
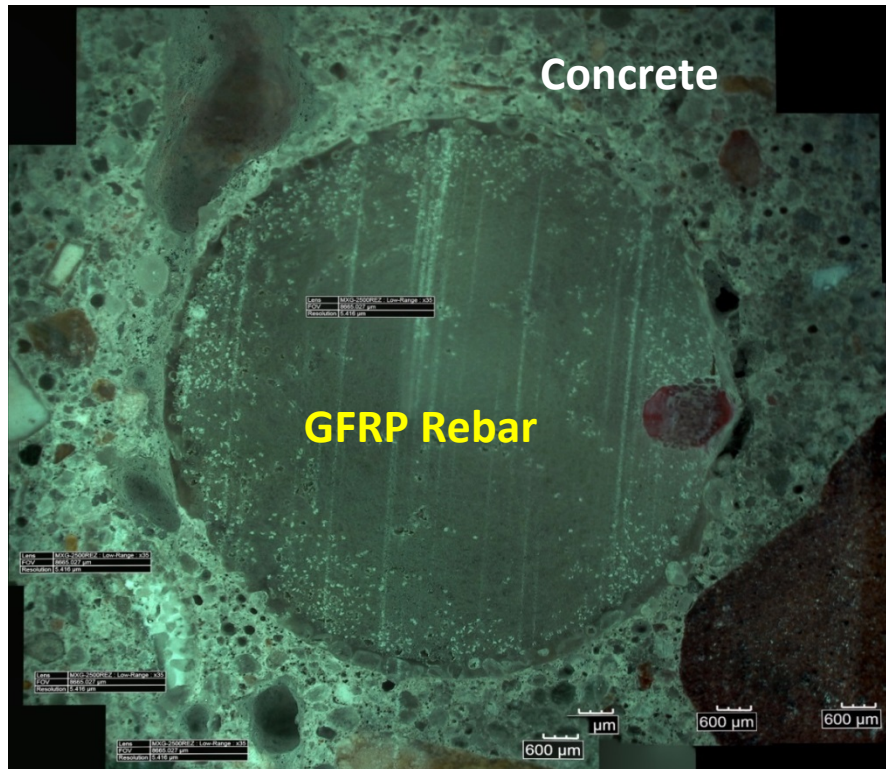
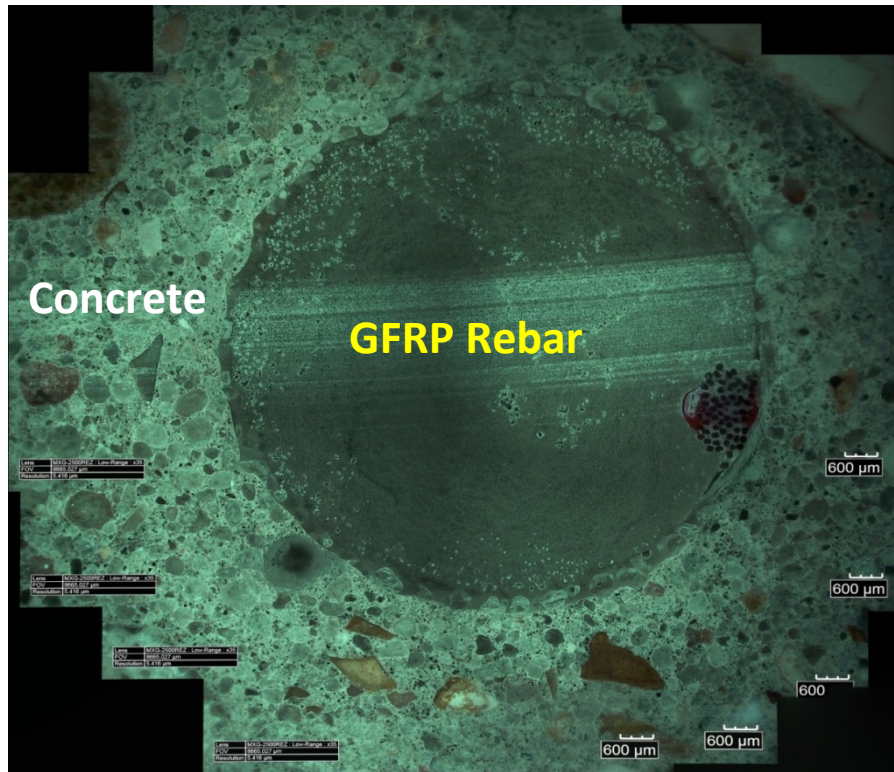
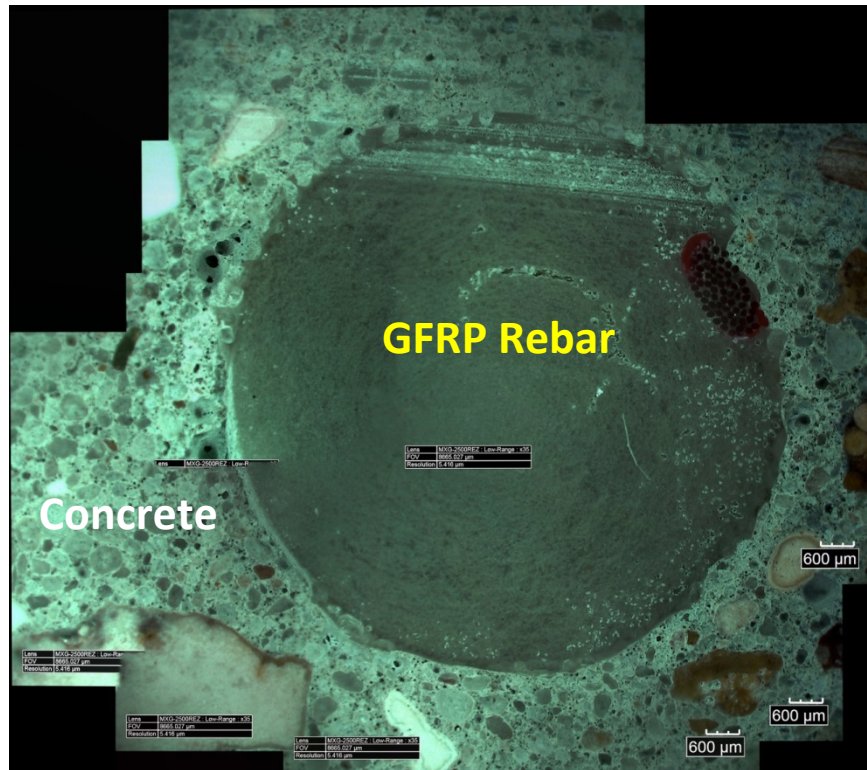
**Figure 10:** Microscopic image for sample from Panel P-1

**Figure 11:** Microscopic image for sample from Panel P-2

**Figure 12:** Microscopic image for sample from Panel P-3

**Figure 13:** Microscopic image for sample from Panel P-4

**Figure 14:** Microscopic image for sample from Panel P-5

**Figure 15:** Microscopic image for sample from Panel P-6

This part focuses on the observation of the concrete specimens with reinforcing rebars to investigate whether their surfaces have any deterioration or de-bonding between concrete and rebars. Figures 10 through 15 show images from samples taken from panels P-1 through P-6, respectively. The pour structure of the concrete including the air void network is visible in these images as well as the reinforcing bars themselves. From this optical imaging, there is no visible deterioration or de-bonding within the transition zones of concrete and reinforcing bars of these specimens after long-term exposure. Therefore, the investigators decided to use a Scanning Electron Microscope (SEM) to obtain a higher level of imaging.

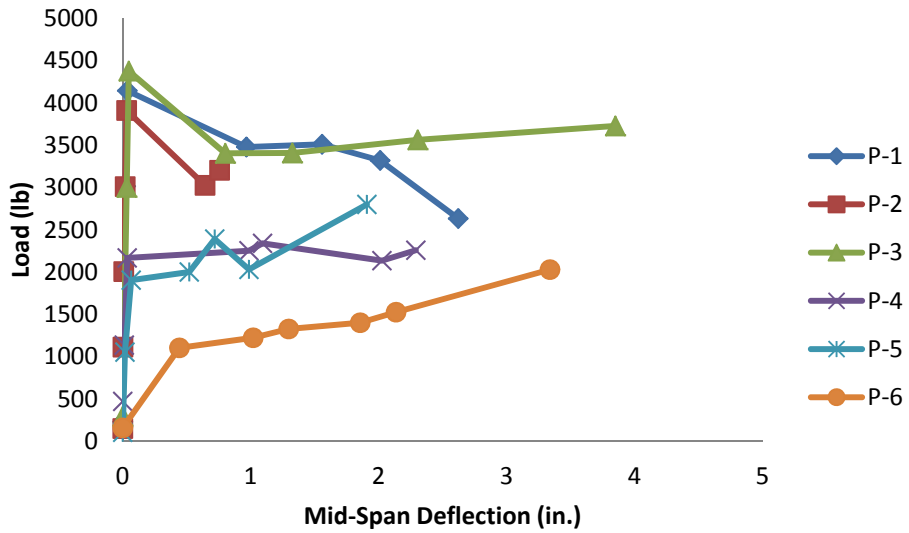
**Figure 24:** Mid-span load-deflection envelope response for Panel P-1 through P-6 (LVDT 1)

**Figure 25:** Third-point load-deflection envelope response for Panel P-1 through P-6 (LVDT 2)

Figure 24 and 25 exhibit the load-deflection envelopes along the member during loading. It may be observed that panels P-1, P-2, and P-3 supported the largest loads respectively during the flexural testing. Panels P-5 and P-6 exhibit the largest loads respectively at the end of the flexural test. These two FRP RC panels had the highest reinforcement ratio.
