**Preservation of Missouri
Transportation Infrastructures:
Validation of FRP Composite
Technology through Field Testing –
In-situ load testing of Bridges P-962,
T-530, X-495, X-596 and Y-298**

J.J. Myers, D. Holdener,
W. Merkle, and E. Hernandez

**UTC
R95**

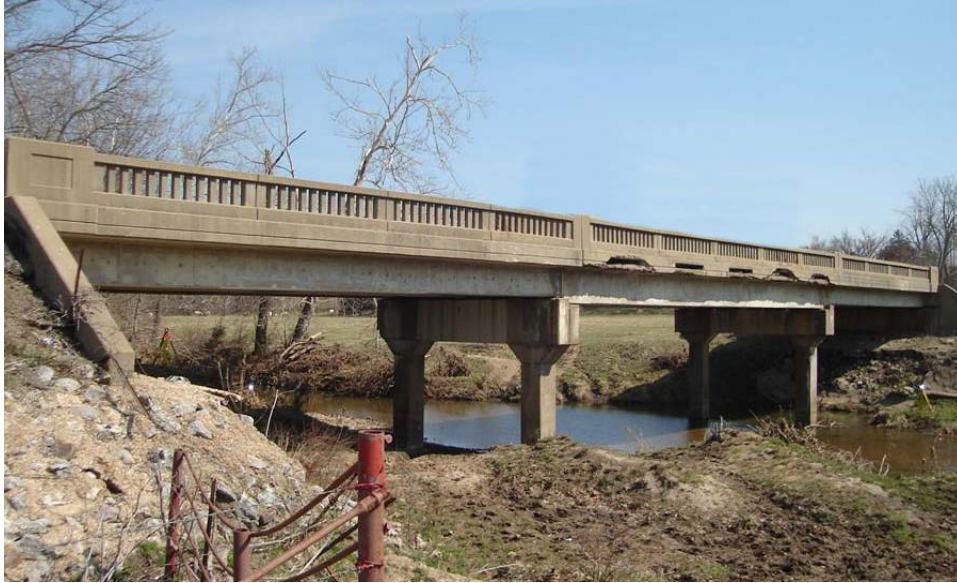
The condition of X-596 prior to strengthening was such that there were cracks in the exterior girders with exposed reinforcement. Figure 3.2 depicts the bridge and Figure 3.3 shows the condition of the superstructure. In addition, there were cracks at the connections between girders and the intermediate diaphragms and bents. The end bents were in overall good condition aside from rusty steel bearing plates.

Figure 3.2. Bridge X-596

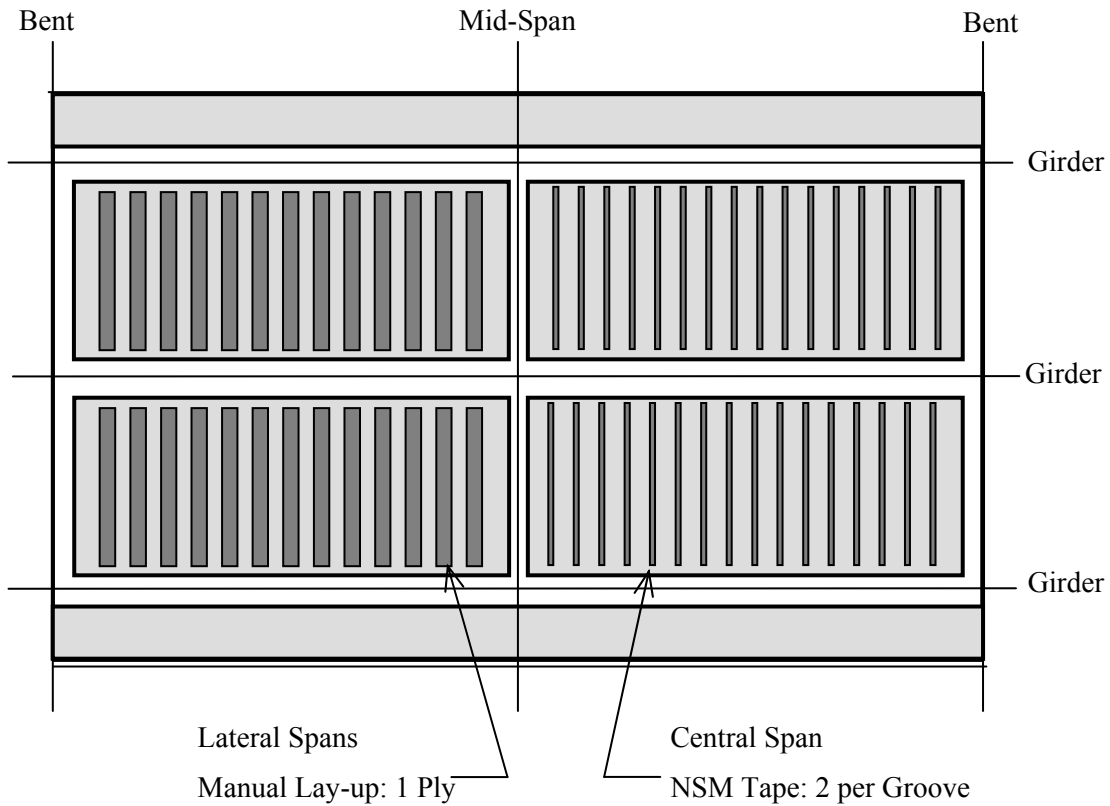
In order to install these composites, 116-ft³ (3.285m³) of deteriorating concrete was removed and the new surface was cleaned. The surface was then prepared for the placement of FRP via manual lay-up by rounding corners and roughening with sandblasting. The installation

details for Bridge X-596 are provided in Figures 3.4, 3.5 and 3.6. These strengthening details were typical for Bridges T-530, X-495 and P-962.

Figure 3.4. Bridge X-596 Plan View Strengthening Detail

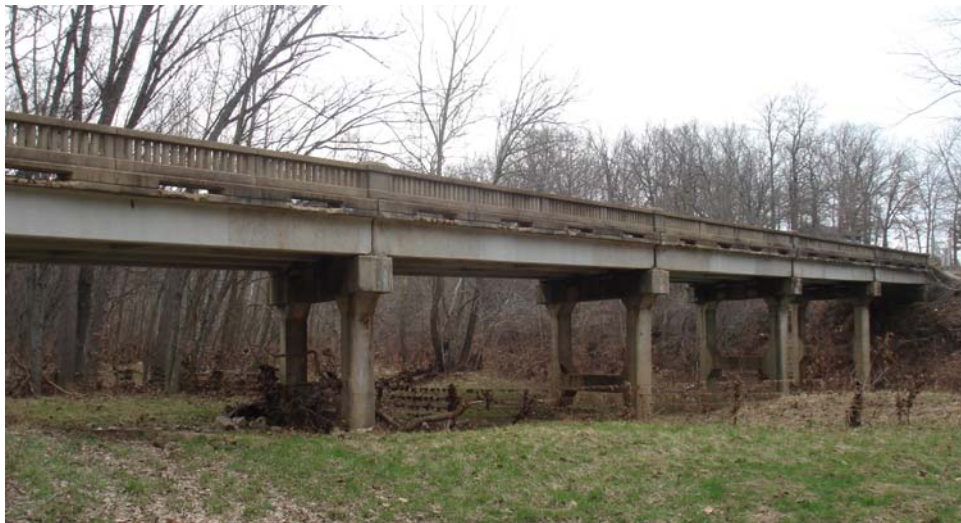
Bridge T-530 before strengthening is shown in Figures 3.7 and 3.8. Prior to strengthening, the concrete exhibited some spalling along the bridge edges. The concrete in the deck and beams was noted to be in good condition, with only minor cracks that required no injection. The piers and abutments were in good condition also, but the bents showed some deterioration due to steel corrosion.

Figure 3.7. Bridge T-530

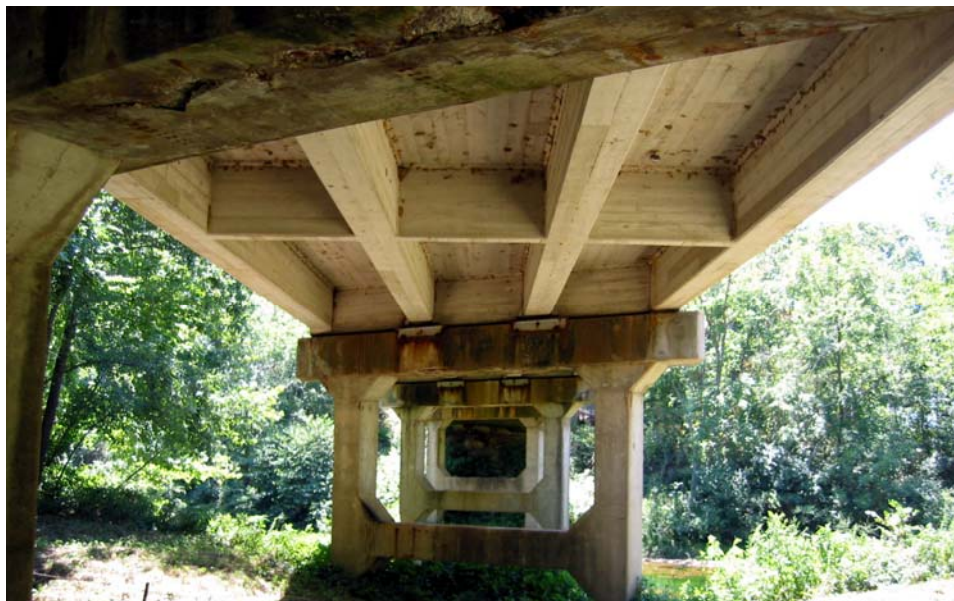
Figure 3.8. Bridge T-530 Substructure

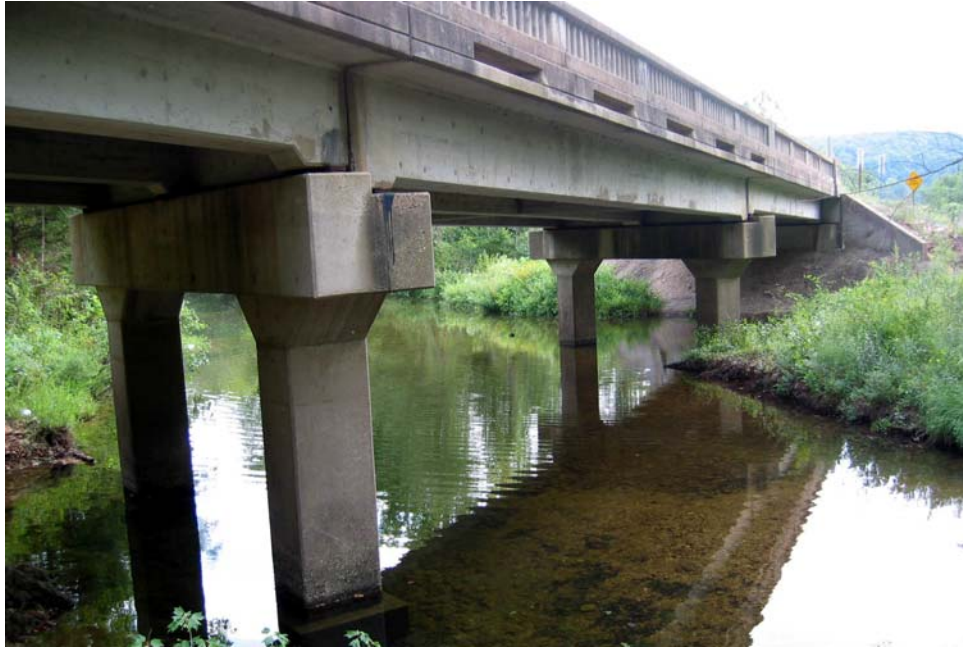
Prior to strengthening, the condition of the beams, abutments and piers were noted to be in good condition. Of the bridges tested in this project, bridge X-495 was in the best condition considering its overall age and average rating. See Figures 3.9 and 3.10 for visual details of the bridge prior to strengthening.

Figure 3.9. Bridge X-495

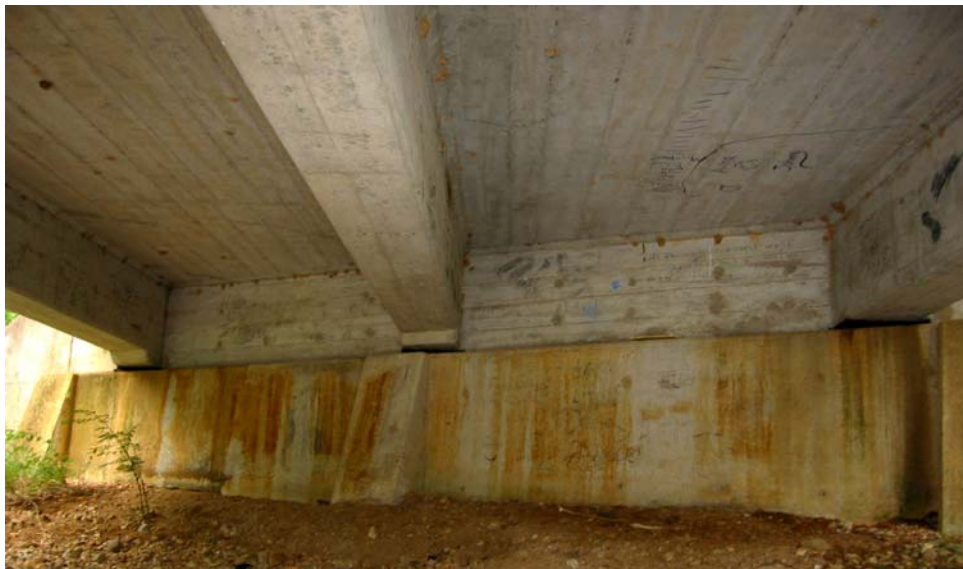
Figure 3.10. Bridge X-495 Substructure

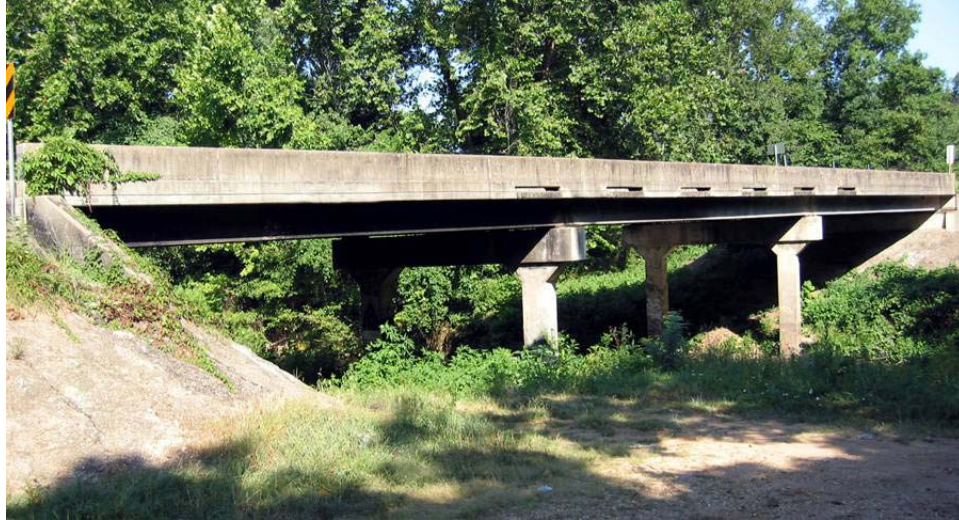
Prior to strengthening, the bridge beams and piers were noted to be in good condition; see Figures 3.11 and 3.12. The abutments were not in good condition and the deck required some repairs.

Figure 3.11. Bridge P-962

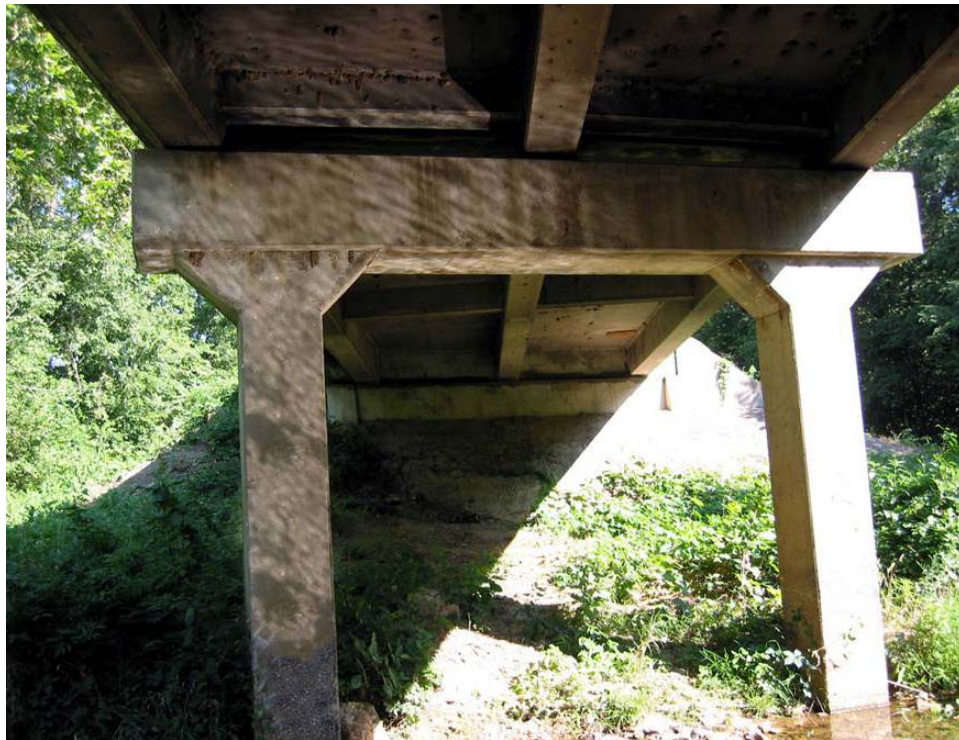
Figure 3.12. Bridge P-962 Substructure

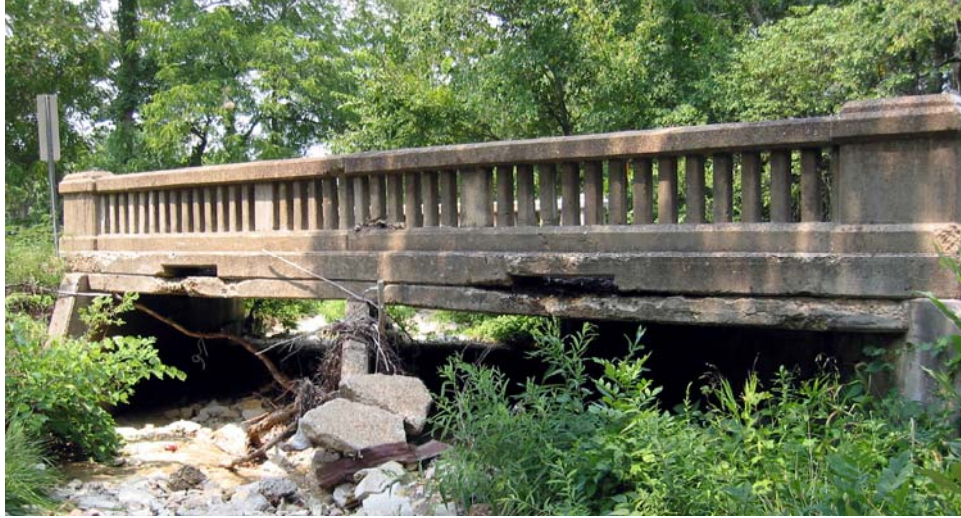
Prior to strengthening, it was noted that the east span was in poor condition due to poor drainage, especially close to the edge of the bridge. Also, upon visual inspection the east span showed permanent deflection. The west span concrete was sound, but, due to improper concrete cover, had some exposed reinforcement. See Figures 3.13 and 3.14 for the visual appearance of Y-298 before strengthening.

Figure 3.13. Bridge Y-298

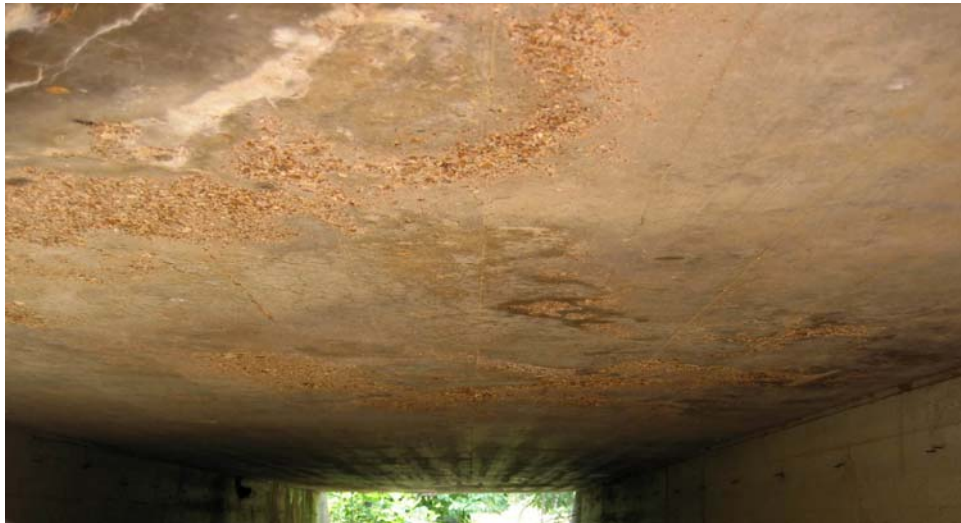
Figure 3.14. Bridge Y-298 Substructure

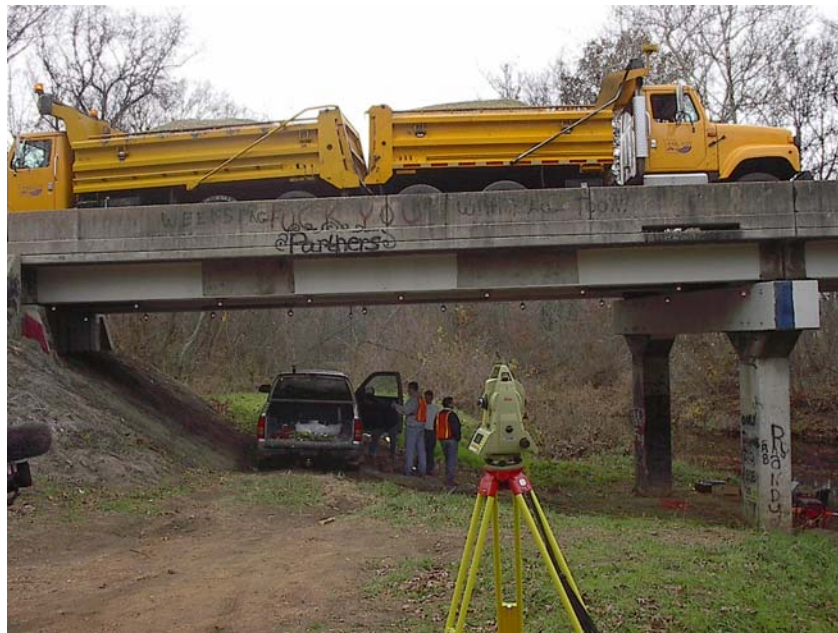
method of testing real structures (Figure 4.1). Dynamic load tests use moving loads to induce vibrations and find the very rapid loading response of the structure. These tests allow for the analysis of dynamic load allowance, frequency, vibration, and a stress range for fatigue evaluation (AASHTO 2003). Driving loaded trucks over pre-determined locations at given speeds is the easiest method of testing dynamic loading.

Figure 4.1. Loaded Trucks Used to Test a Bridge

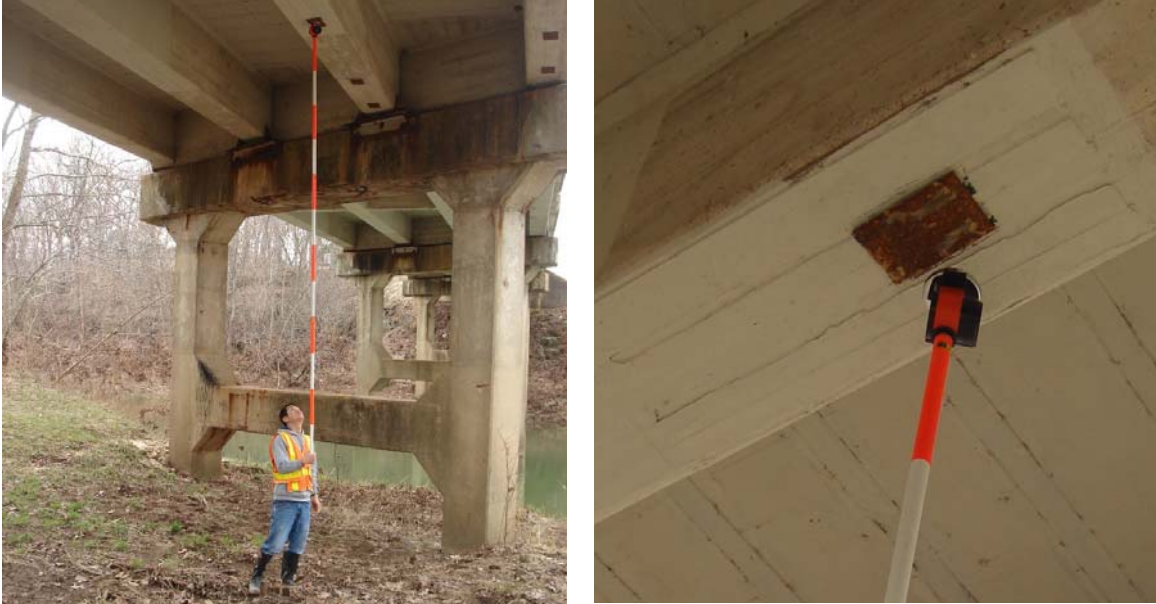
Iron plates were epoxied to the underside of the bridges at predetermined locations along the span and given time to cure prior to load testing. The plates remained for future load tests. Magnetized target prisms were then attached to the plates using a range pole. Figure 5.3 shows the attachment of the magnetized target prisms to the soffit of the bridge girders.

Figure 5.3. Attaching Target Prisms with Range Pole

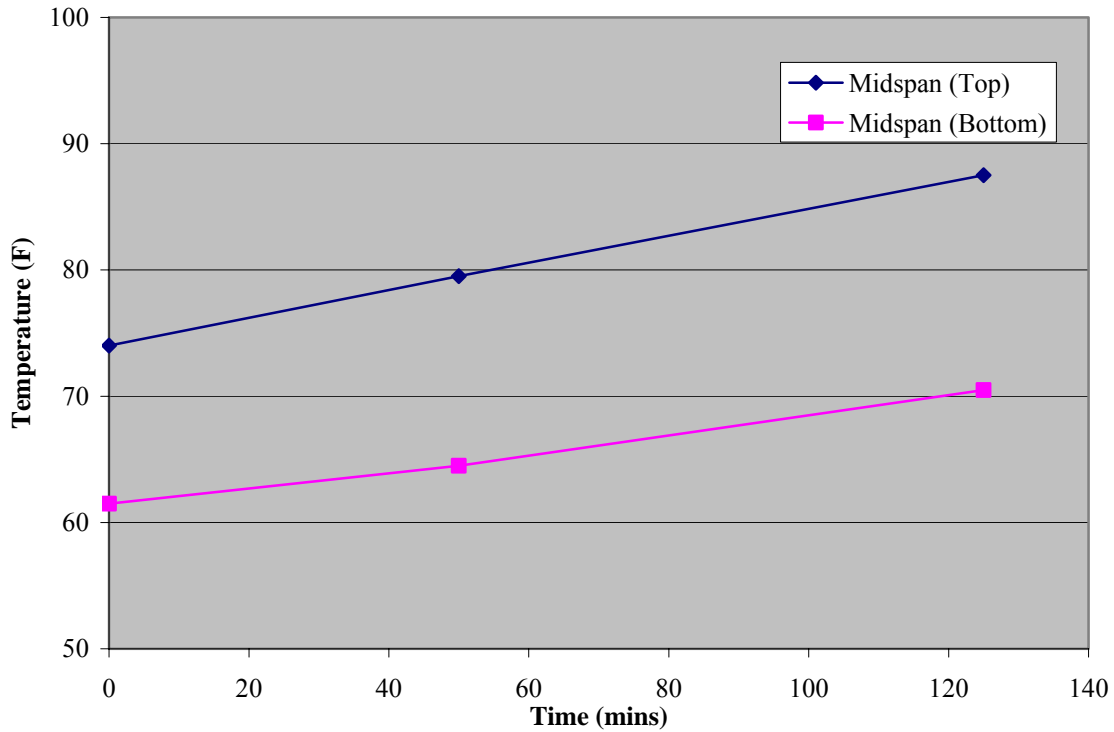
Temperature readings were recorded with a temperature gun on the top deck and at the bottom of the girders three times during testing in order to quantify thermal effects. Figure 6.1 shows the temperature variance over time for Bridge X-596 at midspan of the interior girder. This test was conducted in the morning and an increasing temperature gradient was observed. A similar temperature rise was common for most conducted tests. The temperature variance shown in Figure 6.2 is one of the more extreme cases in temperature fluctuation observed during testing. During overcast days, the temperature variance was observed to be much lower.

Figure 6.1. Bridge X-596 Temperature Over time of Midspan Interior Girder

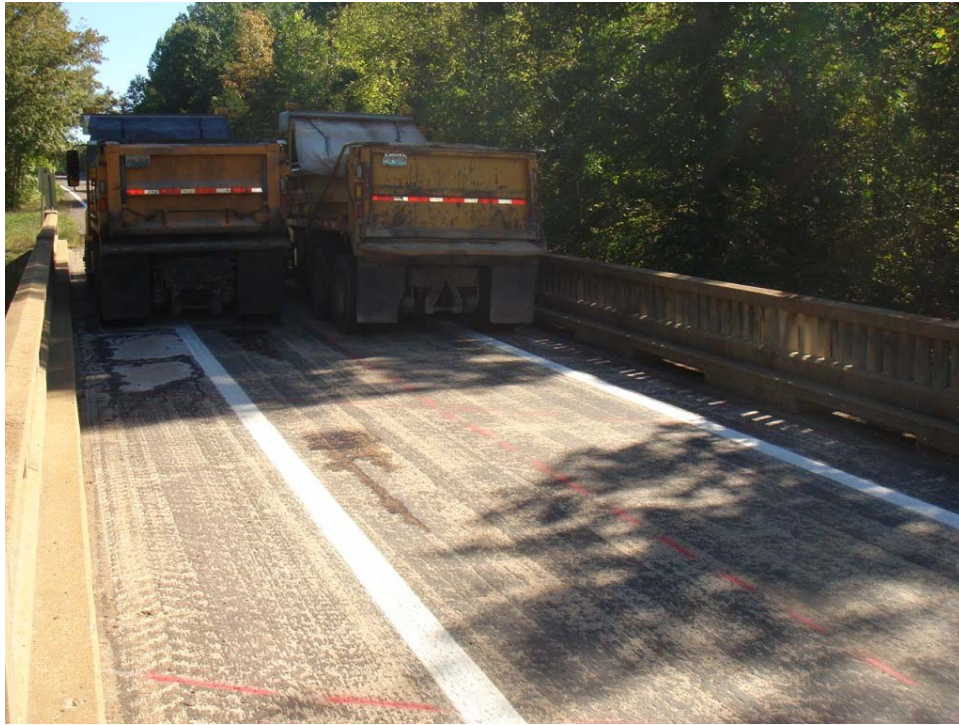
Test 1 occurred closest to the first no load test and therefore used the first no load as a baseline. Test 2 utilized a weighted average of 75 percent camber from the first no load and 25 percent from the second no load and so forth. A linear relationship was the most appropriate way to account for thermal deflections because quantifying the exact temperature throughout the cross section would have been very difficult. In addition, for some bridges portions of the deck could be shaded during the test whereas other spots remained in the sunlight and recorded much larger temperature values. This meant the temperature was not only varying throughout the depth of the bridge section, but over the entire deck surface. Figure 6.4 shows the shading of Bridge X-495 during Stop 3, which was the halfway point of testing. Testing of the bridge began in the early morning with the entire deck shaded; when testing was completed, the entire deck surface was sunlit.

Figure 6.4. Bridge X-495 Shading of Deck During Testing

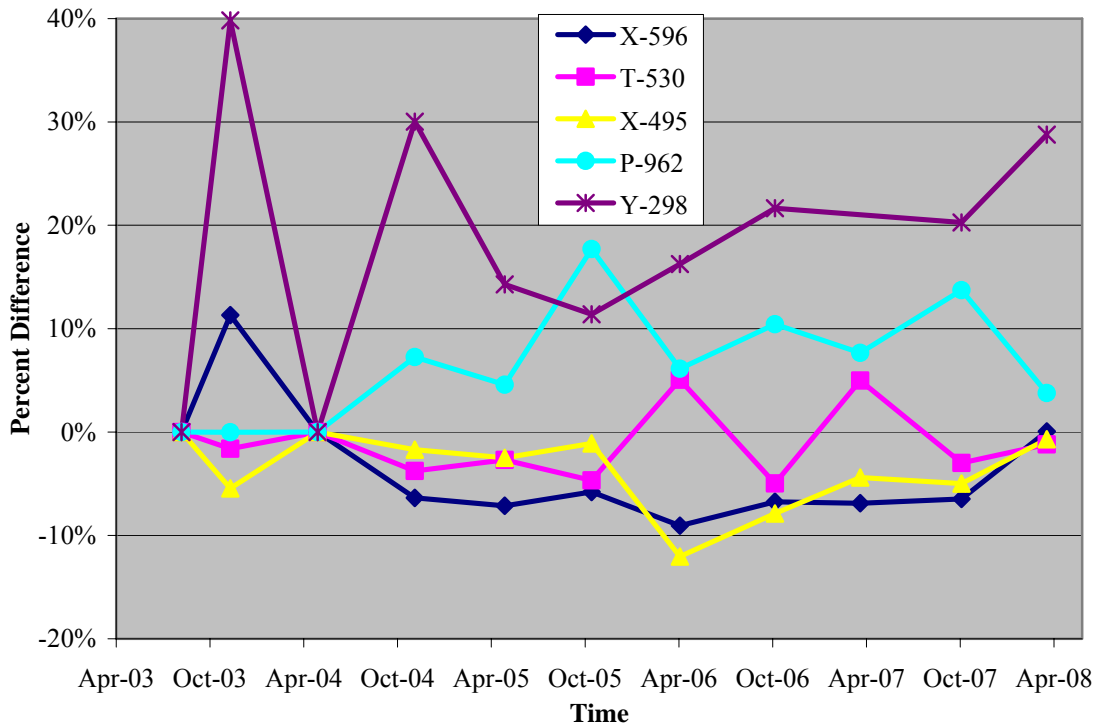
Figure 6.5. Percent Difference of Total Truck Weight over Time

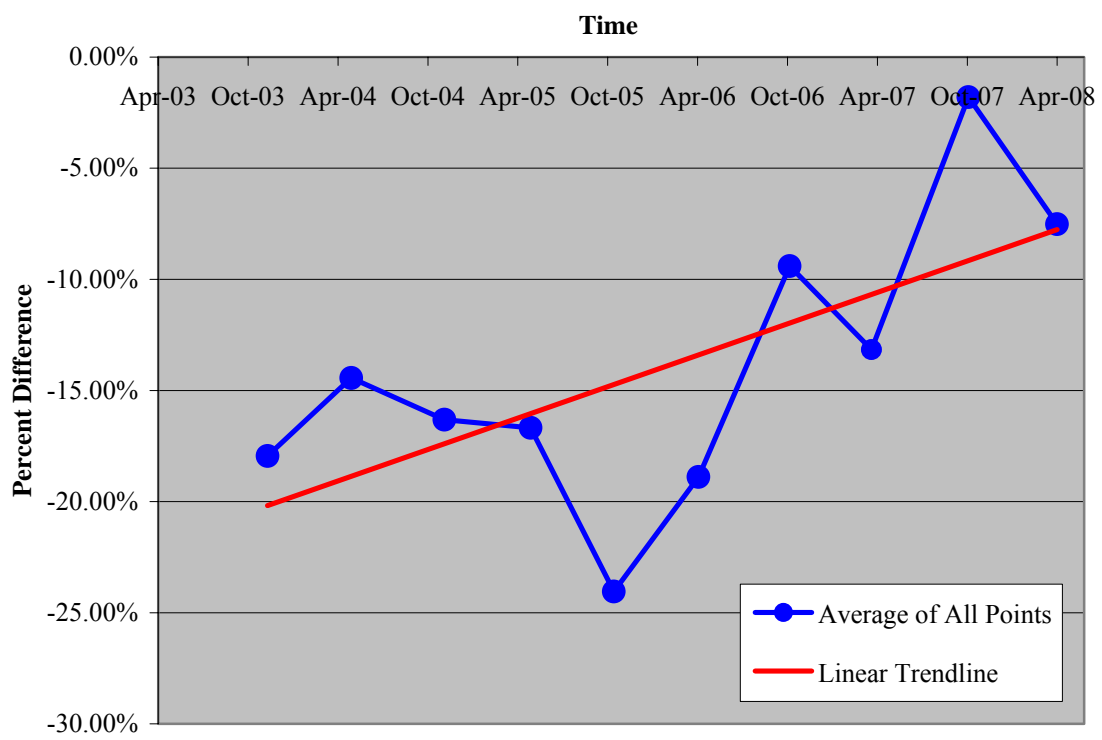
In order to better graphically present this change, the average of all deflected points was calculated for each test and a percent difference was then computed based upon the original Test 1 data. The results are presented in Figure 7.1 and Figure 7.2 for Bridge P-962 and Bridge T-530, respectively. A linearly trend line was plotted and displays a line that approaches the original deflection of the bridge. The apparent increase in deflection could be attributed to a softening of the FRP material utilized during strengthening or to the deterioration of other bridge components as the bridge aged. The varying thermal effects also may have impacted this apparent loss in stiffness, though bond softening at the interface of the FRP composites and the concrete substrate over the observed time could have been a factor as well.

Figure 7.1. Average Deflection Percent Difference Bridge P-962

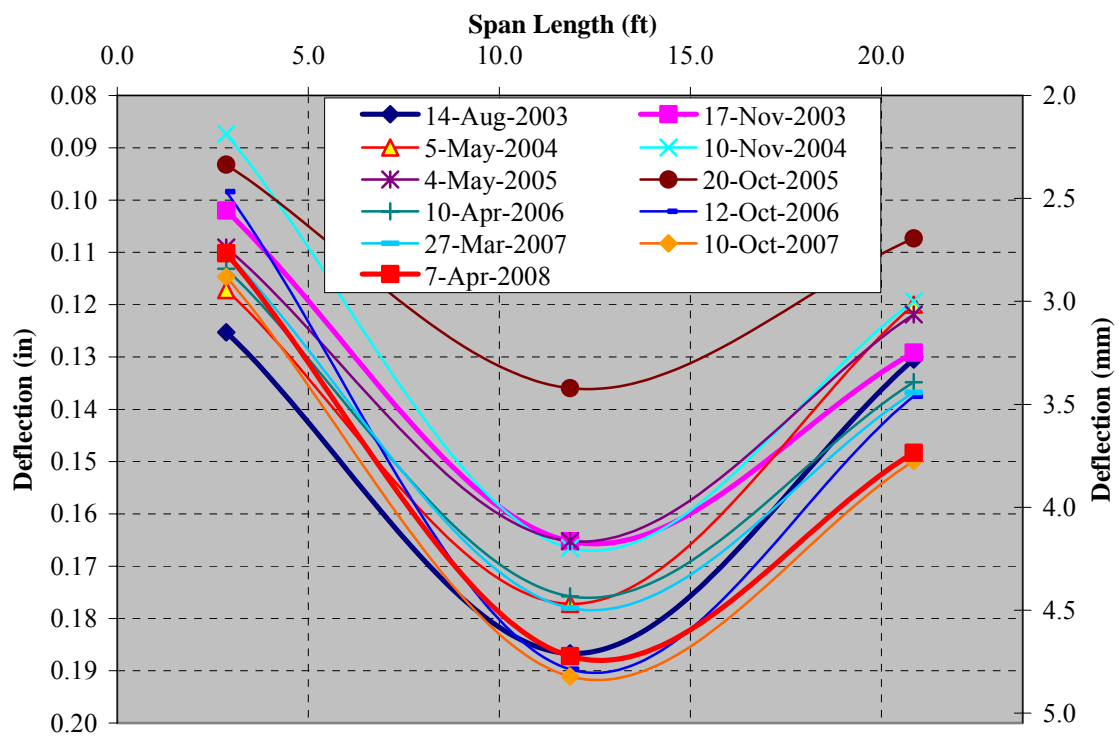
The normalized transverse girder deflection at midspan was plotted to gain an understanding of girder deflections relative to each other. The transverse deflection has been plotted below for span 1 of bridge P-962 in Figure 7.3. The results indicate an increased deflection on the western exterior girder.

Figure 7.3. Bridge P-962 Span 1, Stop 2 Midspan Transverse Normalized Deflection

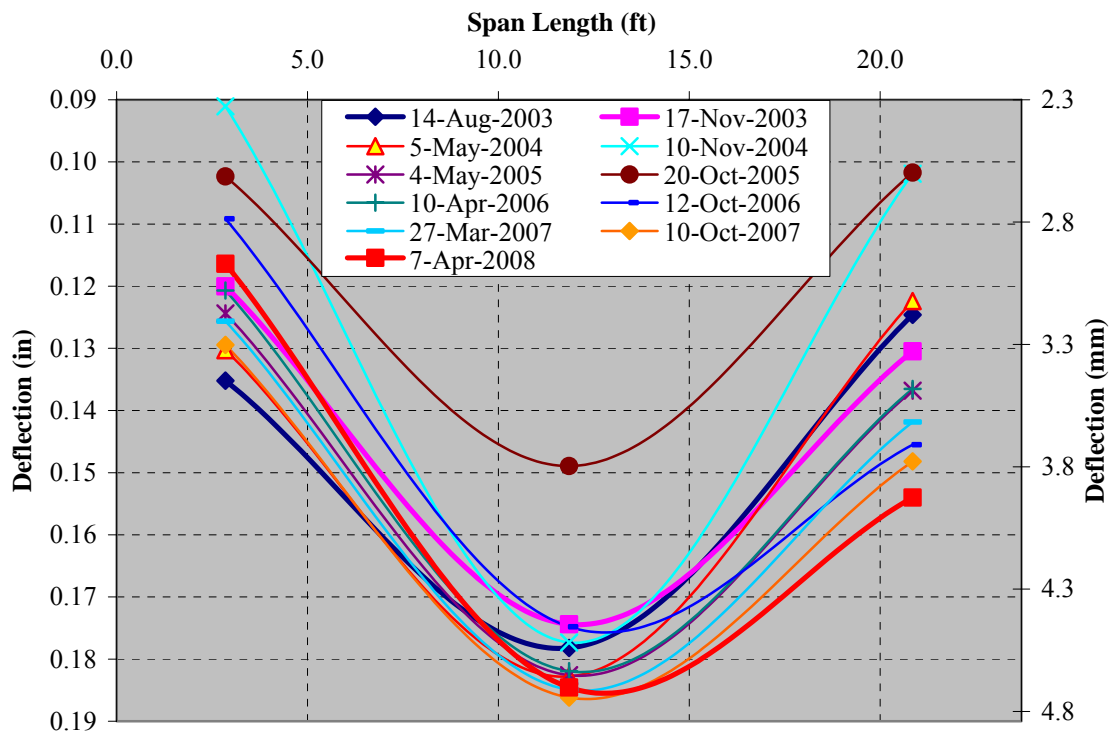
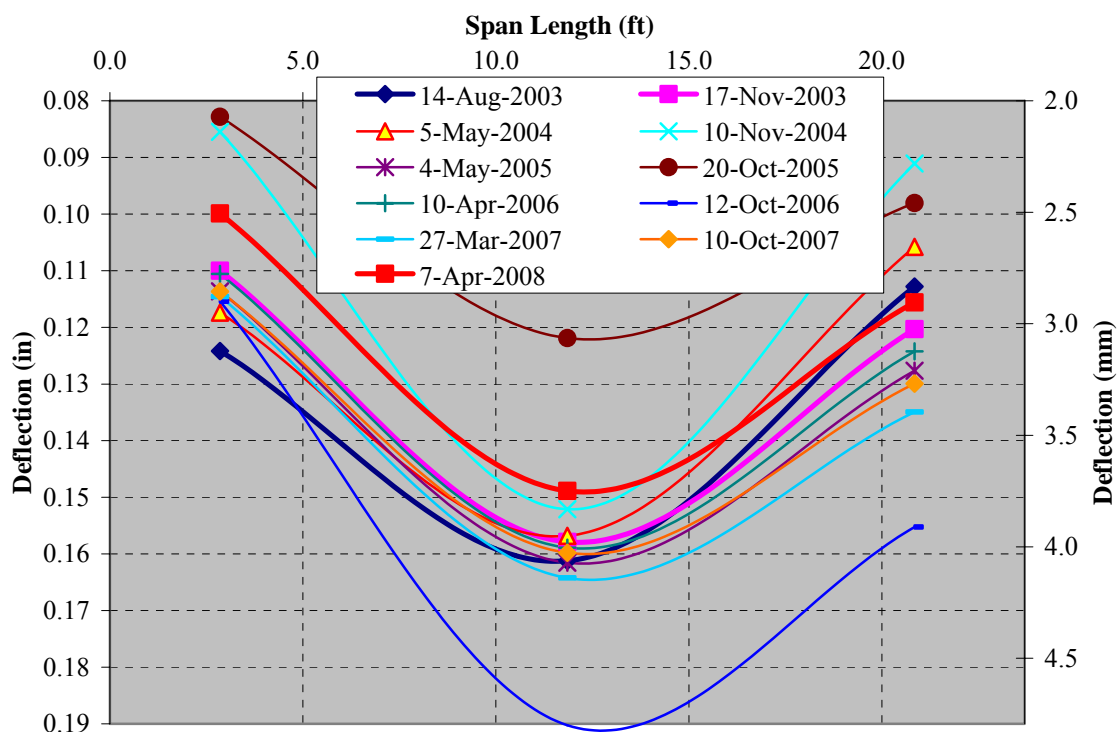
Additionally, spans 2 and 3 were monitored for bridge P-962 under Stop 2 loading configuration. The midspan girder deflections (Figures 7.4 and 7.5) display a similar trend of an increased deflection of the western exterior girders. Note that span 3 was strengthened with SRP reinforcement which upon visual inspection exhibited localized signs of rusting. The deflection data for span 3 does not show larger deflections over time or larger deflections than span 1 or 2. The SRP is therefore still performing adequately with no appreciable loss in steel area due to rusting.

Figure 7.4. Bridge P-962 Span 2, Stop 2 Midspan Transverse Normalized Deflection

Figure 7.5. Bridge P-962 Span 3, Stop 2 Midspan Transverse Normalized Deflection

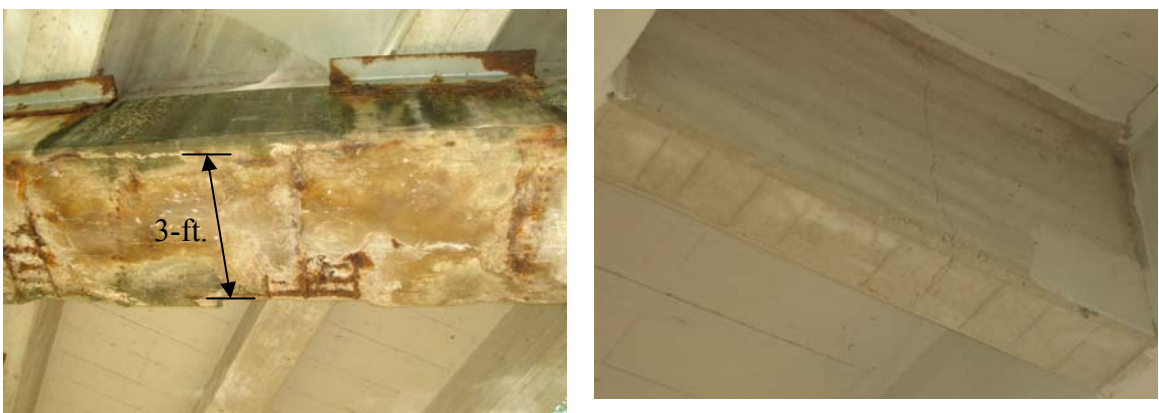
7.6.1. Bridge T-530. Bridge T-530 showed signs of severe corrosion of the bents due to the propagation of water from the deck surface. These bents were corroded before the bridge was strengthened and need to be monitored in the future to ensure structural integrity. The presence of a flexural crack was also noted on the midspan transverse beam of the tested span. The size of the crack was noted, and did not noticeably increase in size when testing under truck load. Figure 7.12 shows the location and a depiction of the corrosion of the bents and the flexural crack of the transverse girder.

Figure 7.12. Bridge T-530 Corrosion of Bents and Cracked Transverse Beam

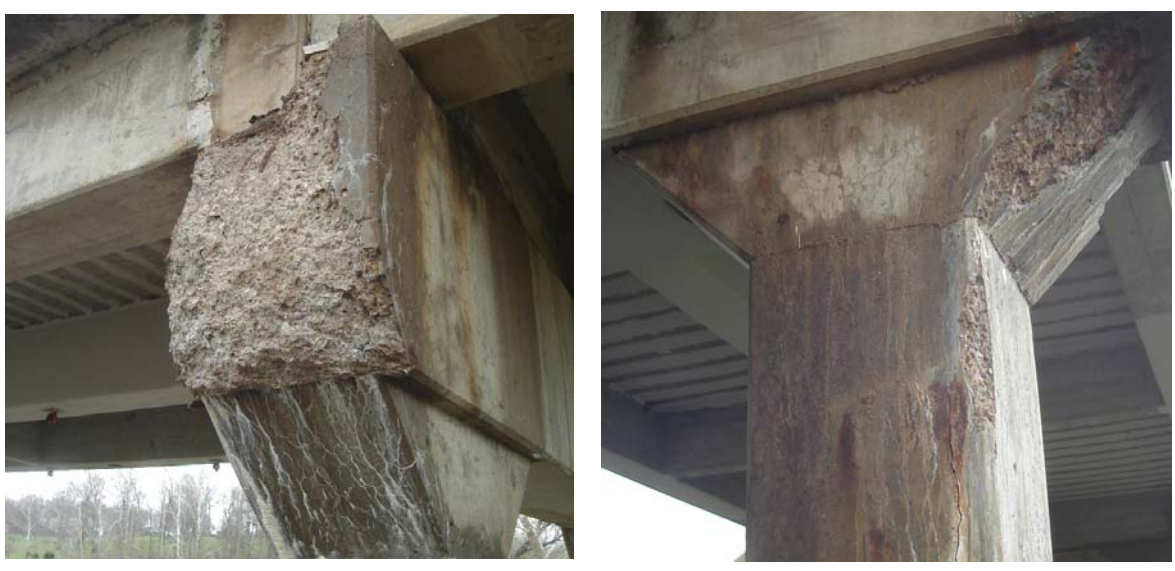
7.6.2. Bridge X-596. Bridge X-596 also exhibited bent corrosion. The exterior face of one bent had spalled off, exposing the reinforcement. This occurred between tests 8 and 9 and was not present prior to construction. In addition, another bent exhibited corrosion at the intersection of the transverse beam with the column. The locations and a picture of each decayed bent are shown in Figure 7.13. Additional corrosion was also observed on the barrier walls in the form of exposed reinforcement and deteriorated concrete.

Figure 7.13. Bridge X-596 Corrosion of Bents

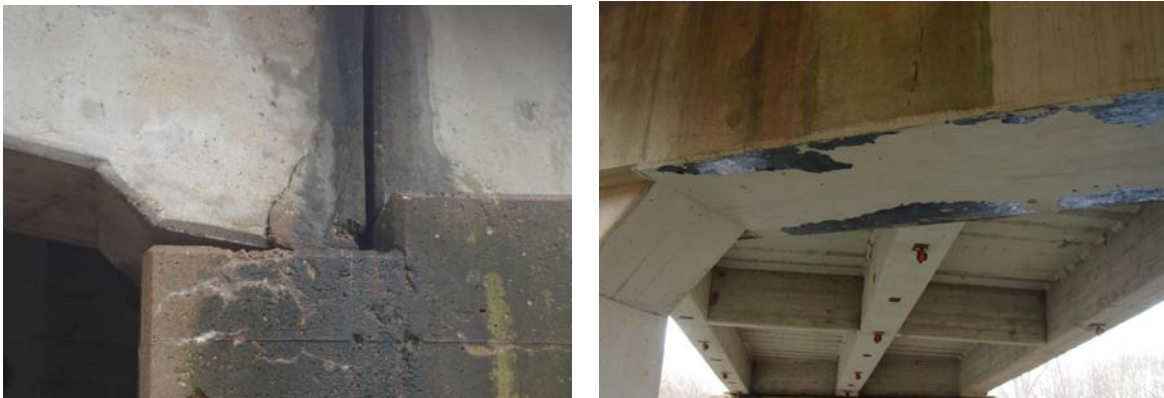
7.6.3. Bridge X-495. The presence of an endspan crack in the disturbed region was noted during the 8th series of tests. This crack did not propagate further when observed during later tests. Additionally, the protective coating on the FRP applied to one bent via manual lay-up is peeling from the bent soffit. This may be due to poor installation or water drainage from the deck. This phenomenon was not observed on the other bent, which was in good condition. The disturbed region crack and protective layer peeling is shown in Figure 7.14 along with the locations of the occurrences. Lastly, there is an appreciable amount of scour around the foundations of one of the bents. This is in the deeper part of the creek and was observed during the 8th test when the water visibility was fairly clear.

Figure 7.14. Bridge X-495 Disturbed Region Crack and Peeling of Protective Coating

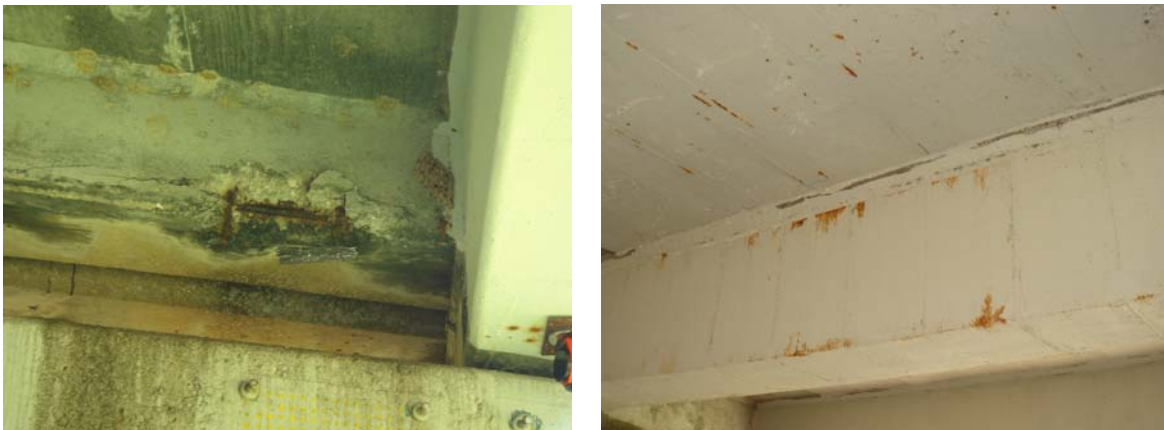
7.6.4. Bridge P-962. The transverse girder at one of the bents showed signs of corrosion in the form of exposed and rusted rebar from spalled concrete. Also, the SRP utilized to strengthen the third span showed signs of rust in many places. This was especially prevalent in locations where water was able to drain from the deck to the girders or bents. The transverse girder corrosion and rusting of SRP can be observed in Figure 7.15 along with the locations of the occurrences.

Figure 7.15. Bridge P-962 Corrosion of Transverse Girder and SRP Reinforcement

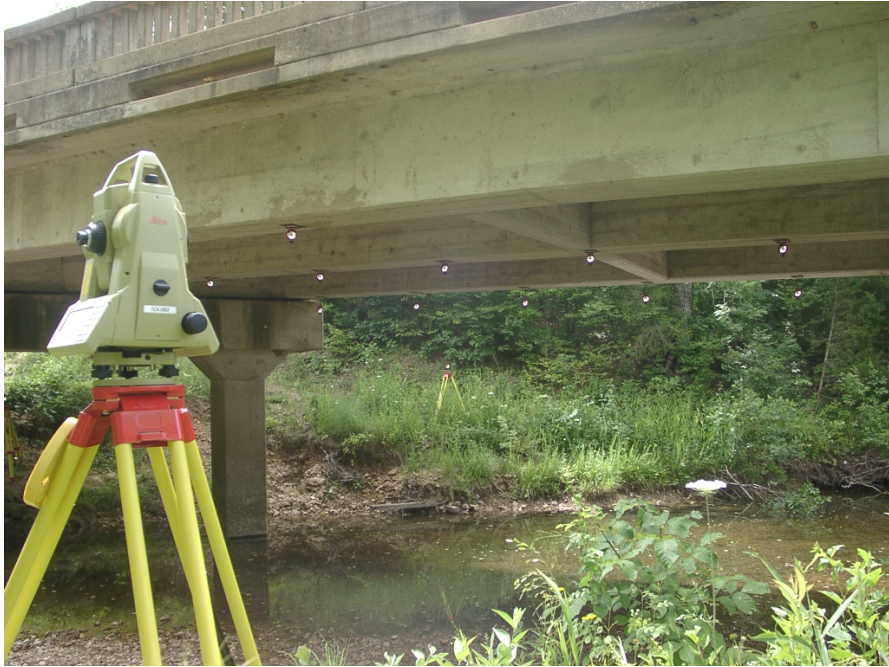
Figure C.2. Site Setup
