<b>1. Report No.</b> RDT01-002C	<b>2. Government Accession No.</b>	<b>3. Recipient's Catalog No.</b>	
<b>4. Title and Subtitle</b> Destructive and Non-Destructive Testing of Bridge J857, Phelps County, Missouri Volume I - Strengthening and Testing to Failure of Bridge Decks Volume II – Feasibility Study on Damage Detection of RC Structures Using Dynamic Signature Tests Volume III-Strengthening and Testing to Failure of Bridge Piers	<b>5. Report Date</b> April, 2001		<b>6. Performing Organization Code</b> UMR
	<b>7. Author/s</b> T. Alkhrdaji, M. Barker, G. Chen, H. Mu, A. Nanni, and X. Yang		
<b>9. Performing Organization Name and Address</b> Center for Infrastructure Engineering Studies University of Missouri at Rolla 223 ERL Rolla, MO 65409-0710	<b>8. Performing Organization Report No.</b> RDT01-002C /RI98-013		<b>10. Work Unit No. (TRAIS)</b>
	<b>11. Contract or Grant No.</b>		
<b>12. Sponsoring Organization Name and Address</b> MoDOT Research Development and Technology 1617 Missouri Blvd., Jefferson City, MO 65101 University Transportation Center - UMR 223 Engineering Research Lab., Rolla, MO 65409	<b>13. Type of report and period covered</b> Technical Report; 10/98 – 9/99		<b>1

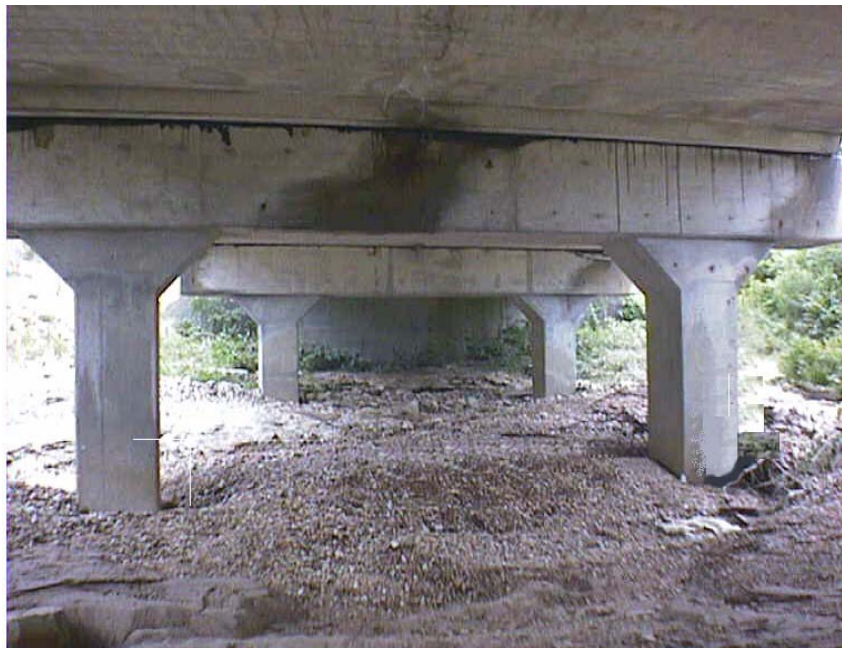
**Figure 2.1.** Photo showing bridge columns.

Bridge decks were supported on two abutments and two bents. Each bent consists of two columns connected at the top by a RC cap beam, as shown in Figure 2.1. The abutments and the bents were all at a 15-degree skew. The columns had a 2 ft x 2 ft (0.6 m x 0.6 m) square cross-section and were reinforced with four #6 (19 mm) deformed steel bars located at the corners of the cross section. The haunch of each column was reinforced with four #6 (19 mm) steel bars that extended 3 ft (0.9 m) into the column from the bottom of the haunch. The transverse reinforcement consisted of #2 (6 mm) steel ties spaced at 18 in. (457 mm) on centers. Each column was supported by a 4 ft by 4 ft by 2.5 ft (1.2 m x 1.2 m x 0.75 m) RC square spread footing. Figure 2.2 shows typical geometry and reinforcement details of a bridge column as given by the original plans.

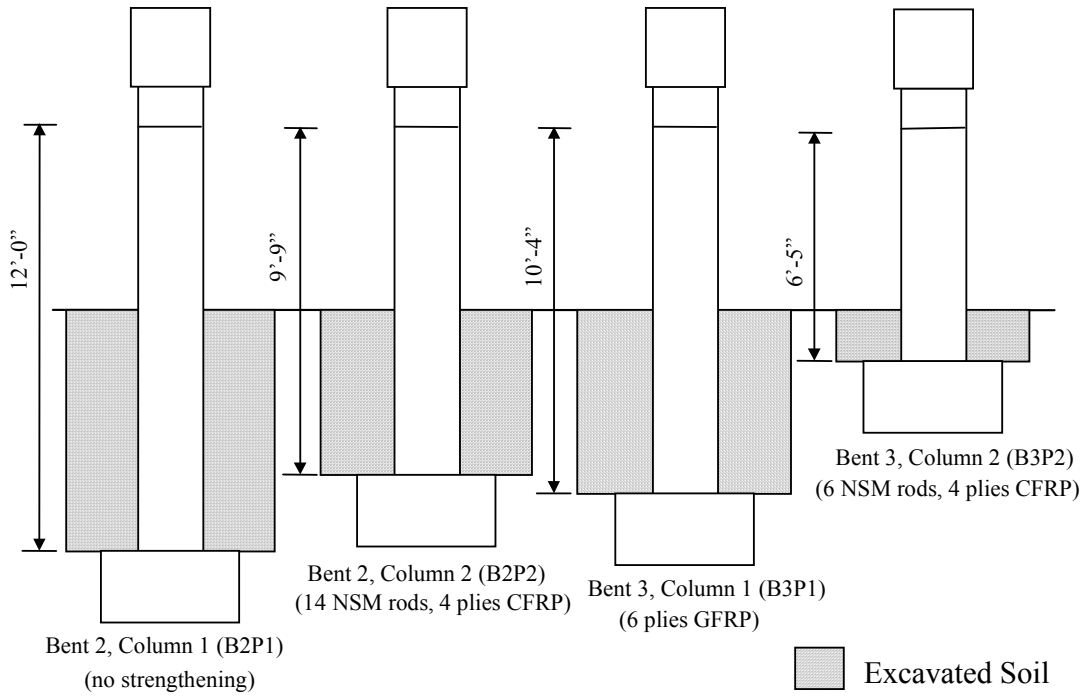
**Figure 2.3.** Clear length of the columns and excavation profile.

According to the bridge plans, the clear length of the columns varied from 3.5 to 5.0 ft (1.1 to 1.5 m). Upon field inspection, it was found that the actual lengths of the columns varied from 6 to 12 ft (1.8-3.7 m). Figure 2.3 shows the measured length of each column and its designation. In general, the condition of the bridge was good and no major damage (e.g., corrosion of reinforcement, or concrete spalling) was observed.

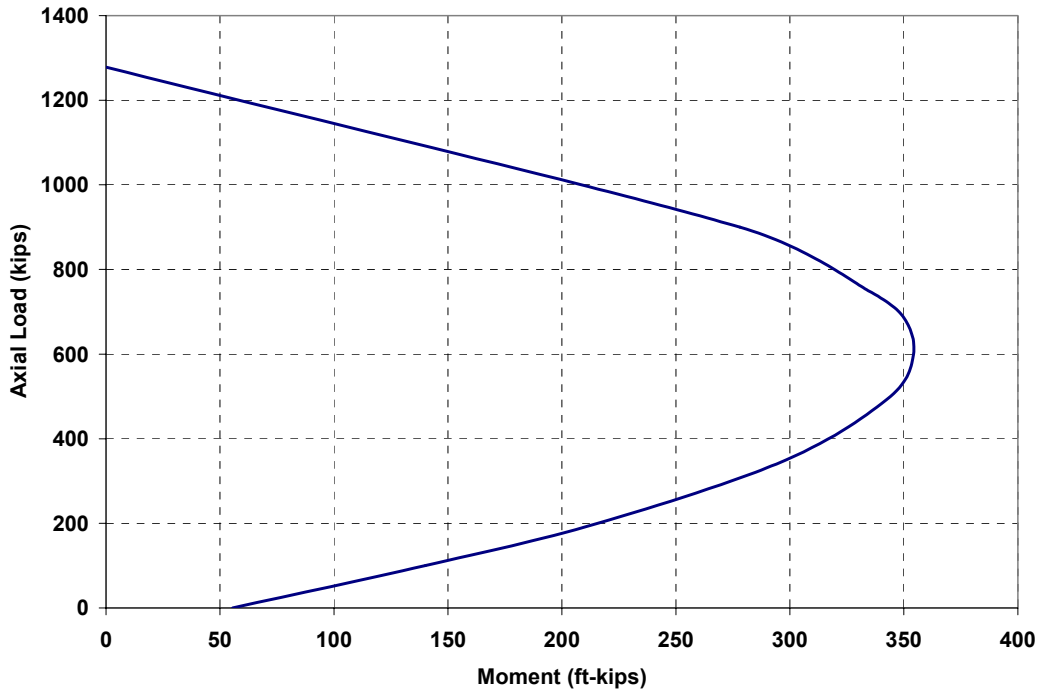
**Figure 2.5.** P-M diagram for a typical column section.

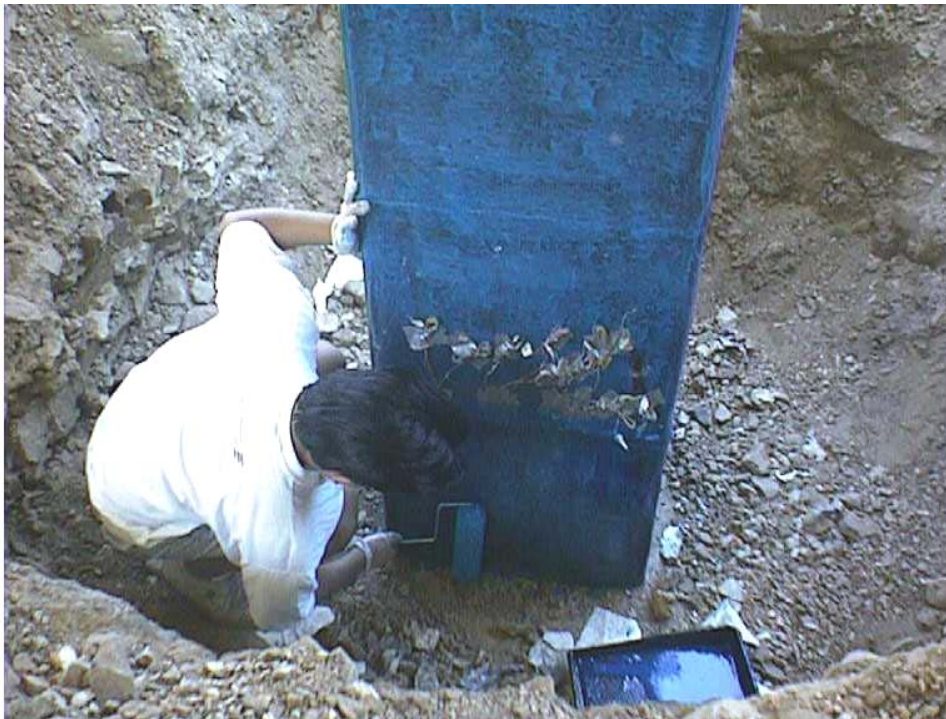
**Figure 2.11.** Applying the bottom lift of the jacket.

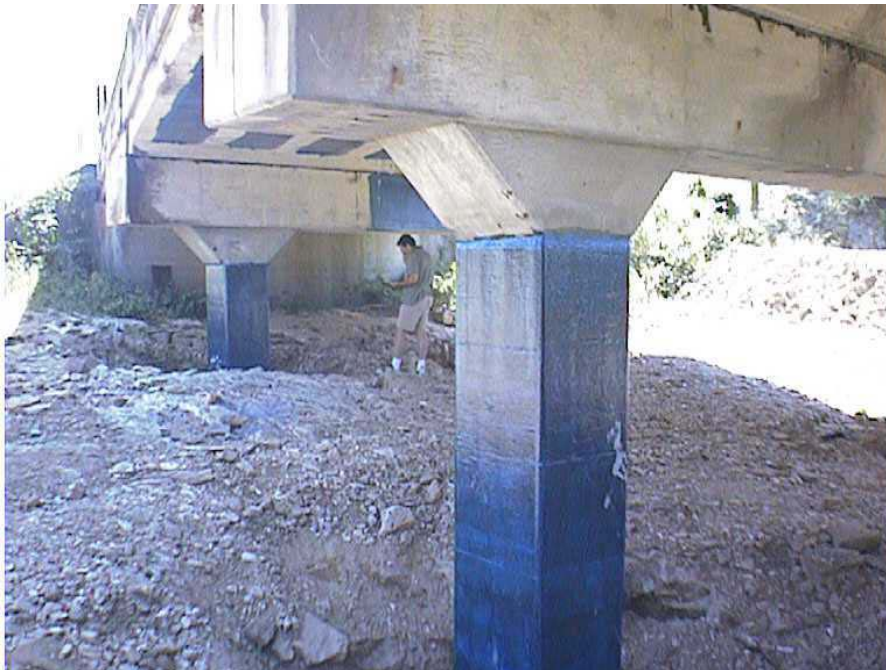
**Figure 2.13.** Photo showing the bridge after strengthening.

Due to variation in column lengths, the number of lifts of CFRP sheets required to cover the entire column was different. The number of lifts for B2P2, B3P2, and B3P2 were 6, 6  $\frac{1}{4}$ , and 4 lifts, respectively, as shown in Figure 2.10. The bottom lift was applied after the rest of the lifts were installed and allowed to cure, as shown in Figure 2.11. This was done to prevent damaging the strain gages wires. The bottom lift was applied after the wires were extended such that they exit between the first and the second lifts from the bottom of the column, as shown in Figure 2.12. A photo showing a general view of the bridge after strengthening is given in Figure 2.13.

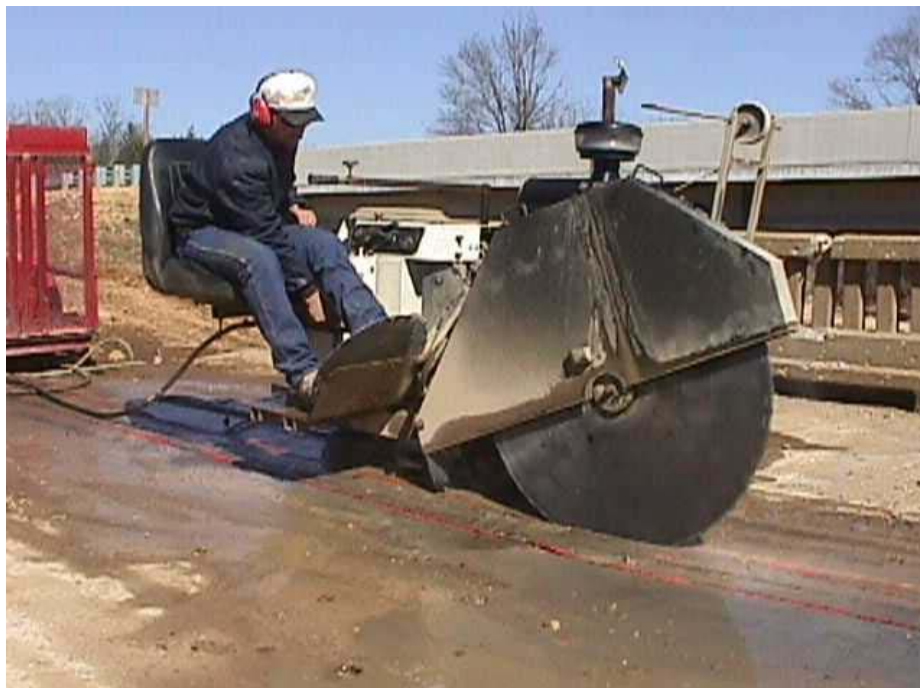
**Figure 3.1.** Cutting the bridge deck.

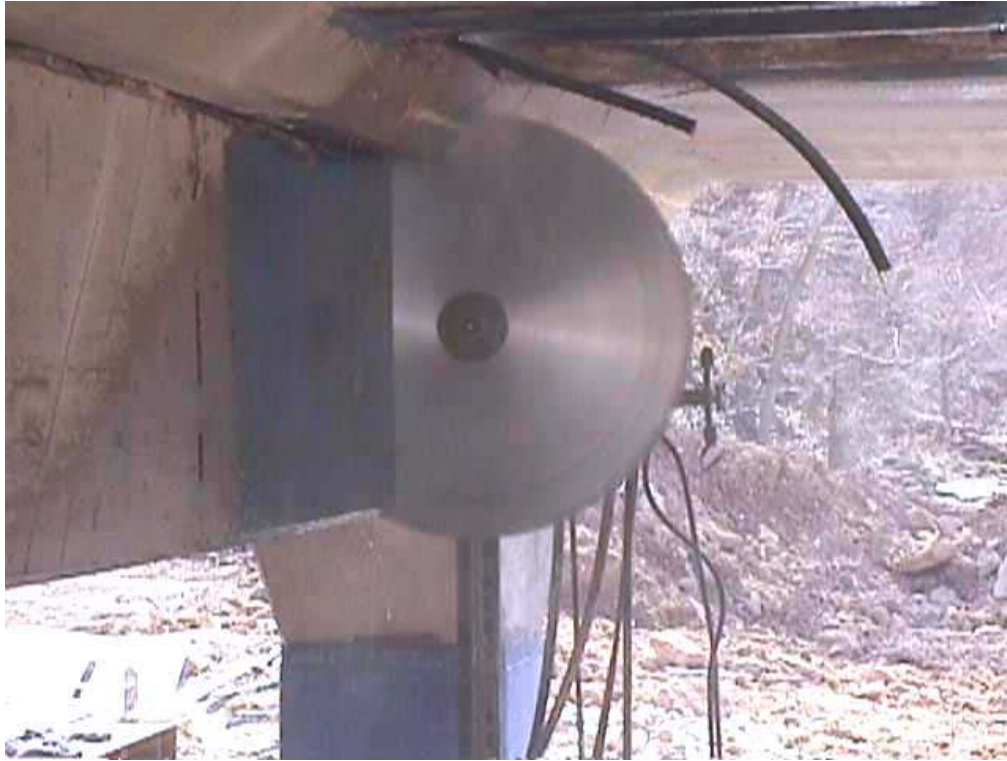
**Figure 3.2.** Cutting the cap beam.

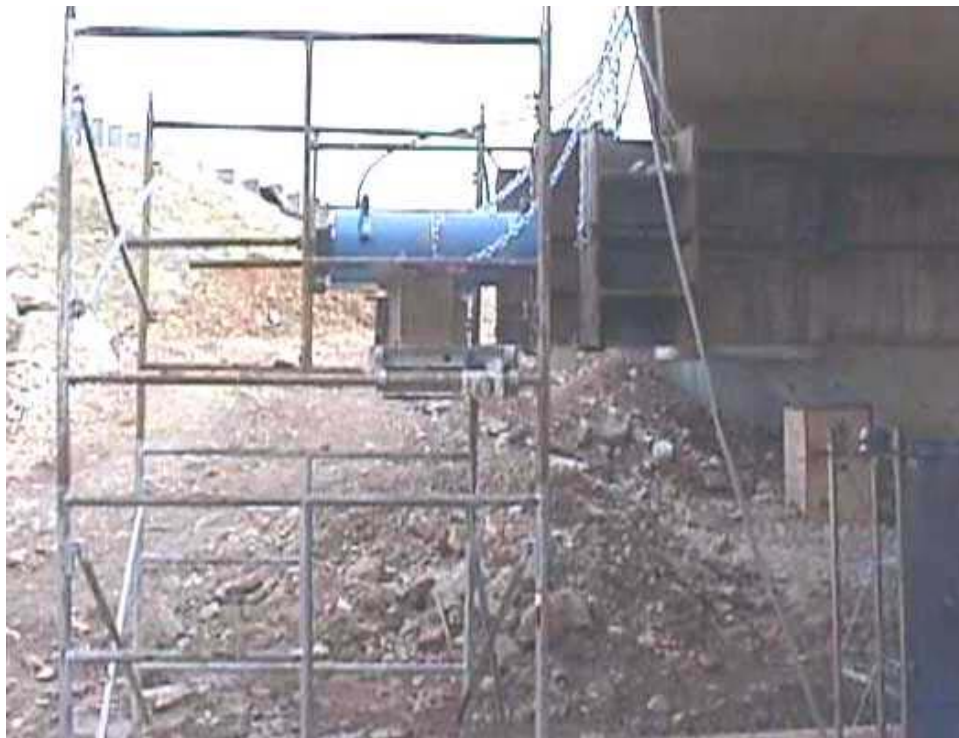
**Figure 3.4.** Confining frame assembly at one end of cap beam.

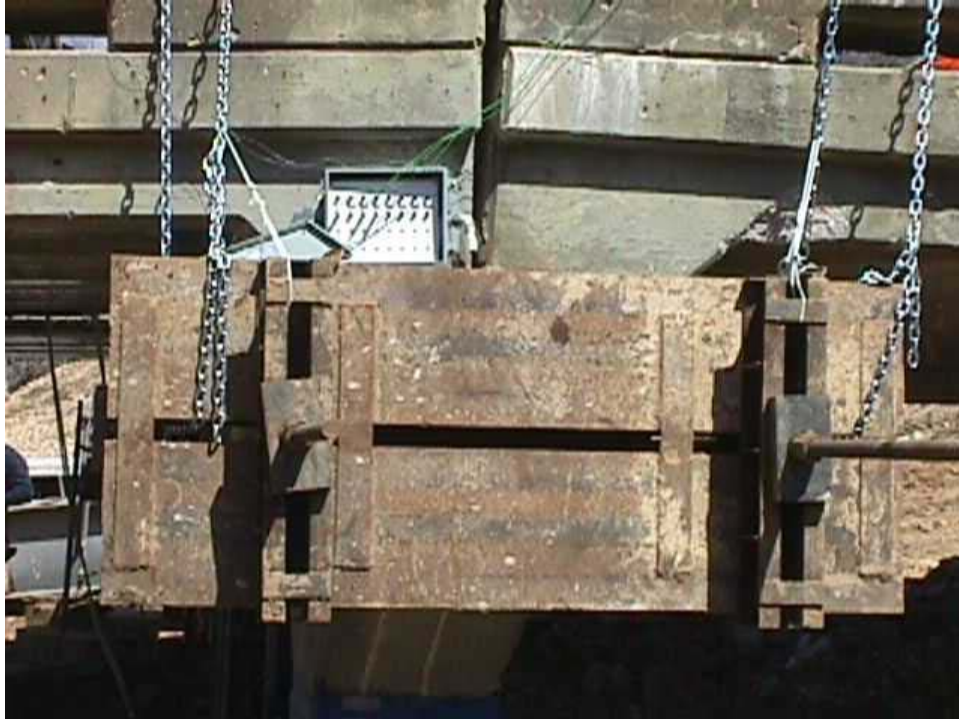
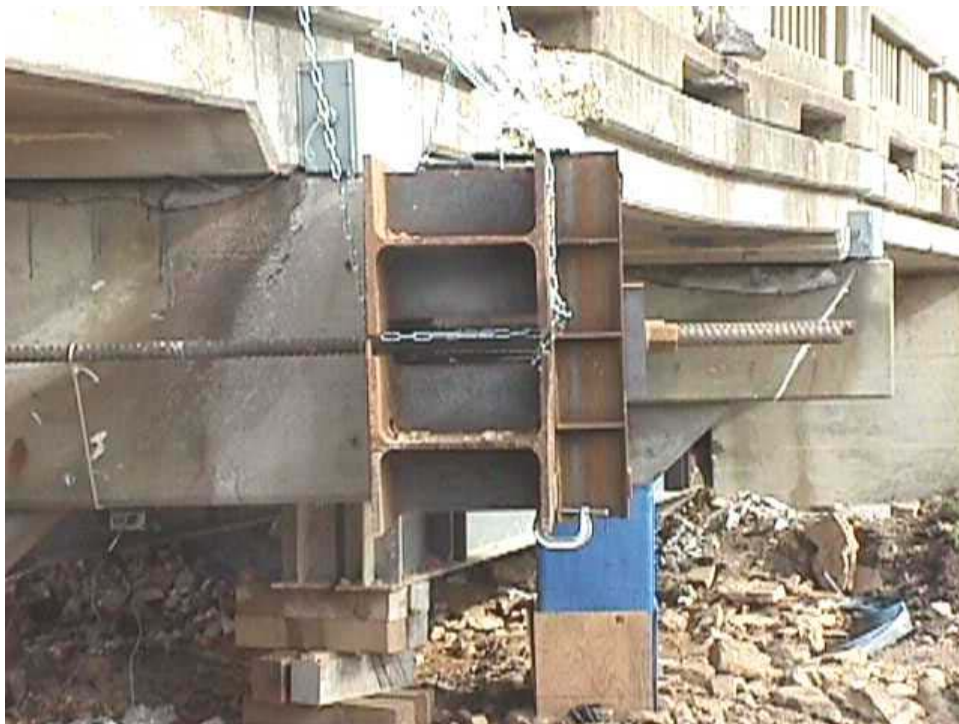
**Figure 3.5.** Confining frame assembly at the other end of cap beam.

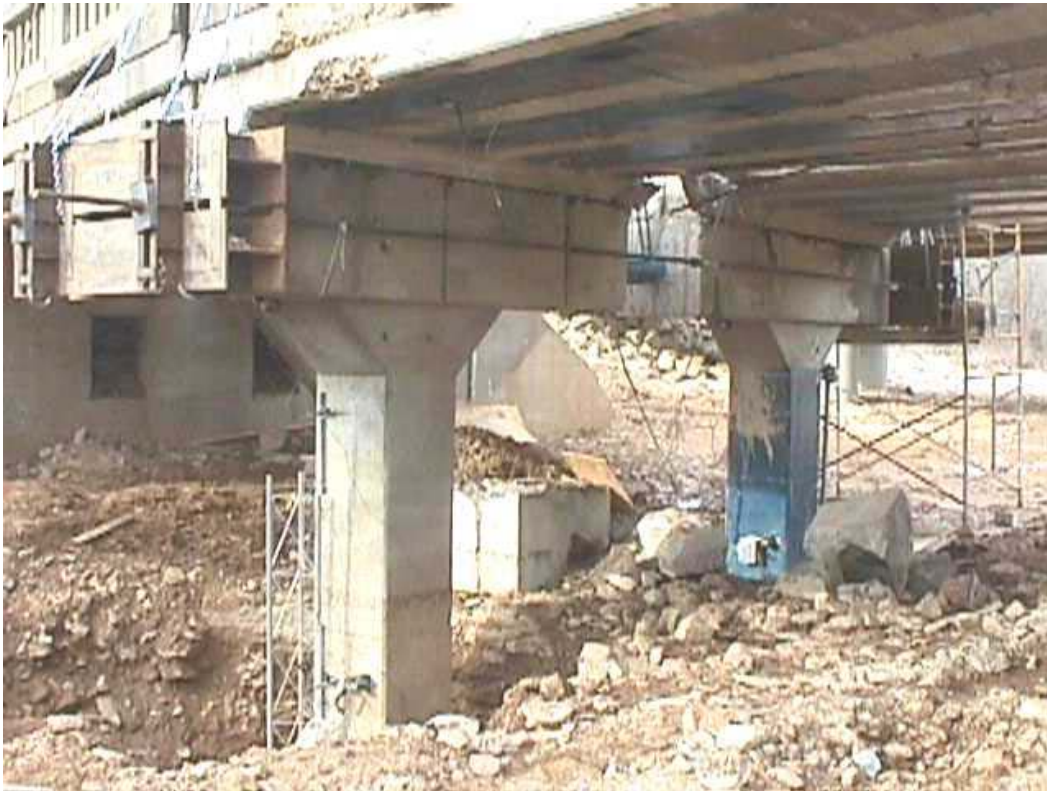
**Figure 3.10.** Photo showing piers test setup.

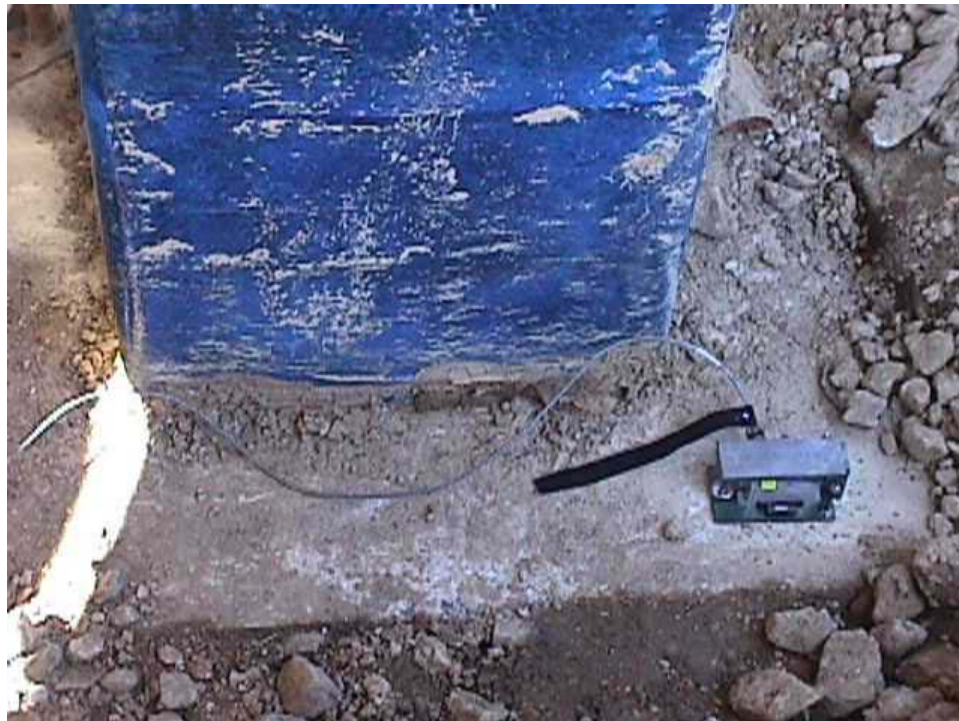
**Figure 3.17.** Inclinometer on the surface of the footing.

Three inclinometers were used to measure the rotation at the top, mid-height, and the footing of each column. The inclinometers used in this project have a range of  $\pm 3$  degrees. The top inclinometer was attached to the cap beam while the bottom inclinometer was attached to the surface of the footing. Figure 3.16 depicts a schematic of inclinometer locations. Figure 3.17 shows a photo of an inclinometer on the surface of the footing.

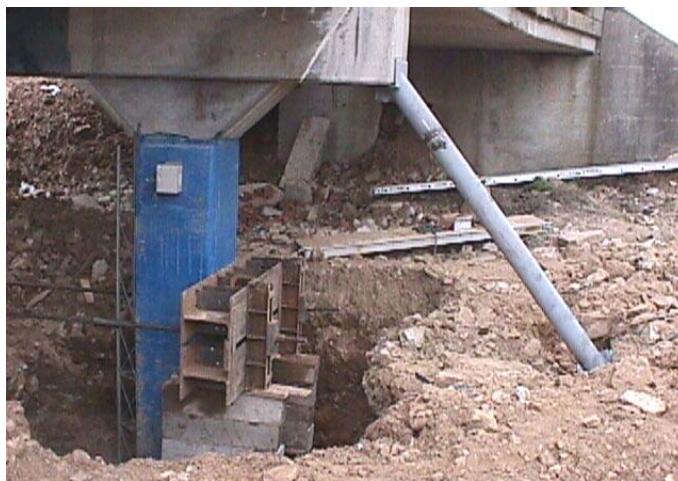
**Figure 3.18.** Diagonal bracing of the failed column.

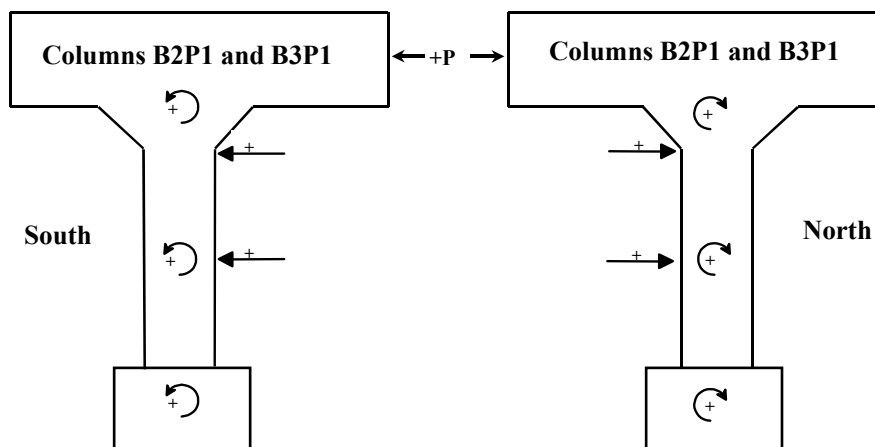
**Figure 4.1.** Sign convention.

To simplify data interpretation, the applied load was assigned a positive sign for push-out loading condition and a negative sign for pull-in loading condition. Also, the outward displacement of the columns was positive while the inward displacement was negative. Similarly, outward rotation was positive and inward rotation was negative. The sign convention used hereafter is shown in Figure 4.1.

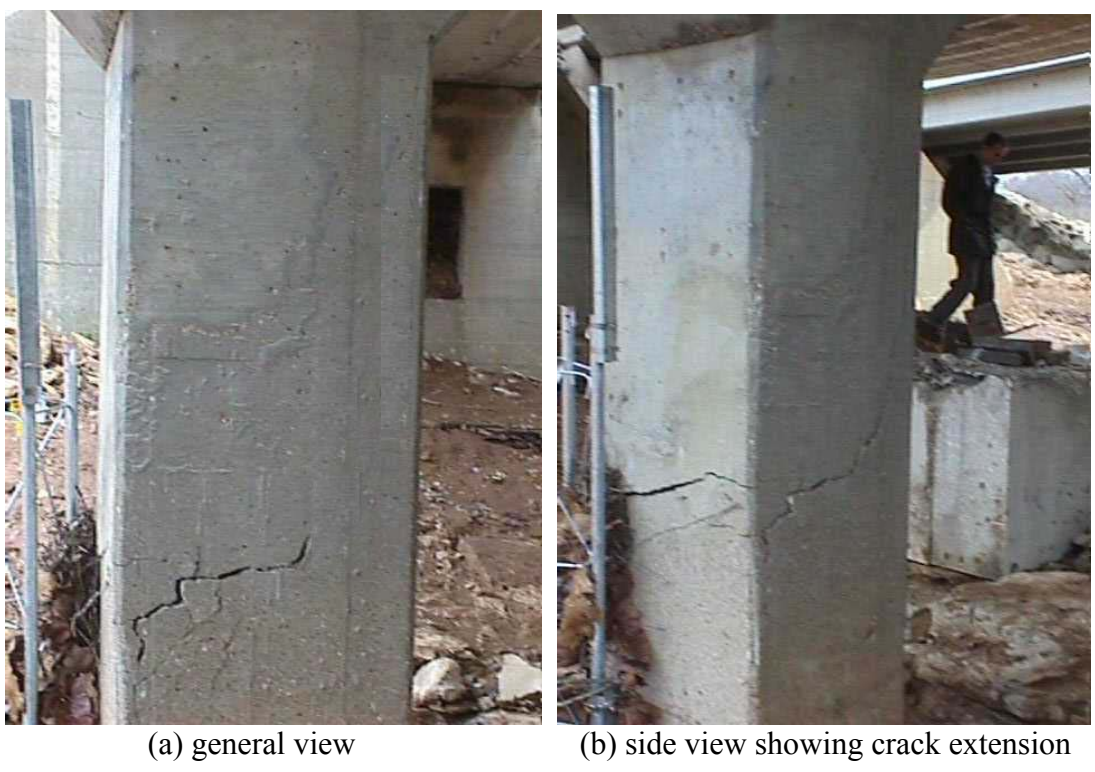
Figure 4.7. Crack on Column B2P1.

The load was increased gradually until it reached 80 kips (356 kN) where the top crack started to widen significantly and the column started to undergo continuous deformation. Similar behavior was observed at the base of the column. The continuous rotation of the footing under constant load indicated that the soil under the footing had failed. A final pull-in load cycle was applied. The load could not be increased beyond 59 kips (262 kN).

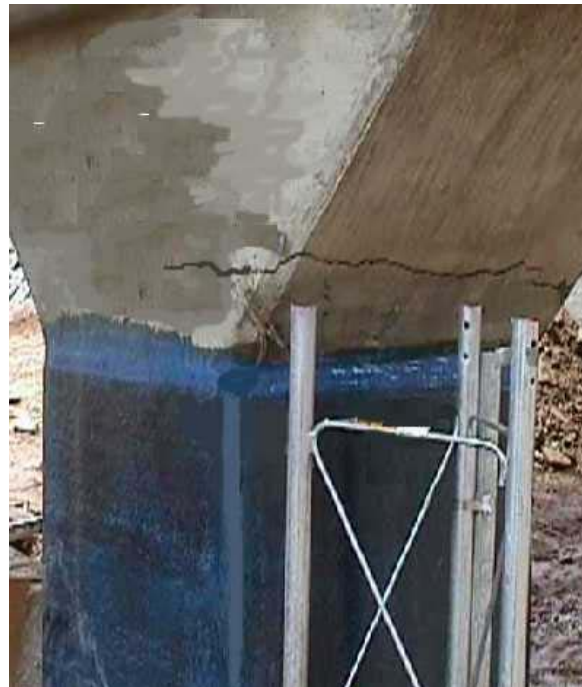
**Figure 4.13.** Crack at failure of column B2P2.

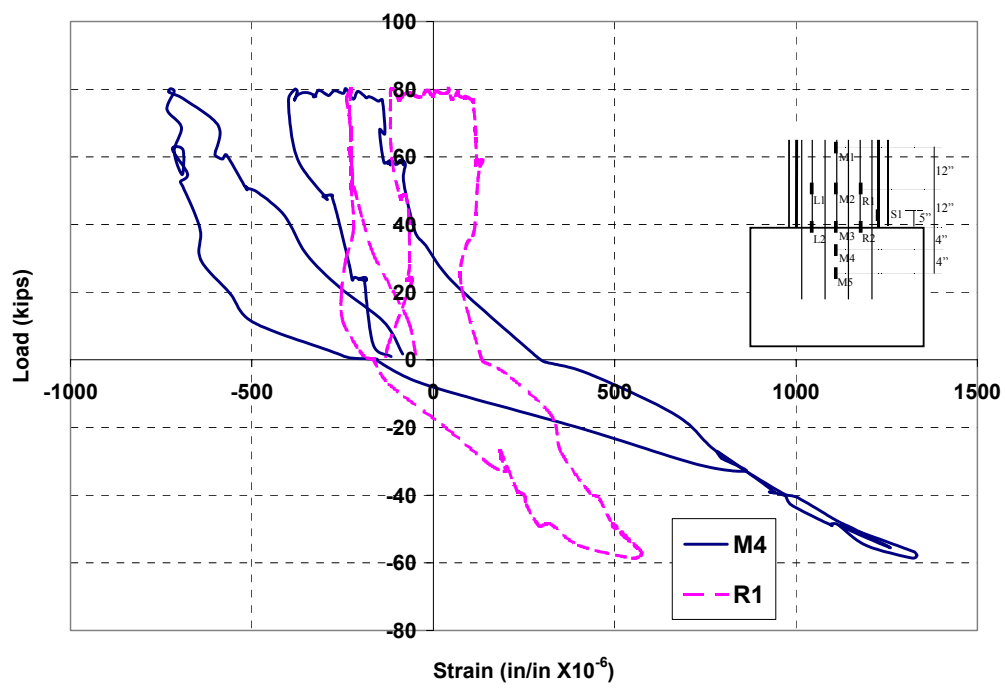
Figure 4.14. Measured strains on the north side of Column B2P2.

Figures 4.14 and 4.15 report the measured strains on the north and south sides of column B2P2 during the last three loading cycles. As shown in these figures, the strain gages on the two opposite sides of the column measured opposite strains. The measured tensile strains were significantly higher than the compressive strains indicating that cracks had formed at the base of the column. At loading cycle 7 (push-out), the maximum applied load was 80 kips (356 kN) and the maximum measured tensile and compressive strains were 2103 and  $-224 \mu\epsilon$ , respectively. Higher residual strains were measured on the north side after the column was unloaded. In loading cycle 9, only column B2P2 was loaded and the failure load of 81 kips (360 kN) was similar to that of column B2P1 (cycle 7). The maximum tensile and compressive strains at load cycle 9 were 1325 and  $-440 \mu\epsilon$ , respectively. These strains were smaller than those measured in cycle 7. This could be related to the softening of the soil due to cyclic loading that reduced its rotational stiffness and resulted in moment redistribution. The measured strains at failure became constant due to the plastic behavior of the soil.

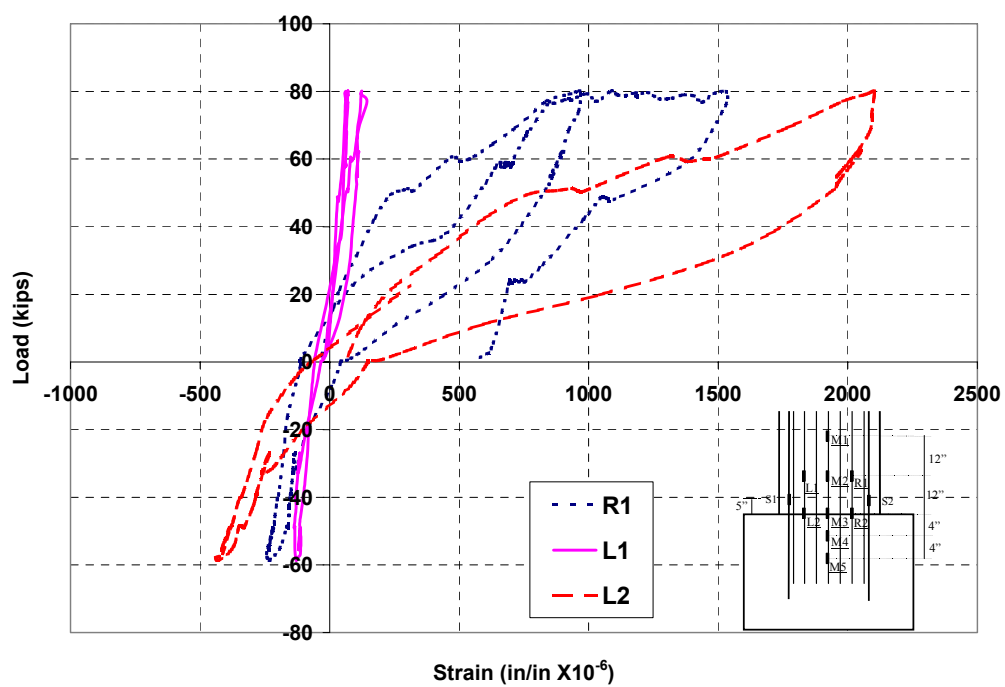
Figure 4.15. Measured strains on the south side of Column B2P2.

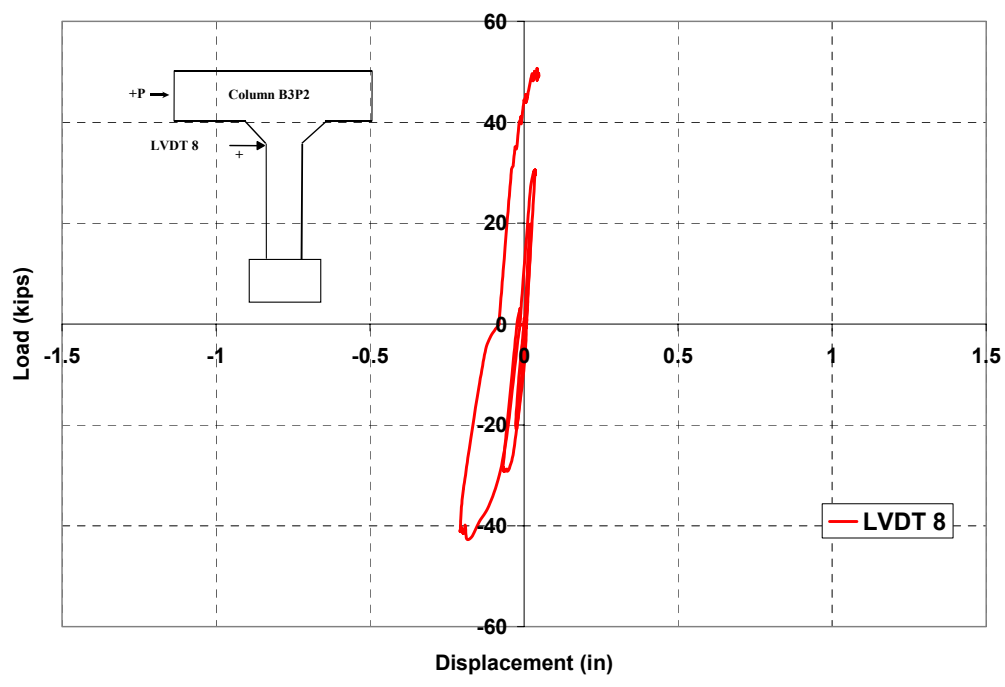
Figure 4.26. Displacement at top of Column B3P2.

This column was the shortest (6.5 ft or 2 m) amongst the bridge columns and its footing was cast into the bedrock. Figures 4.25 and 4.26 show the measured displacements of this column. Figures 4.27 through 2.29 show the measured rotations. The behavior of the column was elastic up to loading cycle 6 (pull-in), at which a crack was detected at maximum load. The crack was located on the north side of the column at the level of the footing. Small residual deformations were measured on the column after the load was removed. Two additional cracks were detected during loading cycle 8. The cracks occurred at maximum load and were located at the top and the base of the column, locations of maximum moments. The crack at the top occurred on the north side at the end of the haunch and the crack at the column base occurred on the south side at the level of the footing. The behavior of the column was elastic during this load cycle with no residual deformations measured when the column was unloaded. Very small rotations were measured on the footing in during all loading cycles.

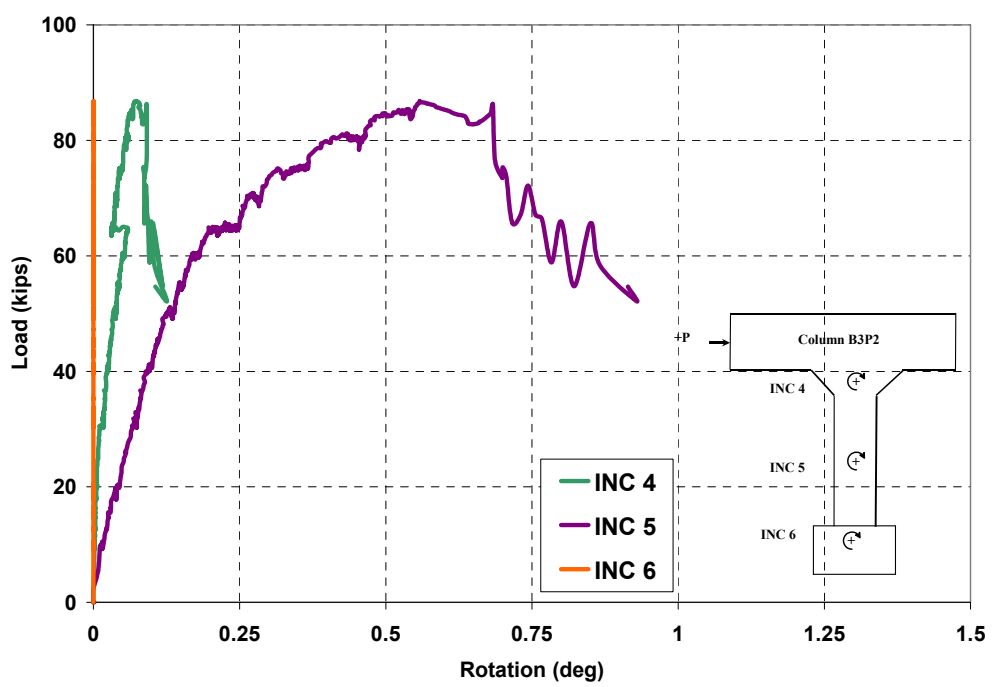
Figure 4.31. Measured rotation at final loading cycle of Column B3P2.

Figures 4.30 and 4.31 illustrate the measured displacements and rotations during the last loading cycle (push-out). Larger deformations were measured on this loading cycle when compared to the previous cycle and the measured rotation of the footing was very small. As the load was increased, the crack at the top started to open indicating a plastic hinge formation, as shown in Figure 4.32. Due to the large rotation of the cap beam, the vertical force caused by the weight of the deck shifted toward the edge of the cap beam, as shown in Figure 4.33. This behavior resulted in an additional moment that acted at the top of the column. Failure was initiated by the rupture of the FRP rods at the base of the column at 86 kips (382 kN), as shown in Figure 4.34. A larger moment developed at the base of the column due to the plastic hinge that formed at the top of the column and the large rotational stiffness of the footing. Figures 4.35 and 4.36 show the measured reinforcement strains on the north and south sides of the column. The maximum measured tensile strain at failure was 9300  $\mu\epsilon$  while the measured compressive strain was approximately 2700  $\mu\epsilon$ .

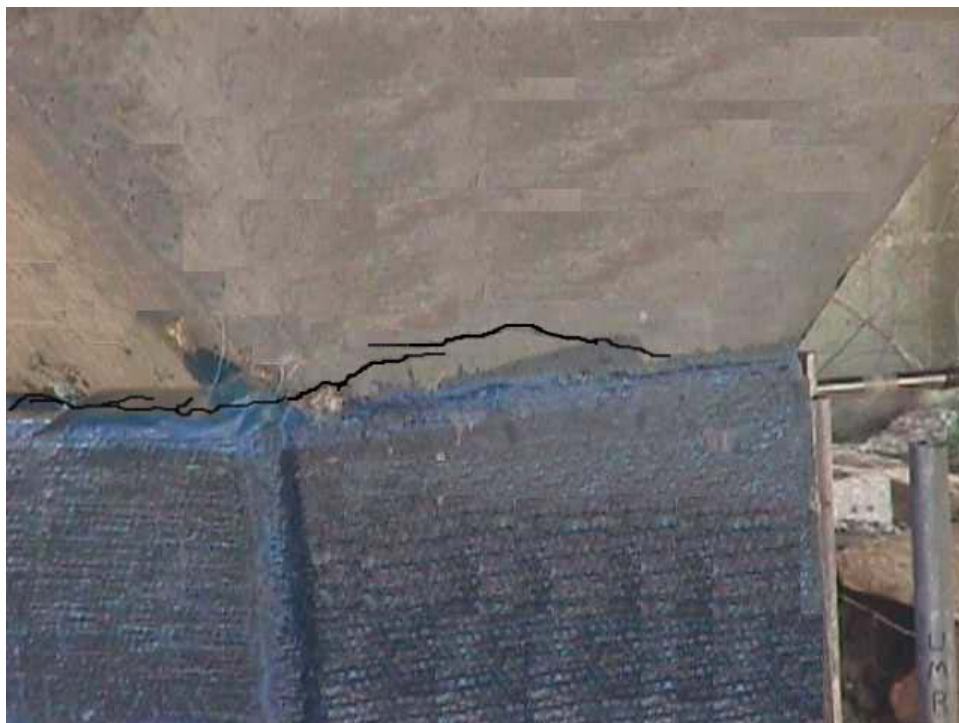
**Figure 4.33.** Crack at column/haunch intersection at failure.
