CENTER FOR INFRASTRUCTURE ENGINEERING STUDIES

SEISMIC RETROFIT OF CISS PILE BENT CAP CONNECTIONS

R86/R108

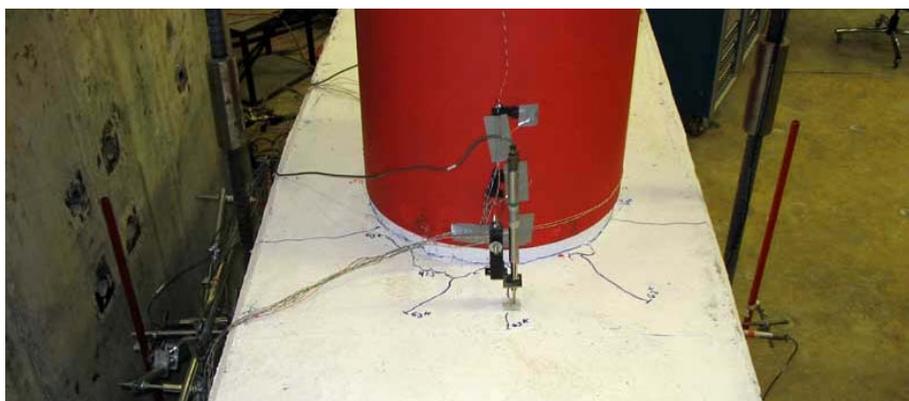
Figure 0-1. Bent Cap Cracking at 1.00V_y

During these four force controlled cycles, inception of first cracking was detected during loading to $0.50V_y$. Micro-cracks were recorded at the interface between the column and the bent cap and within the steel shell gap region. Next at $0.75V_y$, these cracks propagated entirely around the column footprint and remained within widths smaller than 2mm. Then, as shown in Figure 0-1 and Figure 0-2, at $1.00V_y$ cracks propagated into the bent cap in a pattern emanating perpendicular to the column footprint. This crack pattern is indicative of onset of yielding of the column longitudinal reinforcement at the bent cap interface and development of yielding penetration into the joint region. This observation by itself indicates strong correlation to the predicted response, indicating yielding of the longitudinal reinforcement at this load level. As such, testing was continued and the theoretical displacement at ductility level 1 was calculated according to Eq. (0-4).

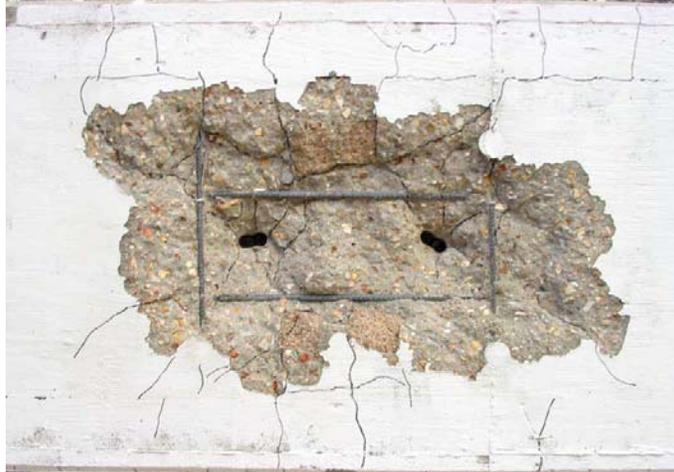
Figure 0-18. Underside of Bent Cap Ultimate Damage

extent of the cracking on the underside of the bent cap is shown in Figure 0-18. Further comparisons and discussions with Units 1 and 2 is discussed in Section 0.
