CENTER FOR INFRASTRUCTURE ENGINEERING STUDIES

Remote Health Monitoring of Hillsborough

County Bridges

**UTC
R141**

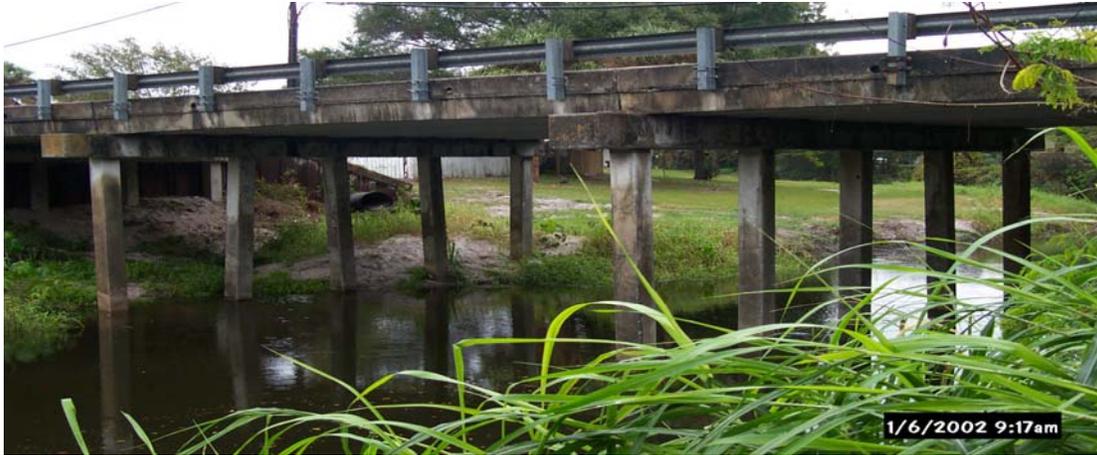
(a) Original Bridge

This section describes in details the construction of the East Bay bridge in Hillsborough county, the first smart bridge in the state of Florida. The installed remote sensing technique was conducted in accordance with the system described in the previous section. Hillsborough County decided to replace an existing concrete bridge with a cast-in-place reinforced concrete bridge on East Bay Drive in Gibsonton, Florida. The original bridge was a low profile concrete structure built in early 1970, and is shown in Fig. (3-a). The bridge was classified as functionally obsolete

due to severe deck cracking from frequent heavy traffic loading, corrosion of the longitudinal reinforcements, as well as due to its narrow width.

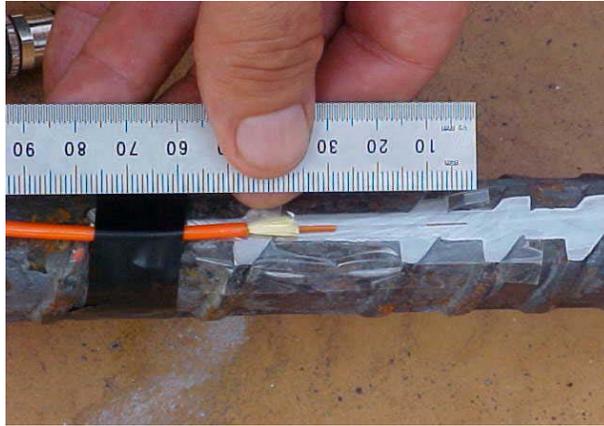
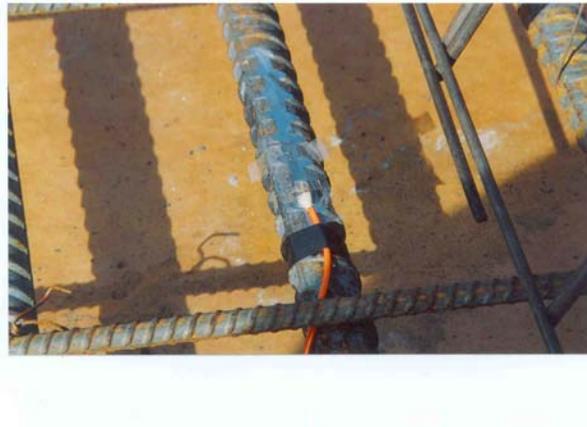
(a) Position of sensor on rebar

(b) Sensor bonded to rebar

FIGURE 5 Installation of sensors on rebars

An electric angle grinder connected to an inverter and to a car's battery was used to grind (mill) the surface of steel rebar flat. An area of approximately 3" long and 3/8" wide on #9 grade 60 rebar (deformed) was milled flat. A straight edge was used to verify the flatness of the area. The milled area was wiped with Isopropyl alcohol and rinsed liberally with M-prep Neutralizer 5A. The sensors were placed on the rebars and held down with electric tape, one inch away from micro capillary. A very small drop of 5 minutes epoxy was placed on the incoming fiber optic, approximately 1/8" from micro capillary. As soon as the 5-minute epoxy was cured, adhesives were prepared per the manufacturer's recommendation and were applied with a linear motion along the entire length of the gage. Figures (5-a) and (5-b) show a close view of the installation process of sensors on rebars.

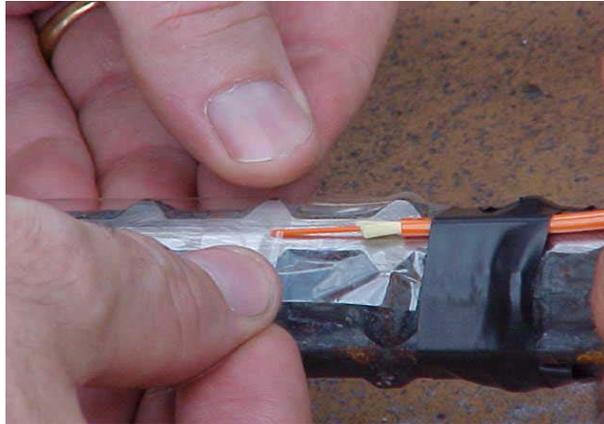
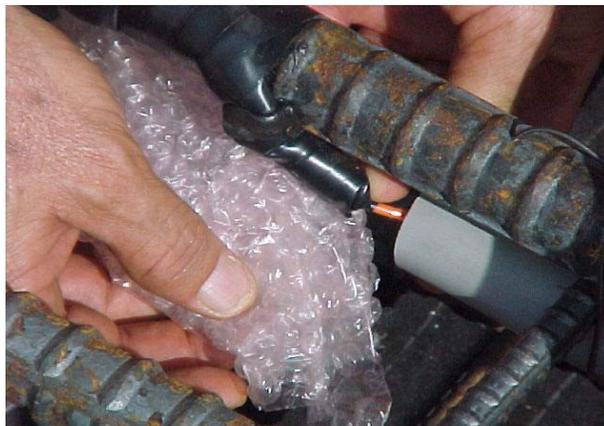
(a) Placing Mylar tape on sensor

(b) Sensor wrapped in Nitrite rubber

FIGURE 6 Protection of sensors on rebars

The remainder of adhesive was applied to the optical fiber up to the fiber jacket. For additional protection, an M-coat Protective coating was applied to the sensor. After this protective coating was dried, a rubberized waterproof sheet, nitrite rubber sheet was wrapped around the sensor. Immediately after application of adhesive over sensitive region of sensor, a piece of Mylar tape was placed over it to keep the sensor in good contact with surface of rebar. Figures (6-a) and (6-b) show the application of protective coating to sensitive region of gauge (M-coating), and application of nitrite rubber sheet over sensor and optical fiber.

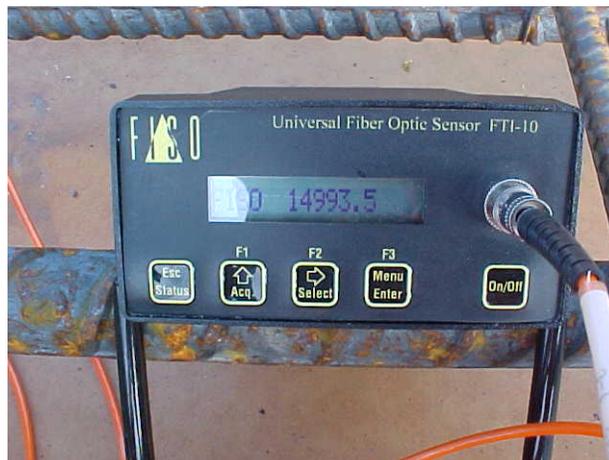
(c) Single channel data logger

Soon after sensors were bonded to rebars, FTI-10, a single channel data logger was used to test the sensors and verify they are properly bonded to the rebar surface, as shown in Fig. (6-c). The reading on the FTI-10 represents the cavity length of FOS-FP sensors in nm.

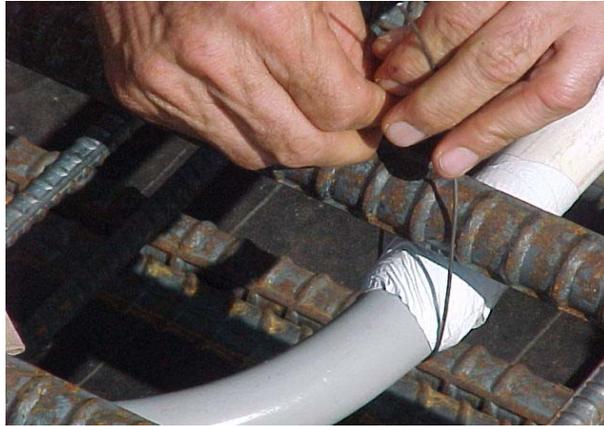
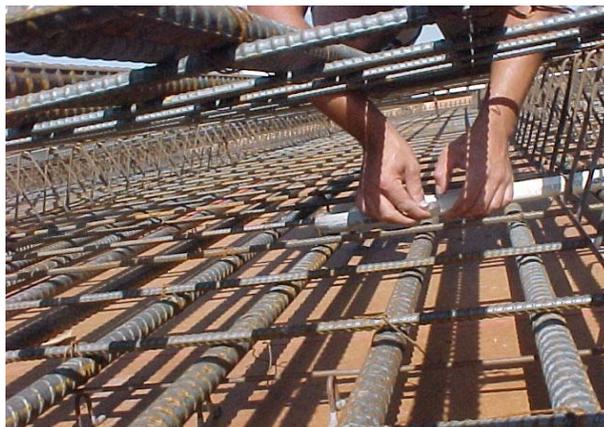
(a) Close view

(b) Plan view

FIGURE 7 PVC conduit protection

cables were inserted into one-inch diameter schedule 40 PVC pipe. The conduits were guided through the crowded rebar mats to the edge of slab. The openings in the conduits were sealed with nitrile rubber sheet and caulking. The conduits were tightly secured to rebars. Figures (7-a) and (7-b) illustrate this process.

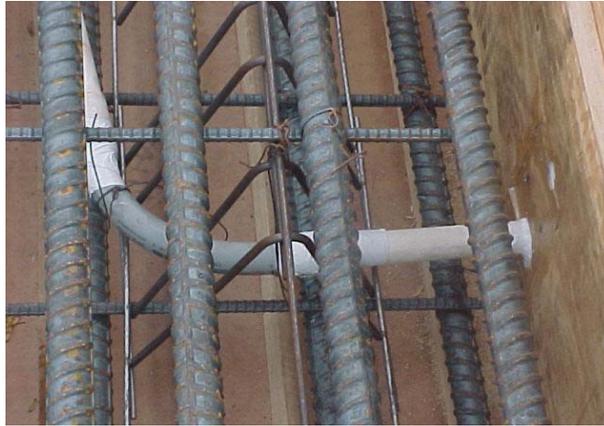
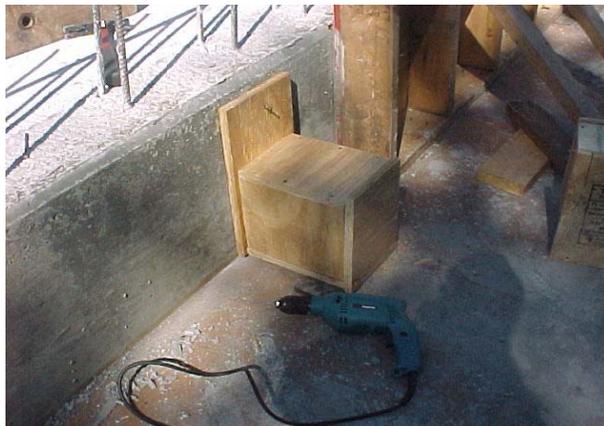
(a) Cable safely moved out of deck

(b) Box housing cables

FIGURE 8 Protection of Fiber Optic cables

Conduits containing fiber optic cables were brought onto the forms for the slab. At this area, the fiber optic cables are most vulnerable to the construction activities such as worker's traffic and placing and removing the forms. A 2" diameter hole was drilled out to allow the conduit to exit the slab. Three small boxes (12"x12"x12") were fabricated to house the cables at the point of exit. A larger piece of form around the conduit was cut out to allow slab's side form to be removed safely and without struggle. The process is illustrated in Figures (8-a) and (8-b). Other alternatives for the cables to exit the forms were evaluated. One option was at the bottom of slab at the abutment. However, removal of slab forms would have severed the cables during disassembling the forms.

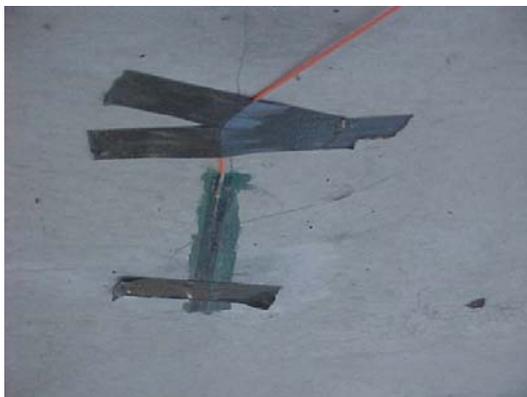
FIGURE 9 Surface-mounted sensors on bottom deck

Six FOS-B (blade) sensors were surface-mounted to the concrete deck, two on the top surface and four on the bottom. The sensors are designated as ASM, BSM, CSM and DSM as shown in Fig. (4-b). The bonding surface was sanded thoroughly using a 100 grids sandpaper to remove the latent and loose debris. The surface was sanded again using a 200 grids sand paper to provide a smooth bonding surface. The sanded surface was dusted and wiped off with non-lint paper tissues (facial tissue) wetted with 75% by volume isopropyl alcohol. The surface was wiped several times, each time with a new tissue and in one direction to avoid surface contamination. A thin layer of epoxy was evenly spread on the concrete and sensor was firmly placed against it. The sensor was held up with duct tape. The remainder of epoxy was spread on

the blade for extra protection, as shown in Figure (9). The process was repeated for two sensors surface-mounted to the top deck surface.

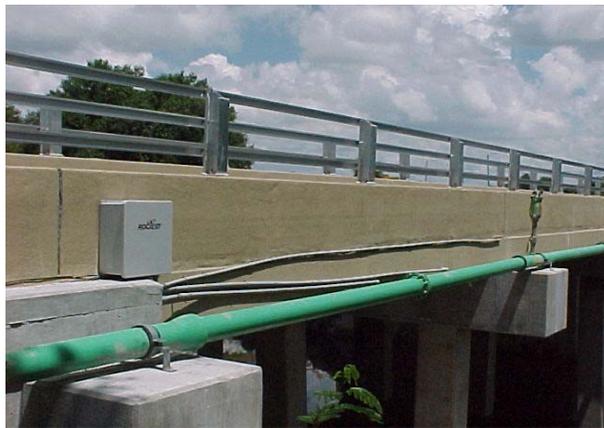
(a) Acquisition system DMI

(b) DMI and utility conduits

FIGURE 10 Housing of acquisition system

Conduits carrying the Fiber Optic cables were attached to the bridge with pipe clamps and tapcon screws. The acquisition system (DMI unit) was attached to the face of concrete parapet with tapcon screws, as shown in Figure (10-a). All conduits were attached to the side of bridge and to DMI case, as shown in Figure (10-b). The tip of each fiber optic cable was cleaned with cotton swap and alcohol thoroughly prior to connecting to DMI ports. The owner's tag was then attached to the DMI case, which was subsequently secured with a lock. The cost of the acquisition system (DMI unit) used with 16 channels is around \$14,000, which accounts for less than 1% of the overall cost of the bridge (\$1.5 Millions). The acquisition system weights only 4.8 Kg (10 lbs), and its sampling rate is 20 Hz.

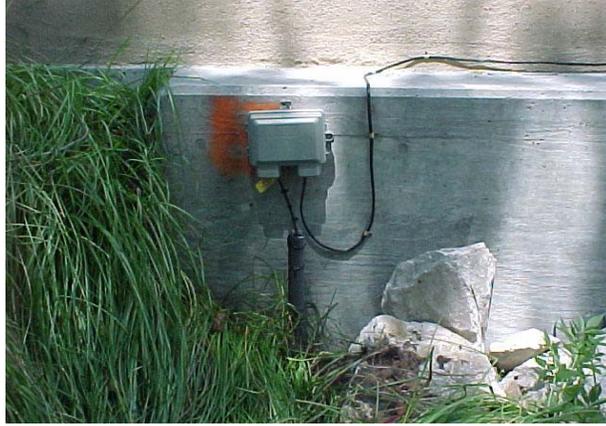
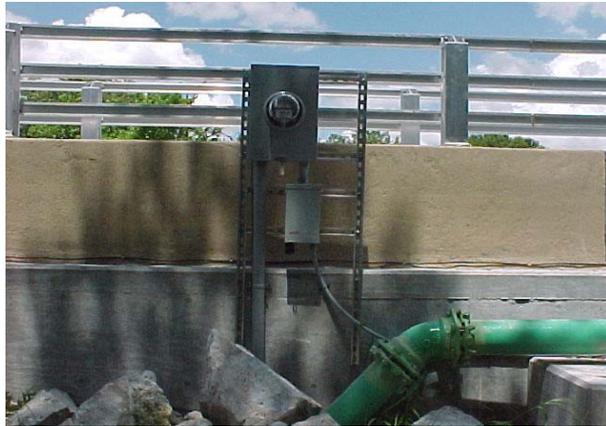
(a) Telephone box

(c) Electric meter and disconnect

FIGURE 11 Electric and phone supply

Remote communication with DMI is established via internal modem. DMI has a 12 volts rechargeable battery to power up the equipment. However, the life of battery during the operation is short. To operate DMI efficiently and continuously, telephone and electric services were required. Telephone and power lines were brought to the bridge from about 200 feet south of the structure. The lines were in conduits and buried 30 inches below the surface. Figures (11-a) and (11-b) show the installation of telephone box and electric meter.

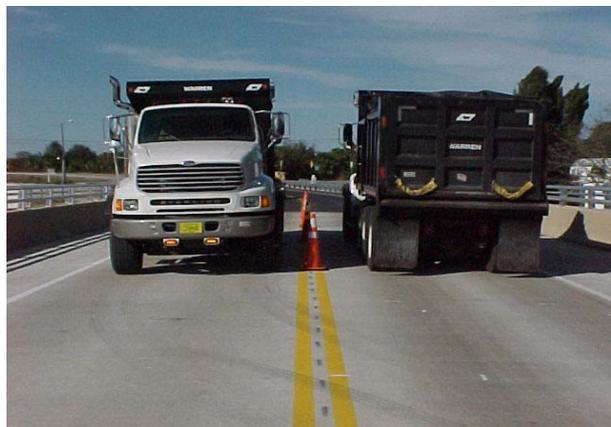
(a) Testing of bridge under SU4 trucks

In order to evaluate the accuracy of FP sensors, static and dynamic tests were performed on the bridge using single unit four axels SU4 trucks as shown in Fig. (12-a). SU4 trucks are
