The Effect of Fatigue on Understrength Shear-Critical Reinforced Concrete Beams Reinforced with External CFRP Stirrups

UTC
R144

**University Transportation Center Program
at the University of Missouri-Rolla**

Technical Report Documentation Page

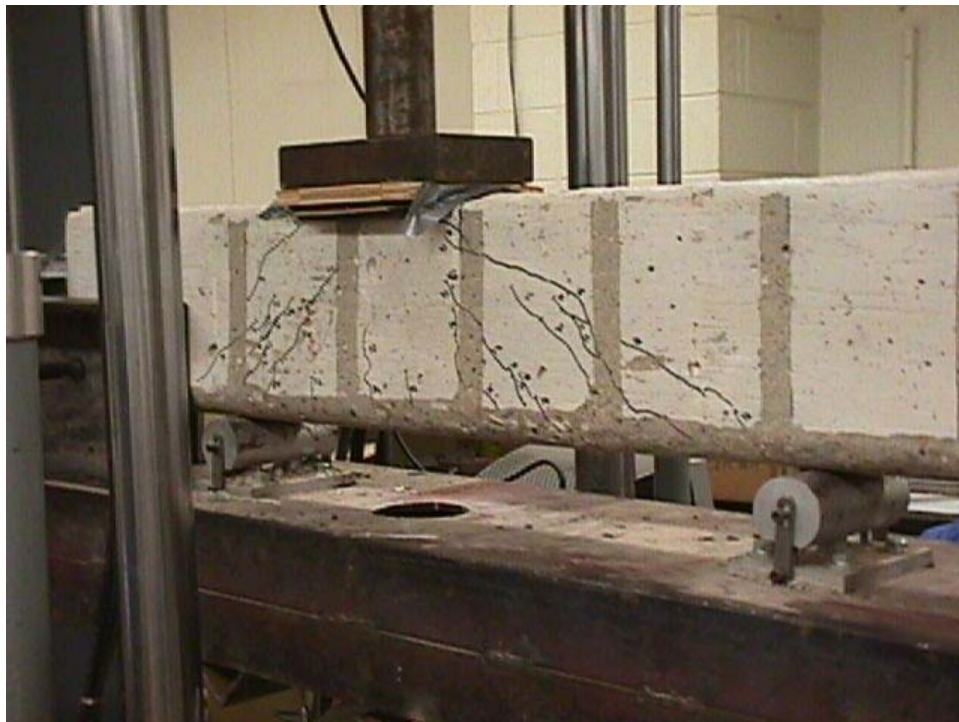
Fig. 2 – Test setup

The test rig consisted of a steel reaction beam with roller supports at 30", placed on a 55-kip MTS Universal Testing Machine. The geometry of the reaction beam and rollers was such that the load was applied at the specimens' 1/3 points. The load was applied by the UTM's ram through a masonry leveling pad and a thick steel plate. The beam lay directly on the rollers. This allowed local crushing but was deemed more acceptable than a bearing plate, which may have provided confinement and altered shear response.

Specimen and loading geometry are shown in Fig. 1. In the description and discussion of results, the part of the beam between the left-hand roller support (in Fig. 1) and the load application point is referred to as the high-shear region. The part of the beam to the right of the load point is called the low-shear region. The test setup is shown in Fig. 2.

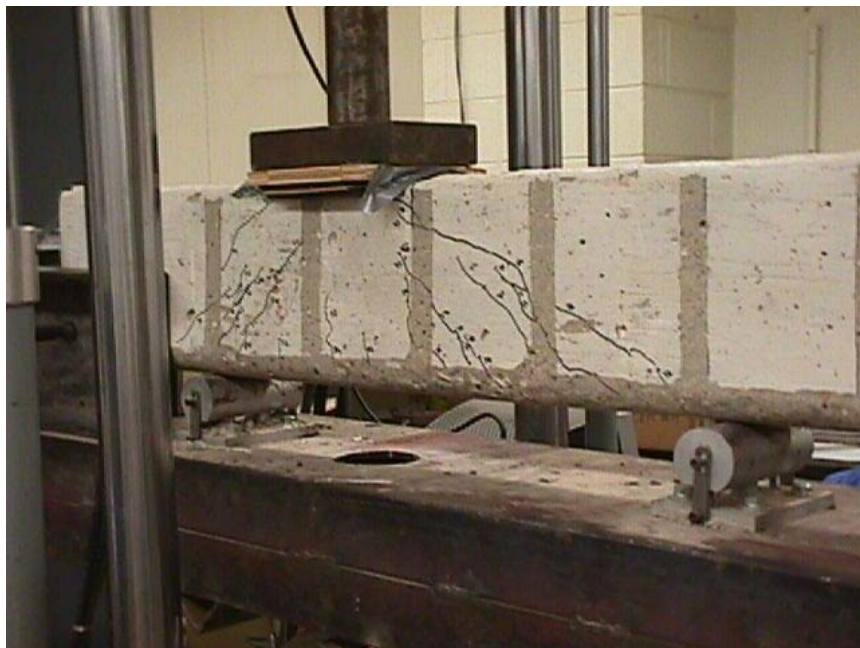
Fig. 4 – Crack patterns in Beam 1

shear region increased to a maximum of 0.01 in. On the lower-shear side of the beam, cracking was seen to be at a shallower inclination (about 30°), and the cracks were wider (maximum width of about 0.02 in). A typical crack pattern for an as-built beam is shown in Fig. 4.

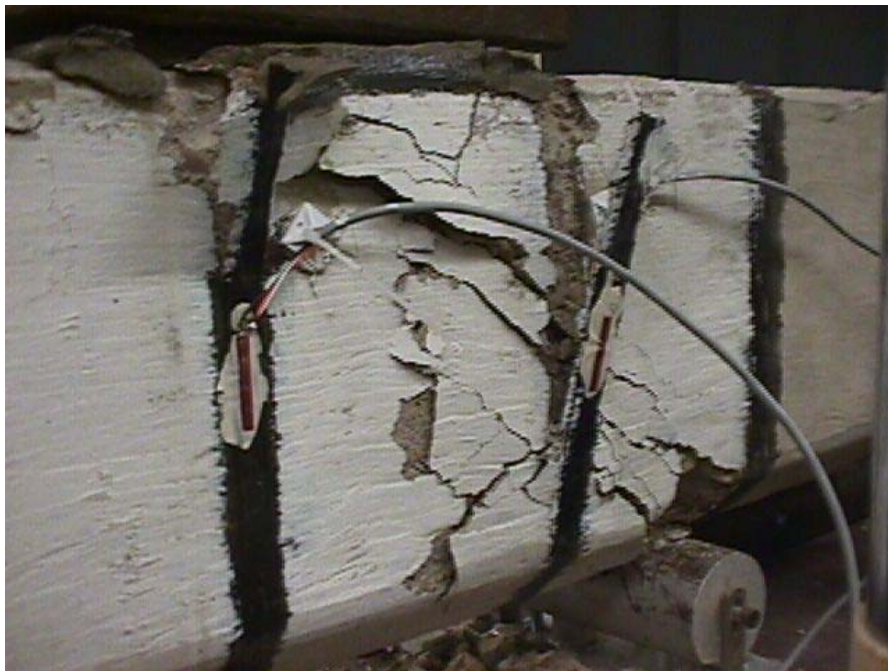
Fig. 13 – CFRP debonding in failure of Beam 3

Failure of Beam 3 came through rupture of the concrete under the CFRP reinforcement in the high-shear region, followed immediately by rupture of the associated steel stirrup. The concrete under the CFRP failed over about 75% of the beam depth.

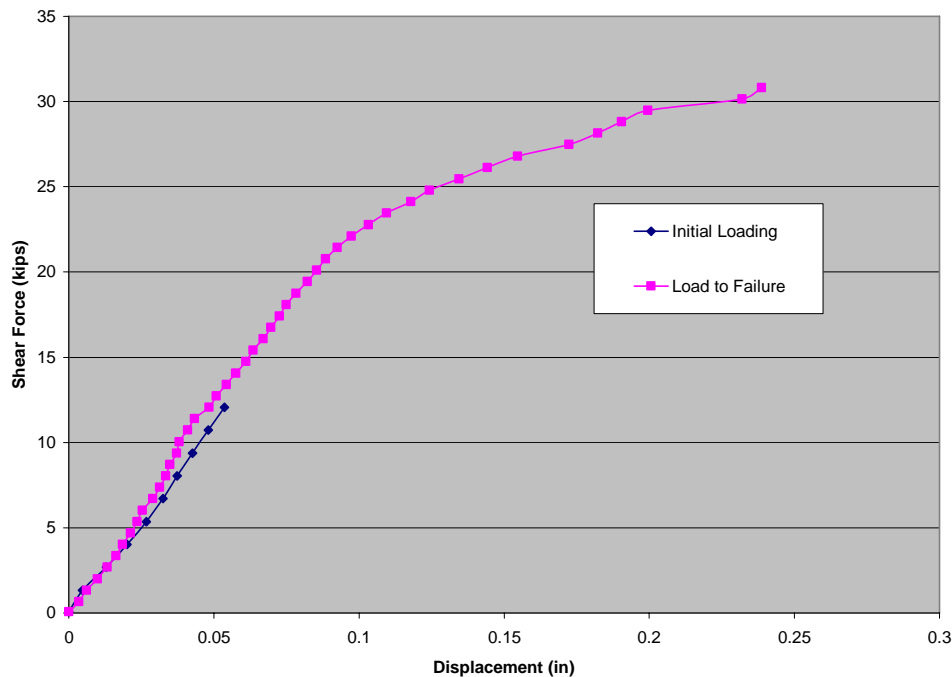
Fig. 14 – Beam 4 force-displacement (CFRP, initial quasi-static loading and quasi-static loading after 100k cycles)

The force-displacement response of Beam 4 is shown in Fig. 14. Beam 4, externally reinforced with CFRP, was initially loaded to first cracking, and then cycled 100,000 times from 1 kip to a load equivalent to 75% of the first cracking load. It was then loaded quasi-statically to failure. In the final loading there was a possible slight increase in stiffness at a load in the vicinity of the first cracking load, which may represent the carbon fiber being mobilized. At a shear load around 23 kips there was a definite reduction in stiffness; second slope stiffness is about half of the original value. This bilinear response continued until failure. The failure mode was fracture of the concrete for about 75% of the beam depth under the carbon-fiber strap in the high-shear region, followed by immediate rupture of the associated steel stirrup, as in Beam 3.

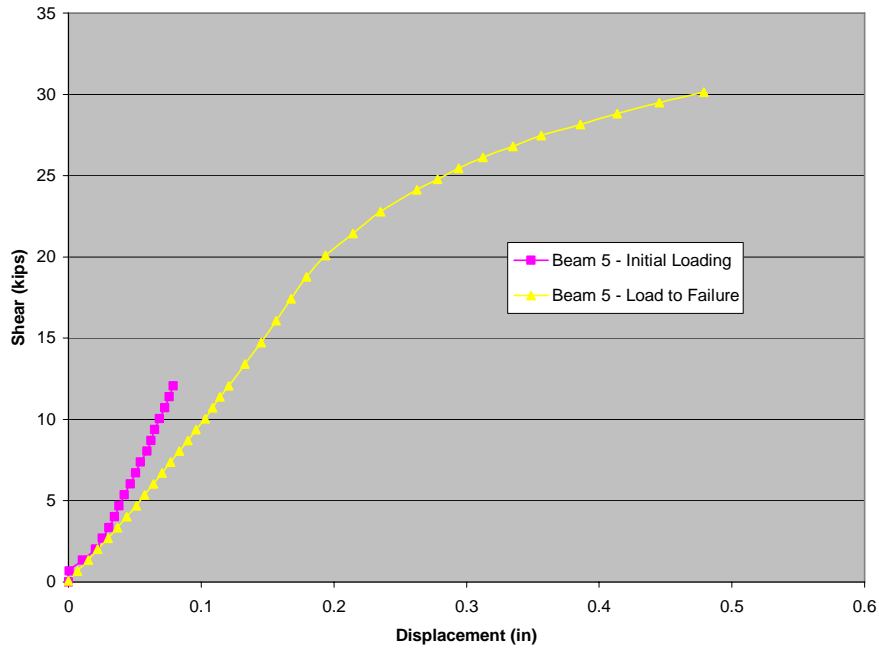
Fig. 16 – Beam 5 force-displacement (as-built, initial quasi-static loading and quasi-static loading after 1M cycles; failure at $V=31$ k, before displacement could be measured)

Beam 5 was an as-built beam. It was first loaded quasi-statically to first cracking, and then cycled 1,000,000 times at a load 75% of that which caused cracking. Its force-displacement response is shown in Fig. 16. Notable is the reduction in stiffness after cycling. The final loading of Beam 5 also produced a pronounced bilinear response.

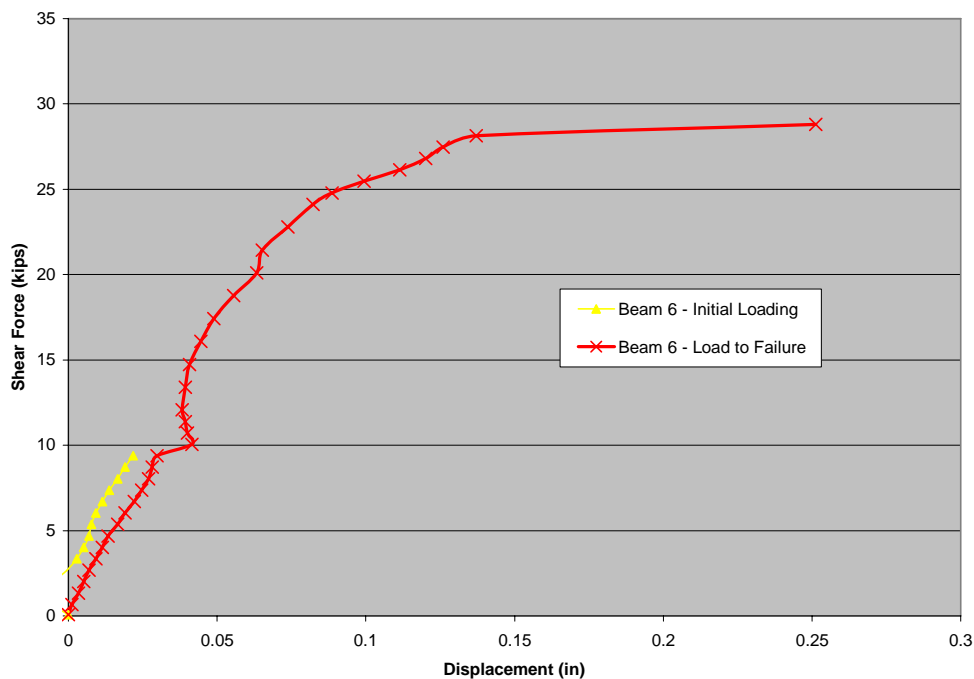
Fig. 18 - Beam 6 force-displacement (CFRP, initial static loading and static loading after 1,000,000 cycles)

The force-displacement response of Beam 6 is shown in Fig. 18. Beam 6 had external CFRP reinforcement. It was loaded quasi-statically to first cracking, and then cycled from 1 kip to 75% of the initial cracking load for 1,000,000 cycles. It was then loaded quasi-statically to failure. The response is clearly bilinear, and there is no discernable difference in stiffness between initial and final quasi-static loading. (The discontinuity at 10 kips in the final loading sequence is a measurement artifact.) The second-slope stiffness is much lower than that recorded in the as-built Beam 5. Since the reinforcement can be assumed to carry a large part of the shear in this part of the loading sequence, this can be assumed to indicate the lower stiffness of the CFRP when compared to steel.
