## **Geotechnical Site Characterization of Transportation Construction Sites and Structures**

*Assessment Of Karst Activity At Highway  
Construction Sites In Greene And Jefferson Counties,  
Missouri, Using The Electrical Resistivity Method*

1. Report No. <b>UTC R161</b>	2. Government Accession No.	3. Recipient's Catalog No.	
4. Title and Subtitle <b>Geotechnical Site Characterization of Transportation Construction Sites and Structures: Assessment Of Karst Activity At Highway Construction Sites In Greene And Jefferson Counties, Missouri, Using The Electrical Resistivity Method</b>		5. Report Date <b>May 2007</b>	6. Performing Organization Code

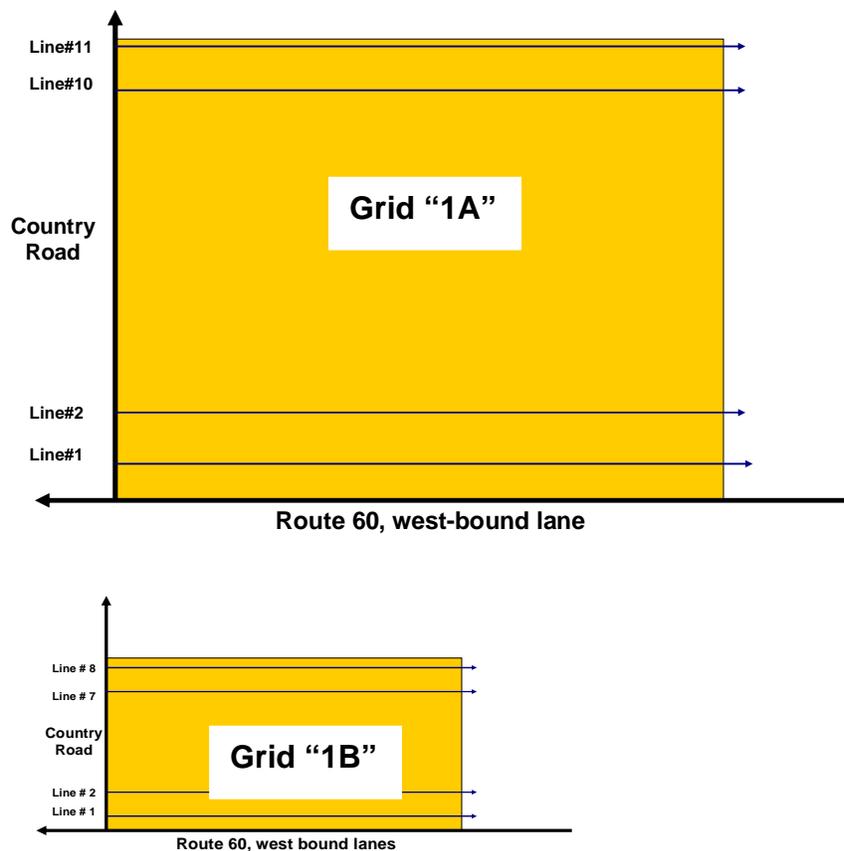
Figure 4: Two grids of electrical resistivity profiles were acquired at the Greene County site. Grid "1A" data, consisting of 11 profiles spaced at 25 ft intervals, were acquired using 68 electrodes spaced at 5 ft intervals. Grid "1B" data, consisting of 8 profiles spaced at 10 ft intervals were acquired using 40 electrodes spaced at 3 ft intervals.

The district geologist was concerned that the small active sinkholes might be connected to one or more larger air-filled voids that could compromise the integrity of the planned intersection and authorized the acquisition of two grids of electrical resistivity profiles (grids "1A" and "1B"; Figure 4). The primary objective was to locate any and all substantive air-filled cavities. It was anticipated that such cavities would have developed along solution-widened joints, so the resistivity profiles were oriented west-east (W-E) effectively perpendicular to the NNW-trending dominant joint system (Figure 4).

Resistivity grid "1A" consisted of 11 W-E traverses, spaced at 25 ft intervals (Figure 4). The grid encompasses the current Route 60 ROW, the current Route 125 ROW and the area across which a planned westbound Route 60 exit ramp will extend. The 2-D profiles were acquired using a 68-channel SuperSting Resistivity unit, a dipole-dipole array configuration and an electrode spacing of 5 ft. Representative 2-D profiles are displayed as Figures 5, 6 and 7. The processed profiles consist of rectangular pixels with widths of 5 ft and heights that vary from 2 ft (minimum depth) to 5 ft (maximum depth). During processing each pixel was assigned an average "resistivity" value. The pixel size is one estimate of the upper end of spatial resolution.

The second grid (grid "1B") of resistivity profiles acquired at the Greene County site Resistivity grid "1B" consisted of 8 W-E traverses, spaced at 10 ft intervals (Figure 4). The grid encompasses the current Route 60 ROW. These 2-D profiles were acquired using a 40-channel SuperSting Resistivity unit with a dipole-dipole array configuration. However, an electrode spacing of 3 ft. was employed, providing for better spatial resolution but less depth of investigation. For comparison purposes, a representative grid "1B" 2-D profile and the corresponding grid "1A" profile are presented as Figure 10. The two profiles appear to correlate very well, the grid "1B" data simply providing better resolution but less depth of investigation. There was no evidence of substantive air-filled voids on any of the grid "1B" profiles.

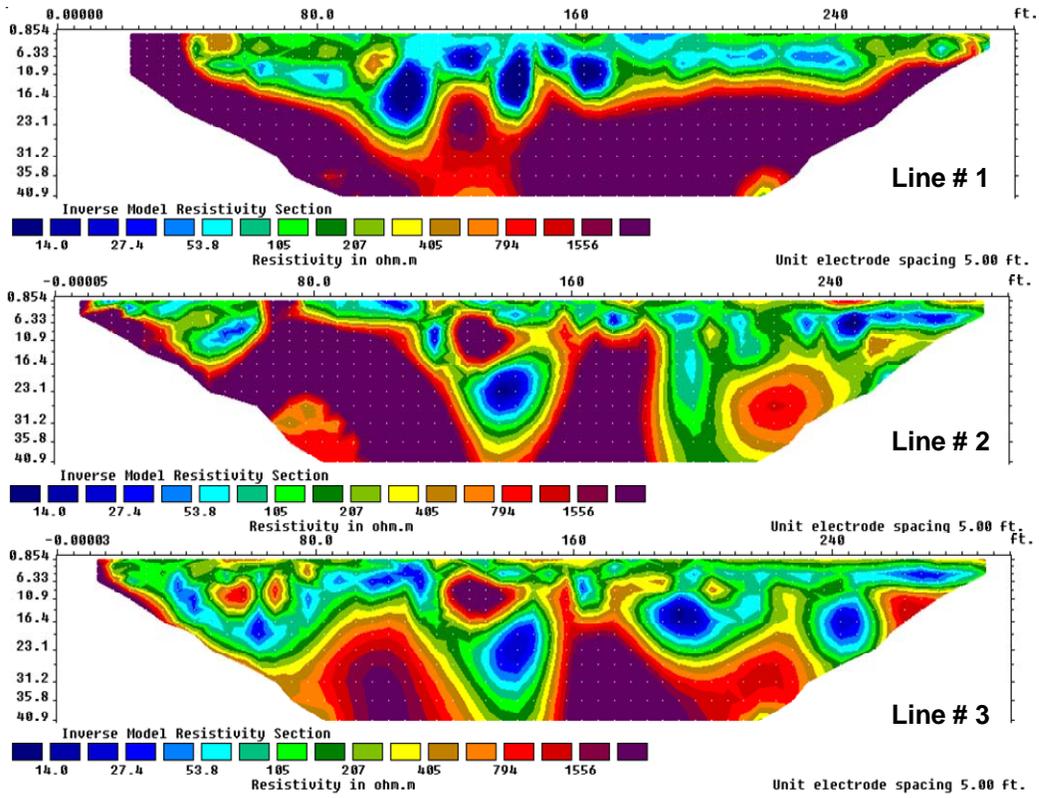
Figure 5: Grid "1A" electrical resistivity profiles 1, 2 and 3 (Figure 4).

The interpretation of the resistivity profiles was relatively straightforward in terms of differentiating and mapping lithologic units. Units with resistivities greater than 405 ohm-m were mapped as limestone; units with resistivities less than 105 ohm-m were mapped as moist soil or clay; units with resistivities greater than 105 ohm-m but less than 405 ohm-m were interpreted as transitional zones probably consisting of moderately to intensely fractured and/or weathered limestone with clay in-fill (Figures 5, 6 and 7).

The interpretation of the resistivity data was used to generate a geologic model of the study area. The model consists of a basal limestone unit which constitutes geophysical bedrock (Figure 8). The depth to the top of geophysical bedrock varies from ground surface (e.g. west end of profile 1; Figures 5 and 8) to in excess of 40 ft (e.g. profile 6; Figures 6 and 8). This bedrock unit appears to be dissected by at least four prominent solution-widened NNW-trending joints (Figure 8). The solution-widened joints of most concern to MoDOT are those that underlie the planned westbound off-ramp. These features are of concern because they are in-filled with thick clays that could densify or be subject to piping under load.

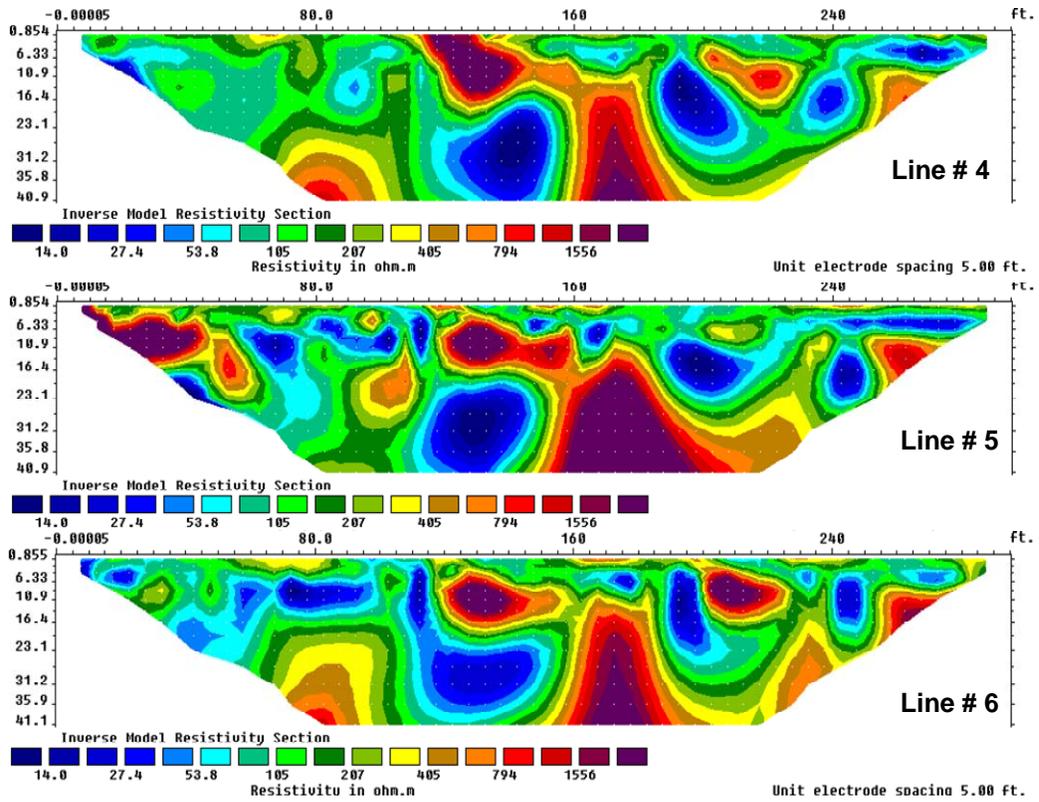
Figure 6: Grid "1A" electrical resistivity profiles 4, 5 and 6 (Figure 4).

Bedrock is interpreted as overlain by soil or clay, and in places (e.g. profile 6; Figures 6 and 9) by relatively continuous limestone lenses (outliers) and intervening clay. The limestone outliers are interpreted as the remnants of karstic processes.

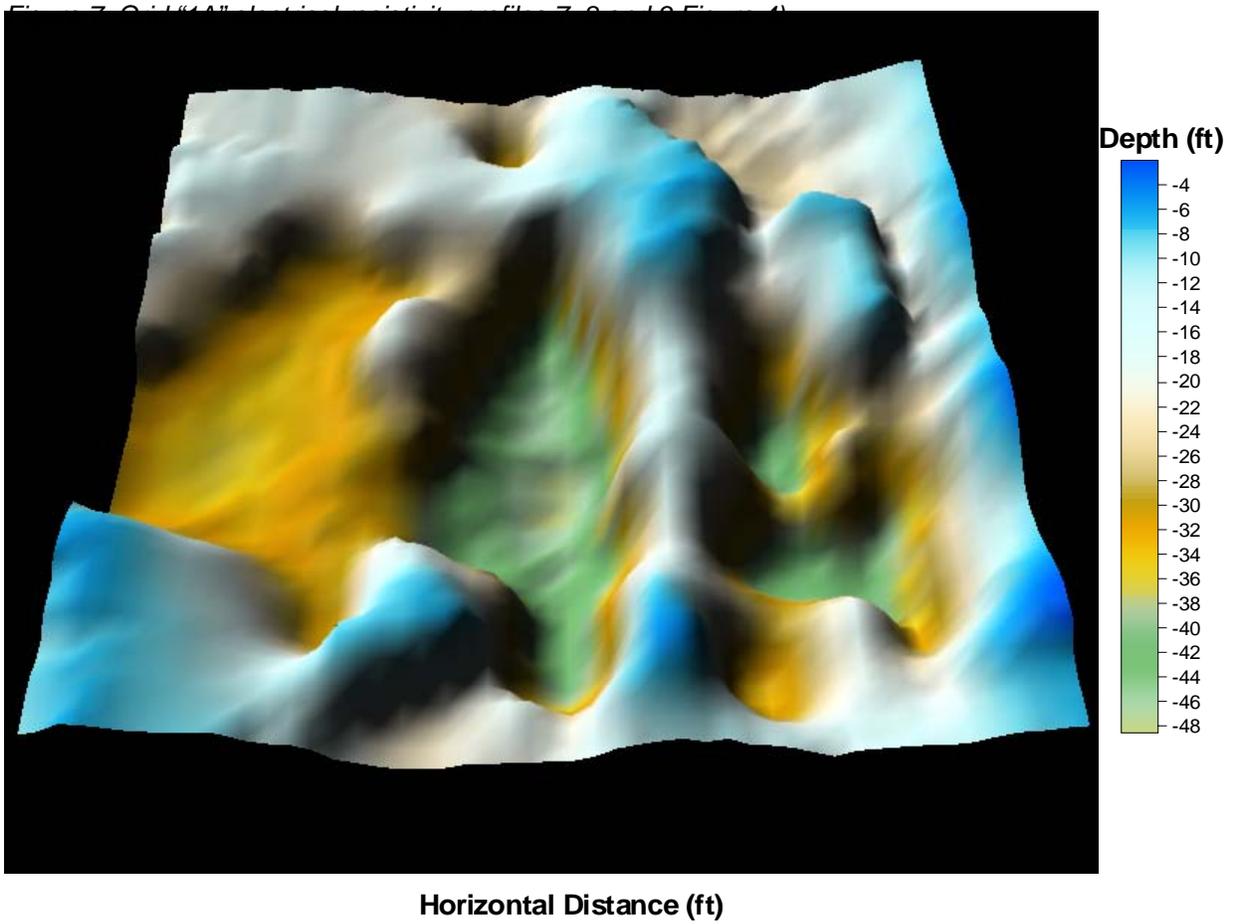
Figure 8: Grid "1A" contour map showing interpreted depth to bedrock.

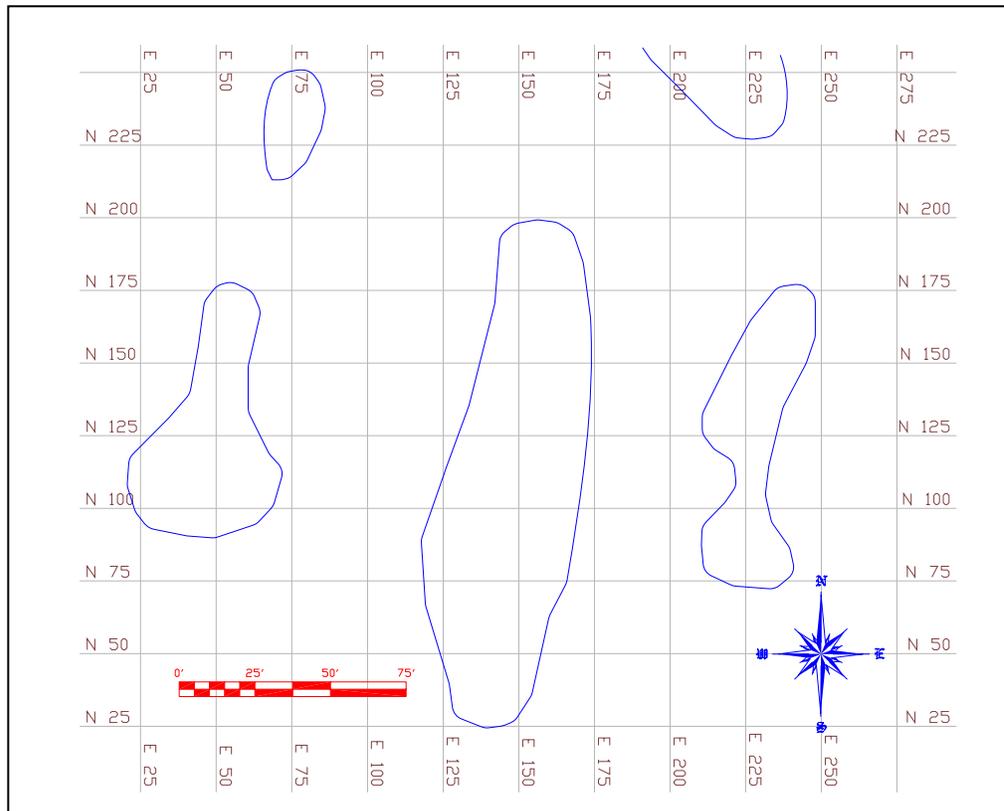
*Figure 9: Grid "1A" map showing interpreted location of shallow limestone lenses.*

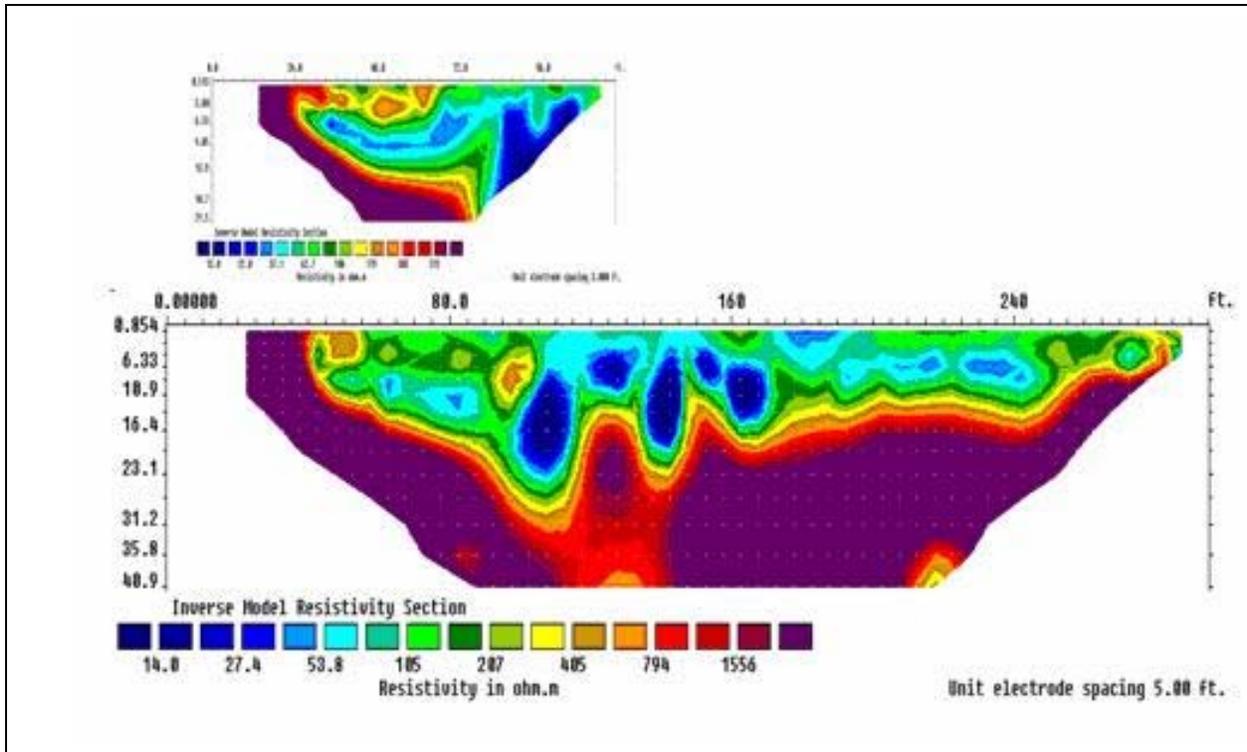
Figure 10: Comparison grid "1A" electrical resistivity profile 1 and grid "1B" electrical resistivity profile 1.

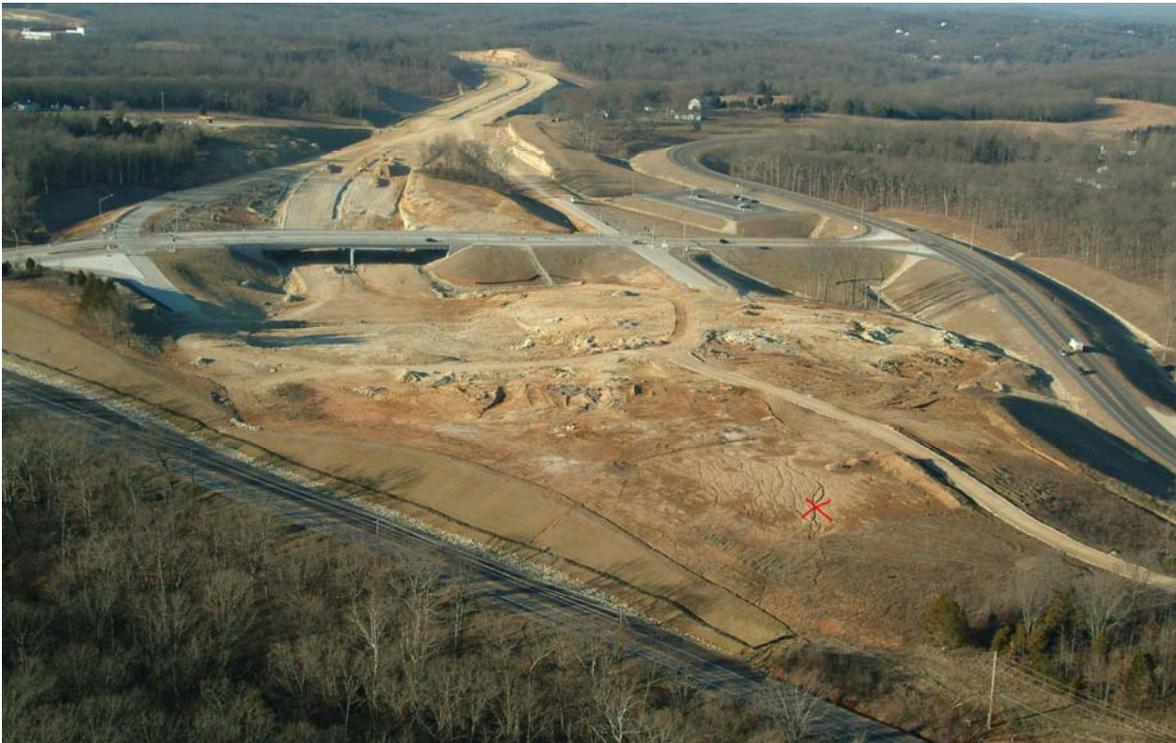
Figure 11: Aerial photograph of the Jefferson County site, prior to the “emptying” of the sinkhole. The approximate location of the sinkhole has been superposed on the photograph.

Jefferson County Site #2 encompasses the northbound lanes of new Route 21, approximately 0.4 miles north of the existing interchange of Route A and new Route 21 (Figures 1 and 3). A relatively dense grid of electrical resistivity data was also acquired at this site because a large clay-filled previously-identified oval-shaped sinkhole (Figures 11-14) near the centerline of the northbound lanes emptied overnight. The "emptying" of the sinkhole was preceded by the stripping of topsoil (to limestone bedrock in much of the study area) and heavy rains, the run-off from which was channeled towards the sinkhole by pre-existing topography on the top of recently exposed rock.

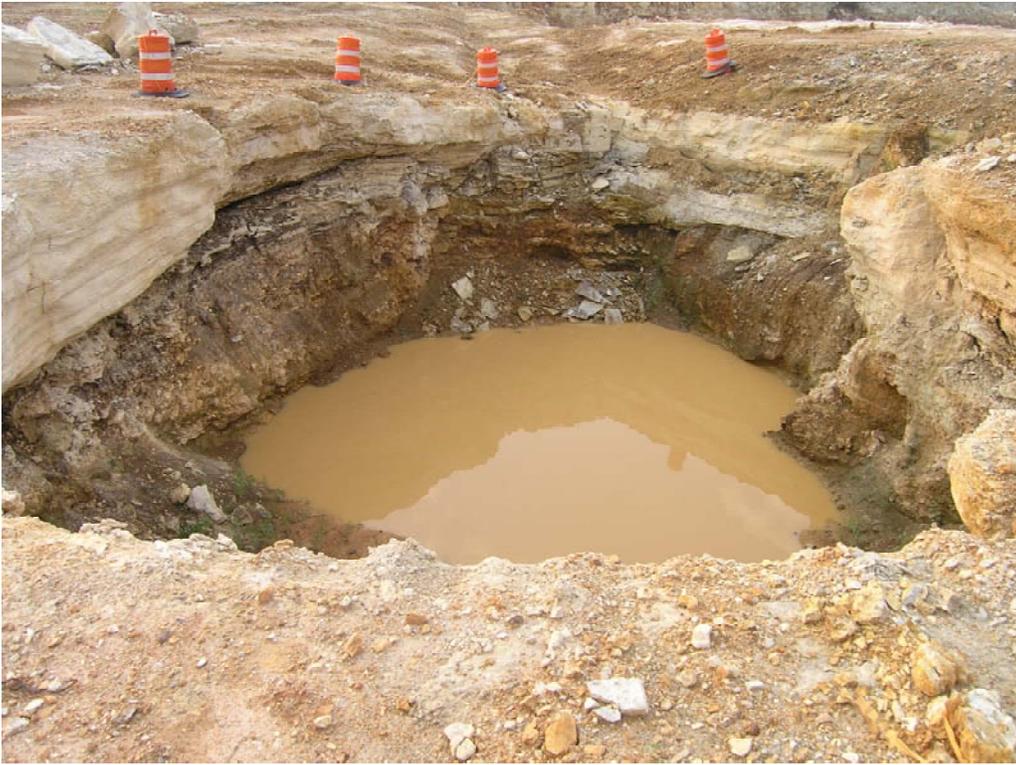
Figure 12: Photograph of the sinkhole, taken from a location immediately to the south of the feature.

The "emptied" sinkhole was oval-shaped, approximately 50 ft long, 35 ft wide and 15 ft deep (top of ponded water to top of sinkhole). The base of the sinkhole was not visible because it was covered with up to 2 ft of ponded water and up to 2 feet of soft clay which proved to have sufficient strength to support 8 ft long vertically-imbedded copper electrical resistivity electrodes (Figures 12-14).

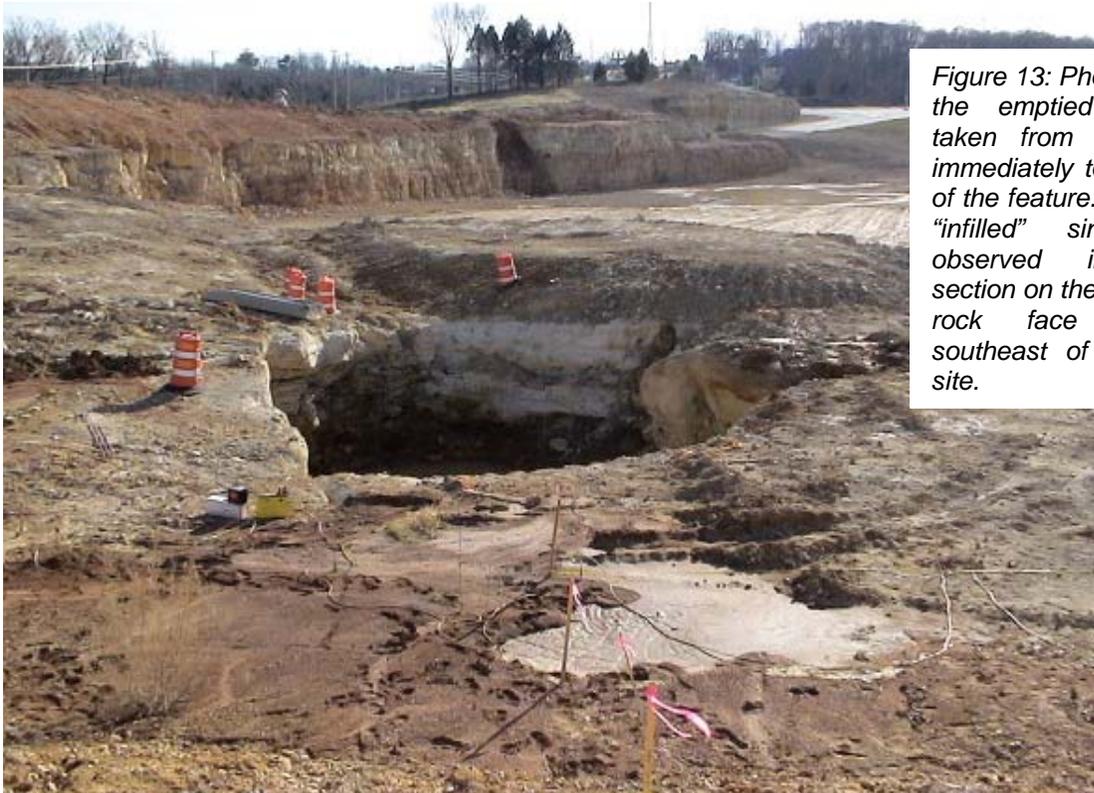
Figure 13: Photograph of the emptied sinkhole, taken from a location immediately to the north of the feature. A second “infilled” sinkhole is observed in cross-section on the excavated rock face to the southeast of the study site.

Visually, the "emptied" sinkhole appeared similar to a second clay-filled sinkhole located several hundred feet to the southeast, near the eastern edge of the construction site (Figures 13 and 15). This second sinkhole had been essentially dissected by excavation equipment, and in cross-section appeared to have near-vertical walls and a relatively flat base comprised of intact limestone (Figure 15).

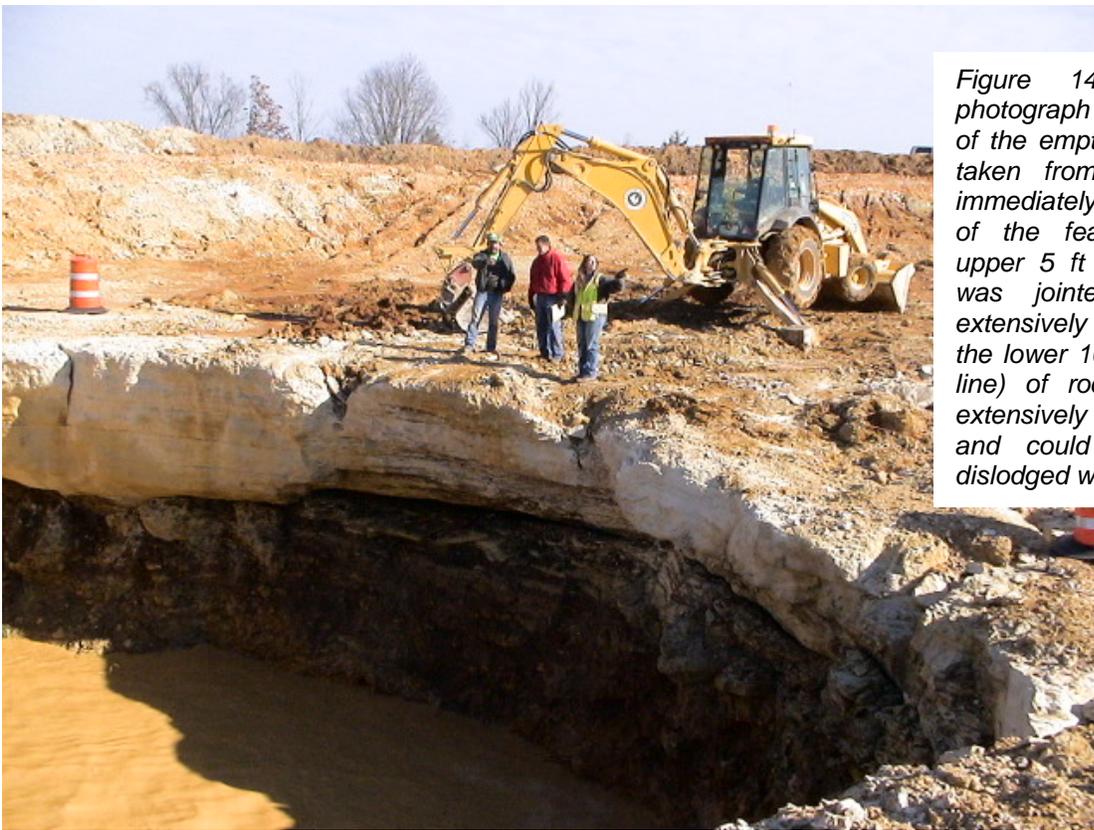
Figure 14: Close-up photograph of the walls of the emptied sinkhole, taken from a location immediately to the south of the feature. The upper 5 ft of rock wall was jointed but not extensively fractured; the lower 10 ft (to water line) of rock wall was extensively fractured and could be readily dislodged with a shovel.

The walls of the "emptied" sinkhole were both steep and weathered, supporting the thesis that the sinkhole was a pre-existing feature that had been rapidly emptied of clay, rather than a newly-developed catastrophic collapse feature (Figure 14). The upper ~5 ft of exposed "cap" rock was dissected in places by prominent NNW-trending and near-orthogonal solution-widened joints, but was otherwise relatively intact; the lower ~10 ft of exposed rock was much more intensely jointed and weathered.

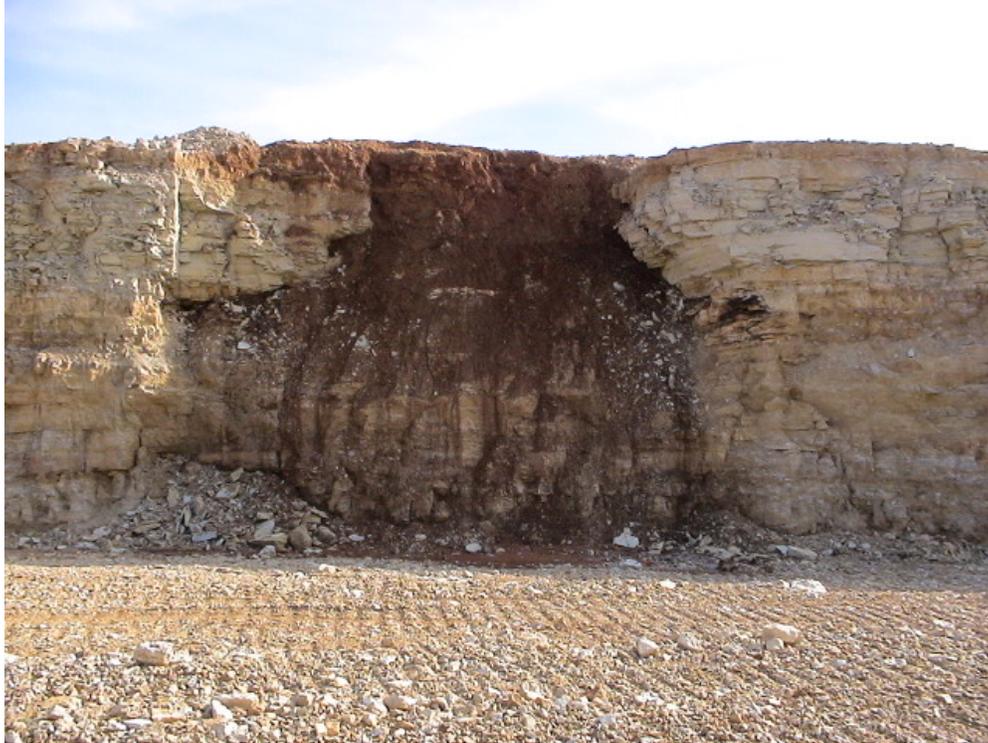
*Figure 15: Close-up of second in-filled sinkhole, located approximately 500 ft SSE of the “emptied” sinkhole. The walls of the second sinkhole were fairly steep; the base was relatively flat.*

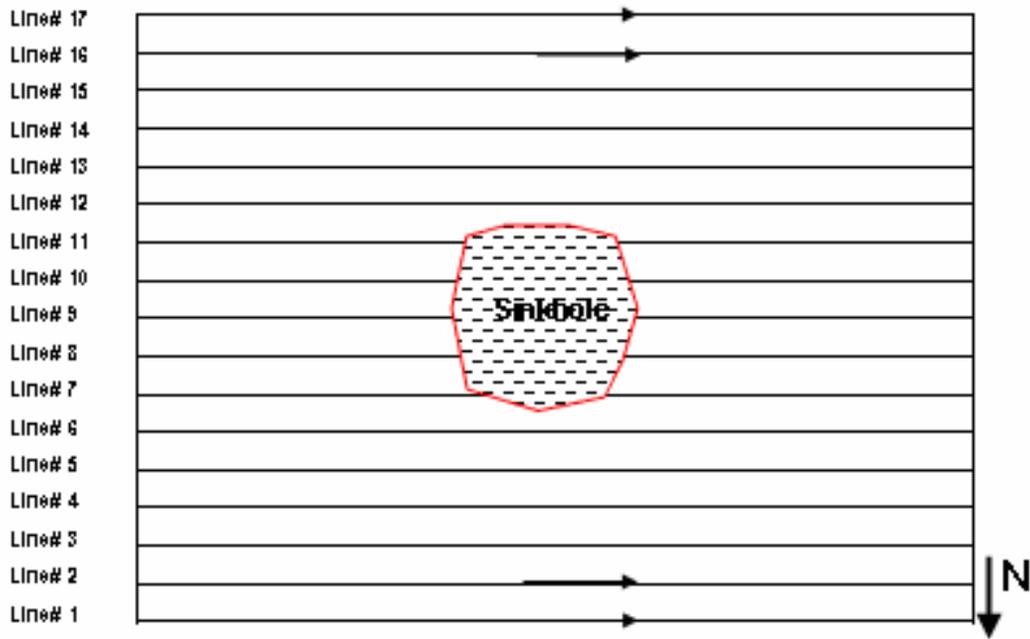
Figure 16: A single grid of electrical resistivity profiles was acquired at the Jefferson County site. The grid consisting of 17 profiles spaced at 25 ft intervals, were acquired using an electrode spacing of 12 ft.

In an effort to image the subsurface below and in proximity to the “emptied” sinkhole to depths on the order of 80 ft, the supervising MoDOT geologist authorized the acquisition of a grid of electrical resistivity profiles (Figure 16). The resistivity profiles were oriented west-east (W-E) effectively perpendicular to the long axis of the oval-shaped sinkhole and the most prominent solution-widened joints, both of which trend northnorthwest. Profiles 1-17 were 420 ft long and spaced at 20 ft intervals. The resistivity data were acquired using a SuperSting resistivity unit with an electrode spacing of 12 ft. A suite of representative electrical resistivity profiles are presented as Figures 17, 18 and 19.

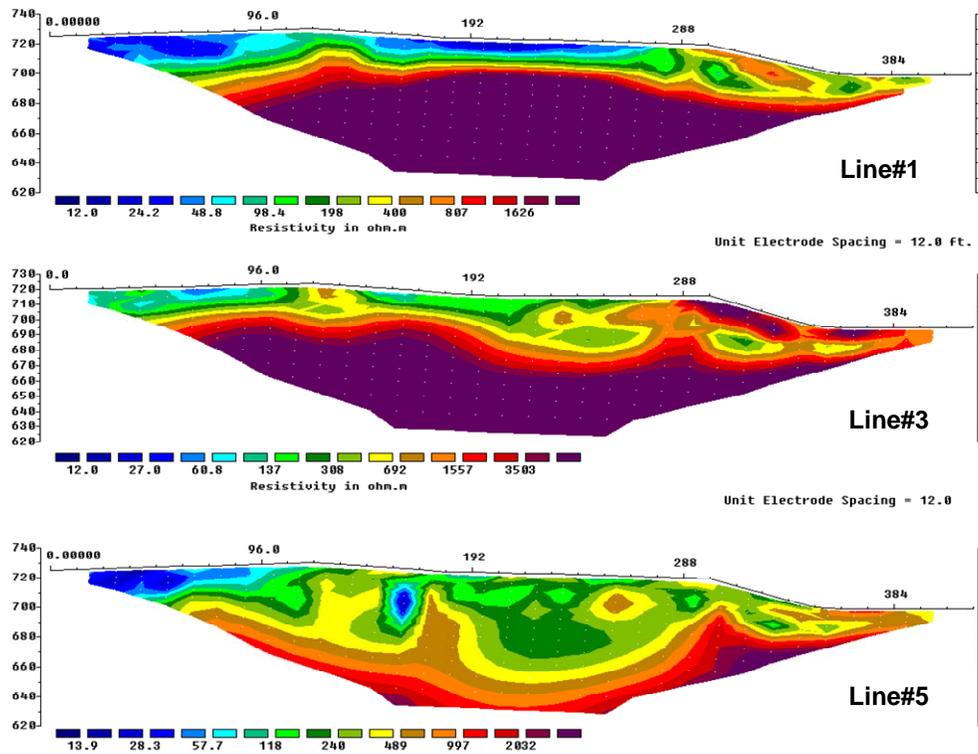
Figure 17: Electrical resistivity profiles 1, 3 and 5.

The uppermost ~20 ft of the subsurface in proximity and to the immediate south to the sinkhole is characterized mostly by resistivities of between 100 ohm-m and 400 ohm-m (Figures 17, 18 and 19). Lower resistivities are observed at the base of the sinkhole, presumably because of the presence of saturated clay and ponded water. Localized lenses of higher resistivity (>400 ohm-m) are observed in the shallowest subsurface (depths <10 ft). Overall, these resistivity values and patterns are very consistent with visual observations at the sinkhole, where remnant surficial soil and ~5 ft of jointed limestone overly at least ~10 ft of intensely weathered rock.

At depths below 20 ft, bedrock beneath and adjacent to the sinkhole (except immediately to the north of the feature) is characterized by resistivities in excess of 400 ohm-m, but less than 2000 ohm-m (Figure 17, 18 and 19). These resistivity values support the interpretation that the sinkhole is not underlain by either a large air- or fluid-filled cavity.

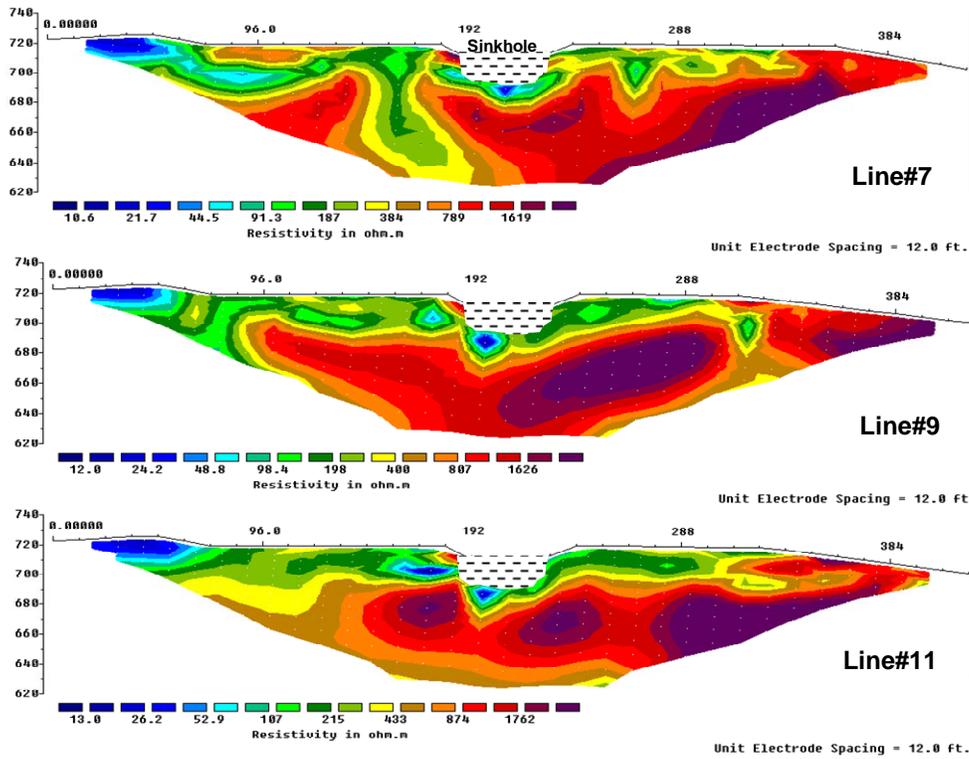
Figure 18: Electrical resistivity profiles 7, 9 and 11.

The subsurface immediately to the north and northeast of the sinkhole is characterized by a different pattern of resistivity values. More specifically, a vertical-trending narrow (<10 ft wide) zone consisting of anomalously low resistivity values (between ~127 and 400 ohm-m) is observed immediately to the east of the sinkhole on profile 8 (Figure 18). This feature is interpreted as a prominent clay-filled solution-widened joint or zone of intensely fractured rock with clay-infill, and extends across profiles 7, 6 and 5. A prominent zone of relatively low resistivities is also observed at depths of between 40 ft and 70 ft on profile 6 immediately to the north of the sinkhole (Figure 18).

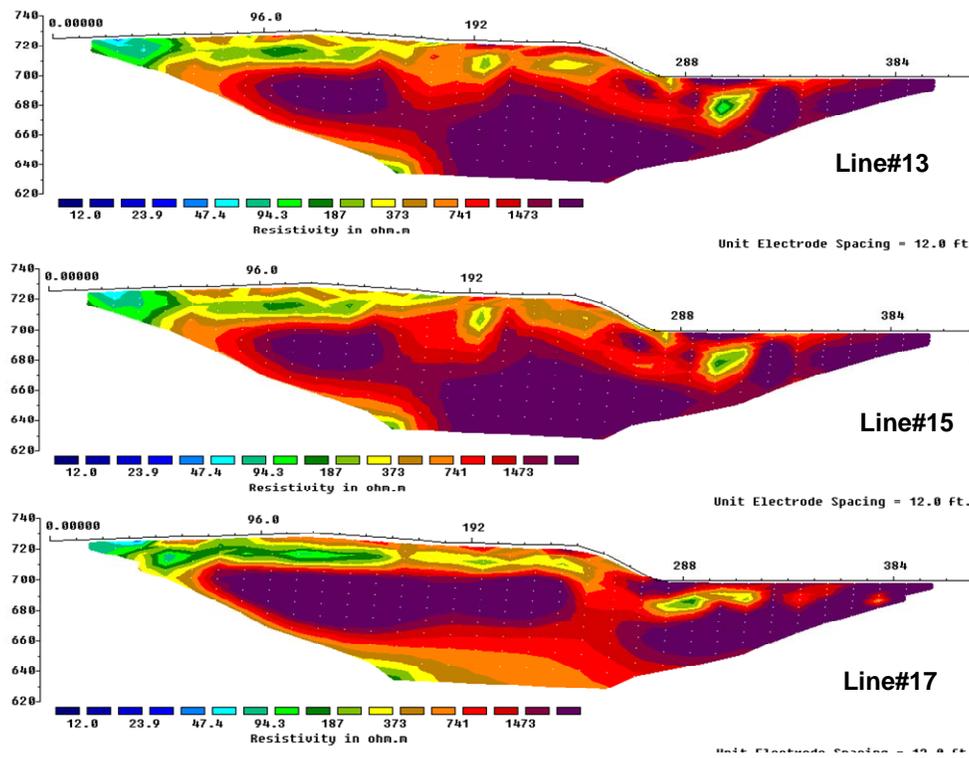
Figure 19: Electrical resistivity profiles 13, 15 and 17.
