In-situ load testing of Bridge A6358 Osage Beach, MO

**UTC
R124-3**

**IN-SITU LOAD TESTING OF BRIDGE A6358
OSAGE BEACH, MO**

PREPARED FOR THE
MISSOURI DEPARTMENT OF TRANSPORTATION

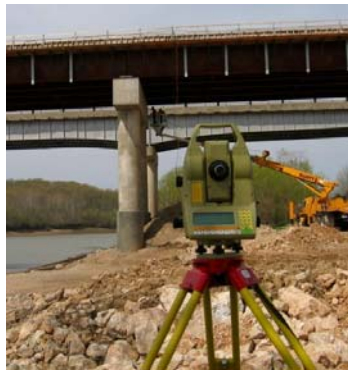
a) Total station

The Automated Total Station (ATS) system used in this project is based on the Leica TCA2003 TS, shown in Figure 4a. The instrument sends a laser ray to reflecting prisms mounted on the structure (Figure 4b) to be monitored. By triangulation with fixed reference points placed outside the structure, the built-in computer can determine the movements of each prism with an accuracy of 0.5" on angular measurements and 0.04 in + 1 ppm on distance measurements, in average weather conditions.

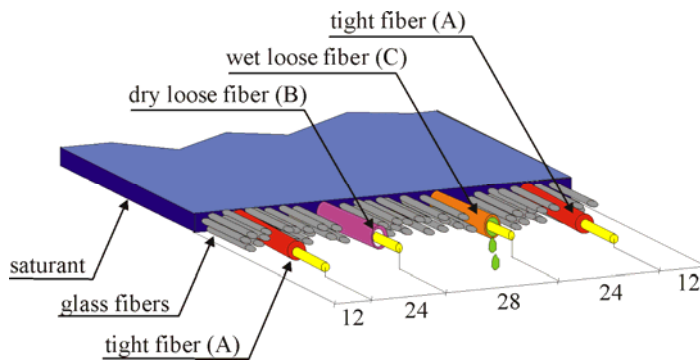
In order to facilitate the installation and reduce the risk of damaging the fibers, an FRP tape with embedded sensing fibers was designed and manufactured. The tape, which is woven from E-glass fiber strands with a 435 g/m² warp and a 68 TEX weft, has a width of 100 mm and carries two strain-sensing and two temperature-sensing fibers (Figure 10).

a) Schematic with location of embedded sensing fibers (dimensions in mm)

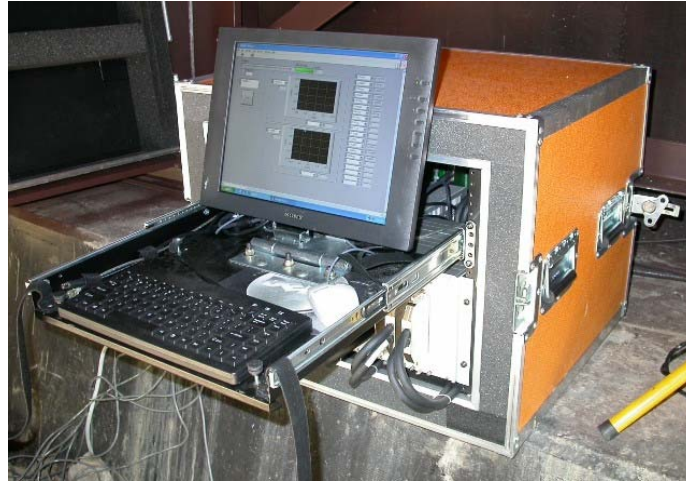
Figure 11 – Portable data acquisition system (“Orange Box”)

The unit consists of a shock-mounted transport box, with removable front and rear covers. Removal of the front cover exposes the computer keyboard and LED display, as well as the front panel of the data acquisition equipment. Removal of the back panel exposes the connector bay, where cables from all the transducers terminate.

A portable data acquisition unit, custom-manufactured at UMR and suitable for use in field testing of structures (see Figure 11), was used for signal conditioning of the strain gauges installed on the girders to provide a reference data for comparison with the results from BOTDR.

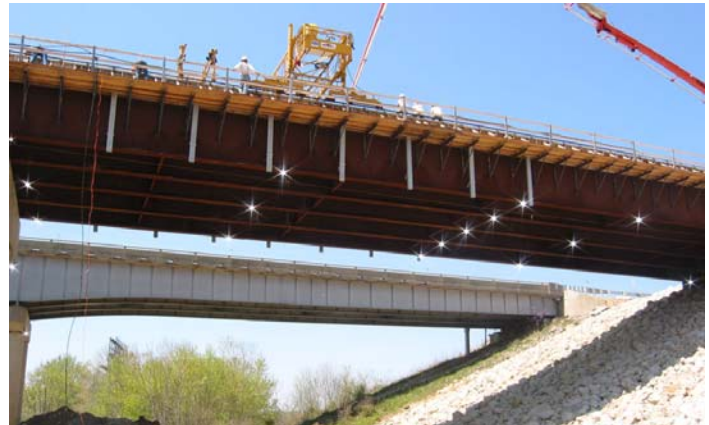
b) Targets in place

Figure 13 – Reflecting prisms mounted on steel I-girders

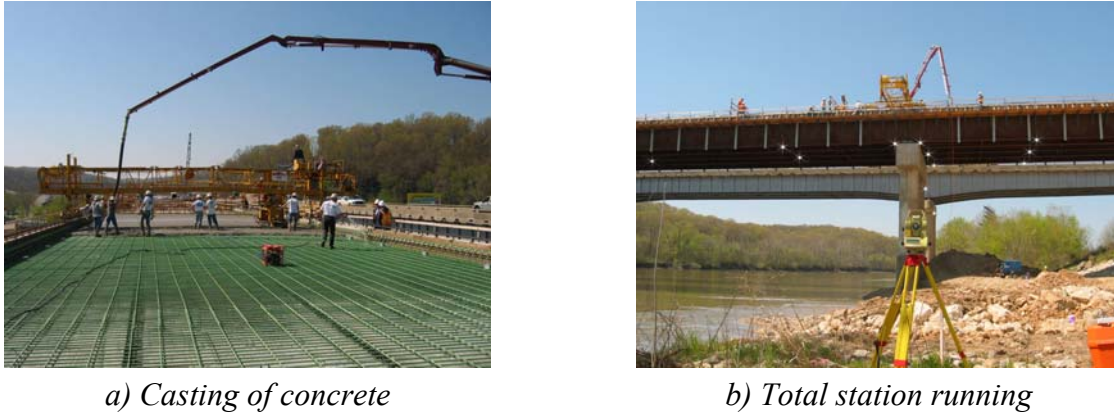
Prior to the final load test, the ATS system was utilized to measure the deflections induced by the pouring of the concrete deck (Figure 14). Data were recorded after pouring of progressive deck portions, starting with the first span on the opposite side of Span 1 and 2, where the targets were mounted. The steps are sketched in Figure 15.

Figure 14 – Pouring of concrete deck and deflection measurement *via* ATS

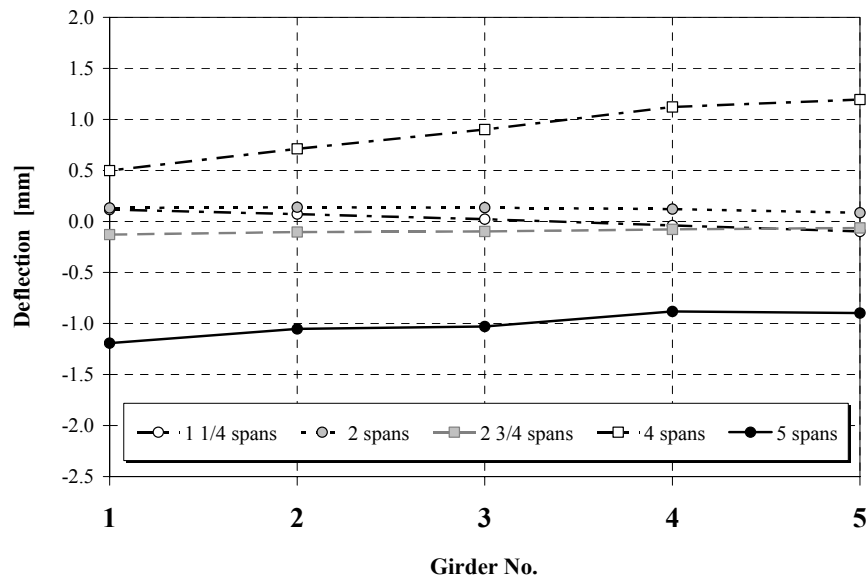
Figure 19 – Measured transversal deflections (deck pouring)

Figure 16, Figure 17 and Figure 18 for Girder 1, Girder 3 and Girder 5, respectively. Figure 19 shows the transversal midspan deflections in Span 1 measured on Girder 1 to 5 through Target 20, 17, 12, 9 and 3, respectively, wherein data from the same reading have been piecewise connected with straight lines for clarity. Raw data are provided in Appendix II.a.

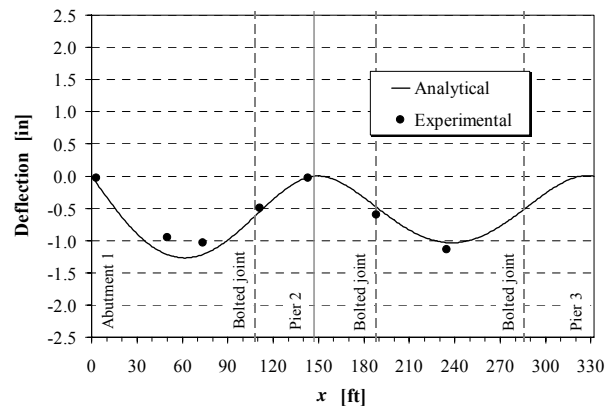
Figure 21 – Comparison between theoretical and experimental longitudinal deflections (deck pouring, Girder 3)

Figure 20, Figure 21 and Figure 22 show the comparison between analytical and representative experimental results for Girder 1, 3 and 5. It can be observed that the predictions fairly describe the measured deflections. Some apparent inconsistencies due to relatively high deflections for Girders 1, 3 and 5, as the concrete was poured on Span 4 in particular, and Span 5, may be attributed to the following variables:

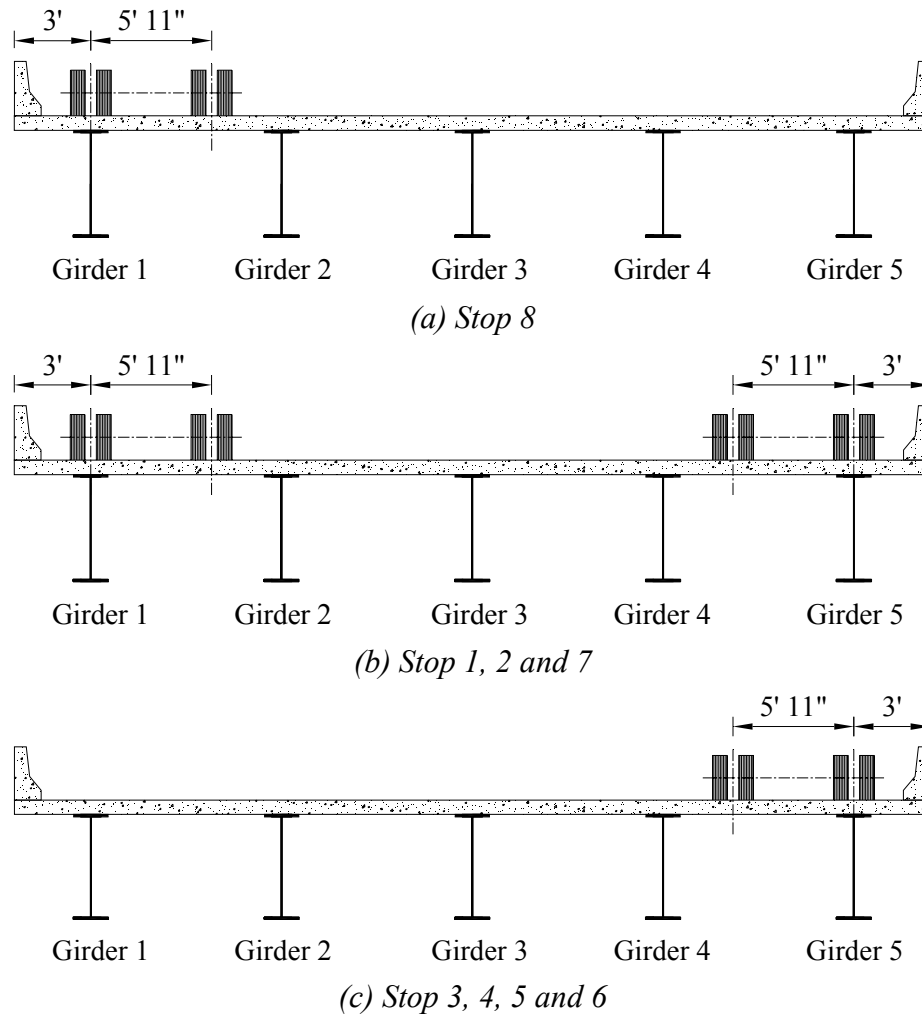
2 and 1, respectively, using a train of six trucks. Stop 5 was planned to induce the maximum negative moment on Girder 5, at Pier 2. Finally, Stop 8 was intended to produce the maximum deflections on Girder 1 in Span 1 using a single lane of six trucks. Figure 24 shows the transverse position of the trucks for the different stops.

Figure 24 – Transverse position of trucks during load test (not to scale)

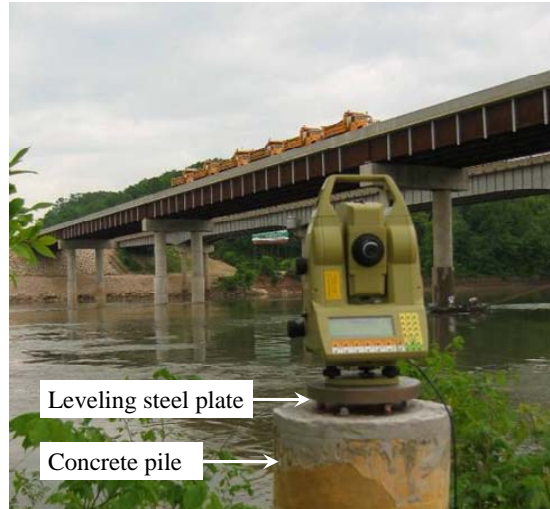
Once the TS was leveled and acclimatized, initial readings were taken for each prism. Then, the trucks drove to the first stop. At each stop, 15 minutes were allowed for potential settlements, before acquiring the data. To ensure stable measurements, four readings were taken for each target, two direct and two inverse, in order to average out possible errors. Once the reading was terminated, the trucks moved to the next stop and the same procedure was repeated.

Figure 25 – Total station in load test configuration

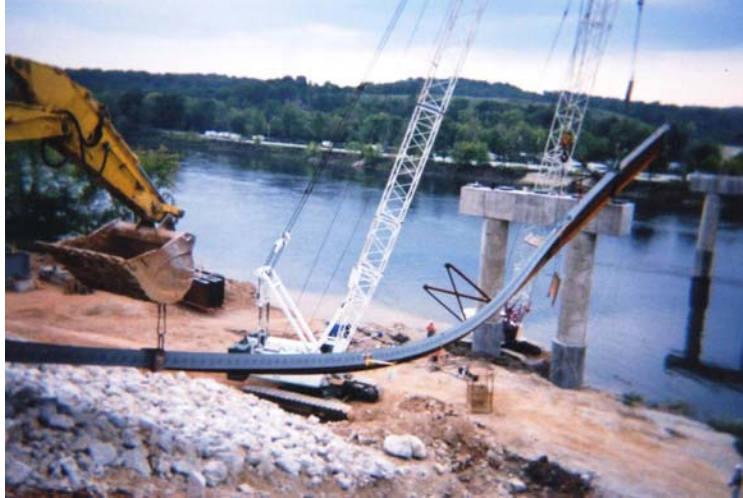
Figure 31 – Girder 1 fallen due to wind during erection of bridge superstructure

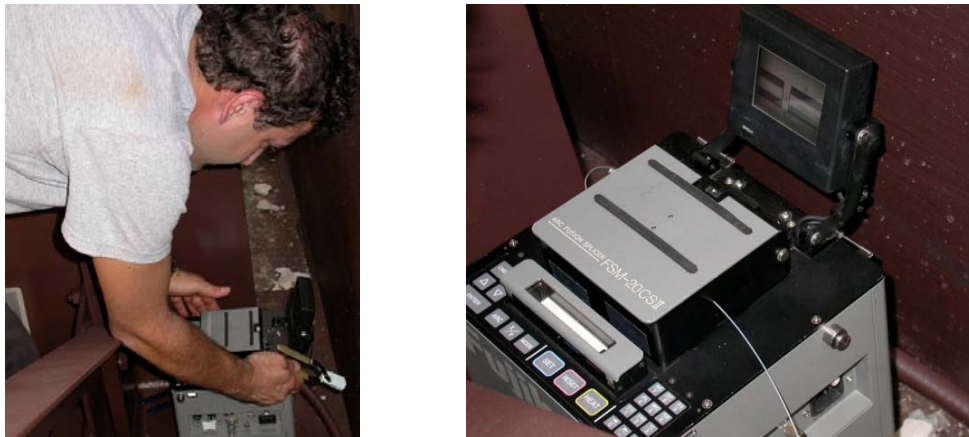
Figure 42 – Optical fiber core-alignment fusion splicing field operation

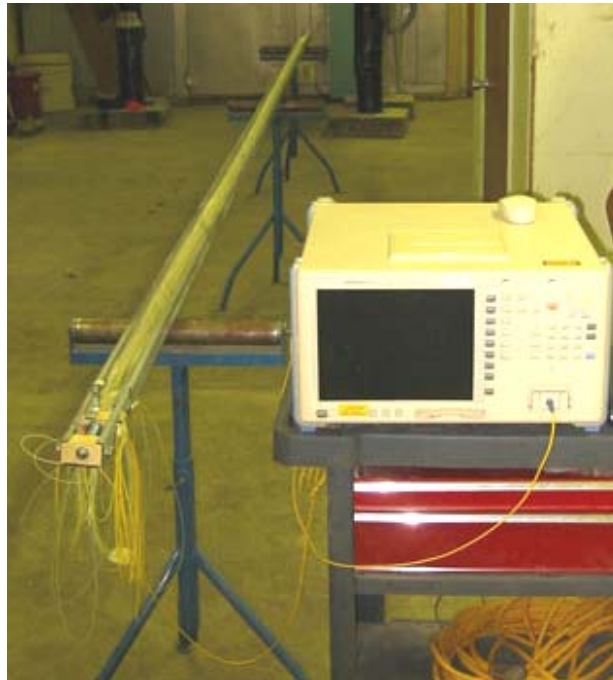
a) Schematic

b) Data recording using AQ8603 strain analyzer

Figure 44 – Strain calibration fixture
