Strut Failure Investigation of Paseo Suspension Bridge in Kansas City, MO

A proposal submitted to Missouri Department of Transportation

by Genda Chen and Lokesh Dharani from University of Missouri-Rolla

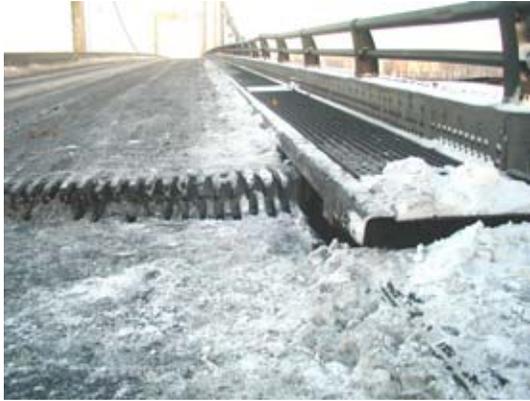
Fig.3 Bridge Deck Rise of the Southern Side Span

The construction of the bridge began 1952. Currently, the bridge supports Interstate I-29 and I-35, and US Highway 71, and carries about 94,000 vehicles every day. On January 22, 2003, the Paseo Bridge was hurriedly closed to traffic during the Wednesday afternoon rush hours when a pronounced gap between sections of the bridge's deck sparked fears about the span's safety. At the time, temperatures hit a record low of 9 below zero and windchills approached 25 degrees below zero. As shown in Fig. 3, the bridge deck of the southern side span raised about 8 inches above the approach deck. Next day, it was found that the strut (web) in the southeastern link anchorage assembly was fractured, see Fig. 4. A closeup view is presented in Figs. 5 and 6. Before the strut was completely fractured, several rivets were sheared off as seen from Fig. 7. Also seen from Fig.7 is a view of the fractured surface, indicating a brittle failure. Based on the discussions with field inspectors, the lower pin in the southeastern hanger was frozen and it does not allow for free rotation of the superstructure, which could be a key factor contributing to the fracture of the strut. This can be seen from the comparison between two pins (east vs. west side) in Fig. 8. The surface condition of the pin on the east side is severely corroded. Decision was made to replace all four hangers of the bridge including the fractured

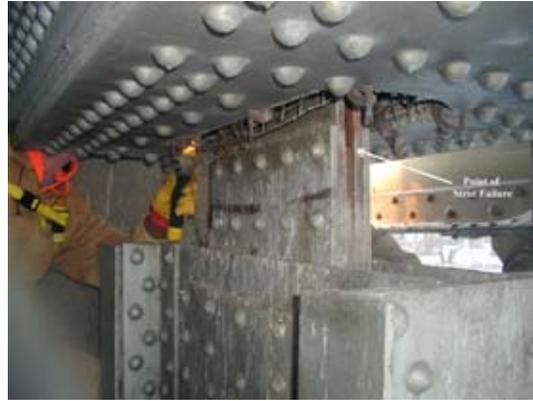
Figure 4 Point of Strut Failure

As a result of the frozen condition in the southeastern pin, the strut is subjected to both tension/compression and bending. The damage of the strut is likely caused by one of the following reasons or their combination: overstressing, thermal expansion/contraction, fatigue, and reduction in fracture toughness associated with low temperatures.

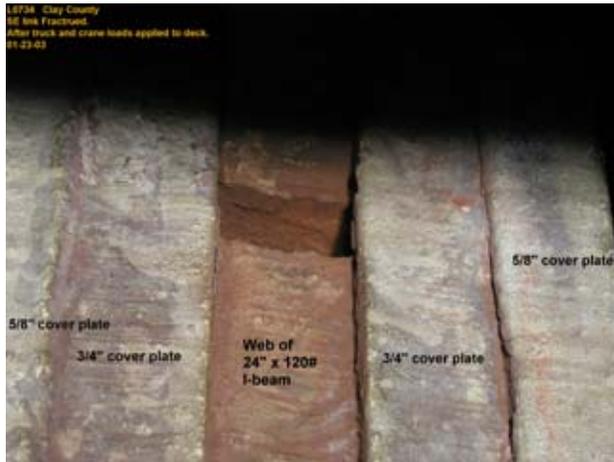
Fig. 5 Web Detail

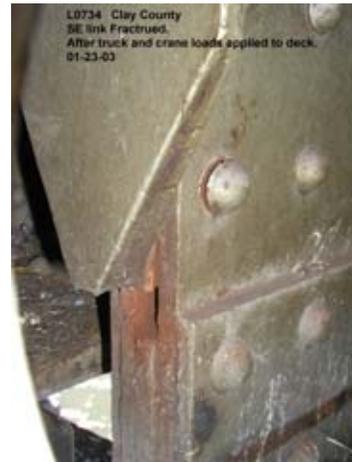
Fig.6 Lower Link Anchorage

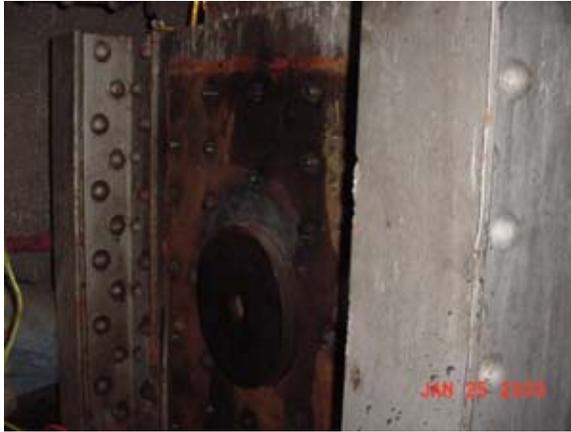
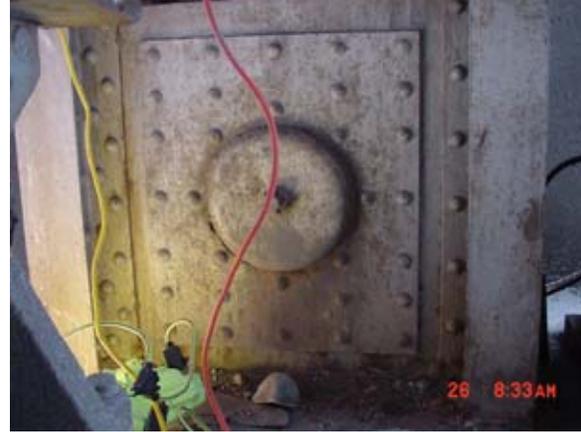
(a) East Side

(b) West Side

Fig. 8 Comparison of Pin Conditions

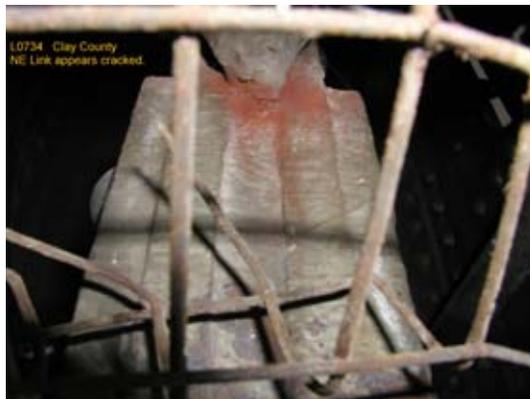
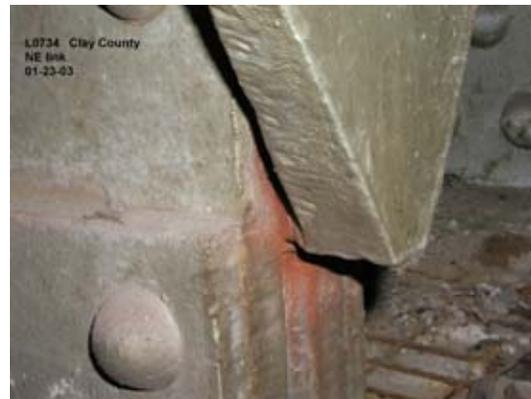
one. When the strut on the southwestern hanger was removed, it was also found to have been cracked, see Fig. 9. However, careful inspection by engineers reported that this crack is due mainly to overstressing as a result of fracturing of the southeastern strut.

Fig. 9 Crack on the Southwestern Strut

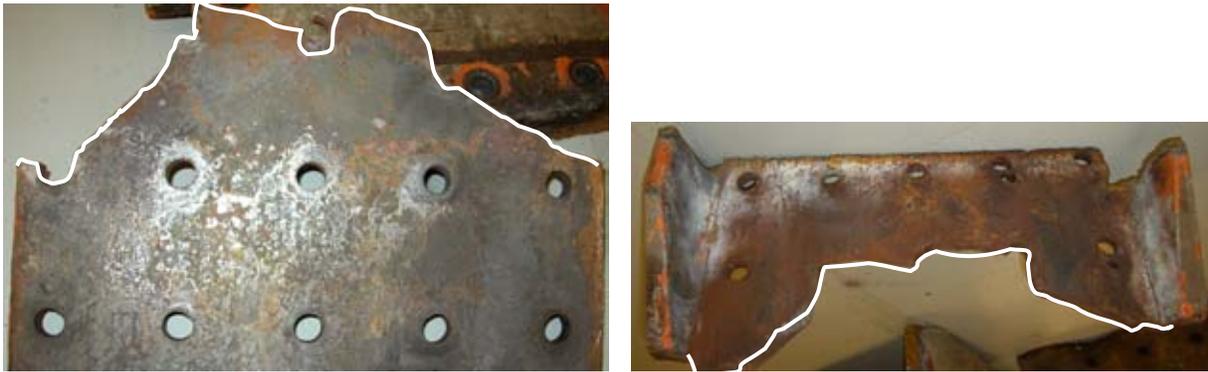
Whether cracking of the fractured strut propagates in one direction (from one end of the strut web to the other) or in two directions (from two ends to the center of the strut web) will significantly change the failure process. Inputs from field inspectors will be solicited to see if any evidence indicates that the strut cracked from both ends of its web and which web end of the strut is near the main bridge. Based on the fracture line of the failed strut, see Fig. 11, it is likely that crack initiated from one end of the web in an approximately 30° angle and propagated about one third of the web before sudden fracture occurred over the remaining section.

Fig. 11 Line of Strut Fracture
