Seismic Retrofit of CISS Column Foundation Shafts to Bent Cap Connections

**NUTC
R203**

An upgrade method for improving the seismic performance of typical bridges built in the state of Alaska is presented herein. This work studied the feasibility of the upgrade method for direct implementation in the field. Three specimens consisting of a cast in place steel shell (CISS) column foundation shaft and a bent cap configured to form a tee connection were built to model a typical bridge bent and tested under simulated seismic loads. Each specimen was retrofitted in the column, bent cap, and their connection according to current seismic design standards. This paper presents key experimental results, and the philosophy used in the design of the test units.

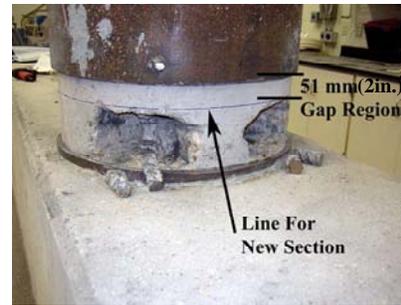
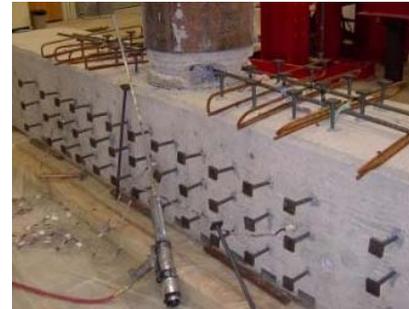
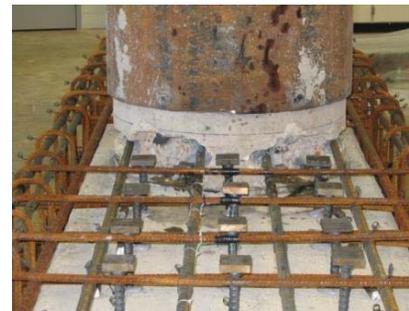
Figure 2. As-Built and Unit 1 Reinforcement Layout

(c) Unit 1

(d) Installation of Headed Bars

(e) New Reinforcement

Figure 2(e) shows the final retrofit cross-section with the longitudinal reinforcement provided to increase the elastic moment capacity and additional transverse and vertical shear reinforcement. The spacing of the stirrups and headed reinforcement are shown in Figure 2(a).

In addition, vertical headed reinforcement was also installed from the top surface of the bent cap, see Figure 2(b) and (d). According to this detail the vertical headed reinforcement extended to a depth equal to the embedded length of the column longitudinal reinforcement. This reinforcement was placed near the center of the as-built bent cap, see Figure 2(e), to ensure proper transfer of forces from the column longitudinal reinforcement to the vertical headed reinforcement by means of the diagonal struts shown in Figure 5.

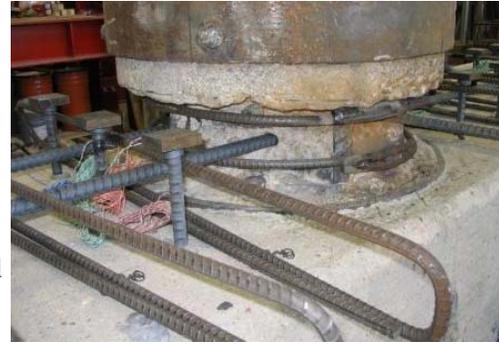
(a) Unit 2 Reinforcement Layout

(b) Unit 2 CISS above Bent Cap Interface

Finally, during the final stages of testing of Unit 1 wide open cracks were observed in the bent cap top surface near the column interface. As such, the following modifications were implemented: *i*) an additional headed rebar was installed through the gap region and within the column longitudinal reinforcement, and *ii*) one additional D13 (#4) closed stirrup was provided on either side of the bent cap running through the column and within the steel shell gap region, see Figure 6(b).

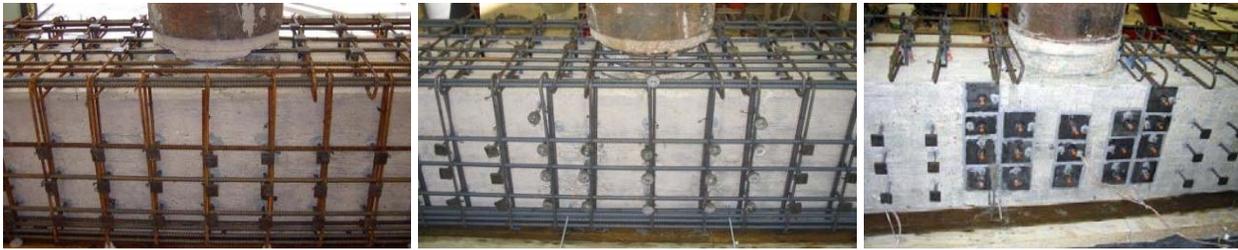
Figure 6. New Bent Cap Section Reinforcement Layout (Side View)

(a) Unit 1

(b) Unit 2

(c) Unit 3

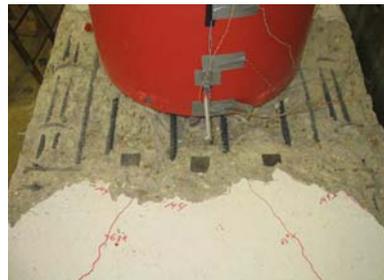
Figure 8. Unit 1 – Key Experimental Results

(a) Load-Deformation Response

(b) Joint Damage

(c) Bent Cap Damage

within the joint region stabilized, and the reinforcement provided in the new bent cap section was effective in preventing further degradation to the test unit.

In Figure 8(a), during subsequent loading to the second and third cycle at ductility 7, excessive levels of strength degradation were observed in combination with pinching in the hysteretic response. These two cycles mark the first significant drop in the lateral load below V'_y . Before this displacement ductility level, the hysteretic response of the test unit was reasonably stable with significant amounts of energy dissipation capacity. Figure 8(b) shows minimum diagonal cracking within the joint region, whereas Figure 8(c) shows significant damage in the top surface of the bent cap and in the vicinity of the column. As previously stated, it is important to emphasize that during loading to the first cycle at ductility 7 the lateral load was nearly the same as the load registered to the third cycle at ductility 5. This indicates that load transfer within the joint region was still within limits capable of sustaining load levels within 80% of the maximum registered lateral load for ductility levels less than 5.

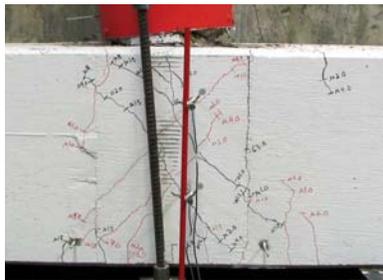
Figure 10. Unit 2 – Key Experimental Results

(a) Load-Deformation Response

(b) Joint Damage

(c) Bent Cap Damage

Unit 2 was tested following the loading protocol shown in Figure 7 and the load deformation response of Unit 2 is shown in Figure 10(a). As in Unit 1, based on a direct investigation of the test results the new displacement at ductility 1 was also set at 31.5mm (1.24in.). This figure shows that Unit 2 response displayed similar features as those described for Unit 1. By comparing the load deformation response for these two test units, one may conclude that the response of Unit 2 displayed an improvement in the seismic response in terms of damage and load degradation at higher ductility levels.

Figure 9(a) clearly shows that compared to Unit 1, Unit 2 experienced lower levels of strength degradation at 228.6mm (9.0in.). This is one of the relevant differences between the performances of these two test units. As before, the unit exhibit significant levels of strain penetration around the column but this was limited to the first row of vertical headed reinforcement. Compared to Unit 1, Unit 2 experienced also lower levels of damage in the bent cap as shown in Figure 10(c). In addition, cracking due to joint shear was minimal and all joint shear cracks were small as shown in Figure 10(b).

Unlike Unit 1, the first significant drop in the lateral load capacity of the test unit below the theoretical yield load level was not observed until the first cycle to ductility 10. However, it is important to recognize that, when loading to ductility 7 and during the pull direction to the third cycle, low cycle fatigue fracture of the longitudinal reinforcement was observed. This is a clear indication that the loss in the strength of the test unit during the last cycles was predominantly due to fracture of the longitudinal reinforcement. In total, four column longitudinal bars fractured due to low cycle fatigue indicating reserve capacity against pullout of the column reinforcement.

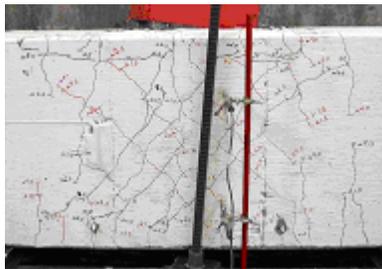
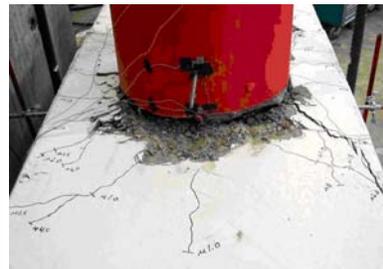
Figure 11. Unit 3 – Key Experimental Results

(a) Load-Deformation Response

(b) Joint Damage

(c) Bent Cap Damage

Test results clearly indicate that reducing the steel shell gap to 13mm (1/2in.) prevented excessive crushing of the concrete cover, and buckling of the column longitudinal bars, as observed in Unit 1 and 2. Cracking on the sides of the bent cap resulting from joint shear was minimal and all cracks stayed small as shown in Figure 11(b), and damage above the bent cap was nearly the same as in Unit 2, see Figure 11(c). However, the crack pattern was more distributed than in Units 1 and 2.

The first significant drop in the lateral load capacity of Unit 3 below the theoretical first yield load level was observed during the third cycle to ductility 6, see Figure 11(a). This indicates similar levels of load degradation, indicating that reducing the steel shell gap did not translate directly into an improvement of the seismic response of the test unit. This suggests that the steel shell gap should not be reduced below levels that can lead to significant increase in the load capacity of the unit, leading to higher principle tensile stress demands in the joint.
