Spalling Solution of Precast - Prestressed Bridge Deck Panels

**NUTC
R234**

FINAL REPORT

PROJECT 1B

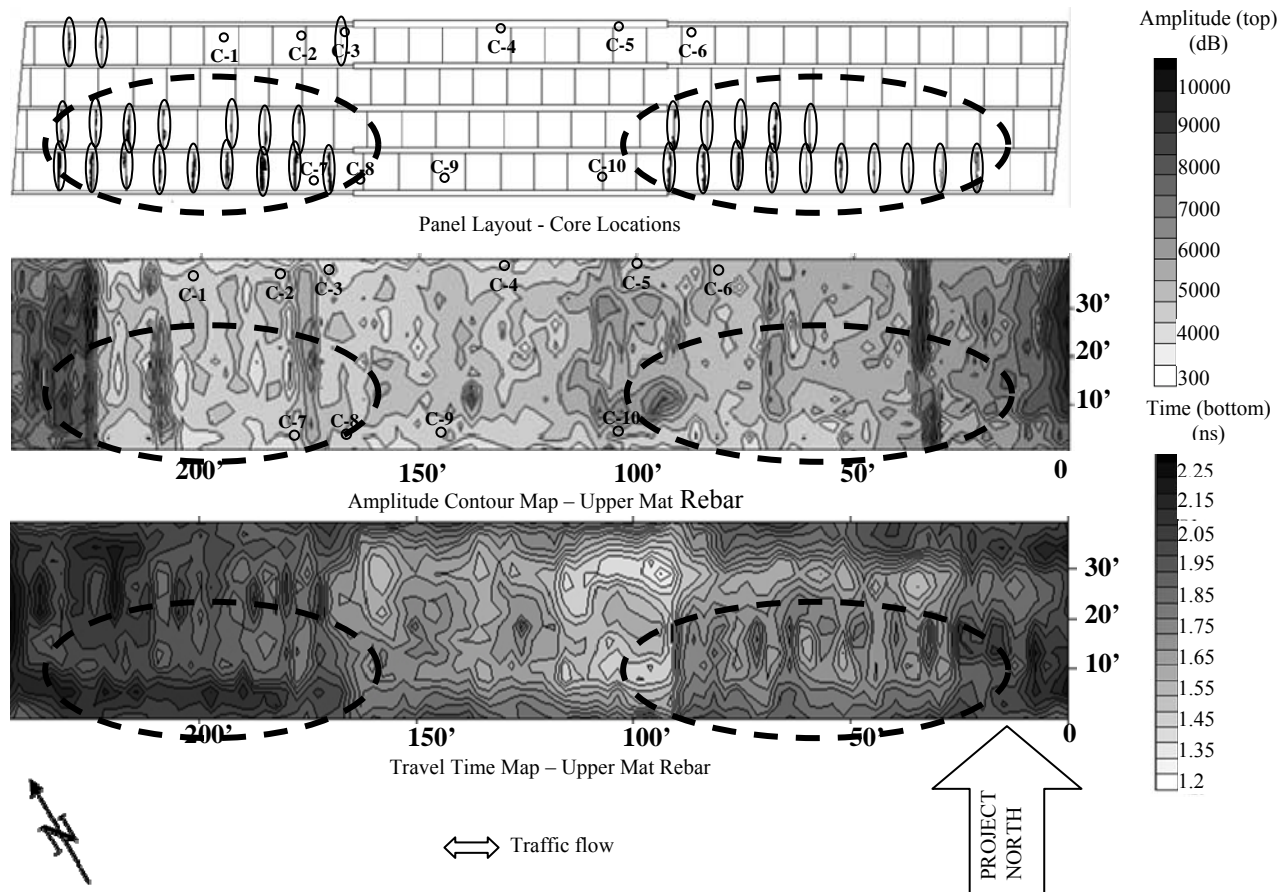
A contour map of the travel times to the upper mat of rebar is also presented in Figure 4-12 that shows the signal travel times to the upper mat of rebar in nanoseconds (ns). The velocity at which EM energy travels through a material is dependent upon the material dielectric constant, or dielectric permittivity. As the dielectric constant of the material increases, the velocity at which EM energy propagates through the given material decreases. Normally, the longer travel times would indicate more deterioration in the system.

Figure 4-12 Visual Inspection Results and GPR Contour Map Comparison

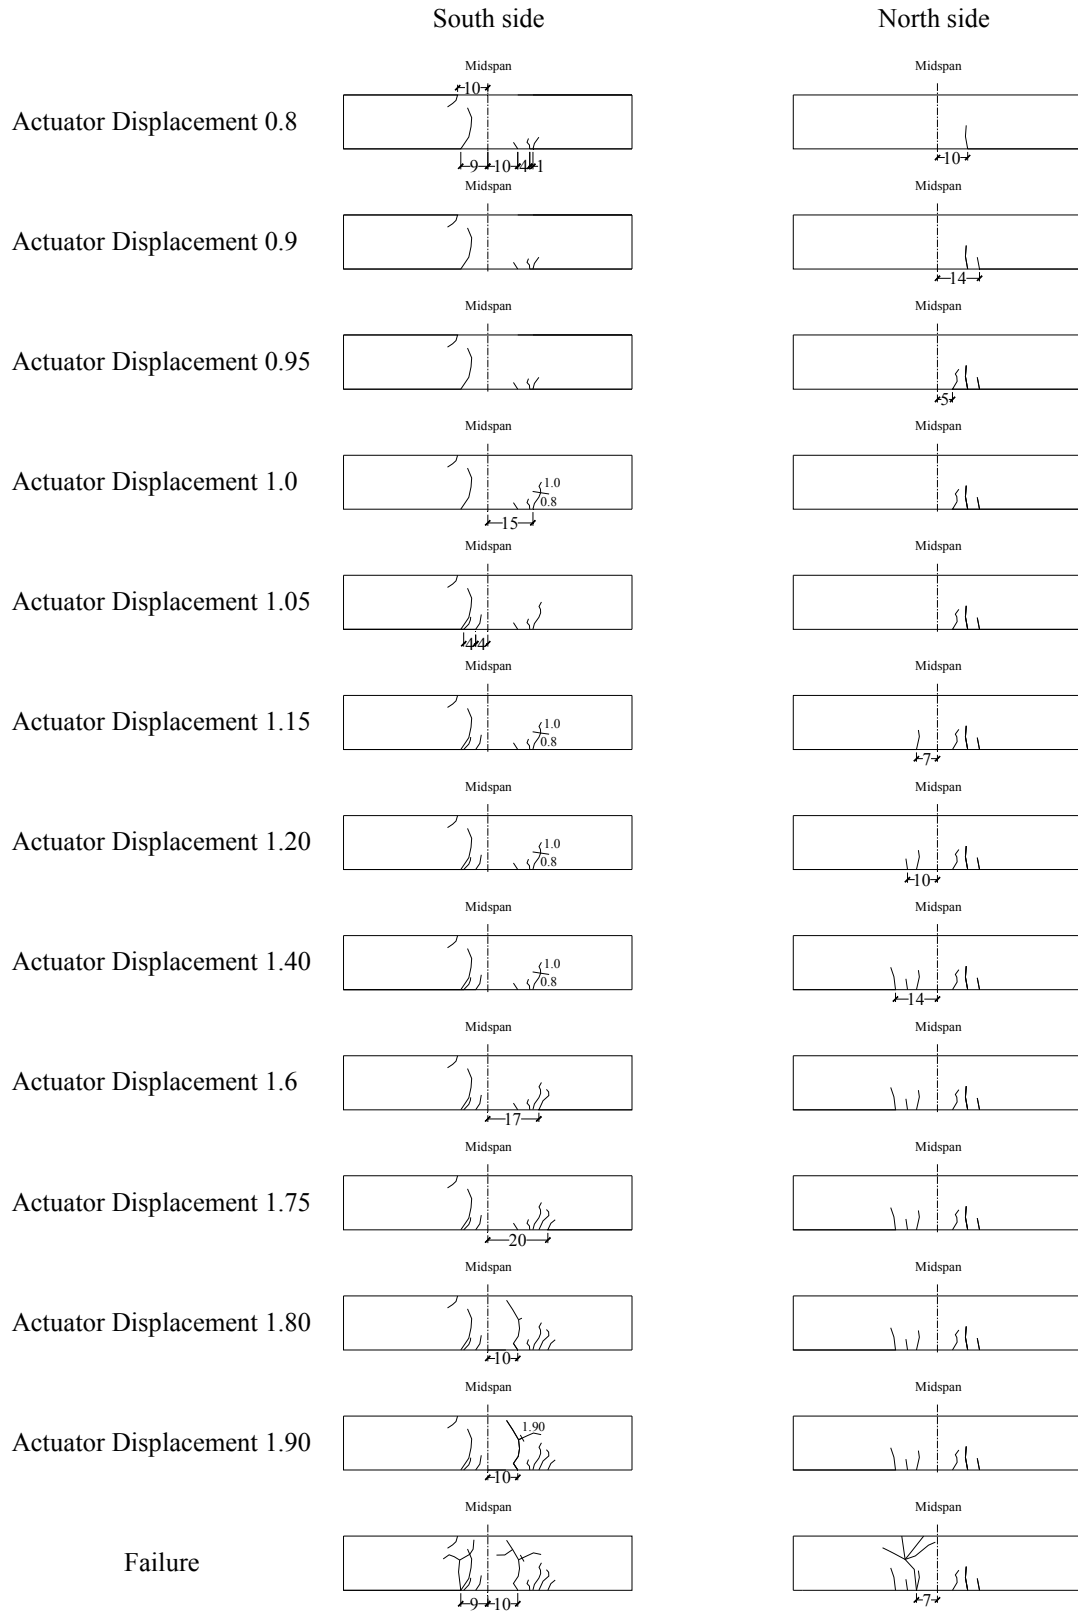
Figure C- 17 Panel ST-FRC-SL: Propagation of Cracking

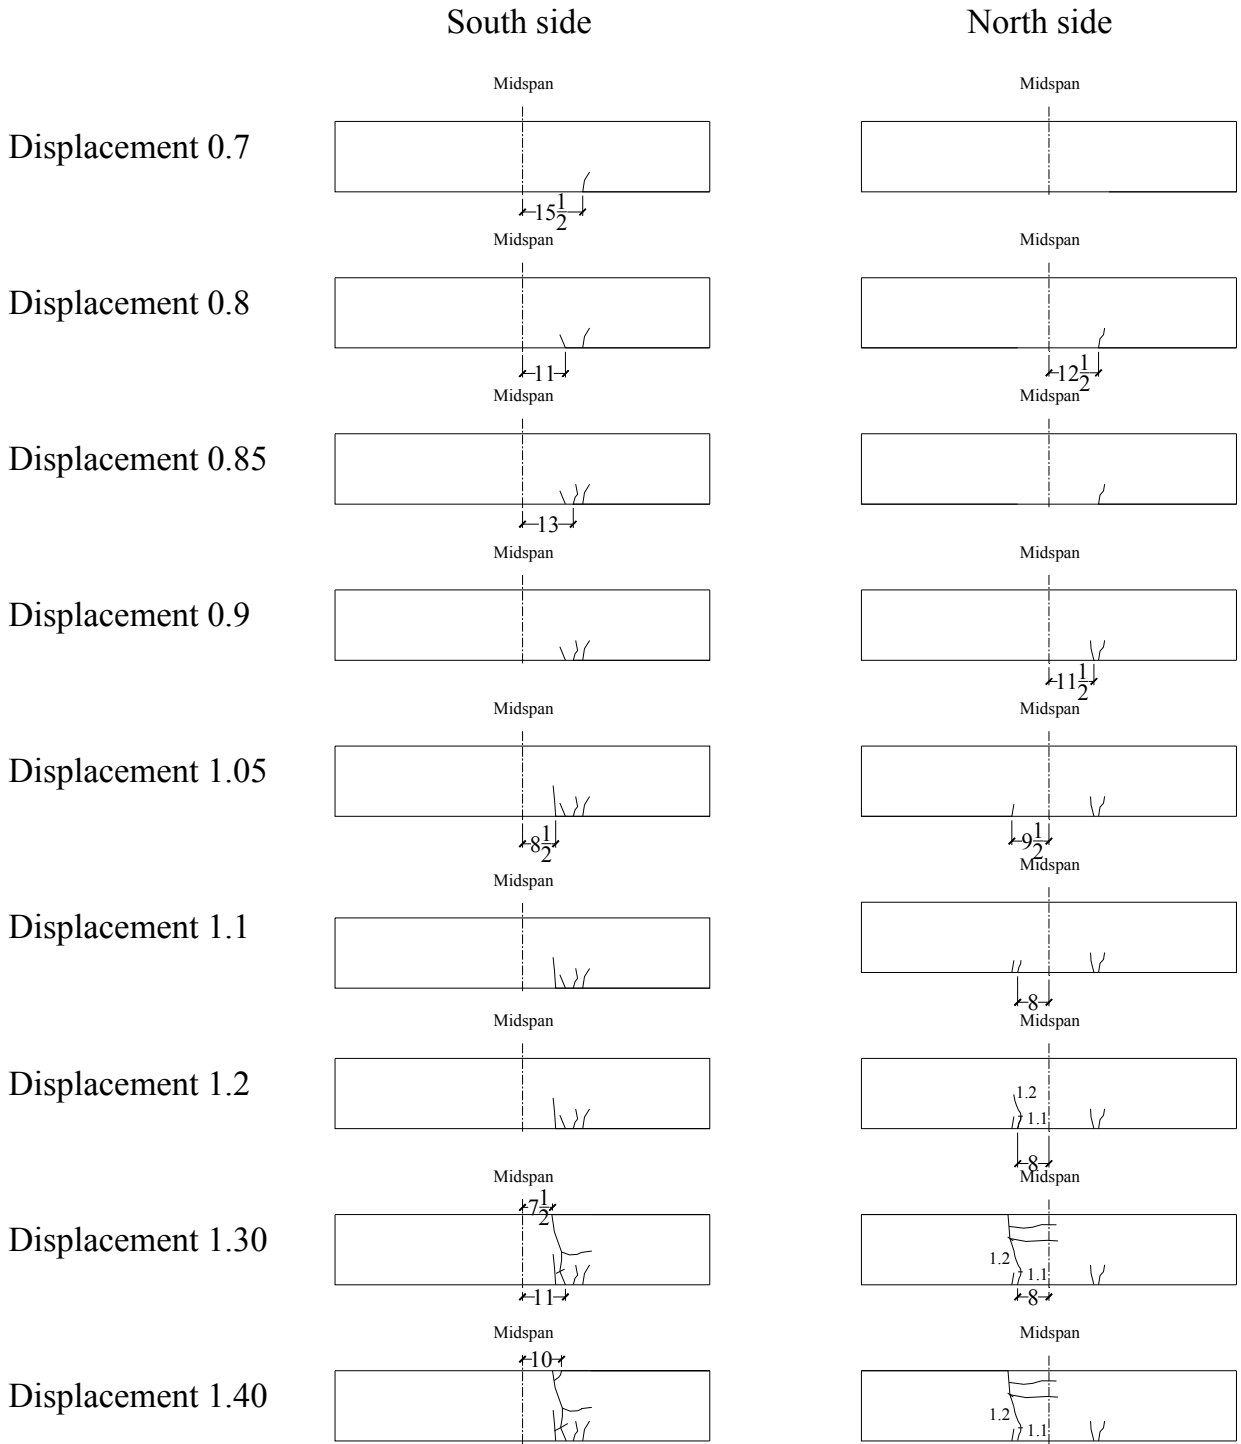
Figure C- 25 Panel ECST-NC-SL: Propagation of Cracking

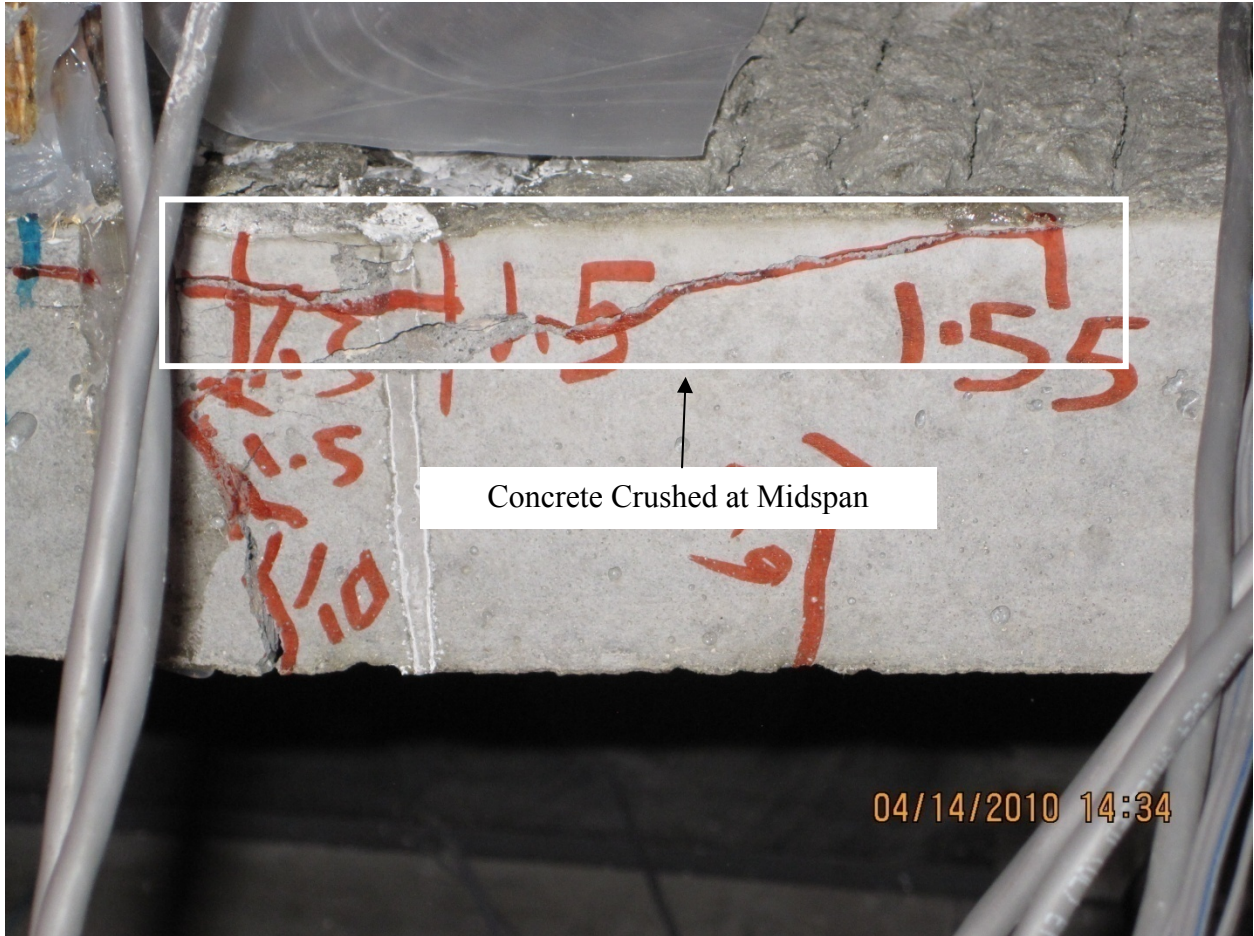
Figure C- 40 Flexural Failure at Midspan by Concrete Crushing of Panel CFRPT-NC-SL

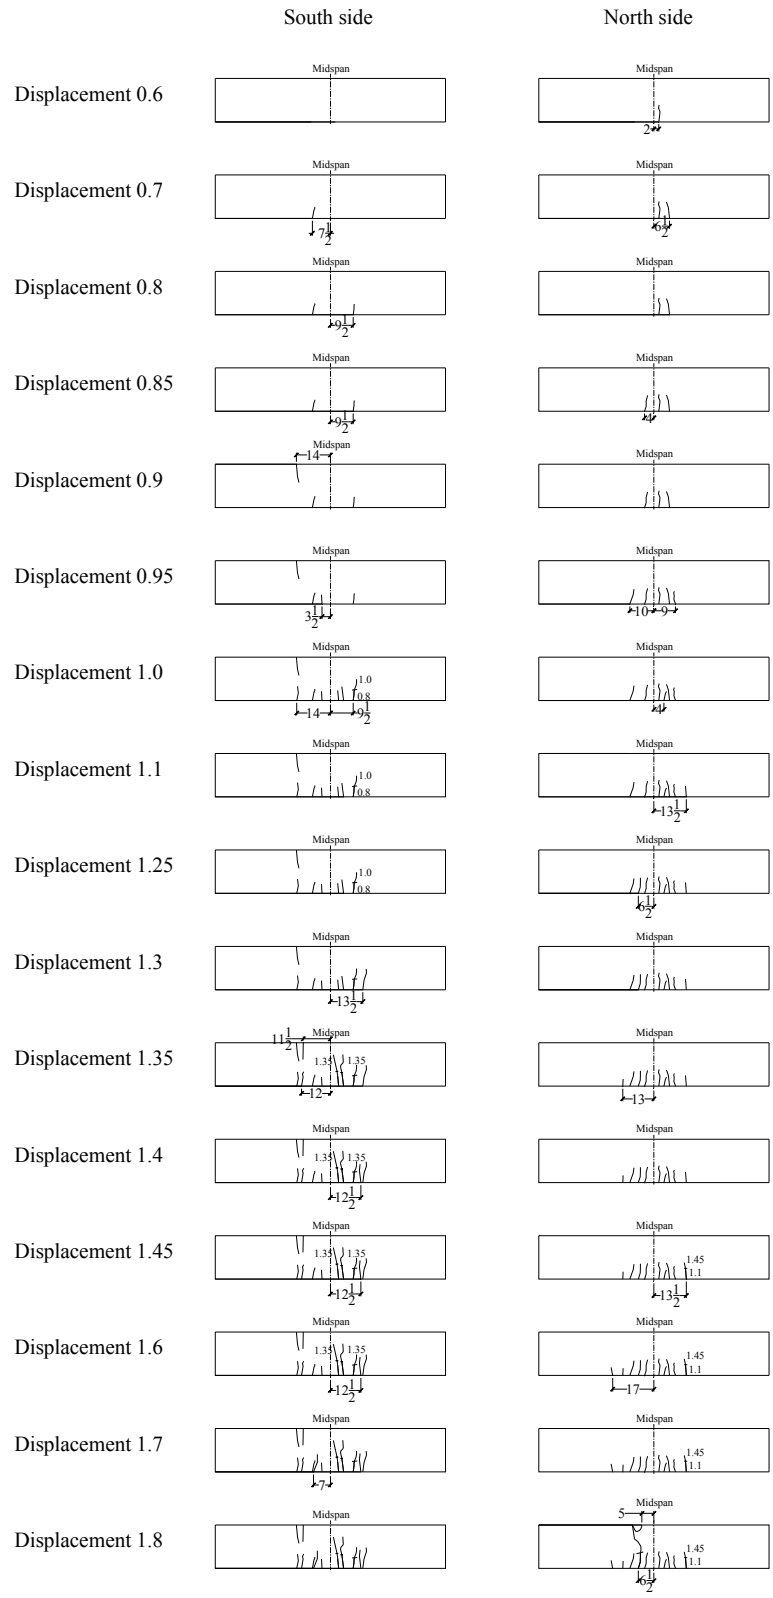
Figure C- 49 Panel CFRPT-FRC-SL: Propagation of Cracking

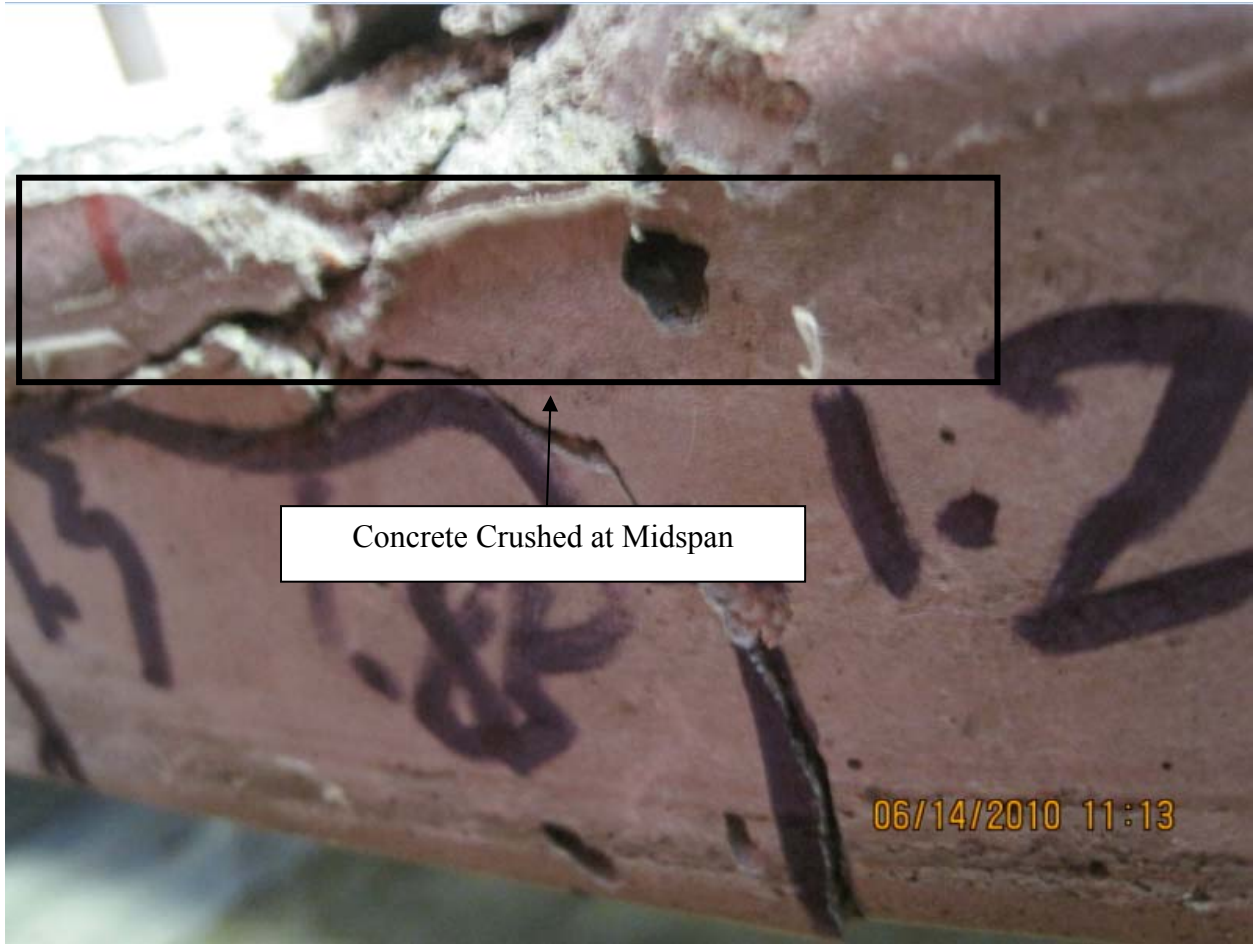
Figure C- 56 Flexural Failure at Midspan by Concrete Crushing of Panel ST-NC-FL

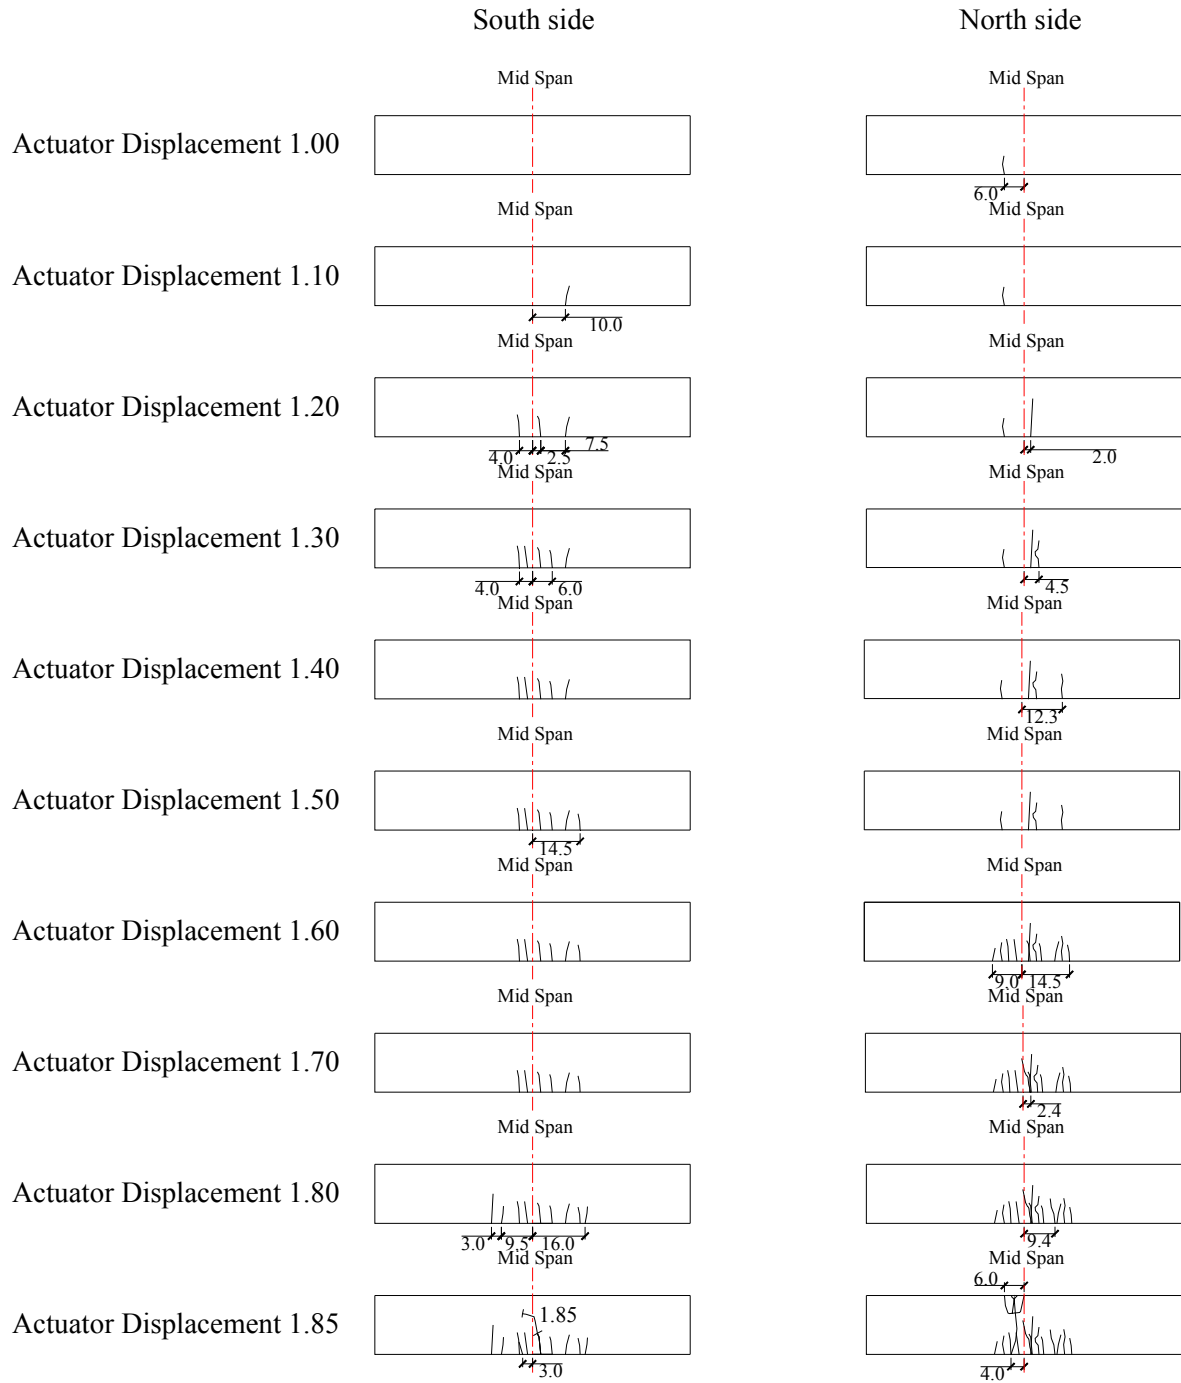
Figure C- 57 Panel ST-NC-FL: Propagation of Cracking

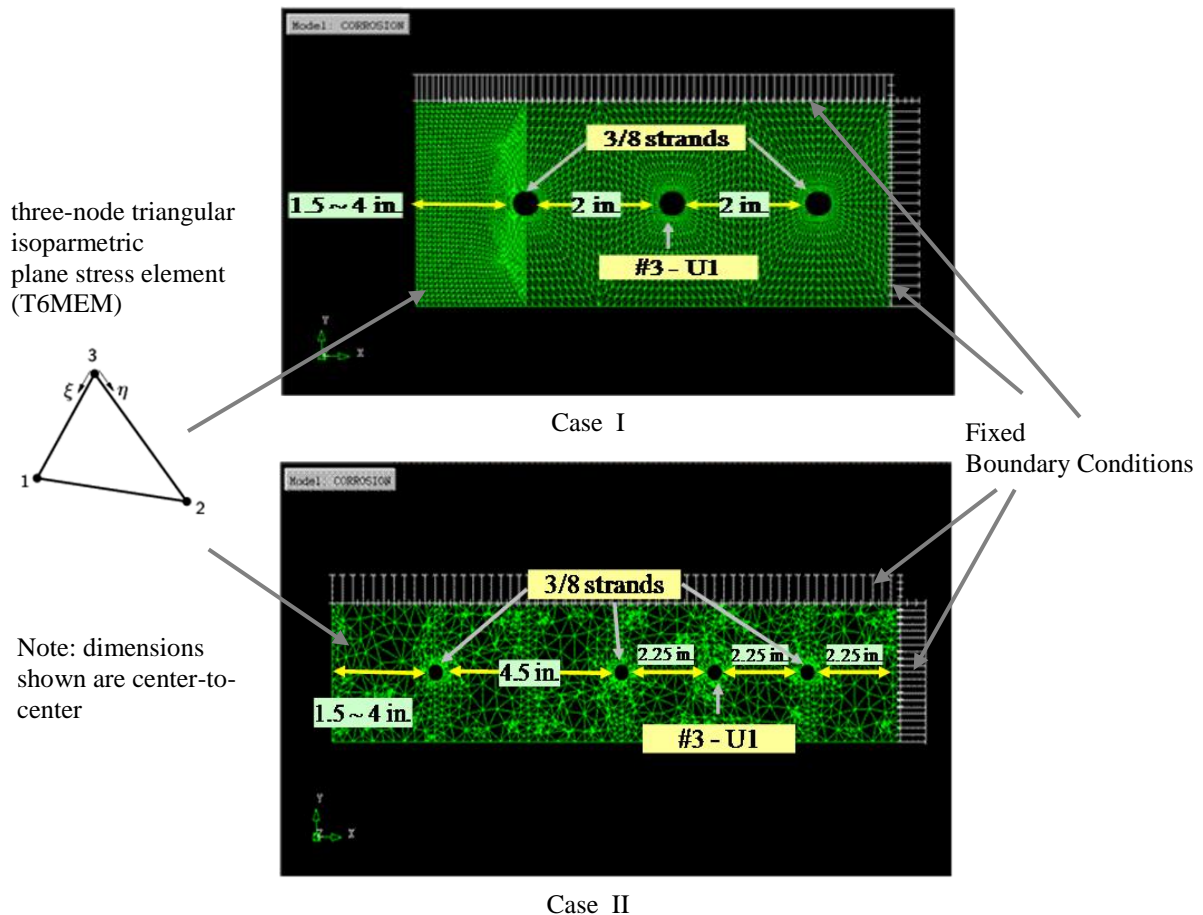
Two main FE models were developed according to different locations of the U1 bar as shown in Figure D-1. Case I represents a critical configuration of reinforcement arrangement that can occur, while Case II represents a typical reinforcement arrangement. Based on these models, side cover was varied from 1.5 in. to 4 in. in both FE models. Crack patterns and Von Mises stress variations for all simulated FE models are presented in this section to compare the effects of the parameters considered.

Figure D-1 Two-Dimensional FE Models for Corrosion Process
