CENTER FOR TRANSPORTATION INFRASTRUCTURE AND SAFETY

Coated Steel Rebar for Enhanced Concrete-Steel Bond Strength and Corrosion Resistance

**NUTC
R236**

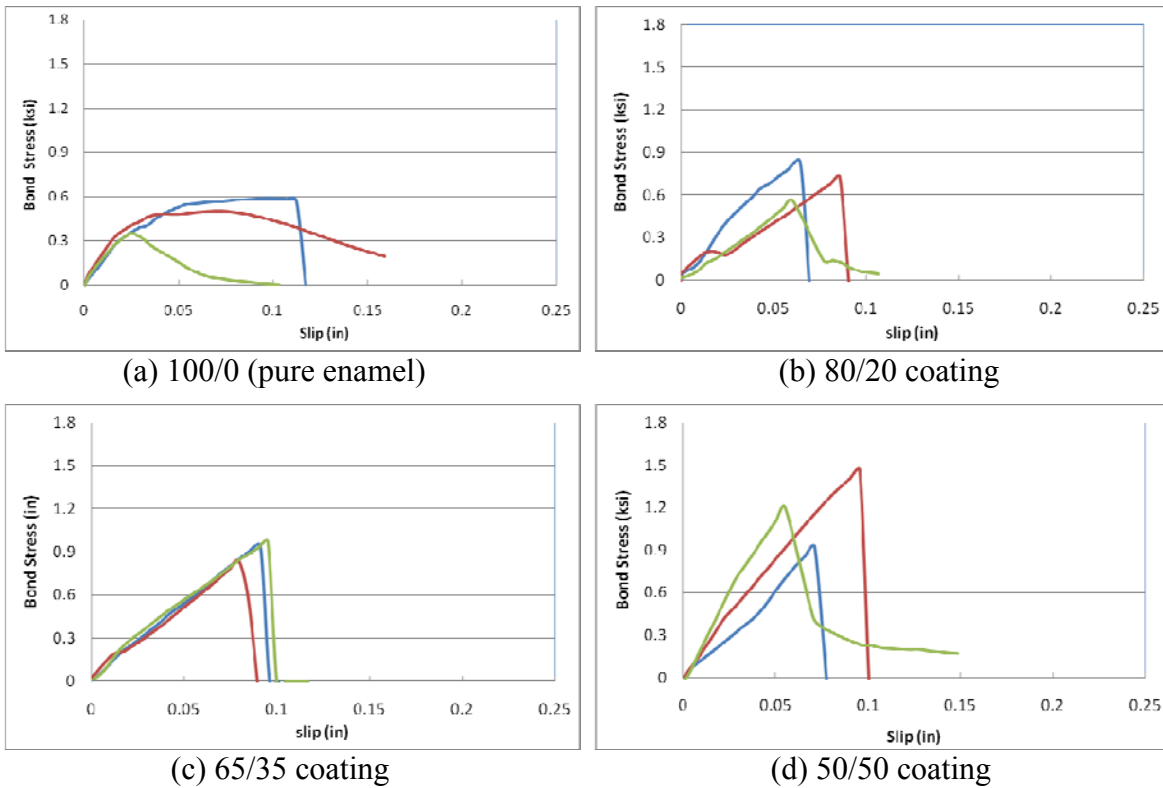
Figure 4.10 Stress-slip curves of specimens with various coatings at curing age of 60 days.

The bond stress-slip curves are depicted in Figures 4.8 through 4.10. They indicated that the rods coated with pure enamel experienced much larger slippage and their corresponding specimens have a more ductile bond behavior than the remaining specimens. Rods coated with enamels with 20% calcium silicate also exhibited a greater degree of slipping, particularly at early curing ages. These results reflect the difference in failure modes between the samples. As shown in Figure 4.11, the steel rods coated with pure enamel were consistently pulled out of the mortar cylinders due to low surface roughness and no chemical reaction with the mortar. When rods coated with the reactive enamel were pulled out, the mortar cylinders often split. The slip between a rod and mortar before the applied load reached its peak decreased with increased curing age for the pure enamel coating and increased for the 65/35 enamel coating. This was also related to the switch in failure modes, but attributable to the fact that mortar becomes stronger with curing time. Stronger mortar becomes more brittle at the mortar-steel interface with pure enamel but delays the splitting failure that controls the slip in the 65/35 coating. The change from ductile to brittle bond behavior of mortar cylinders reinforced with the 80/20 coating was observed as the curing age increased, indicative of the switch from a rod pullout failure to concrete splitting failure. Although the specimens with 50/50 coating consistently failed by the concrete splitting mode, the level of slips before failure follows no consistent pattern, and is most likely due to inconsistent mortar and casting conditions for various specimens. At 28 days of curing, one 65/35 specimen and one 50/50 specimen were damaged during the tests.

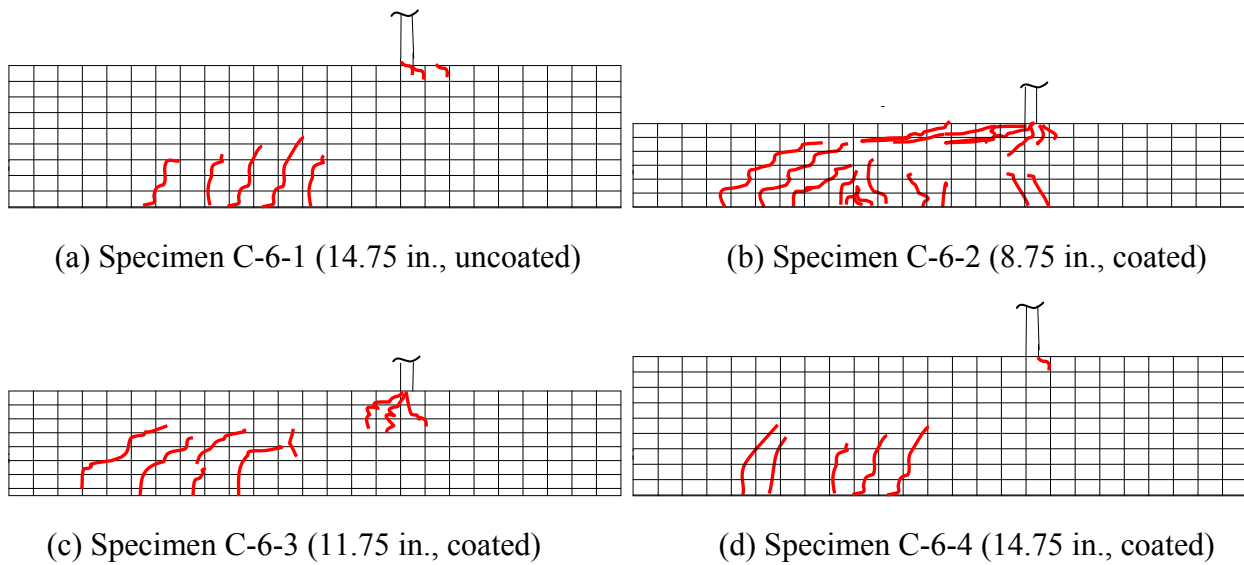
Cracks on the sides of Specimens C-6-1 to C-6-4 were mapped and illustrated in Figure 5.32. It is clearly seen from Figure 5.32 that less cracks in number were observed as the development lengths increased from Specimen C-6-2 to C-6-4. With equal development lengths, Specimen C-6-4 and C-6-1 experienced similar cracks. The former appeared to have less cracks near the dowel bar, which is likely related to the use of enamel coating in Specimen C-6-4. It was interesting to note that severe cracks occurred but no concrete spalling was observed on Specimen C-6-2 even though only 60% of the required length for uncoated bars was considered. Due to the strong bond between enamel-coated rebar and concrete, the cracked concrete pieces most likely remained attached to the rebar in Specimen C-6-2.

Figure 5.32 Crack patterns on the side of various specimens in Group I (marks traced on the pictures in B&W).

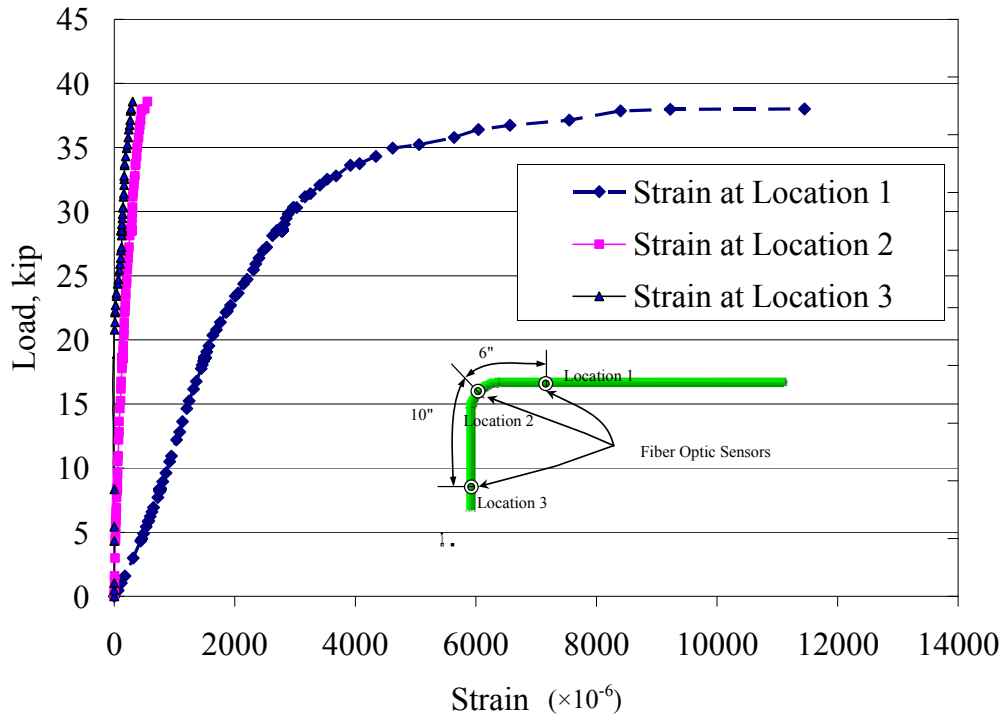
with what was observed from the load-slip curves in Figure 5.30(b). Note that the maximum load in Figure 5.37 is smaller than that in Figure 5.30(b) since the FBG sensors began to malfunction at approximately 38.5 kips.

Figure 5.37 Measured strains at three locations by FBG sensors.

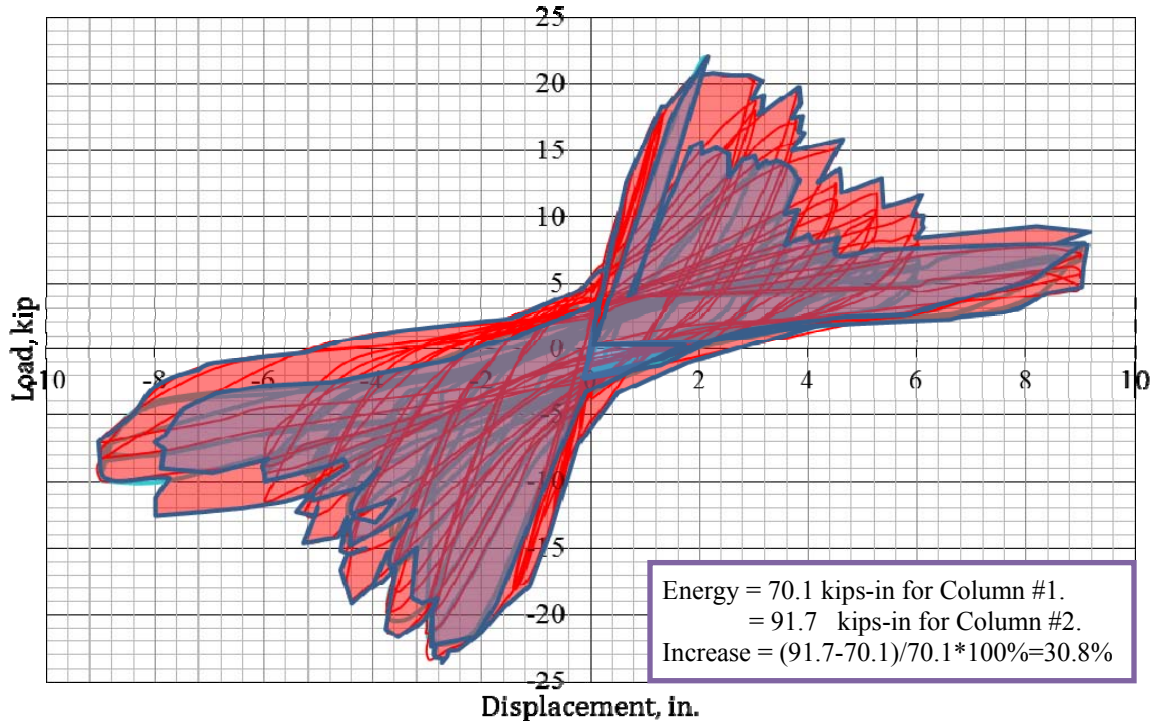
It can also be observed from Figure 5.51 that the envelope of the load-displacement curves of Column #2 basically covers that of Column #1. In two consecutive cycles, Column #1 suddenly experienced a maximum drop of 35.2% in load capacity whereas Column #2 gradually dropped a maximum of 11.6% in load capacity. In comparison with Column #1, Column #2 can dissipate 30.8% more energy over a range of the test displacement, as illustrated and evaluated in Figure 5.52. Here, the energy dissipated is measured by the shaded area in Figure 5.52.

Figure 5.52 Dissipated energy in two columns.

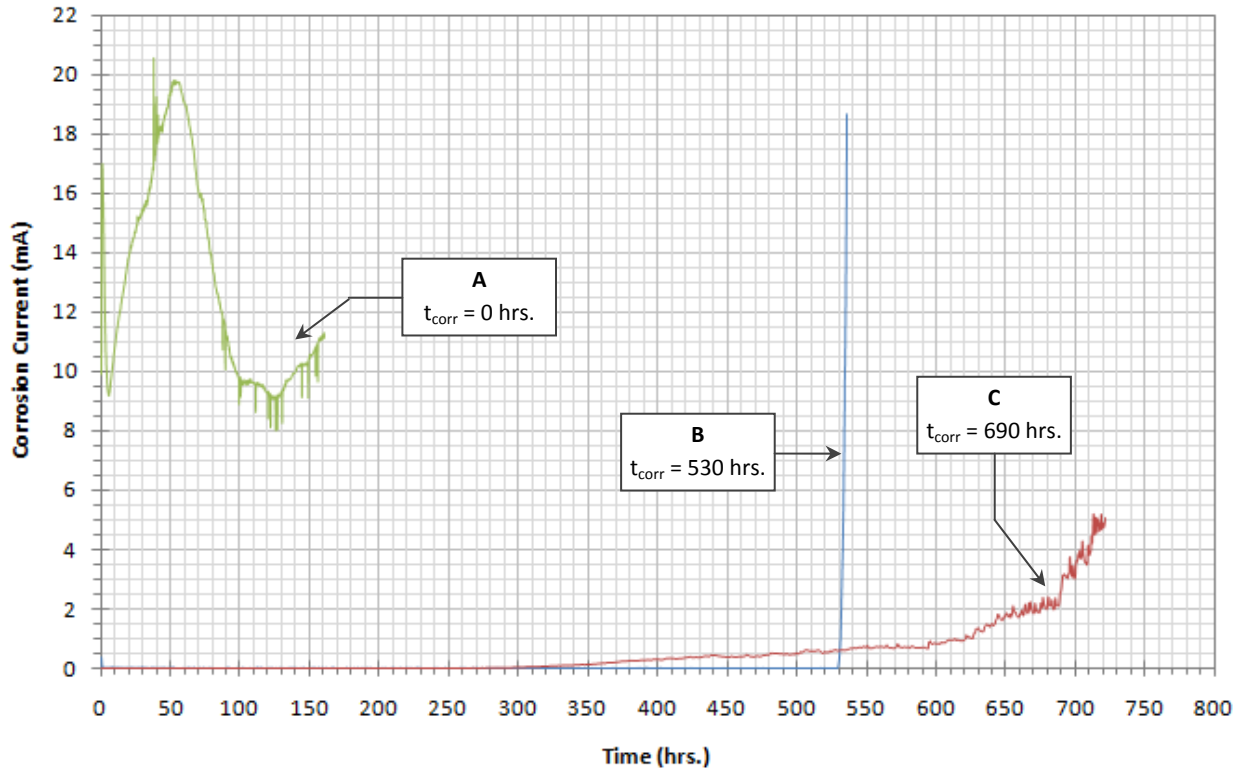
Figure 6.25 Three test results commonly seen during the ACT phase.

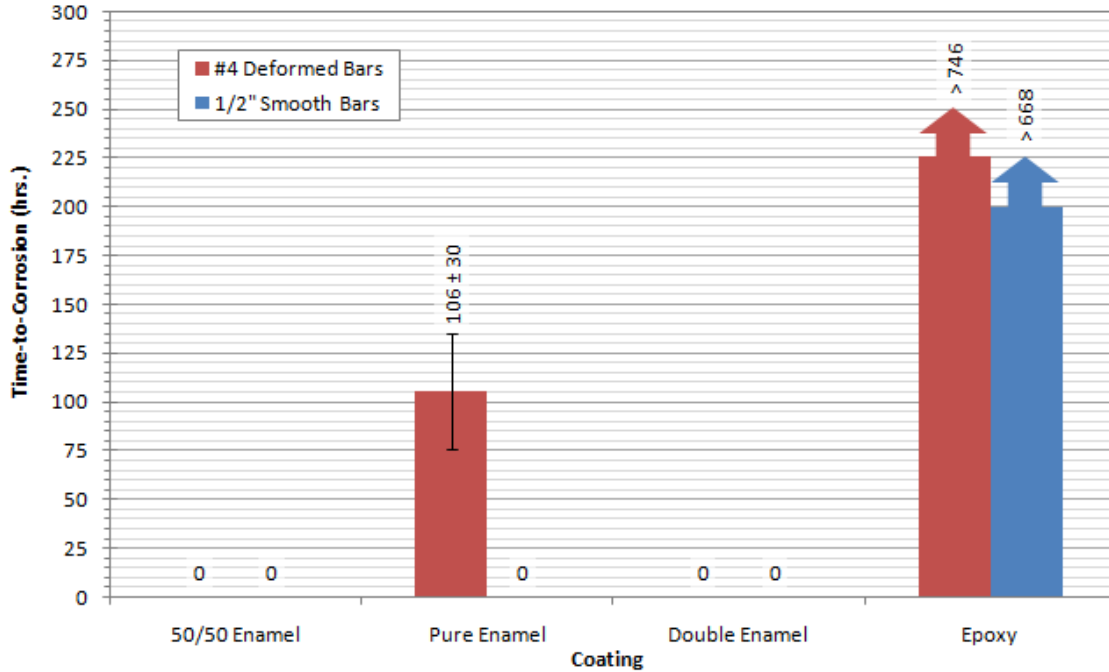
A summary of the ACT results for the non-grouted specimens is shown in Figure 6.26. The 95 percent confidence interval for each set’s average t_{corr} is also included in Figure 6.26. A set’s confidence interval was developed using the standard error of a set’s mean value (SEM). The SEM for a set of specimens was calculated by dividing the standard deviation of the sample set by the square root of the number of specimens used in deriving the set’s average t_{corr} value.

Figure 6.26 Test result summary for the non-grouted specimens.

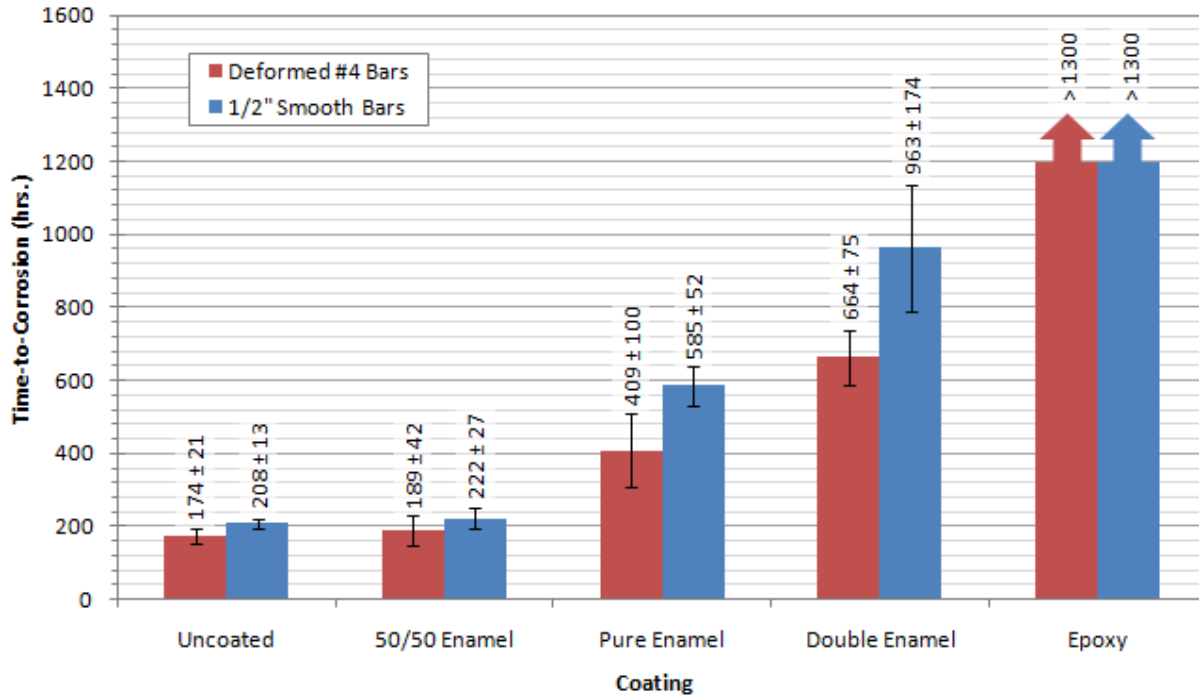
A summary of the ACT results for the grouted specimens is shown in Figure 6.27. The 95 percent confidence interval for each set's average t_{corr} is also included in the figure. A set's confidence interval was developed using the standard error of a set's mean value (SEM). The SEM for a set of specimens was calculated by dividing the standard deviation of the sample set by the square root of the number of specimens used in deriving the set's average t_{corr} value.

Figure 6.27 Test result summary for the grouted specimens.

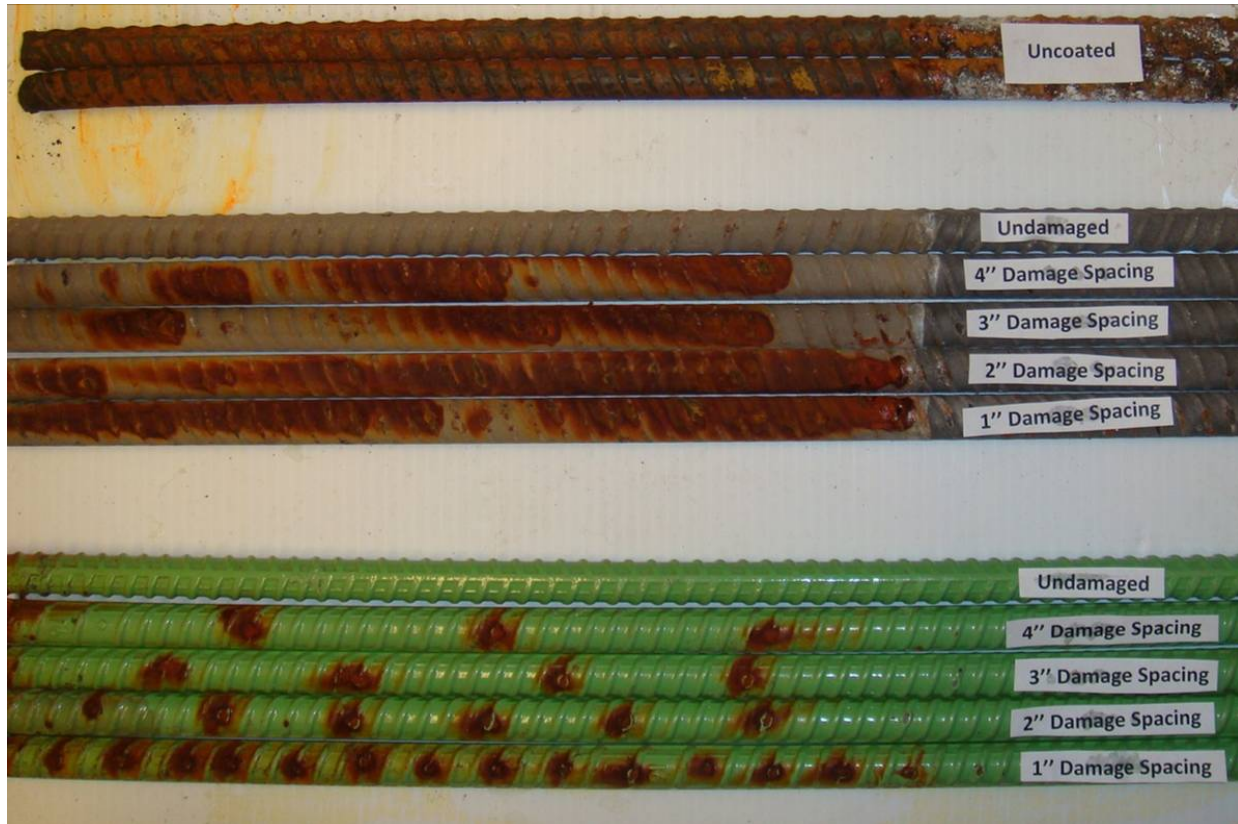
Figure 6.31 Surface conditions of all tested rebar after testing

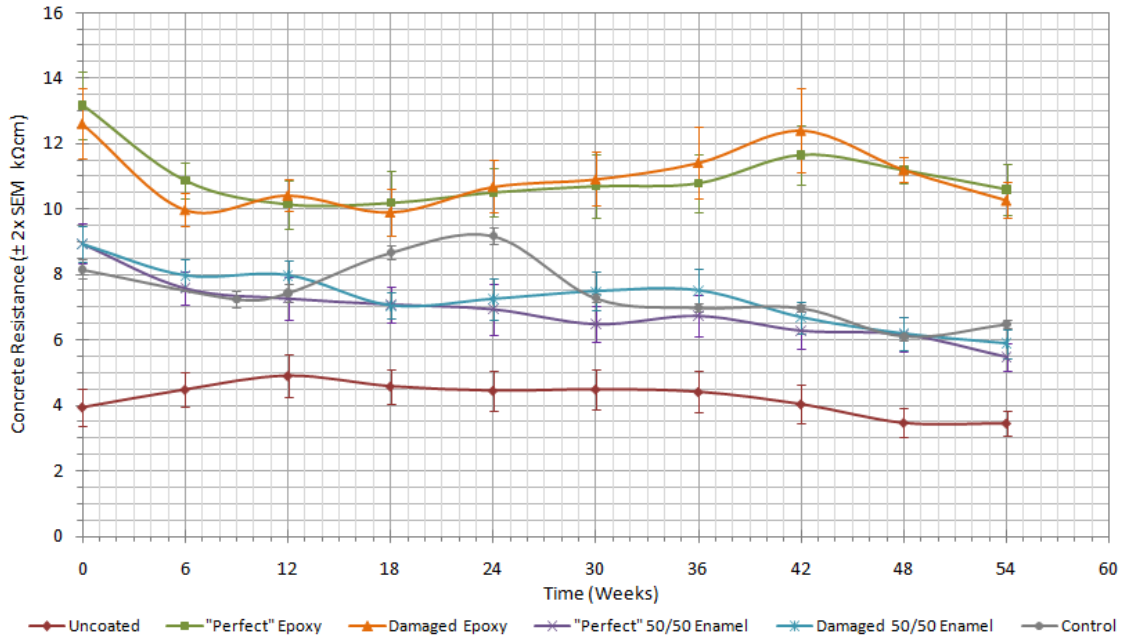
As shown in Figure 6.39, the resistivity for each group of specimens remained relatively constant during the testing period. Both the "perfect" and damaged 50/50 enamel specimens have approximately the same resistance throughout the 54 weeks of testing. Similarly, both the "perfect" and damaged epoxy groups have the overall resistance values of 11.0 kΩcm. A specimen group's overall resistance was calculated by averaging the group's ten data points shown within Figure 6.39. The overall resistance for each of the six groups of specimens, along with the 95% confidence interval corresponding to each value, is shown in Figure 6.40.

Figure 6.39 Average resistance of each specimen type during the 54 weeks of testing.

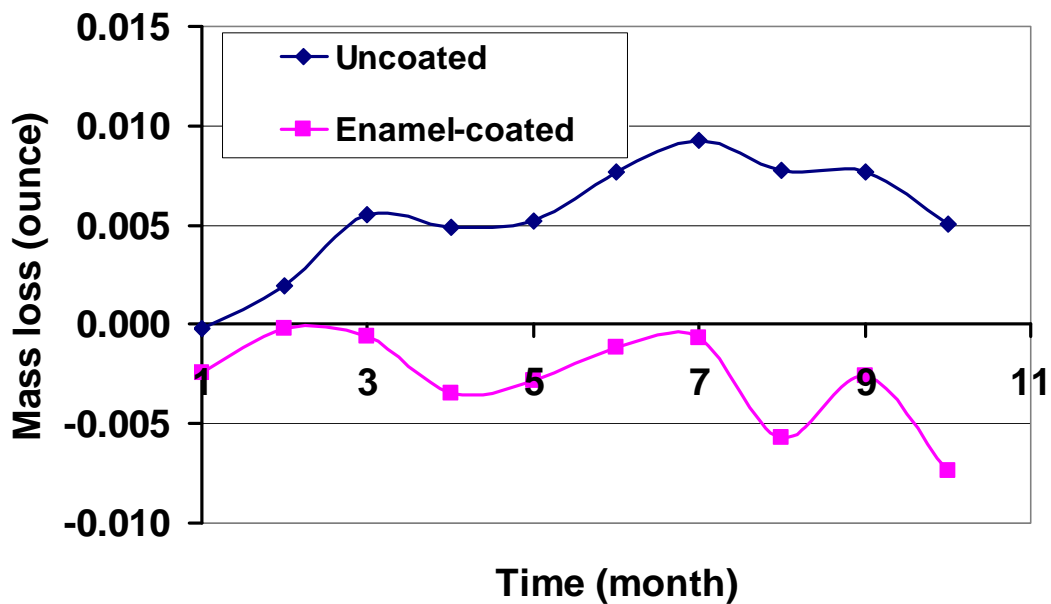
Figure 6.57 Mass loss of steel disc samples with time.

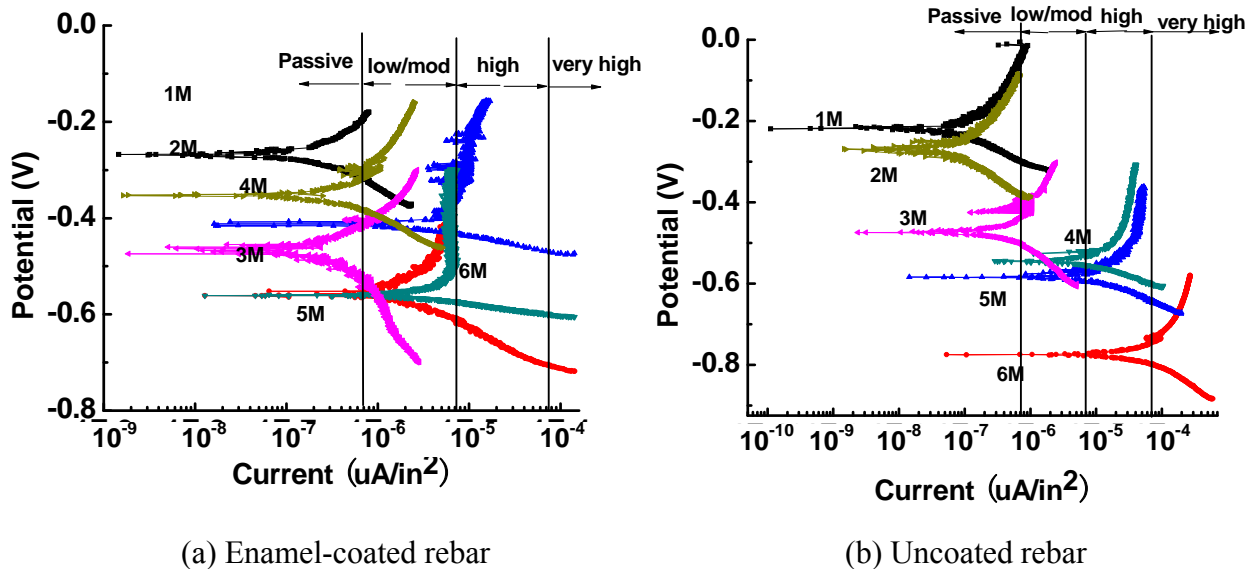
Figure 6.60 Tafel plots of mortar cylinder samples.

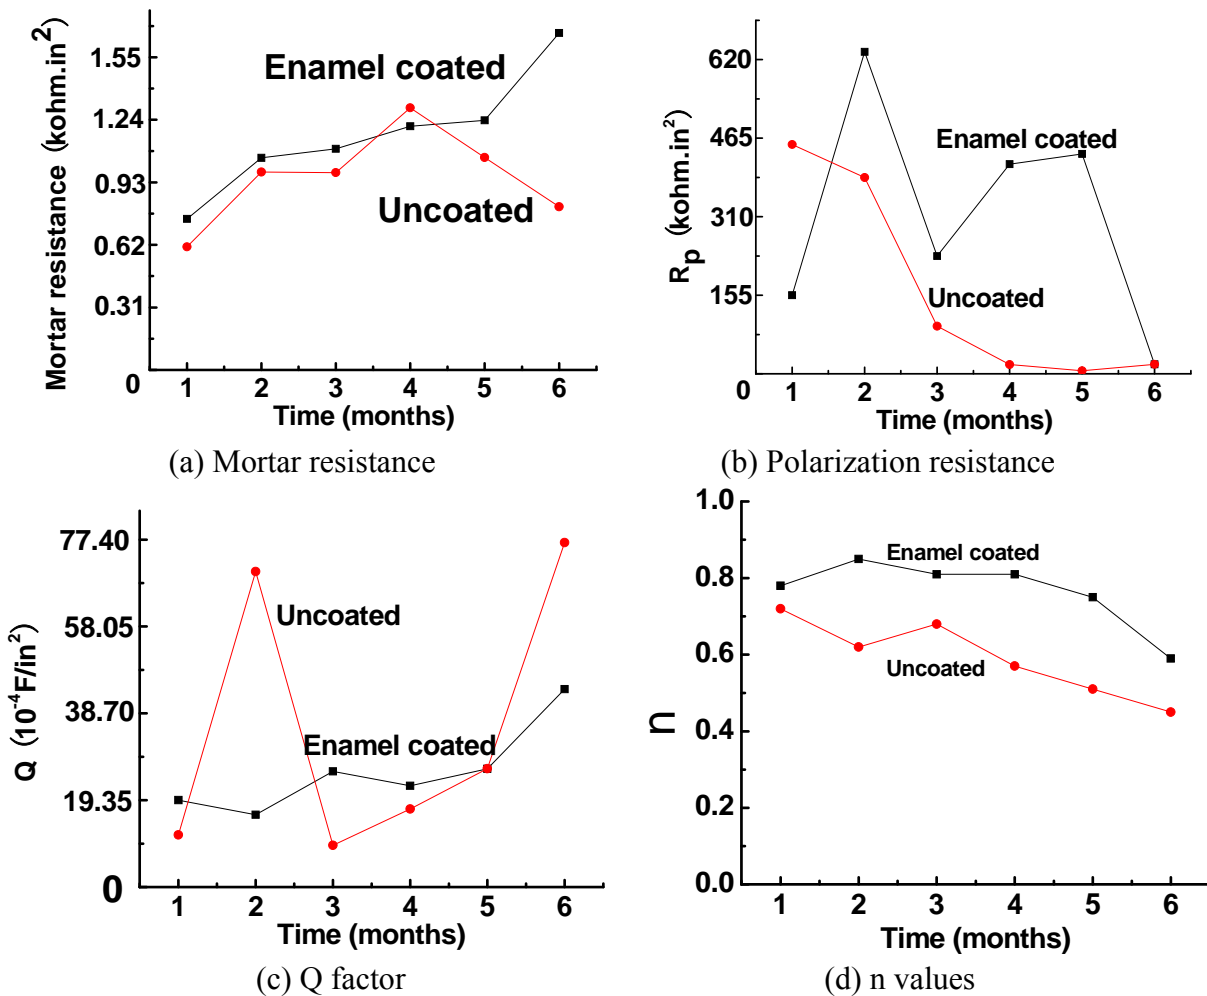
Figure 6.66 EEC model parameters changes over time.

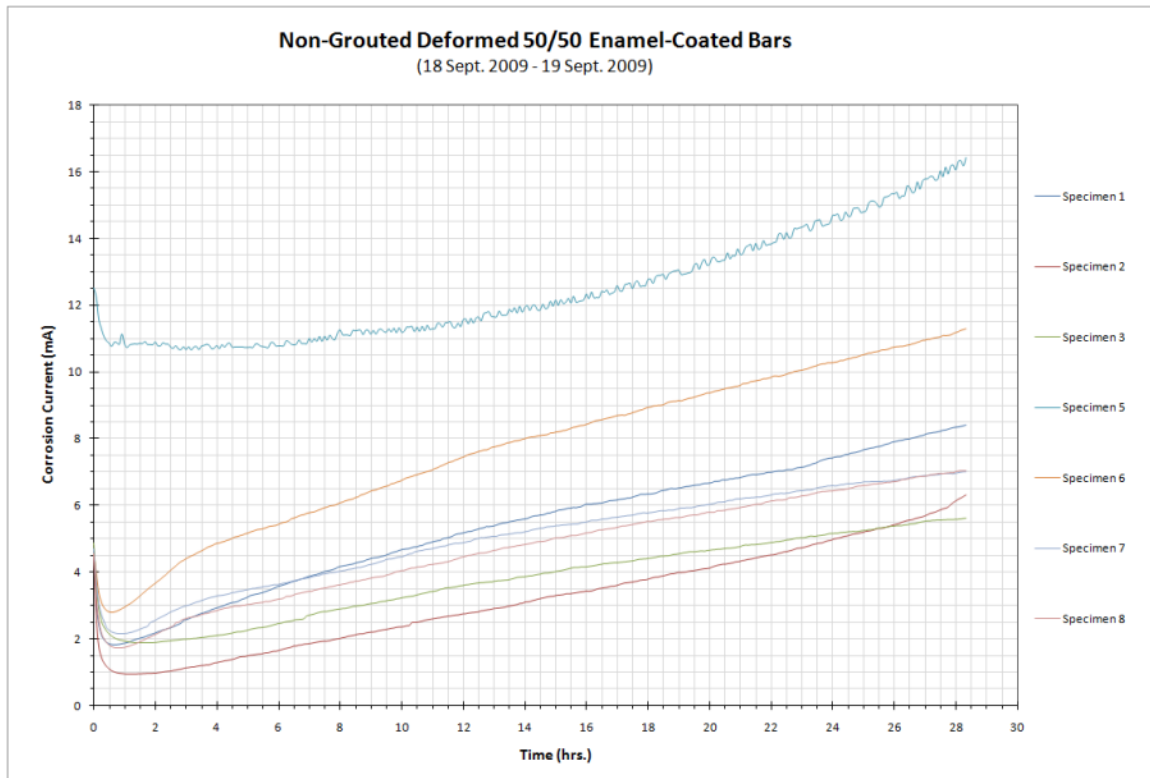
Figure B - 2: Corrosion current versus time plot for the non-grouted deformed 50/50 enamel-coated ACT specimens.

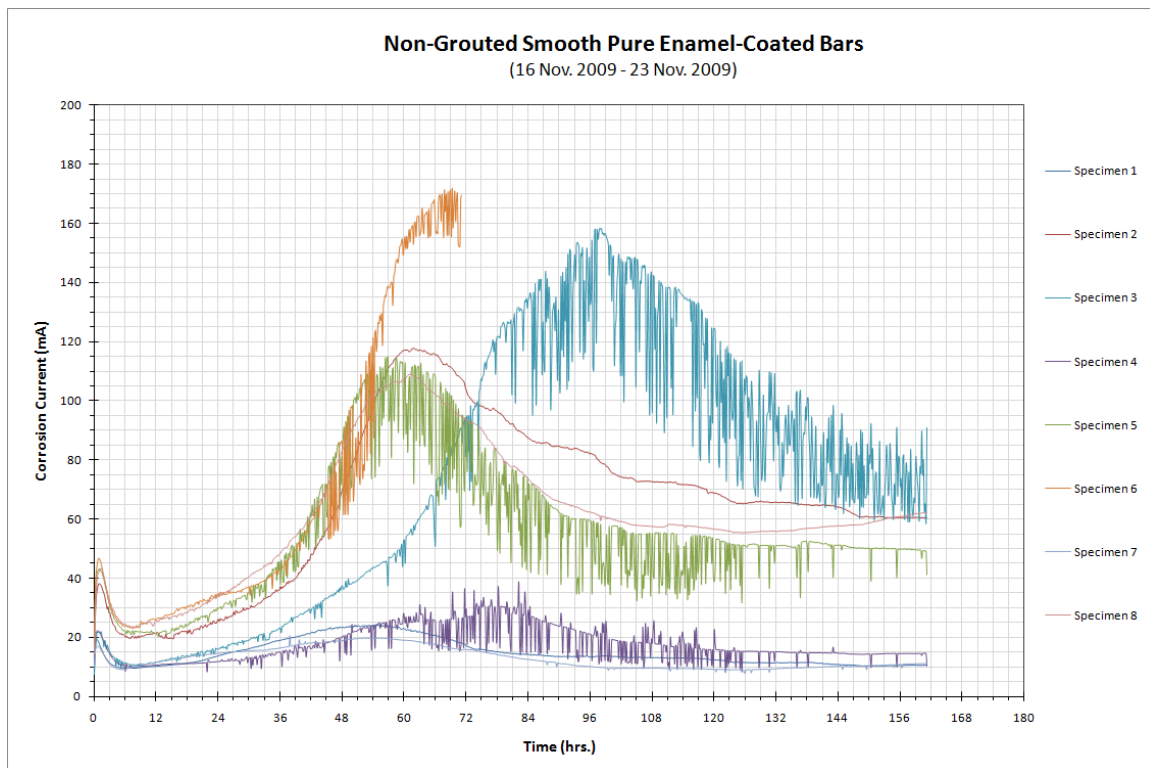
Figure B - 3: Corrosion current versus time plot for the non-grouted smooth pure enamel-coated ACT specimens.

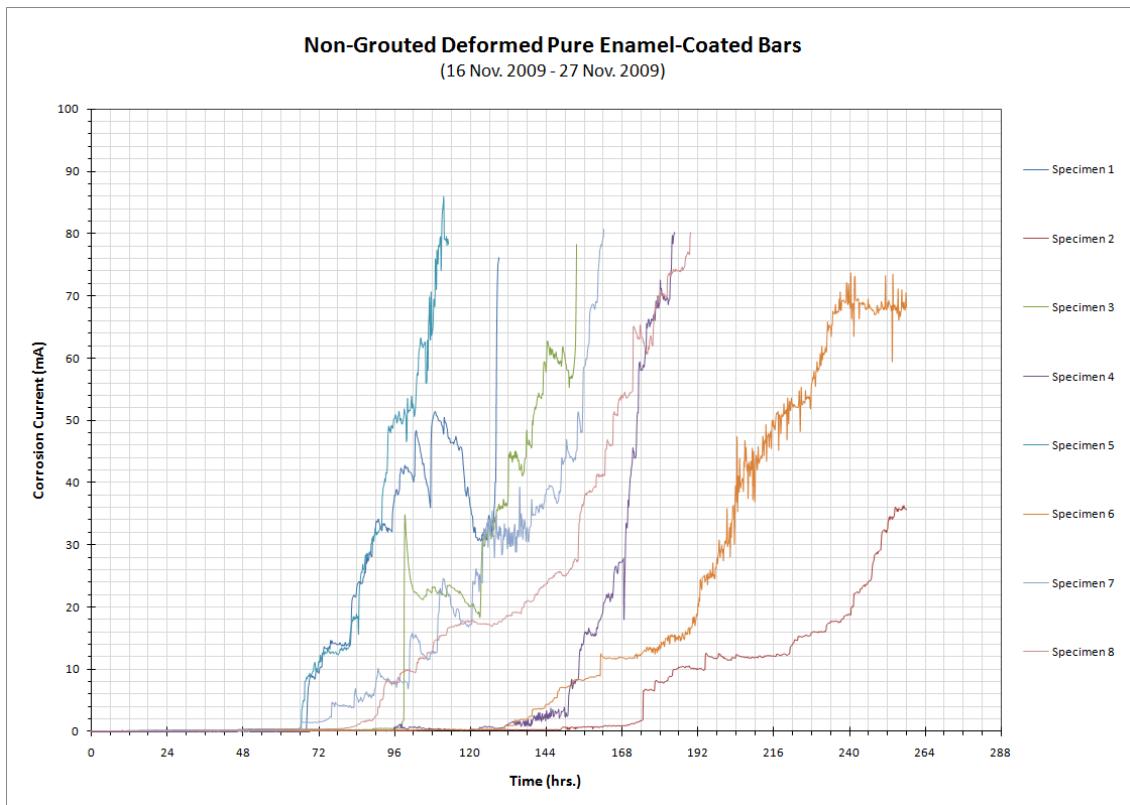
Figure B - 4: Corrosion current versus time plot for the non-grouted deformed pure enamel-coated ACT specimens.

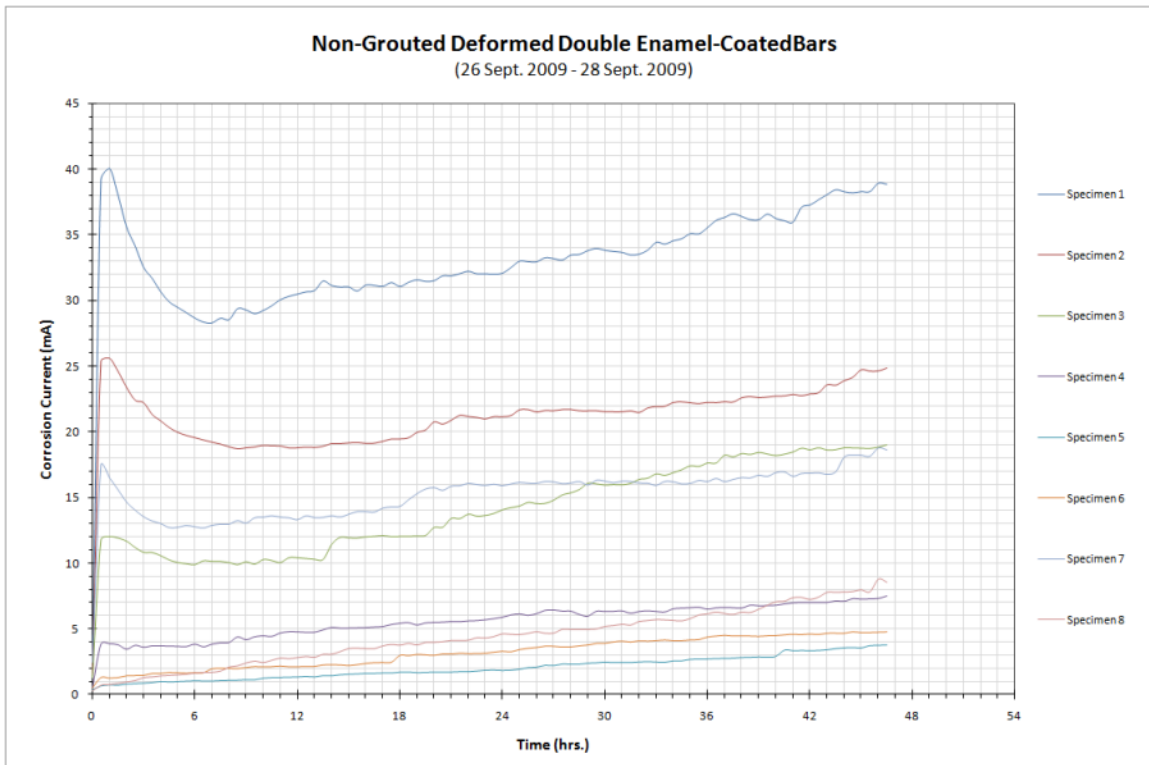
Figure B - 6: Corrosion current versus time plot for the non-grouted deformed double enamel-coated ACT specimens.

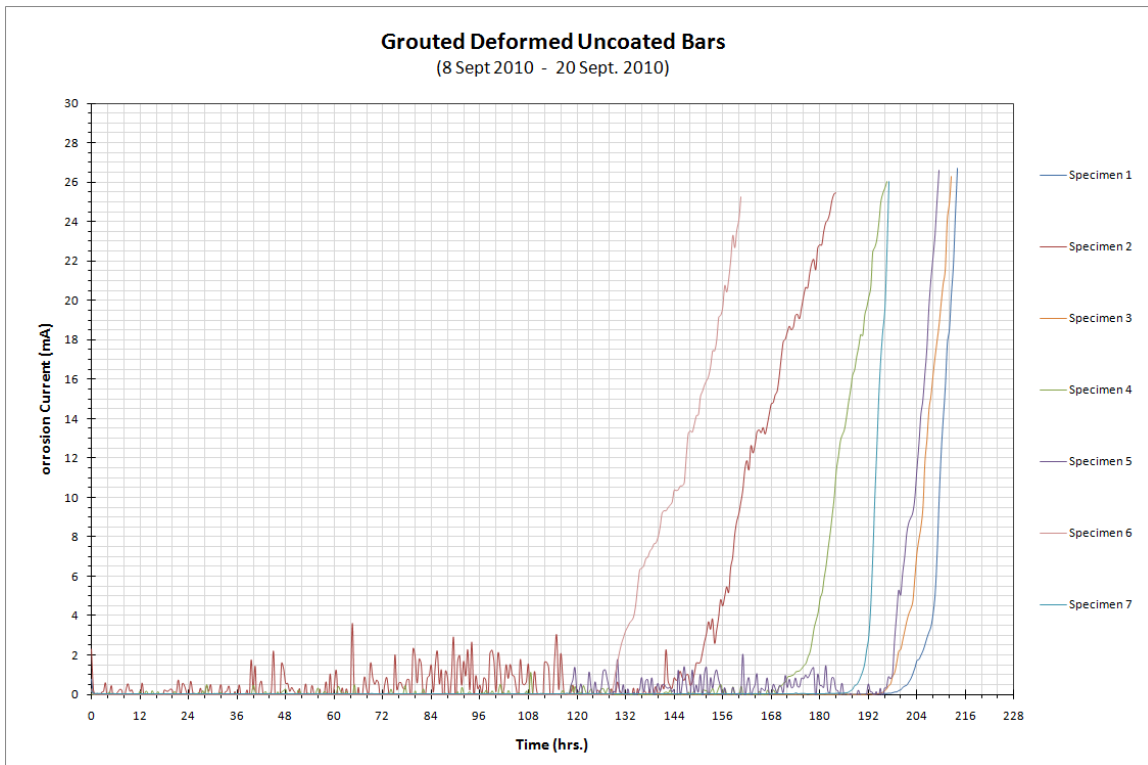
Figure B - 10: Corrosion current versus time plot for the grouted deformed uncoated ACT specimens.

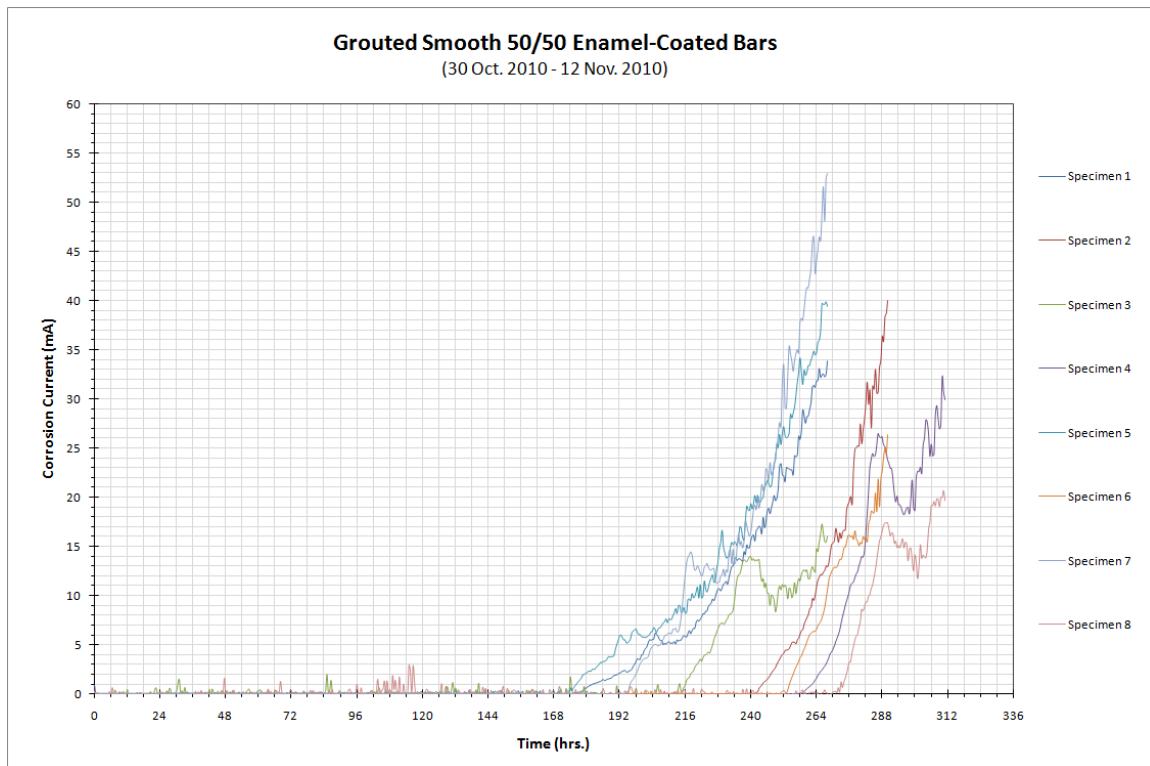
Figure B - 11: Corrosion current versus time plot for the grouted smooth 50/50 enamel-coated ACT specimens.

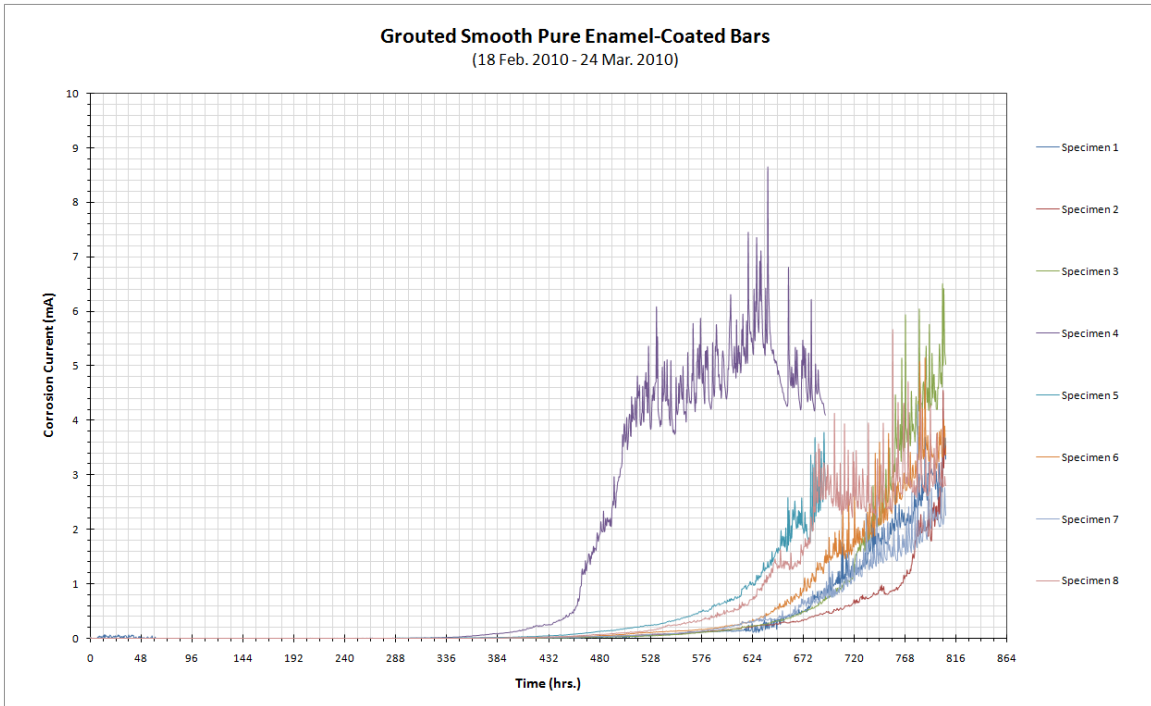
Figure B - 13: Corrosion current versus time plot for the grouted smooth pure enamel-coated ACT specimens.

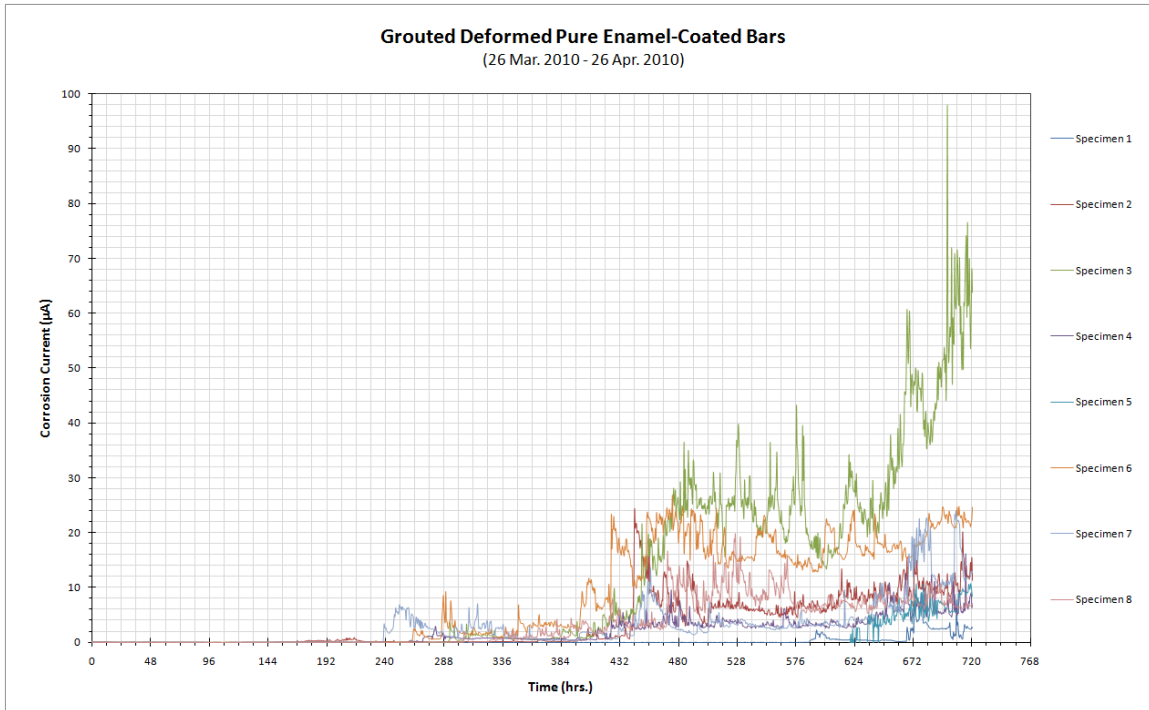
Figure B - 14: Corrosion current versus time plot for the grouted deformed pure enamel-coated ACT specimens.

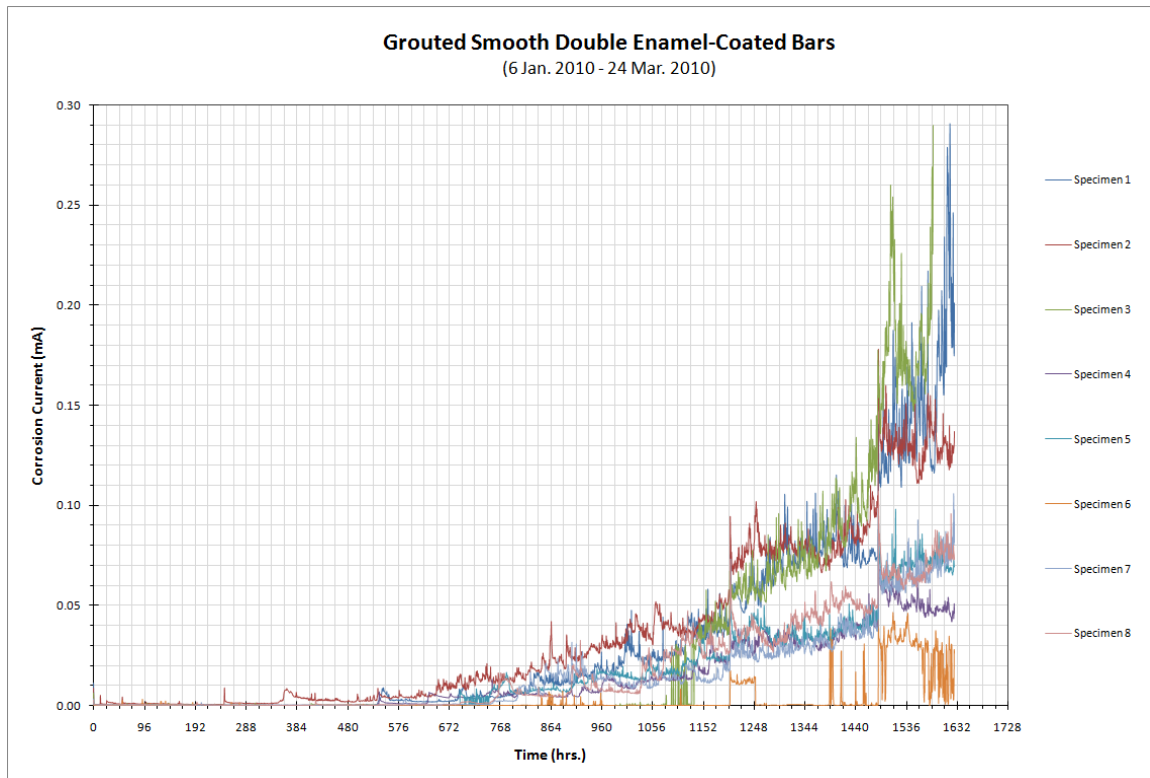
Figure B - 15: Corrosion current versus time plot for the grouted smooth double enamel-coated ACT specimens.

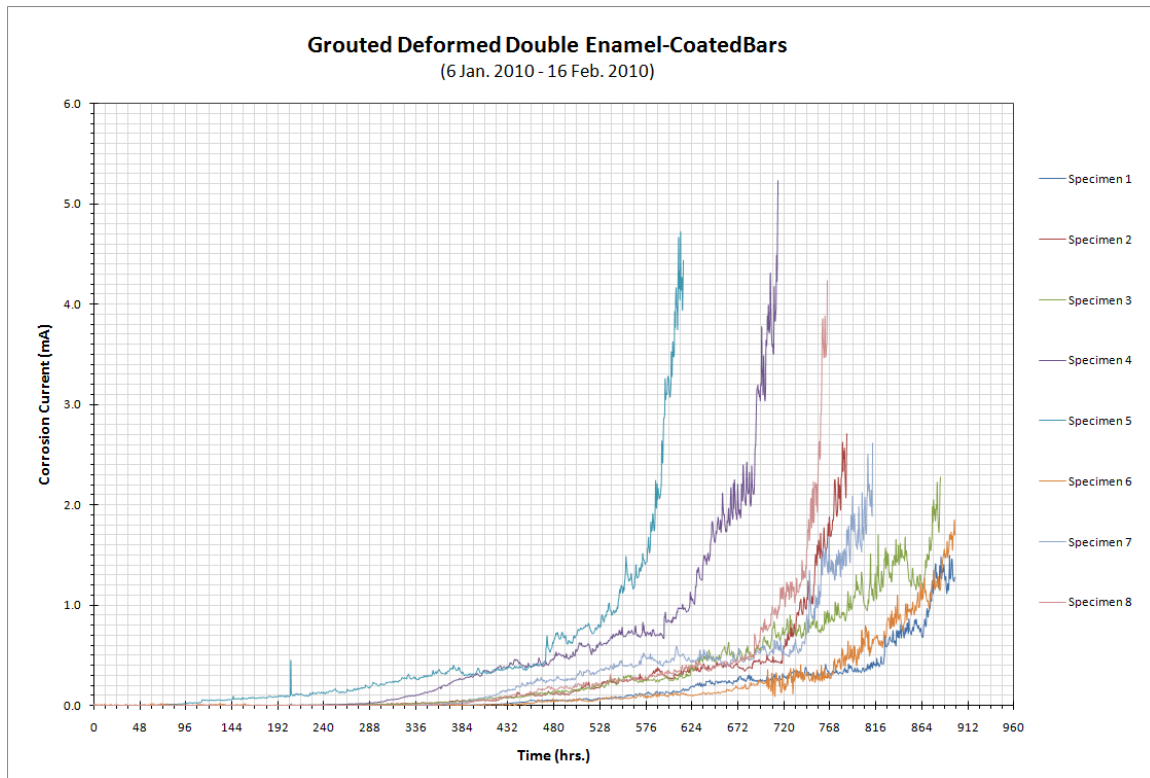
Figure B - 16: Corrosion current versus time plot for the grouted deformed double enamel-coated ACT specimens.

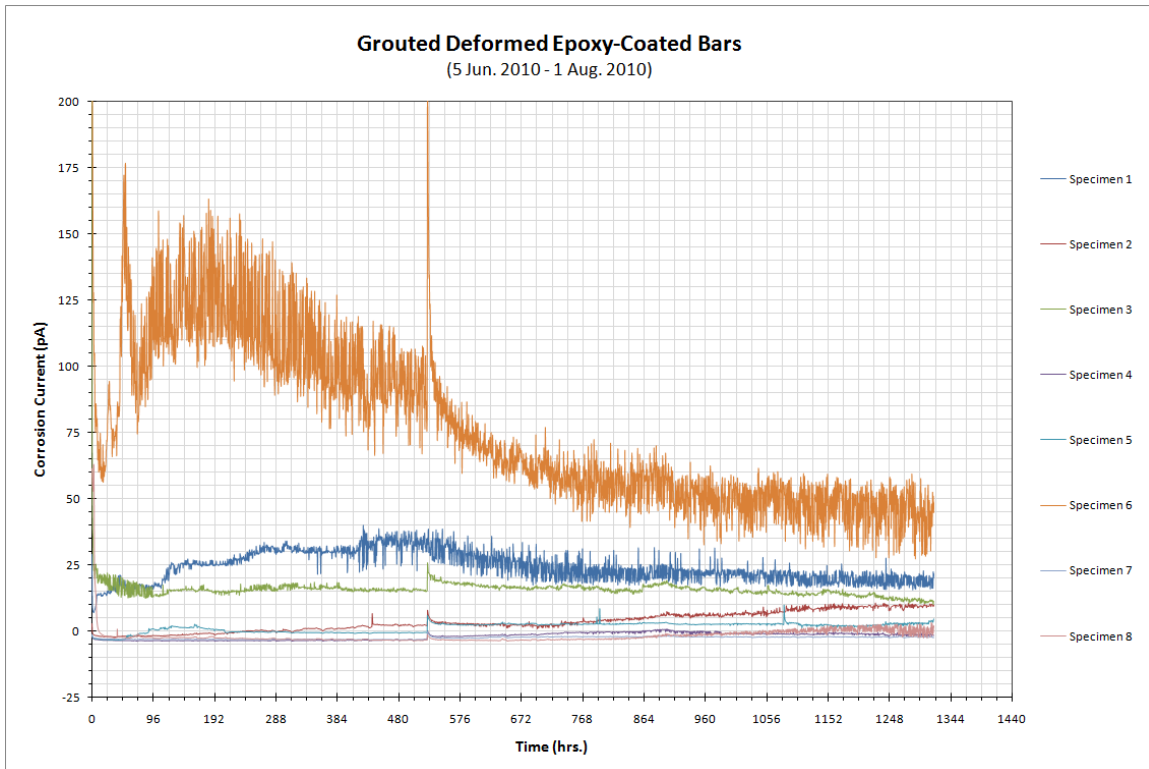
Figure B - 18: Corrosion current versus time plot for the grouted deformed epoxy-coated ACT specimens.
