Field Evaluation of Alternative and Cost-Efficient Bridge Approach Slabs

**NUTC
R272 /
R273**

1. Report No. NUTC R272 / R273	2. Government Accession No.	3. Recipient's Catalog No.	
4. Title and Subtitle Field Evaluation of Alternative and Cost Efficient Bridge Approach Slabs	5. Report Date November 2013

FINAL REPORT

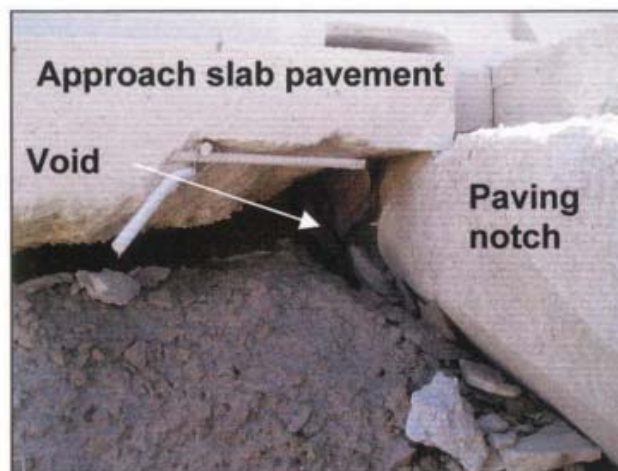
Figure 2-2 Erosion of Soil at the BAS and Abutment Joint [3]

Some geotechnical factors that affect the performance of BASs include settlement of the embankment soil and primary and secondary compression of the foundation soil under the abutments [7]. The embankment fill has a significant impact on the performance of a BAS. Three factors that affect the performance of embankment fills is the type of soil, the density at which it is compacted, and if the fill is susceptible to erosion [8]. Figure 2-2 shows a void formation under the BAS near the abutment, due to infiltration of water. The California Department of Transportation (Caltrans) performed a BAS study which indicated erosion and settlement of the soil to be the two main issues with BAS failure. A recommendation to help mitigate water infiltration was to extend the BAS over the wingwalls [9].

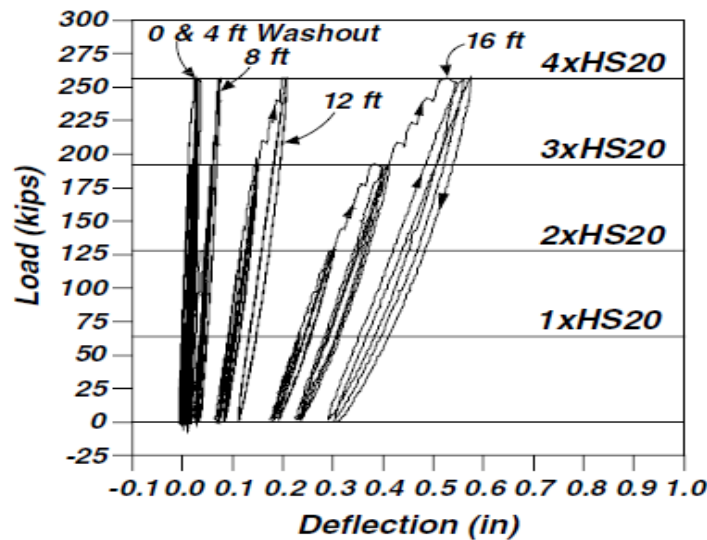
Figure 2-5 Load vs. Deflection at Various Washout Lengths [12]

Results indicated that when the slab is fully supported by the soil, the rotation and settlement of the slab were insignificant. It was determined for this panel length that once the washout length reached 6 ft., the slab began losing stiffness. The rotation near the abutment did not exceed a slope of 1/200 until it reached a washout distance of 10 ft. for the loading condition of 256 kips. The deflection was a concern based on a loading of 256 kips. The deflection when the washout was 16 ft. could cause severe motorist discomfort and would need immediate repair based on a differential settlement of 4 in. [12].

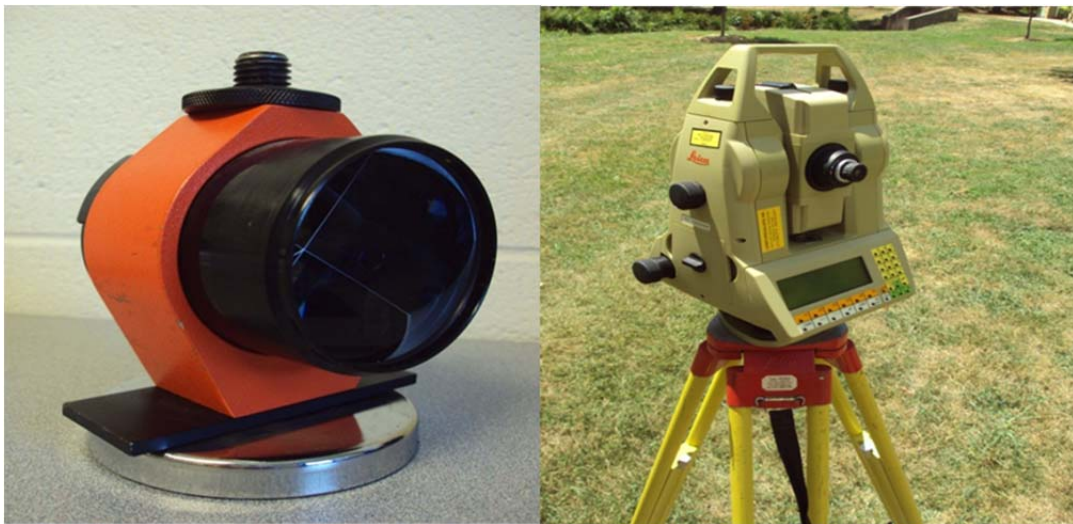
Figure 3-1 Surveying prism (left) and the Total Station (right)

One method used to evaluate the performance of the new BAS designs was to monitor the deflections of the slabs over time. Elevations of 6 points on the newly constructed BASs were determined relative to a point on the abutment using a high precision TCA 2003 Total Station manufactured by Leica Geosystems. The abutments were assumed to provide a stable benchmark since they were supported by pile foundations. The initial readings were used as a reference to determine if the BASs were deflecting due to various reasons such as water infiltration and loss of support or due to settlement of embankment soils. The Total Station was placed off the roadway roughly 50 to 100 ft. from the BAS to provide a wide line of sight to the selected points on the BAS. The total station rested on a tripod placed firmly in the soil to eliminate any movement when readings were being taken. Surveying prisms were placed on the selected 6 points of the BAS and on the abutment to perform the surveying. Figure 3-1 shows a surveying prism and the TCA 2003 Total Station. The surveying prisms had to be placed on a smooth and flat surface to collect accurate readings unlike the concrete surface of the BAS. Therefore monitoring plates were installed on the BASs at the selected 6 points. Detailed information on the monitoring plates is provided in the following sections.

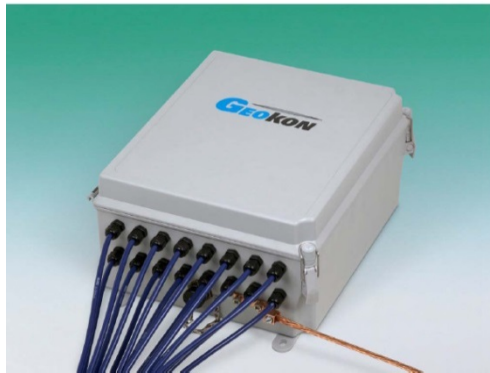
Figure 3-7 LC2x16 data logger

Geokon LC2x16 sixteen channel data logger was installed at site and used to collect and store VWSG recordings. The LC2x16 sixteen channel data logger is a battery powered measurement instrument that can read up to 16 VWSGs equipped with thermistors and store 3555 data arrays. The data can be downloaded using a USB modem and Log View software installed on a PC or laptop. Each data array contains the strain recorded (in microstrain units) and temperature readings (in degrees Celsius units) for each of the 16 VWSGs. Log View software allows the data to be downloaded in Microsoft Excel format. The microstrain readings can then be converted to actual strain and load values as described in following sections. Figure 3-7 shows the data logger with 16 cable connections for the gauges and the copper grounding cable.

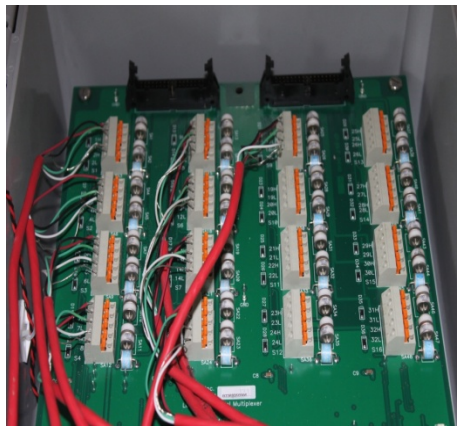
Figure 3-8 Terminal strip

Each VWSG connection cable consisted of five wires that were connected to terminal strips inside the data logger as shown in Figure 3-8. Table 3-3 shows the data transferred in each of the wires of a connection cable. The connections were made before installing the batteries for safe guarding the equipment.

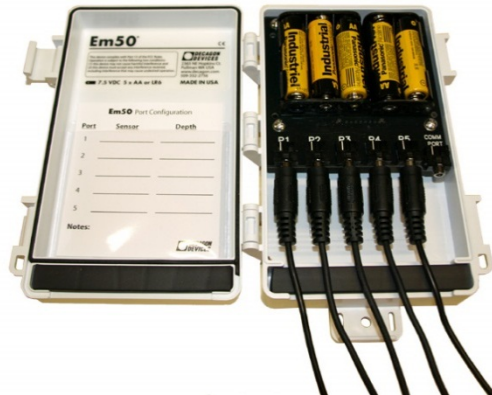
Figure 3-10 Decagon EM50 data logger

A Decagon EM 50 data logger was used to collect the moisture gauge readings which can read and store data for up to five gauges. Figure 3-10 shows the EM50 data logger. Data was collected at set time intervals and transferred to a laptop using a USB modem at the same time when VWSG data was transferred. The collected VWC data is transferred in Microsoft excel format and application of any correction factors is not necessary since the 10 HS Moisture gauges were pre-calibrated with the EM 50 data logger.

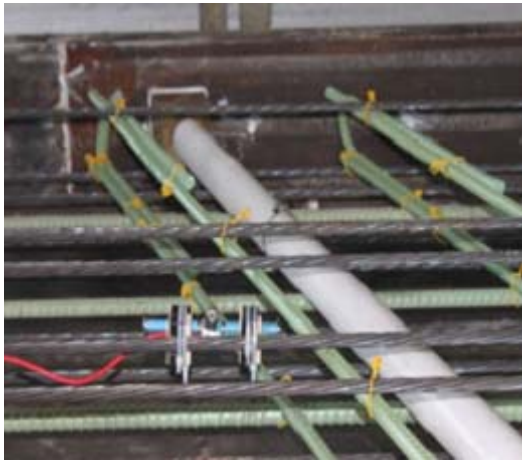
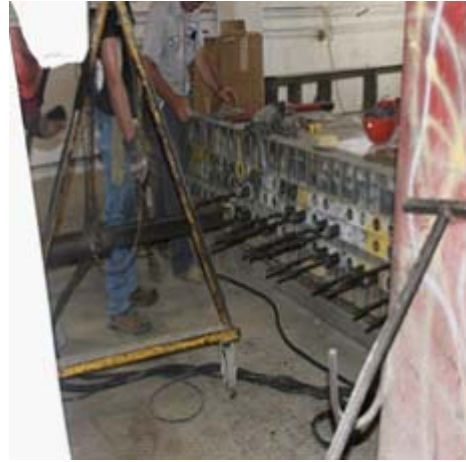
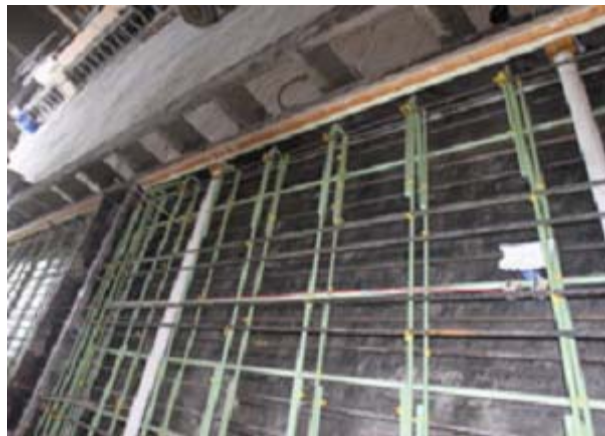
Figure 3-13 (a) Gauge anchored to steel, (b) Prestressing tendons, (c) Cables tied to steel rebar

The gauges were anchored to the steel after the reinforcement was laid out (see Figure 3-13a) and prestress tendons stressed in the formwork (Figure 3-13b). The gauges were anchored as described in Chapter 2. The VWSG-LT-006 gauge was anchored at about 45 degrees angle to allow for proper concreting around the gauge.

The cables were tied to the steel at about every three feet as shown in Figure 3-13c and taken out of the formwork and connected to the data logger for initial readings during concreting. The cables were checked for any damage before concreting of precast panels.

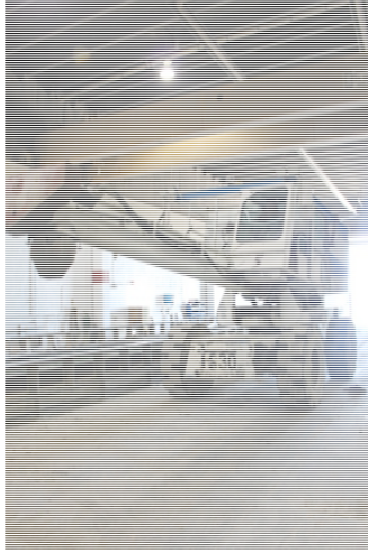
Figure 3-14 Tuckerbuilt Concrete Transport Vehicle

The concreting was done using a Tuckerbuilt Concrete Transport Vehicle pour truck (see Figure 3-14) and a team of four construction workers spreading and finishing the concrete and one construction worker using an immersion type vibrator (see Figure 3-15). The concrete mix was of a 10 inch slump which made it easy for concreting the instrumented panels. Care was taken by the construction team to pour the concrete away from the gauges first so that the fresh concrete can flow below the gauges and secure them in elevation. The formwork was marked for location of the gauges to avoid damage of gauges during the use of vibrators and other finishing operations (see Figure 3-16). The initial set took approximately 15 minutes and the final set was achieved in approximately 10 hours.

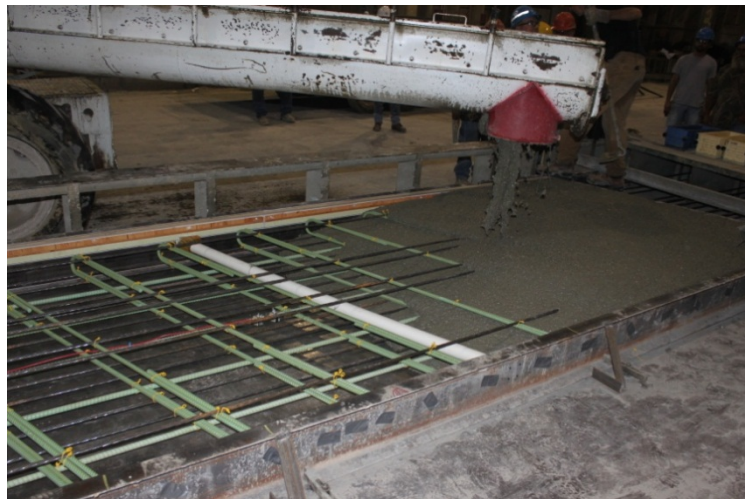
Figure 3-16 Marking of gauge location on formwork to prevent damage

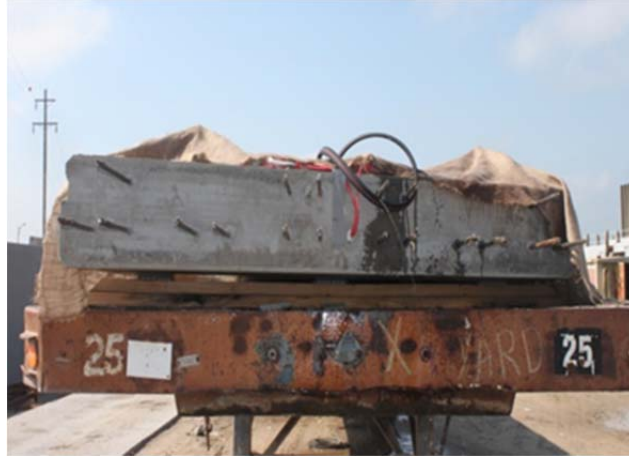
Figure 3-17 Curing of PCPS slabs

The first of two concrete pours were for four panels each. The four panels were laid out longitudinally. The prestress tendons were anchored at one end and stressed at the other end of the four panels. The prestress tendons between two panels were cut after the concrete was hardened and gained minimum strength. For the first pour, the data logging of the gauges was stopped before the prestress tendons were cut. For the second pour the data logging was stopped after the prestress tendons were cut to record any changes in concrete strain. The cables were carefully handled during removal of formwork and anchored to the slab panel top surface using zip lock plastic bags and tape. The curing was done using wet burlap. The cables were protected from being wet as they were housed in zip lock plastic bags (see Figure 3-17).

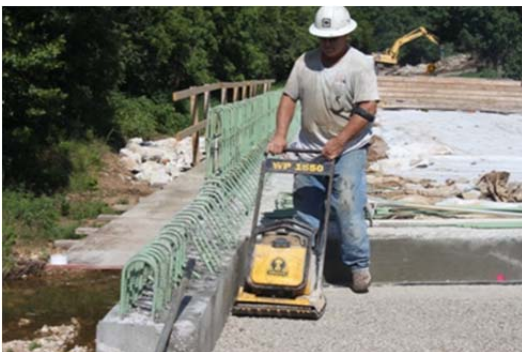
Figure 3-18 WP 1550 Compactor

The moisture gauges were embedded into the subgrade soil below the bridge approach slab on August 9 2011. The holes for placing gauges were dug out after placing and compacting (see Figure 3-18) 4 inch layer of type 1 aggregate (type 5 is the typical aggregate base MoDOT requires for roadway but type 1 can be substituted with no effect) on top of natural soil below the bridge approach slab. Rock material was found at most of the gauge locations (see Figure 3-19). The pockets dug out for gauges were filled with natural material. A two inch deep trench was dug out for running the cables out of the subgrade below the bridge approach slab (BAS). All the cables were collected on the north end of the BAS close to the abutment. The trench was filled with type 1 aggregate after running the cables between the probe and abutment (see Figure 3-19).

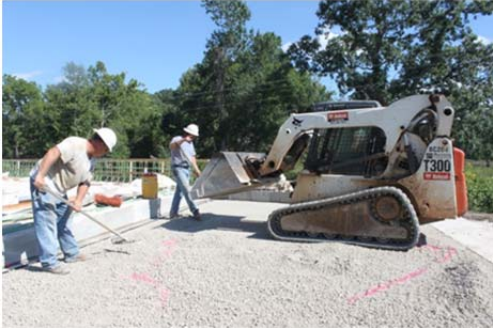
Figure 3-20 Moisture Gauge Cabling

Figure 3-20 and Figure 3-21 show the cable and gauge locations of the moisture gauges and Figure 3-22 shows the routing process of all the cables through PVC pipes to the location of the data logger. The data logger for both the strain gauges and the moisture gauges were placed under the bridge adjacent to the outermost girder.

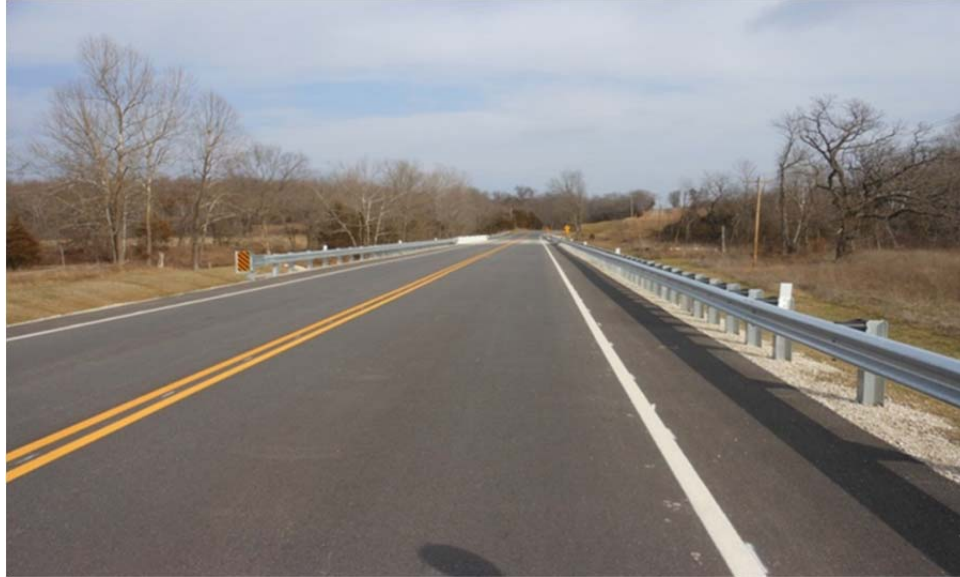
Figure 4-2 Bridge 7767 located on MO38 in Webster County, MO

Twenty feet PCPS panels were selected for the BAS on MO38 spanning Greer Creek. Each panel is 6 ft. wide by 20 ft. long and 10 in. thick. The slab contains a 2.0 in asphalt overlay to provide an adequate riding and wearing surface. The design drawings that were issued to the contractor by MoDOT are provided in Appendix I. Figure 4-2 shows the completed picture of the bridge.

After the installation of the bearing pads and polyethylene sheeting, the PCPS panels were installed and were tied using tie rods in the transverse direction. The tie rod consisted of 1 in. diameter Grade 60 steel (Figure 4-9). After tying the slabs together the keyways were grouted. This helps the BAS function as a single unit without significant movement (deflection and rotation) between each panel. The connection to the abutment was created by drilling holes in the abutment through the preformed holes in the BAS (Figure 4-10), then placing $\frac{3}{4}$ in. epoxy coated dowel bars through the slab into the abutment. These dowel bars were placed at 24 in. on center and will help to develop a zero moment transfer connection between the BAS and bridge deck. Figure 4-11 shows all the panels placed prior to laying the asphalt layer. Figure 4-2 shows the completed BAS with the asphalt overlay.

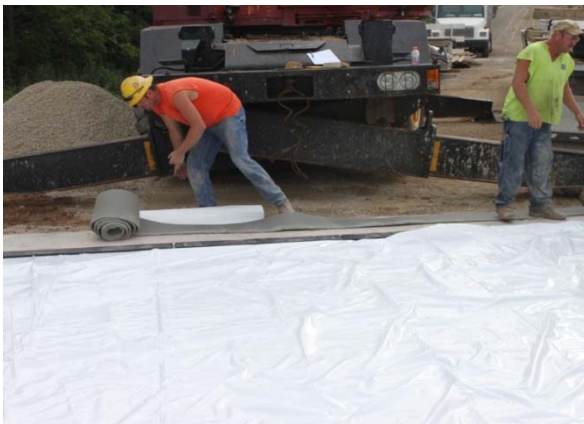
Figure 4-3 Installation of Plastic Membrane, Bearing Pads, and Joint Filler

The PCPS panels were installed at the jobsite on August 9, 2011. Each BAS consisted of 5 panels. The panels were placed on bearing pads on the abutment and sleeper slab to help create a uniform support and to allow for hinging action (see Figure 4-3). The precast panels were placed on the leveled type 1 aggregate using a crane (see Figure 4-4). Two layers of polyethylene sheets were placed between the aggregate (see Figure 4-3) and precast panels on the east end to facilitate sliding without friction between the PCPS slab and the aggregate base. However, the precast panels on the west end were placed directly on top of the aggregate on the west end to allow any leakages of water between panels to seep into the subgrade below. This allowed the moisture gauges to measure any leakages of water from the joints between the panels.

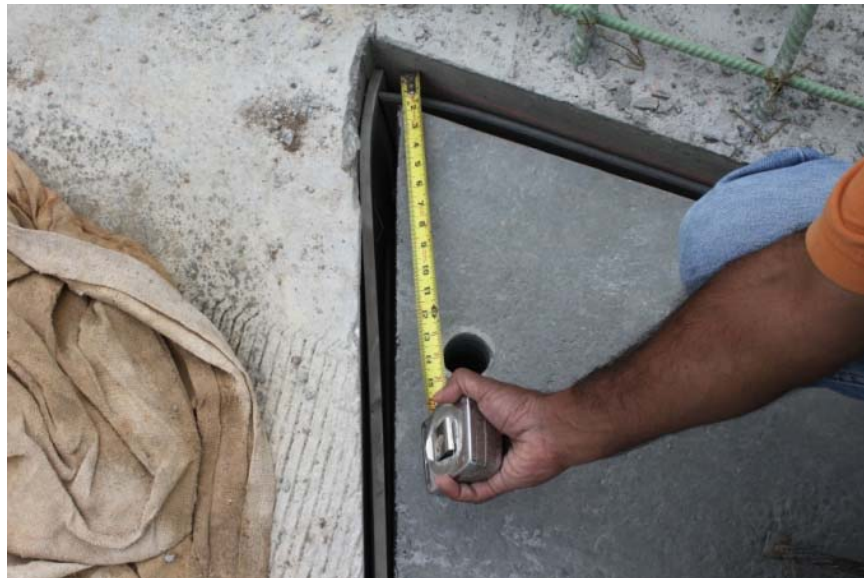
Figure 4-7 Alignment of PCPS slab with abutment

The cast in situ construction of the curb on west end did not match the planned dimensions of the set of precast panels Figure 4-7 & Figure 4-8. Hence, the panels were removed after trying to place them initially, and a part of the concrete in the south end wing wall was chipped away to fit the panels between the two curbs. The construction activity was further delayed because the specific washers for connections between transverse tie rods were not delivered by the contractor with the panels. The site contractor's preference was full length tie rods instead of individual tied rods for each panel with connections. This option was discussed with MODOT engineers at the site and it was agreed upon to use the full length option.

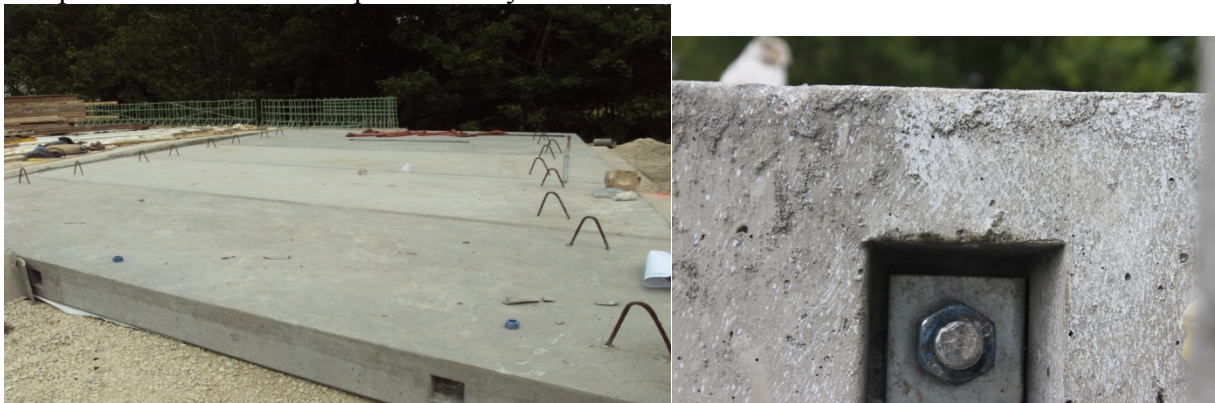
Figure 4-9 Picture showing the recesses for transverse tie rods (left) and the tie rod placed in the slabs (right)

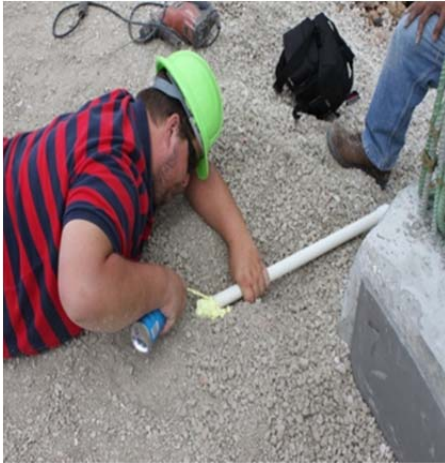
Figure 4-12 Sealing PVC Joint Conduits

The cables from the embedded strain gauges in the precast panels were collected at the sleeper slab end (in the expansion joint) and run under the bridge using PVC conduits. The cables for strain and moisture gauges were run in separate PVC conduits along the curb and back up under the bridge between the 1st and 2nd concrete girders on the north-west end. The level of cables was kept above the planned level of rip rap along the curb to avoid damage to the conduit. The cable conduit connections were sealed with PVC cement. The T pipe joints which collected the cables from individual panels, the open ends of conduit and any other openings were sealed with foam sealant for water tightness (see Figure 4-12 and Figure 4-13).

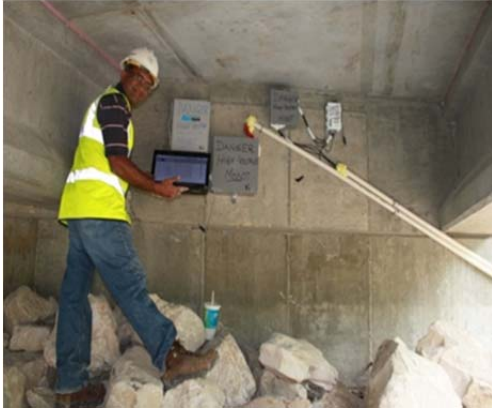
Figure 4-14 Data collection equipment

The data loggers were anchored to the abutment wall below the bridge between the 1st and 2nd girders on the north-west end (see Figure 4-14). Two additional weather proof boxes were also anchored to the abutment wall and the additional spool of cables were housed in the two additional boxes. All the boxes were labeled MoDOT / DANGEROUS / HIGH VOLTAGE to avoid theft during the course of collection of data. The location of data loggers was selected to prevent direct exposure to weather conditions, damage of data loggers and cable conduits during removal of bridge curb formwork and theft. Two one and a half inch holes were made in the storage boxes (one at side and one at bottom) to route the cables from the conduits to the data loggers. The holes were later sealed with foam sealant. The gauge cables were labeled at the end connecting to the data collection equipment (see Figure 4-15).

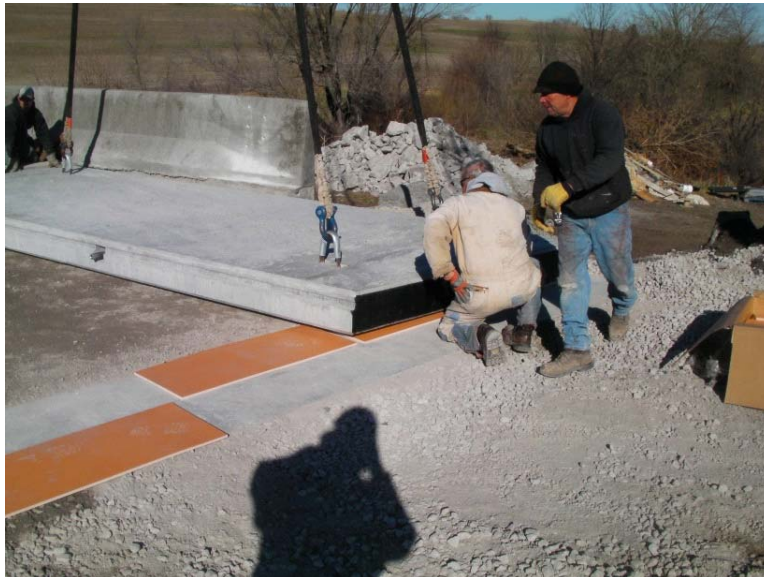
Figure 4-21 Placement of First PCPS Panel on US136 on Bearing Pads on Sleeper Slab

After completion of the compaction of the aggregate base the contractors recommended the use of sand or lime to make it easier to level. The large aggregate made it difficult to form a flat surface and the addition of a finer material would help. After the base was level, rubber fabric pads were placed on the sleeper slab and along the bridge deck and wingwall to provide for expansion as seen in Figure 4-21.

Figure 4-21 shows the laying of the first panel at the east end of the bridge. No polythene sheets were specified for this bridge. Figure 4-22 shows placement of the middle panel and Figure 4-23 shows the placement of the last panel. These panels were connected using the shorter transverse tie rods that connect two adjacent panels. It was observed that the construction crew had a difficult time trying to reach in between the panels in order to tighten the nut of the tie rods.

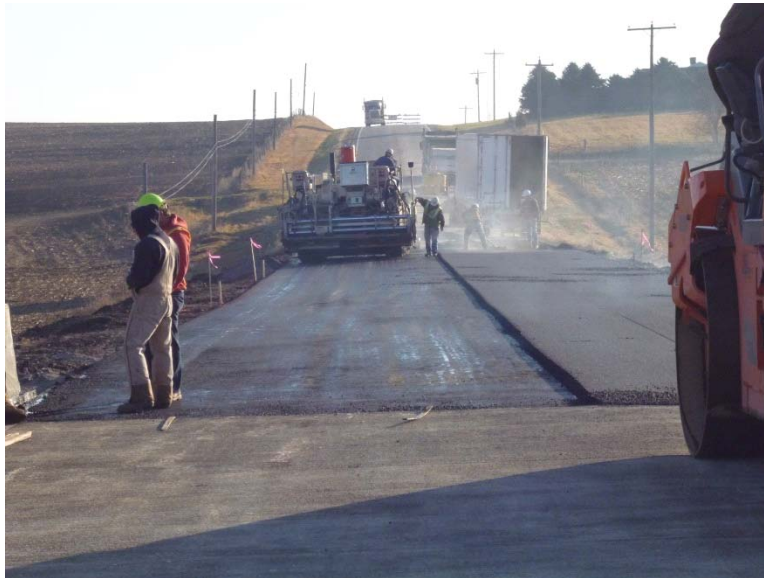
Figure 4-24 Laying of Asphalt over PCPS Panels on Bridge A7934

Finally Figure 4-24 shows the laying of the asphalt layer on the east end of the bridge over the PCPS panels as the finished riding surface and Figure 4-25 shows the completed picture of the PCPS system over bridge A7934 on US136.

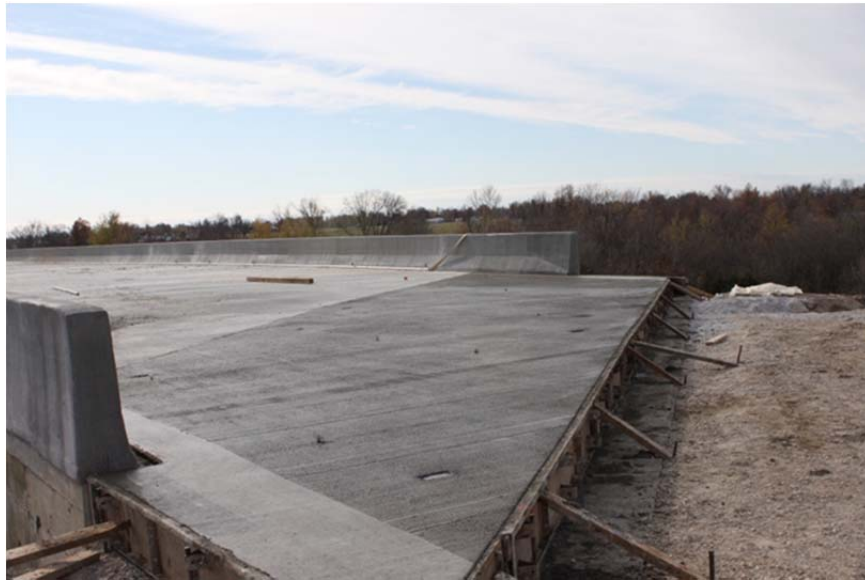
Figure 4-29 Completed Picture of 20 ft. CIP BAS on Bridge B0563

The slab is 20 feet long, approximately 38 feet in width and 12 inches in depth. The CIP BASs were constructed in November 2011 for Bridge B0563. The polyethylene sheeting was placed on the base then all metal formwork was constructed. Block outs for mud jacking were placed then the steel rebar cage was constructed. The assembly of the steel cage and formwork prior to pouring is shown in Figure 4-27. The concrete was placed using a hydraulic excavator and concrete bucket as shown in Figure 4-28. As the concrete was poured, a vibratory truss screed was used to finish the concrete surface level with the formwork. Once this was performed, trowels were used to give the BASs its smooth finish. The concrete was then tined using a texture comb to improve skid resistance and traction for motorists upon entering/exiting the bridge. The completed CIP BAS for Bridge B0563 can be found in Figure 4-29.

Six monitoring plates were placed on fresh concrete (see Figure 4-30 and Figure 4-29) for load testing purposes using load trucks and inclinometers. Figure 4-30 shows the schematic of the location of the monitoring plates and Figure 4-31 shows the monitoring plates in this bridge being placed on fresh concrete.

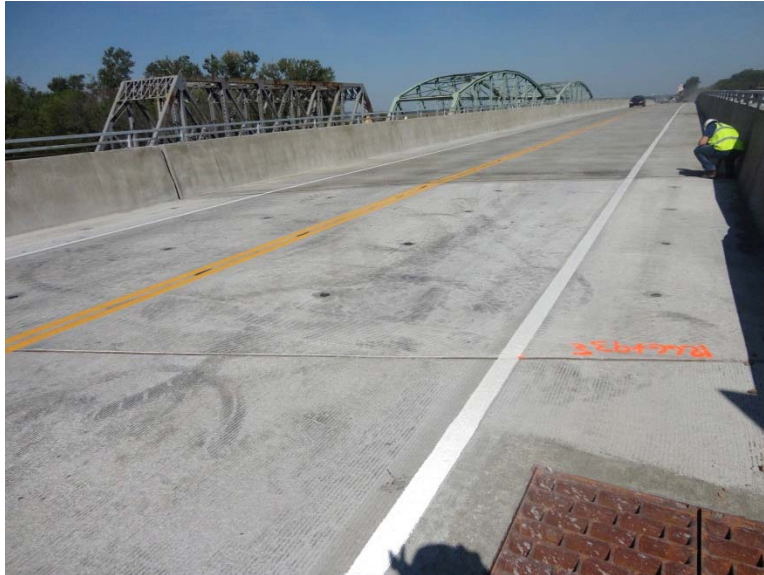
Figure 4-34 Completed View of the 25 ft. CIP BAS with No Sleeper Slab on MO45

Bridge approach slab CIP25NOSLP for bridge A7925 in Platte County, Missouri was constructed using a cast-in-place slab (Figure 4-34). It has a 25 foot span, approximately 42 feet wide and 12 inch deep and does not have a sleeper slab. The bottom longitudinal and transverse reinforcement used are #6 @ 8" c/c and #4 @ 12" c/c respectively. The top longitudinal and transverse reinforcement used are #5 @ 12" c/c and #4 @ 12" c/c respectively. At the pavement end of the slab additional #4 bottom transverse rebar were used at 3" c/c. The bridge approach slab was placed on type-1 aggregate base. The schematic view for the slab is provided in Appendix V.

Figure 4-34 shows the constructed photograph of this BAS. One observation that was made on this particular BAS was the loss of some support soil under the BAS after the completion of the electrical work as seen in Figure 4-35.

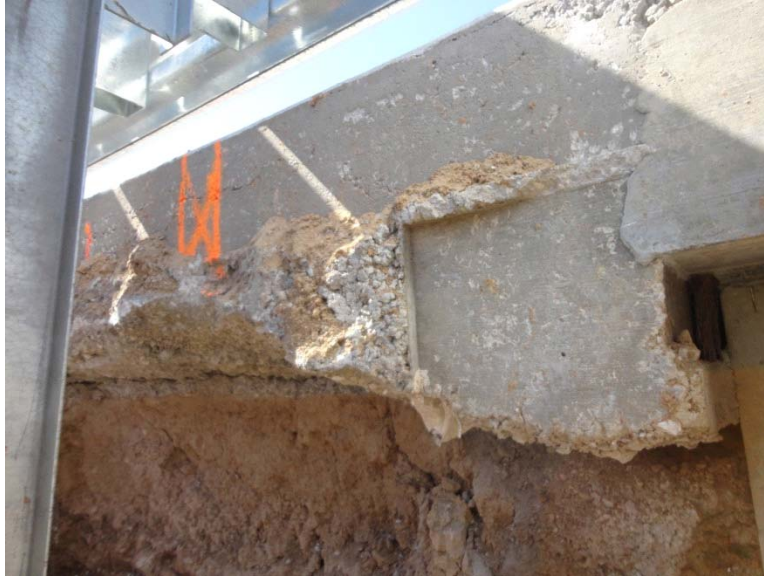
Figure 4-35 Partial Loss of Soil Support at the Edge of the BAS on the West End of MO45

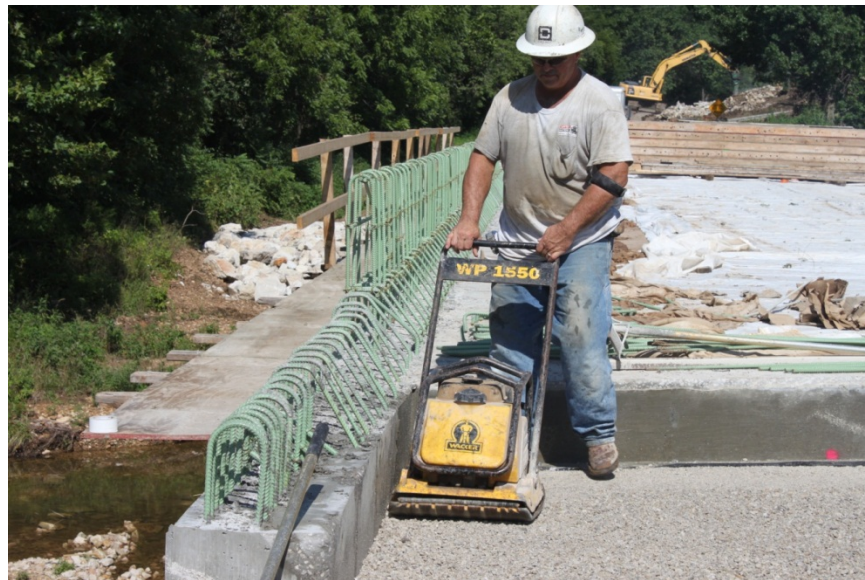
Figure 4-39 Compaction of Aggregate Base under PCPS BAS

The bases under each BAS were compacted using a Wacker WP 1550 vibratory plate compactor as shown in Figure 4-39. The compactor has a compaction depth up to 12 in. and a vibration frequency of 6,000 vibrations per minute. These specifications were used when conducting the lab study on the PCPS panel outlined in a later chapter.

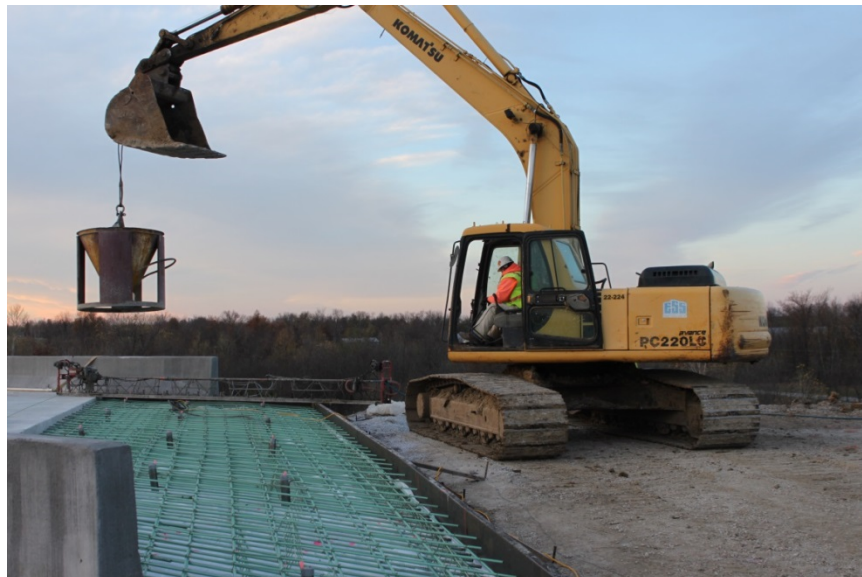
Figure 5-1 Construction of bridge B0563

The new 20 ft. CIP BAS design developed by the researchers was used on Bridge B0563 on US71 in Jasper County, MO over the M&NA railroad. The bridge and the approach slabs are skewed 45° and the BASs are 38 ft. wide. The BAS was constructed by a local subcontractor. Epoxy coated reinforcement was used for bottom and top mats and plastic cylindrical inclusions were used to allow mud-jacking of the slab later if necessary. The slab was cast using a 3 yard concrete bucket attached to a Komatsu PC220LC hydraulic excavator and a crew of 6 workers including a foreman. The concrete bucket was filled directly from the ready mixed concrete trucks using the chute about 20 ft. away from the formwork and were lifted and transported to the formwork using the hydraulic excavator. A gas electric generator was used to power a concrete vibrator and vibrating screed was used to place the concrete. A broom finish was applied to the surface for a rough surface after placement of the monitoring plates. The monitoring plates were used later to place inclinometers during static load testing. The finished BAS was sprayed with a liquid curing compound and was not covered. Figure 5-1 shows construction equipment used for the BAS on bridge B0563 on US71.

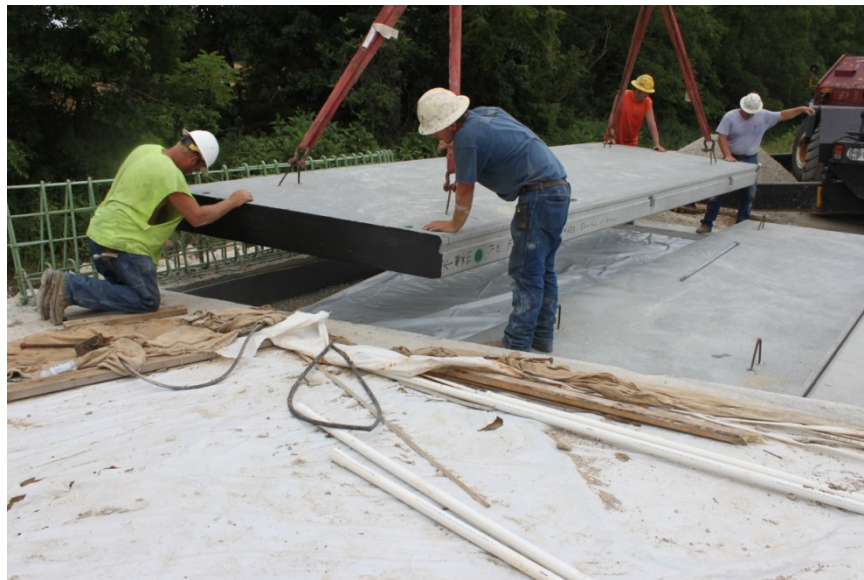
Figure 5-2 PCPS Panel placement on Bridge A7767

The BASs of bridge A7767 are skewed 30° and they are 30 ft. wide consisting of five 6 ft. wide PCPS panels on each end of the bridge. The PCPS panels were produced at CORESLAB's Marshall Plant in Missouri and delivered to the site on flatbed trucks. The PCPS panels were placed using a 33 ton rough terrain crane with a 92 ft. boom directly from the truck to the aggregate base covered with polyethylene sheeting. Figure 5-2 shows placement of PCPS panels. Placement of the panels had to be stopped on the east side after the placement of the first panel because of uneven support caused by high spots in the aggregate base. The panel and polyethylene sheeting were removed and the aggregate base was re-leveled using a 2x6 between the abutment and sleeper slab. During the placement of panels on the west end, the south side wing wall had to be chipped to fit the panels between the wing walls.

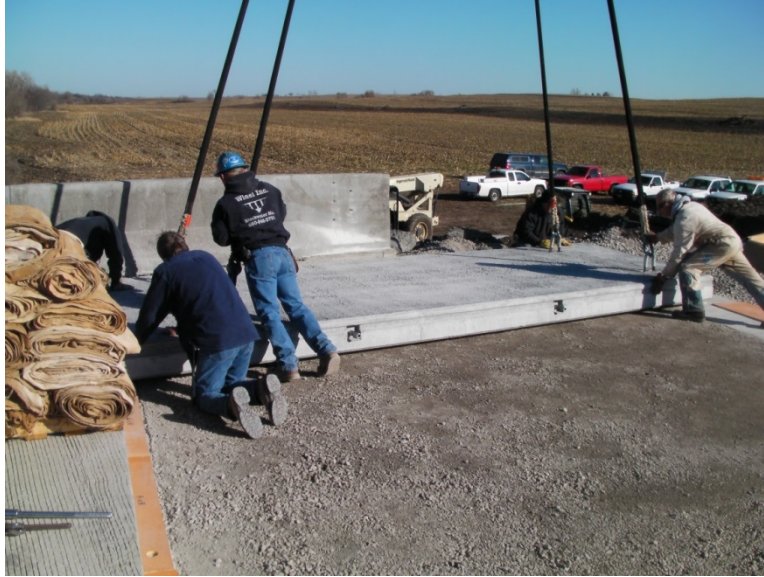
Figure 5-3 Placement of the first PCPS panel on A7934

The second bridge, A7934, which implemented the 20 ft. PCPS BAS design, is in Atchison County, MO over Little Tarkio Creek. The BASs were 32 ft. wide. The most important difference between the two implementations of the 20 ft. PCPS design was the width of the PCPS panels used. The A7767 bridge used five 6 ft. wide PCPS panels to construct the BASs but in this project the BASs consisted of four 8 ft. wide panels. The lower number of total panels allowed the precast producer to cast all the panels in two casts instead of three, which had an important effect on the cost. Similar to the A7767 project the PCPS panels were lifted and placed using a crawler crane on compacted and leveled aggregate base. Rubber pads were placed on the abutment and on the sleeper slab prior to the placement of the PCPS panels. Placement of the four panels for one BAS took approximately four hours. Placement of the fourth panel took the longest due to complications aligning the tie rods and accessing the key hole for tightening of the hex sleeve. The fourth panel had to be disconnected from the crane and panel three had to be reconnected to slightly lift the panel. This allowed proper alignment and allowed a construction worker to get his torque wrench between the slabs to tighten the hex sleeve. Figure 5-3 shows the placement of the first PCPS panel and the tie rod holes. The contractor used a crew of five people in addition to a foreman and crew operator to place the slabs and placement of both BASs took approximately 8 hours.

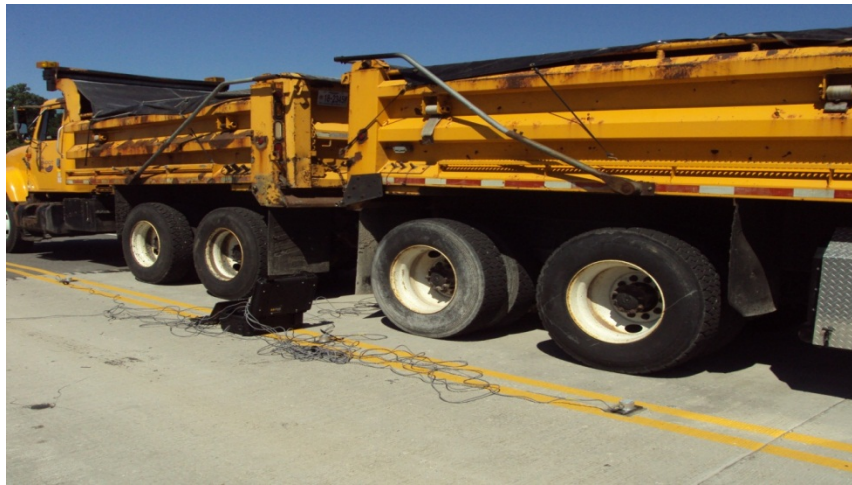
Figure 6-2 Overloading left lane for the BAS on Bridge A7890

The load test was conducted using two HS20 MoDOT dump trucks as shown in Figure 6-2 and Figure 6-3. Each load test occurred in the lanes where the BASs experience service loading. This provided a uniform test between all three (3) slab designs and represented actual load locations once the bridge was opened to traffic.

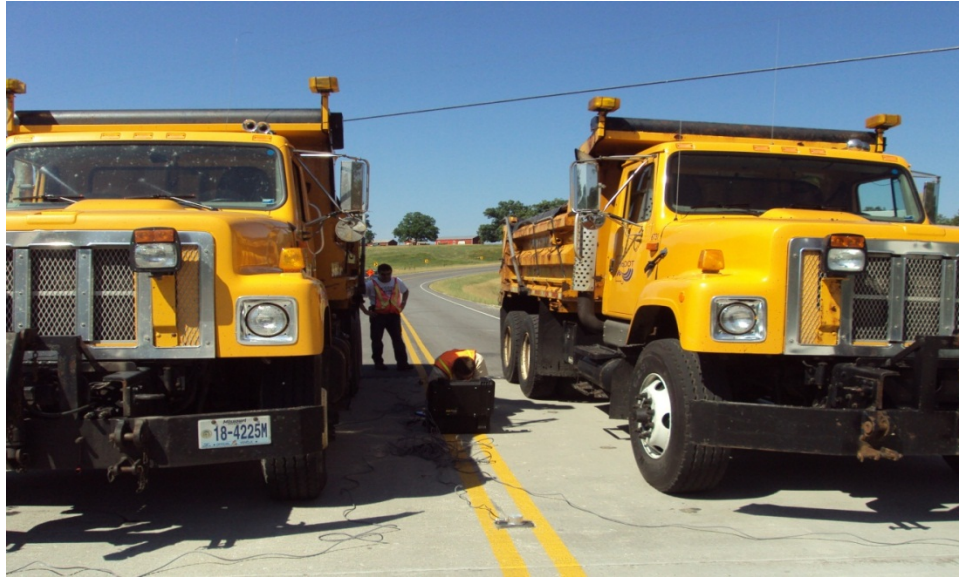
Figure 6-3 Tandem loads placed near the flexible pavement on Bridge A7890

the flexible pavement. Load case 4 determined how much rotation the slabs experience based on the support condition (two designs were supported on sleeper slabs while one design relies on the full elastic support of the soil). The diagrams and dimensions of the loading cases mentioned above can be found in Figure 6-4 to Figure 6-6.

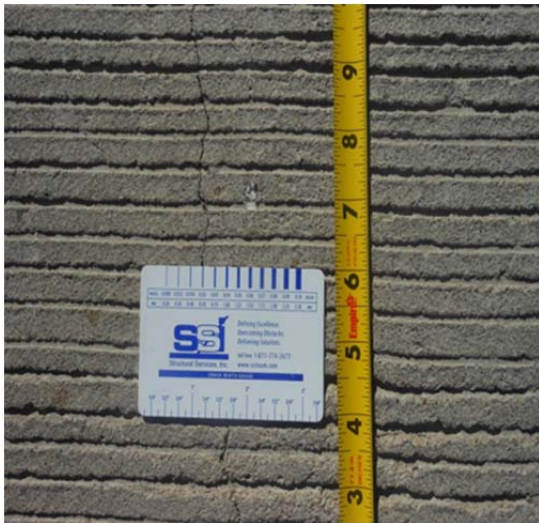
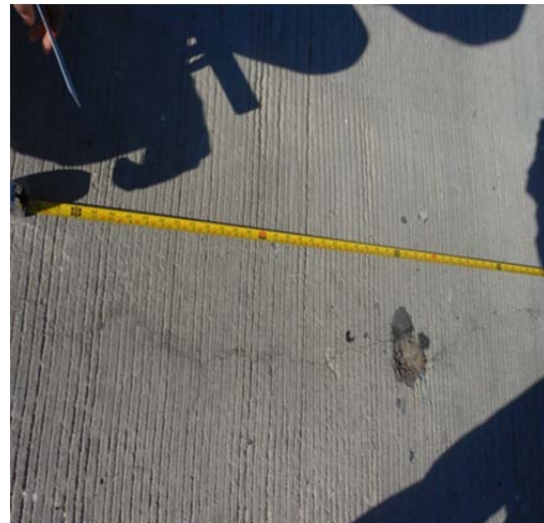
a) Measurement of crack width

b) Measurement of crack length

Figure 6-43 Surface Crack on 25 ft. CIP BAS on Bridge A7890

This section presents site observations following construction of the approach slabs. The slabs were monitored through visual inspection periodically over the next 21 months. The BASs were inspected visually for any signs of cracking and deflection. The slabs were also investigated for any signs of washout. There are no current signs of visual washout or deflection which is reflected based on the load testing. However, the 25 ft. CIP BAS on Bridge A7890 showed a slight longitudinal surface crack down the middle of the east bound lane (see Figure 6-43) during the site visit on August 2012. It had a crack width of roughly 0.079 in. (2 mm) and is not considered an issue at this time.

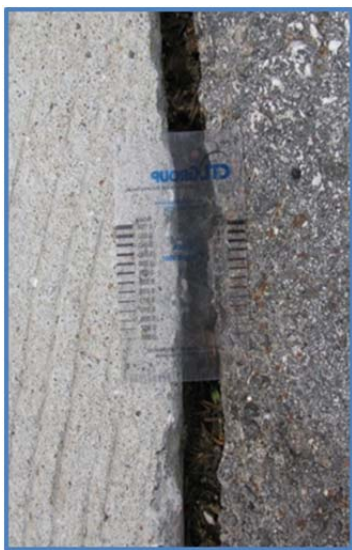
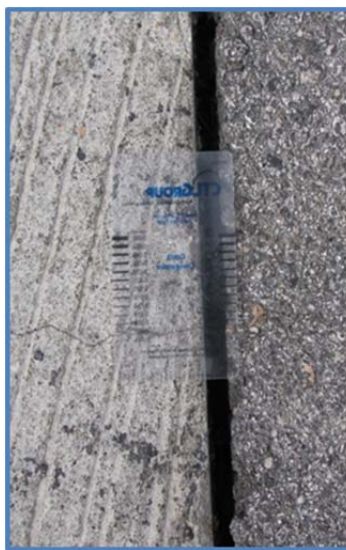
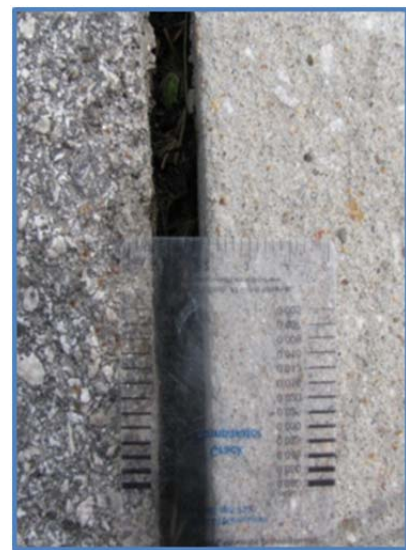
Figure 6-44 Gap between the approach pavement and approach slab at north shoulder, center & south shoulder respectively on Bridge A7890 at Final Site Inspection

Besides slight surface cracking of the asphalt shoulder there were no significant changes until the final site visit. Between 19 and 21 months a gap of approximately 0.75 inches formed between approach slab and approach pavement of the bridge. This can be seen in Figure 6-44.

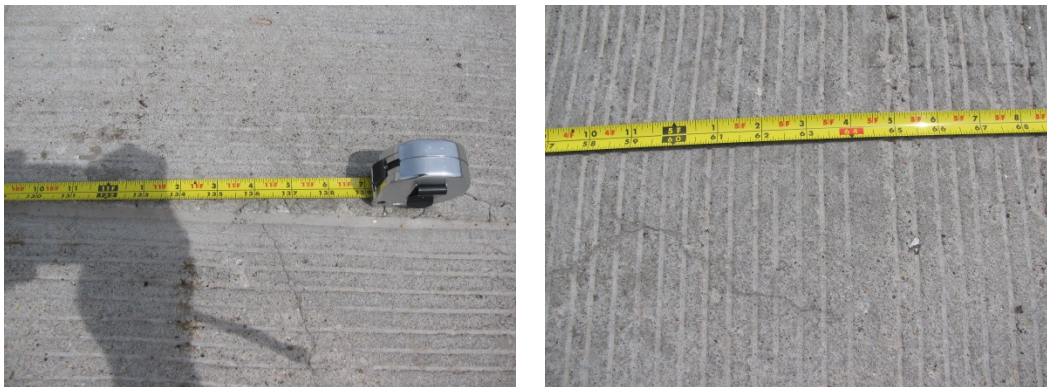
Figure 6-45 Longitudinal Crack at West End of PCPS on MO38 – 11’4” distance from the wing wall (left) and 5’4” crack (right)

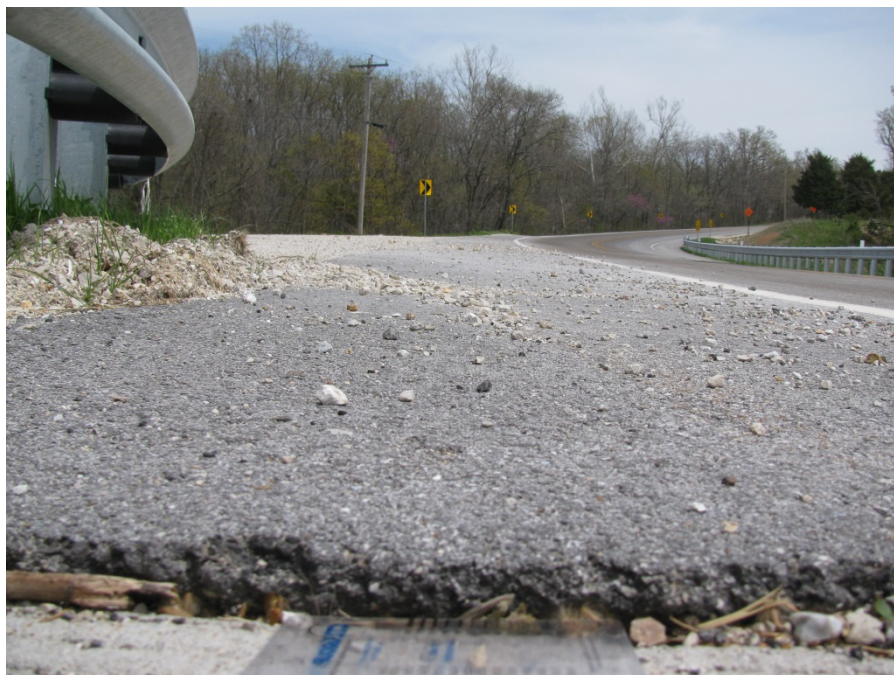
Figure 6-46 Shoulder asphalt level above the CIP BAS on MO38

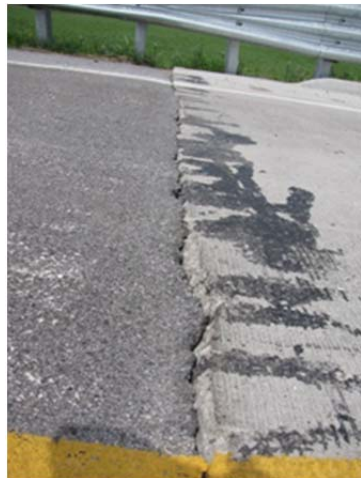
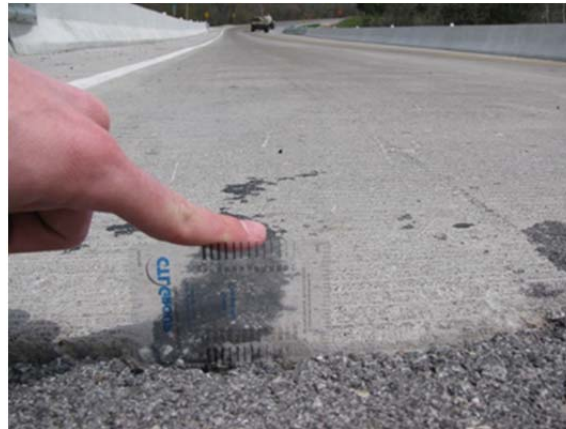
Transverse view

close up view

Figure 6-47 Gap observed between pavement and CIP BAS on MO38

During the last site visit on April 22, 2013 it was observed at the east end of the bridge the asphalt is approximately one inch higher (Figure 6-46) than the slab but is still flush with the bridge. On the west end it can be seen (Figure 6-47) that the approach slab is now about an inch higher than the asphalt but again is still flush with the bridge. At both ends the movement appears to be uniform across the width of the bridge.

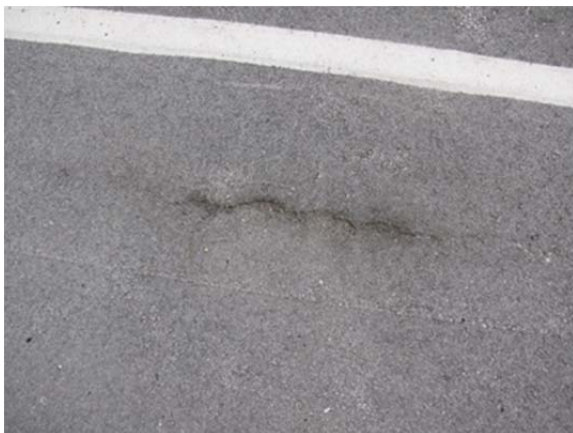
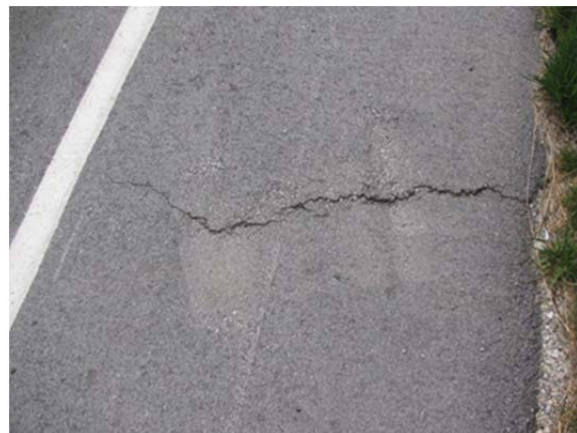
(a) Minor Longitudinal Crack

(b) Transverse Shoulder Crack

Figure 6-48 Asphalt cracks on MO38 PCPS Slab

For the PCPS bridge there is longitudinal surface cracking of the asphalt on the north shoulder of the east end on the bridge (Figure 6-48a). On that same shoulder near the end of the slab there is some transverse cracking of the asphalt (Figure 6-48b). During the final site visit in April 2013 a gap between the bridge deck and the asphalt overlay on the west end was observed and is shown in Figure 6-49. The gap appears to be uniform all the way across the bridge.

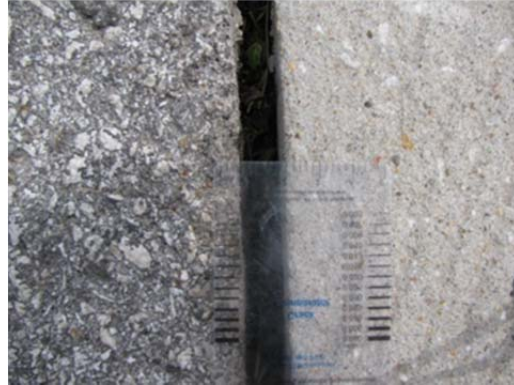
(b) Close up at widest point

Figure 6-49 Gap Observed Between the Bridge Deck and the Asphalt Overlay on MO38

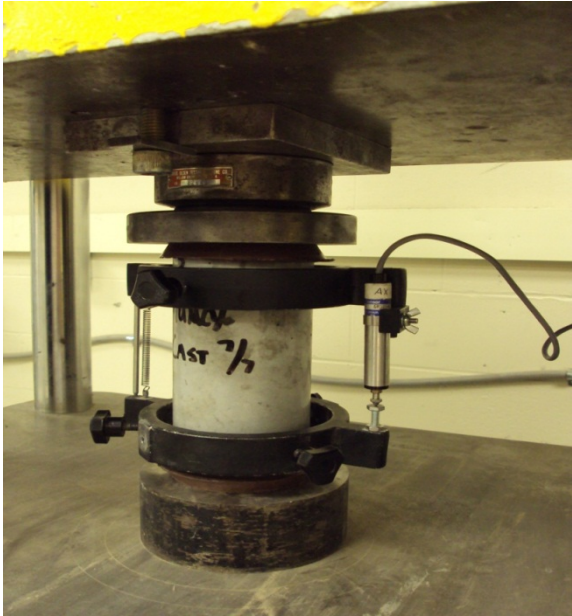
Figure 7-1 Test setup for compressive strength in the Tinius-Olsen

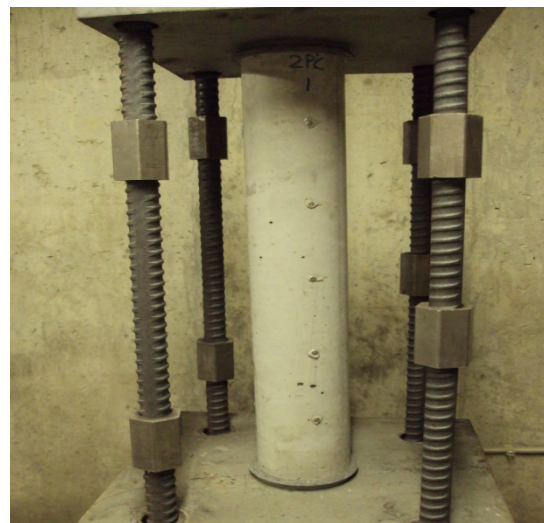
Figure 7-2 DEMEC Point Locations and Cylinder Loaded in Creep Frame [21]

ASTM C512 (2010) [19] and ASTM C157 (2008) [20] were used to determine the creep and shrinkage, respectively. Cylinders that were 4 in. in diameter and 24 in. long were used to perform these tests. These cylinders were constructed by attaching polyvinyl chloride (PVC) pipe to a wooden base using silicone. The cylinders were removed from the molds 28 hours after casting and demountable mechanical (DEMEC) points were installed in 9 different areas using a quick set epoxy. After the epoxy cured, baseline readings were measured and recorded. The total strain of the specimen was determined by averaging all 9 readings per cylinder. Figure 7-2 shows the layout of the DEMEC discs and a cylinder loaded into a creep frame.
