Field Evaluation of Alternative and Cost-Efficient Bridge Approach Slabs

**NUTC
R272 /
R273**

1. Report No. NUTC R272 / R273	2. Government Accession No.	3. Recipient's Catalog No.	
4. Title and Subtitle Field Evaluation of Alternative and Cost Efficient Bridge Approach Slabs	5. Report Date November 2013

FINAL REPORT

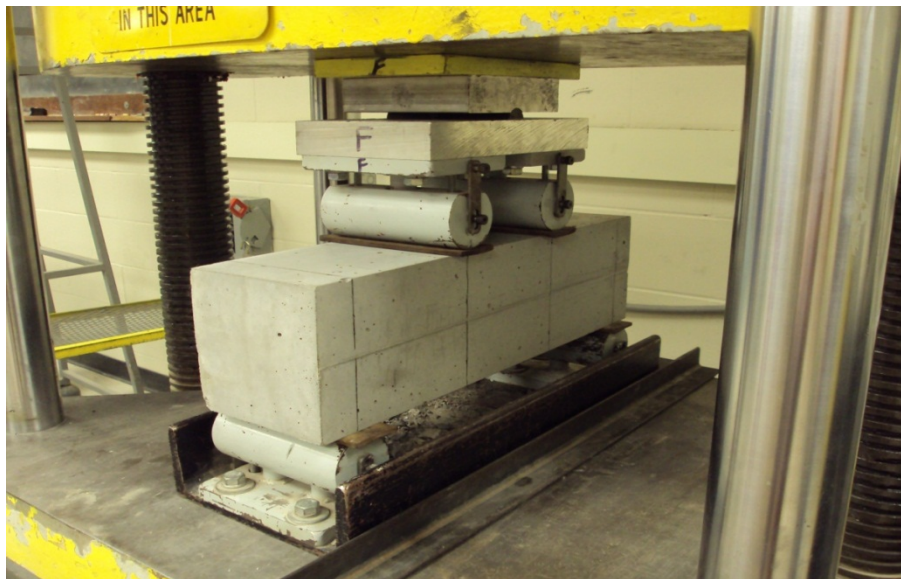
Figure 7-4 MOR Test Setup

The modulus of rupture (MOR) was performed in the Butler-Carlton Civil Engineering Materials Load Frame Laboratory using the aforementioned Tinius-Olsen testing machine. Concrete specimens with dimensions of 6 in. by 6 in. by 21 in. were tested following ASTM C78 (2010) “Standard Test Method for Flexural Strength of Concrete (Using Simple Beam with Third-Point Loading).” The beams were loaded at a rate of 30 lb/s until failure occurred in the tension face of the beam [22]. The MOR load test setup can be seen in Figure 7-4.

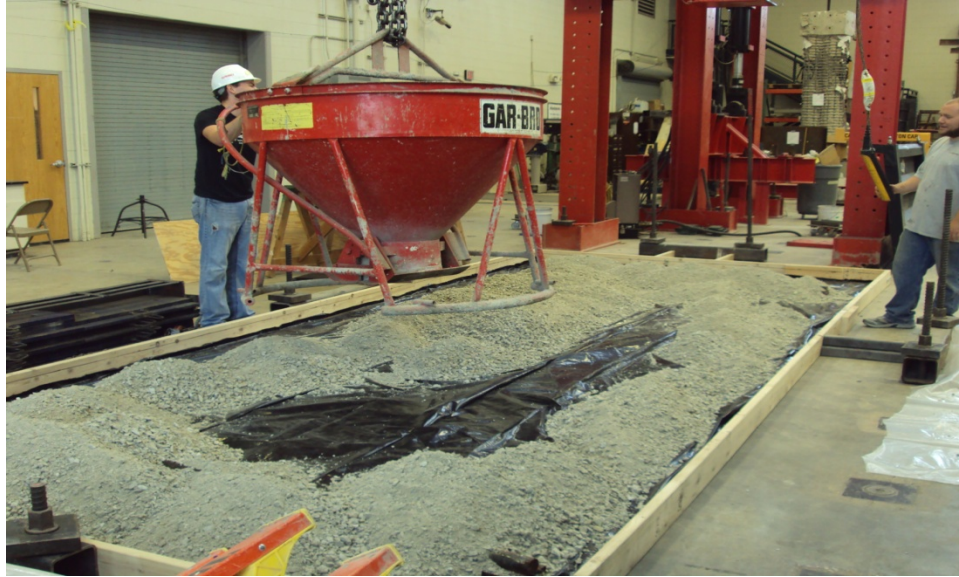
Figure 7-7 Placement of the aggregate base

The test setup began with installing a containment box lined with plastic polyethylene sheeting for the aggregate base. The containment box was approximately 9 ft. – 6 in. wide by 26 ft. in length. The roller supports for the panel were placed in the box before adding the aggregate base. Once the supports were in place, the type 5 aggregate base was placed in the containment box as shown in Figure 7-7. All aggregate was obtained from Capital Quarries in Rolla, MO.

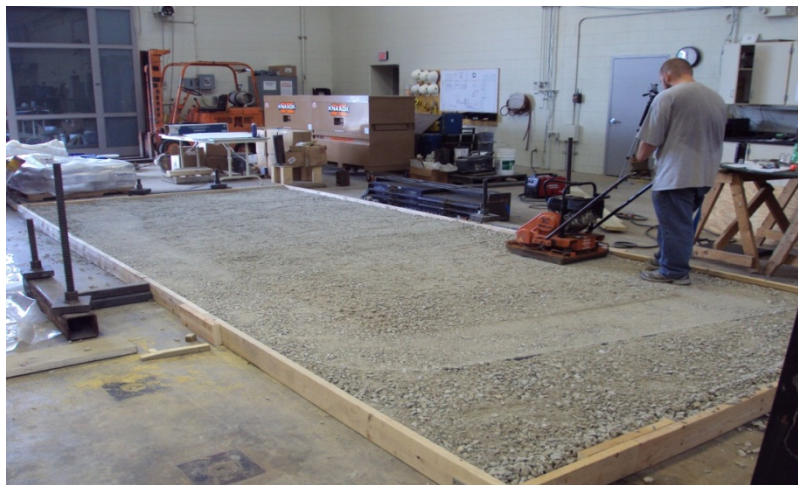
Figure 7-8 Base Material Compaction

The depth of the type 5 aggregate base was 4 in. which was used to replicate field conditions and meet MoDOT’s current specifications. Once the aggregate was level it was compacted using a Wacker WP 1500 portable vibratory compactor as shown in Figure 7-8. This was the same compactor used for the aggregate base on Bridge A7767. In order to create full bearing support, sand was added near the supports and at low points as needed.

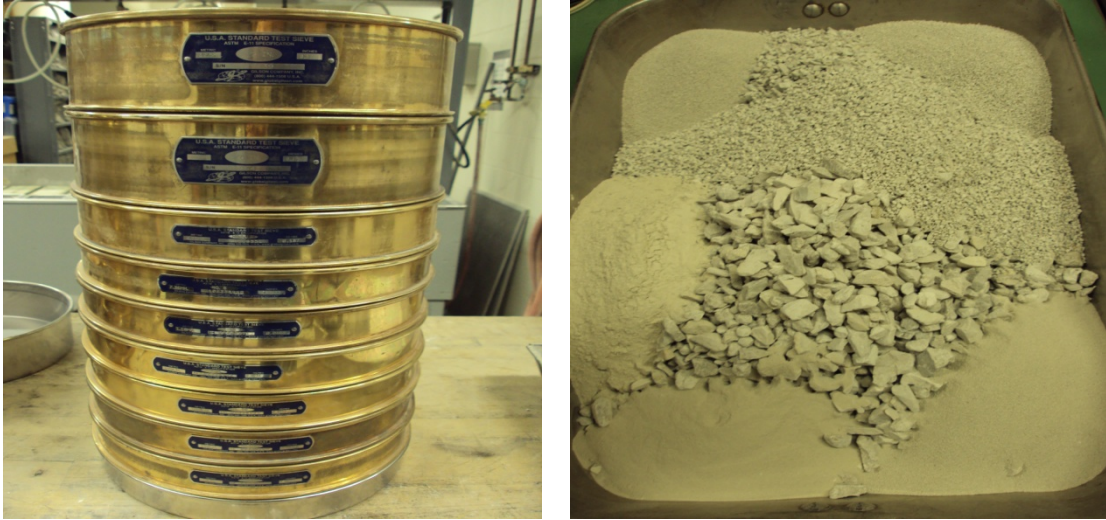
Figure 7-9 Sieves and Graded Material

Samples of the aggregate base material were taken to determine if the material met MoDOT's gradation requirements and a minimum compaction of 95%. A sieve analysis was performed using ASTM D6913-04 (2009) "Standard Test Methods for Particle-Size Distribution (Gradation) of Soils Using Sieve Analysis." A sample of approximately 11 lbs was used for the sieve analysis. Once the gradation was performed, the weight retained in each sieve was recorded. The sieves and graded test material are shown in Figure 7-9. The percent passing was calculated for each sieve and plotted against the sieve size as shown in Figure 7-10 which indicates that the base material meets MoDOT specifications for a type 5 aggregate base.

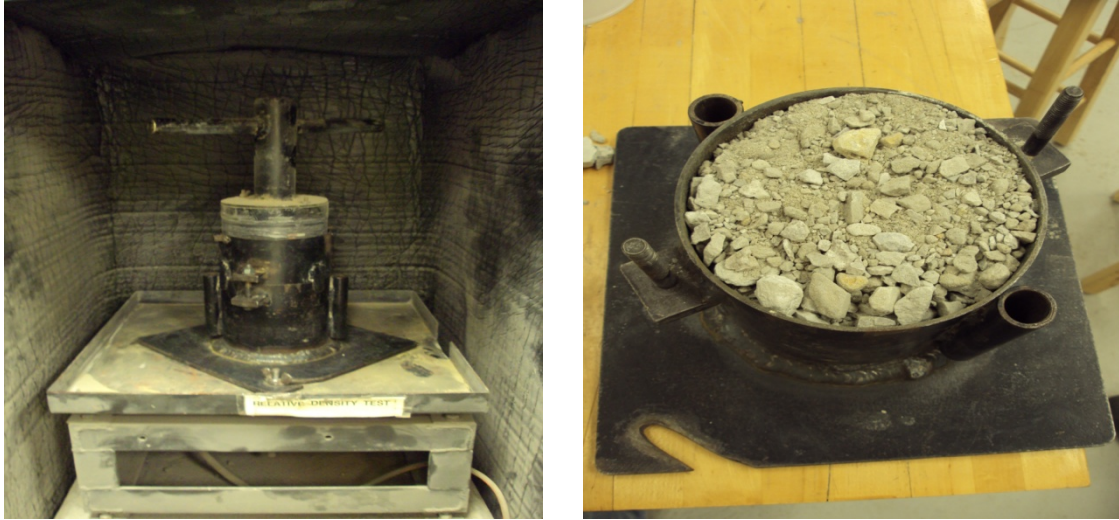
Figure 7-11 Vibratory Table and Compaction Mold

The percent compaction was determined and compared to the MoDOT specifications. There were two tests performed to determine the percent compaction. ASTM D4253-00 “Standard Test Methods for Maximum Index Density and Unit Weight of Soils Using a Vibratory Table” was used to determine the maximum density of the base material. A mold with known dimensions was filled to the top and the weight was recorded. Then the mold had a weight placed on the surface and was placed on a vibratory table for roughly 10 minutes as shown in Figure 7-11. The new dimensions of the base material in the mold were examined and recorded. The maximum unit weight was calculated to be 120 lbs/ft³.

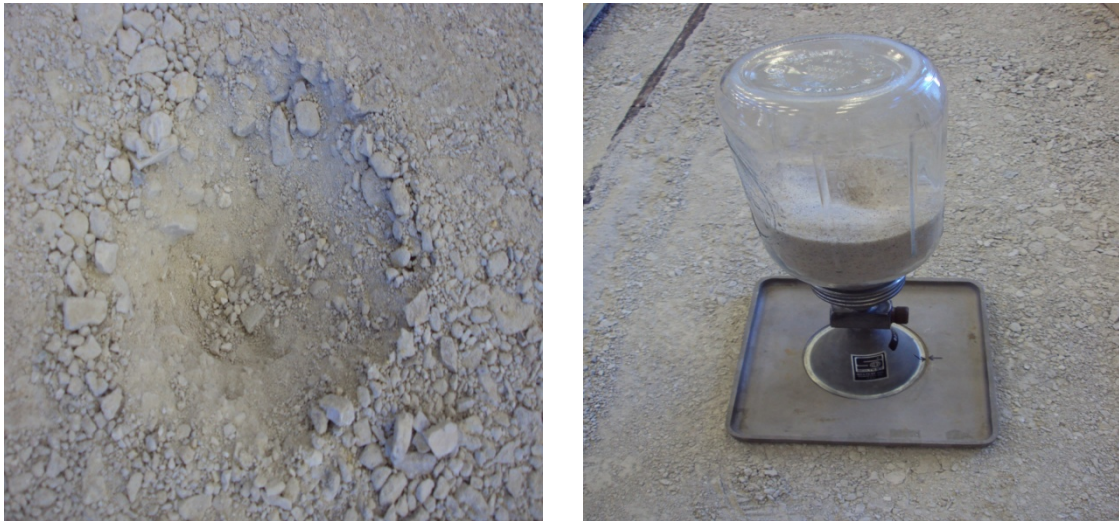
Figure 7-12 In Place Density Testing Using the Sand Cone Method

The in place density of the base material was determined using ASTM D1556-07 “Standard Test Method for Density and Unit Weight of Soil in Place by Sand-Cone Method” as shown in Figure 7-12. The weight of the sand and volume of the sand cone was recorded prior to testing. A hole was excavated according to the ASTM and the weight of the removed aggregate was recorded. Based on the weight of the removed aggregate and volume of the sand cone, the in place unit weight of the soil was calculated to be 114 lbs/ft³. Based on the maximum density it was determined that the compaction of the base material met the MoDOT specification for a minimum compaction of 95%.

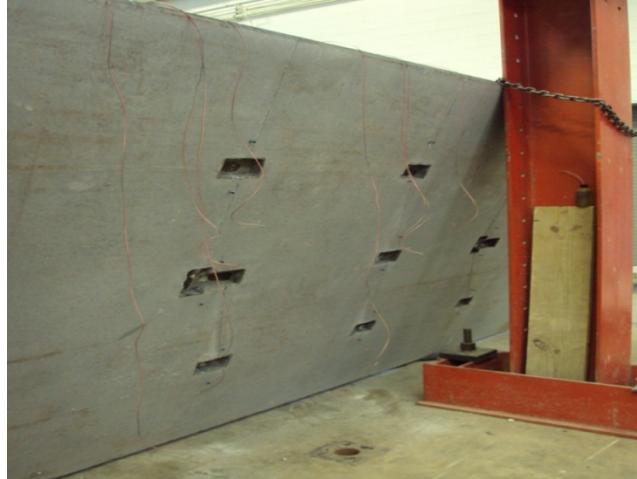
Figure 7-14 Exposure of Box Outs on the Bottom of the Panel

When the panel arrived it was placed on its side to allow the strain gauges to be installed. This helped expose all the box outs as shown in Figure 7-14. The inside surface of the box outs were sanded to provide a rough surface profile for the adhesive. AE 10 adhesive from Vishay was placed on the surface to fill in any small voids. After six hours the adhesive was sanded down to the concrete surface and prepared for the installation of concrete strain gauges. Two inch concrete strain gauges were applied using the AE 10 adhesive and left overnight to bond to the concrete. Once the adhesive cured the wires were soldered to the gauges. Prior to load testing, each gauge was tested with a volt meter to ensure it was properly installed. The completed gauge installation is shown in Figure 7-15. The box outs were covered with a thin aluminum plate to protect the gauges and all wires were run in a groove to the edge of the panel. After the installation of the strain gauges was completed, the slab was placed on the base material and metal roller supports.

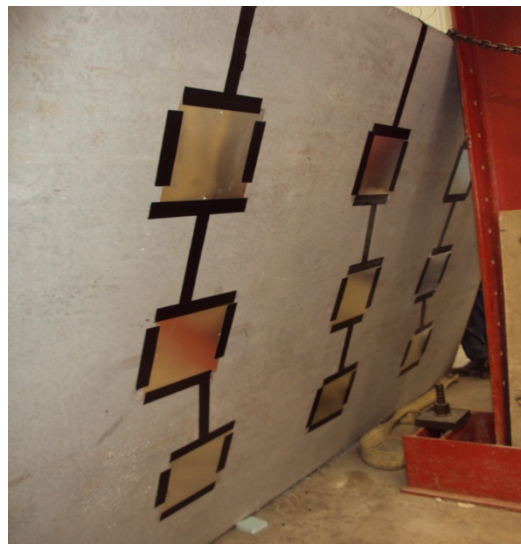
a) surface mounted strain gauge

b) bottom surface of panel prior to testing

Figure 7-15 Completed Concrete Strain Gauge Installation

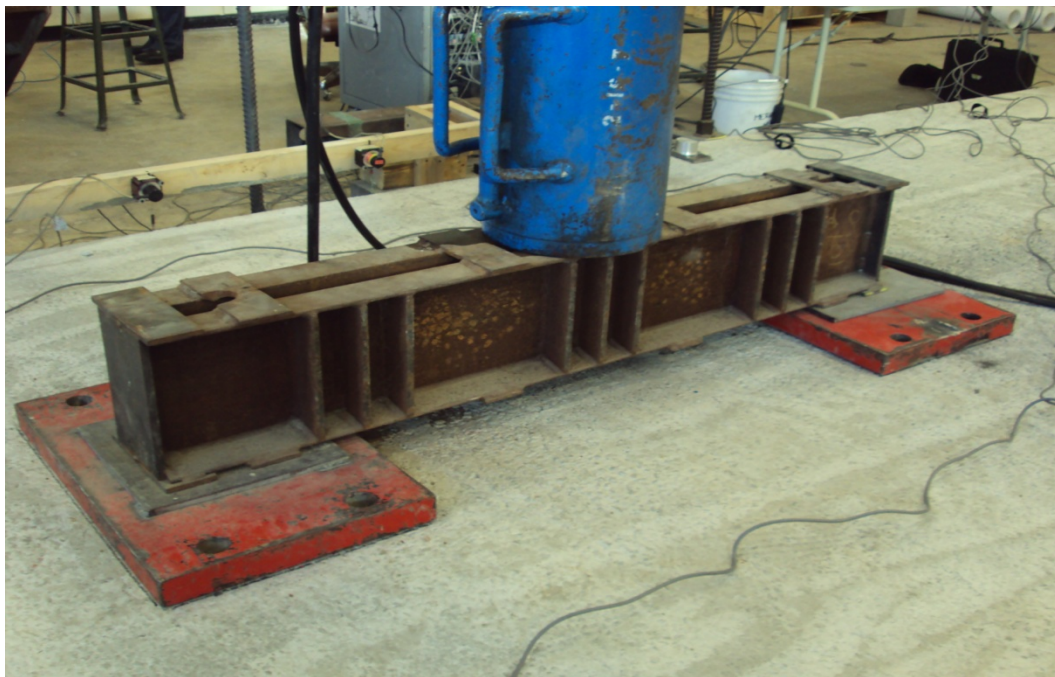
Figure 7-19 Spreader Beam and Bearing Plates

The steel framing was constructed as shown in Figure 7-18. A primary beam consisting of a W21X62 wide flange section was used to carry the load applied by the hydraulic jack. The hydraulic jack rested on a 5 ft. long spreader beam to transfer the load to the bearing plates. The 24 in. x 16 in. x 1.5 in. bearing plates represented the area of dual tires on a truck. Prior to placing the plates on the concrete surface, fine sand was placed on the surface to create a uniform bearing pressure when the load was applied. Figure 7-19 shows the spreader beam and the bearing plates. Figure 7-20 indicates the bearing plate locations. The hydraulic jack applied a 16 kip load to the spreader beam which, distributed 8 kips to each bearing plate.

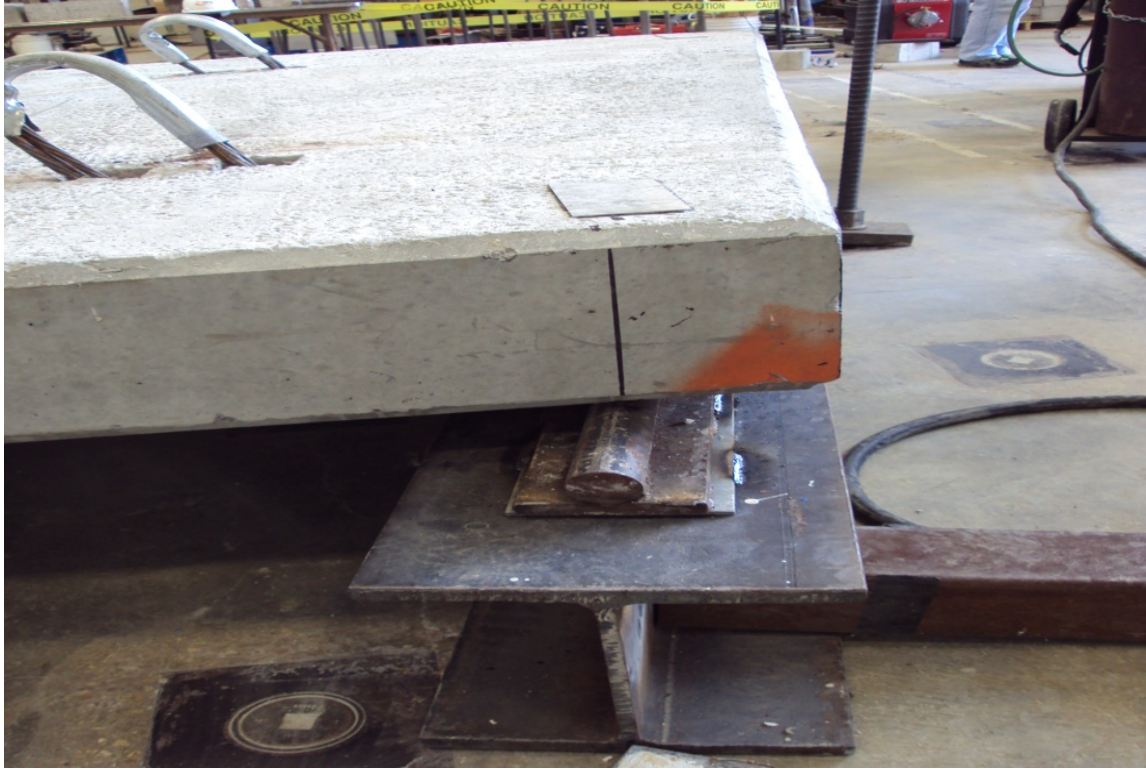
Figure 7-21 Panel End Support When Testing to Failure

When testing the panel to flexural failure, a similar steel frame was constructed as outlined earlier in this section. The panel was simply supported on two roller supports as shown in Figure 7-21. The roller supports were placed on a 12 in. structural steel wide flange sections with web stiffeners. The panel was supported at 6 in. from the end producing a longitudinal clear span of 19 ft. The test setup prior to testing is shown in Figure 7-22. This figure shows an LVDT used to monitor deflection. It was later determined that string potentiometers would be used instead of LVDTs.

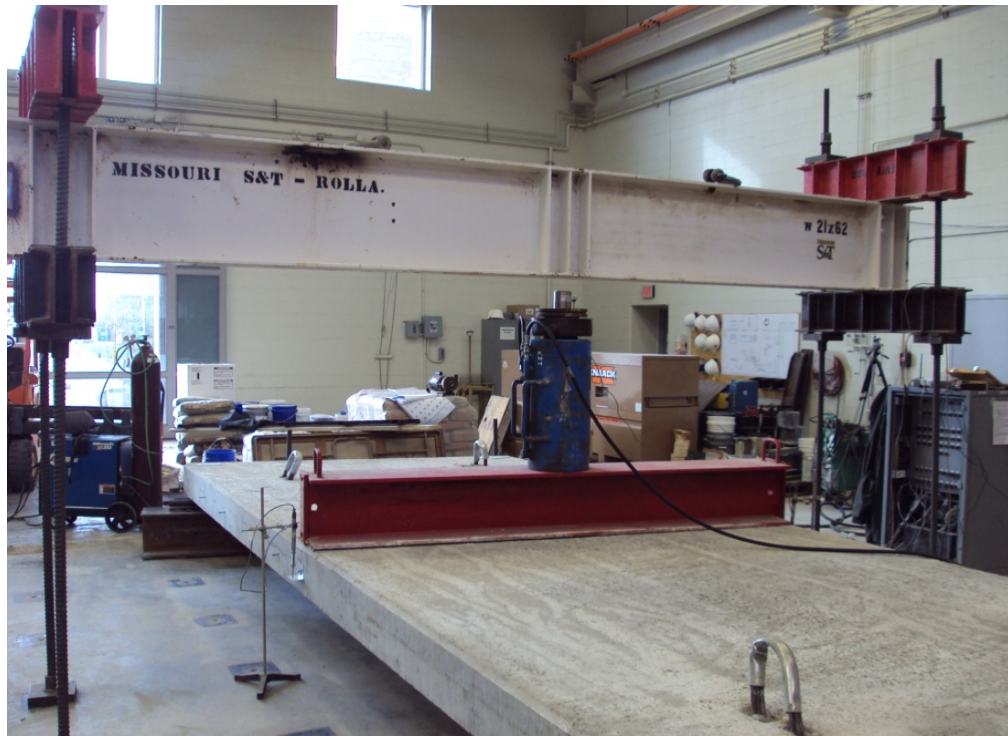
Figure 7-22 Testing Apparatus for Testing Panel to Failure

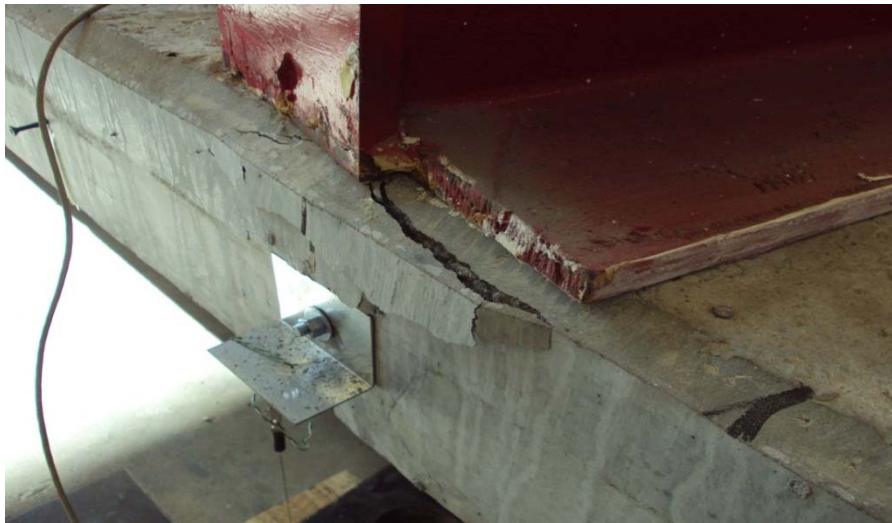
Figure 7-24 Localized Failure Due to Non-Uniform Pressure of Line Load

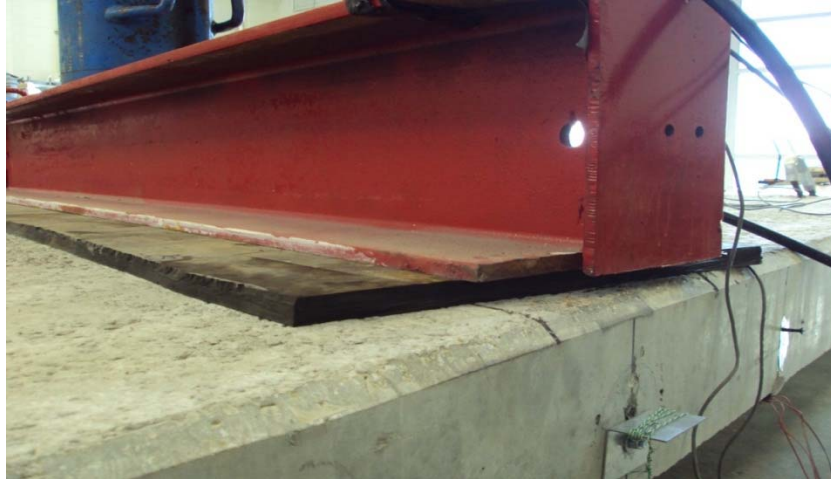
Figure 7-25 Spreader Beam with Neoprene Pad
