MISSOURI
S&T

Development of a Quantitative Model for the Mechanism of Raveling Failure in Highway Rock Slopes using LIDAR

**NUTC
R274**

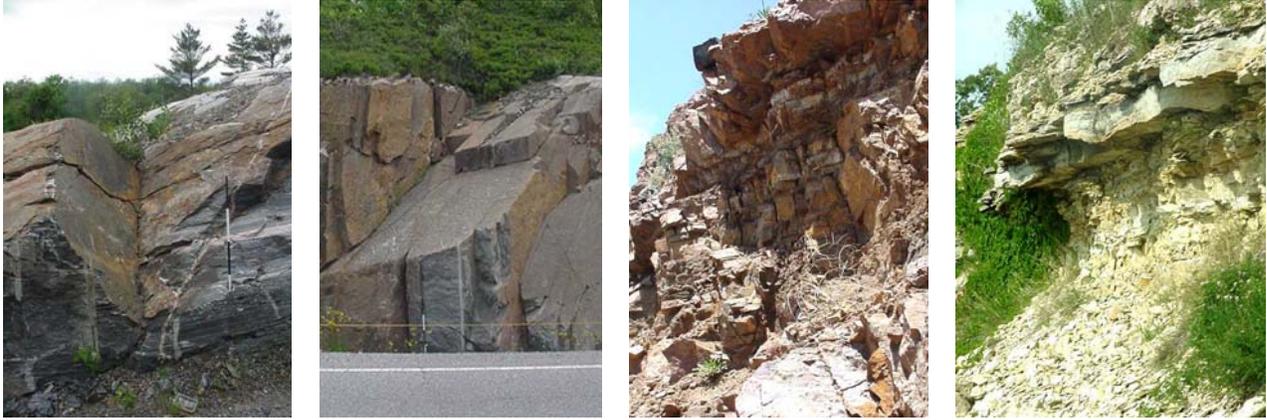
Figure 1: Example of wedge, planar, raveling, undercutting failures along road cuts.

In many terrains the discontinuities are oriented in such a way that they contribute to create wedge, planar sliding, or toppling failures (Figure 1) which are easy to analyze. Franklin and Senior (1997b) report that of 415 analyzed cases of failure in Northern Ontario, only 33% of failures involved these mechanisms (23% toppling, 8% planar sliding, 2% wedge sliding). Analysis methods for these failures are well known, and can range from limiting equilibrium analysis to numerical modeling (Hoek and Bray, 1981; Piteau, 1979c; Piteau, 1979d). The mapping of discontinuity orientations is a requirement, before or after the cut has been exposed (Piteau, 1979a; Piteau, 1979b; Piteau 1979g). Rock determined to be loose with the potential for failure must be removed or restrained in some way (Piteau, 1979e). Prescribed designs for remediation and/or mitigation are easy to find (Brawner, 1994; Konya and Walter, 1991; Piteau, 1979f; Franklin and Senior, 1997a). In the Northern Ontario study, 65% of the failures were of the “raveling” type (Figure 2). These included raveling (25%), overhang/undercutting failure (15%), ice jacking (14%), and rolling blocks (11%). In other terrains, most notably flat lying sedimentary rock, such as is found in much of the US, the predominant failure mechanism of the raveling type is even greater.

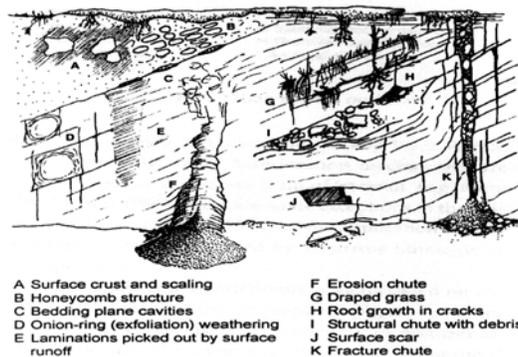
Figure 2: Erosional morphology due to deterioration (Nicholson, 2003).

Nicholson (2003) quantitatively describes deterioration related morphologies. Figures 2 and 3 show erosional and depositional morphologies due to deterioration. Nicholson does not quantify any of the processes, nor does anyone else in the literature. Nicholson (2003) presents a quantitative classification along axes of material size, frequency of events and velocity of events.

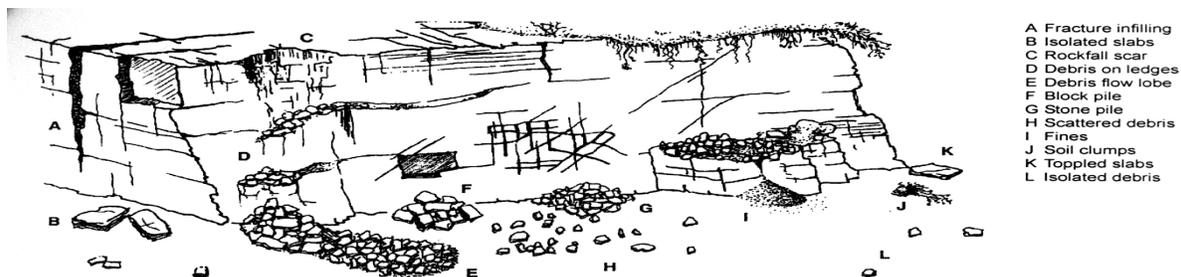
Figure 3: Depositional morphology due to deterioration (Nicholson, 2003).

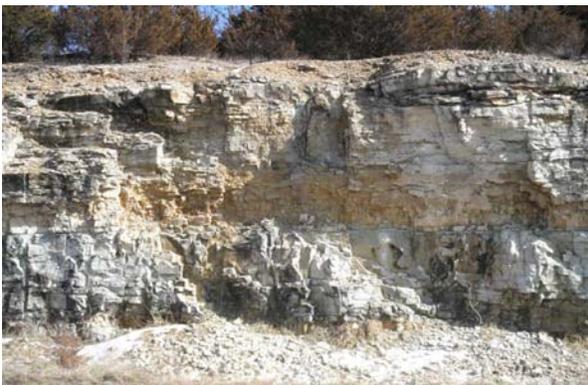
Figure 4: Scan section of a rock face in a local quarry.

The Scan Station II LIDAR unit is typically set up at a stationary location, facing a slope, bluff, structure, or topographical feature (Figure 4). The device can automatically scan 360° horizontally and 270° vertically. The device will scan at a scan rate of 50,000 points per second. The device stores a “point cloud” which is a list of x, y, z coordinates that describe the topography with an accuracy of up to 2 mm (Figure 5). For this project, “before” and “after” LIDAR point clouds will be used to map the raveling process over time (Figure 5). LIDAR measurements allowed us to measure and map the sequence and removal of blocks, even blocks as small as or smaller than 1 cm on edge. Rock cuts were be measured and mapped. Measurements were correlated to rainfall, temperature, seismic, and hydraulic conditions.

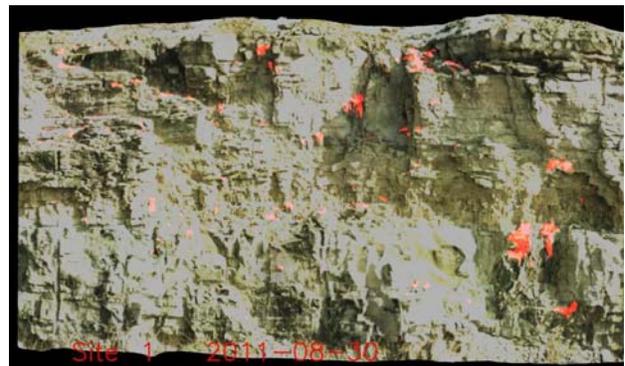
Figure 5: Point cloud of the scan and resulting areas of rock loss painted in red.

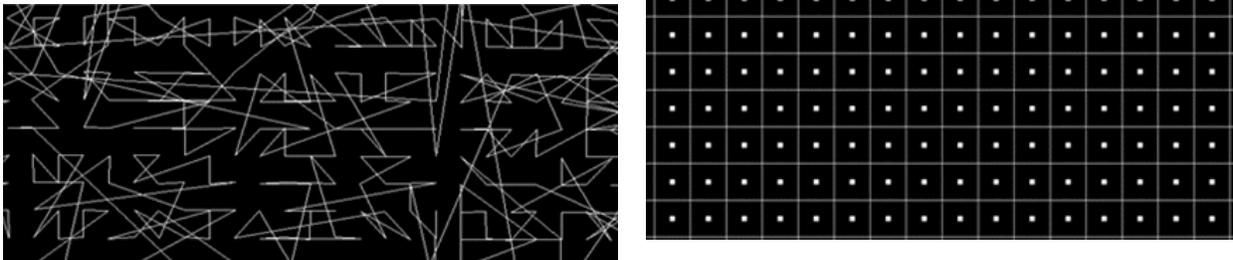
Figure 6: Convert spatial randomness of raw database (left) to ordered 3 mm by 3 mm bins on a spherical surface (right).

1. Converting raw point cloud data into a single spherical surface representation (Figure 6).
2. Filling gaps in the data (empty bins) (Figure 7).
3. 3-D registration process of sequential scan images (Mikhail et al., 2001) (Figure 8).
4. Vegetation and other non-rock artifact detection and removal (Figure 9).
5. Cropping to a common horizontal and vertical domain (Figure 10).
6. Creation of a difference surface between any two registered scans (Figure 11).
7. Difference surface artifact removal (Figure 12).
8. Individual lost-rock statistics and volume determination (Figure 13).

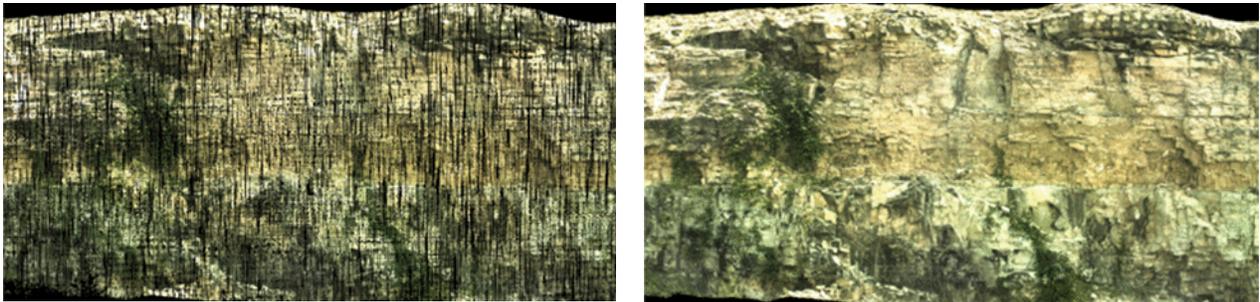
Figure 7: Gaps in binning due to mechanical imprecision of the LIDAR (left) are removed by interpolating between the two closest opposing bins (right).

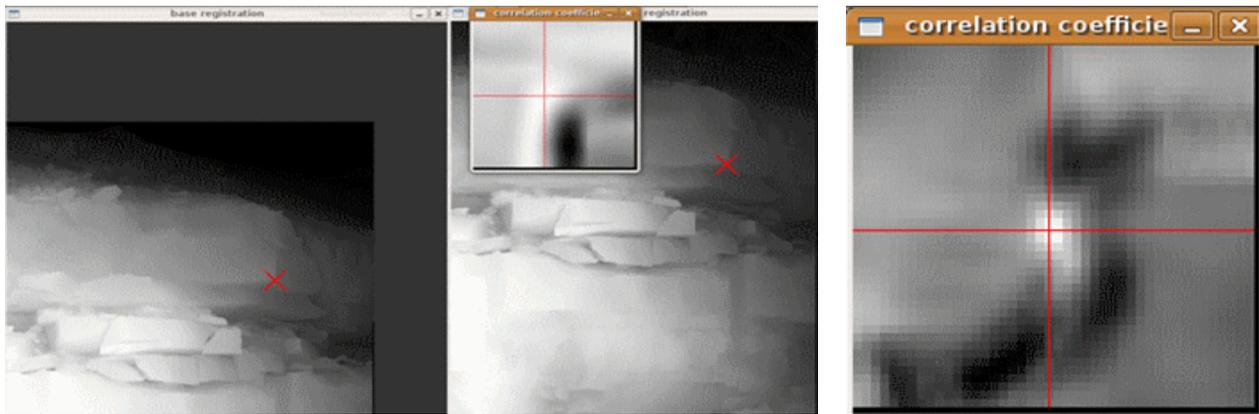
Figure 8: Pick points (red x's in left image) are selected in areas where no change is seen or anticipated. A 50 by 50 kernel is fitted around the "pick point" to automatically establish a registration point (right). A 7 parameter shape-preserving conformal process is used to transform the data to a common coordinate system using between 4 and 16 registration points, resulting in a RMS error of less than 5mm for the 3 mm scan resolution.

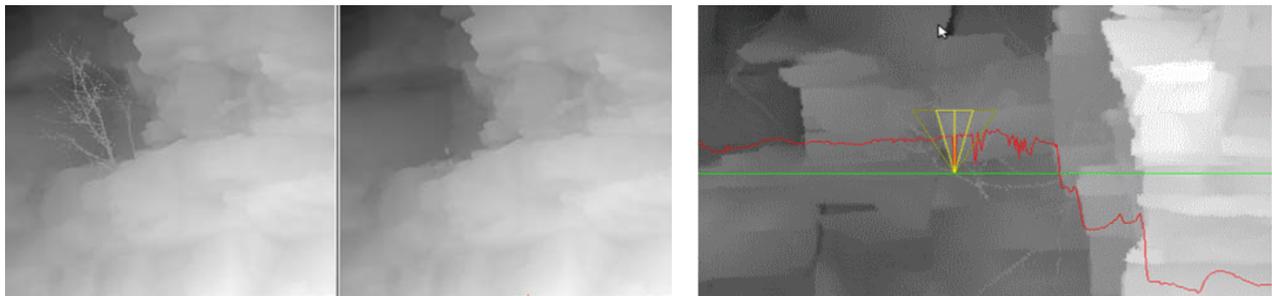
Figure 9: Vegetation removal (left) using a virtual articulating conical probe (right) that determines whether each point in the cloud is part of the rock surface or an artifact such as vegetation or a bird/insect/other obstruction in the scan. (Green line is scan line, red line is the distance to the surface, and the yellow shows the articulating cone).

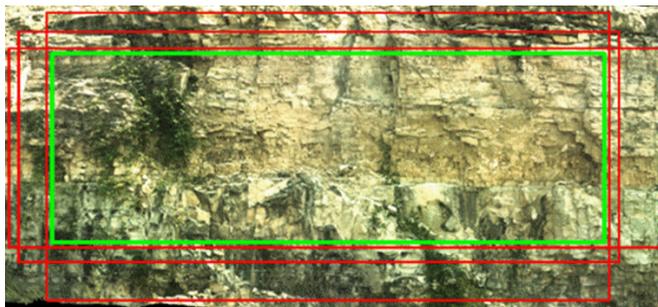
Figure 10: Red lines show crop areas of the different scans. The green box shows the largest minimum bounding rectangle common to all datasets.

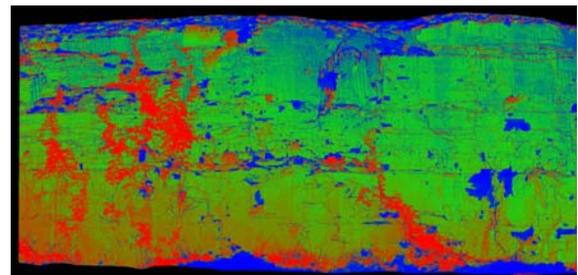
Figure 11: Color coded difference surface. Blue areas indicate lost material, red areas indicate gained material, and green areas indicate no change. (Gained areas could be rock that has dropped into the image from above or small errors below the measurement threshold).

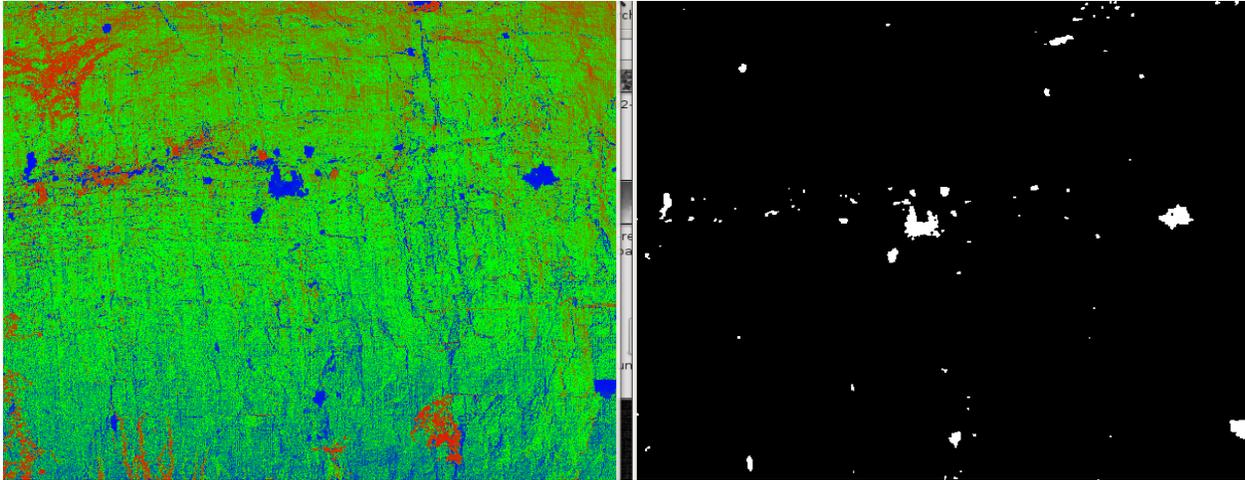
Figure 12: Several techniques are used to differentiate real lost rock material (right) from the residual artifacts in the difference map (left). These include successive dilate and erode functions and blob analysis. Lost rock is identified in reverse chronological sequence to reduce the incidence of false positive identifications.

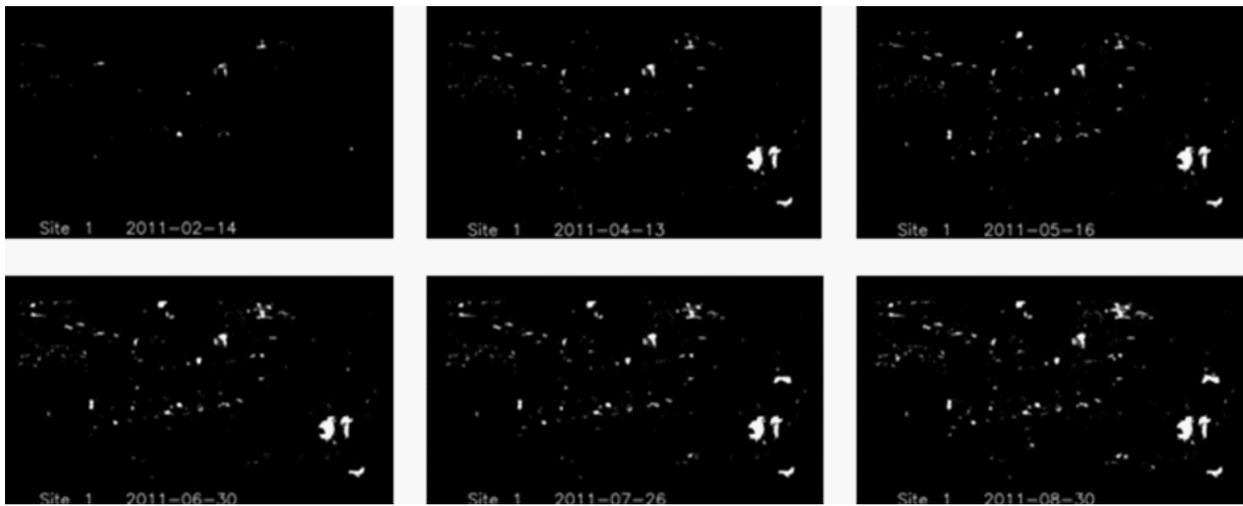
site: 1	date: 2011-03-17	lost rock volume to date:	-23.169	liters
site: 1	date: 2011-03-30	lost rock volume to date:	-23.4827	liters
site: 1	date: 2011-04-13	lost rock volume to date:	-27.9623	liters
site: 1	date: 2011-04-20	lost rock volume to date:	-28.4457	liters
site: 1	date: 2011-05-06	lost rock volume to date:	-28.0523	liters
site: 1	date: 2011-05-16	lost rock volume to date:	-29.3877	liters
site: 1	date: 2011-06-07	lost rock volume to date:	-29.7487	liters
site: 1	date: 2011-06-23	lost rock volume to date:	-31.9413	liters
site: 1	date: 2011-06-30	lost rock volume to date:	-32.3318	liters
site: 1	date: 2011-07-06	lost rock volume to date:	-33.2313	liters
site: 1	date: 2011-07-15	lost rock volume to date:	-32.392	liters
site: 1	date: 2011-07-26	lost rock volume to date:	-34.6256	liters
site: 1	date: 2011-08-02	lost rock volume to date:	-34.894	liters
site: 1	date: 2011-08-10	lost rock volume to date:	-34.879	liters

site: 1	date: 2011-08-17	lost rock volume to date:	-34.8887	liters
site: 1	date: 2011-08-30	lost rock volume to date:	-35.1946	liters
site: 1	date: 2011-09-07	lost rock volume to date:	-35.1046	liters
site: 1	date: 2011-09-15	lost rock volume to date:	-36.3219	liters
site: 1	date: 2011-09-29	lost rock volume to date:	-36.7425	liters

Figure 13: Individual lost rock statistics (right) and graphical representation (top).

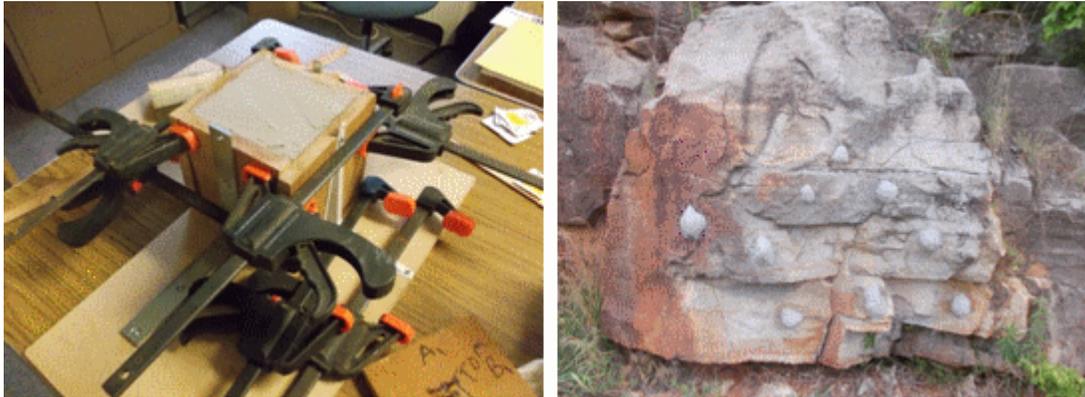
Figure 14: Clay pressed into a mold with a volume of 3706 ml (left) and the clay attached to the rock outcrop simulating 9 individual blocks.

A rock fall simulation was conducted in which a known volume of clay, measured in regular shaped mold, was stuck to a rock outcrop (Figure 14) in 9 “blobs” to simulate 9 rock blocks. The outcrop was scanned with the LIDAR scanner, before and after attachment of the simulated rock blobs. In the first case the scanner was not moved between scans to simulate “perfect” registrations. In the second case the scanner was removed and repositioned and normal registration techniques were applied. Results showed that the accuracy of the measurement was 2% or less (Table 1).

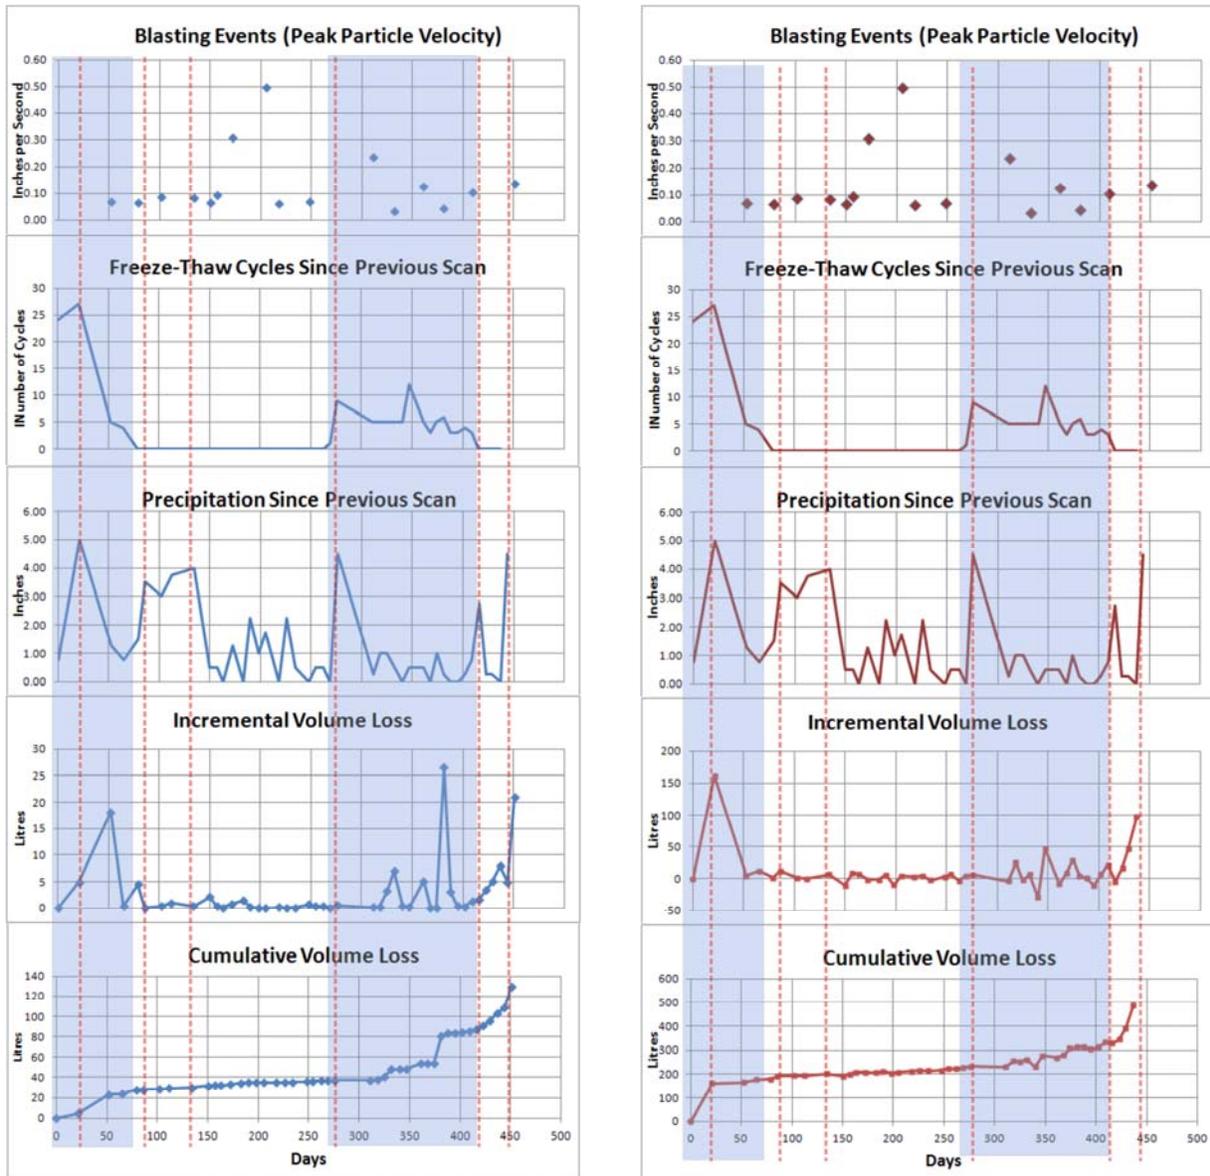
Figure 15: Results of scanning over 475 days. Left: Site 1; right: Site 2. Light blue zones indicate winter seasons; brown dotted lines indicate peak rainfall episodes.

Preliminary correlations (Figure 15) between volume of blocks lost and freeze-thaw cycles, blasting episodes, and rainfall are somewhat tentative at this point:

1. In both sites significant episodes of volume loss occurred continually during the winter months when freeze-thaw cycles occurred. Significantly less volume loss occurred during most of the non-winter months.
2. A single precipitation event (between days 24 and 45 in the winter time frame), resulted in large volume loss in both sites.
3. A single precipitation event (between days 468 and 475 in the non-winter time frame), resulted in large volume loss in both sites.
4. Not all precipitation events resulted in volume loss.
5. There was no obvious correlation between volume loss and blasting parameters such as peak particle velocity

6. Cumulative rock loss was similar in both sites over the duration of the project; incremental rock loss was significantly different.
7. Some episodes of volume loss were seemingly uncorrelated to any of the measured stimuli.

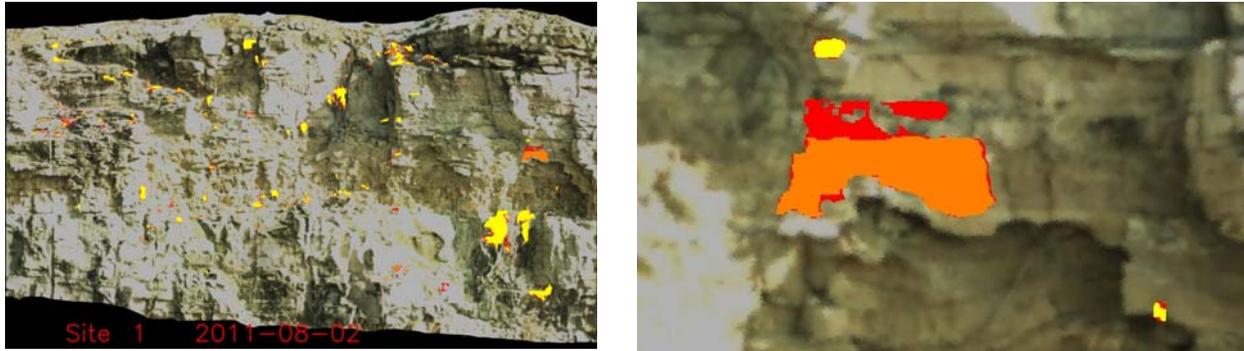
Figure 16: Progressive raveling loss (left). Yellow, 7/15/2011, brown 7/26/2011, red 8/02/2011. Right: Close up of a small area.

The raveling sequence was progressive, with significantly higher rates of raveling in the winter season (when the diurnal temperature cycle typically crosses back and forth over the freezing mark (frost wedging).

1. Raveling rates in some (weaker) layers of rock were higher than in other layers of rock, typically strata-bound. In addition raveling rates were found to be higher under obvious overhangs.
2. Raveling was progressive within a small area. Often an identifiable block or cluster, rather than fall down in a single episode and break on impact below, would ravel a little bit at a time (Figure 16).
3. There may be a threshold of rainfall to initiate acceleration of rock fall
4. There may be an interaction between rainfall and freeze thaw cycles.

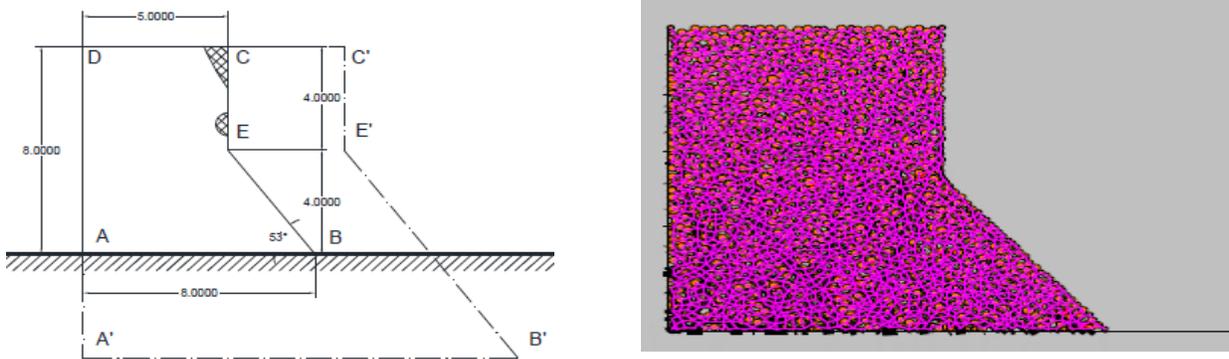
Figure 17: Model configuration (left), and intact rock slope (right).

The basic particle used in PFC is the ball with unit thickness. Since the rocks are in various shapes, the balls were bonded through contact and parallel bonds to represent the rock masses. An original rock slope was created with the balls ranged from 0.05 m to 0.10 m in radius. The initial void ratio of the slope was set to 0.15. And the balls were then generated one by one until the void ratio reached 0.15 within the polygonal area, A'B'C'E'D, which was enlarged from the original slope area, ABCED. The walls, A'B', C'E', and E'B', were then moved toward the positions of ABCE to compact the balls into the prescribed slope zone, ABCED.

The material properties used in the model were estimated. The contact bonds were installed to make the slope stand vertically. Once the magnitude of the tensile normal or shear contact force exceeds the respective strength, the bond breaks. After the material properties were given, a number of calculation steps were performed to compute the movement of the balls as they approached a mechanical equilibrium state, which means that the mean unbalanced force approached to a very small value, based upon the prescribed material properties. After the sufficient calculation cycles, the original rock slope was successfully created, as shown in Figure 17.

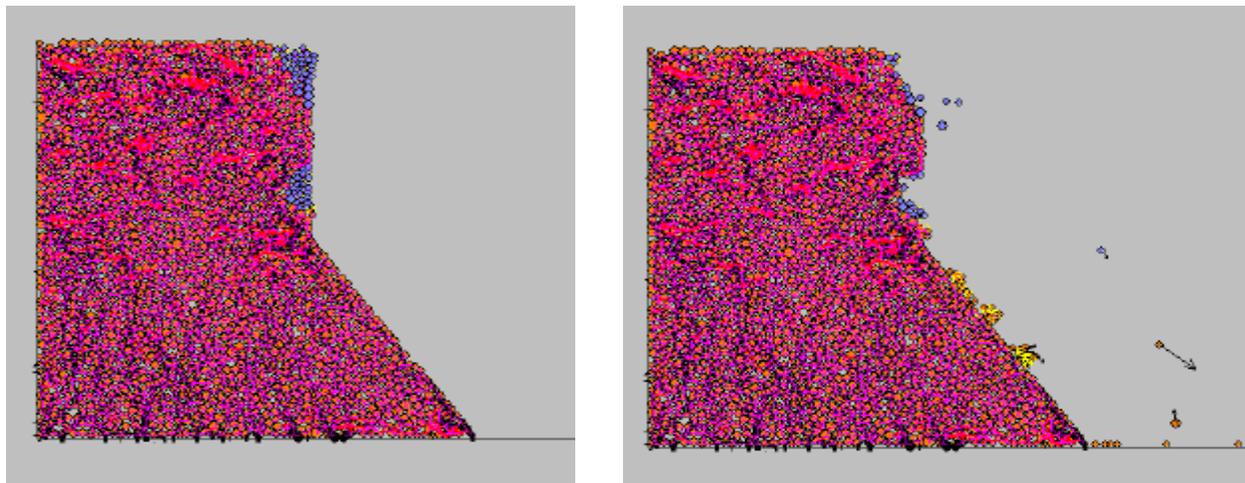
Figure 18: Modified slope with clusters of weaker mechanical properties (left) and rock fall after 2070 time steps (right).

Near surface clusters are weakened by reducing bonding strengths as a trigger for raveling (Figure 18). (Contact bonds also vary randomly within the slope, and the weakened sections.) Time stepping results in failures that appear very realistic, but have not yet been compared to LIDAR measurements.
