**Imaging Voids Beneath Bridge Bent
Using
Electrical Resistivity Tomography**

**NUTC
R283**

Imaging Voids Beneath Bridge Bent Using Electrical Resistivity Tomography

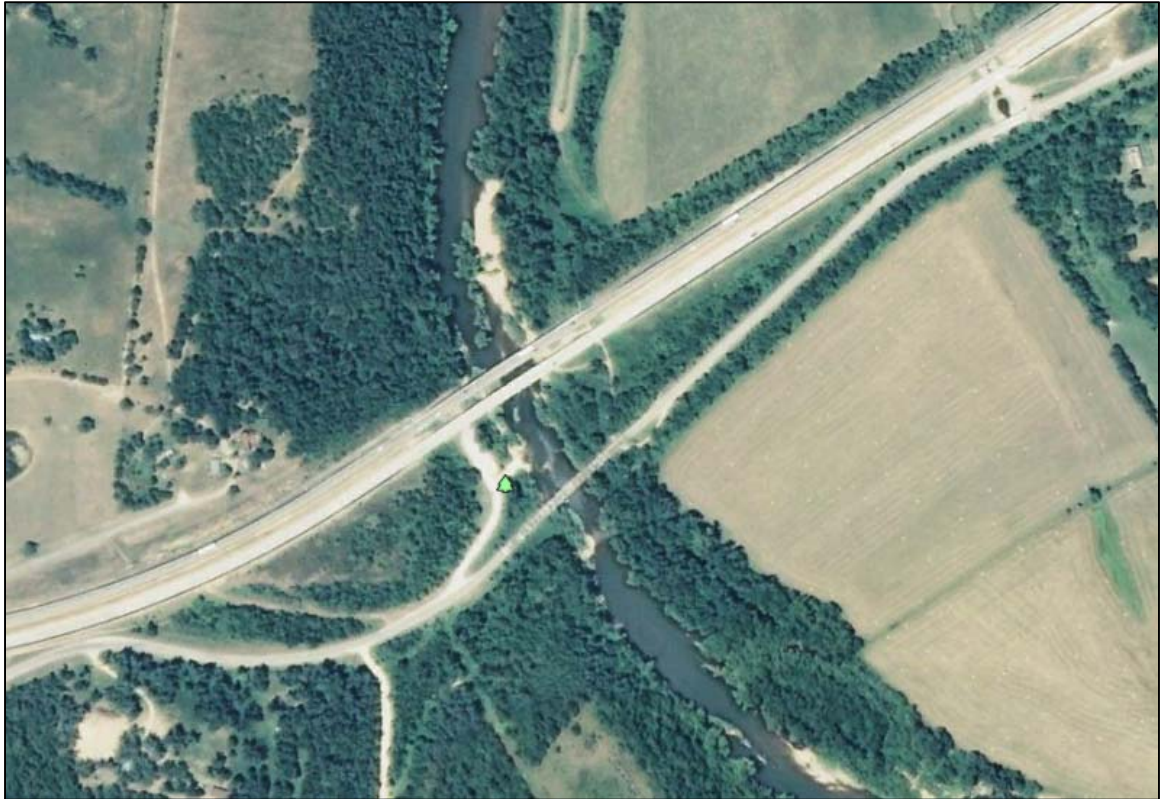
Figure 6.1. Aerial photograph of the Gasconade River study site.

The westbound lane bridge was constructed in 1955, it carries west-bound traffic on the interstate over the Gasconade River in Laclede County, Missouri (Figure 6.1). The construction conducted in 2011 included building a temporary substructure north of the existing bridge to support a new replacement bridge deck. After the new deck was completed and the old deck removed, the new deck was transferred into place – on the existing bridge foundations, supporting the new bridge deck.

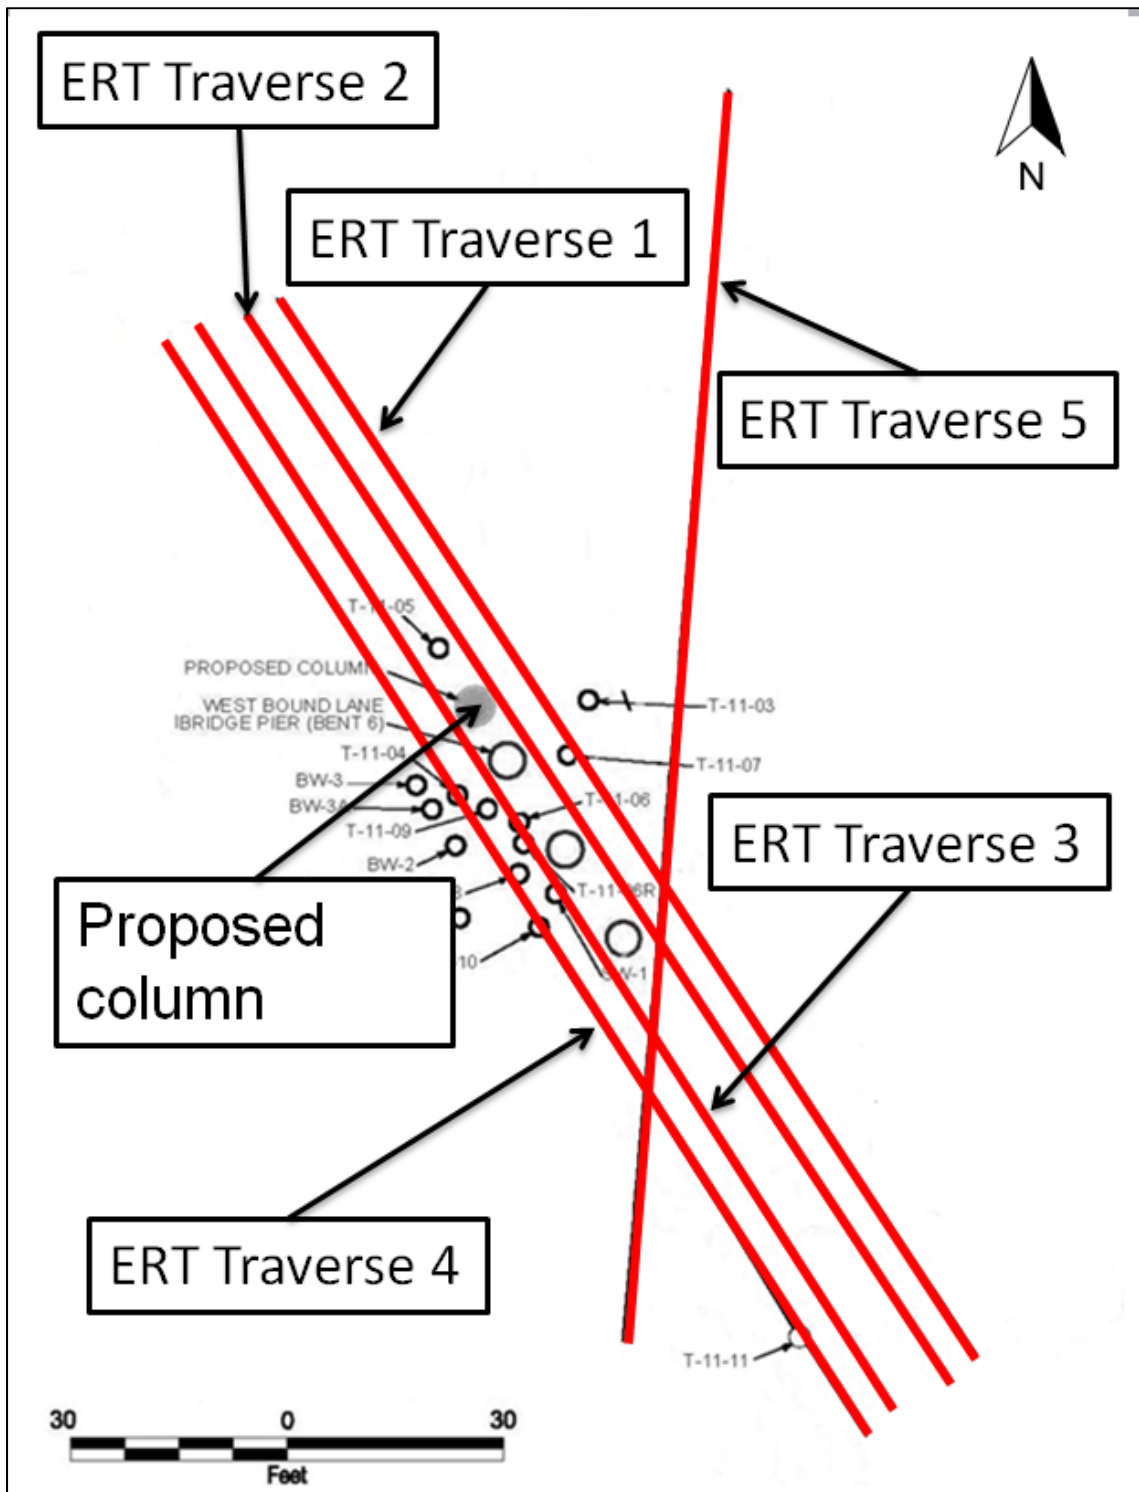
Figure 6.2. ERT traverses and borehole locations.

Subsequent borings and ERT data confirmed the presence of rock openings adjacent to or at the foundation bearing level of the northern and central Westbound Lane Bridge footings (Figure 6.2).

6.5.1. Acquisition of ERT Data. Electrical resistivity profiles were acquired along five traverses (Traverses 1, 2, 3, 4 and 5, Figure 6.2) in an effort to determine extension of the encountered underground openings in rock during the drilling program and any other rock openings, if present, and map variations in rock quality in immediate proximity to the bridge foundations.

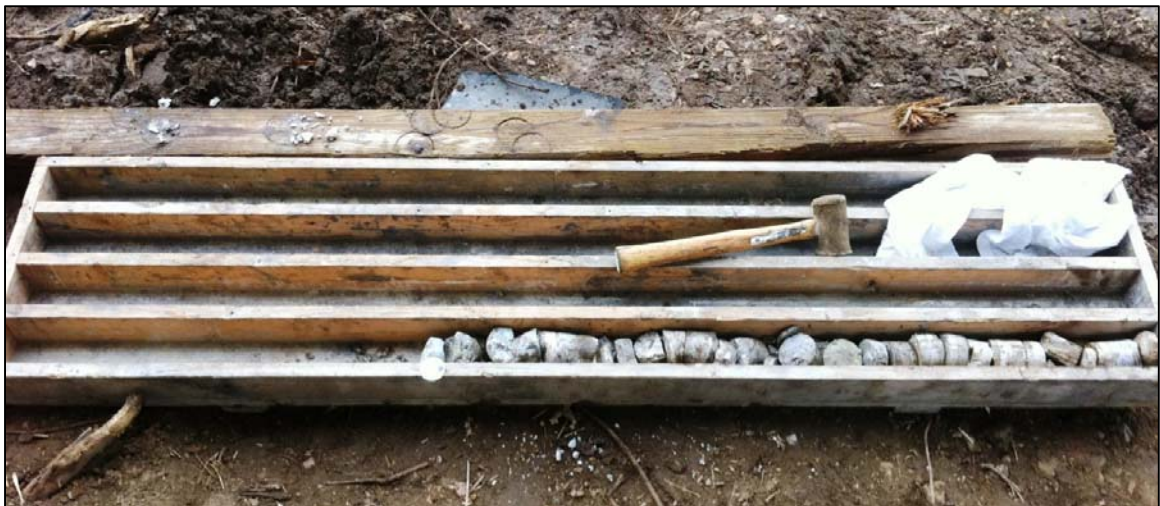
Figure 6.4. Highly weathered, cherty Gasconade Dolomite from borehole T-11-06.

The sloping valley floor first intercepts the Gasconade Dolomite directly upstream of the project site, and cuts deeper into the Gasconade as it progresses downstream. The Gasconade Dolomite is represented mostly by a light brownish-gray, cherty dolomite, and is highly weathered in the study area (Figure 6.4). The Roubidoux Formation, overlying the Gasconade, outcrops on the valley slopes in the vicinity of the project site.

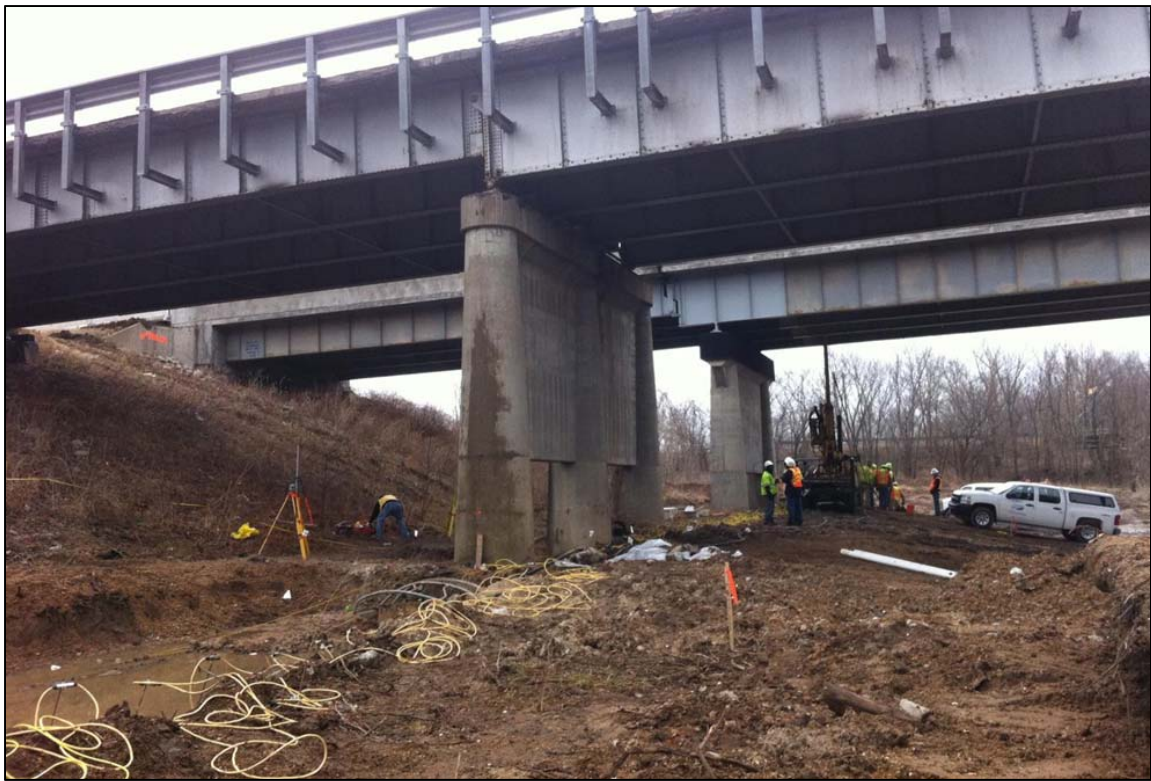
Figure 6.7. Photograph of the study site (looking southeast). ERT data are being acquired on Traverse 3.

The ERT data were acquired using an AGI SuperSting R8/IP resistivity unit equipped with a dipole-dipole array consisting of 72 electrodes (Figure 6.7). Typical depth of investigation is 20 percent of the length of the electrical resistivity array. With 72 available electrodes and the required depth of investigation 35 ft, a 2.5 ft spacing between the electrodes was chosen for this ERT survey. The ERT data were acquired in February, after two days of rain.

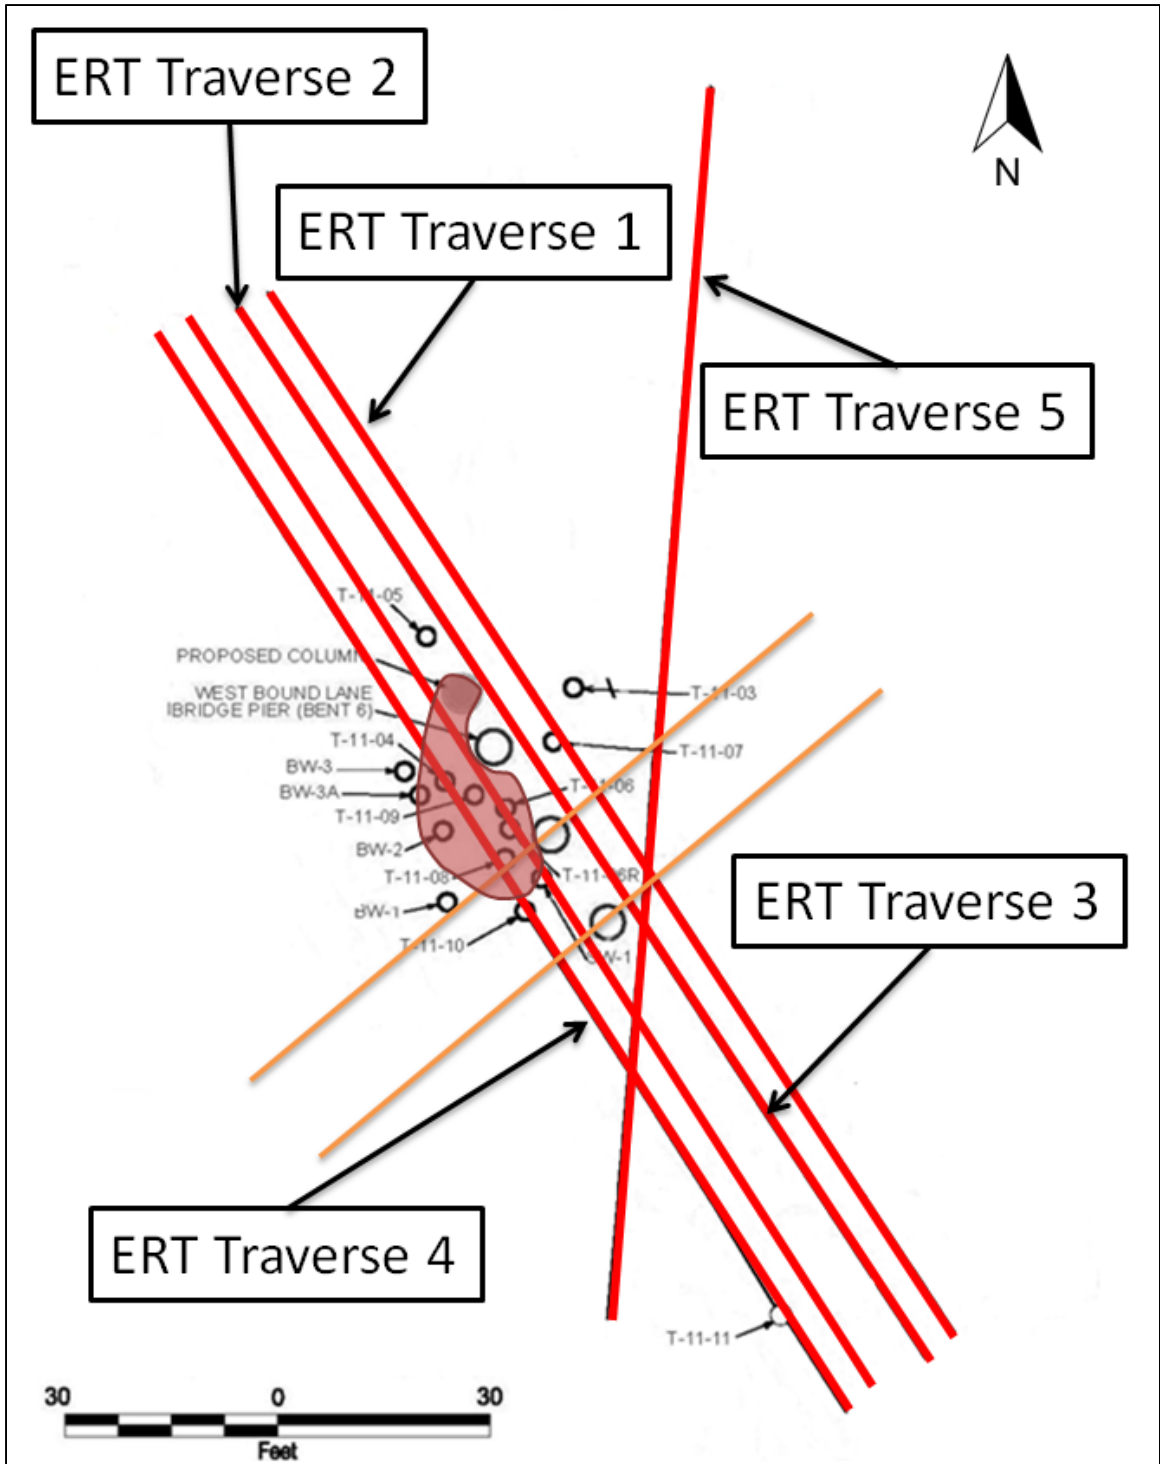
Figure 6.16. Interpreted set of solution-widened joints superposed on the ERT profiles and boreholes location map. Orange lines show mapped zone of solution-widened joints trending southwest-northeast. Red polygon shows estimated extension of the water-filled rock opening assuming with the assumed height 5 ft was over 400 square ft.

The interpreted set of solution-widened joints, trending southwest-northeast, was superposed on the ERT profiles location map (Figure 6.16) and on a map of known faults and lineaments with marked preferential surface flow path in the study area (Figure 6.18). The orientation of the interpreted set of solution-widened joints was consistent with the preferential surface path flow oriented southeast-northwest and perpendicular to the known faults and lineaments in the study area.

The interpreted electrical resistivity tomography data and borehole control did not indicate the presence of other than the encountered water-filled rock openings at the study site. However volume of injected grout (78 cubic yards) suggested the area of extension of the water-filled rock opening, assuming the rock opening height 5 ft, was up to approximately 32 ft by 17 ft (Figure 6.16). The ERT method was not able to map the water-filled rock opening due to the similar resistivity values of saturated weathered and vuggy rock and water-filled rock opening.

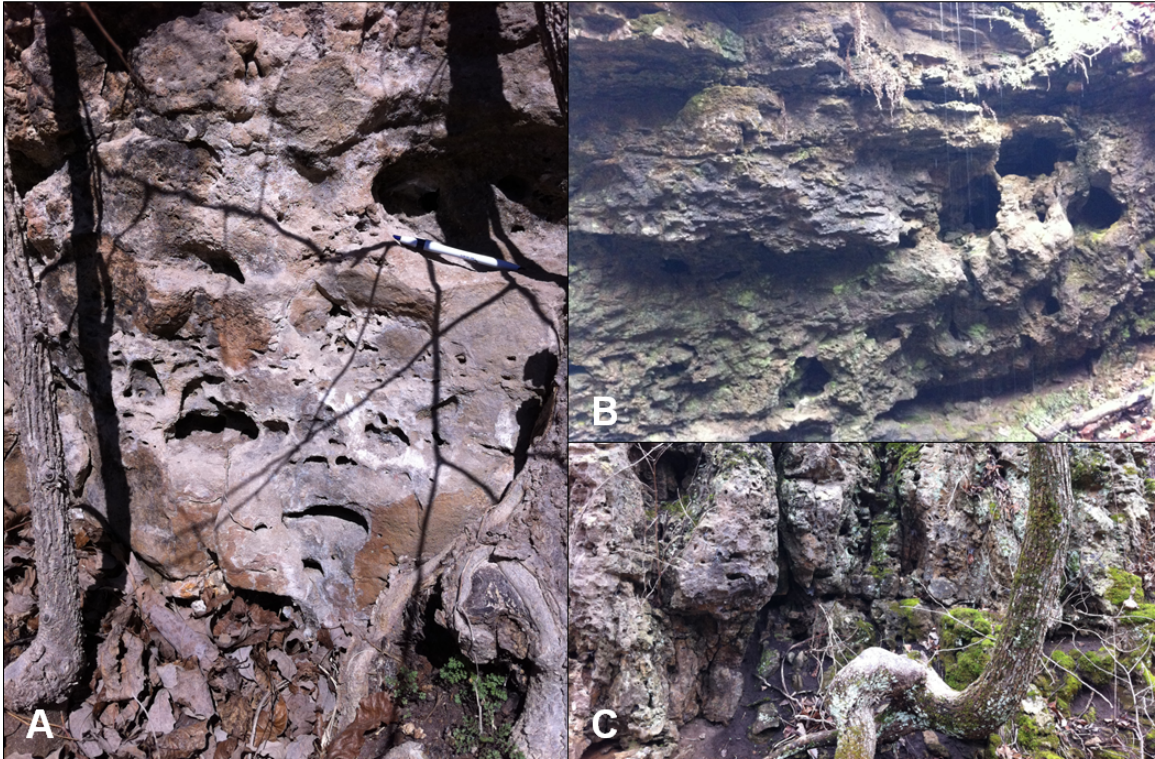
Figure 6.17. Premier example of karst landform features in Late Cambrian Eminence Dolomite in Ha Ha Tonkas State Park, Missouri: vugs (A), karst developed along bedding planes (B), vertical solution-widened joints (C).

southwest-northeast (Figure 6.16). Solution-widened joint is a typical feature for karst landform. An example of solution-widened joints with vuggy dolomite is shown in Figure 6.17.
