Extending the Usage of High Volume Fly Ash in Concrete

**NUTC
R336**

Part I: Insights into the Mechanisms of Salt Scaling of High Volume Fly Ash Concrete

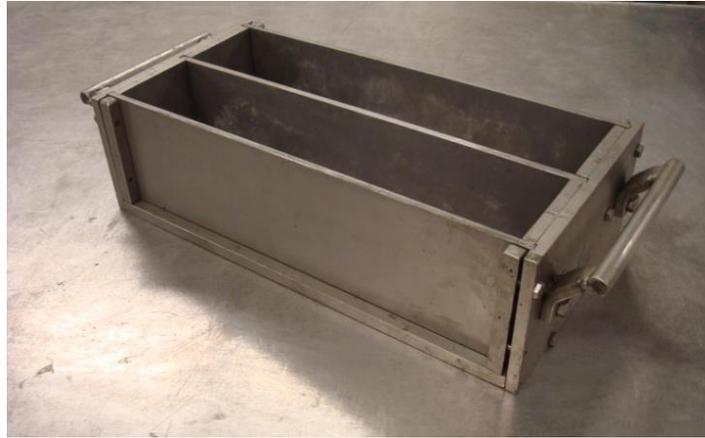
Figure 1 – Freezing and Thawing Specimen Molds

The ends of each mold contained a threaded hole to install a specialized bolt. This bolt contained a rounded end, and when the concrete specimens were de-molded, the end of this bolt protruded from both ends of the prism. The embedded bolt provides a mechanism to measure the length change of the concrete prism as it was subjected to freezing and thawing cycles.

The specimens for the rapid freeze-thaw test were fabricated according to ASTM C 666–03, “Standard Test Method for Resistance of Concrete to Rapid Freezing and Thawing.” The molds used in the fabrication of these specimens are shown in Figure 1. These stainless steel molds measured 3.5 in. in width, 4.5 in. in height, and 16 in. in length and conformed to ASTM C 666 requirements for specimen dimensions.

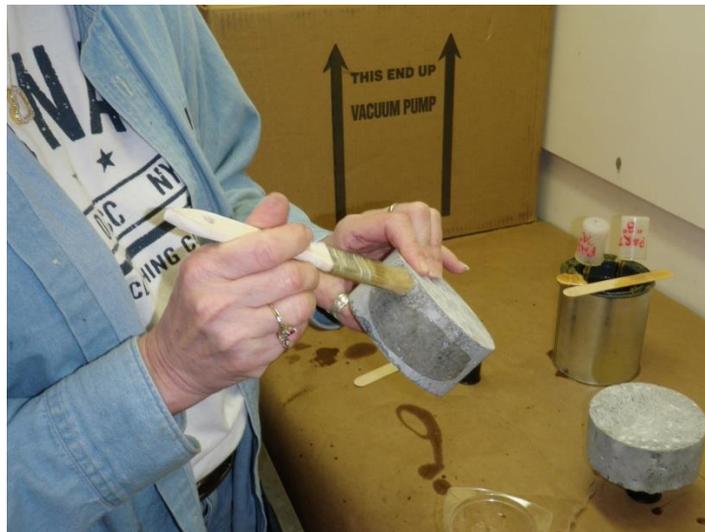
Figure 2 – Application of Setting Coating

The rapid chloride ion penetration test is outlined in ASTM C 1202-10, “Standard Test Method for Electrical Indication of Concrete’s Ability to Resist Chloride Ion Penetration.” The test specimens consist of 4 in. diameter by 2 in. thick concrete disks. These disks were cut from specimens cast according to ASTM C 192. Two disks were cut from each concrete cylinder, with two concrete cylinders cast from each mix, which resulted in a total of 4 concrete disks for each concrete mix. One disk was cut from the top of the cylinder and the other from the middle. These disks were labeled with the mix design name and noted as either middle or top. The specimens were allowed to surface dry for at least 1 hour before the sides of the disks were coated with a setting coating as shown in Figure 2.

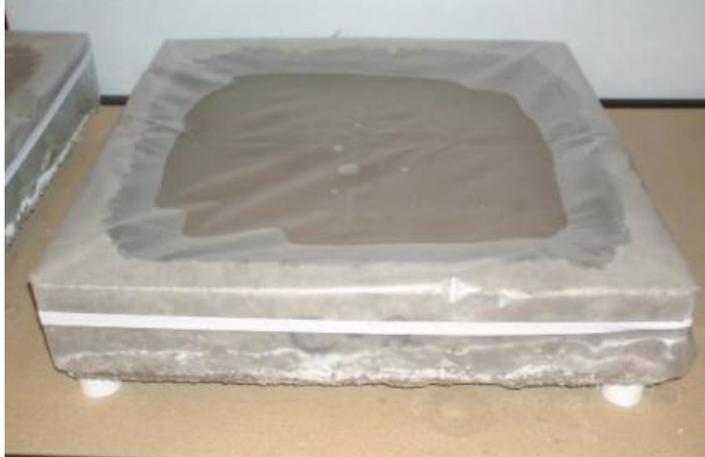
Figure 5 – Ponding Test Specimen

The test procedure involved placing a 5% by weight chloride solution into the ponding specimen reservoir. The solution had to be at a depth of 0.6 ± 0.2 in. A photograph of a typical ponding specimen is shown in Figure 5. When the required amount of solution was poured into the reservoir, the concrete specimens were covered with plastic sheeting and the sheets were secured with elastic bands to prevent evaporation of the solution. Every two weeks, the specimens were checked to ensure that the proper depth of the solution was maintained. If the reservoir was low, additional solution was added. After 60 days of ponding, the reservoir was vacuumed dry and fresh solution was added. The sheeting was replaced and the specimens were monitored every two weeks. After another 60 days, the chloride solution was vacuumed off and the specimen allowed to air dry. A few days later, a core was taken from the center of the specimen to determine the chloride profile.

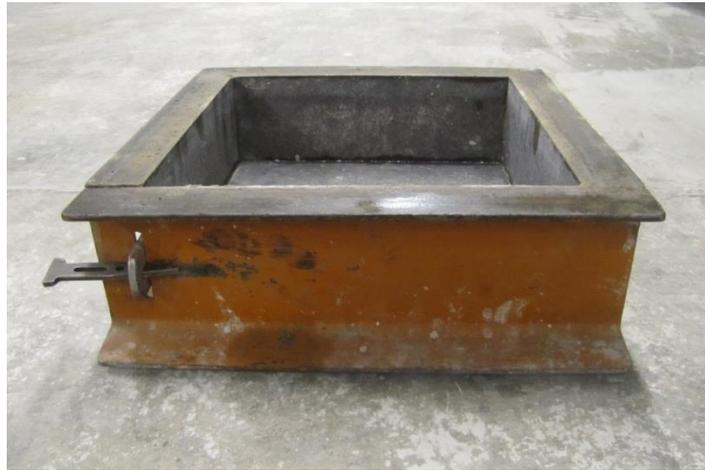
Figure 6 – Scaling Specimen Form

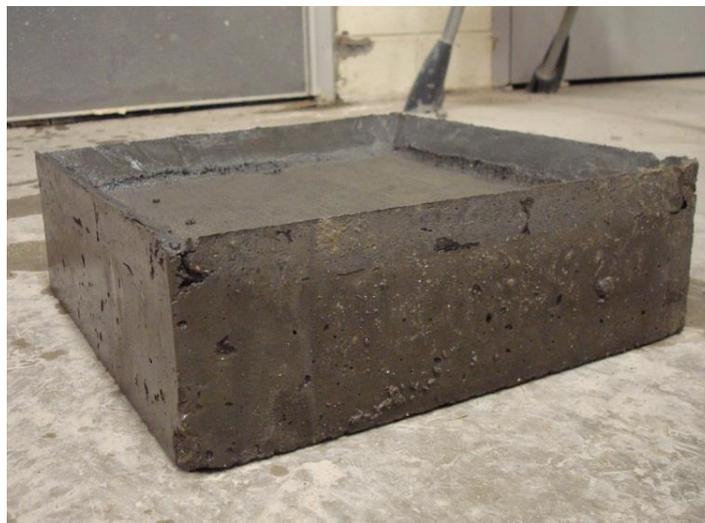
Figure 7 – Salt Scaling Specimen
