Strength of Unbonded Post-Tensioned Walls

Mohamed Elgawady and Ahmed Gheni

August 2014

A National University Transportation Center at Missouri University of Science and Technology

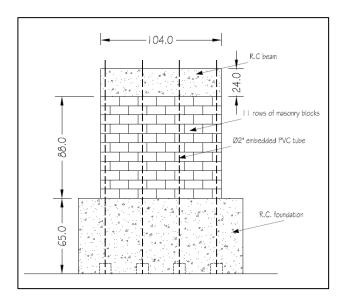
Figure (1): Post-tensioned wall with 32 inch spacing

Tests were carried out on three 88 inch height and 103.6 inch width fully grouted masonry walls. A 7.625 X 7.625 X 15.625 inch masonry blocks were used in to build the walls. Two variables were investigated in an experimental study. The first parameter is the spacing between the post-tensioned bars. A 32 inch (fig.1) and 96 inch (fig.2) spacing were used consequentially with a constant axil net force on the walls. The second investigated parameter is the effect of the horizontal bond beam (shear reinforced beams). One wall with a two bond beams in the thirds of the height was tested to compare with same post-tension bars spacing (fig.3). Other parameters were studied in this project by using nonlinear finite element model solved by LS DYNA software.

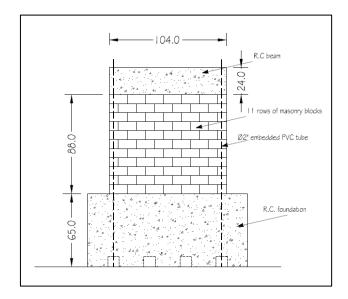
Figure (2): Post-tensioned wall with 96 inch spacing

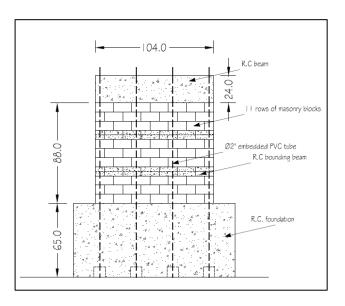
Figure (3):Post-tensioned wall with32 inch spacing and two bond beams

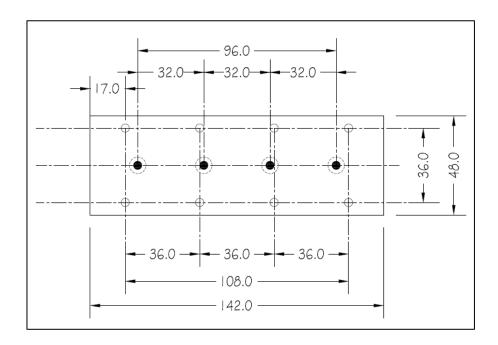
Figure (6): footing top view

tension load in the bar which connect the wall to the footing and the footing to the floor. For that, a PVC pipes were used to made the holes fig (6),(8),(9) and another technique was used to made the grove that contain the ending plate and nut of the post-tensioned bars fig(5).

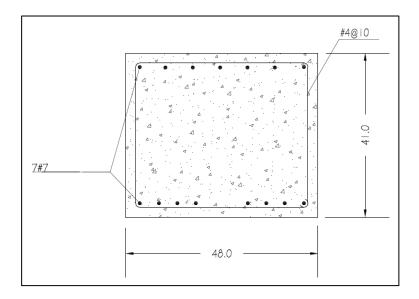
Figure (7): RC pedestal cross section

To control the aspect ratio of the walls, a RC base was used under the footing fig (7). Its dimension is 41 height and 48X142 inch.

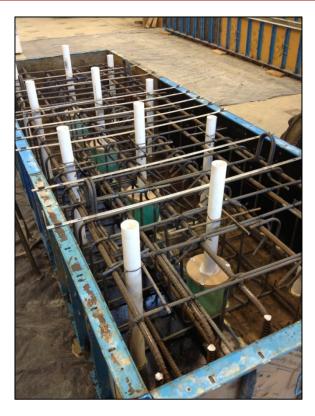
Figure (8): Reinforcements and holes in wall footing

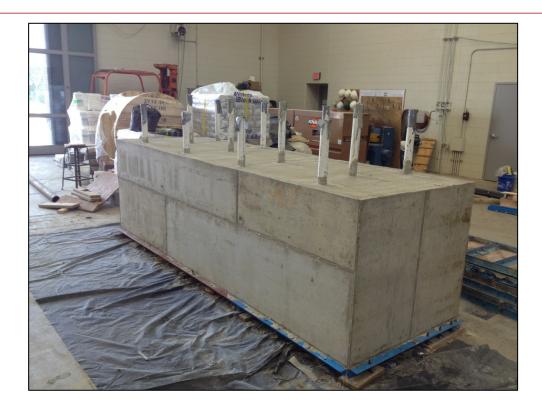
Figure (9): Reinforced Concrete pedestal

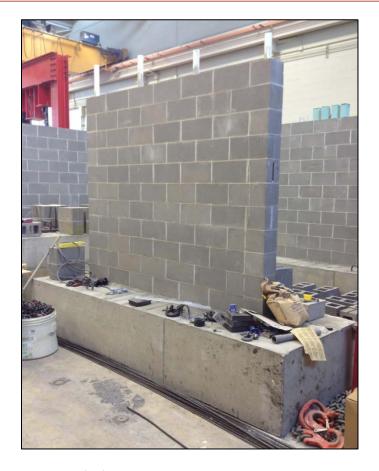
Figure (10): The masonry block wall with PVC pipe

The second part of the walls is the masonry block walls. It is fully grouted walls and they don't have any conventional reinforcements. A 2 inch PVC pipes were put in the walls to provide the unbounded length for the post-tensioned bars fig (10). Strain gages were attached to the steel reinforcement of the horizontal bond beam.

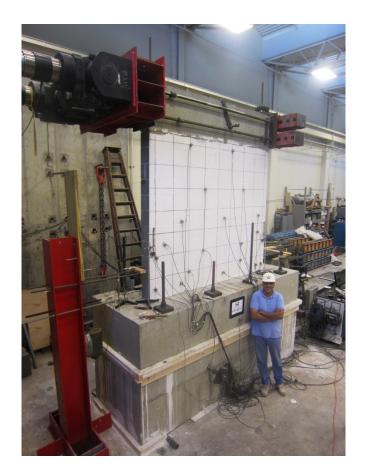
Fig (12): The wall with top beam

The third part of the walls is the top beam. It is a RC beam that used to distribute the axil loads evenly and to transfer the cyclic lateral loads from the actuators to the wall. The design of the top beam took in the consideration that the top beam will be used with different post-tensioned bar spacing and different amount of load in each time fig (11). This beam contains a PVC pipes to create holes which match the holes in the walls and the foundations fig (12).

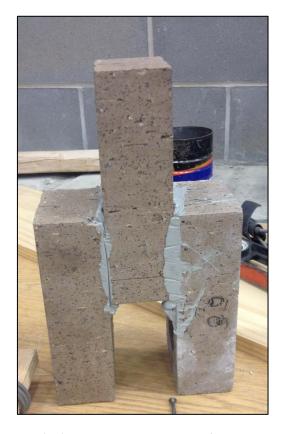
Fig (14): Testing the adhesion of the epoxy

More than one technique had been used to avoid to sliding between the top beam and the wall during applying the lateral load. Finally, using the 8x epoxy fig (13) was the best way to get a fully attached beam and wall. Before that, non-standard tests were done to find the adhesion for each type of epoxy fig (14)

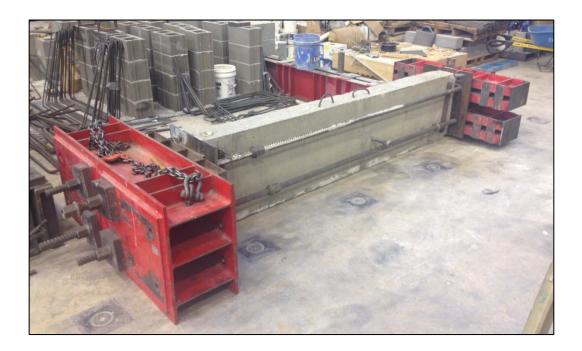
Fig (15): Top beam with the test setup

Since the loads were applied as a push and pull to simulate the seismic loads. Special fixtures were needed to satisfy that. The load applying setup consists of two strong end plates connected by four high strength 1.5 inch diameter post-tensioned bars. An adapter was fixed at the head of

the actuators to transfer the loads from the two actuators to the end plate and later to the wall through the top beam fig (15).

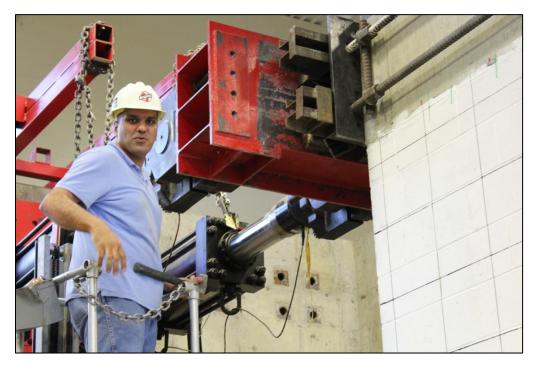
Figure (16): Attaching the adaptor to the top beam

The top beam was attached to the actuators by using a special rigid adaptor. The reason behind that was keeping the wall and the test setup stable and having a one steady concentrated load comes from two actuators fig (16) (17).

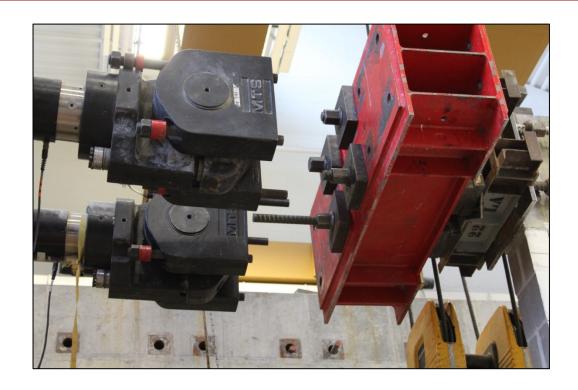
Figure (17): Attaching the adaptor to the top beam

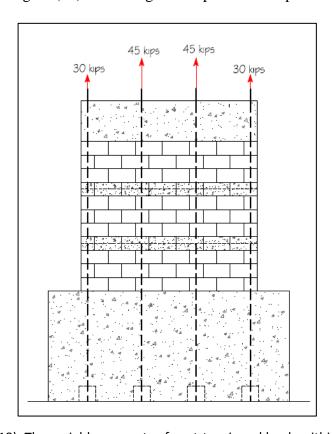
Figure (18): The variable amounts of post-tensioned loads within the wall

The next step is applying the post-tensioned forces to the walls. In this project, a unique technique which is never been used before were used. This technique is applying the post-tensioned forces with a different amount in each bar based on its location fig (18). This idea came from the fact that the strain in each bar will be different based on its location with respect to the N.A.

Using this technique has two advantages. The first one is avoiding the early yielding in the bars that have the farthest position from the N.A. the second advantage is increasing the resisting capacity of the walls.

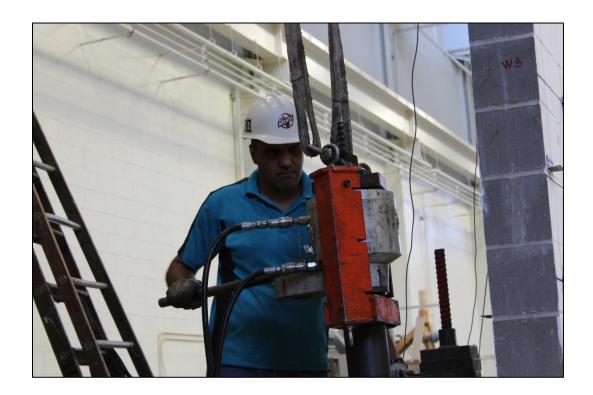
Figure (19): Applying the post-tensioned forces by using hydrolic jack

A very sensitive load cells were attached during applying the loads and during the tests to each post-tensioned bars. A hydraulic jack was used to apply the post-tensioned forces fig (19). These load cells recorded the forces in each bar during the tests and the can give indications about reaching the yield limit or not.

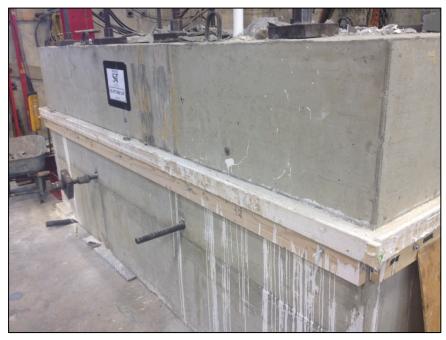
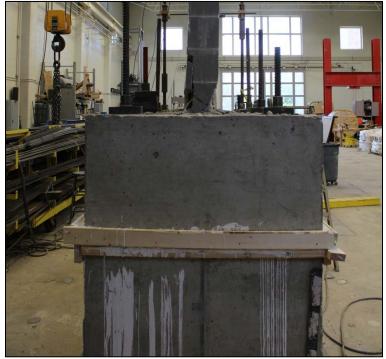
Figure (20): Fixing the footing and the prdestel to the floor with layer of hydroston between them

The footing and the bedstil were conected together to the rigid floor by using eight 1.5 diameter post-tensioned high strength bars to insure a perfect fixation for the walls.in adition, a thick layer of high strength hydroston were put between the footing and the bedstil to prevent any sliding or sliping fig(20).

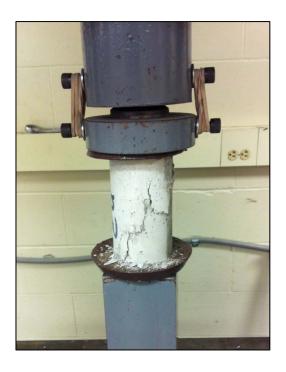
Figure (21): Mortar testing

Material properties are summarized in Table 1. Many samples were taken to be tested in 28 days and in the day of testing the walls to get the exact properities of the materials in the day of tasting fig (21),(22),(23). A Midwest brand mortar and high strength groute were used. An all thread linch diameter grade 150 DSI post-tensioned bars with its standard accessoroes were used in this project fig (24).

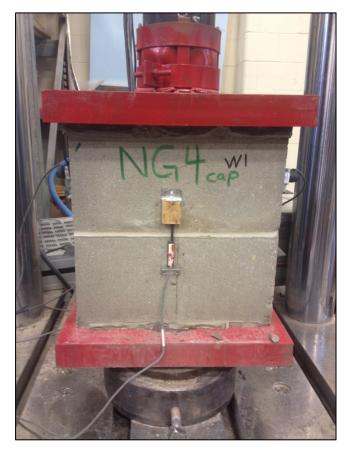
Figure (23): Masonry block prism test

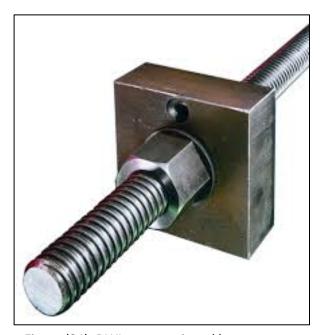
Figure (24): DWI post-tensioned bar system

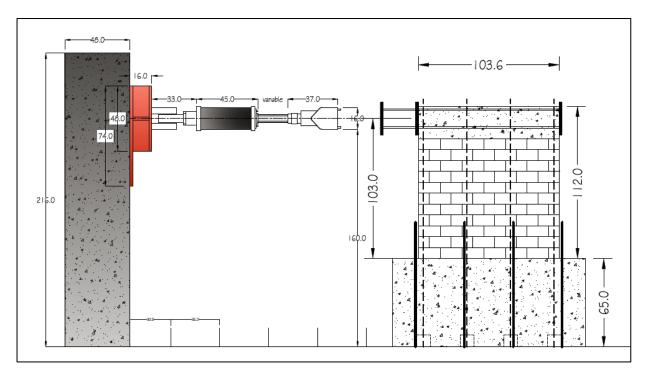
Figure (25): Test setup

The walls were tested in a hydraulically controlled MTS Testing system (rigid wall) of 400 kips capacity under controlled rates of ram frequency. Fig (25), (26)

Prior to testing, a wide measurement system was installed and hooked up the data accusation box to collect the data with 10 reading per second. The measuring system consists of LVDT's to measure the lateral and vertical displacements, strain, and drifting for the top beam, wall, footing and pedestal. The force in each post-tensioned bar was monitored.

Load was monitored by independent measurement across the hydraulic ram stroke was measured by an internal LVDT. However, stroke measurements were affected by machine flexibility; an accurate measurement for the stroke was measured by other external LVDT.

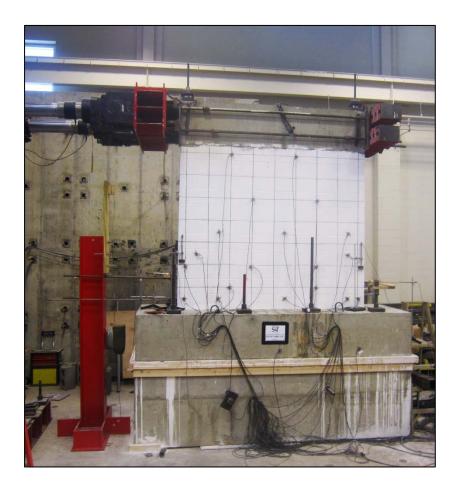
Figure (26): Specimen ready for testing

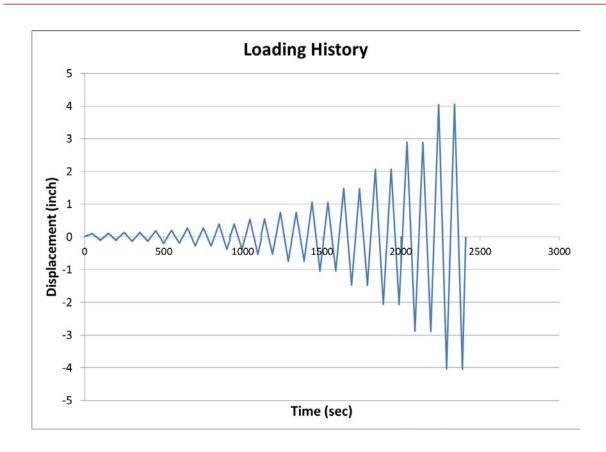
Figure (27): Loading history

Regarding to the loading rate, a constant frequency was used to control the loading. Therefore; each single cycle has been finished within 50 seconds. This testing regime has been adopted by FEMA to give a better simulation of the seismic action fig (27).

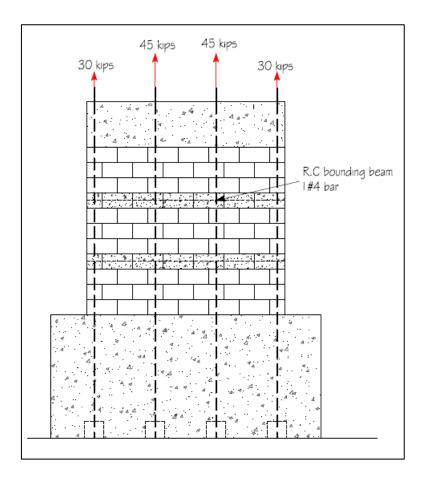
Figure (28): Details of wall 1

This wall contains four post-tensioned bar with 32 inch spacing between them. The force in each bar was different from the other ones fig (28). This wall contains shear reinforcement as a two horizontal bond beams. These beams were reinforced with 1#4 bar for each beam. The bars in each bond beam were hocked around the post-tensioned bars fig (29).

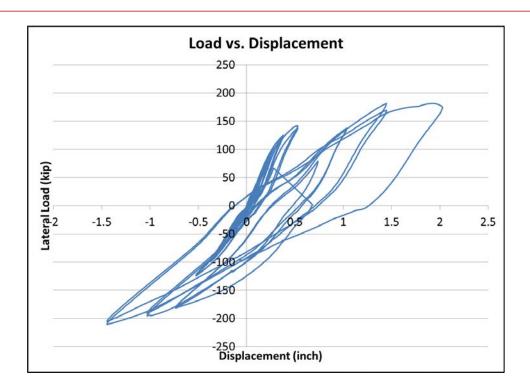
Figure (30): Lateral load vs. Displacement curve for wall 1

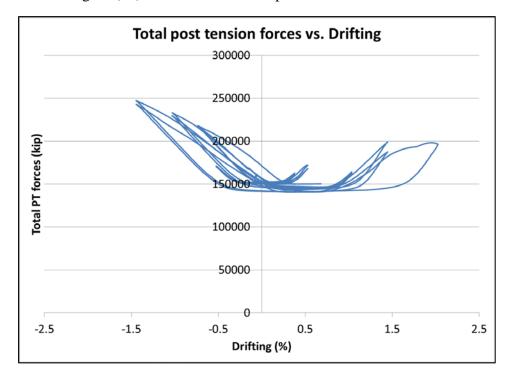
Figure (31): Total post tension forces vs. drifting curve for wall 2

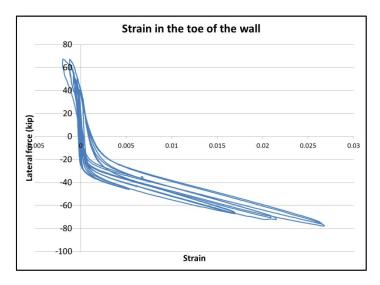
Figure (33): Strain in the north toe of wall 1

The small spacing with the horizontal bond beams made the wall very strong and very stiff. As results, the shear failure was dominant fig (35). However, the post-tensioned bars were in the elastic range fig (32) but the shear reinforcements have yielded fig (34). The toe crashing was very clear fig (35). The strain in the toe was very high comparing to the maximum strain in concrete fig (33).

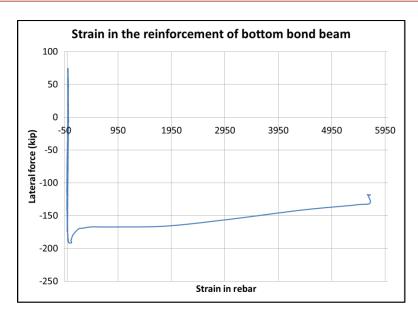
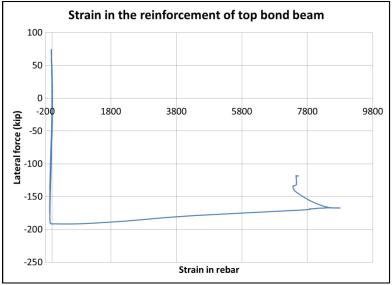
Figure (34): Strain in the reinforcement of the upper and lower bond beams

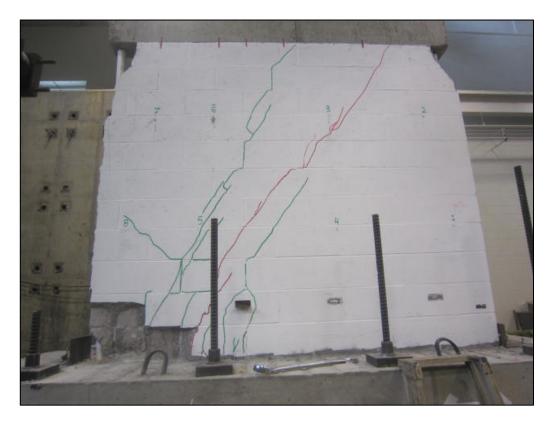
Figure (35): The general mode of failure for wall ${\bf 1}$

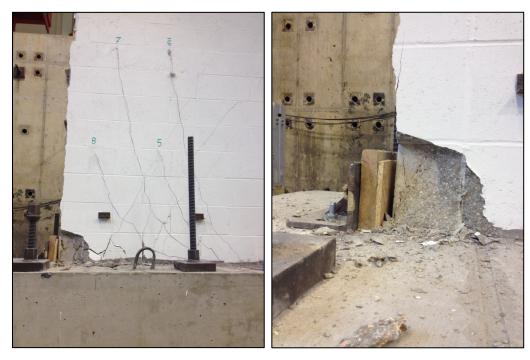
Figure (36): The toe failure for wall 1

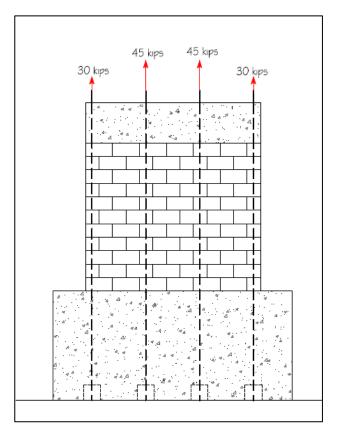
Figure (37): The details of wall 2

This wall contains four post-tensioned bar with 32 inch spacing between them. The force in each bar was different from the other ones fig (32). This wall did not contain any shear reinforcements or bond beams.

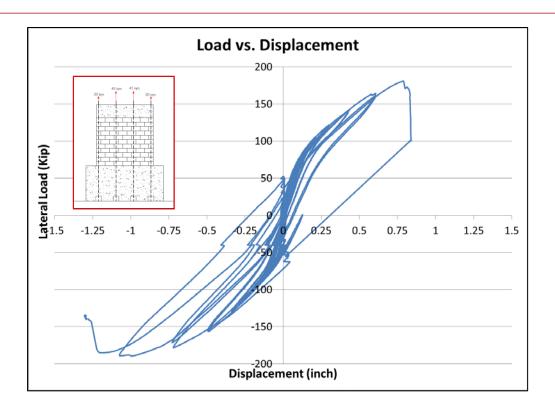
Figure (38): lateral load vs. Displacement curve for wall 2

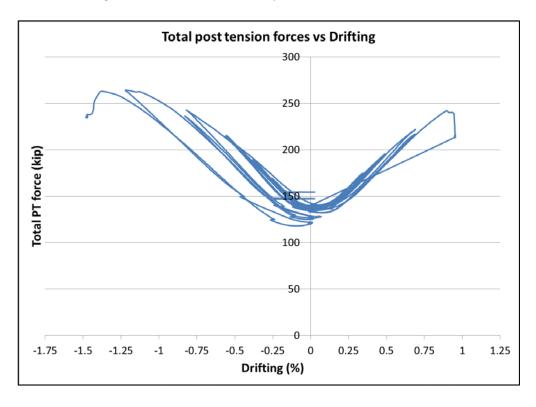
Figure (39): total post tension forces vs. drifting curve for wall 2

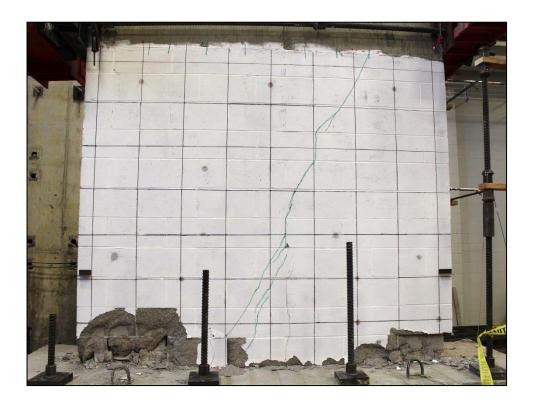
Figure (41): The general failure of wall 2

The small spacing made the wall very strong and very stiff. As results, the shear failure was dominant fig (41). However, the post-tensioned bars were in the elastic range fig (40). The toe crashing was very clear fig (35). The strain in the toe was very high comparing to the maximum strain in concrete fig (43), (44), and (45). There is no that much impact of removing the bond beams in wall 2.

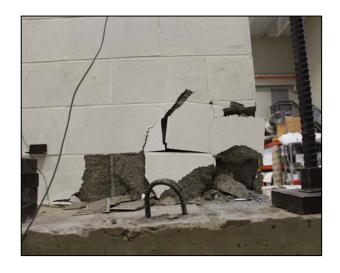
Figure (42): The toe failure for wall 2

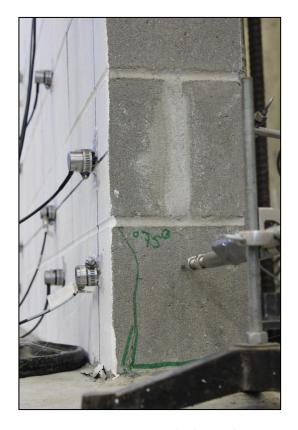
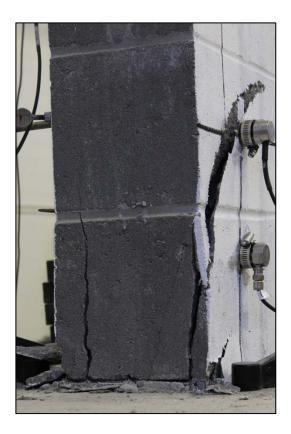
Figure (43): The first crack in the toe at 0.75 inch displacement

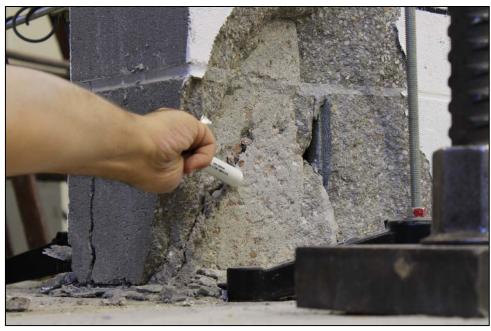
Figure (44): Developed toe crack

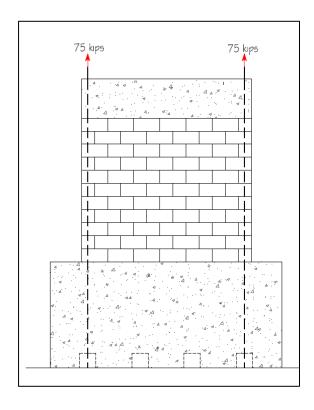
Figure (45): The details of wall 3

This wall contains two post-tensioned bar with 96 inch spacing between them. Each bar has the same amount of force fig (45). This wall did not contain any shear reinforcements or bond beams.. At the end of the day, this wall has the same amount of axil post-tensioned force.

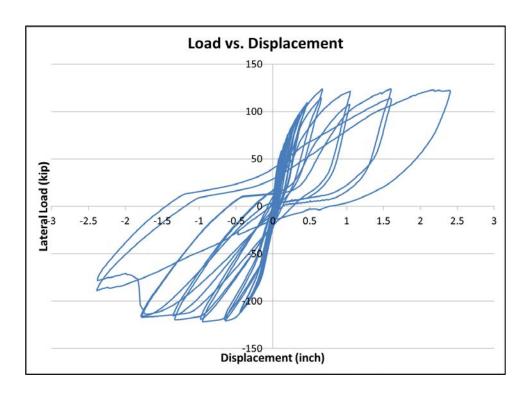
Figure (46): lateral load vs. Displacement curve for wall 2

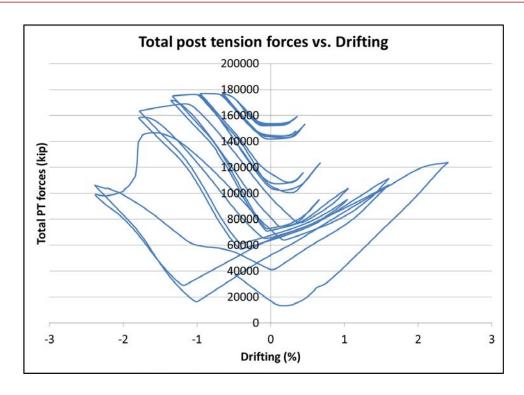
Figure (47): total post tension forces vs. drifting curve for wall 2

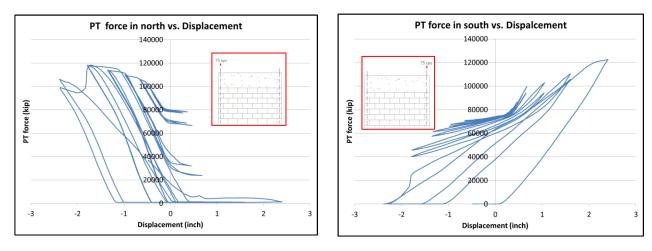
Figure (48): Post-tension force in each bar vs. Displacement curve for wall 3

The large spacing without the horizontal gave the wall a significant amount of drifting. As results, the shear failure was not dominant fig (49). However, the post-tensioned bars have yielded fig (48). The toe crashing was very clear fig (50). The strain in the toe was very high comparing to the maximum strain in concrete. Due to the big difference in forces between the two ends of the wall, a vertical crack developed close to the edge of the wall fig (49). This fact was stated before by using finite element model with large spacing between the post-tensioned bars.

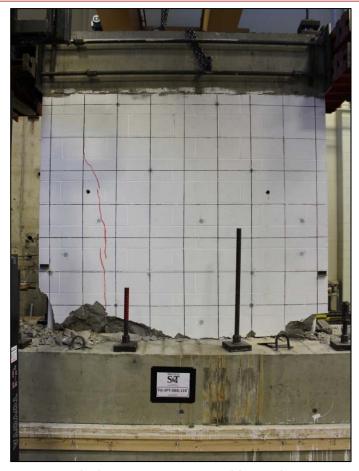
Figure (49): The general mode of failure for wall 3

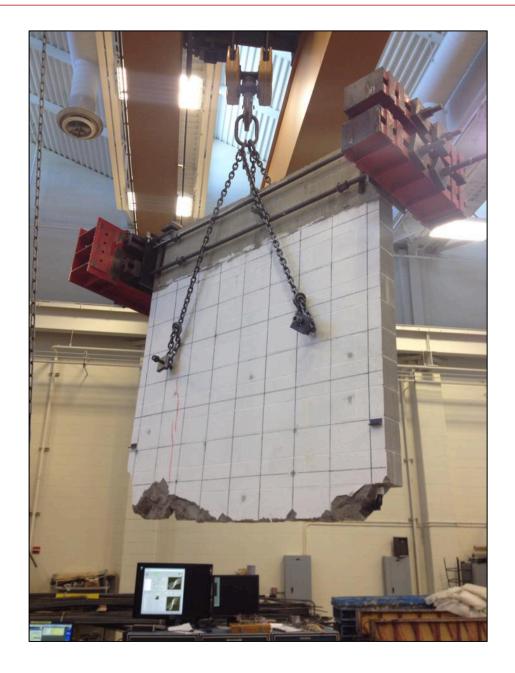
Figure (52): Moving the wall after testing

Even after failure, the wall still acts as a one piece fig (52). Therefore; it is very easy to repair the toe only by replacing the broken or crashed blocks to give back the original strength to the wall.
