Seismic Evaluation and Retrofit of Beam-Column Joints of Mid-American Bridges Part 1: Fiber Reinforced Polymer Retrofit

Pedro F. Silva, Ph.D., P.E.
Genda Chen, Ph.D., P.E.
University of Missouri-Rolla (UMR)
gchen@umr.edu

Geotechnical and Bridge Seismic Design Workshop
New Madrid Seismic Zone Experience

October 28-29, 2004, Cape Girardeau, Missouri

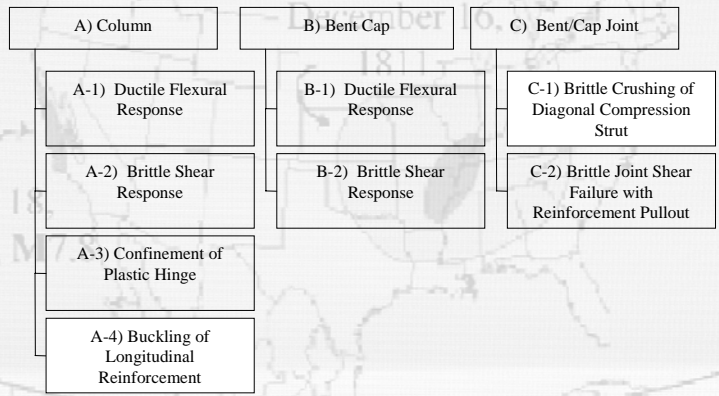
Performance Levels for a Typical Bent Cap/Column-bent Connection

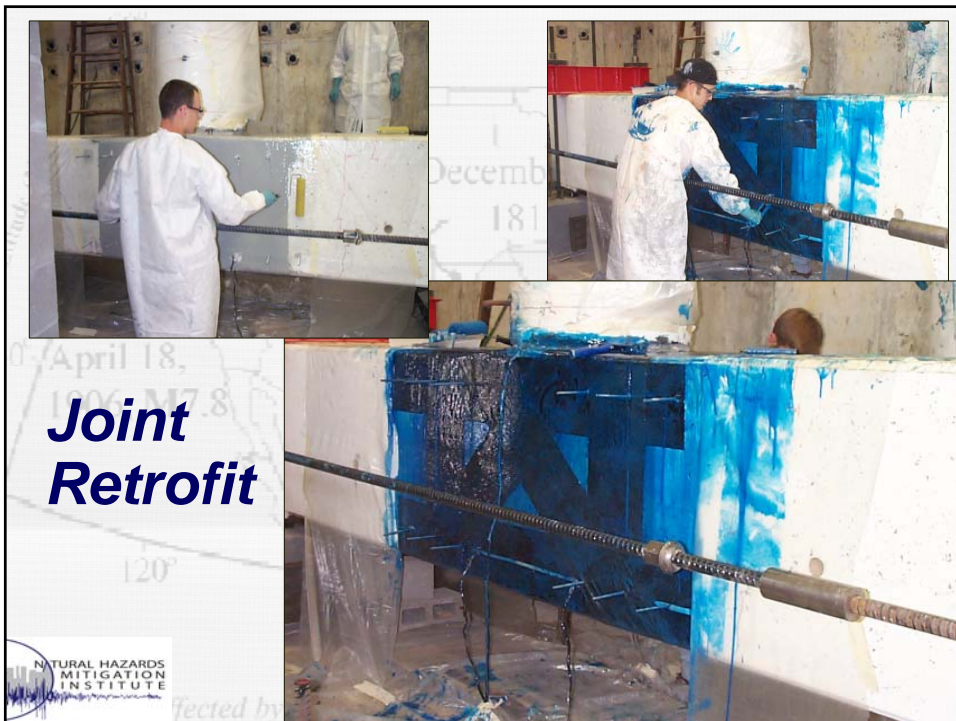
Joint Retrofit

Unit 2 – Retrofit Specimen

- ◆ Column shear capacity was enhanced by applying CFRP sheets in the hoop direction
- ◆ Strengthening of the joint region was adequate in preventing joint shear failure
- ◆ Some level of strength degradation was observed in the joint region
- ◆ Main failure mode was characterized by fracture of the column long. reinforcement

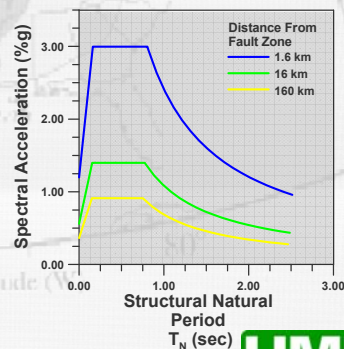
Natural Period

$W = 710\text{kN}$
 $F_Y = 320\text{kN}$
 $\Delta_Y = 10.2\text{mm}$
 $T_N = 0.31\text{sec.}$
