POST-EARTHQUAKE CONDITION ASSESSMENT OF RC STRUCTURES PART 1: CRACK SENSOR

Genda Chen, Ph.D., P.E.
Associate Professor of Civil Engineering
University of Missouri-Rolla (UMR)
gchen@umr.edu

Geotechnical and Bridge Seismic Design Workshop
New Madrid Seismic Zone Experience

October 28-29, 2004, Cape Girardeau, Missouri

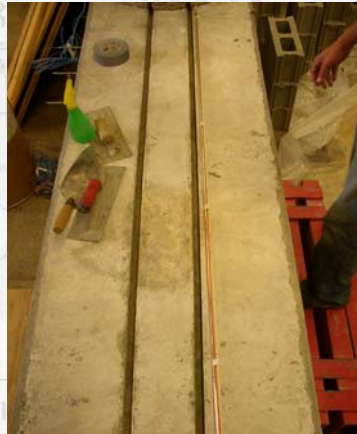
Installation of Distributed Sensors

- Sensors are near surface mounted on a member and installed in a 1.25cm x 1.25cm groove.
- Sensors are grouted into place with grout materials that are more brittle than concrete.

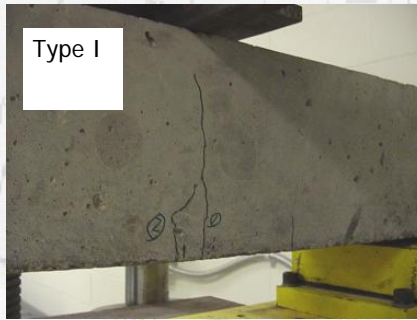
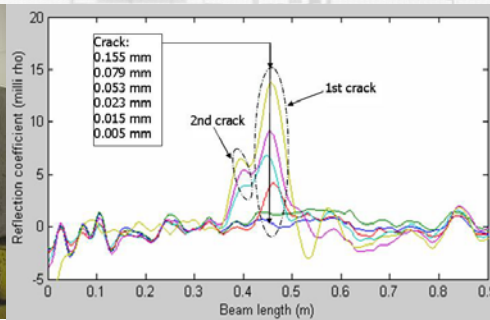
Static Tests on Beam Specimens

- Crack pattern and reflected waveform

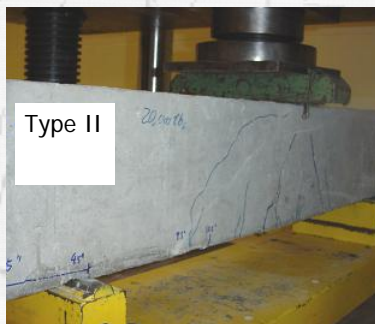
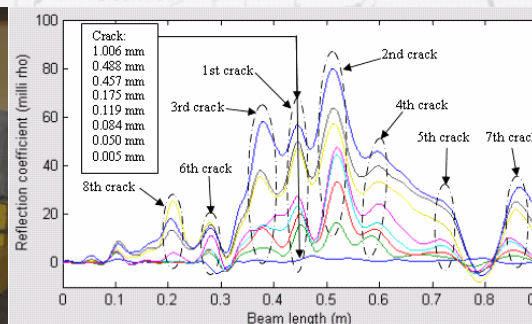
Static Tests on Beam Specimens

- Crack pattern and reflected waveform

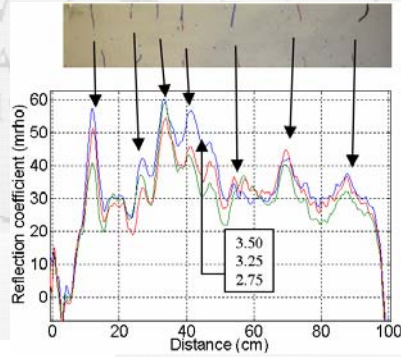
(a) Column C1

Results of Dynamic Tests

- Shows location and size of crack in column
- Detects crack in advance of visual detection
- Detects crack beneath FRP reinforcement

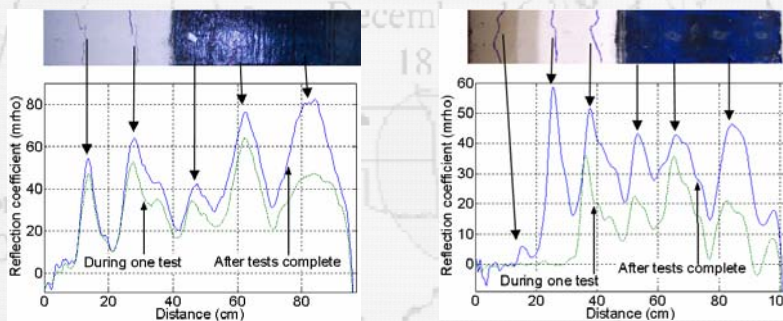
Discovery of Memory Feature

(a) Column C4

(b) Column C5

- Sensor continues to operate after several test cycles (upwards of 20,000)
- Only one sensor ceased to operate, reason was because of connector, not actual sensor
- Sensor shows location of cracks after testing ceases (column reinforcement failure)

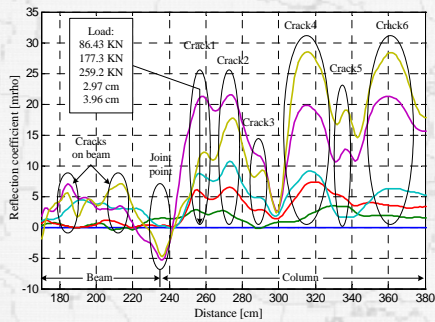
Specimen # 1 (Rubber Sensor)

(a) Crack pattern at 177.3 kN (b) Crack pattern at 1.98 cm

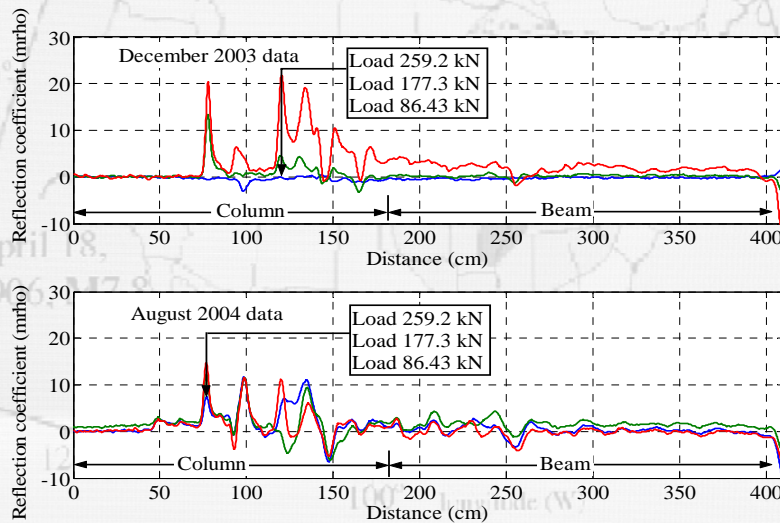
Specimen # 3 Results (Teflon)

- Both rubber and Teflon sensor installed into specimen
- Specimen tested in December of 2003 without any retrofit
- Testing resumed August 2004 with retrofit scheme

- After six months of inactivity sensors still show comparable results at same loading levels
- Both detect location and relative size of cracks
- 90° bend at construction joint is a detriment to sensor performance

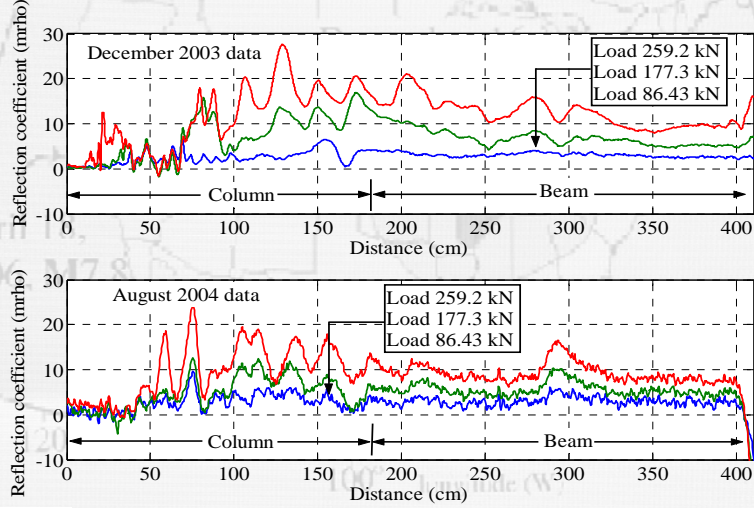
Specimen # 3 Results (Rubber)

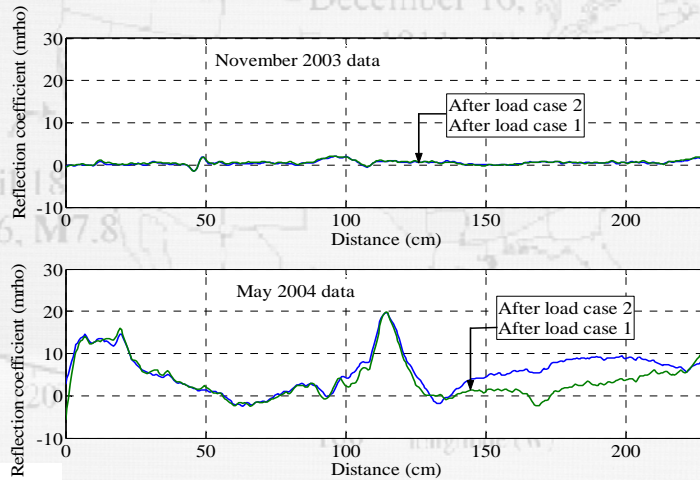
Difference Signals Taken at Zero Loading (Sensor 1)

- Sensors show no degradation after several months of exposing to the elements

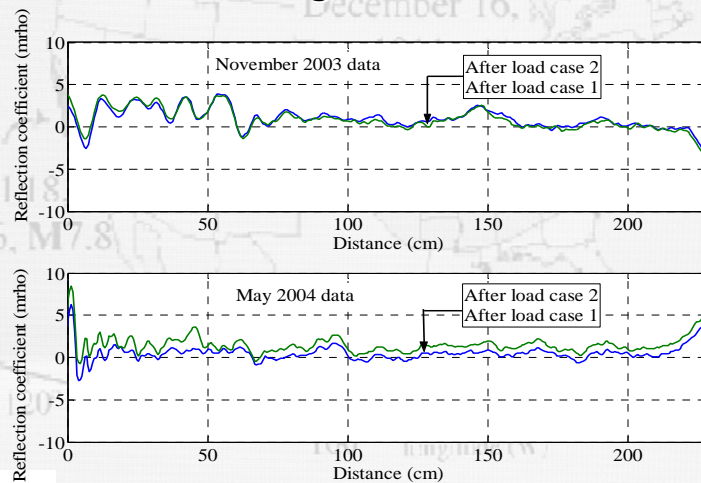
Difference Signals Taken at Zero Loading (Sensor 2)
