PRESERVATION OF MISSOURI TRANSPORTATION INFRASTRUCTURES

VALIDATION OF FRP COMPOSITE TECHNOLOGY
THROUGH FIELD TESTING

Strengthening of Bridge X-0596 Morgan County, MO

Prepared for:
Missouri Department of Transportation
University of Missouri-Rolla
(Project Code R03M01 - 1)

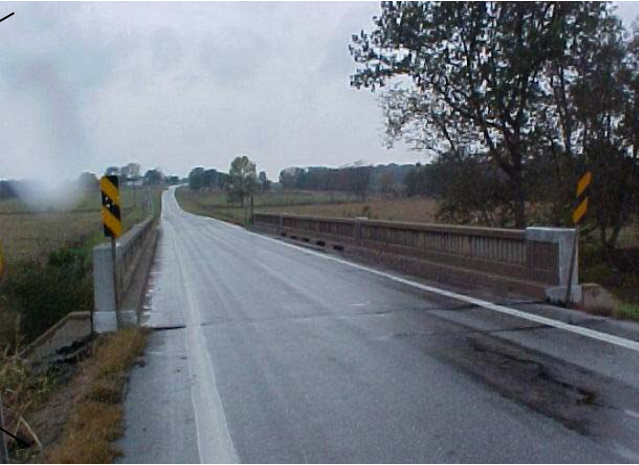
District: 5	County: Morgan
Year Built: 1946	Feature Intersected: Lander Fork Creek
Main Spans Construction: RC T-Beam	Number of Main Spans: 3
Total Length: 137.5 ft (41.9 m)	Rating (Deck/Sup/Sub): 6/5/5
Load Posting: Trucks over 18 ton (16.33 tons in SI units), 15 mph (24.14 km/hr)on the bridge.	
BRIDGE FEATURES	
Geometry <ul style="list-style-type: none"> • Roadway width is 20 ft (6 m) • Alignment is tangential. • Three-span deck girder (Three RC T-Beams spaced 9 ft = 2.7m on centers). • Slab thickness is 6 in (15 cm) 	
Concrete Condition before Strengthening <ul style="list-style-type: none"> • Cracks in the exterior girders, some reinforcement exposed and some concrete deteriorated. • Some cracks at girders and intermediate diaphragm connections. • Cracks and deterioration of beams in intermediate Bents • Cracks and deterioration of the ends of the girders at intermediate Bents • End Bents in better condition (but with rusty steel bearing plates).

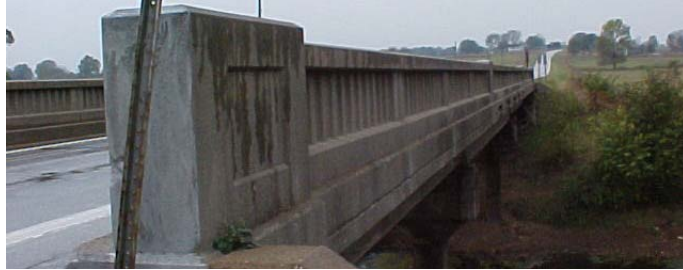
Figure 1. Bridge X-0596

Bridge X-0596 is located in Morgan County, MoDOT District 5. The structure has three spans, each with three RC girders monolithically cast on a 6 in (15 cm) slab (see Table 1, Figure 1, Figure 2 and Figure 3).

The total bridge length is *137.5 ft* (41.9 m) and the total width of the deck is *23.6 ft* (7.2 m). Each span has one transversal beam with the same depth as the main girders (Figure 3). Two FRP system technologies were used for the flexural strengthening of this bridge. The FRP systems consist of FRP manual lay-up laminates and NSM bars for reinforcement of the deck, girders and bents of spans. U-wrapped FRP laminates were installed on all the main longitudinal girders using manual lay-up to hold the flexural reinforcement in place.

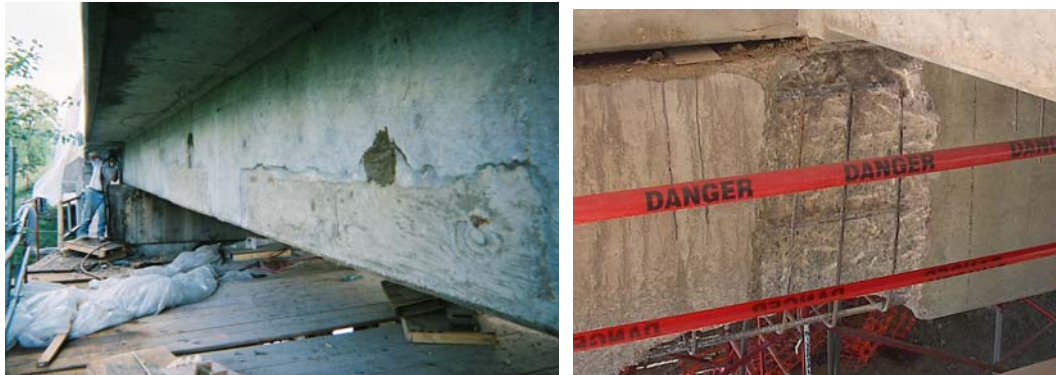
Figure 4. Repair of deteriorated areas on girder and bent

In order to place CFRP and SRP on the underside of the bent system, repair work was done by removing 116 cubic feet (3.28 m³) of concrete from the deteriorate areas, cleaning the area, installing repair materials, finishing and texturing (Figure 4).

The concrete repair work consisted of the following parts:

- Partial-depth repairs of deteriorated concrete on deck and bents
- Removal of sound concrete along the deck, bents and girders to establish a suitable surface profile

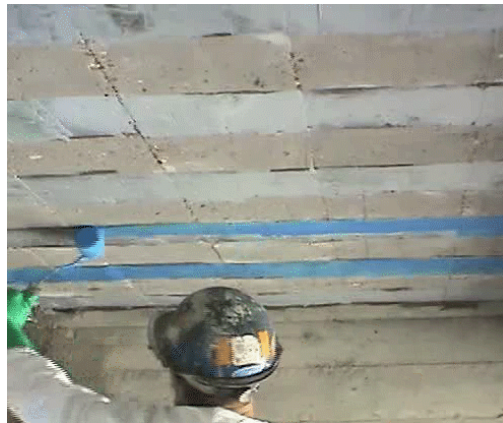
Figure 6. Saturant application

A saturant coating (Table 2) was applied with a medium nap roller after application of the primer and putty (Figure 6). Afterward, the pre-cut fiber sheets were attached according to Contract drawings.

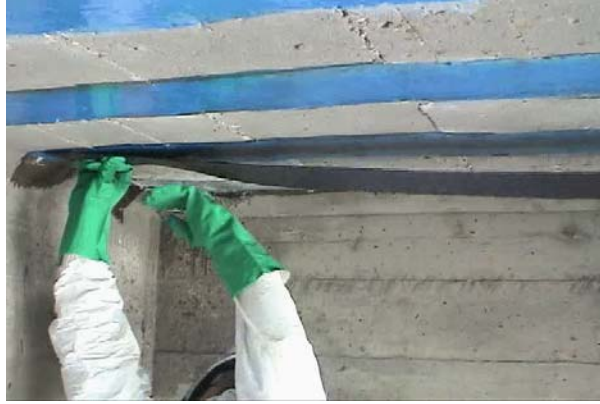
Figure 7. Manual lay-up CFRP sheet installation.

The carbon fiber sheets were installed by manual lay-up method (Figure 7). The sheets were properly aligned and set into the surface saturant. The fiber plies were aligned on the structural member according to the Contract Documents. Any deviation in the alignment more than 5° (approximately 87 mm/m or 1 in/ft) was not acceptable. The sheets were saturated by rolling out the external surface. This operation also removed excess of saturant and bubbles (Figure 8). After appropriate time (10 minutes), a second saturant application over the carbon fiber sheets were applied to a complete impregnation (Figure 8). The saturant was applied in strict accordance with the manufacturer's recommendations (Manufacturers Literature).

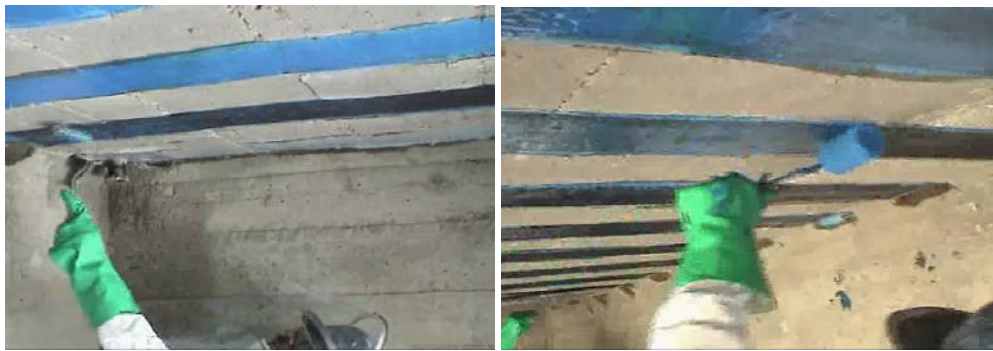
Figure 8. Squeezing of air bubbles and saturation over laminates

The process must allow sufficient working time for the rolling of the carbon fiber sheet and saturant to produce a uniform system that is completely free of voids and trapped air. It must be completed within the limits of saturant pot-life.

Because saturant is susceptible to temperature, special care shall be taken to minimize the elapsed time between mixing and application of the saturant. This must be applied to the sheet at least 15 minutes prior to any thickening. In order to avoid vibrations during the installation, traffic control was used. Speed of the car was limited to 15 mph (24.14 km/hr). Finally, a topcoat was applied to the sheet to provide a cosmetic finish and environmental protection.

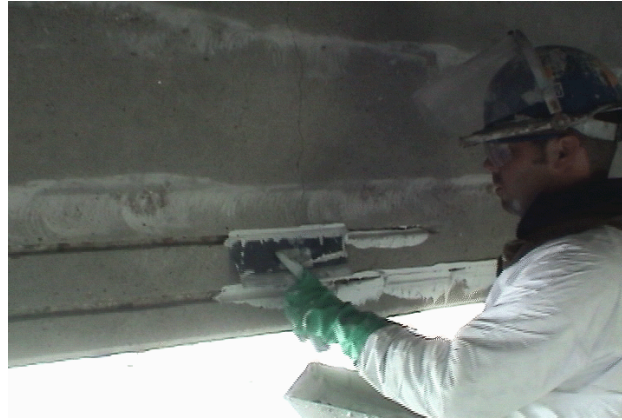
Figure 9. Epoxy adhesive in slot cut in the concrete surface

Installation of the bars was achieved first by grooving the concrete surface. The grooves have square cross section, 5/8 inch per side, to allow embedment. This value is equivalent to the diameter of the bar plus one eighth of an inch per side). Concrete was grooved making parallel saw cuts of 5/8 in depth and spaced at 5/8 in. The groove is created by chipping out the concrete between the two cuts. The system included a primer/sealer for the concrete surface

A high modulus, high strength and high viscosity epoxy adhesive was used (Table 3). This epoxy paste is chemically compatible with the individual properties of the primer and bars, so a solid bonding can be developed (see Figure 9)

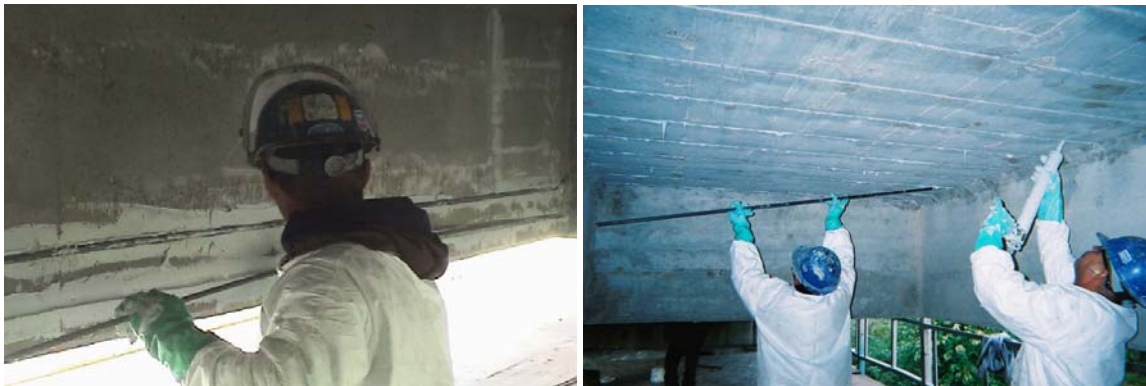
Figure 10. Bar installation on girder and slab

The NSM bars were then placed into the grooves and lightly pressed to force the paste to flow around the bar. The bars are sometime placed with the help of wedges. Excess material was removed manually and the surface was leveled (Figure 10).
