Validation and Calibration of Testing Equipment for In-Situ Load Tests

UTC
R130

IN-SITU LOAD TESTING OF BRIDGE A6102

LEXINGTON, MO

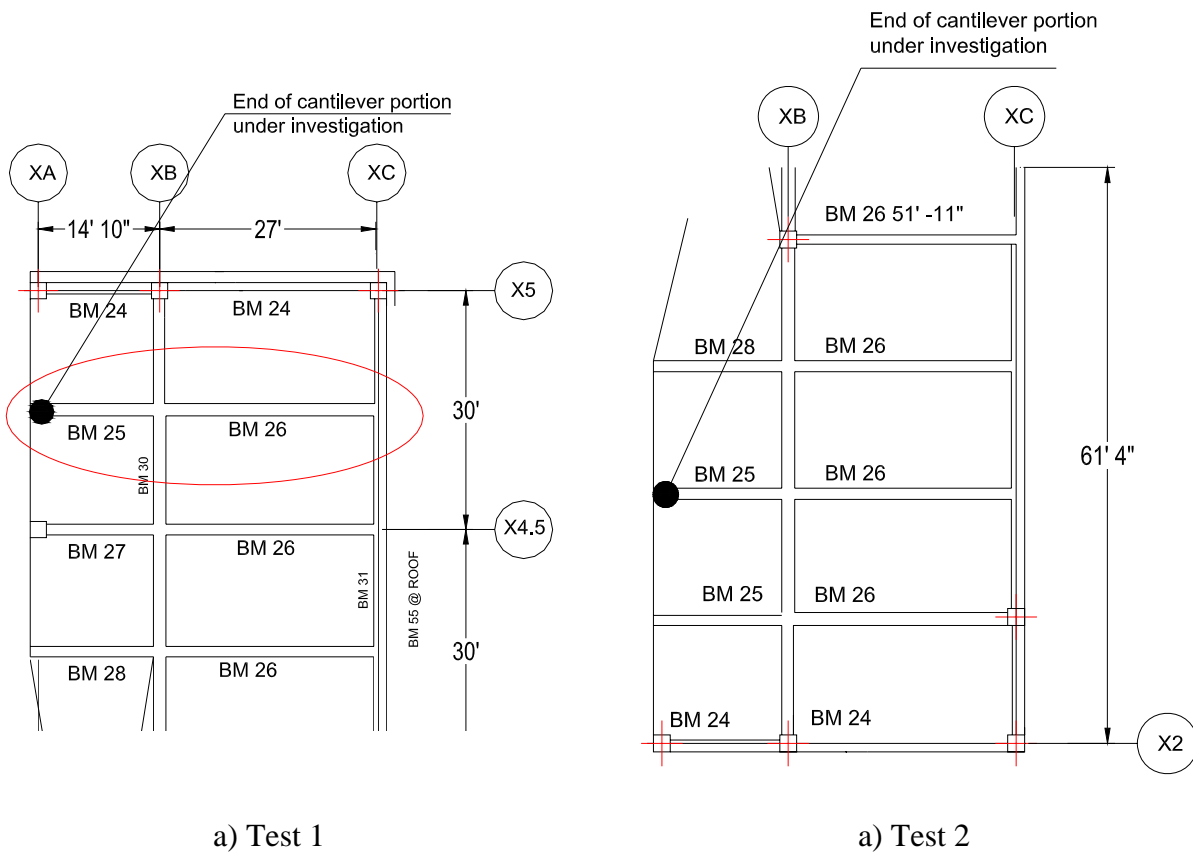
Figure 1-4 Cantilever Portions Under Investigation

Load test evaluation was commissioned in order to investigate whether the cantilevered portions, at the two ends of the speed ramp, were experiencing unexpected permanent deflections, as it was found out during construction.

Each test will consist in evaluating the performance of a 15 ft width of the beam-slab interaction along the North-South direction, between column lines X5/X4.5 for Test 1 and between column lines X2/X3 for Test 2, as reported in Figure 1-4. Thus, for all load tests, the critical test section is at the end of the cantilever portion in terms of displacement and over the intersection between beam, along alignment XB, and joist perpendicular to it, in terms of negative moment.

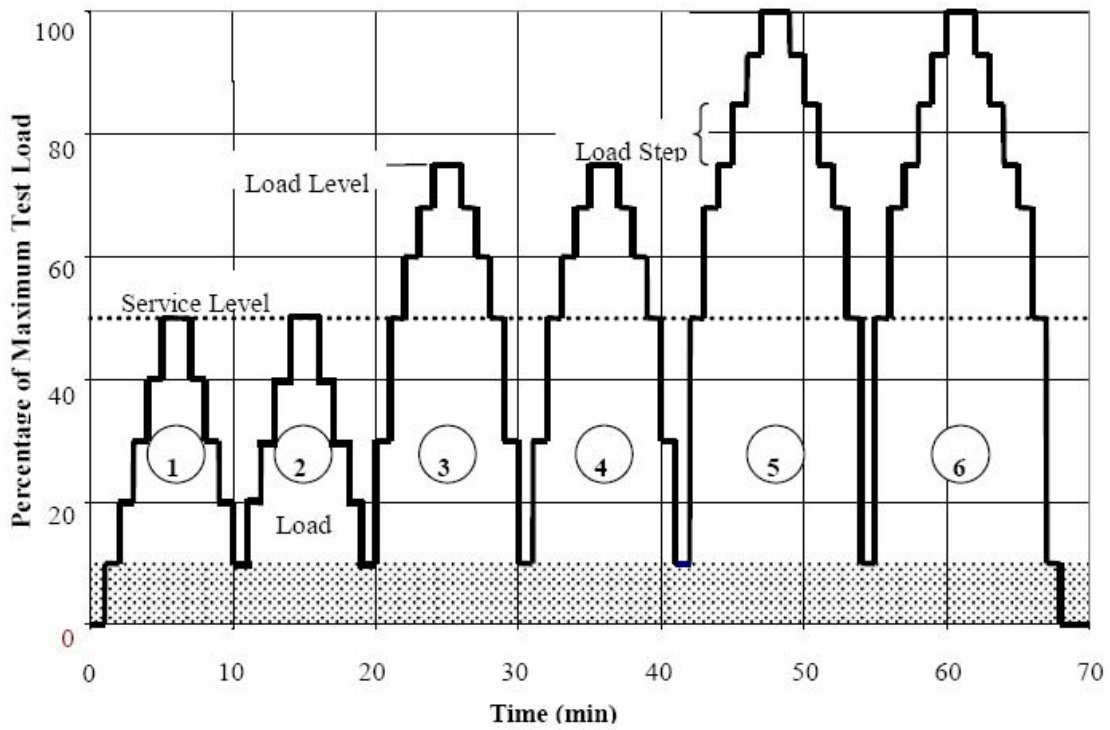
Figure 5-1 - Load steps and cycles for a diagnostic load test

Once all instruments were connected, a preliminary load was applied to seat all test setup components and to eliminate slack in the system. Following the preliminary load, the structural component was loaded in six loading cycles. The peak load for each successive cycle is gradually increased to approach the maximum test load. Each cycle consisted of a minimum of 4 approximately equal load steps followed by at least 2 steps to unload the structure (See Figure 5-1). Each load step was maintained for at least 2 minutes. During this time, deflections of the structure were monitored for stability. The peak load for each successive cycle was gradually increased to approach the maximum test load. Two cycles using the maximum test load were applied to verify repeatability of the measurements.

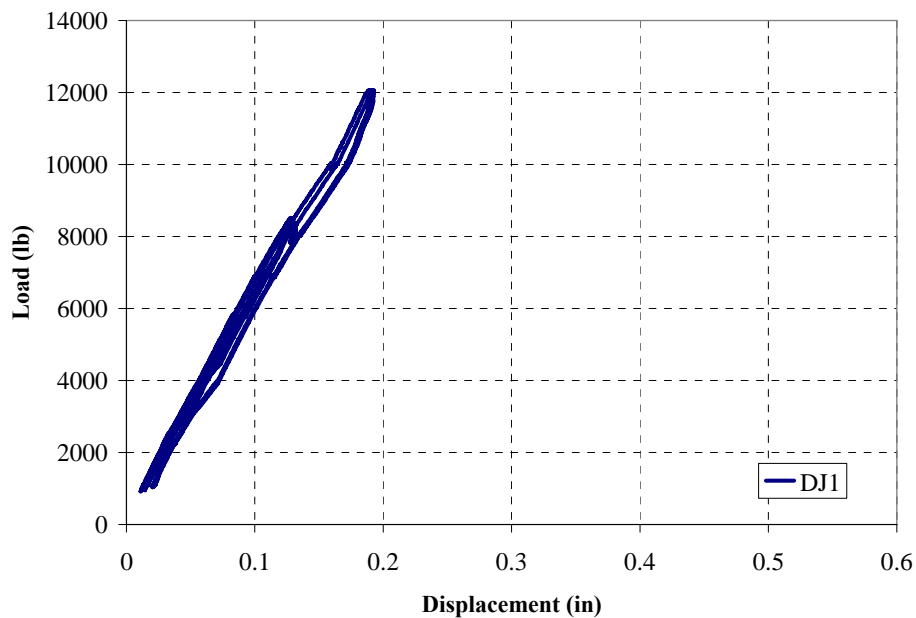
Figure 6-1 – Load Deflection Diagram Corresponding to Test 1

The joist was loaded to a maximum total load of 12100 lb. At the critical section, this load produced a negative moment (-M) similar to that caused by uniformly distributed load (UDL) of 102 psf. No failure signs were observed at this load level. Relatively small deflections were measured during testing with no signs of cracking. Figure 6-1 shows the measured deflections by LVDT DJ1 during the six cycles. As seen in the figure, the behavior of the joist was elastic with no residual deflection measured when the load was removed. The joist passed the test since repeatability, permanency and deviation from linearity were within the limits prescribed by ACI 437 (See Table 6-1).

Cycle	Repeatability (≥ 95%) (%)	Permanency (≤ 10%) (%)	Deviation from Linearity (≤ 25%) (%)	Performance
1 and 2	110.3	0.4	2.1	Satisfactory
3 and 4	101.1	0.8	6.7	Satisfactory
5 and 6	101.3	0.9	11.3	Satisfactory

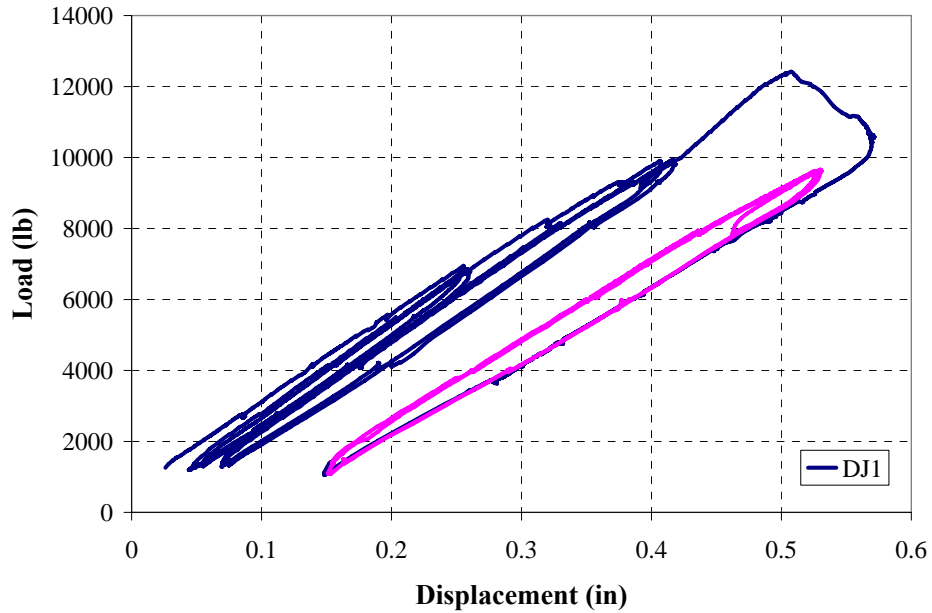
Figure 6-2 – Load Deflection Diagram Corresponding to Test 2

The joist was supposed to be loaded to a maximum total load of 13,800 lb. At the critical section, this load produced a negative moment (-M) similar to that caused by uniformly distributed load (UDL) of 102 psf. No cracking signs were observed up to a load level of 12,400 lb. At this load level a flexural crack produced in the slab at the maximum negative moment area which caused the load to decrease to 11,000 lb. At this point the test was considered "not passed" and the structure was gradually unloaded to 1,300lb (i.e., 10% of the planned maximum load). Two more load cycles were applied at a maximum load of 10000 lb. in order to guarantee the safety of the structure al a lower load level (See Table 6-3).

Figure 6-2 shows the measured deflections by LVDT DJ1 during the seven cycles. As seen in the figure, the behavior of the joist was elastic until reaching 12,400 lb. After the formation of the crack, the joist behaved un-elastically presenting a relevant plastic deformation after unloading. The two additional cycles at a lower load level were considered to be satisfactory since they passed requirements on repeatability, permanency and deviation from linearity prescribed by ACI 437 (See Table 6-3). Only a 2% reduction in the stiffness was recorded while comparing cycles 6-7 with cycles 3-4.

| Cycle	Repeatability (≥ 95%) (%)	Permanency (≤ 10%) (%)	Deviation from Linearity (≤ 25%) (%)	Performance
1 and 2	99.2	3.2	0.3	Satisfactory
3 and 4	101.0	1.2	11.7	Satisfactory
5	N/A	18.6	30.56	Not passed
6 and 7	98.4	2.2	N/A	Satisfactory

The joists were loaded to a maximum total load of 12,100 lbs and 12,400 lb for Test 1 and Test 2 respectively. Test 1 was considered satisfactory since repeatability, permanency and deviation from linearity were within the limits prescribed by ACI 437. In Test 2 the joist experienced cracking at a load of 12,400 lb and the planned maximum load of 13,800 lb was never applied. Such cracking generated significant residual deflections after the member was unloaded. This test is considered "not passed".

1. Since the two tests, performed on very similar portions of the structure, gave conflicting results in terms of cracking, a more detailed analysis by the engineer of record is suggested.
2. Even though the deck portion subjected to Test 2 experienced cracking, it is considered safe under the existing service loads (a service load of 70 psf corresponds to the two additional cycles performed at 10,000 lb). However, the engineer of record may not have intended for the system to crack at a service load corresponding to 90 psf (12,400 lb). One of the possible reasons for the observed performance could be an unintended loss of prestress. It is suggested that the engineer of record re-compute the effective prestress

force based on the field determined cracking moment. Based on the findings, it could be established if an upgrade action is needed.

3. It is suggested that the area cracked during testing be repaired to prevent fatigue or durability problems over time.
