CENTER FOR TRANSPORTATION INFRASTRUCTURE AND SAFETY

Field Evaluation of Alternative and Cost-Efficient Bridge Approach Slabs

NUTC R272 / R273

FINAL REPORT

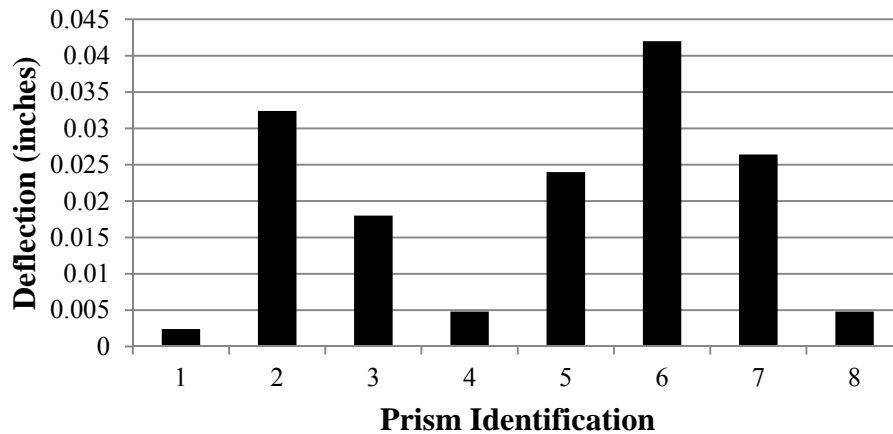
Figure 6-11 3 Month Experimental Deflections of 20 ft. PCPS and 25 ft. CIP BAS

The 25 ft. CIP BAS experienced very minimal deflections near the abutment and showed up to 0.032 in. near the pavement end. The 20 ft. PCPS BAS monitoring plates near the abutment experienced less settlement than those near the flexible pavement end. The maximum deflection recorded for the 20 ft. PCPS BAS was 0.042 in. In roughly 3 months the BASs showed minimal deflections at the monitoring plate locations and do not appear to be a problem for motorists. This also indicates that the load is transferring directly from the BAS to the base indicating that no washout or settlement is occurring.

Longitudinal differential deflection was measured to ensure the BASs were not creating a bump as motorists enter/exit the bridge. The results indicated negligible differential deflections that could be detected by the high precision surveying equipment. The small deflections that were detected are due to slight imperfections in the surface such as texturing (25 ft. CIP BAS) and the asphalt overlay (20 ft. PCPS BAS). When crossing the bridge in a vehicle, the transition between the bridge and flexible pavement was smooth indicating exceptional performance in both BASs located in Marshfield, MO.

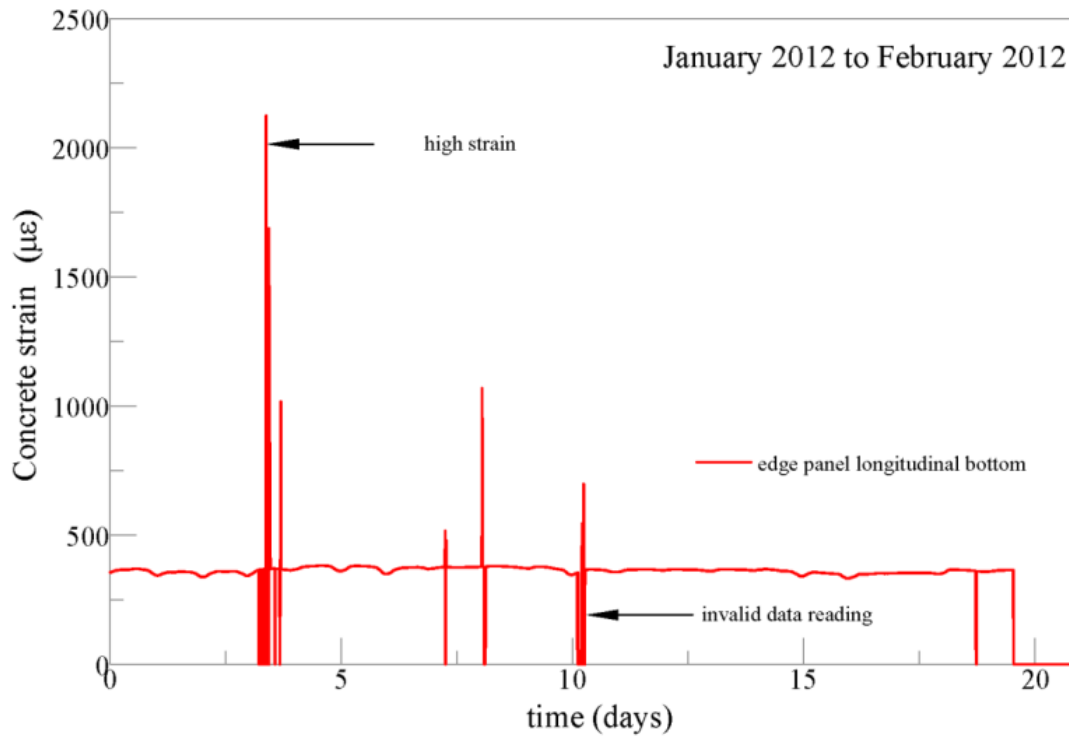
Figure 6-26 Variation in concrete strain in edge panel from January to February 2012

The concrete strains were recorded at 10 minute intervals from January to February 2012 to check the performance of the data logger and relevant settings. The recorded strains showed that one of the strain gauges was probably damaged due to larger strain than the gauge is capable of withstanding as illustrated in Figure 6-26 below. The other strain gauges showed expected strain values as illustrated in Figure 6-27 to Figure 6-29.

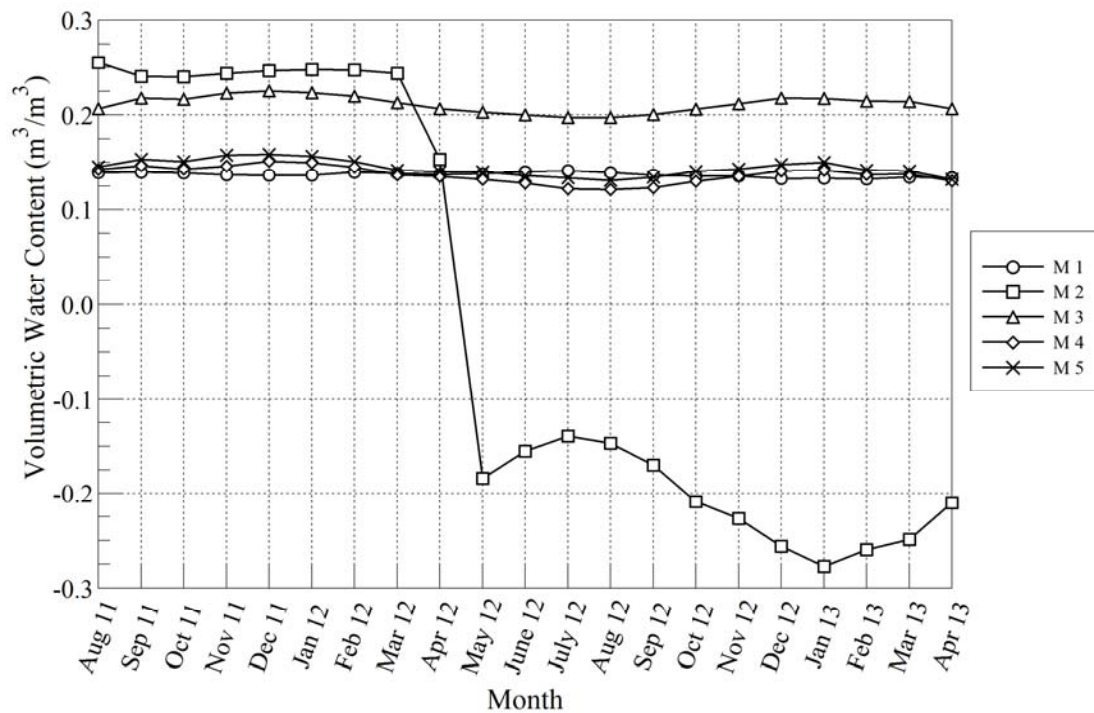
Figure 6-42 Average Moisture Content Data Recorded Over 18 Months

It can be seen from the Table 6-9 and Figure 6-42 that one of the gauges towards the sleeper slab (DMG002) and one gauge towards the abutment (DMG003) show higher moisture levels as compared to others until month of March-12. The gauge towards sleeper slab (DMG002) is showing some negative readings at the end. This gauge has probably failed and needs to be checked at next site visit. However, the moisture readings are very stable indicating an effective drainage system working properly.

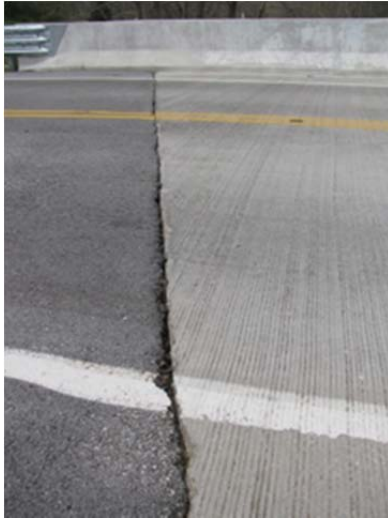
Figure 6-48 Asphalt cracks on MO38 PCPS Slab
