Investigation of Subsidence Along Segment of Missouri Route 65, Springfield, Missouri

Neil L. Anderson and Evgeniy V. Torgashov

**NUTC
R221**

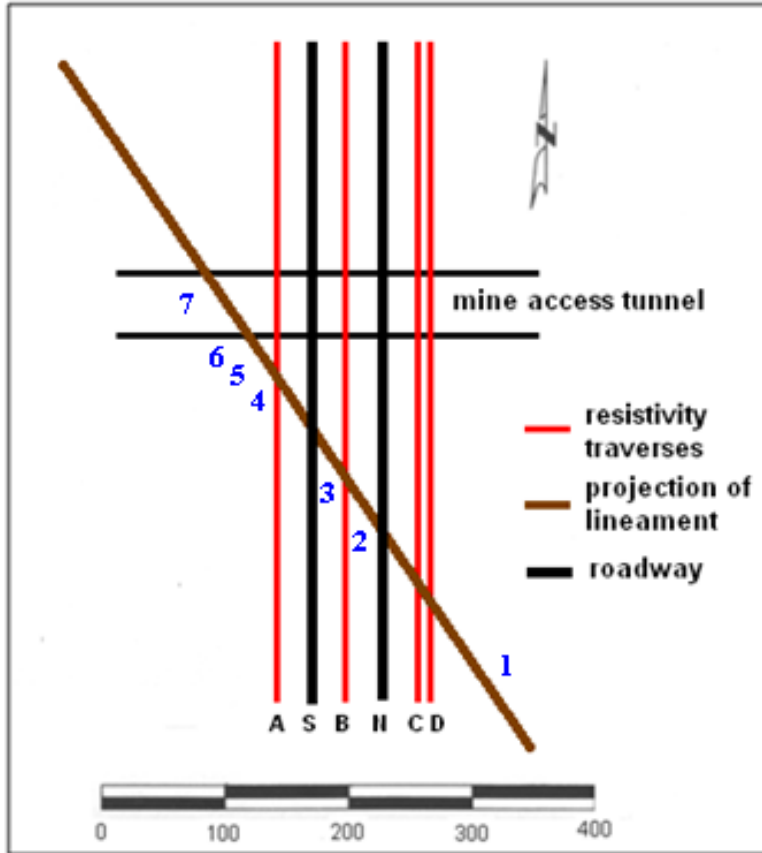
Figure 1: Map of study site showing locations of four north-south surface electrical resistivity tomography profiles (A, B, C and D). The centerlines of the northbound (N) and southbound (S) roadways, the mine access tunnel, the projected lineament and the approximate locations of seven boreholes are shown.
