**An Investigation of Rock Fall
and Pore Water Pressure
Using LIDAR in
Highway 63 Rock Cuts**

Norbert Maerz

**NUTC
R364**

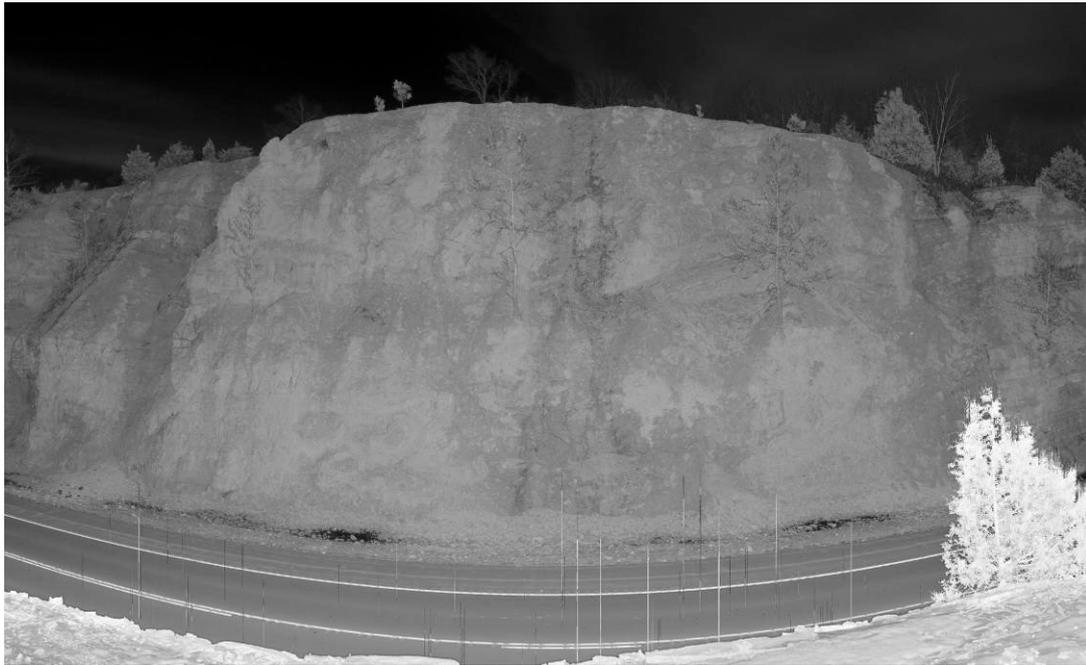
Figure 13 shows the results of a completed scan of the entire cut. Figure 14 shows the results of a completed scan of 2/22/14, right hand side of the cut, cropped to the active face.

Figure 13: Scanning result. Vertical lines show when the scanner intercepted cars speeding done the highway. These are easily edited out.
