**Preservation of Missouri  
Transportation Infrastructures:  
Life-Cycle Inspection and Monitoring  
of FRP-Strengthened Concrete Structures  
using Near-Field Microwave Nondestructive  
Testing Methods**

S. Kharkovsky, V. Stephen,  
A.C. Ryley, J.T. Robbins and R. Zoughi

**UTC  
R97**

**PRESERVATION OF MISSOURI  
TRANSPORTATION INFRASTRUCTURES**  
VALIDATION OF FRP COMPOSITE TECHNOLOGY  
THROUGH FIELD TESTING

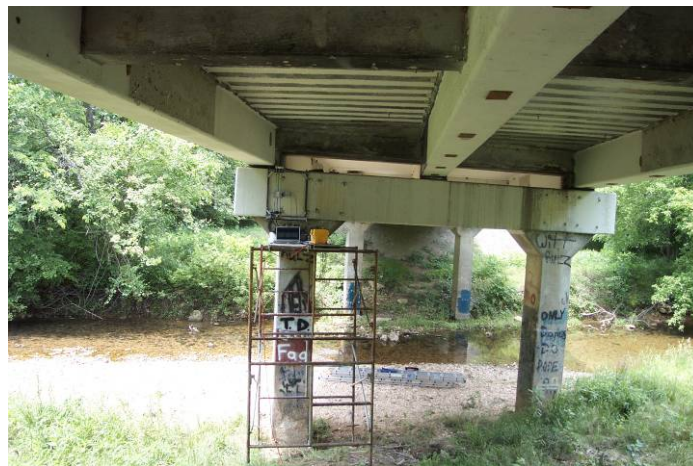
Figure 17 shows the picture of the bent of the bridge with the CFRP patches and the 2D scanning mechanism with the microwave reflectometer testing a CFRP patch.

Figure 17 - A picture of the bent with CFRP patches and 2D scanning mechanism with the microwave reflectometer testing CFRP patch #1.

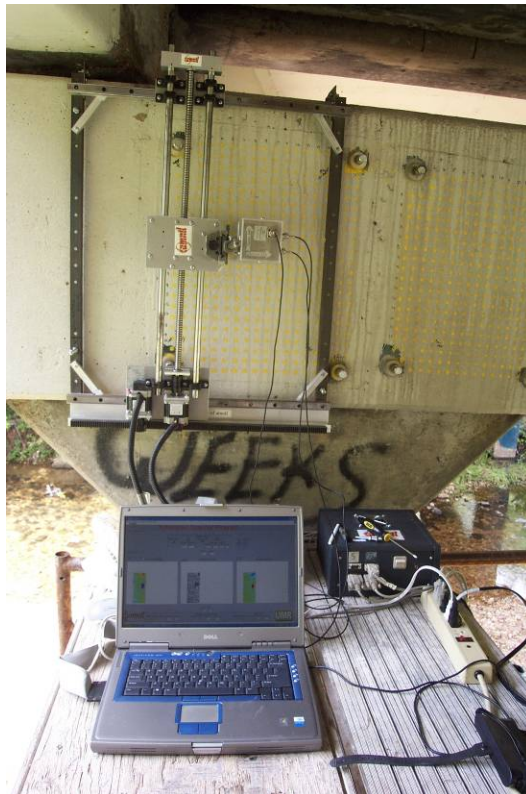
The bent patches were painted with white paint. As mentioned early, the disbonds produced in the bent were thinner than the disbonds produced in the abutment (i.e., not visible and difficult to detect). Close-up view of bent patch #1 while being tested by the dual-polarized reflectometer attached to a computer-controlled scanning platform is shown in Figure 18. Figure 18 also shows the three microwave images of the 270 mm by 330 mm scanned area of the CFRP patch in the laptop display.

Figure 18 - The dual-polarized microwave reflectometer attached to a scanning platform while inspecting a CFRP patch #1 bonded to the bent of a bridge.

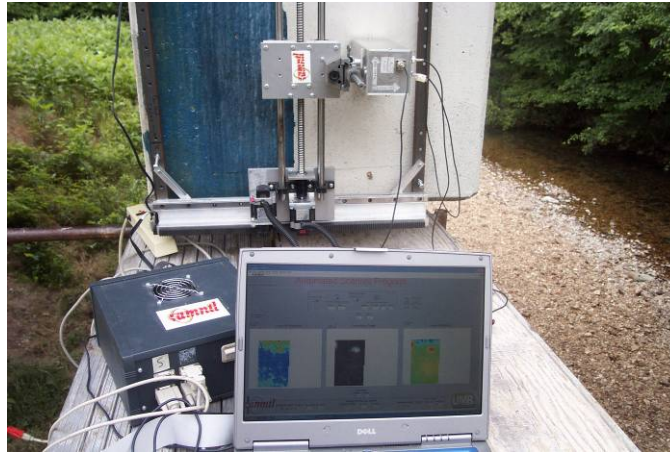
One of the CFRP patches was bonded on the side wall of the bent. Figure 20 shows this patch tested by the reflectometer. Half of the bent patch was painted as can be seen in Figure 20. This was done to visually blend in the presence of the patch into the natural color of concrete. Figure 21 shows the microwave images of the 260 mm by 360 mm scanned area of the bonded CFRP patch on the side wall of the bent. The results show that the image from the bent patch at perpendicular polarization is more non-uniform than the image of the abutment patch (Figure 16a). This is due to the fact that the disbonds produced in the bent were thinner than the disbonds produced in the abutment and the influence of standoff distance variation was also relatively more significant. It must be noted that there is indication of the boundary of paint in all three images. This fact once more confirms the ability of microwave signals to penetrate through low loss materials such as paint. The compensated image (shown in Figure 21c) clearly indicates the disbonds as well as the local non-uniformity associated with them. The locations and sizes of the detected disbonds, indicated by these compensated images, agreed well with their locations and sizes on the bonded CFRP patches and were corroborated by tap testing.

Figure 20 - A picture of the 2D scanning mechanism and the microwave reflectometer testing CFRP patch bonded to the side wall of the bent.
