RI 97-019

SIGNAL MAST ARM FATIGUE FAILURE INVESTIGATION

MISSOURI DEPARTMENT OF TRANSPORTATION RESEARCH, DEVELOPMENT AND TECHNOLOGY

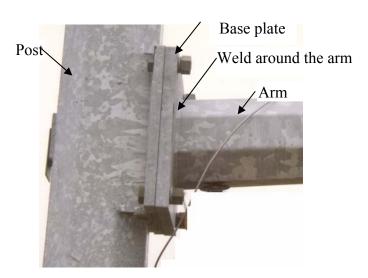
Figure 2.1 Arm-to-post connection

the surface of the base plate. The post and arm are individually pre-fabricated in the factory.
They are assembled together in the field with four bolts as observed in Figure 2.1.

The cracks on all failed mast arms are located at the connection of arm to the base plate. They were observed to initiate on top of the arms and are primarily associated with the bending effect of the mast arms in the vertical plane.

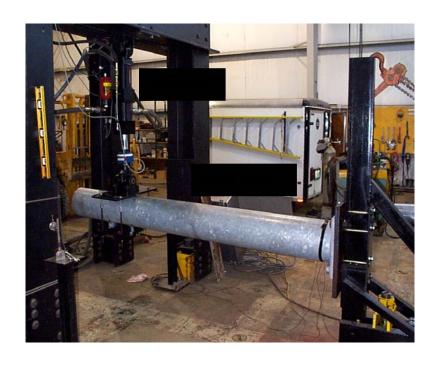
Figure 2.10 Test Set-Up for Fatigue Tests Valmont Mast Arm CB 12917

Mast Arm	Manufacturer	Weld Type	Failure Cycles	Comments
254682	Valmont	Old	1.8 million	None
BB 34970	Valmont	New	2.1 million	None
CB 12917	Valmont	New	0.4 million	Possible lack of fusion of weld
88791	Union Metals	Old	0.5 million	Flaw detected by Mag Particle prior to loading
9539 CL54	JEM	Old	0.0 million	Flaw detected by inspection prior to loading

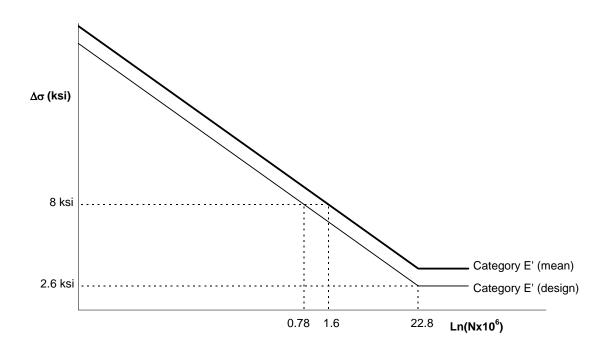
Figure 2.11 Fatigue Resistance of Category E' Detail

The actuator applied a sinusoidal cyclic loading to create a measured stress range of 8 ksi to simulate constant fatigue loading cycles. Therefore, the maximum actuator load created a maximum stress of 18 ksi and the minimum load caused a minimum stress of 10 ksi. The 8 ksi stress range was chosen by using the design curve for a Category E' connection detail, shown in Figure 2.11. From the mean curve, it was determined that an 8 ksi stress range should cause a detectable crack at 1.6 million cycles. This number of cycles was a practical number to use at a significant stress range to examine the fatigue resistance and fatigue cracking. It would not

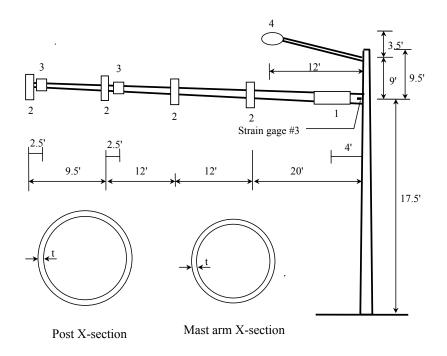
Figure 4.1 Traffic signal support structure at Stadium & Forum

The aim of this task is to set up an appropriate truck-induced gust model and calibrate it with the field test records (Alderson, 1999). A series of field tests have been conducted on two traffic signal support structures in Columbia, MO. One structure is located at Stadium (Rt. 740) & Forum Blvd, manufactured by Valmont Industries. Its elevation is schematically shown in Figure 5.1. Both the mast arm and post have circular cross sections of size $12.5"\times4.65"\times54'\times7GA(0.1793")$ and $14.5"\times11.4"\times27'\times0.2188"$, respectively. The luminaire arm is $4.17"\times2.38"\times11GA$. The specific geometry and weight of various components of the signal and sign supporting structure are summarized in Table 4.1.

As mentioned in the preceding section, only one record shows a significant gust effect. It represents the longitudinal strain on the front face of the arm-to-post connection at gage #3 as indicated in Figures 4.1 and 4.3(a). The strain response was converted to stress, which is plotted in Figure 4.4. Since the peak response occurs at approximately 80 s, the wind load from 60 s to 100 s is focused on below.

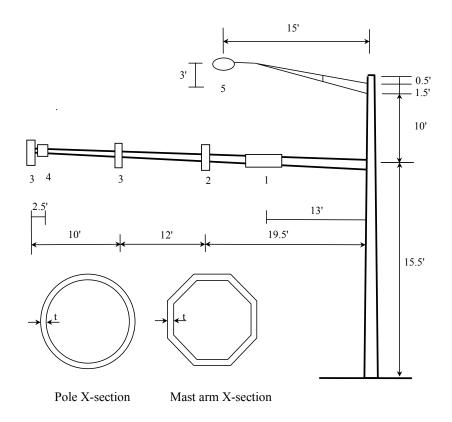
Figure 4.2 Traffic signal support structure at Providence & Green Meadows

The other structure is located at Providence (Rt. 163) & Green Meadows Rd, which was manufactured by JEM Engineering. Its elevation is shown in Figure 5.2. The mast arm is octagonal and the post is circular. They are respectively $10.5"\times3.5"\times42'\times7GA(0.1793")$ and $14.25"\times11.5"\times27.5'\times0.2188"$. The luminaire arm was built with a 2" schedule 40 pipe. The geometry and weight of the supporting structure is given in Table 4.2.

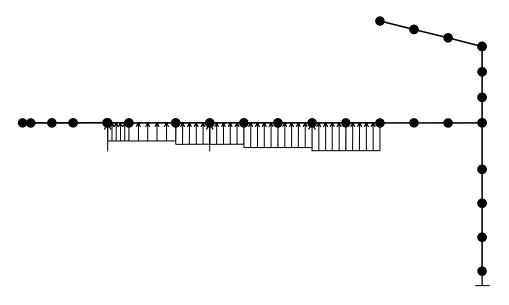
Figure 4.5 Structural model for SAP 2000 Nonlinear Analysis

The signal support structure at Stadium & Forum Blvd. was modeled and analyzed using the SAP2000 Nonlinear software. Figure 4.5 presents the finite element model of the structure. Under normal operational conditions, the support structure is subjected to both truck and natural wind-induced loading. The natural wind gust is assumed to distribute uniformly along the entire length of the arm. The truck-induced gust, however, depends on the traffic lane arrangement of the highway. For simplicity, the truck gust pressure is assumed to act uniformly on the middle portion of the arm, 12' to 44' away from the base, both in horizontal and vertical directions. The gust pressure distribution is shown in Figure 4.5. The horizontal effective projected area is assumed to be 2 ft² for each signal.

The natural frequencies and vibration modes of the structural model were calculated. The fundamental period of 1.34 sec corresponds to the out-of-plane motion associated with the torsional effect of the post while the 2nd mode of period 1.28 sec represents the in-plane motion due to bending in the arm and post of the signal support structure. The fundamental period agrees well with the time elapsed in each cycle of the measured response as indicated in Figure 4.4.

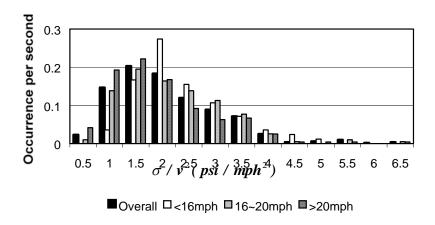
Figure 4.14 Response statistics based on different data sets (Stadium & Forum)

To see whether the load spectrum shown in Figures 4.12 and 4.13 is representative for all wind gusts regardless of wind speed, the test data were grouped into three subsets according to their wind speeds. For the structure at Stadium & Forum Blvd., the wind speed of each subset ranges up to 13 mph, 13 to 16 mph, and greater than 16 mph. For the structure at Providence & Green Meadows Rd., it ranges up to 16 mph, 16 to 20 mph, and greater than 20 mph, respectively. The load spectrum for each subset can be determined in the same fashion. All three spectra, together with the overall spectrum, are compared in Figure 4.14 for the Stadium & Forum structure and Figure 4.15 for the Providence & Green Meadows structure. As one can see, they are very similar in terms of stress distribution, though small difference in detail exists at several points. Therefore, the response distribution in Figures 4.12 and 4.13 can be used for other wind speed ranges.

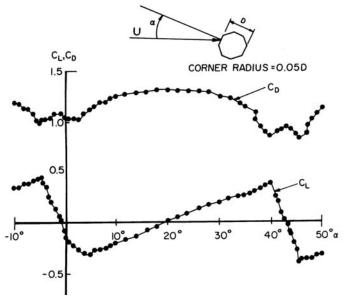
Figure 4.16 Force coefficients on an octagonal cylinder ($Re=1.2\times10^6$)

Galloping occurs when the total damping d<0. To approximately evaluate the possibility of galloping, the lift and drag coefficients for an octagonal section from Simiu and Scanlan (1996) were used. They are reproduced in Figure 4.16. According to this figure, a slender octagonal mast arm could be susceptible to galloping in certain attack angle ranges $(-5^{\circ} < \alpha < 5^{\circ})$ because

When $\xi=4\%$ as used in Section 4.1.2, $U_g=48$ mph. This result indicates that the signal support structure could be vulnerable to galloping under wind gusts of 48 mph or higher.

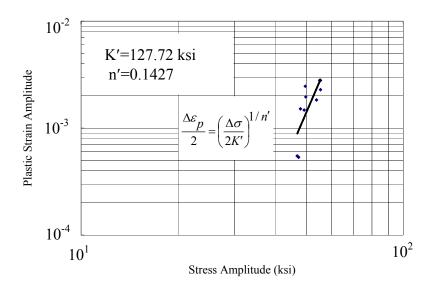
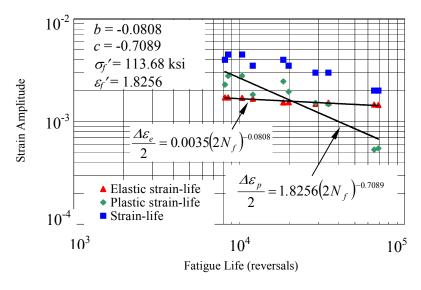
Figure 5.5 Parameters in the crack initiation prediction model

To determine the parameters in the above equations, ten flat-sheet specimens were made from the failed mast arm and tested on MTS810 machine according to the ASTM standard E606-92. The test results are presented in Figure 5.5. The parameters in Equation 5.1 and 5.2 are identified by curve fitting the plastic strain-stress and the strain-life model with the experimental data and they are listed in Table 5.1. The corresponding parameters of A-595A steel determined

using the monotonic stress-strain relation and other associated material properties are also listed in Table 5.1. The general agreement between the two sets of data gives assurance.

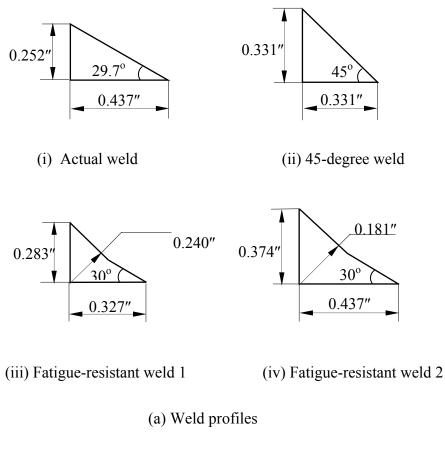
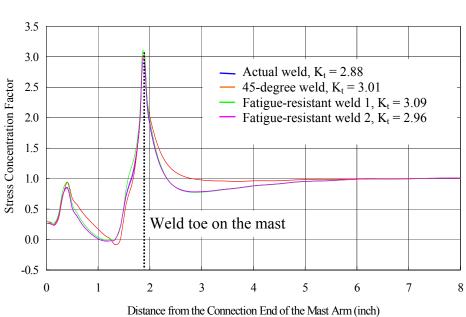
Figure 5.6 Stress concentration factors for various weld profiles

The Missouri Department of Transportation has recently introduced a so-called fatigue resistant weld profile with varying slopes. For this weld profile, the weld length on the mast arm is 1.83T, and that on the base plate is 1.57T, where T is the weld throat, i.e. the shortest distance between the root of the joint and the face of the weld. The maximum slope of the fatigue resistant weld is 30 degree. To understand the effects of weld profile on the stress concentration, four profiles for the octagonal mast arm are selected as shown in Figure 5.6(a). Profile (i) is the typical weld used in the current structure. Profile (ii) is a comparative weld, which possesses the same area as that of (i), but its slope on the mast arm is 45 degree. Profile (iii) is a fatigueresistant weld with the weld throat equal to the thickness of the mast arm tube (0.1793 in). Profile (iv) is another fatigue-resistant weld. Its length on the mast arm is equal to that of Profile (i). Their effects on the stress concentration are presented in Figure 5.6(b). It can be observed that the actual weld yields the smallest concentration of stress with a factor of 2.88 at the weld toe even though its weld leg on the base plate is the shortest. This is mainly because the actual weld has the longest weld leg and the smallest slope on the mast arm wall. The stress concentration factor for the 45-degree weld is 3.01, although it has the same weld area as (i). The fatigue-resistant weld 1 has the largest stress concentration factor of 3.09, because its length on the mast arm is the shortest. Increasing the length of the fatigue-resistant weld to that of the actual weld, the stress concentration factor will be decreased to 2.96. Therefore, it is concluded that the stress concentration not only depends upon the slope of a weld profile but also depends on the weld length along the mast arm wall. The fatigue-resistant design could lessen the stress concentration if used to lengthen the weld leg on the arm wall.

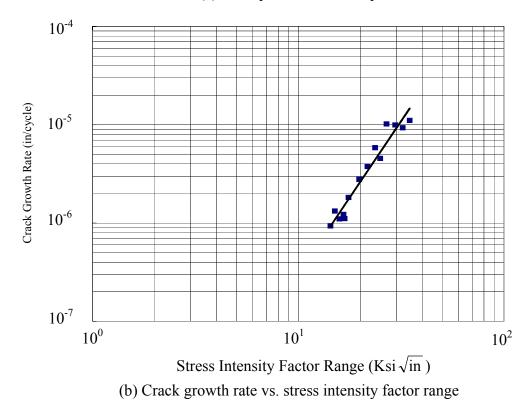
Figure 5.7 Determination of constants in the crack growth rate model

in which a is the crack length, N is the number of stress cycle applied to the structure, and C and m are two material constants. To determine these two constants, several compact tension specimens were made from the failed octagonal mast arm and tested in the MTS810 system according to ASTM standard E 647 - 95a. The test specimen and setup is shown in Figure 5.7(a). The material constants can be estimated as $C = 2.36 \times 10^{-10}$ in the units of a as inch and K as $k \sin \sqrt{in}$ and m = 3.11 from the test data shown in Figure 5.7(b).

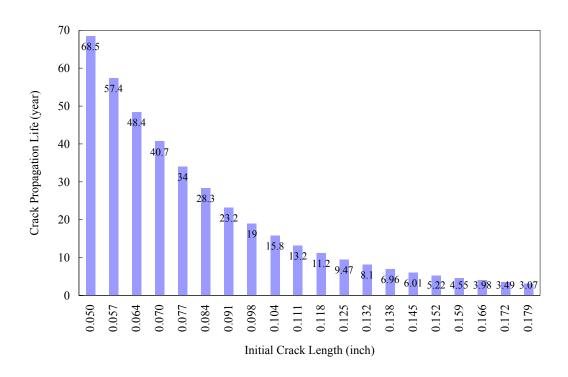
Figure 5.9 Crack propagation life for the mast arm at Providence & Green Meadows

For each increment of crack length, compute ΔK_i for different stress level, and then use Equation 5.5 to get ΔK_{rms} . Use $\frac{\Delta a}{\Delta N} = C(\Delta K_{rms})^m$ to get ΔN_i . The total crack propagation life in cycles was obtained by summing ΔN_i . Figure 5.9 and 5.10 show the crack propagation life for different initial crack length.

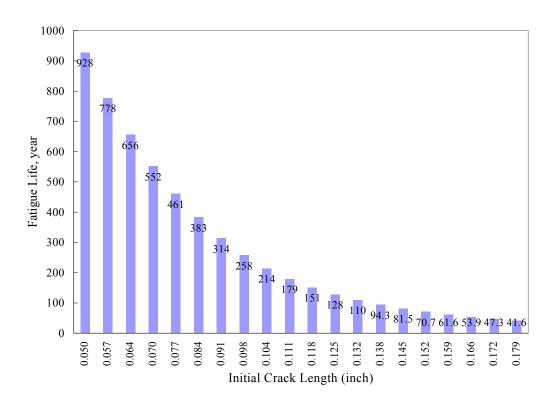
Figure 5.11 Remaining fatigue life for the mast arm at Providence & Green

For welded structures, the above-mentioned flaws (such as inclusions, discontinuity, lack of penetration and undercut) are likely to be present; it is reasonable to assume that the entire fatigue life of the structure to consist of crack propagation phase. By comparing the predicted life with that determined experimentally in Section 2.3, a modified stress concentration factor is calculated for each cross section (octagonal and circular) of the mast arm. These modified stress concentration factors are 1.25 for octagonal section and 2.03 for circular section. Here, the analytical model predictions and the experimental test fatigue life data correspond to constant amplitude loading case. Using these stress concentration factors that are calibrated using constant amplitude fatigue data, the crack propagation life (remaining life) of the mast arm subjected to natural wind gusts (variable amplitude loading) is calculated. The remaining life predictions for the mast arm at Providence & Green Meadows and at Stadium & Forum are given in Figures 5.11-5.14.

- 3. Due to the initial weld defects or discontinuities or lack-of-penetration, the remaining fatigue life can be considered equal to the crack propagation life. With the stress concentration factor correlated with the fatigue tests in Section 2.3, the remaining fatigue life for the mast arm was predicted. The Stadium & Forum mast arm is likely vulnerable to the development of any finite size crack because the stress level is relatively high (the mast arm is longer) while the Providence & Green Meadows mast arm is not unless a visible crack is developed. The magnitude of the modified stress concentration factor due to the quality of weldment also affects the remaining fatigue life.
