Quality Control And In-Service Inspection Technology for Hybrid-Composite Girder Bridges

**NUTC
R282**

1. Report No. NUTC R282		2. Government Accession No.		3. Recipient's Catalog No.	
4. Title and Subtitle Quality Control And In-Service Inspection Technology for Hybrid-Composite Girder Bridges				5. Report Date August 2014

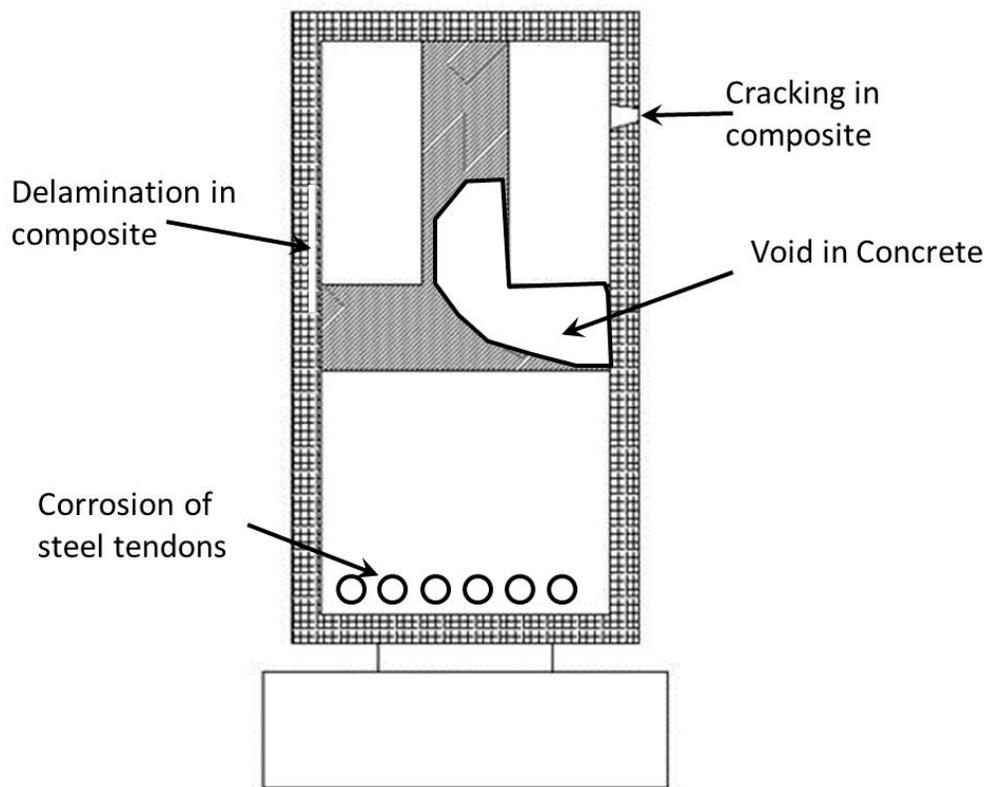
Figure 1: Example of potential damage modes for HCB.

43 Figure 1 shows a schematic diagram of a HCB member to illustrate the
44 anticipated damage modes. These include cracking of the composite shell surrounding
45 the core, delamination in the composite shell, voids in the concrete, and corrosion
46 damage in the prestressing strands that form the tie of the internal arch in the HCB
47 members. Each of these damage modes is discussed in this section.

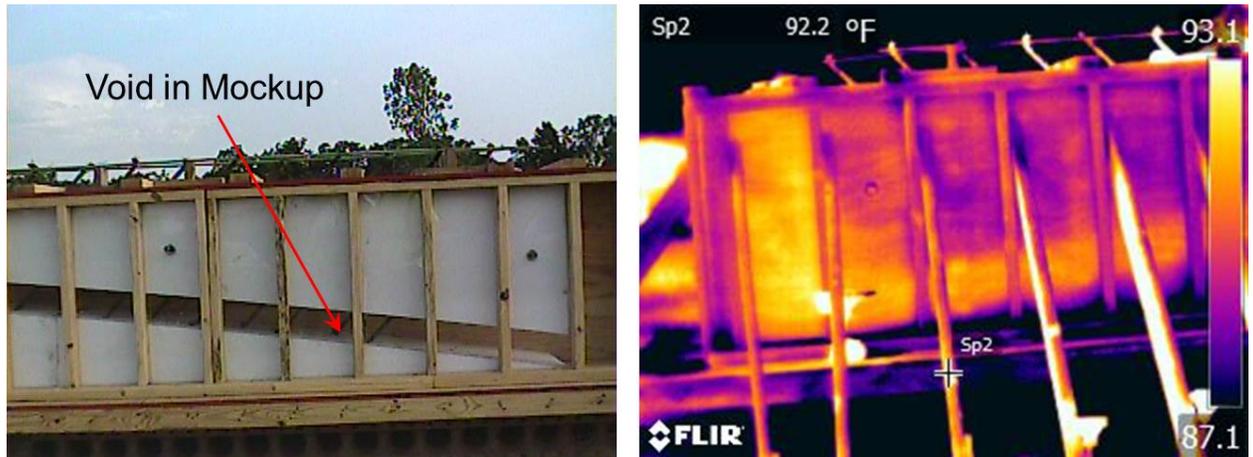
620 The mock-up of the HCB was tested using the S65 thermal camera as a proof of
 621 concept test to establish if the proposed methodology for assessing the integrity of the
 622 concrete arch was implementable. The forms for the mockup specimen consisted of
 623 plexiglass and plywood, as discussed previously. It was found during the testing that
 624 the thermal signature of the arch could not be imaged well through the Plexiglas wall of
 625 the form. These materials are often opaque in the IR range, so this result was not
 626 unexpected. Thermal images of the plywood wall of the form clearly showed the
 627 thermal signature of the concrete following placement. Figure 13 illustrates a thermal
 628 image of the concrete arch, along with a photograph of the mockup. Note that the
 629 photograph of the mockup is taken from the side with a plexiglass wall, and shows the
 630 void prior to concrete placement. The thermal image is taken from the opposite side of

635 **Figure 13. Photograph (left) and thermal image (right) of the mockup specimen showing concrete arch.**

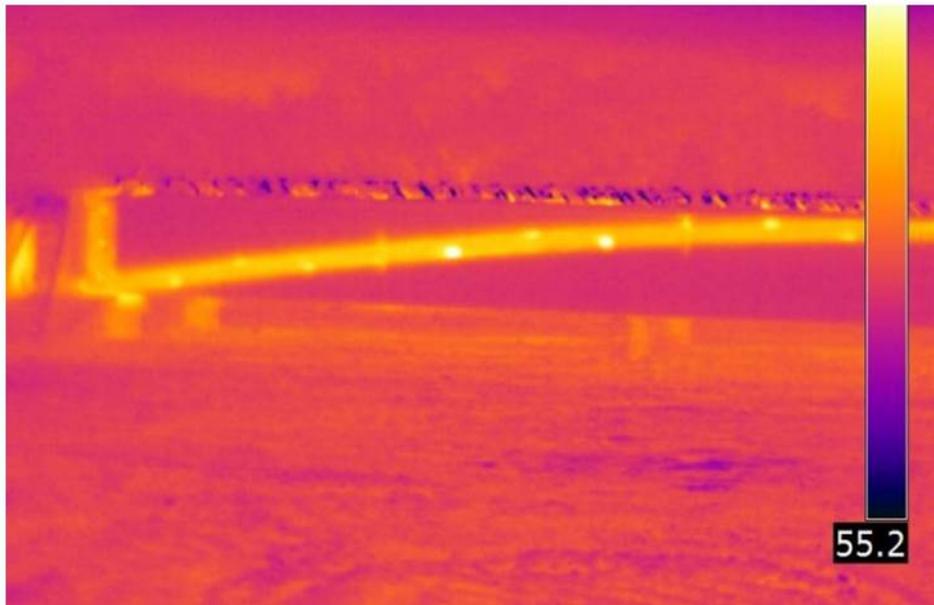
642 The application of the infrared thermography for QC testing of the HCB was
643 demonstrated through the project. The procedure for acquiring IR data was to utilize a
644 hand-held infrared camera to acquire data from a standing position adjacent to the
645 HCB. A typical IR image is shown in Figure 14. This figure, which was acquired 24
646 hours after the concrete pour, illustrates how the process works. As shown in the
647 image, the heat of hydration of the concrete in the arch results in a thermal signature on
648 the surface of the composite that images the internal arch. This thermal signature is
649 revealed through the foam inserts and the composite wrapping that surrounds the arch.

651
 652 **Figure 14. Example thermal image showing thermal signature of the arch during the hydration of concrete.**

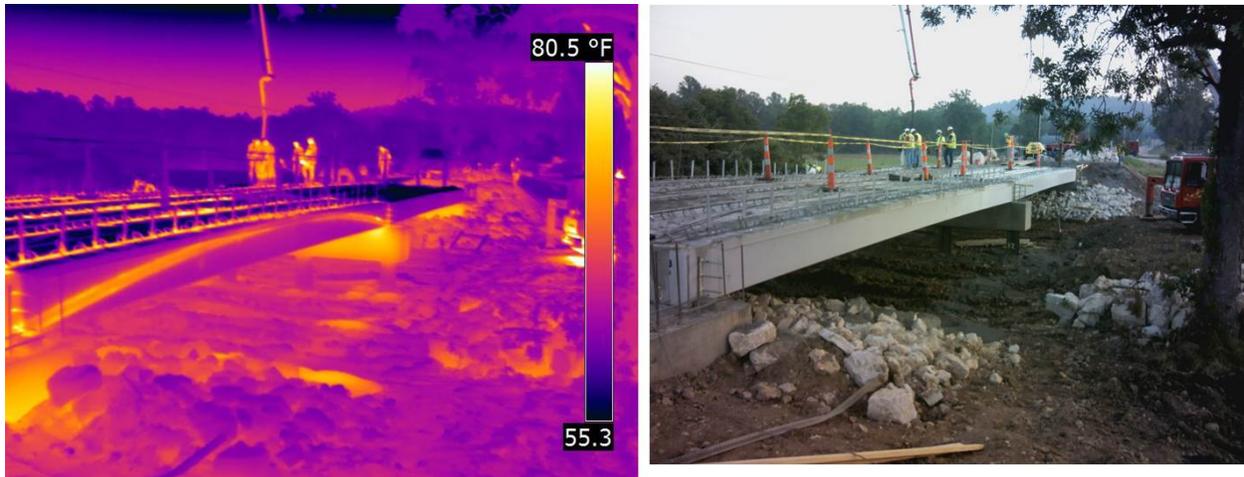
653 Testing was completed during the fabrication of each of the three HCB bridges;
 654 testing was completed at the fabrication yard for two of the bridges, and for the third
 655 bridge testing was completed during the erection process as shown in Figure 15. In this
 656 figure, a span cast the previous day is imaged using the IR camera. Workers on the
 657 bridge shown in the photograph (Figure 15, right) are placing concrete on the next span.

666
 667 **Figure 15. Example of IR image (left) and photograph of HCB (right) being placed in the field.**

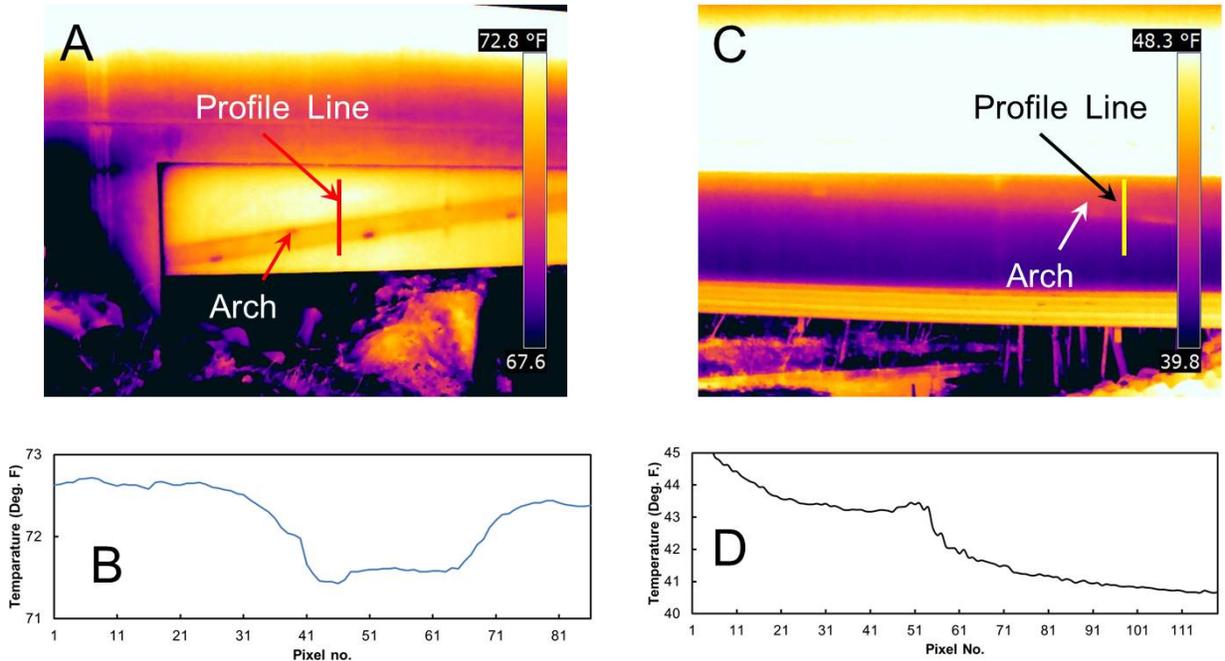
788 Thermal images of the HCBs were captured after the bridges were placed in-
789 service, to assess if IR thermography could effectively image the arch after the
790 hydration of the concrete was complete. The arch of Bridge B0439 was placed in
791 August 2011. Thermal images were captured at the time of the casting, as well as in
792 March 2012 (seven months after casting) and in April 2013. The results of these tests
793 indicated that the concrete arch could be imaged after the hydration of the concrete was
794 complete, due to the thermal inertial differences between the concrete arch and the
795 surrounding foam and composite materials. Figure 22 illustrates the behavior of the
796 concrete arch during the morning and evening hours. Figure 22 A shows a thermal
797 image of the HCB at 6 pm in the evening, at which time the concrete arch appears
798 cooler than the other portions of the HCB shell. The temperature gradient along the line

799 shown in Figure 22A is shown in Figure 22B. The data in Figure 22B illustrate the
800 actual temperature variation between the composite shell and the arch signature.
801 Figure 22C shows an elevation of the HCB at 5 am in the morning. In this image, there
802 is a significant gradient through the depth of the member, as illustrated in the gradient
803 along the line shown in Figure 22D. This gradient results from the significant thermal
804 energy stored in the concrete deck and parapets of the structure. Because these
805 concrete elements store the thermal energy from the previous day, conduction of this
806 thermal energy into the HCB results in the gradient shown. The gradient results in the
807 arch signature being difficult to observe in the image, relative to the image captured at 6
808 pm.

809
 810 **Figure 22. Thermal images of B0439 20 months after concrete placement showing HCB at (A) 6 pm with**
 811 **thermal profile (B), and (C) 5 am with thermal profile (D).**

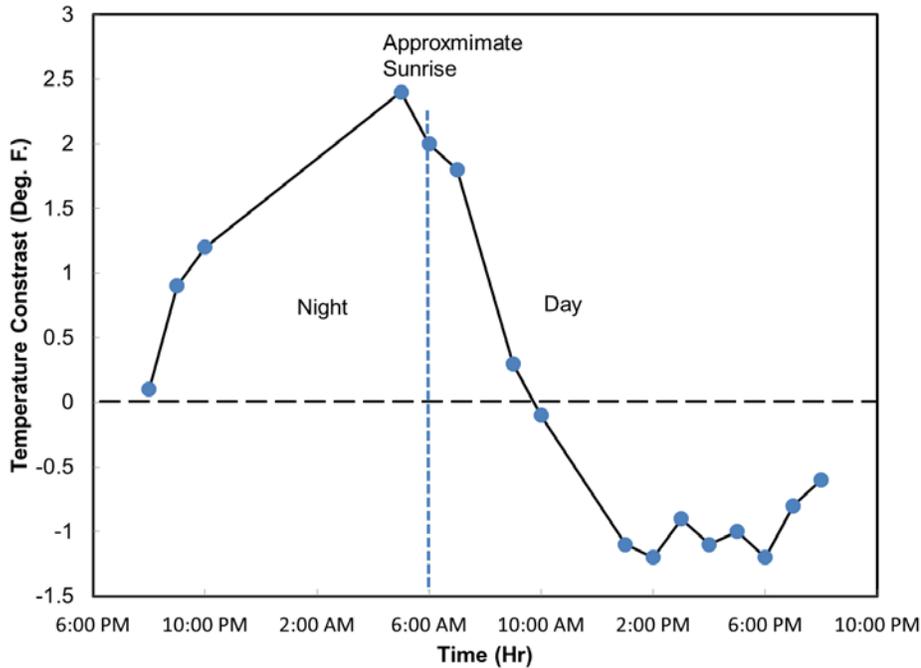
812 The thermal contrast between the concrete arch signature and the composite
 813 shell was monitored over a 24 hour period to determine the optimum times to conduct
 814 an inspection for an in-service bridge. As shown in Figure 23, the greatest thermal
 815 contrast between the concrete arch and the composite shell occurs in the early morning
 816 hours, prior to sunrise. However, as noted above, the thermal images may be more
 817 difficult to interpret at this time due to the thermal gradient along the elevation of the
 818 member. It should also be noted that the behavior of the concrete arch is opposite of,
 819 for example, a delamination in the composite shell would be. A delamination in the
 820 concrete shell would be cold in the overnight hours, when that arch signature is warmer
 821 than the surrounding area. During the day, a delamination would appear warmer than
 822 the surrounding area. As a result, such a defect could be easily discerned from the arch

823 signature. There were no composite delamination defects observed over the course of
 824 the project.

Figure 23. Thermal contrasts over a 24 hour period for B0439, 20 months after placement of concrete arch.
